**FINAL REPORT: GORDON LAKE
GROUP REMEDIAL ACTION
PLAN**

Prepared for:
Public Works and Government
Services Canada and Aboriginal
Affairs and Northern
Development Canada

Prepared by:
Stantec Consulting Ltd.

March 31, 2016

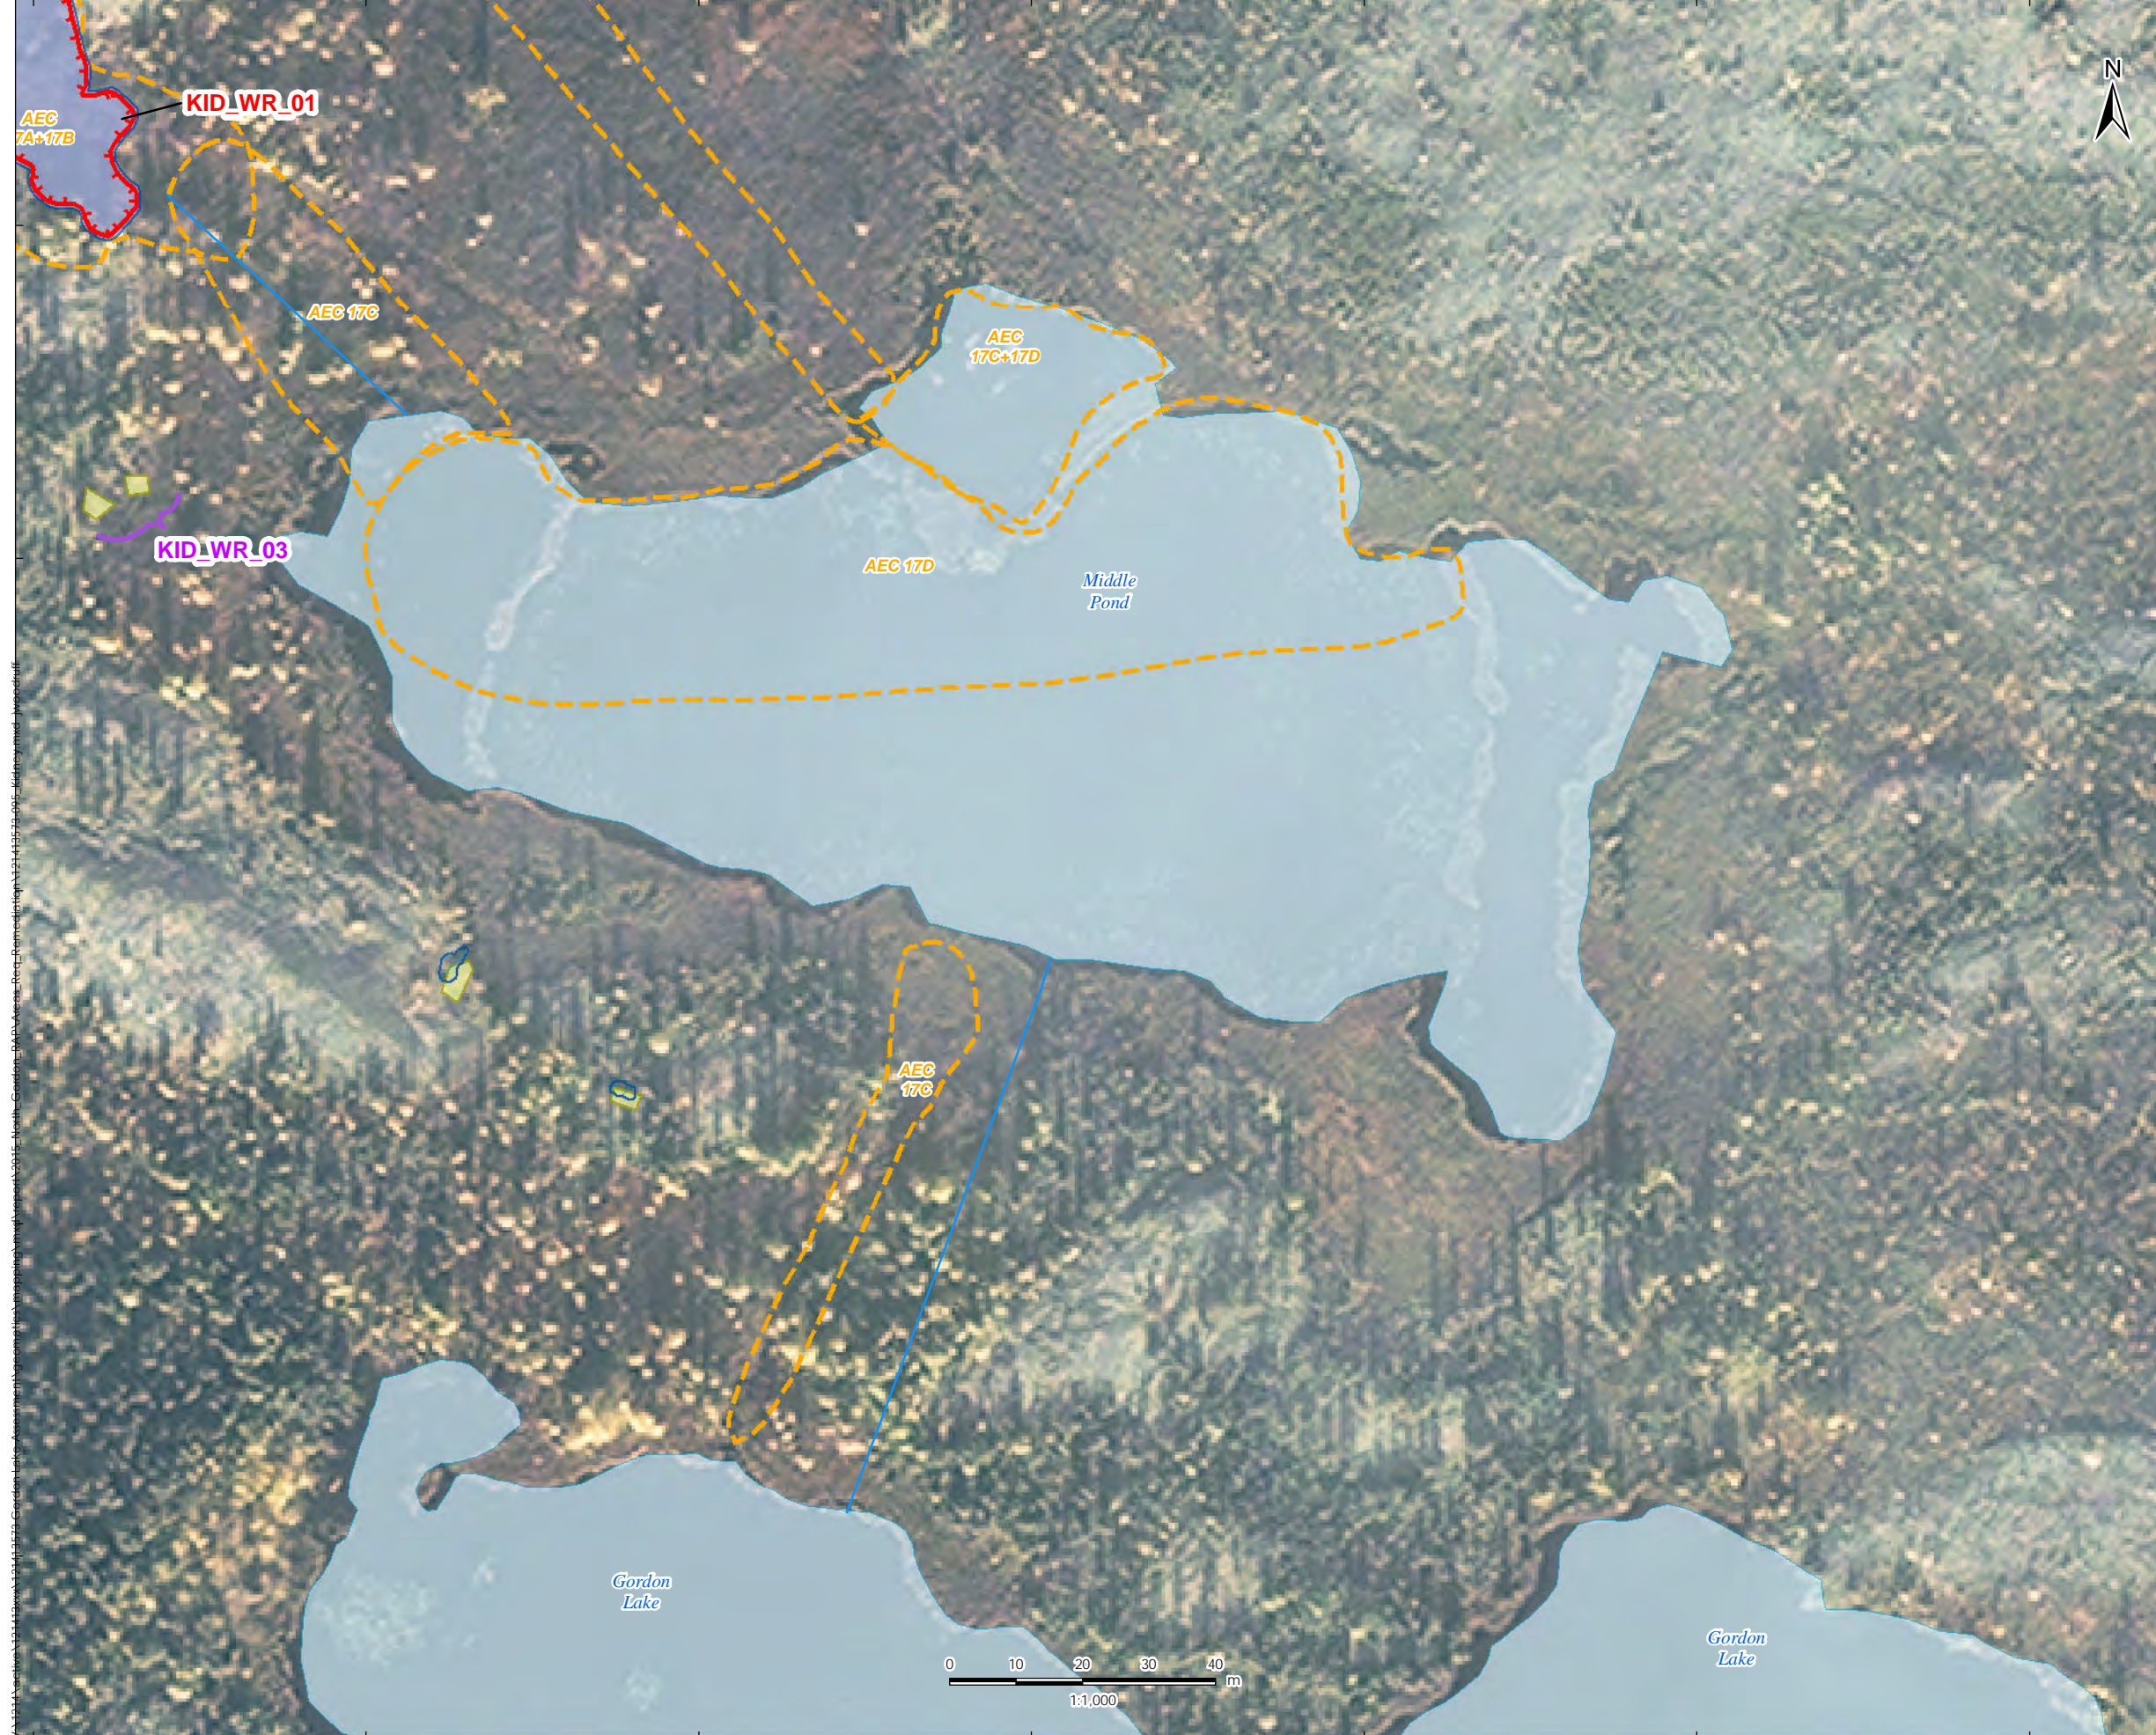
Title
**Kidney Pond - Exploration Camp
Summary of Hazard Components**

- Impacting Material Requiring Remediation
- Moderate Risk Impacting Material
- Overland Drainage
- Wet Area
- Trench/Shaft
- Waste Rock/Ore
- Areas of Environmental Concern (AEC)
- Watercourse
- Water body
- Map Extent

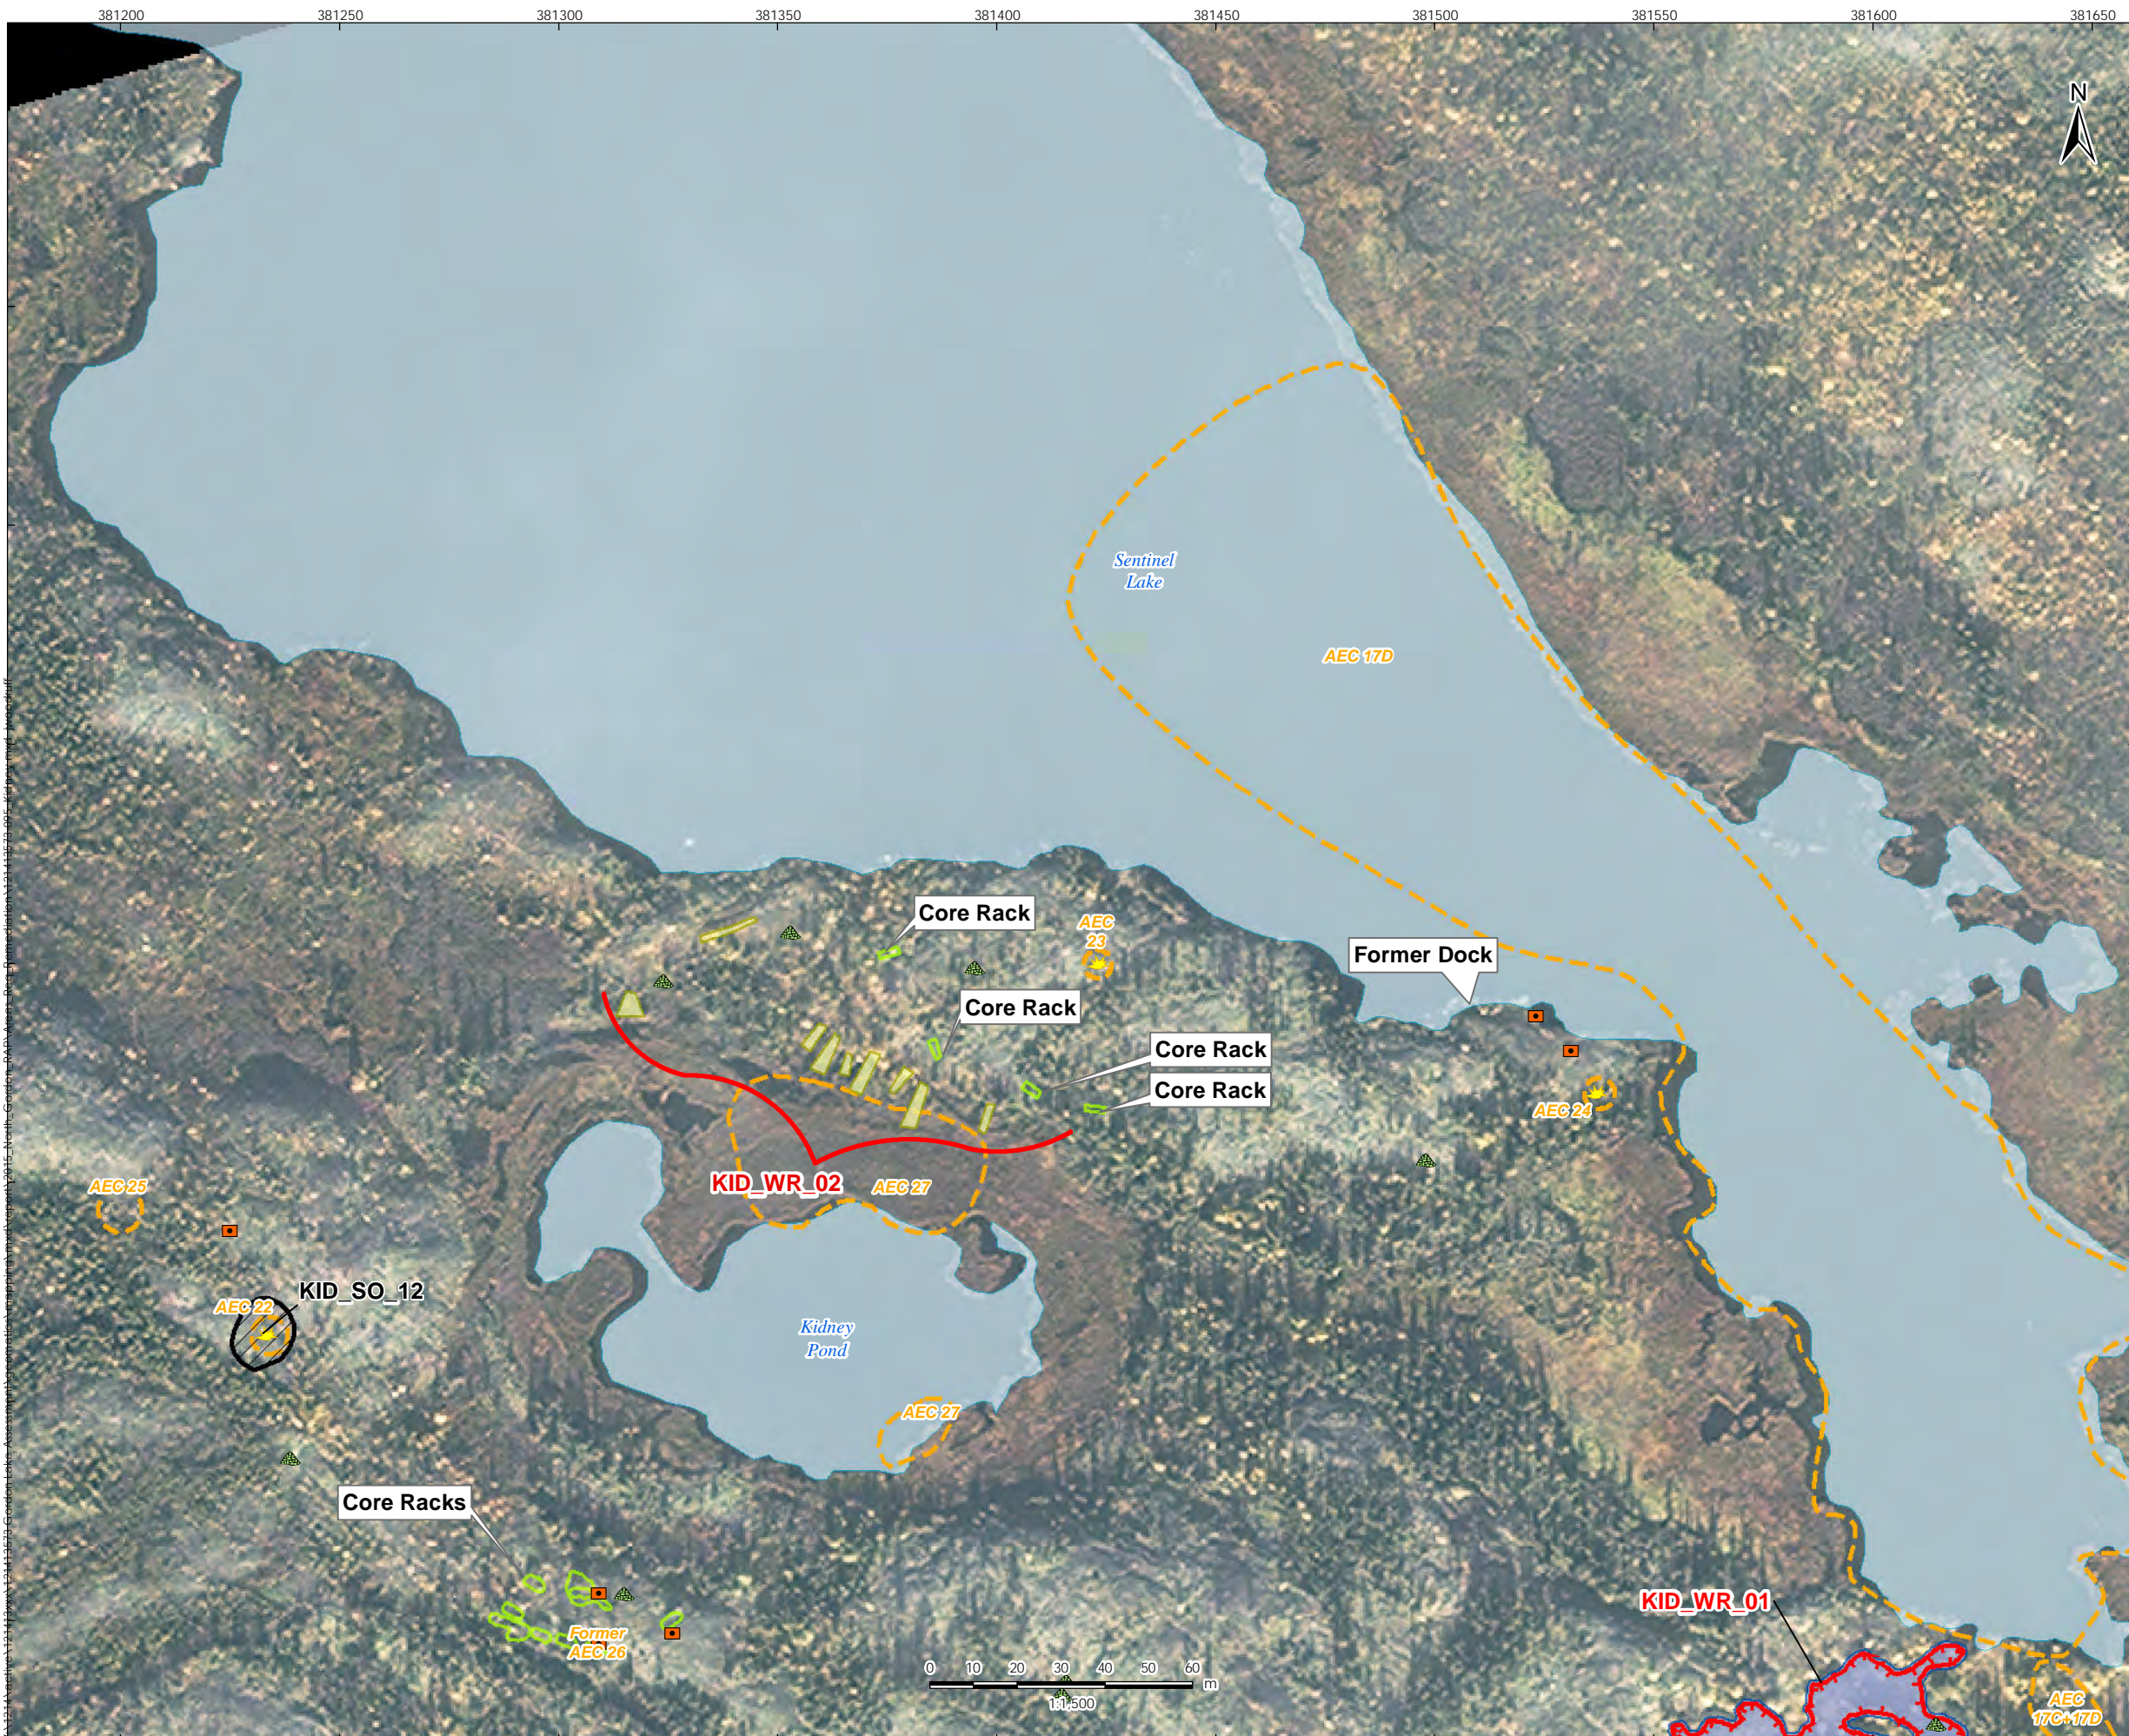
Title
Kidney Pond - Portal Area
Summary of Hazard Components

Impact Type	Features Observed
Metals	Burn Pit
Impacting Material Requiring Remediation	Debris
High Risk Impacting Material	Structure Remains
	Other (as labeled)
	Trench/Shaft
	Waste Rock/Ore
	Areas of Environmental Concern (AEC)
	Watercourse
	Water body
	Map Extent

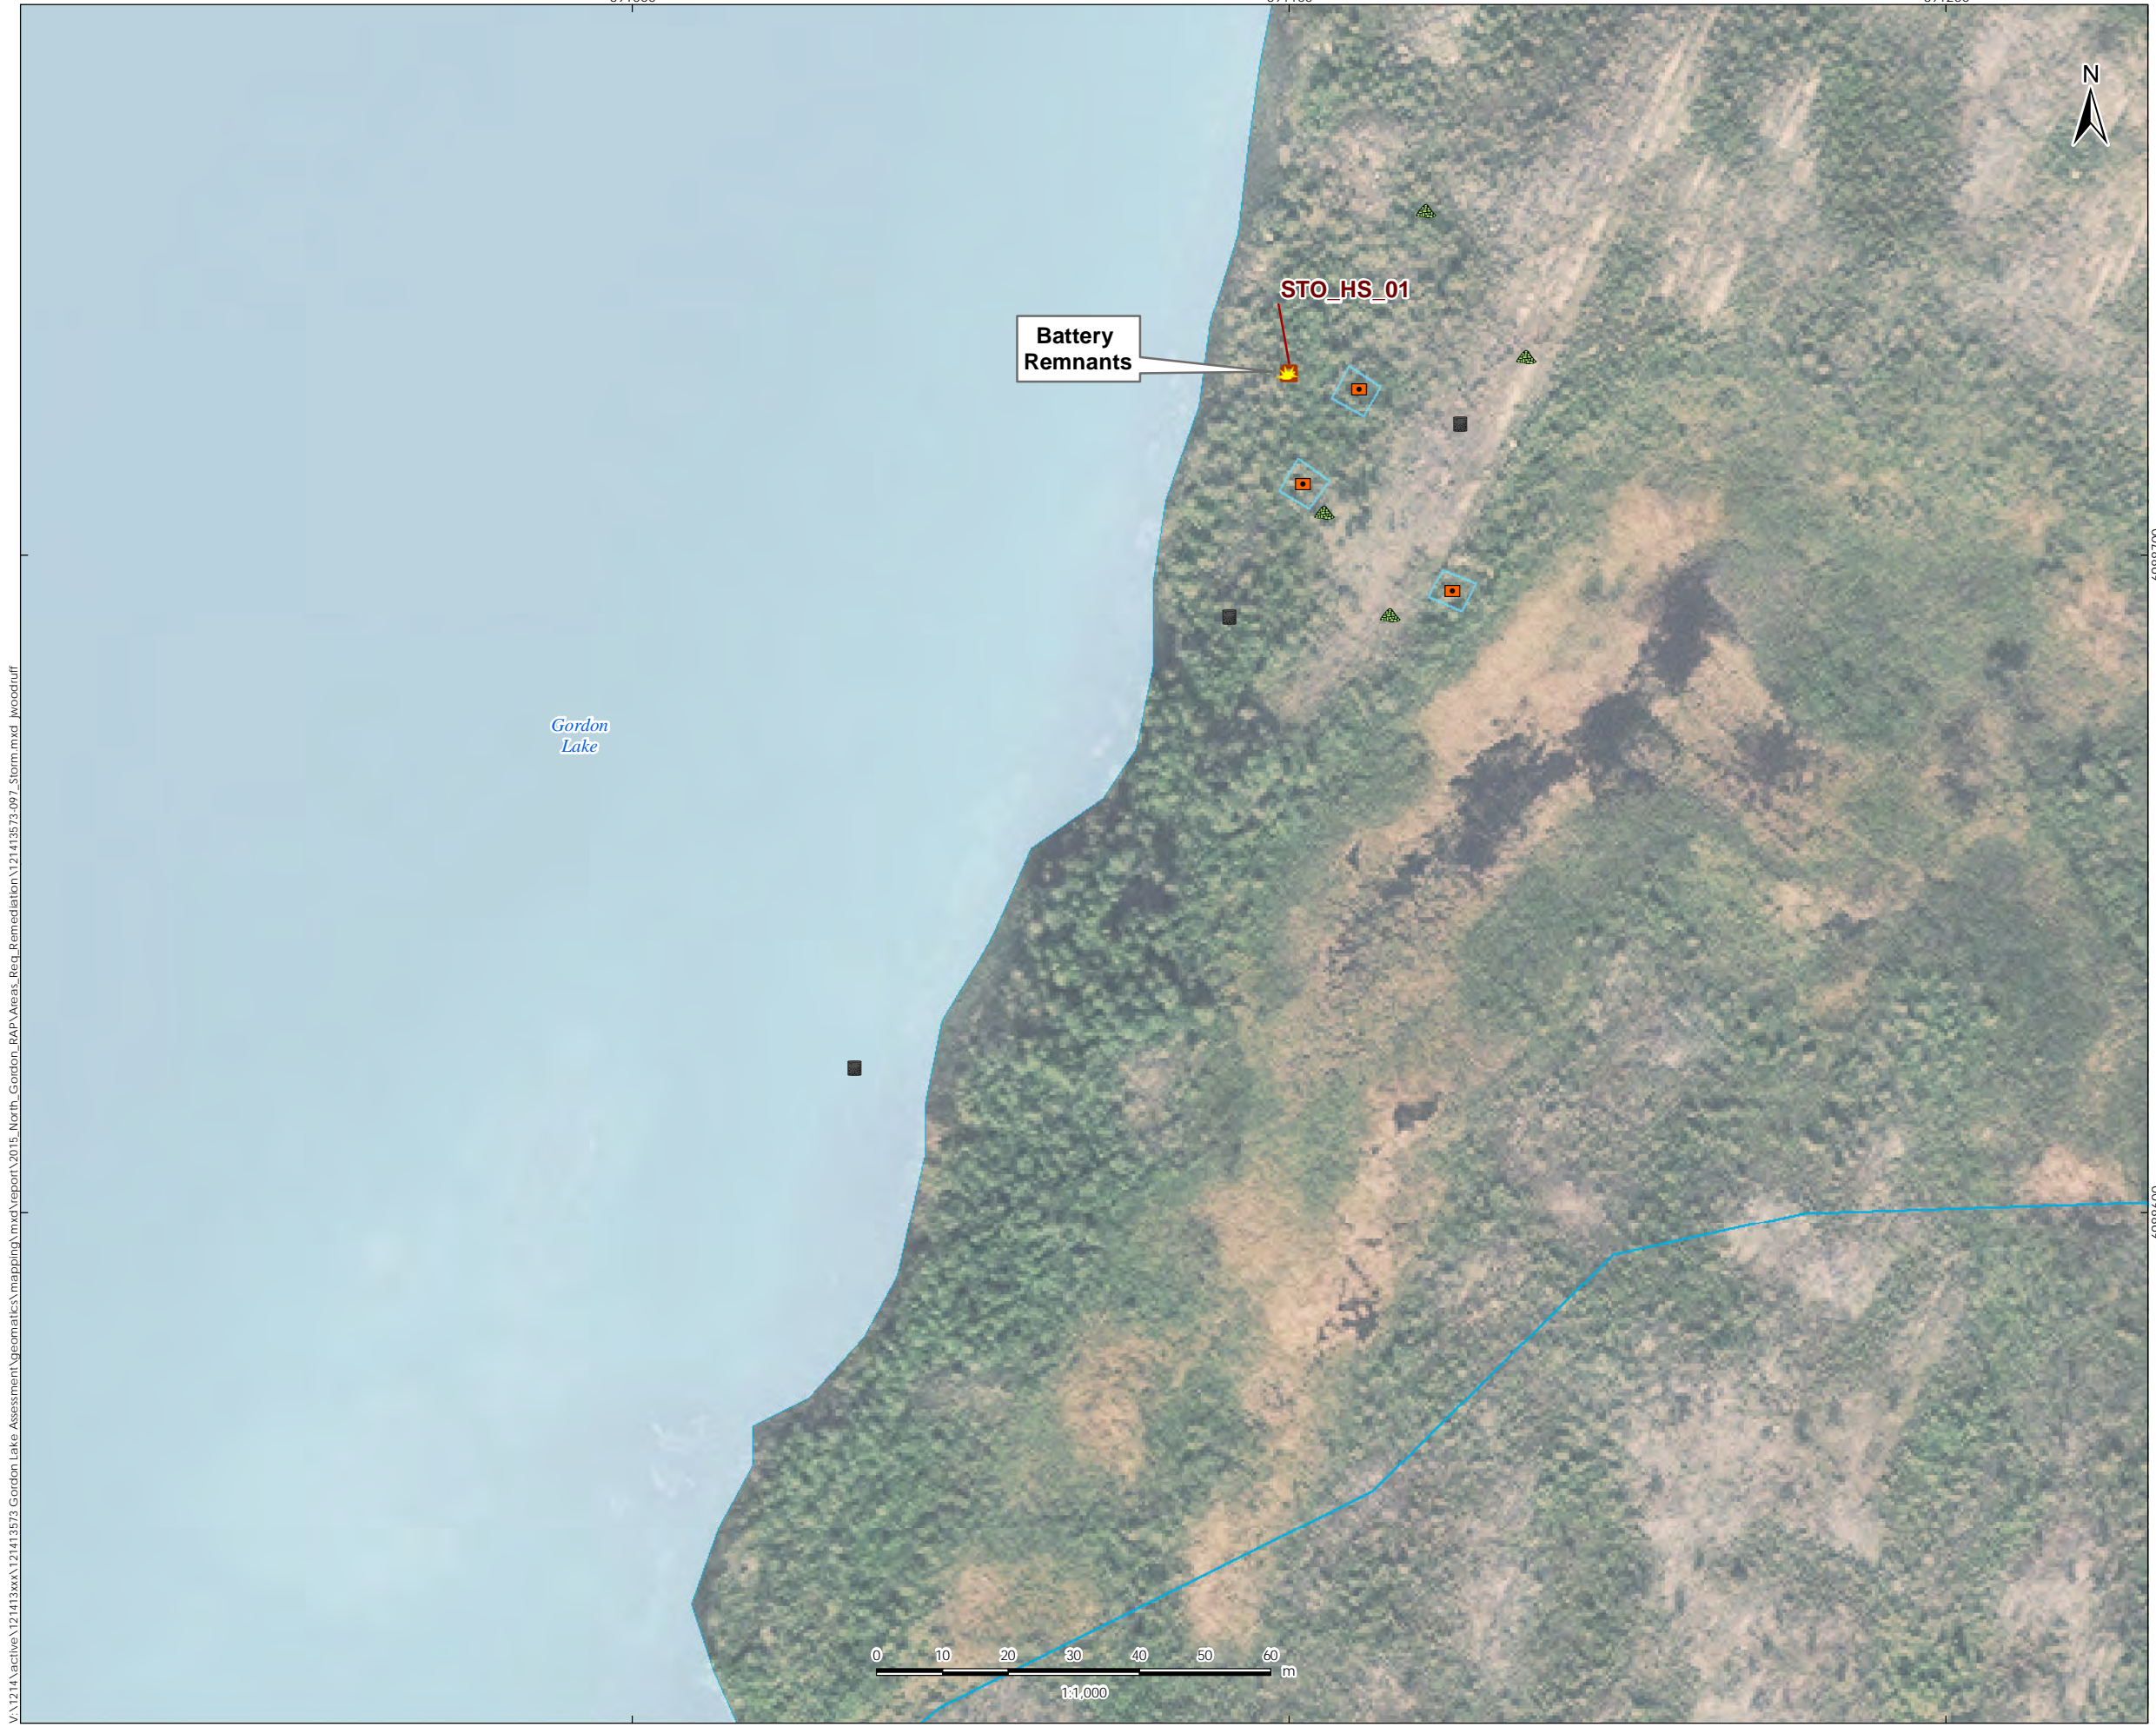
Title
Storm Property - Camp Area
Summary of Hazard Components

Battery Remnants

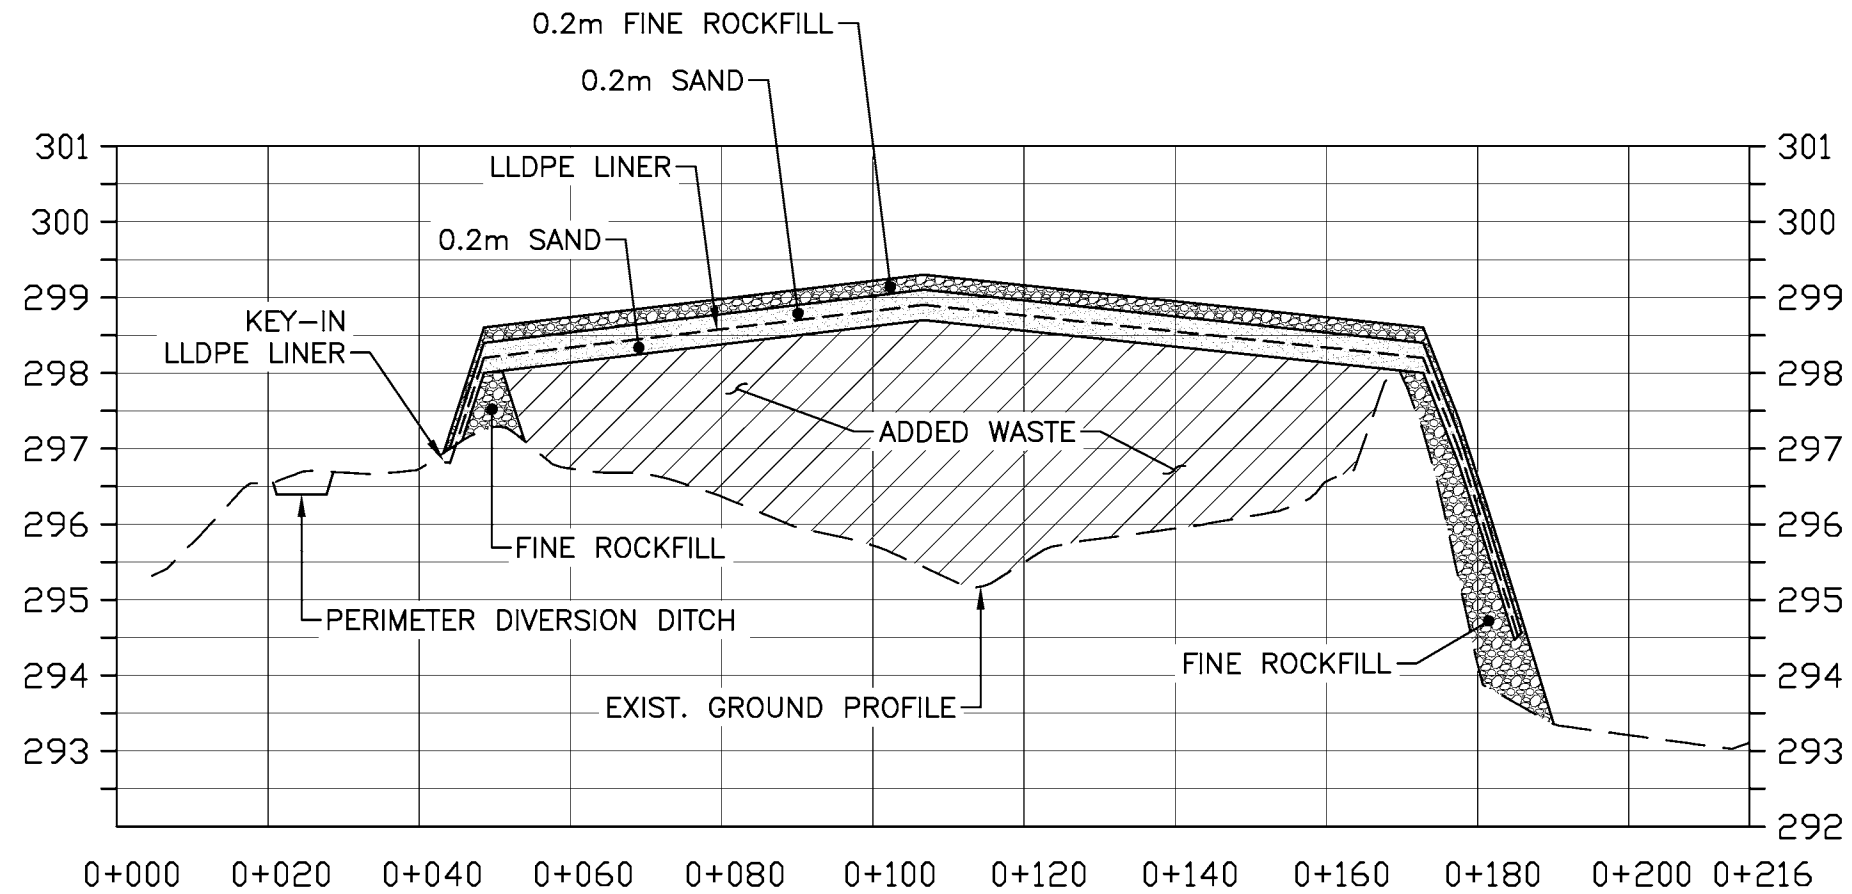
CAMLAREN PROFILE VIEW

SCALE : 1:1000 HORIZ.

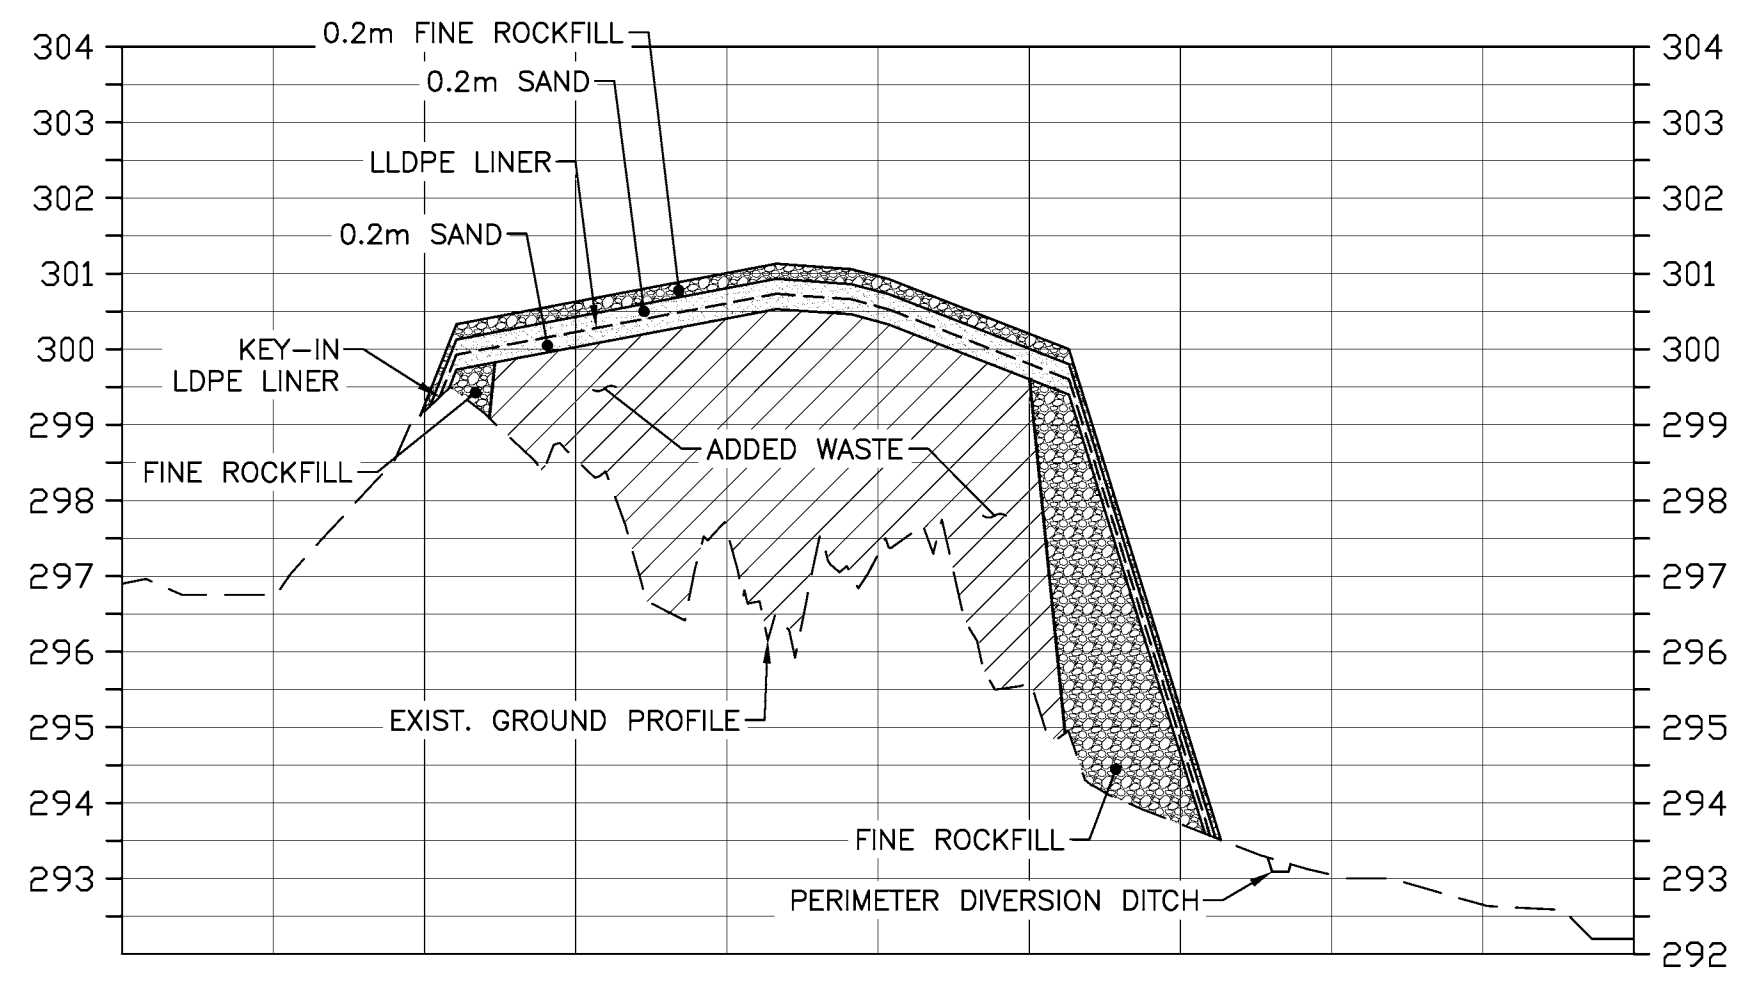
KIDNEY POND PROFILE VIEW

SCALE : 1:1000 HORIZ.

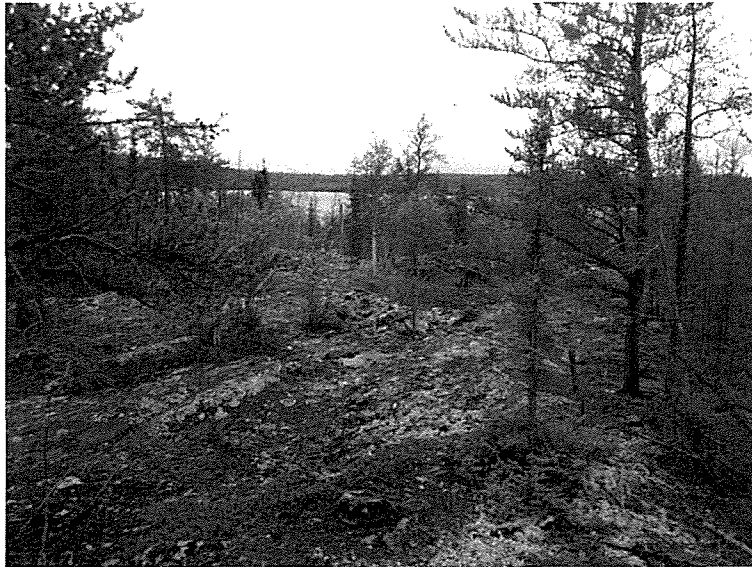
Figure 1 – Habitat at the Storm Property Shaft Area

Although a potential risk is indicated, vegetation within the Storm Property Shaft Area did not appear to be impacted during fieldwork performed in support of the 2014 HHERA (SLR, 2014). That is, there did not appear to be a difference between the abundance, density or diversity of plants between the Storm Property Shaft Area and the surrounding areas. Given the northern location and climatic conditions, both would be characterized as low density, low productivity habitats dominated by bare or lichen-covered bedrock outcrops and rocky, sparsely vegetated soils (see Figure 1).

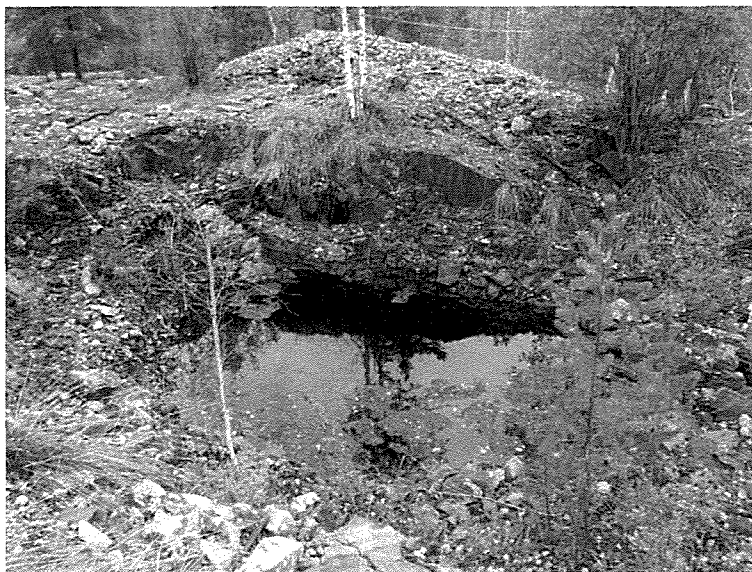
Figure 2 – Mine Shaft at the Storm Property

Although there are poorly vegetated areas at the site that are likely the product of soil contamination and/or lingering physical disruption of the thin surface soil (see Figure 2), these areas are relatively small and do not pose a significant risk to the larger ecosystem, including species higher up in the food web such as birds and mammals (SLR, 2014).

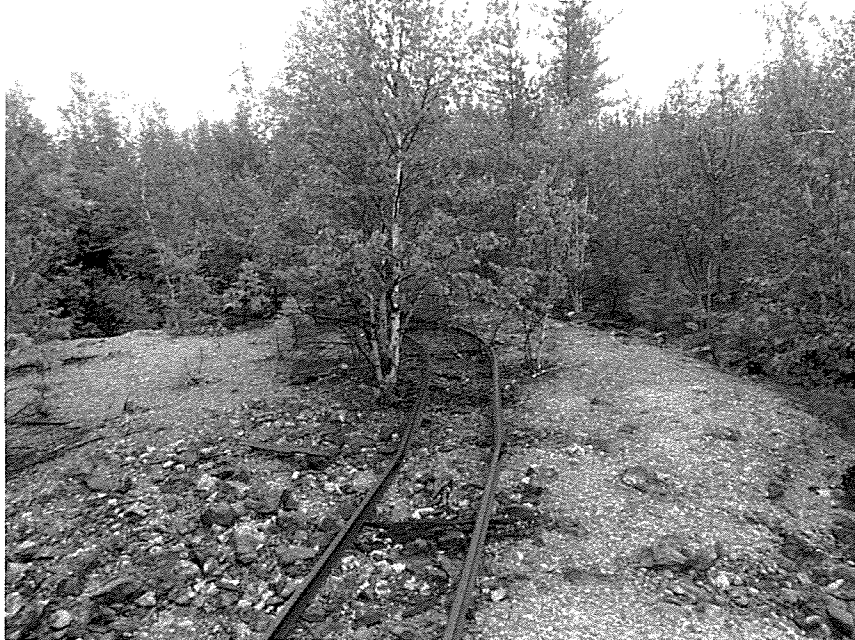
Figure 3 – Waste Rock at the Try Me Main Camp Area

Localized effects on the terrestrial environment (i.e., barren rock that is recovering at a slow pace) are evident in the vicinity of the waste rock at the site (see Figure 3). However, given the limited spatial distribution of the contaminated waste rock (53 m²) and the fact that remediation would require the construction of a new winter road spur into the site (which would necessitate extensive brush clearing and associated impacts, including potential permafrost degradation), maintaining conditions in their current state represents a reasonable alternative.

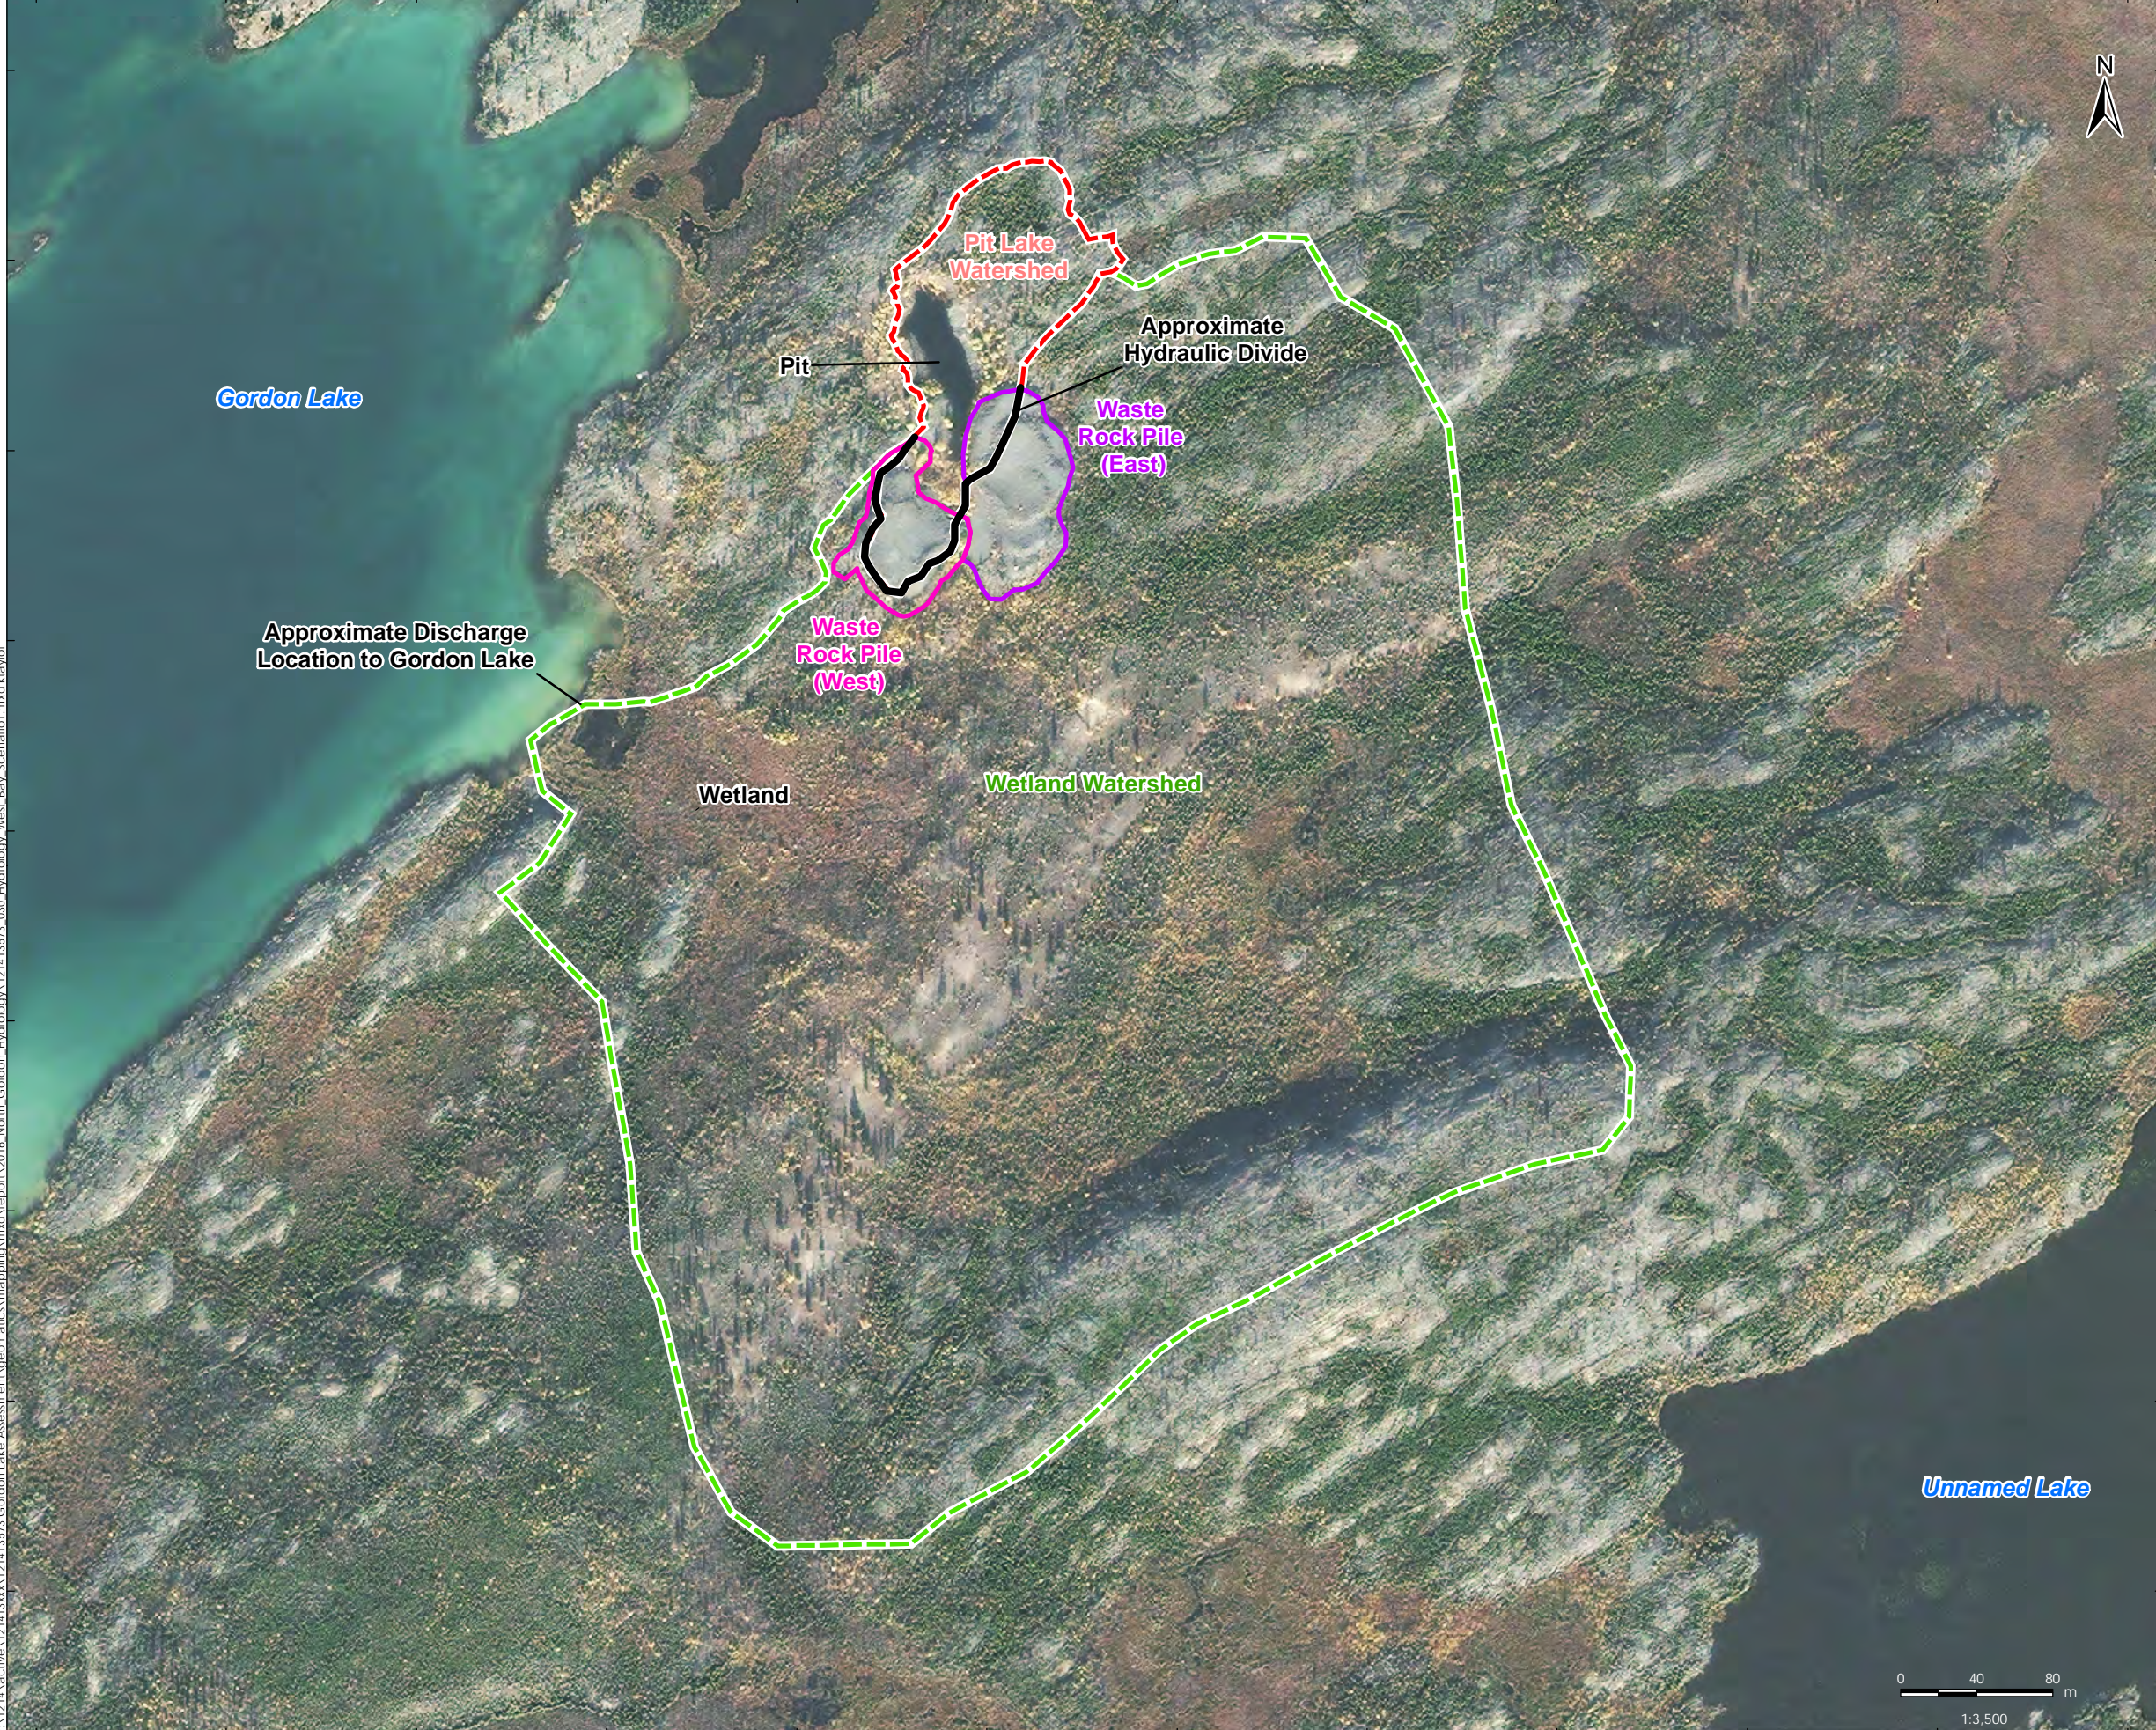
- Legend
- Approximate Hydraulic Divide
 - East Waste Rock Pile
 - West Waste Rock Pile
 - Pit Lake Watershed (Scenario 1)
 - Wetland Watershed (Scenario 1)
