**FINAL REPORT: GORDON LAKE
GROUP REMEDIAL ACTION
PLAN**

Prepared for:
Public Works and Government
Services Canada and Aboriginal
Affairs and Northern
Development Canada

Prepared by:
Stantec Consulting Ltd.

March 31, 2016

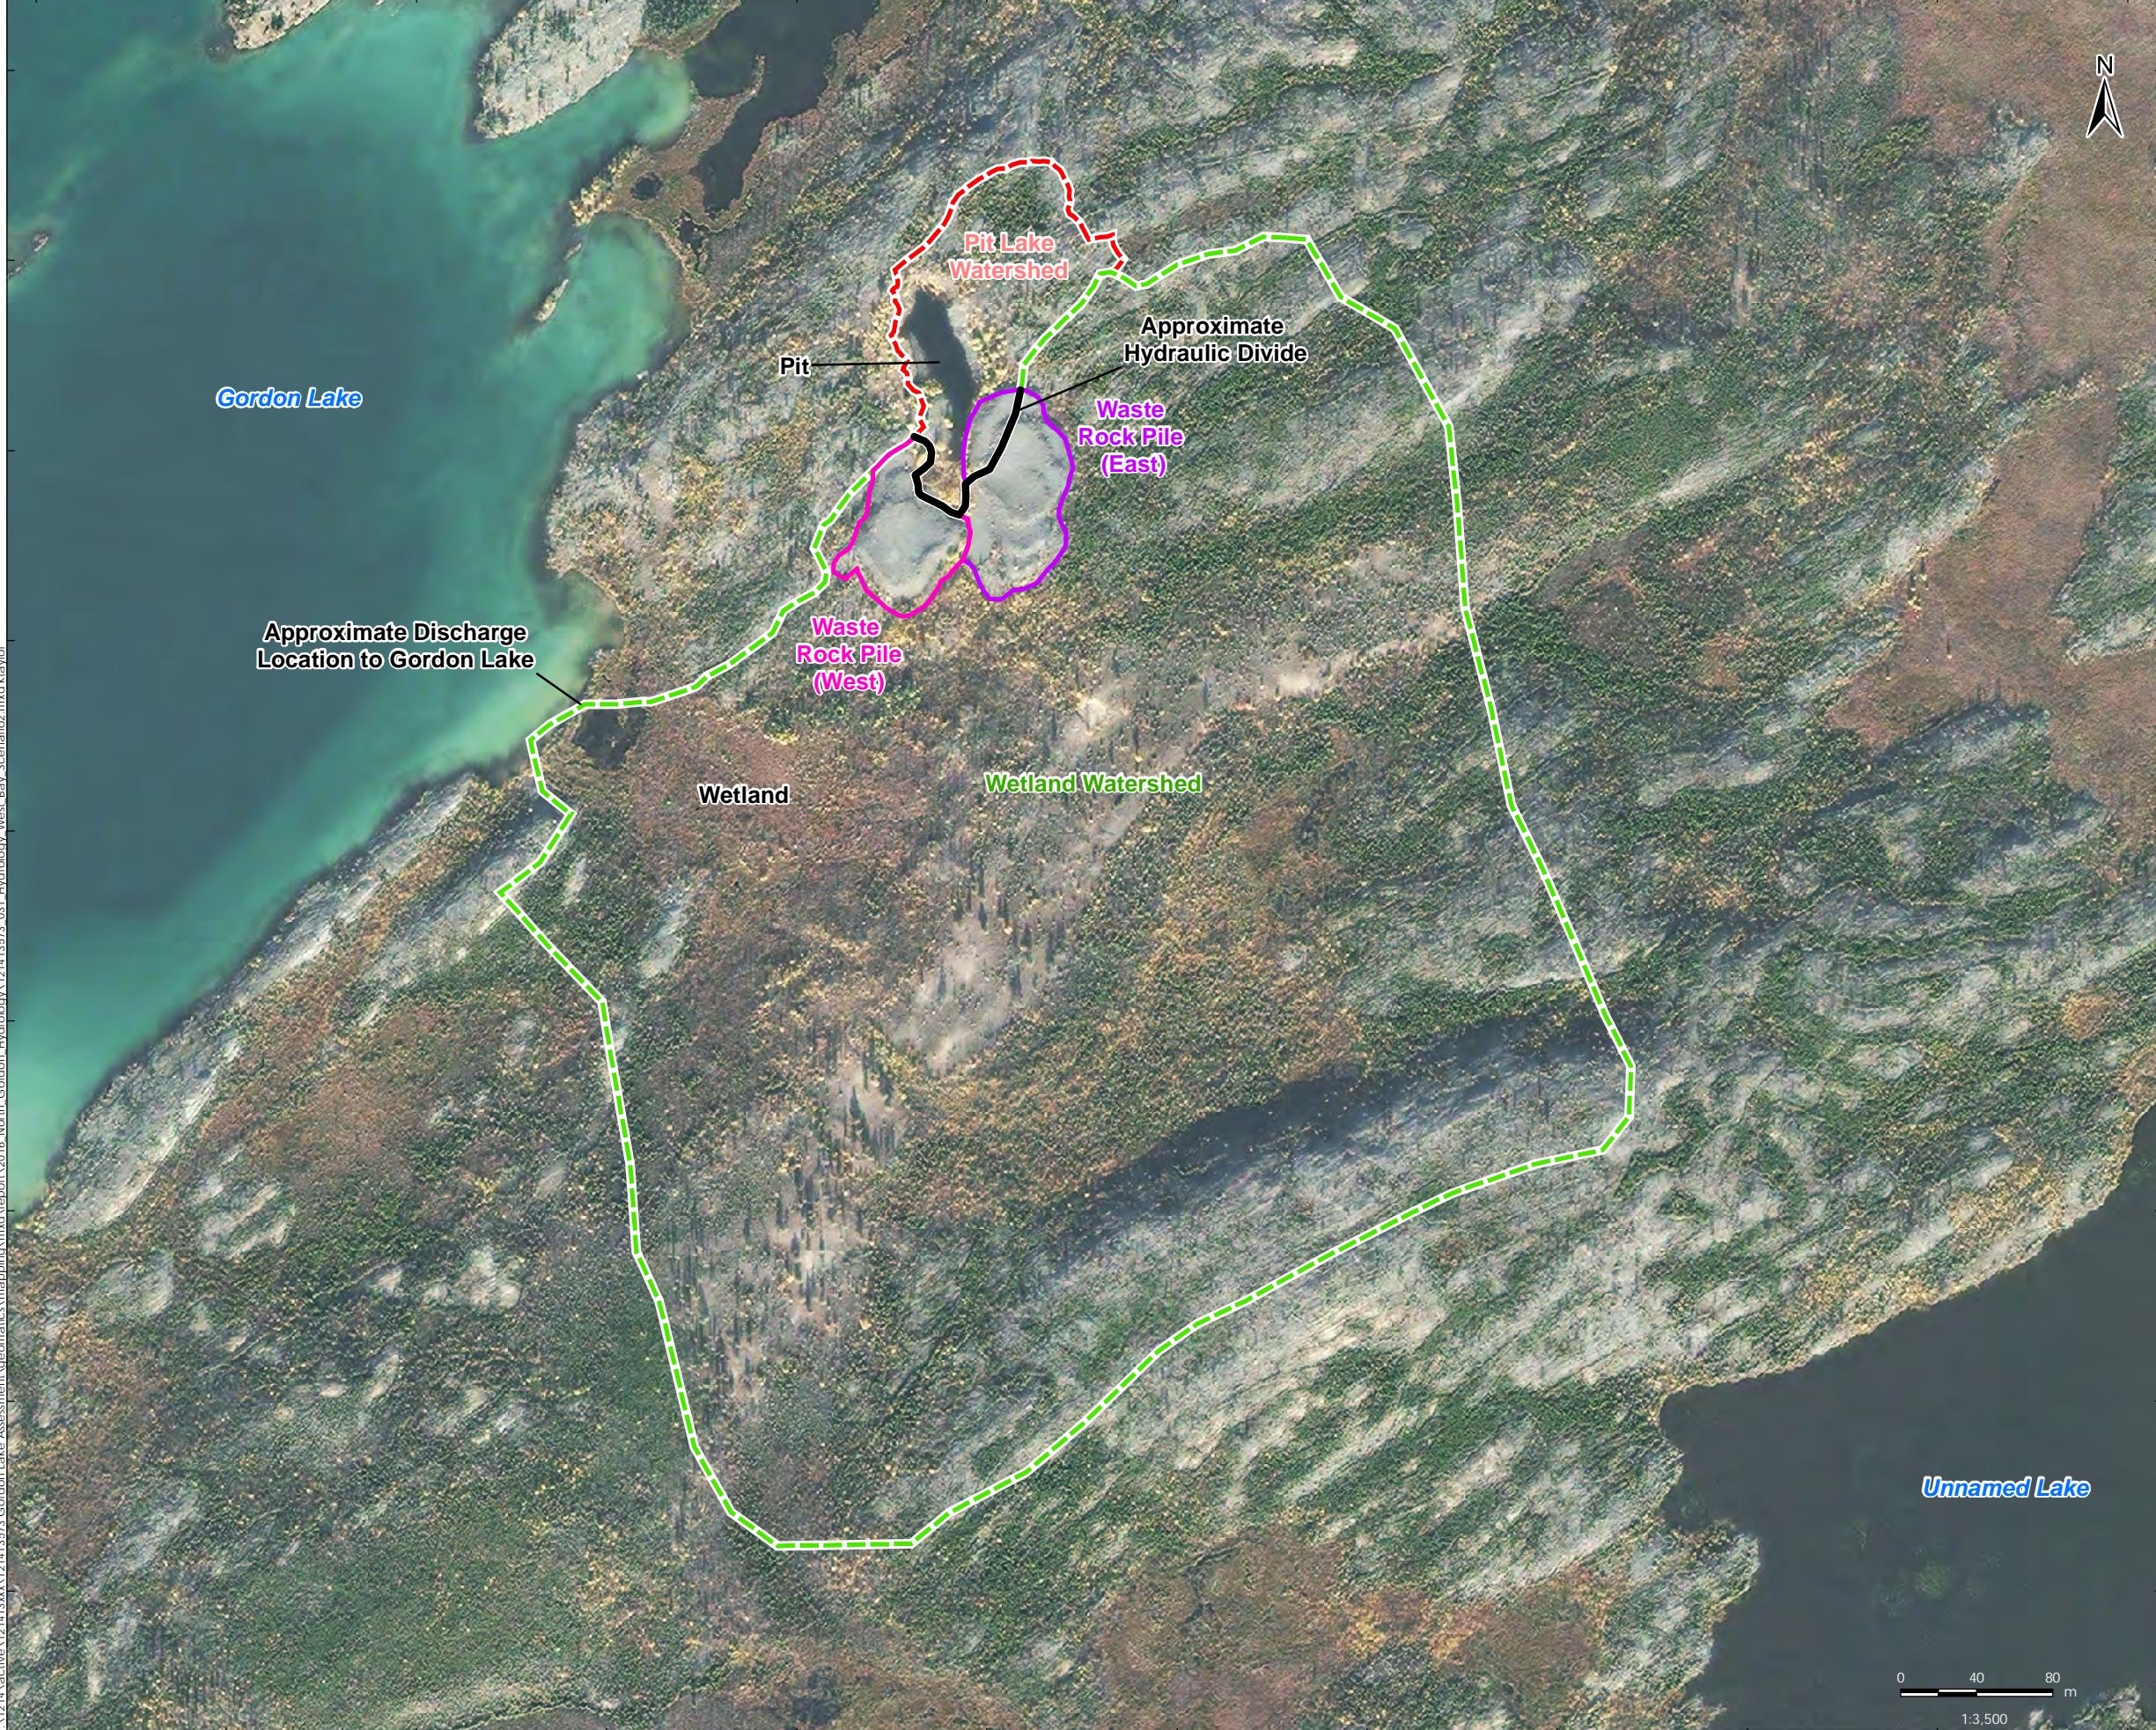
- Legend
- Approximate Hydraulic Divide
 - East Waste Rock Pile
 - West Waste Rock Pile
 - Pit Lake Watershed (Scenario 2)
 - Wetland Watershed (Scenario 2)

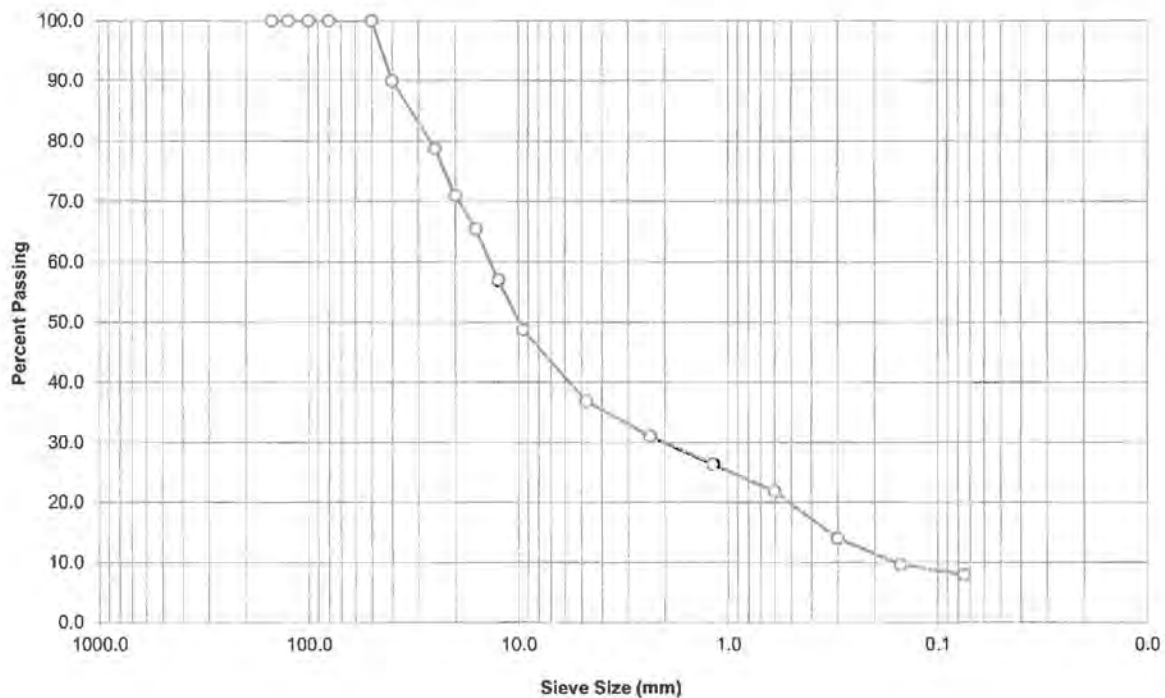
SAMPLE #: **BS-2015-002A**
SOURCE: **GD65**
TESTED BY: **ST**

DATE RECEIVED: **September 4, 2015**
DATE TESTED: **September 15, 2015**
SAMPLE DESCRIPTION: **Well graded gravel with silt and/or clay and sand**

Sieve (mm)	Sample % Passing	Specifications	
		Lower	Upper
150.0	100.0	-	-
125.0	100.0	-	-
100.0	100.0	-	-
80.0	100.0	-	-
50.0	100.0	-	-
40.0	89.9	-	-
25.0	78.7	-	-
20.0	70.9	-	-
16.0	65.4	-	-
12.5	57.0	-	-
9.5	48.7	-	-
4.75	36.8	-	-
2.36	31.0	-	-
1.18	26.4	-	-
0.600	21.8	-	-
0.300	14.0	-	-
0.150	9.6	-	-
0.075	7.9	-	-

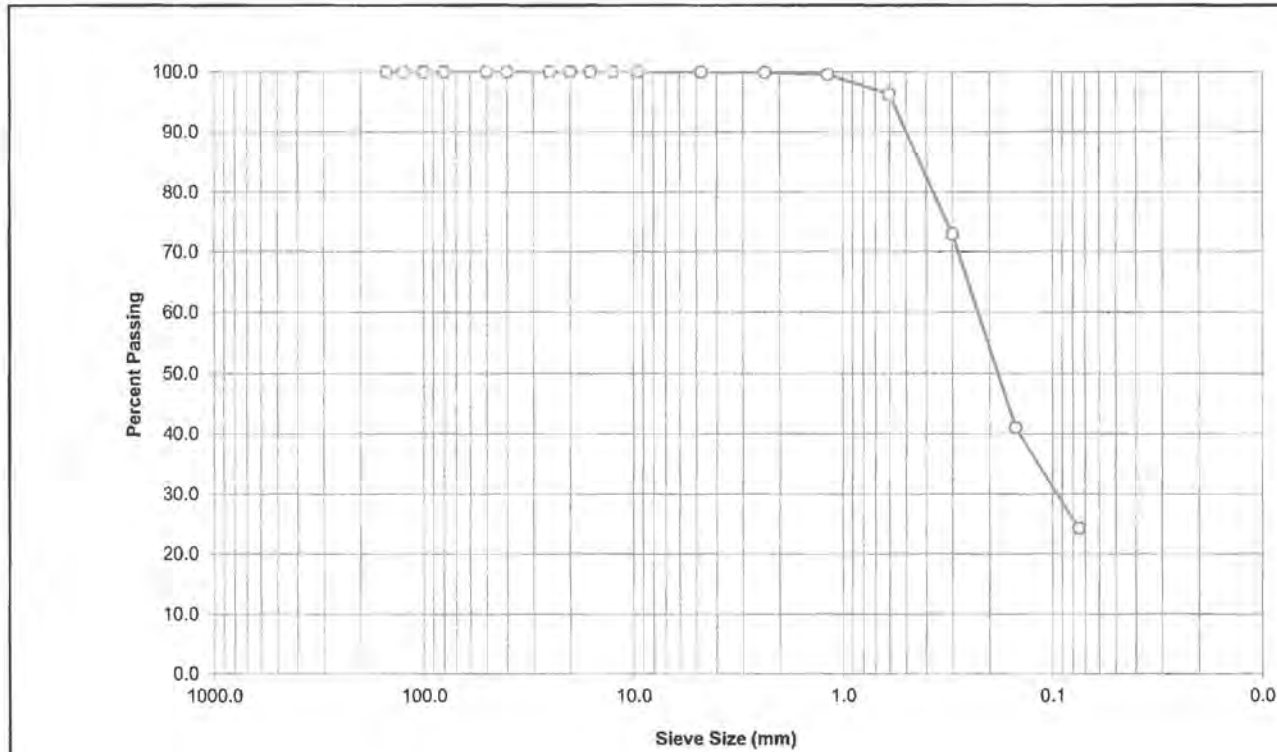
SAMPLE #: **BS-2015-002B**
SOURCE: **GD18**
TESTED BY: **ST**

DATE RECEIVED: **September 4, 2015**
DATE TESTED: **September 15, 2015**
SAMPLE DESCRIPTION: **Silty and/or clayey sand**

Sieve (mm)	Sample % Passing	Specifications	
		Lower	Upper
150.0	100.0	-	-
125.0	100.0	-	-
100.0	100.0	-	-
80.0	100.0	-	-
50.0	100.0	-	-
40.0	100.0	-	-
25.0	100.0	-	-
20.0	100.0	-	-
16.0	100.0	-	-
12.5	100.0	-	-
9.5	100.0	-	-
4.75	99.9	-	-
2.36	99.9	-	-
1.18	99.5	-	-
0.600	96.2	-	-
0.300	72.9	-	-
0.150	41.0	-	-
0.075	24.3	-	-

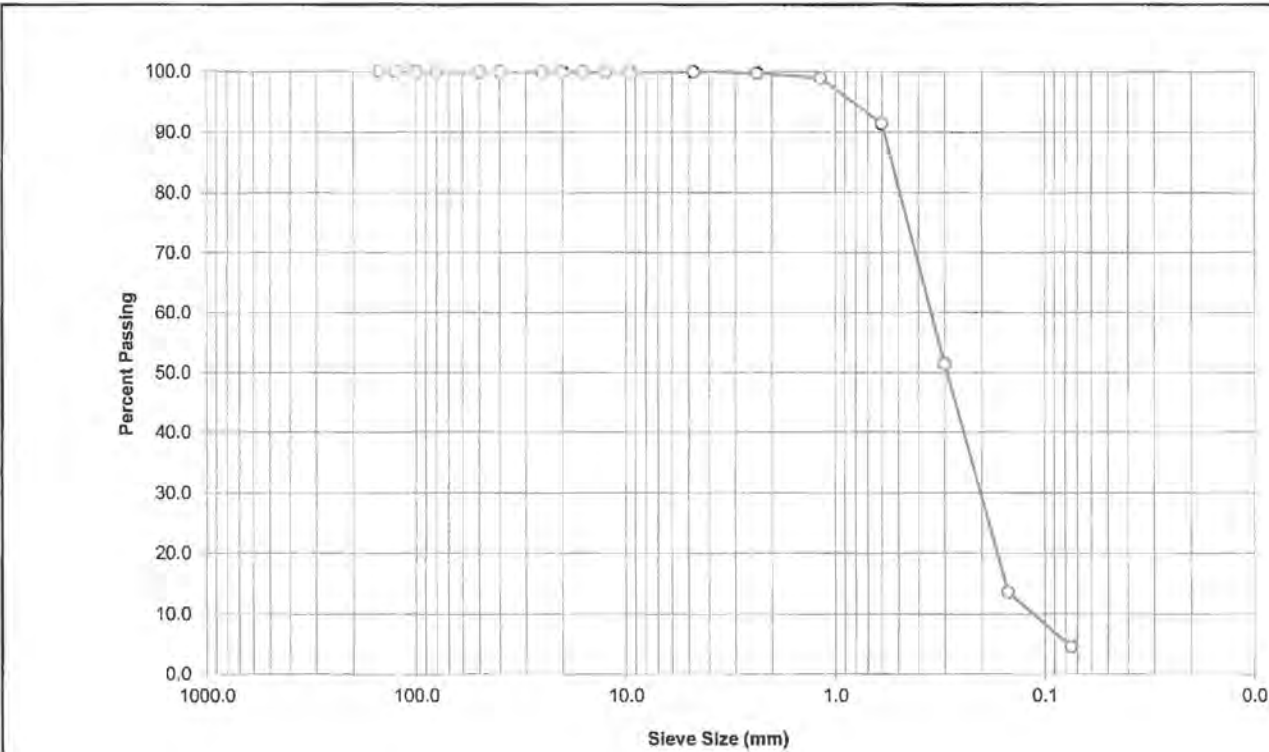
SAMPLE #: **BS-2015-001C**
SOURCE: **GD18**
TESTED BY: **ST**

DATE RECEIVED: **September 4, 2015**
DATE TESTED: **September 15, 2015**
SAMPLE DESCRIPTION: **Poorly graded sand**

Sieve (mm)	Sample % Passing	Specifications	
		Lower	Upper
150.0	100.0	-	-
125.0	100.0	-	-
100.0	100.0	-	-
80.0	100.0	-	-
50.0	100.0	-	-
40.0	100.0	-	-
25.0	100.0	-	-
20.0	100.0	-	-
16.0	100.0	-	-
12.5	100.0	-	-
9.5	100.0	-	-
4.75	100.0	-	-
2.36	99.8	-	-
1.18	98.9	-	-
0.600	91.4	-	-
0.300	51.3	-	-
0.150	13.7	-	-
0.075	4.6	-	-

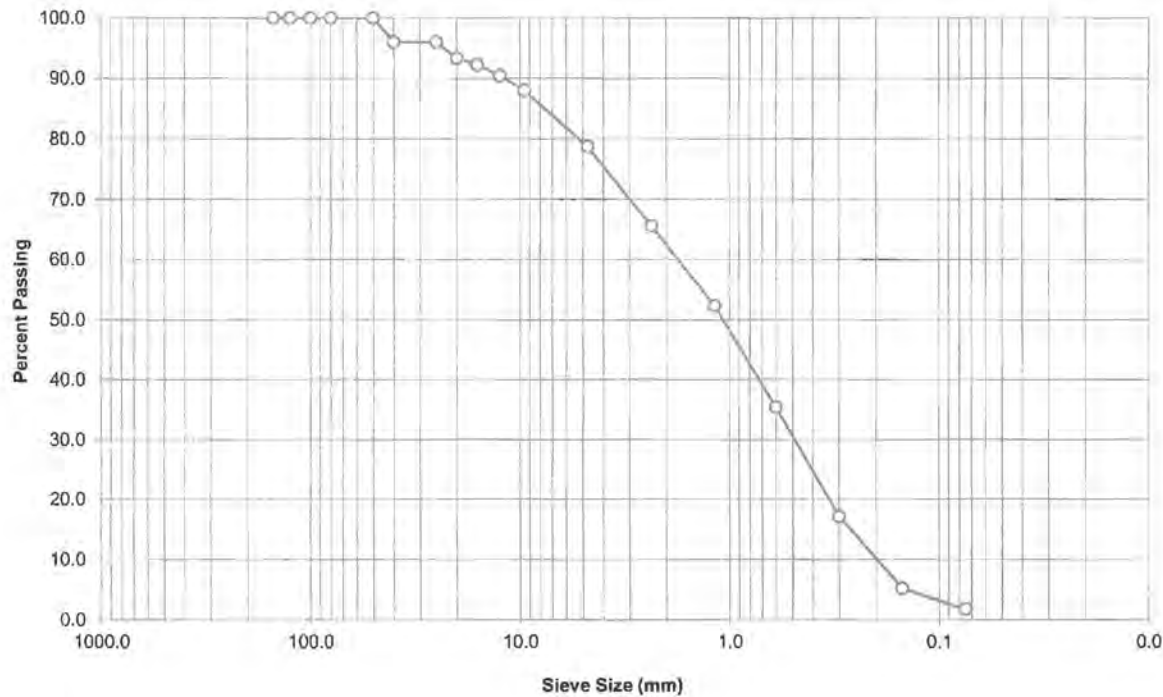
SAMPLE #: **BS-2015-001**
SOURCE: **GD45**
TESTED BY: **ST**

DATE RECEIVED: **September 4, 2015**
DATE TESTED: **September 15, 2015**
SAMPLE DESCRIPTION: **Poorly graded sand with gravel**

Sieve (mm)	Sample % Passing	Specifications	
		Lower	Upper
150.0	100.0	-	-
125.0	100.0	-	-
100.0	100.0	-	-
80.0	100.0	-	-
50.0	100.0	-	-
40.0	96.0	-	-
25.0	96.0	-	-
20.0	93.3	-	-
16.0	92.2	-	-
12.5	90.4	-	-
9.5	88.0	-	-
4.75	78.7	-	-
2.36	65.6	-	-
1.18	52.3	-	-
0.600	35.4	-	-
0.300	17.1	-	-
0.150	5.2	-	-
0.075	1.8	-	-

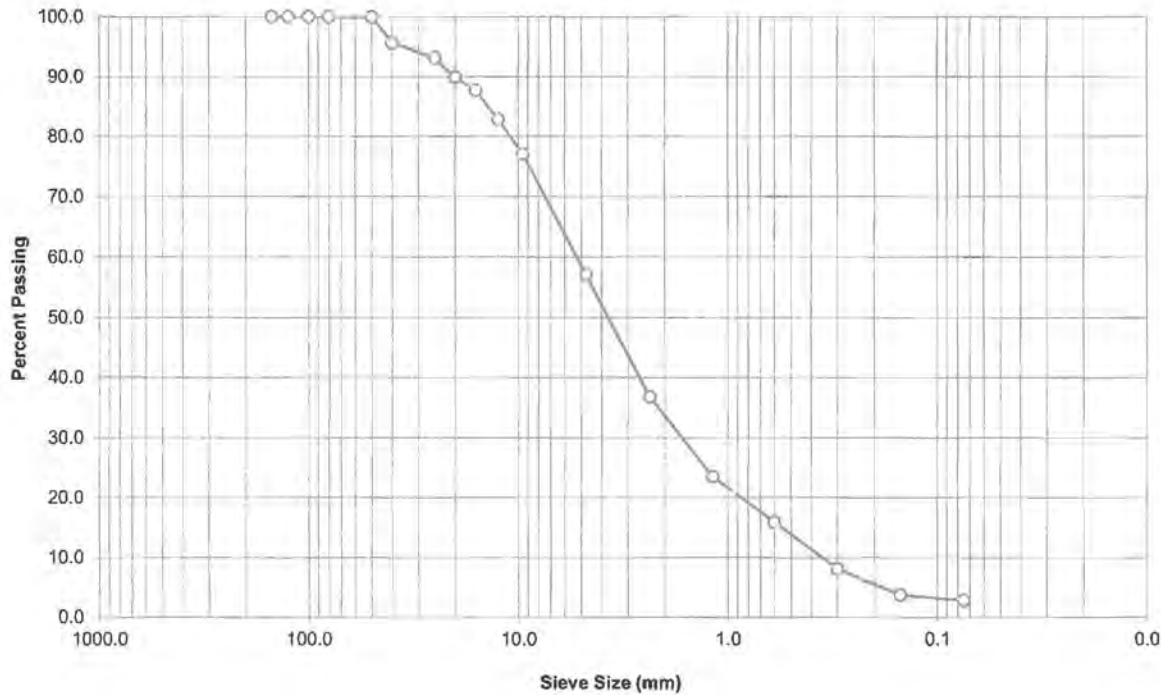
SAMPLE #: **BS-2015-002**
SOURCE: **GD45**
TESTED BY: **ST**

DATE RECEIVED: **September 4, 2015**
DATE TESTED: **September 15, 2015**
SAMPLE DESCRIPTION: **Well graded sand with gravel**

Sieve (mm)	Sample % Passing	Specifications	
		Lower	Upper
150.0	100.0	-	-
125.0	100.0	-	-
100.0	100.0	-	-
80.0	100.0	-	-
50.0	100.0	-	-
40.0	95.6	-	-
25.0	93.1	-	-
20.0	89.9	-	-
16.0	87.7	-	-
12.5	82.9	-	-
9.5	77.0	-	-
4.75	57.0	-	-
2.36	36.8	-	-
1.18	23.5	-	-
0.600	16.0	-	-
0.300	8.1	-	-
0.150	3.7	-	-
0.075	2.8	-	-

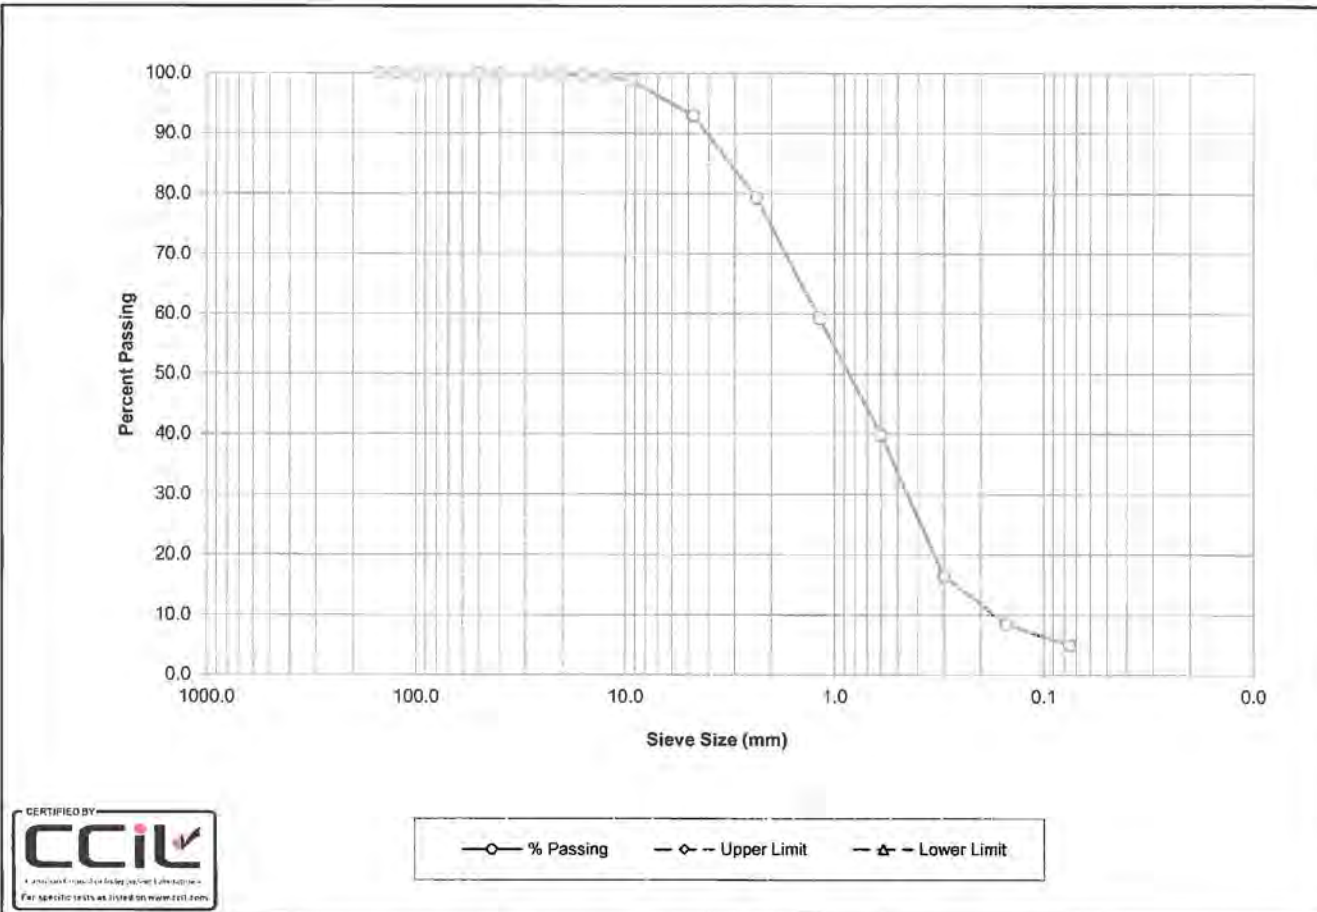
SAMPLE #: **BS-2015-001A**
SOURCE: **GD37**
TESTED BY: **ST**

DATE RECEIVED: **September 4, 2015**
DATE TESTED: **September 15, 2015**
SAMPLE DESCRIPTION: **Poorly graded sand**

Sieve (mm)	Sample % Passing	Specifications	
		Lower	Upper
150.0	100.0	-	-
125.0	100.0	-	-
100.0	100.0	-	-
80.0	100.0	-	-
50.0	100.0	-	-
40.0	100.0	-	-
25.0	100.0	-	-
20.0	100.0	-	-
16.0	99.6	-	-
12.5	99.4	-	-
9.5	98.8	-	-
4.75	93.0	-	-
2.36	79.3	-	-
1.18	59.2	-	-
0.600	39.8	-	-
0.300	16.5	-	-
0.150	8.5	-	-
0.075	4.9	-	-

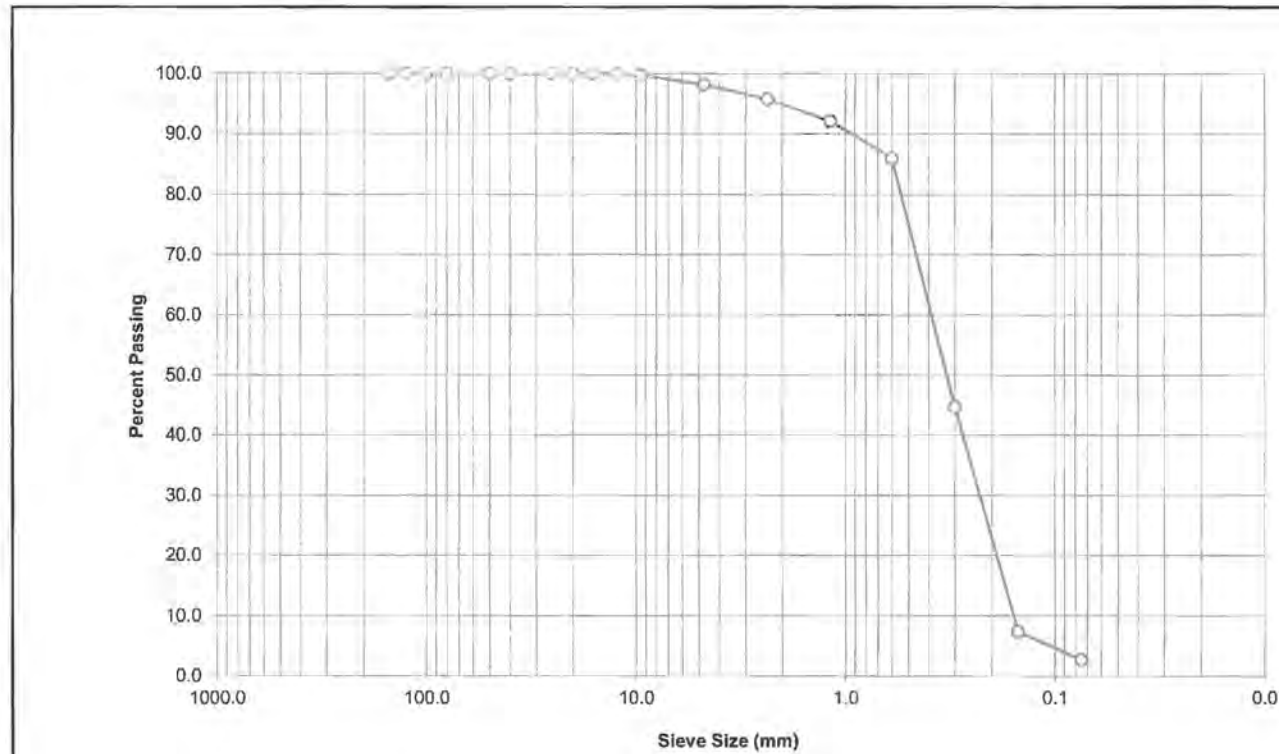
SAMPLE #: **BS-2015-001B**
SOURCE: **GD37**
TESTED BY: **ST**

DATE RECEIVED: **September 4, 2015**
DATE TESTED: **September 15, 2015**
SAMPLE DESCRIPTION: **Poorly graded sand**

Sieve (mm)	Sample % Passing	Specifications	
		Lower	Upper
150.0	100.0	-	-
125.0	100.0	-	-
100.0	100.0	-	-
80.0	100.0	-	-
50.0	100.0	-	-
40.0	100.0	-	-
25.0	100.0	-	-
20.0	100.0	-	-
16.0	100.0	-	-
12.5	100.0	-	-
9.5	99.7	-	-
4.75	98.2	-	-
2.36	95.7	-	-
1.18	92.1	-	-
0.600	85.9	-	-
0.300	44.7	-	-
0.150	7.4	-	-
0.075	2.7	-	-

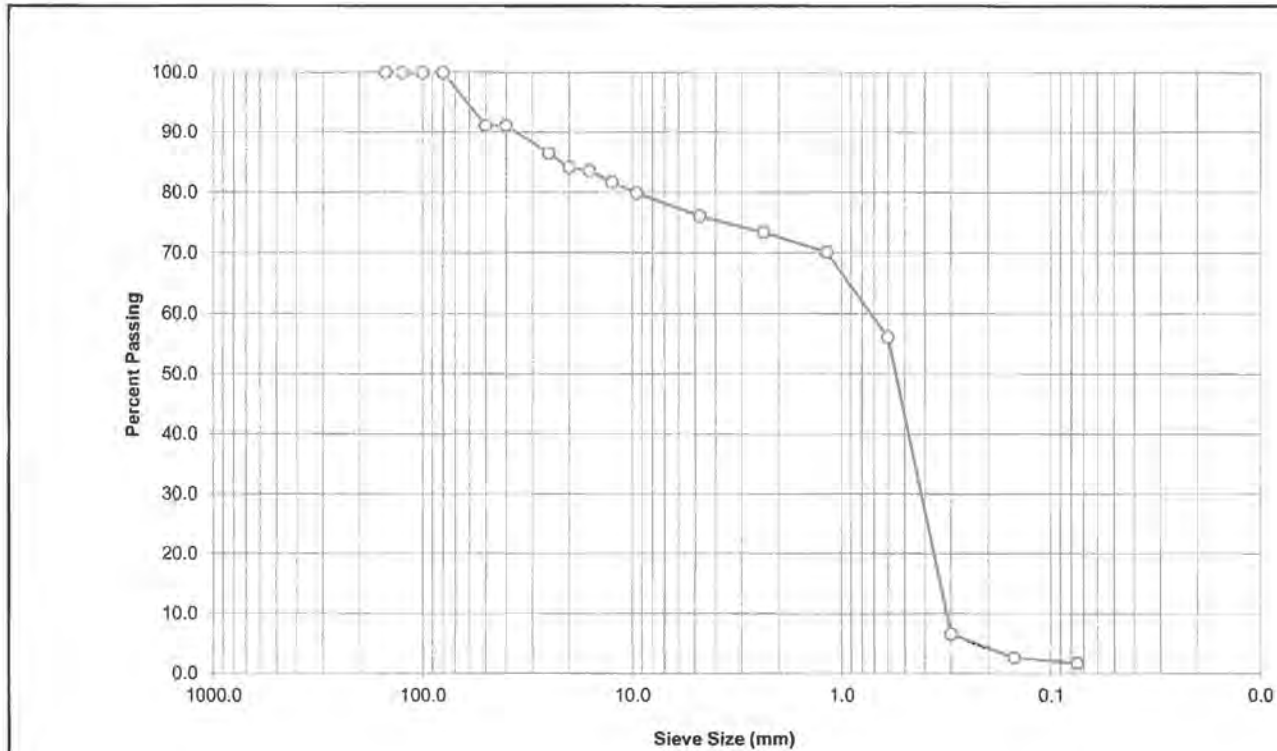
SAMPLE #: **BS-2015-002B**
SOURCE: **GD37**
TESTED BY: **ST**

DATE RECEIVED: **September 4, 2015**
DATE TESTED: **September 15, 2015**
SAMPLE DESCRIPTION: **Poorly graded sand with gravel**

Sieve (mm)	Sample % Passing	Specifications	
		Lower	Upper
150.0	100.0	-	-
125.0	100.0	-	-
100.0	100.0	-	-
80.0	100.0	-	-
50.0	91.1	-	-
40.0	91.1	-	-
25.0	86.5	-	-
20.0	84.1	-	-
16.0	83.6	-	-
12.5	81.7	-	-
9.5	79.9	-	-
4.75	76.1	-	-
2.36	73.4	-	-
1.18	70.1	-	-
0.600	56.1	-	-
0.300	6.5	-	-
0.150	2.6	-	-
0.075	1.7	-	-

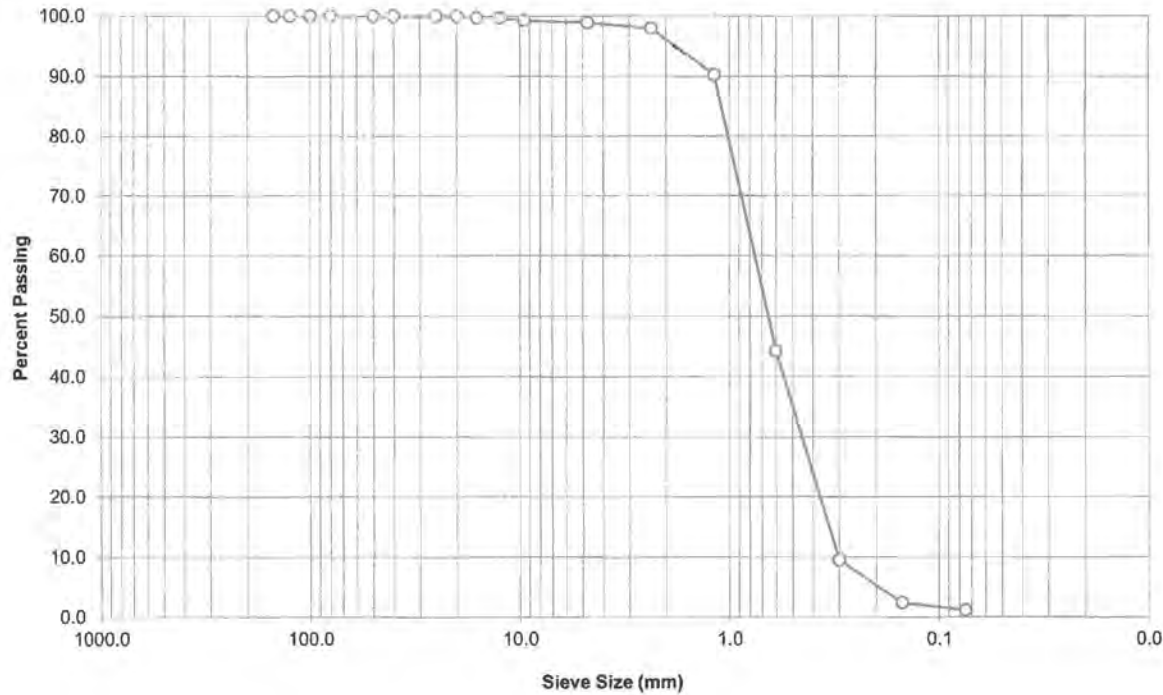
SAMPLE #: **BS-2015-003B**
SOURCE: **GD37**
TESTED BY: **ST**

DATE RECEIVED: **September 4, 2015**
DATE TESTED: **September 15, 2015**
SAMPLE DESCRIPTION: **Poorly graded sand**

Sieve (mm)	Sample % Passing	Specifications	
		Lower	Upper
150.0	100.0	-	-
125.0	100.0	-	-
100.0	100.0	-	-
80.0	100.0	-	-
50.0	100.0	-	-
40.0	100.0	-	-
25.0	100.0	-	-
20.0	100.0	-	-
16.0	99.6	-	-
12.5	99.6	-	-
9.5	99.3	-	-
4.75	98.9	-	-
2.36	97.9	-	-
1.18	90.3	-	-
0.600	44.2	-	-
0.300	9.5	-	-
0.150	2.4	-	-
0.075	1.2	-	-

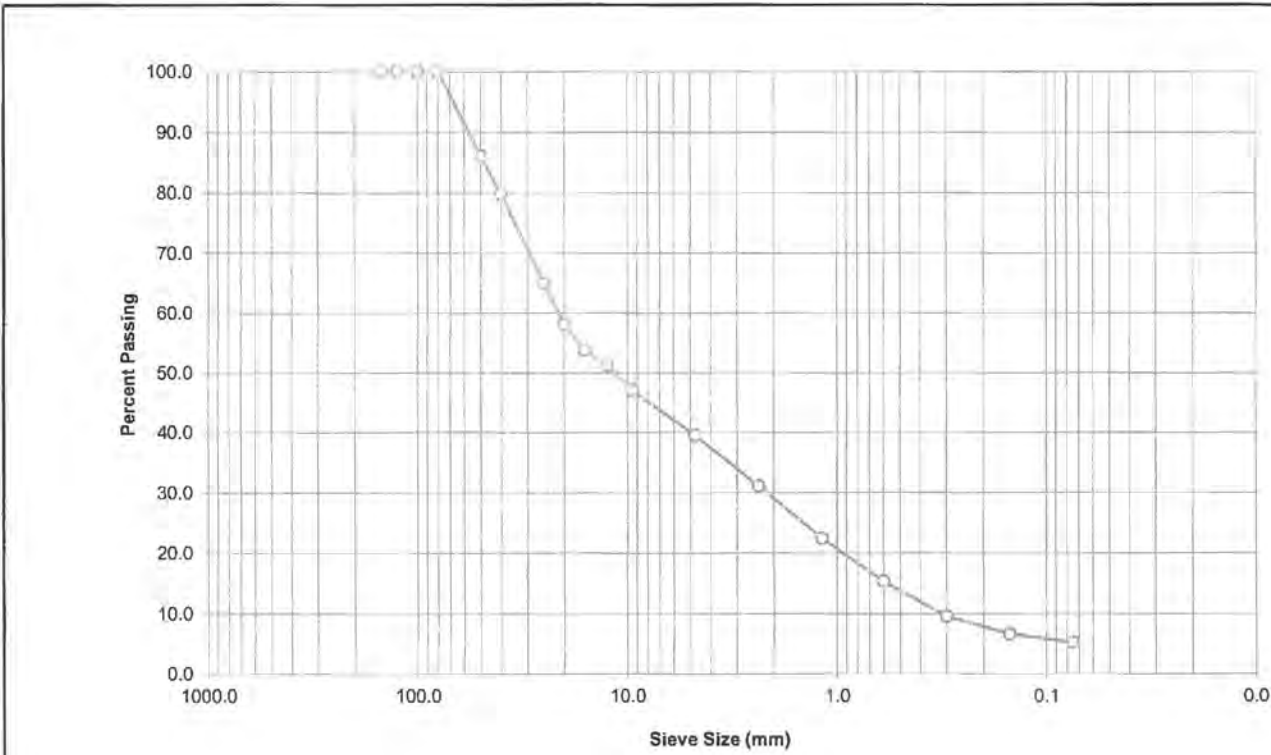
SAMPLE #: **BS-2015-001A**
SOURCE: **GD18**
TESTED BY: **ST**

DATE RECEIVED: **September 4, 2015**
DATE TESTED: **September 15, 2015**
SAMPLE DESCRIPTION: **Poorly graded gravel with silt and/or clay and sand**

Sieve (mm)	Sample % Passing	Specifications	
		Lower	Upper
150.0	100.0	-	-
125.0	100.0	-	-
100.0	100.0	-	-
80.0	100.0	-	-
50.0	86.1	-	-
40.0	79.8	-	-
25.0	65.0	-	-
20.0	58.1	-	-
16.0	53.8	-	-
12.5	51.3	-	-
9.5	47.1	-	-
4.75	39.5	-	-
2.36	31.1	-	-
1.18	22.4	-	-
0.600	15.3	-	-
0.300	9.6	-	-
0.150	6.6	-	-
0.075	5.2	-	-

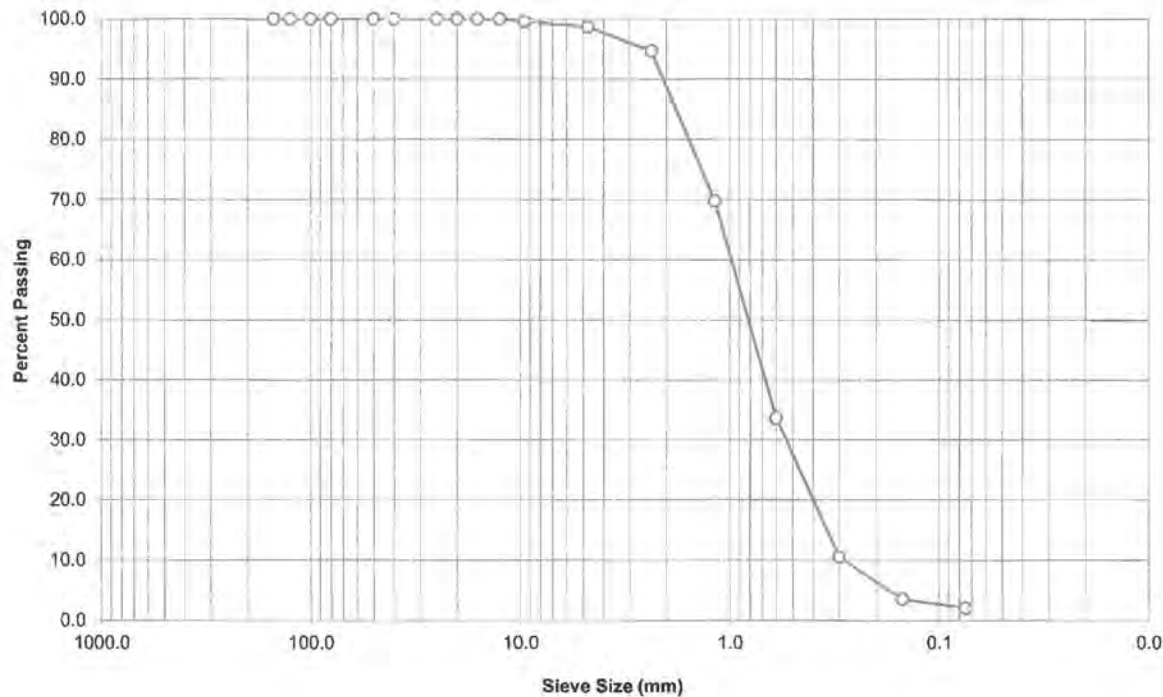
SAMPLE #: **BS-2015-001B**
SOURCE: **GD18**
TESTED BY: **ST**

DATE RECEIVED: **September 4, 2015**
DATE TESTED: **September 15, 2015**
SAMPLE DESCRIPTION: **Poorly graded sand**

Sieve (mm)	Sample % Passing	Specifications	
		Lower	Upper
150.0	100.0	-	-
125.0	100.0	-	-
100.0	100.0	-	-
80.0	100.0	-	-
50.0	100.0	-	-
40.0	100.0	-	-
25.0	100.0	-	-
20.0	100.0	-	-
16.0	100.0	-	-
12.5	100.0	-	-
9.5	99.6	-	-
4.75	98.6	-	-
2.36	94.7	-	-
1.18	69.8	-	-
0.600	33.6	-	-
0.300	10.5	-	-
0.150	3.5	-	-
0.075	2.1	-	-

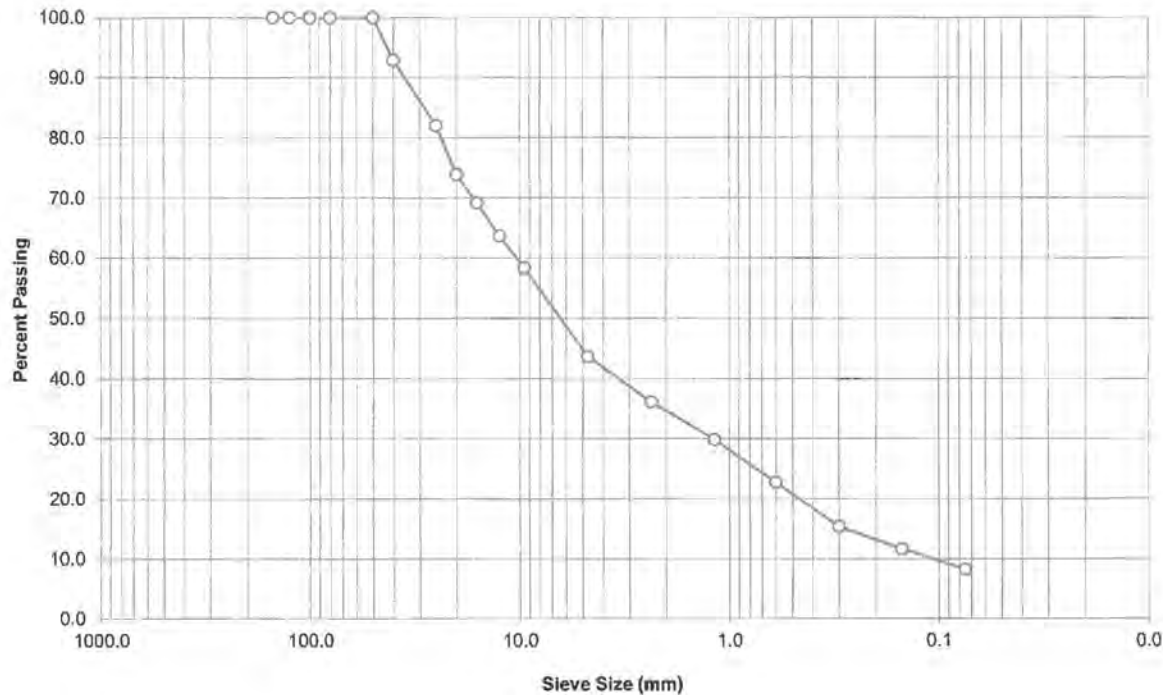
SAMPLE #: **BS-2015-002C**
 SOURCE: **GD18**
 TESTED BY: **ST**

DATE RECEIVED: **September 4, 2015**
 DATE TESTED: **September 15, 2015**
 SAMPLE DESCRIPTION: **Well graded gravel with silt and/or clay and sand**

Sieve (mm)	Sample % Passing	Specifications	
		Lower	Upper
150.0	100.0	-	-
125.0	100.0	-	-
100.0	100.0	-	-
80.0	100.0	-	-
50.0	100.0	-	-
40.0	92.9	-	-
25.0	82.0	-	-
20.0	73.9	-	-
16.0	69.2	-	-
12.5	63.7	-	-
9.5	58.4	-	-
4.75	43.7	-	-
2.36	36.1	-	-
1.18	29.8	-	-
0.600	22.7	-	-
0.300	15.4	-	-
0.150	11.6	-	-
0.075	8.2	-	-

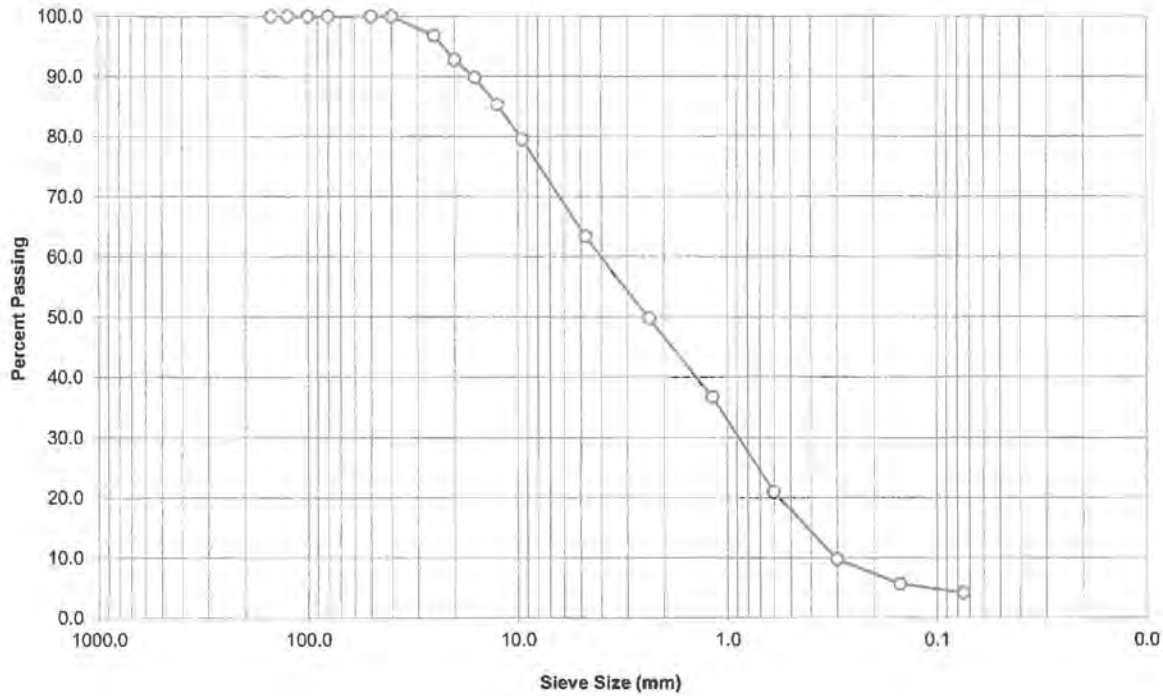
SAMPLE #: **BS-2015-003**
SOURCE: **GD18**
TESTED BY: **ST**

DATE RECEIVED: **September 4, 2015**
DATE TESTED: **September 15, 2015**
SAMPLE DESCRIPTION: **Poorly graded sand with gravel**

Sieve (mm)	Sample % Passing	Specifications	
		Lower	Upper
150.0	100.0	-	-
125.0	100.0	-	-
100.0	100.0	-	-
80.0	100.0	-	-
50.0	100.0	-	-
40.0	100.0	-	-
25.0	96.8	-	-
20.0	92.8	-	-
16.0	89.8	-	-
12.5	85.3	-	-
9.5	79.5	-	-
4.75	63.3	-	-
2.36	49.7	-	-
1.18	36.7	-	-
0.600	20.9	-	-
0.300	9.7	-	-
0.150	5.6	-	-
0.075	4.1	-	-

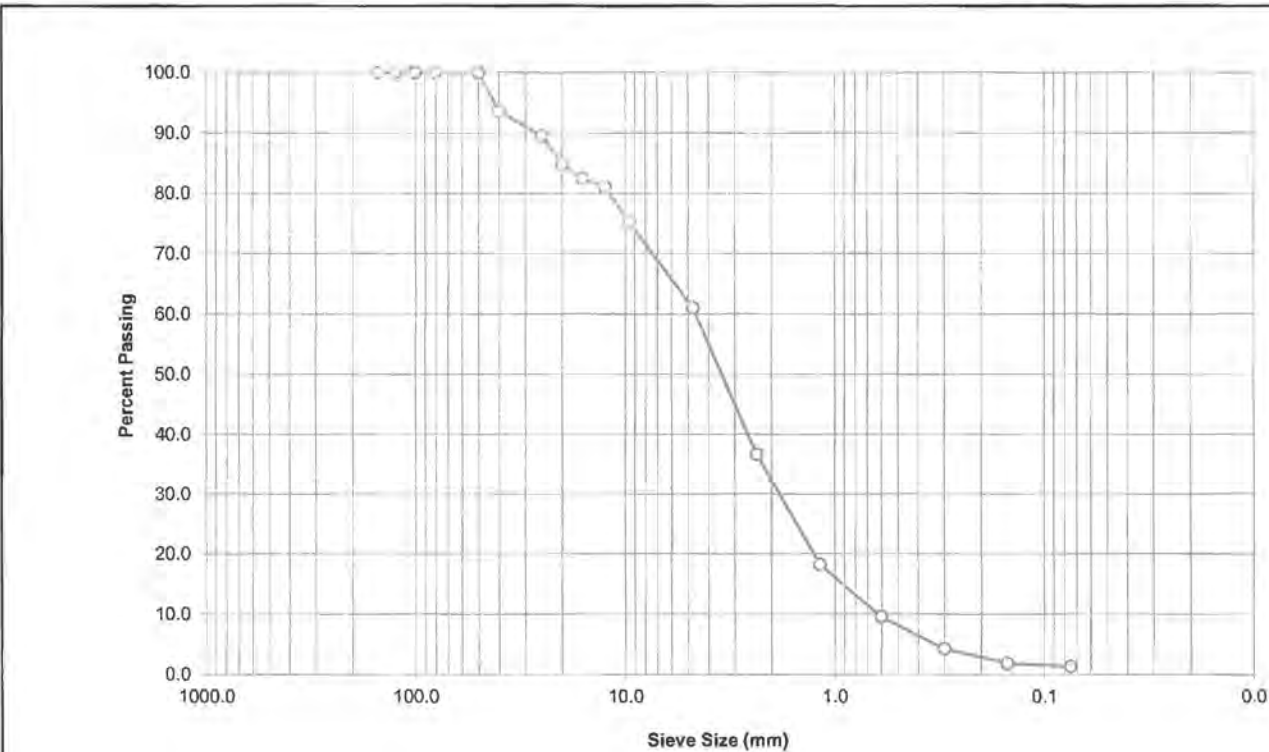
SAMPLE #: **BS-2015-001**
SOURCE: **GD11**
TESTED BY: **ST**

DATE RECEIVED: **September 4, 2015**
DATE TESTED: **September 15, 2015**
SAMPLE DESCRIPTION: **Poorly graded sand with gravel**

Sieve (mm)	Sample % Passing	Specifications	
		Lower	Upper
150.0	100.0	-	-
125.0	100.0	-	-
100.0	100.0	-	-
80.0	100.0	-	-
50.0	100.0	-	-
40.0	93.6	-	-
25.0	89.5	-	-
20.0	84.9	-	-
16.0	82.4	-	-
12.5	81.0	-	-
9.5	75.0	-	-
4.75	61.0	-	-
2.36	36.6	-	-
1.18	18.2	-	-
0.600	9.5	-	-
0.300	4.3	-	-
0.150	1.9	-	-
0.075	1.4	-	-

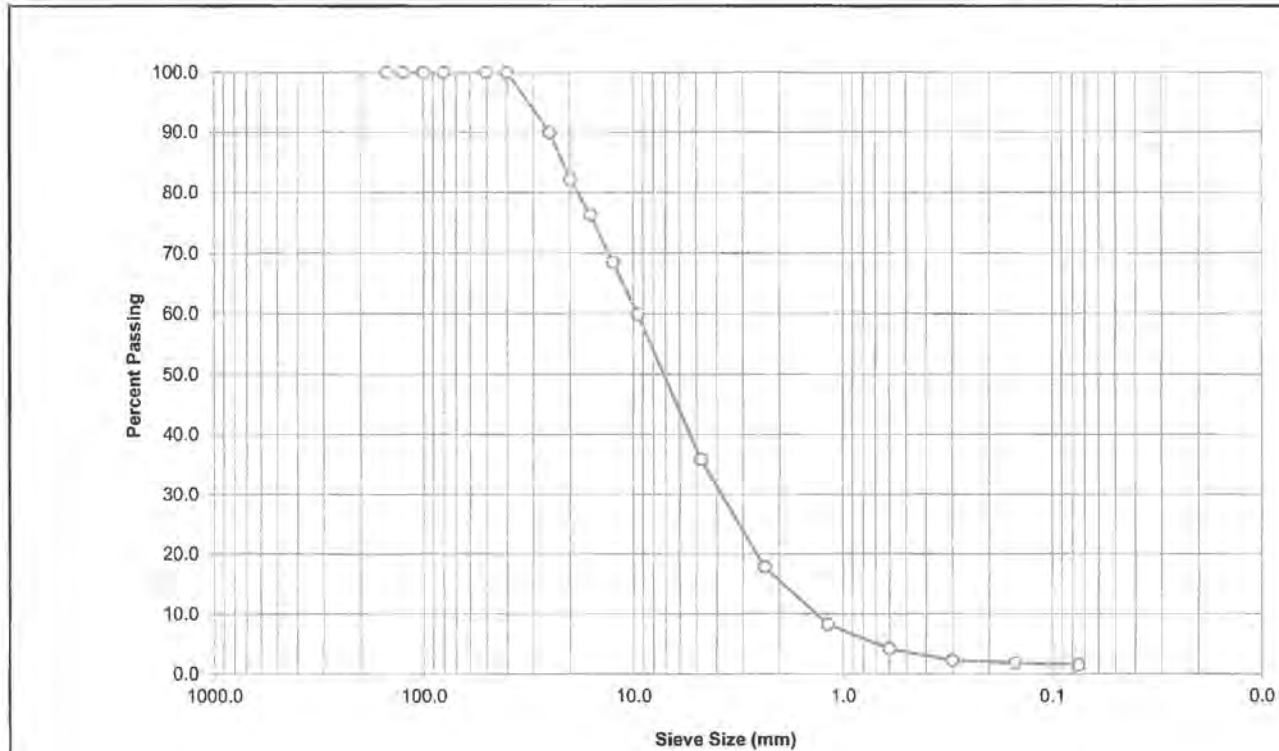
SAMPLE #: **BS-2015-002**
SOURCE: **GD11**
TESTED BY: **ST**

DATE RECEIVED: **September 4, 2015**
DATE TESTED: **September 15, 2015**
SAMPLE DESCRIPTION: **Well graded gravel with sand**

Sieve (mm)	Sample % Passing	Specifications	
		Lower	Upper
150.0	100.0	-	-
125.0	100.0	-	-
100.0	100.0	-	-
80.0	100.0	-	-
50.0	100.0	-	-
40.0	100.0	-	-
25.0	89.9	-	-
20.0	82.2	-	-
16.0	76.3	-	-
12.5	68.5	-	-
9.5	59.9	-	-
4.75	35.8	-	-
2.36	17.8	-	-
1.18	8.2	-	-
0.600	4.2	-	-
0.300	2.3	-	-
0.150	1.8	-	-
0.075	1.5	-	-

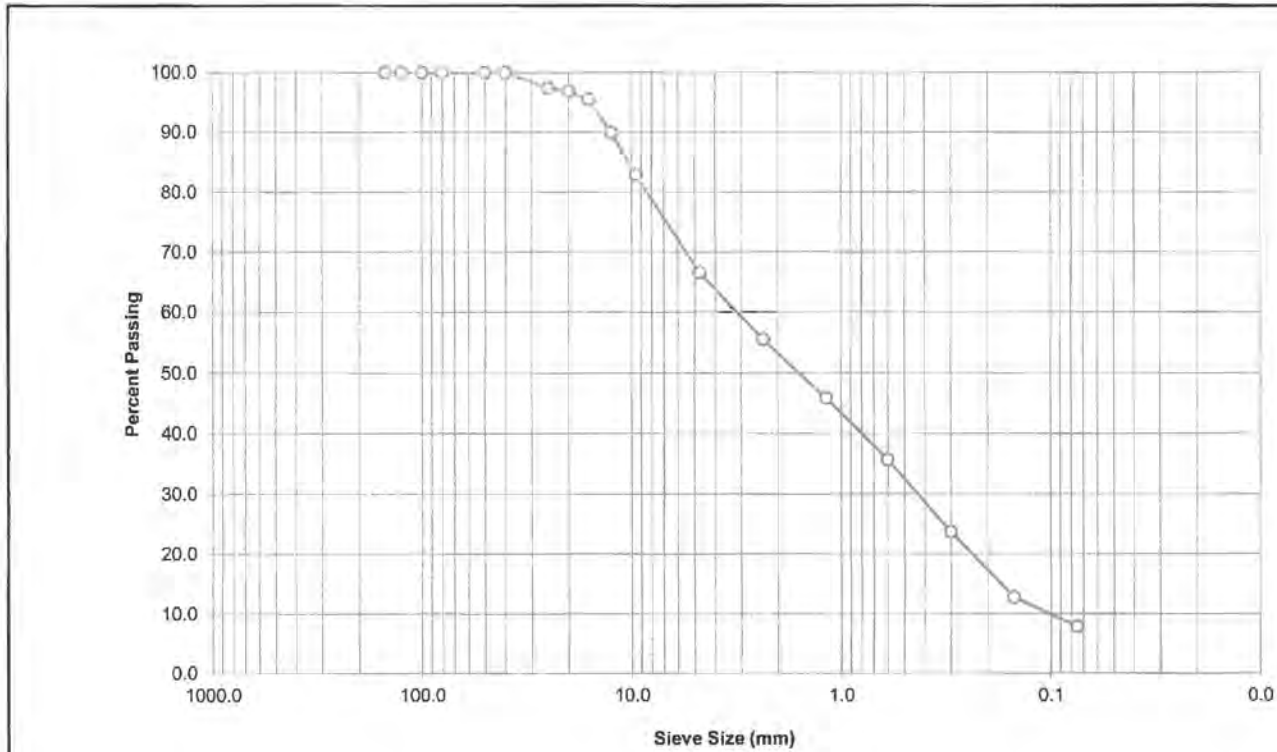
SAMPLE #: **BS-2015-003**
SOURCE: **GD11**
TESTED BY: **ST**

DATE RECEIVED: **September 4, 2015**
DATE TESTED: **September 15, 2015**
SAMPLE DESCRIPTION: **Poorly graded sand with silt and/or clay and gravel**

Sieve (mm)	Sample % Passing	Specifications	
		Lower	Upper
150.0	100.0	-	-
125.0	100.0	-	-
100.0	100.0	-	-
80.0	100.0	-	-
50.0	100.0	-	-
40.0	100.0	-	-
25.0	97.3	-	-
20.0	96.9	-	-
16.0	95.5	-	-
12.5	89.9	-	-
9.5	82.9	-	-
4.75	66.5	-	-
2.36	55.5	-	-
1.18	45.8	-	-
0.600	35.7	-	-
0.300	23.6	-	-
0.150	12.7	-	-
0.075	7.8	-	-

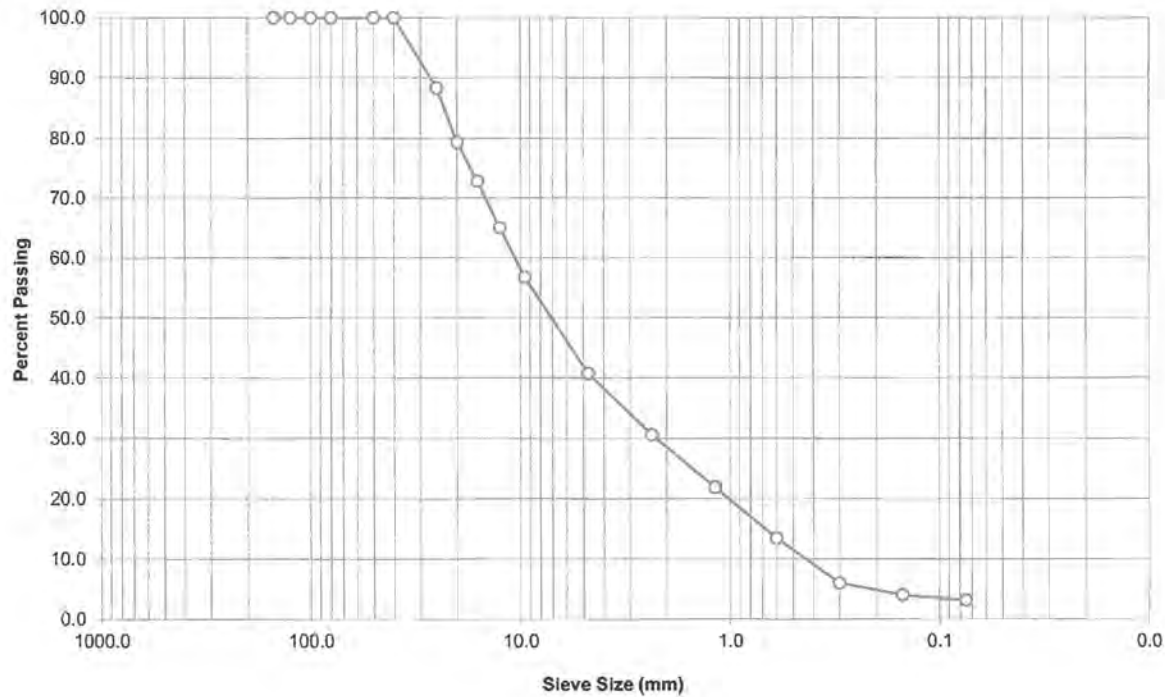
SAMPLE #: **BS-2015-001A**
SOURCE: **GD28**
TESTED BY: **ST**

DATE RECEIVED: **September 4, 2015**
DATE TESTED: **September 15, 2015**
SAMPLE DESCRIPTION: **Well graded gravel with sand**

Sieve (mm)	Sample % Passing	Specifications	
		Lower	Upper
150.0	100.0	-	-
125.0	100.0	-	-
100.0	100.0	-	-
80.0	100.0	-	-
50.0	100.0	-	-
40.0	100.0	-	-
25.0	88.3	-	-
20.0	79.3	-	-
16.0	72.8	-	-
12.5	65.0	-	-
9.5	56.7	-	-
4.75	40.7	-	-
2.36	30.6	-	-
1.18	21.9	-	-
0.600	13.4	-	-
0.300	6.0	-	-
0.150	4.0	-	-
0.075	3.2	-	-

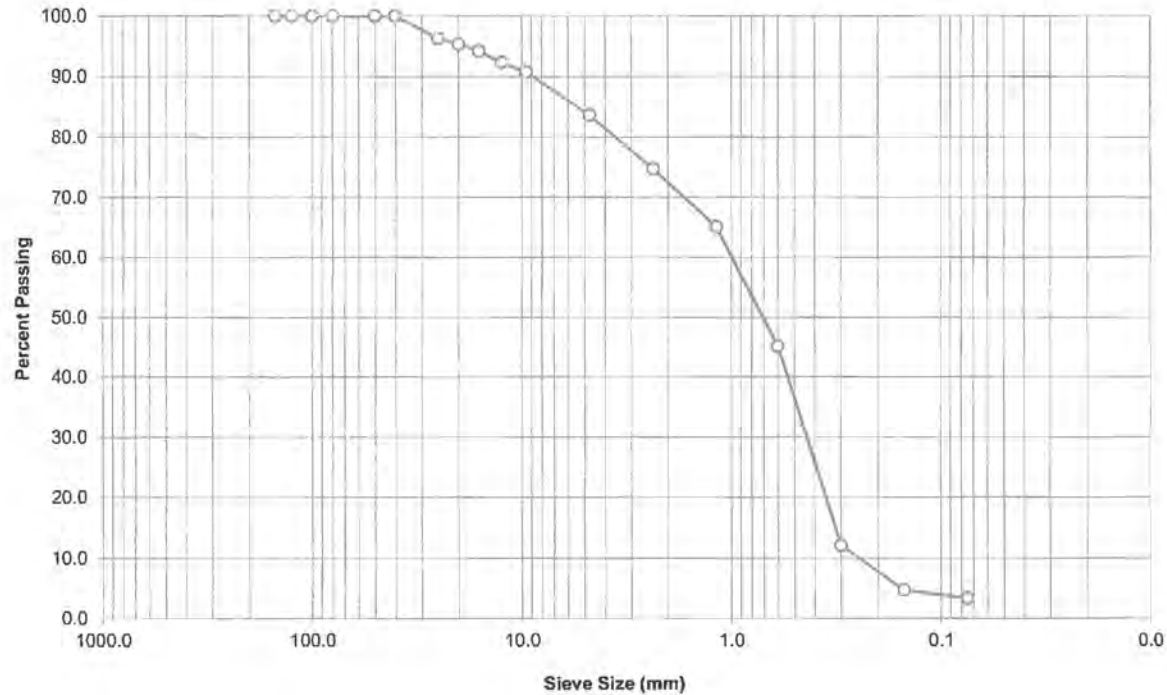
SAMPLE #: **BS-2015-001B**
SOURCE: **GD28**
TESTED BY: **ST**

DATE RECEIVED: **September 4, 2015**
DATE TESTED: **September 15, 2015**
SAMPLE DESCRIPTION: **Poorly graded sand with gravel**

Sieve (mm)	Sample % Passing	Specifications	
		Lower	Upper
150.0	100.0	-	-
125.0	100.0	-	-
100.0	100.0	-	-
80.0	100.0	-	-
50.0	100.0	-	-
40.0	100.0	-	-
25.0	96.3	-	-
20.0	95.3	-	-
16.0	94.2	-	-
12.5	92.3	-	-
9.5	90.7	-	-
4.75	83.7	-	-
2.36	74.7	-	-
1.18	65.1	-	-
0.600	45.2	-	-
0.300	12.1	-	-
0.150	4.7	-	-
0.075	3.4	-	-
