**FINAL REPORT: GORDON LAKE
GROUP REMEDIAL ACTION
PLAN**

Prepared for:
Public Works and Government
Services Canada and Aboriginal
Affairs and Northern
Development Canada

Prepared by:
Stantec Consulting Ltd.

March 31, 2016

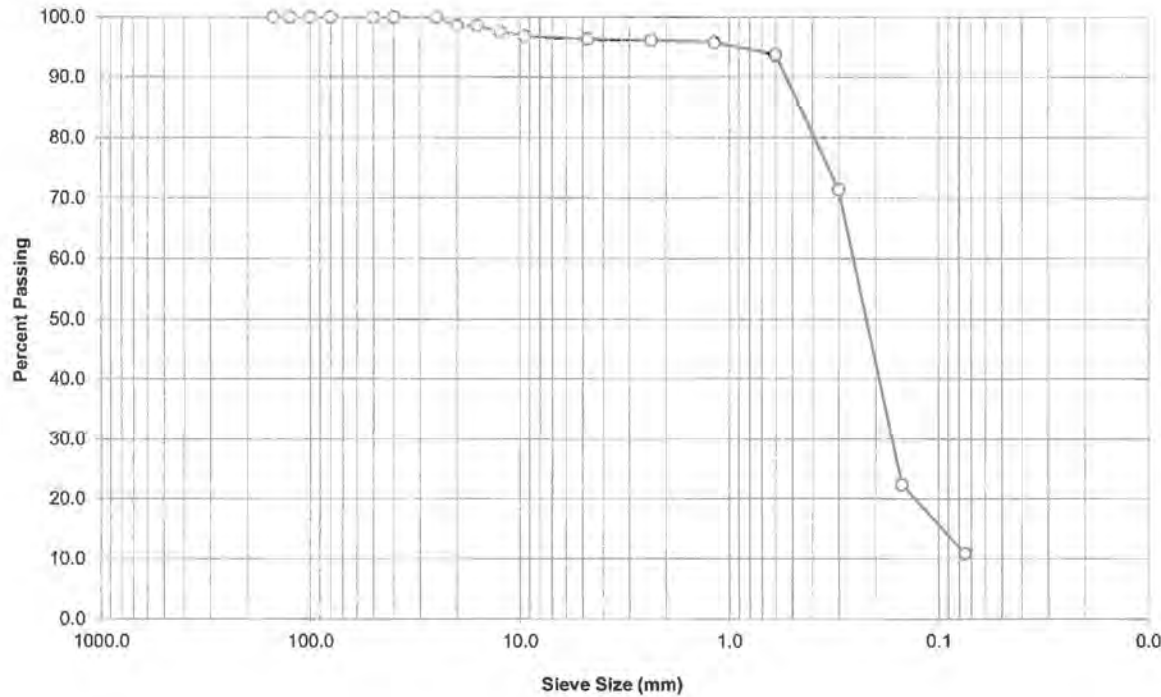
SAMPLE #: **BS-2015-002**
SOURCE: **GD28**
TESTED BY: **ST**

DATE RECEIVED: **September 4, 2015**
DATE TESTED: **September 15, 2015**
SAMPLE DESCRIPTION: **Poorly graded sand with silt and/or clay**

Sieve (mm)	Sample % Passing	Specifications	
		Lower	Upper
150.0	100.0	-	-
125.0	100.0	-	-
100.0	100.0	-	-
80.0	100.0	-	-
50.0	100.0	-	-
40.0	100.0	-	-
25.0	100.0	-	-
20.0	98.5	-	-
16.0	98.5	-	-
12.5	97.6	-	-
9.5	96.8	-	-
4.75	96.3	-	-
2.36	96.1	-	-
1.18	95.8	-	-
0.600	93.7	-	-
0.300	71.4	-	-
0.150	22.3	-	-
0.075	10.8	-	-

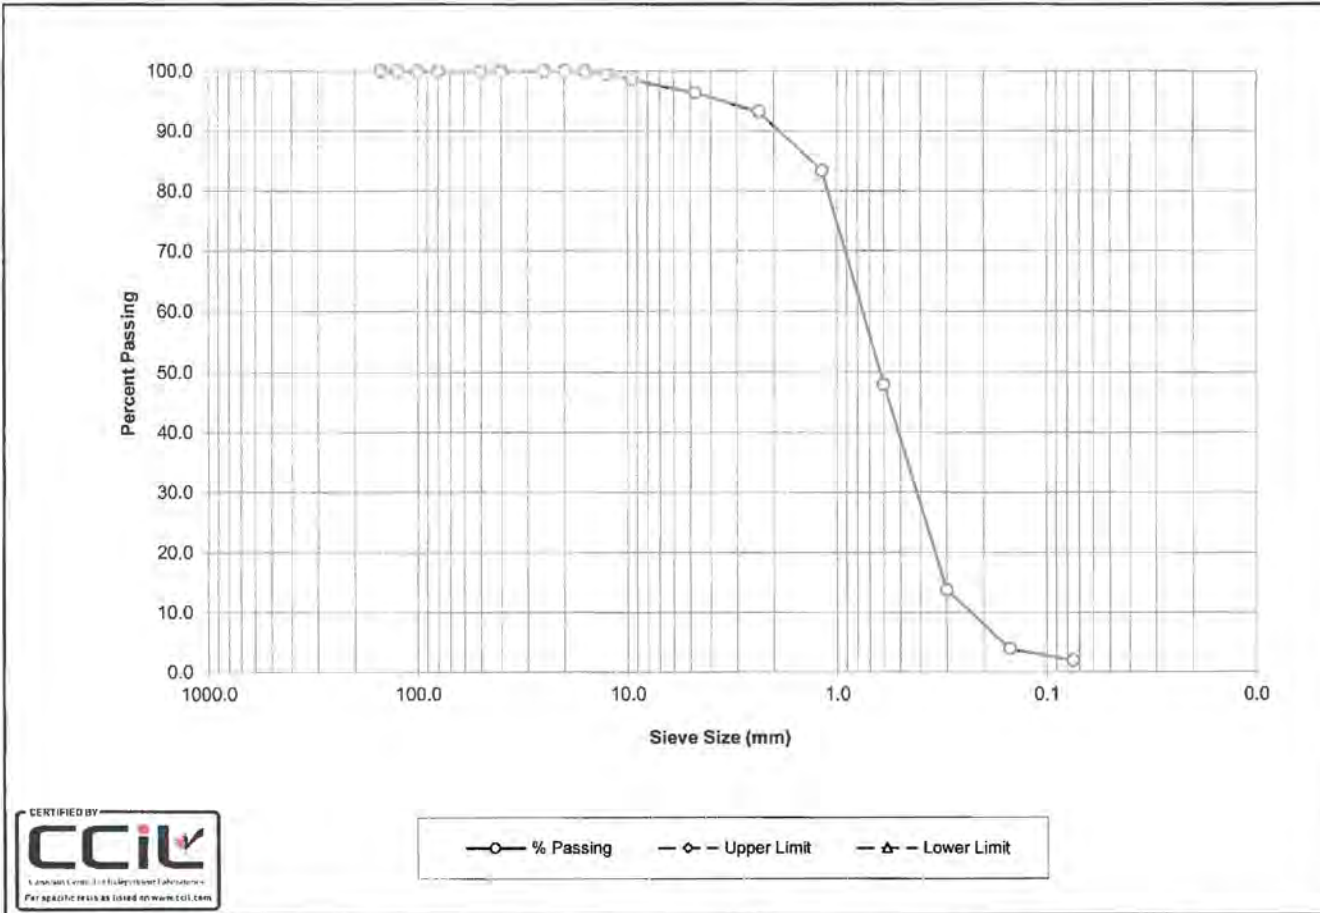
SAMPLE #: **BS-2015-003** DATE RECEIVED: **September 4, 2015**
 SOURCE: **GD28** DATE TESTED: **September 15, 2015**
 TESTED BY: **ST** SAMPLE DESCRIPTION: **Poorly graded sand**

Sieve (mm)	Sample % Passing	Specifications	
		Lower	Upper
150.0	100.0	-	-
125.0	100.0	-	-
100.0	100.0	-	-
80.0	100.0	-	-
50.0	100.0	-	-
40.0	100.0	-	-
25.0	100.0	-	-
20.0	100.0	-	-
16.0	100.0	-	-
12.5	99.3	-	-
9.5	98.5	-	-
4.75	96.3	-	-
2.36	93.2	-	-
1.18	83.3	-	-
0.600	48.0	-	-
0.300	13.7	-	-
0.150	3.8	-	-
0.075	1.9	-	-

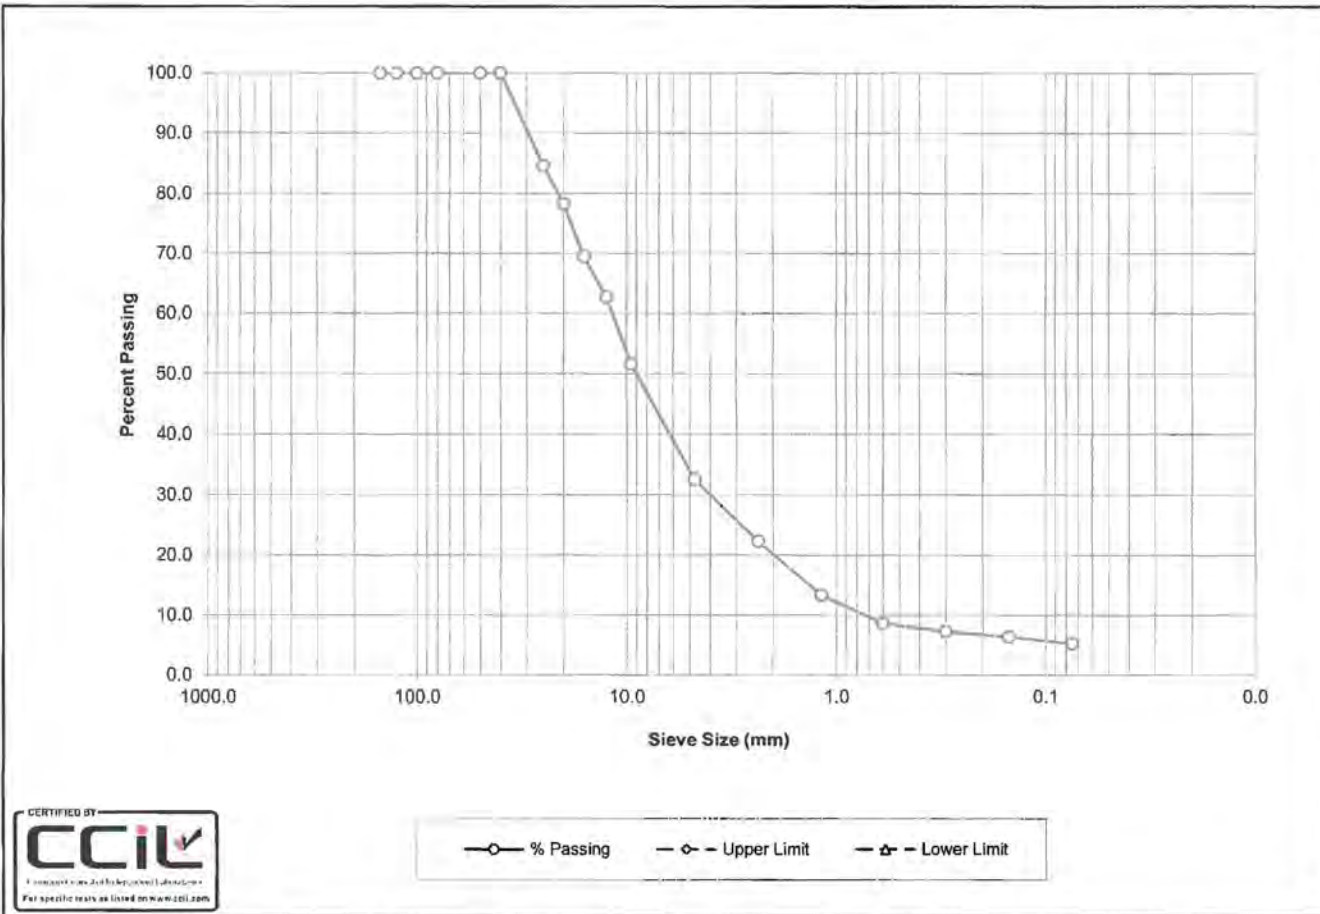
SAMPLE #: **BS-2015-001**
SOURCE: **GD65**
TESTED BY: **ST**

DATE RECEIVED: **September 4, 2015**
DATE TESTED: **September 15, 2015**
SAMPLE DESCRIPTION: **Well graded gravel with silt and/or clay and sand**

Sieve (mm)	Sample % Passing	Specifications	
		Lower	Upper
150.0	100.0	-	-
125.0	100.0	-	-
100.0	100.0	-	-
80.0	100.0	-	-
50.0	100.0	-	-
40.0	100.0	-	-
25.0	84.6	-	-
20.0	78.2	-	-
16.0	69.5	-	-
12.5	62.7	-	-
9.5	51.6	-	-
4.75	32.6	-	-
2.36	22.3	-	-
1.18	13.3	-	-
0.600	8.6	-	-
0.300	7.3	-	-
0.150	6.4	-	-
0.075	5.2	-	-

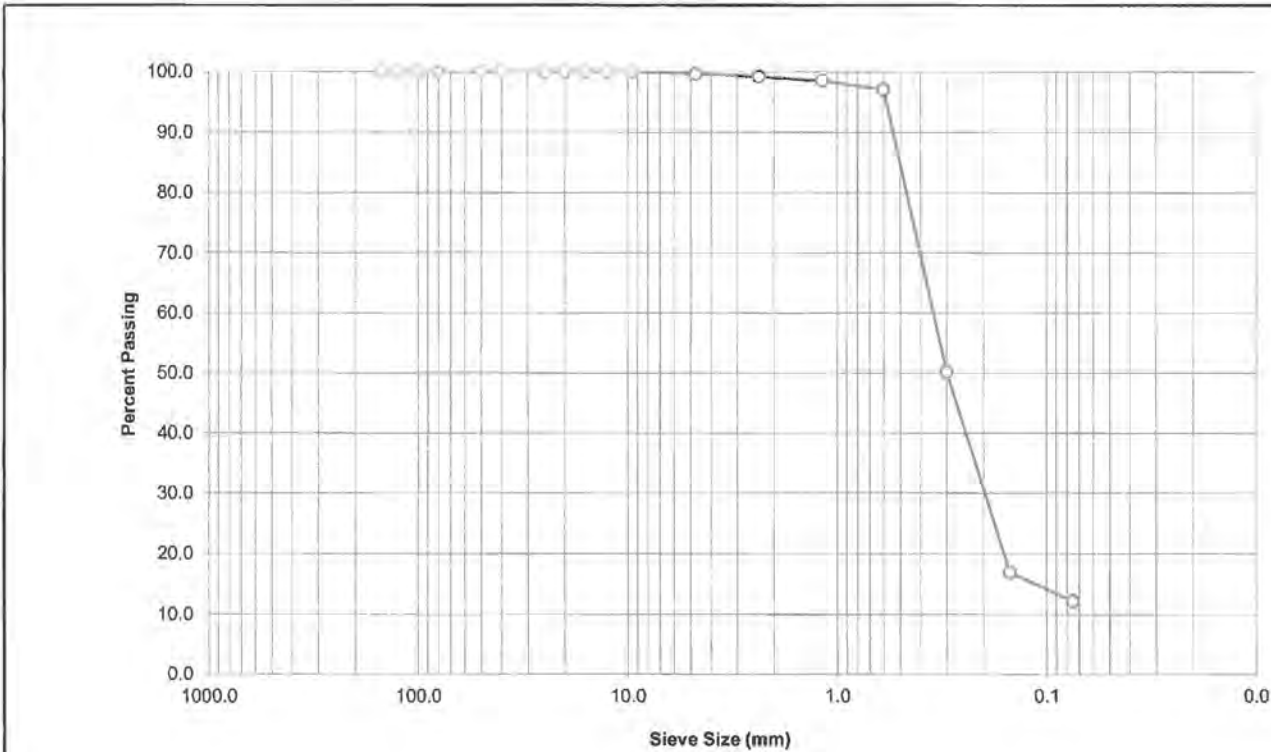
SAMPLE #: **BS-2015-002B**
 SOURCE: **GD65**
 TESTED BY: **ST**

DATE RECEIVED: **September 4, 2015**
 DATE TESTED: **September 15, 2015**
 SAMPLE DESCRIPTION: **Silty and/or clayey sand**

Sieve (mm)	Sample % Passing	Specifications	
		Lower	Upper
150.0	100.0	-	-
125.0	100.0	-	-
100.0	100.0	-	-
80.0	100.0	-	-
50.0	100.0	-	-
40.0	100.0	-	-
25.0	100.0	-	-
20.0	100.0	-	-
16.0	100.0	-	-
12.5	100.0	-	-
9.5	100.0	-	-
4.75	99.6	-	-
2.36	99.2	-	-
1.18	98.5	-	-
0.600	97.1	-	-
0.300	50.1	-	-
0.150	16.9	-	-
0.075	12.2	-	-

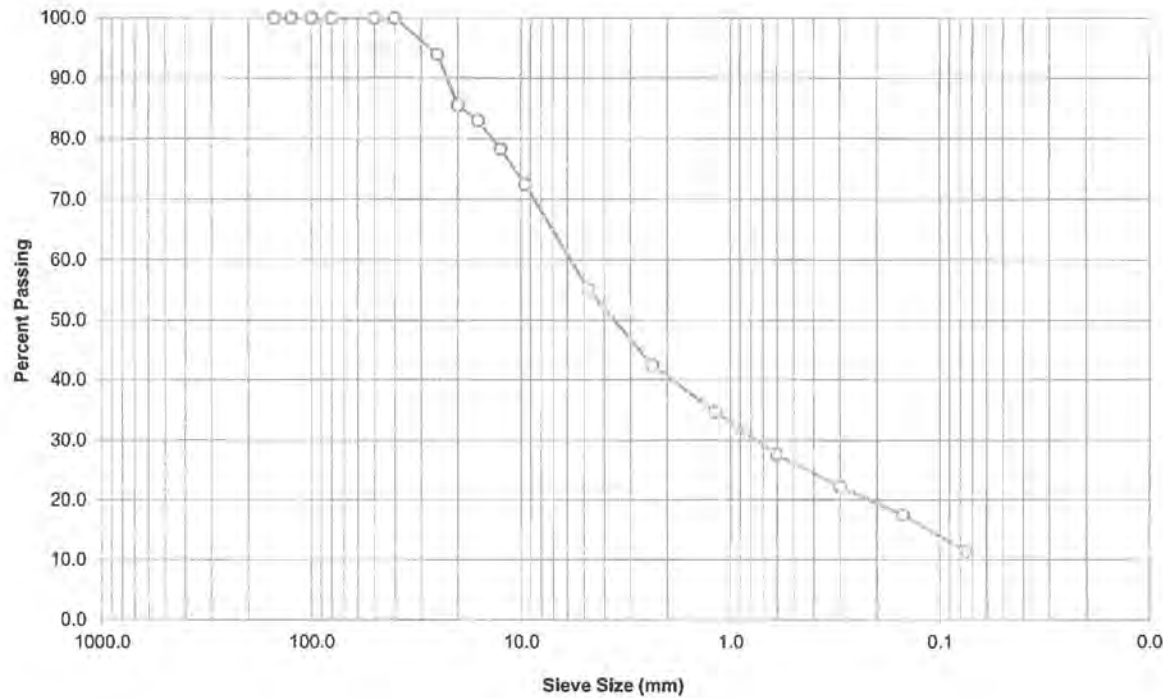
SAMPLE #: **BS-2015-003**
SOURCE: **GD65**
TESTED BY: **ST**

DATE RECEIVED: **September 4, 2015**
DATE TESTED: **September 15, 2015**
SAMPLE DESCRIPTION: **Well graded gravel with silt and/or clay and sand**

Sieve (mm)	Sample % Passing	Specifications	
		Lower	Upper
150.0	100.0	-	-
125.0	100.0	-	-
100.0	100.0	-	-
80.0	100.0	-	-
50.0	100.0	-	-
40.0	100.0	-	-
25.0	93.9	-	-
20.0	85.6	-	-
16.0	83.0	-	-
12.5	78.3	-	-
9.5	72.4	-	-
4.75	55.1	-	-
2.36	42.5	-	-
1.18	34.7	-	-
0.600	27.6	-	-
0.300	22.2	-	-
0.150	17.5	-	-
0.075	11.4	-	-

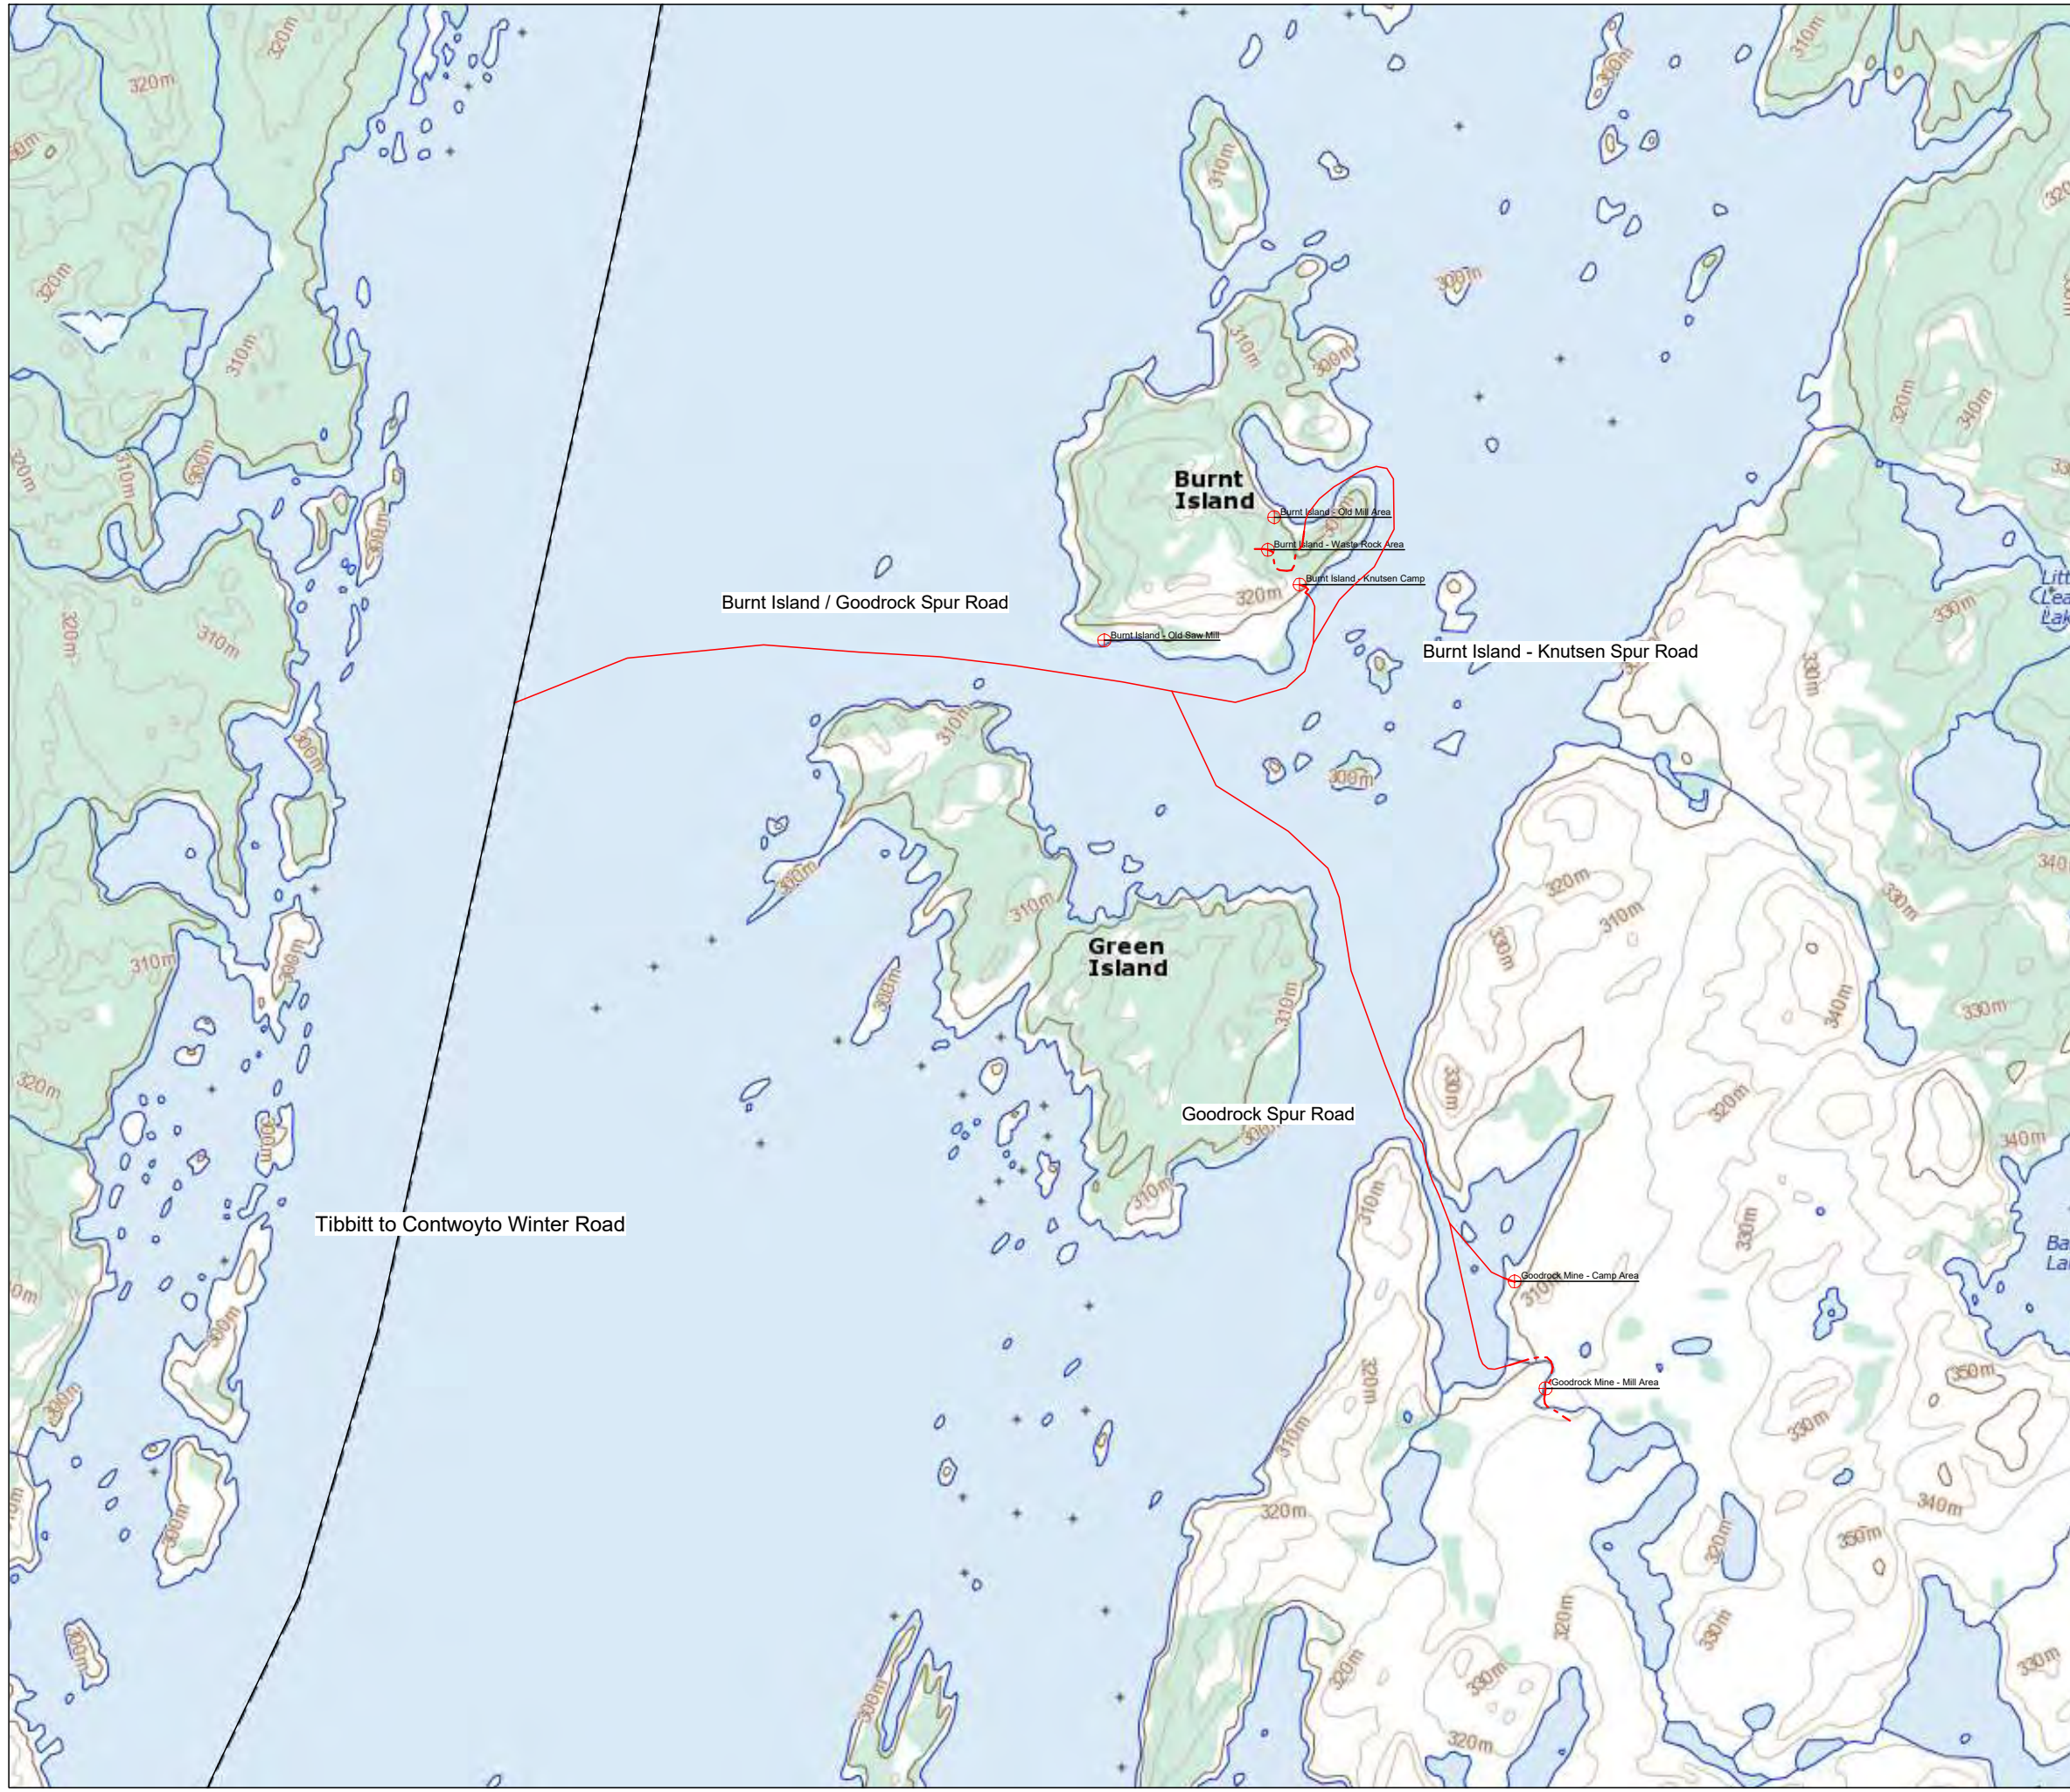
Gordon Lake Group Remediation Project - Routing Study

Reference base maps from Natural Resources Canada:
Toporama - 085P03 - GORDON LAKE, Northwest Territories
Map Projection: UTM NAD '83 Zone 12N, Metric (metres)

Plan Scale 1:25,000

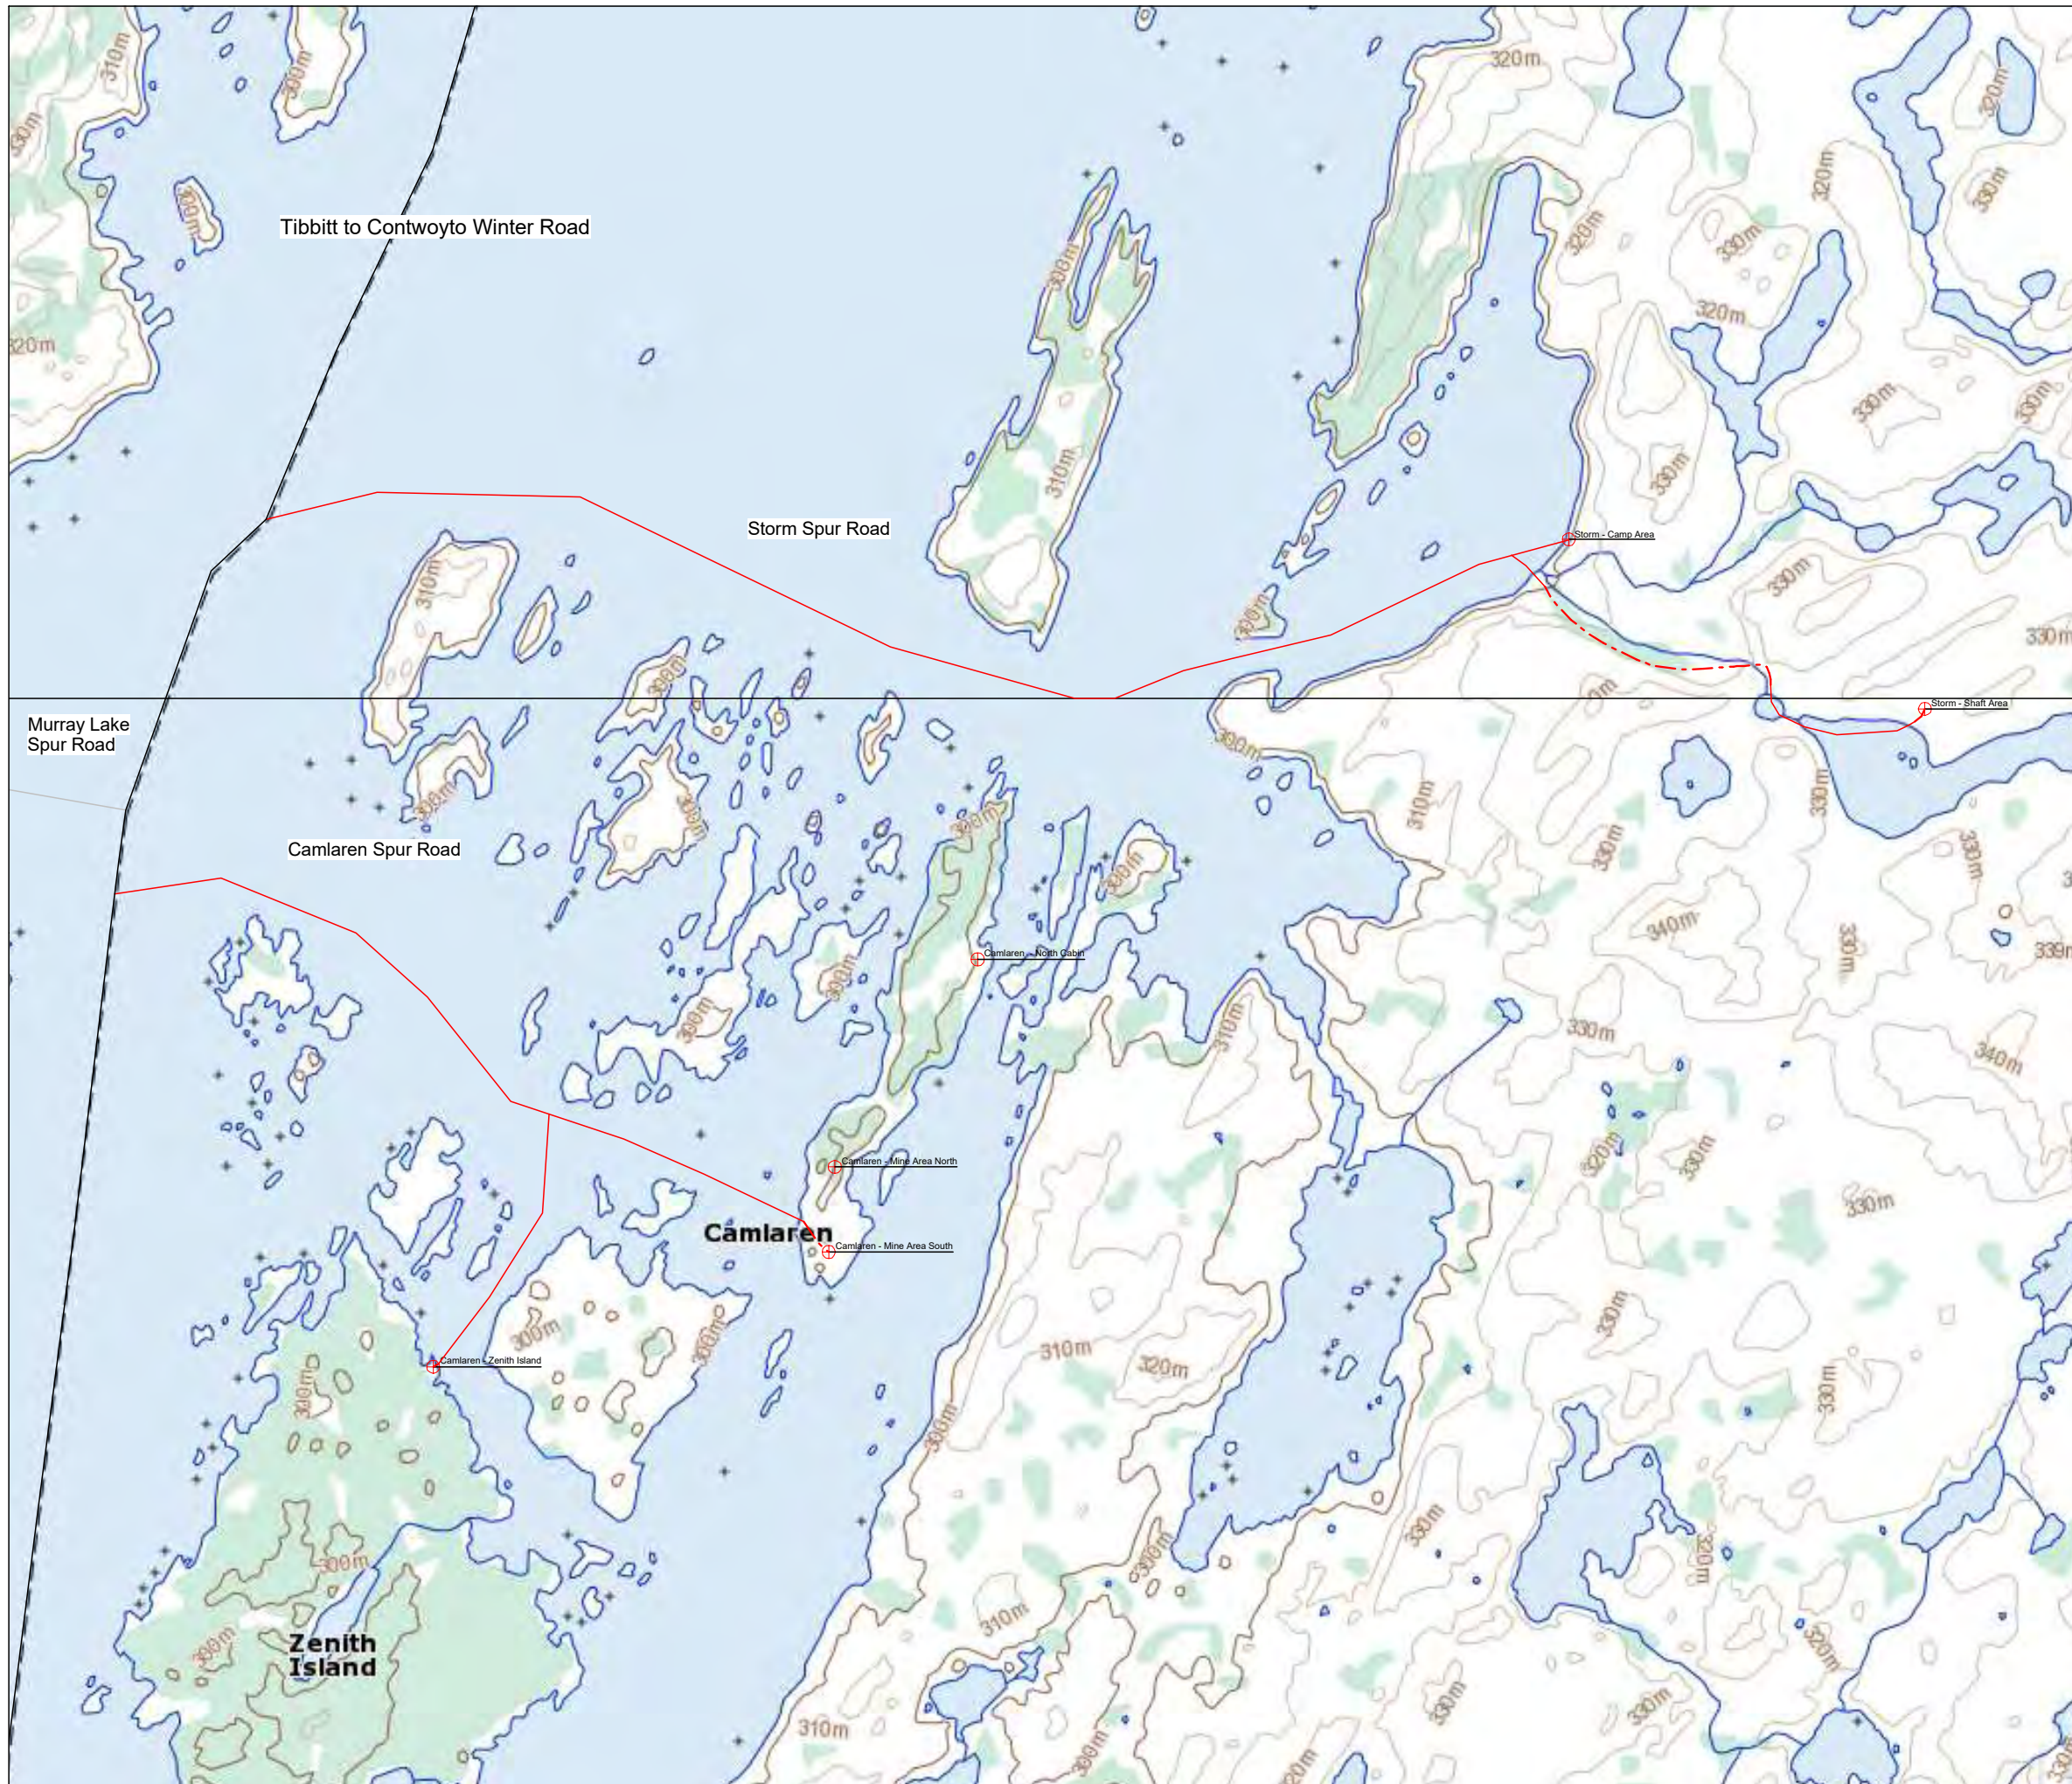
Gordon Lake Group Remediation Project - Routing Study

Reference base maps from Natural Resources Canada:
Toporama - 085P03 - GORDON LAKE, Northwest Territories
Toporama - 085I14 - ZENITH ISLAND, Northwest Territories
Map Projection: UTM NAD '83 Zone 12N, Metric (metres)

Plan Scale 1:25,000

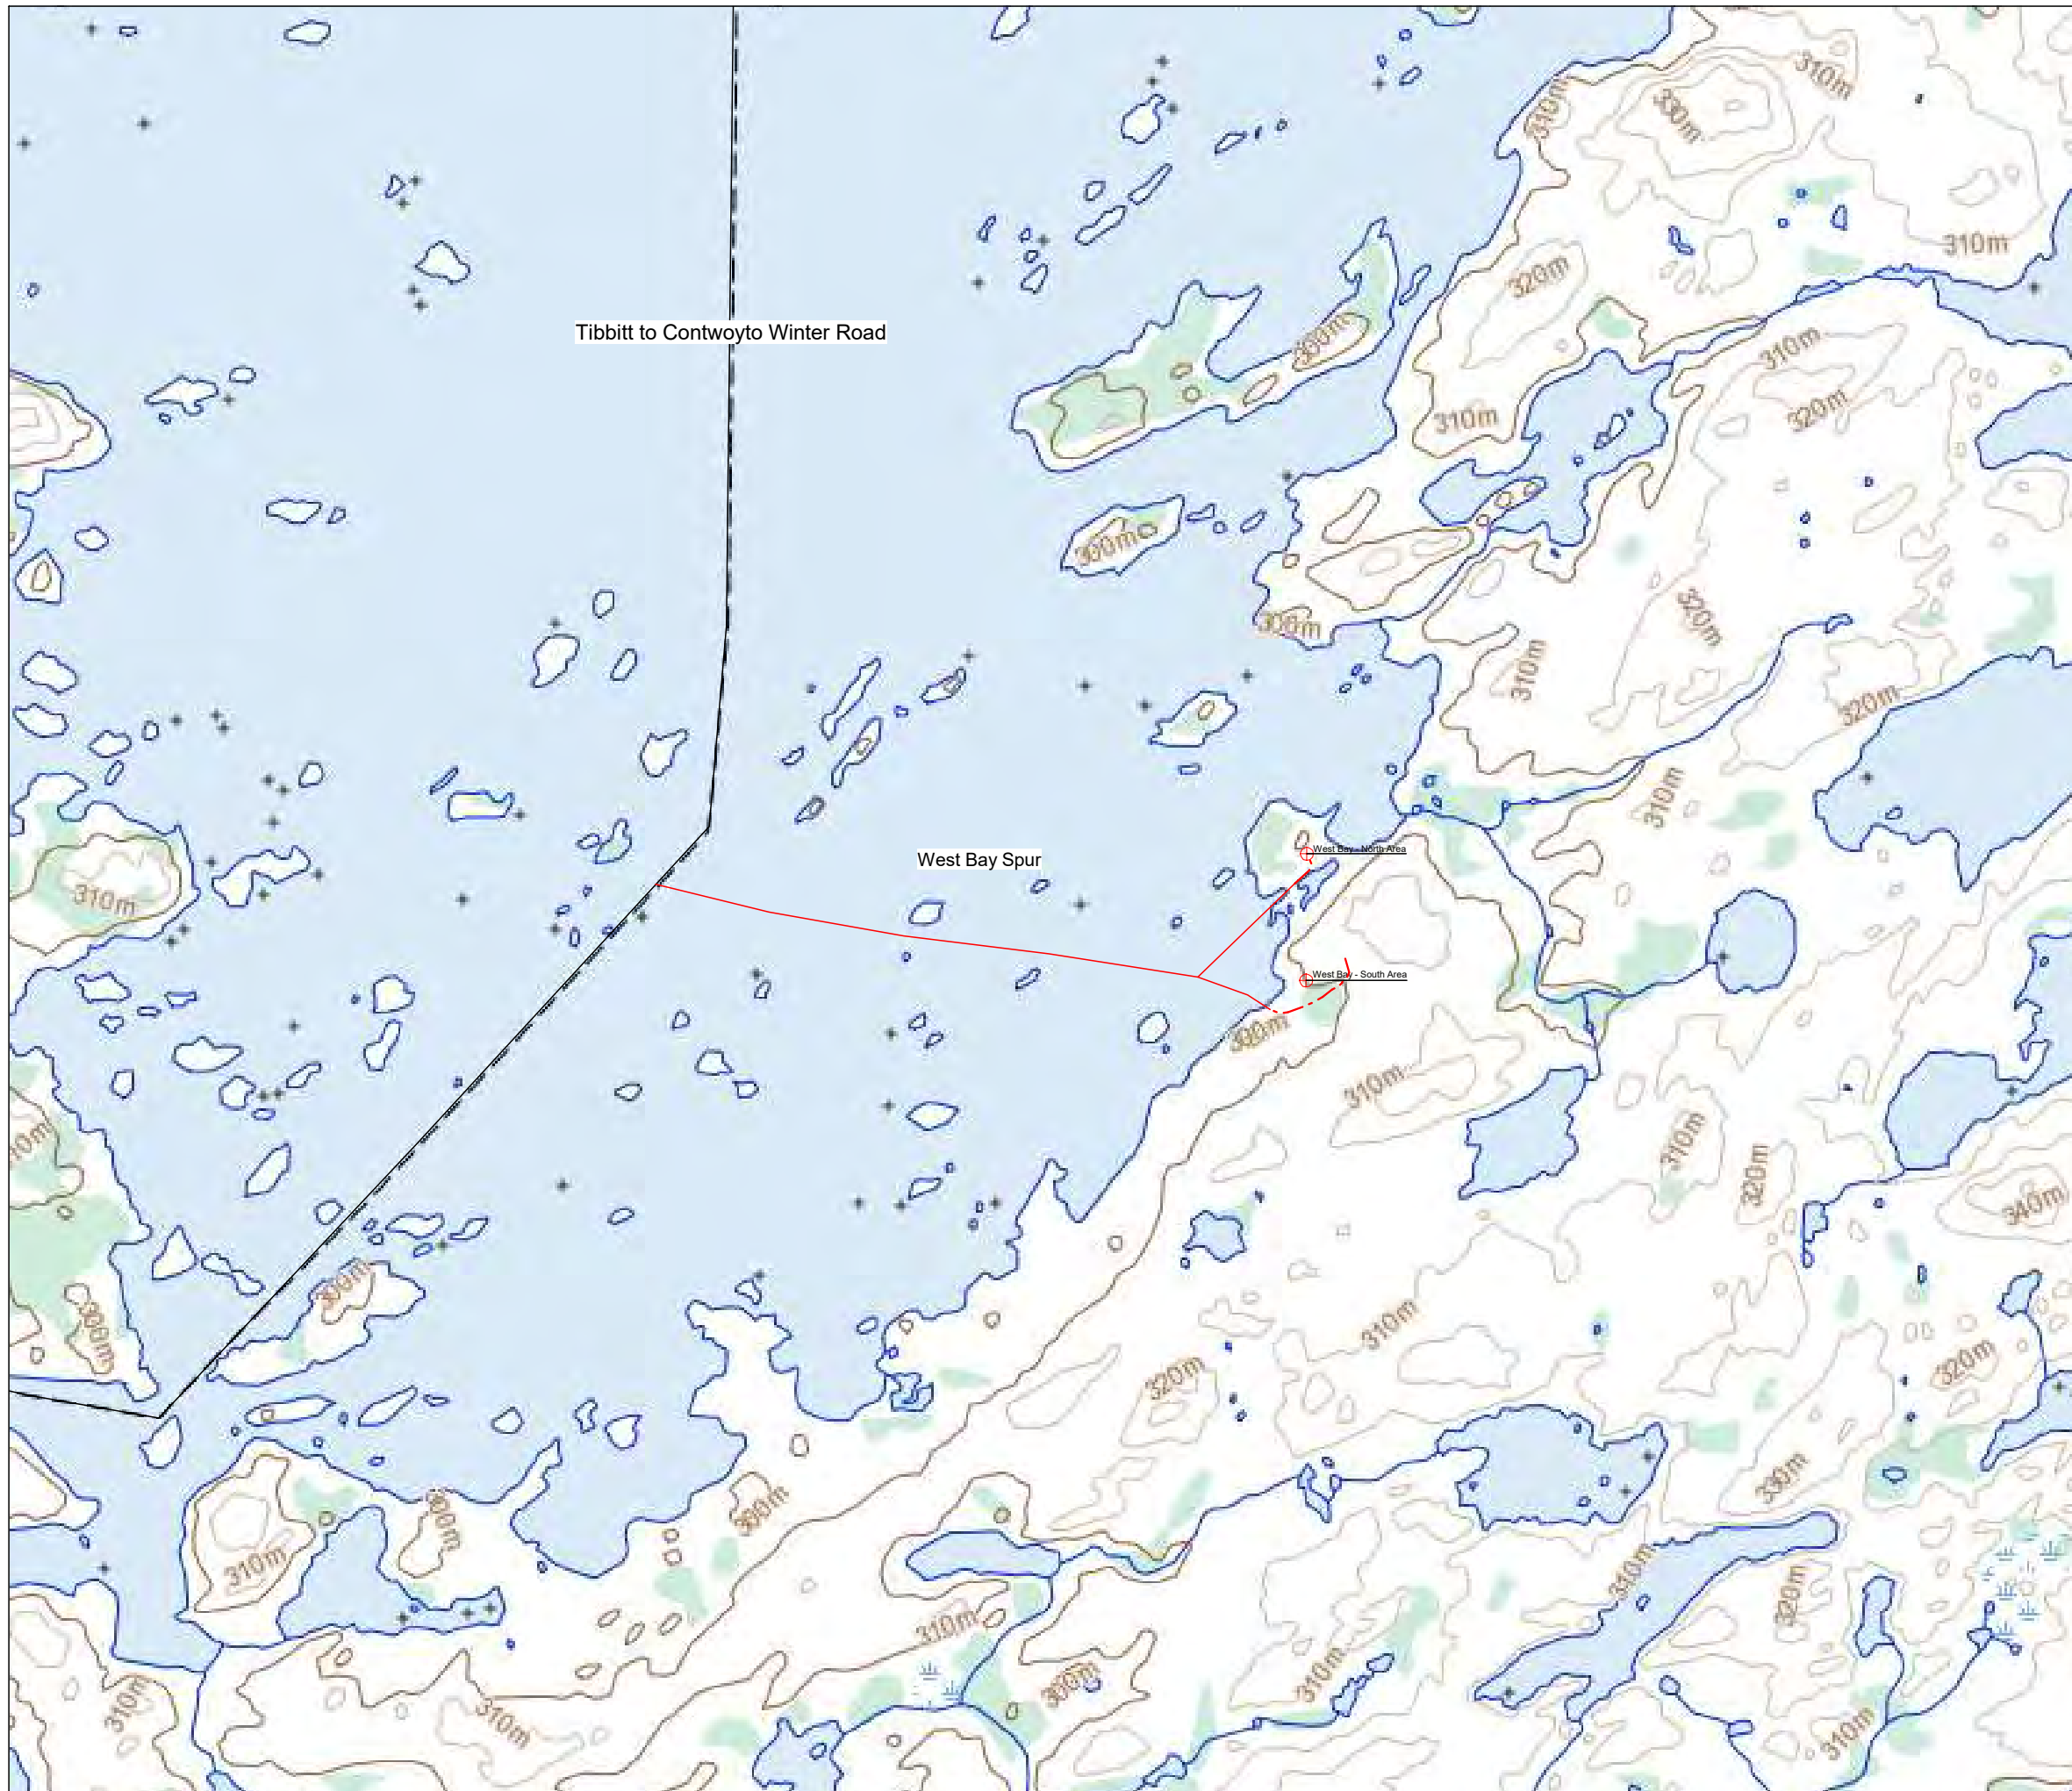
Gordon Lake Group Remediation Project - Routing Study

Reference base maps from Natural Resources Canada:
Toporama - 085114 - ZENITH ISLAND, Northwest Territories
Map Projection: UTM NAD '83 Zone 12N, Metric (metres)

Plan Scale 1:20,000

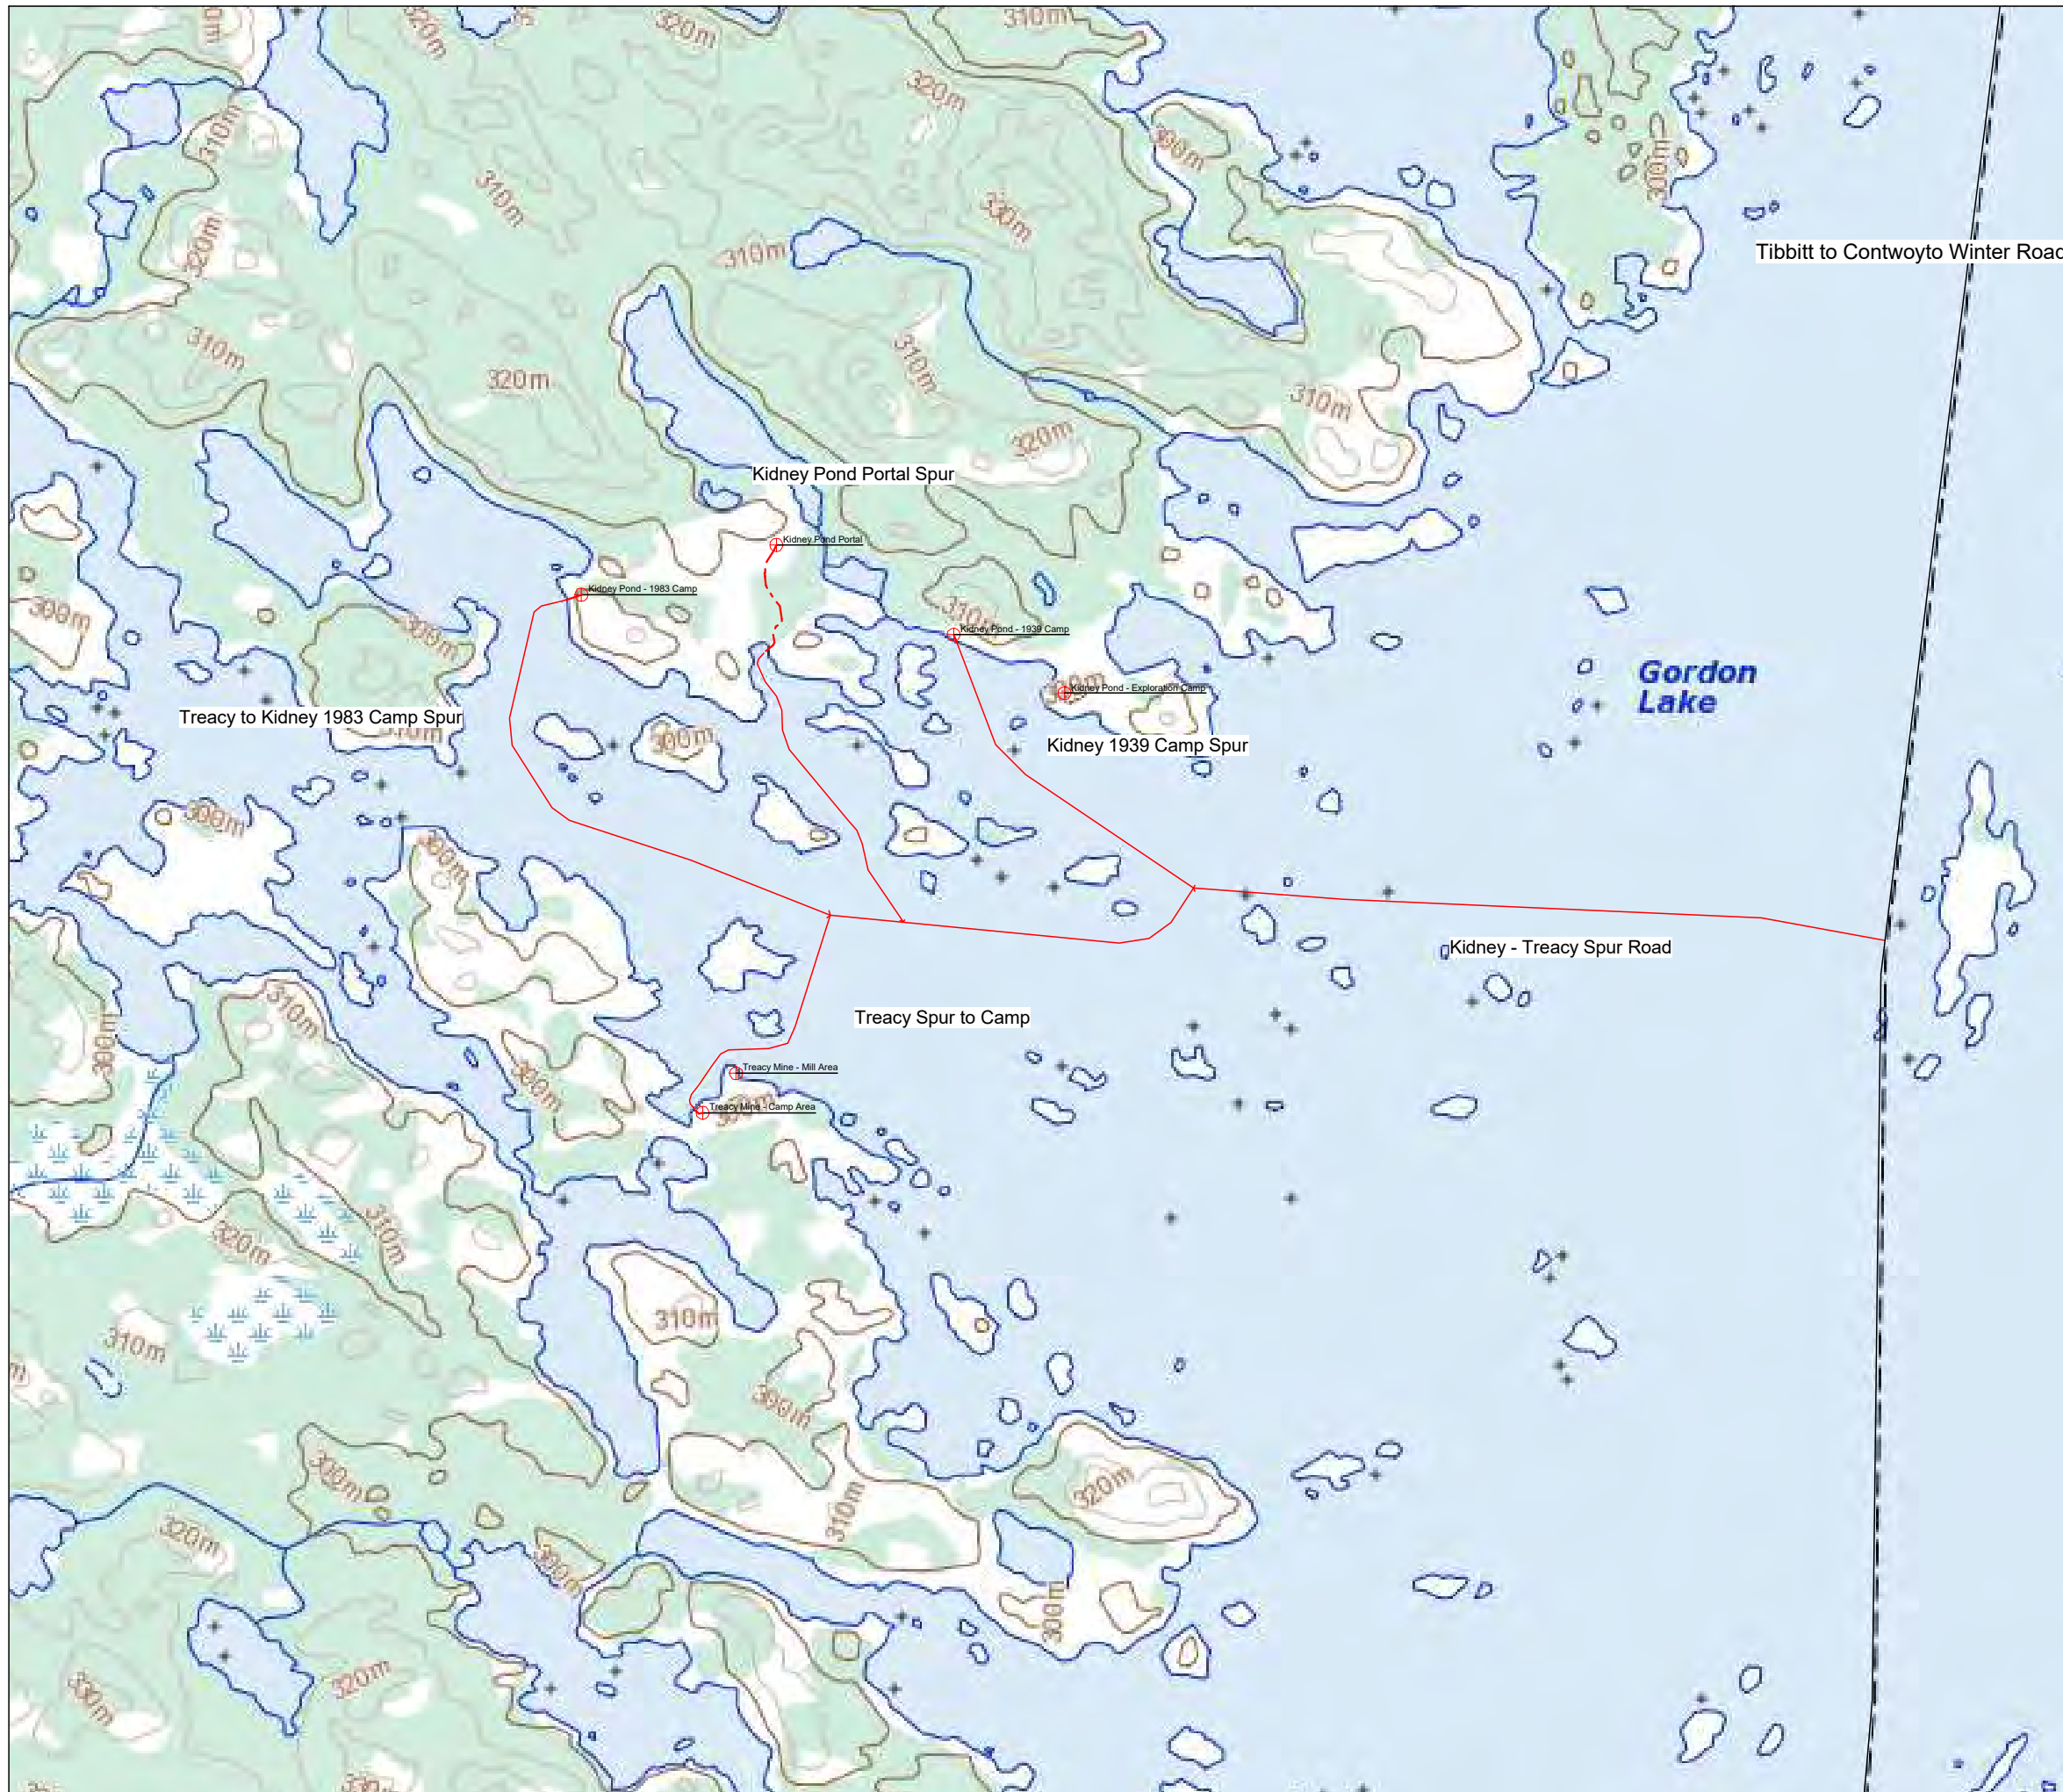
Gordon Lake Group Remediation Project - Routing Study

Reference base maps from Natural Resources Canada:
Toporama - 085114 - ZENITH ISLAND, Northwest Territories
Map Projection: UTM NAD '83 Zone 12N, Metric (metres)

Plan Scale 1:20,000
