**FINAL REPORT: GORDON LAKE
GROUP REMEDIAL ACTION
PLAN**

Prepared for:
Public Works and Government
Services Canada and Aboriginal
Affairs and Northern
Development Canada

Prepared by:
Stantec Consulting Ltd.

March 31, 2016

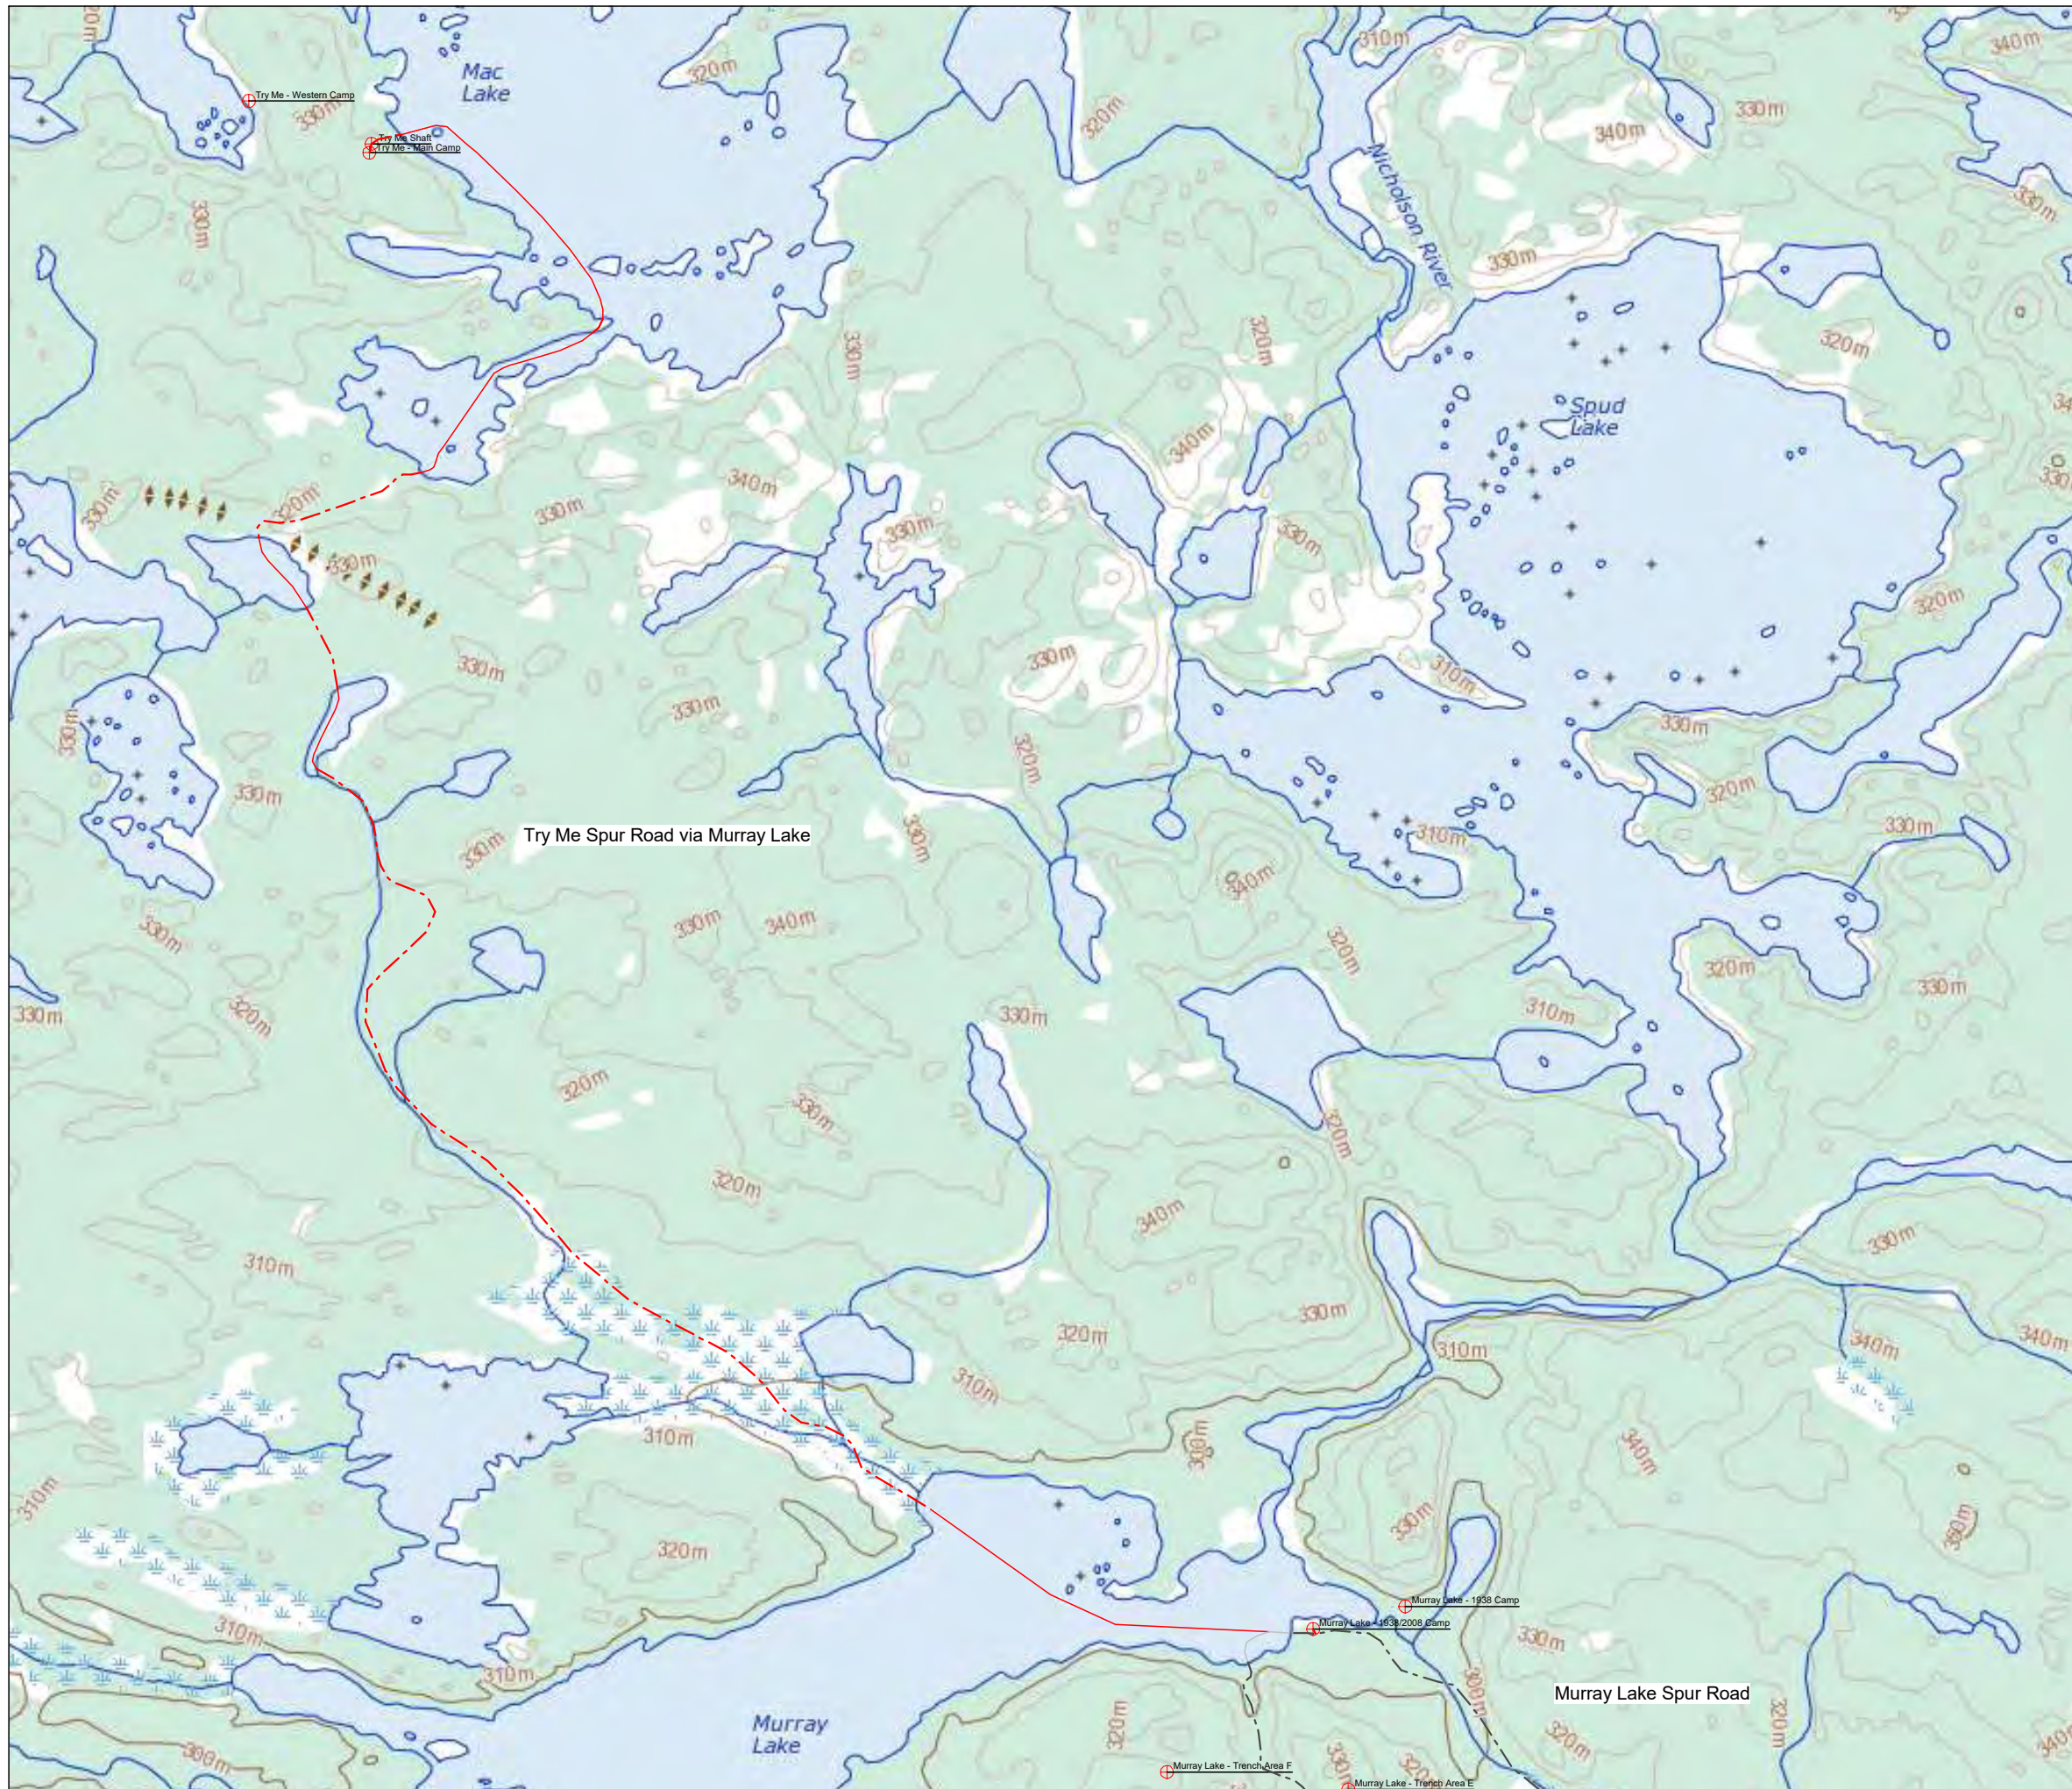
Reference base maps from Natural Resources Canada:
Toporama - 085P03 - GORDON LAKE, Northwest Territories
Map Projection: UTM NAD '83 Zone 12N, Metric (metres)

Plan Scale 1:25,000
