Operation, Maintenance, and Surveillance (OMS) Manual

Giant Mine Remediation Project

Operation, Maintenance and Surveillance Manual (Version G)

Reference No. 18102211-863-R-Rev0-45000D

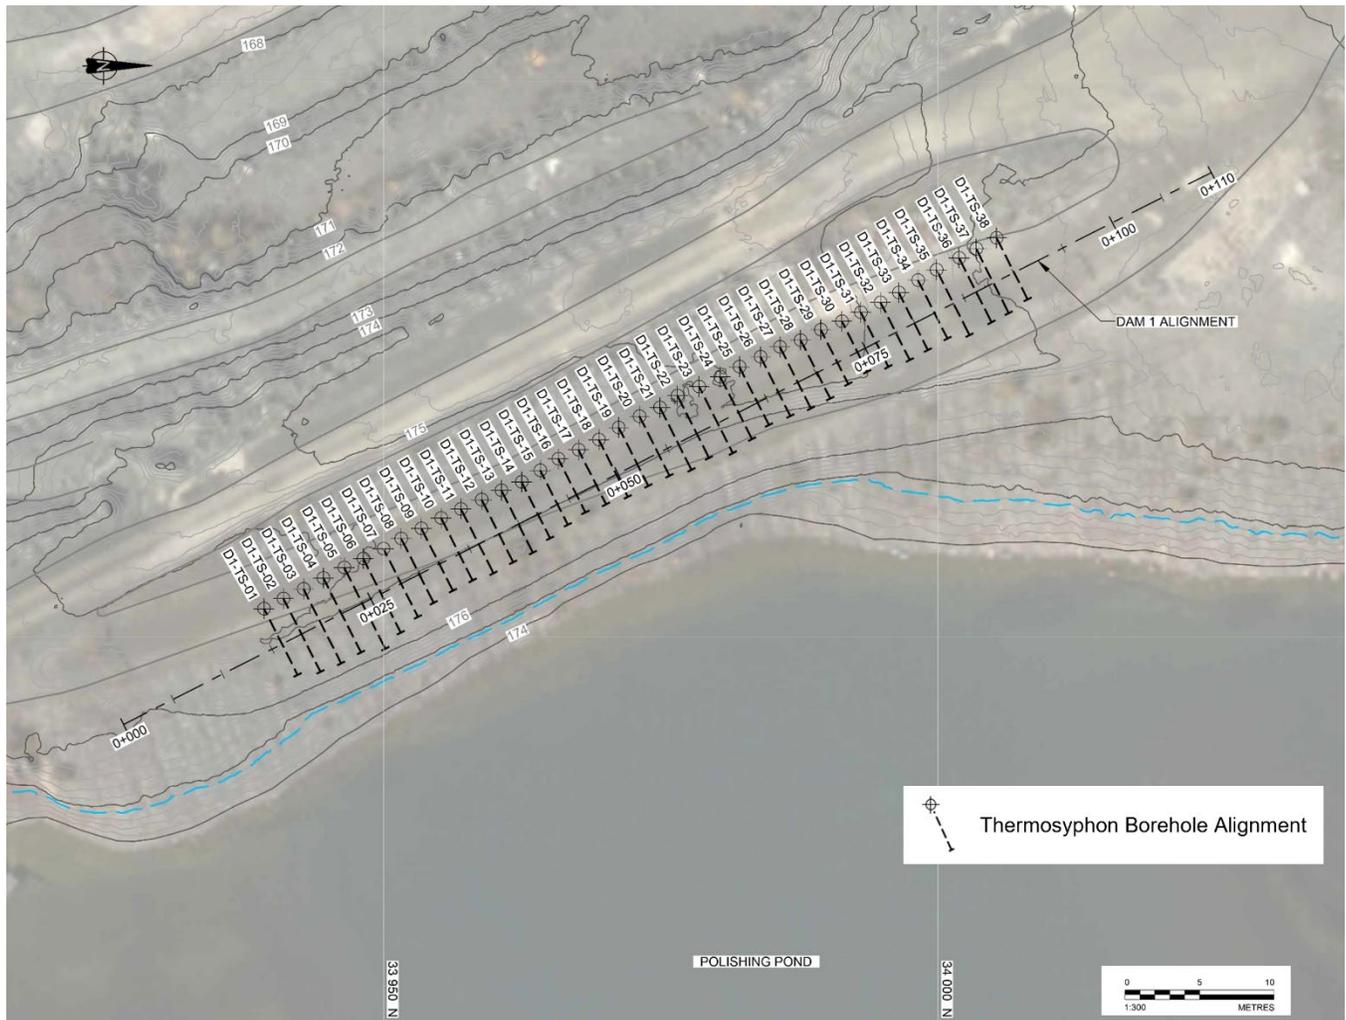
Figure 16: Dam 1 Thermosyphons Alignment

Thirty-eight inclined passive thermosyphons were installed in a row at Dam 1 during remediation works completed in 2020 (Golder 2021b). The location of the thermosyphon row is shown in Figure 16. The thermosyphons were installed to extract heat from the foundation of Dam 1 to induce freeze-back of the permafrost to limit the settlement of the dam.

The thermosyphons are to be visually inspected as part of the routine inspections of Dam 1. Inspections are to identify if thermosyphons appear damaged or require maintenance. If damage is observed, report it to the Mine Manager (Section 9.4.5 provides further maintenance instructions). Also, inspections should note if ponded water or accumulation of snow are observed near the thermosyphons as this may affect thermal performance.
