Water License MV2023L2-0006
Surveillance Network Program (SNP) Monthly Reporting
August 2024

Parsons Inc. (Parsons) was retained by North American Tungsten Corporation Ltd. (NATC) to complete the monthly SNP inspection, sampling and reporting for NATC's Cantung Mine as per Water Licence MV2023L2-0006 (the Licence). NATC carried out its obligations under the License during the August field activities.

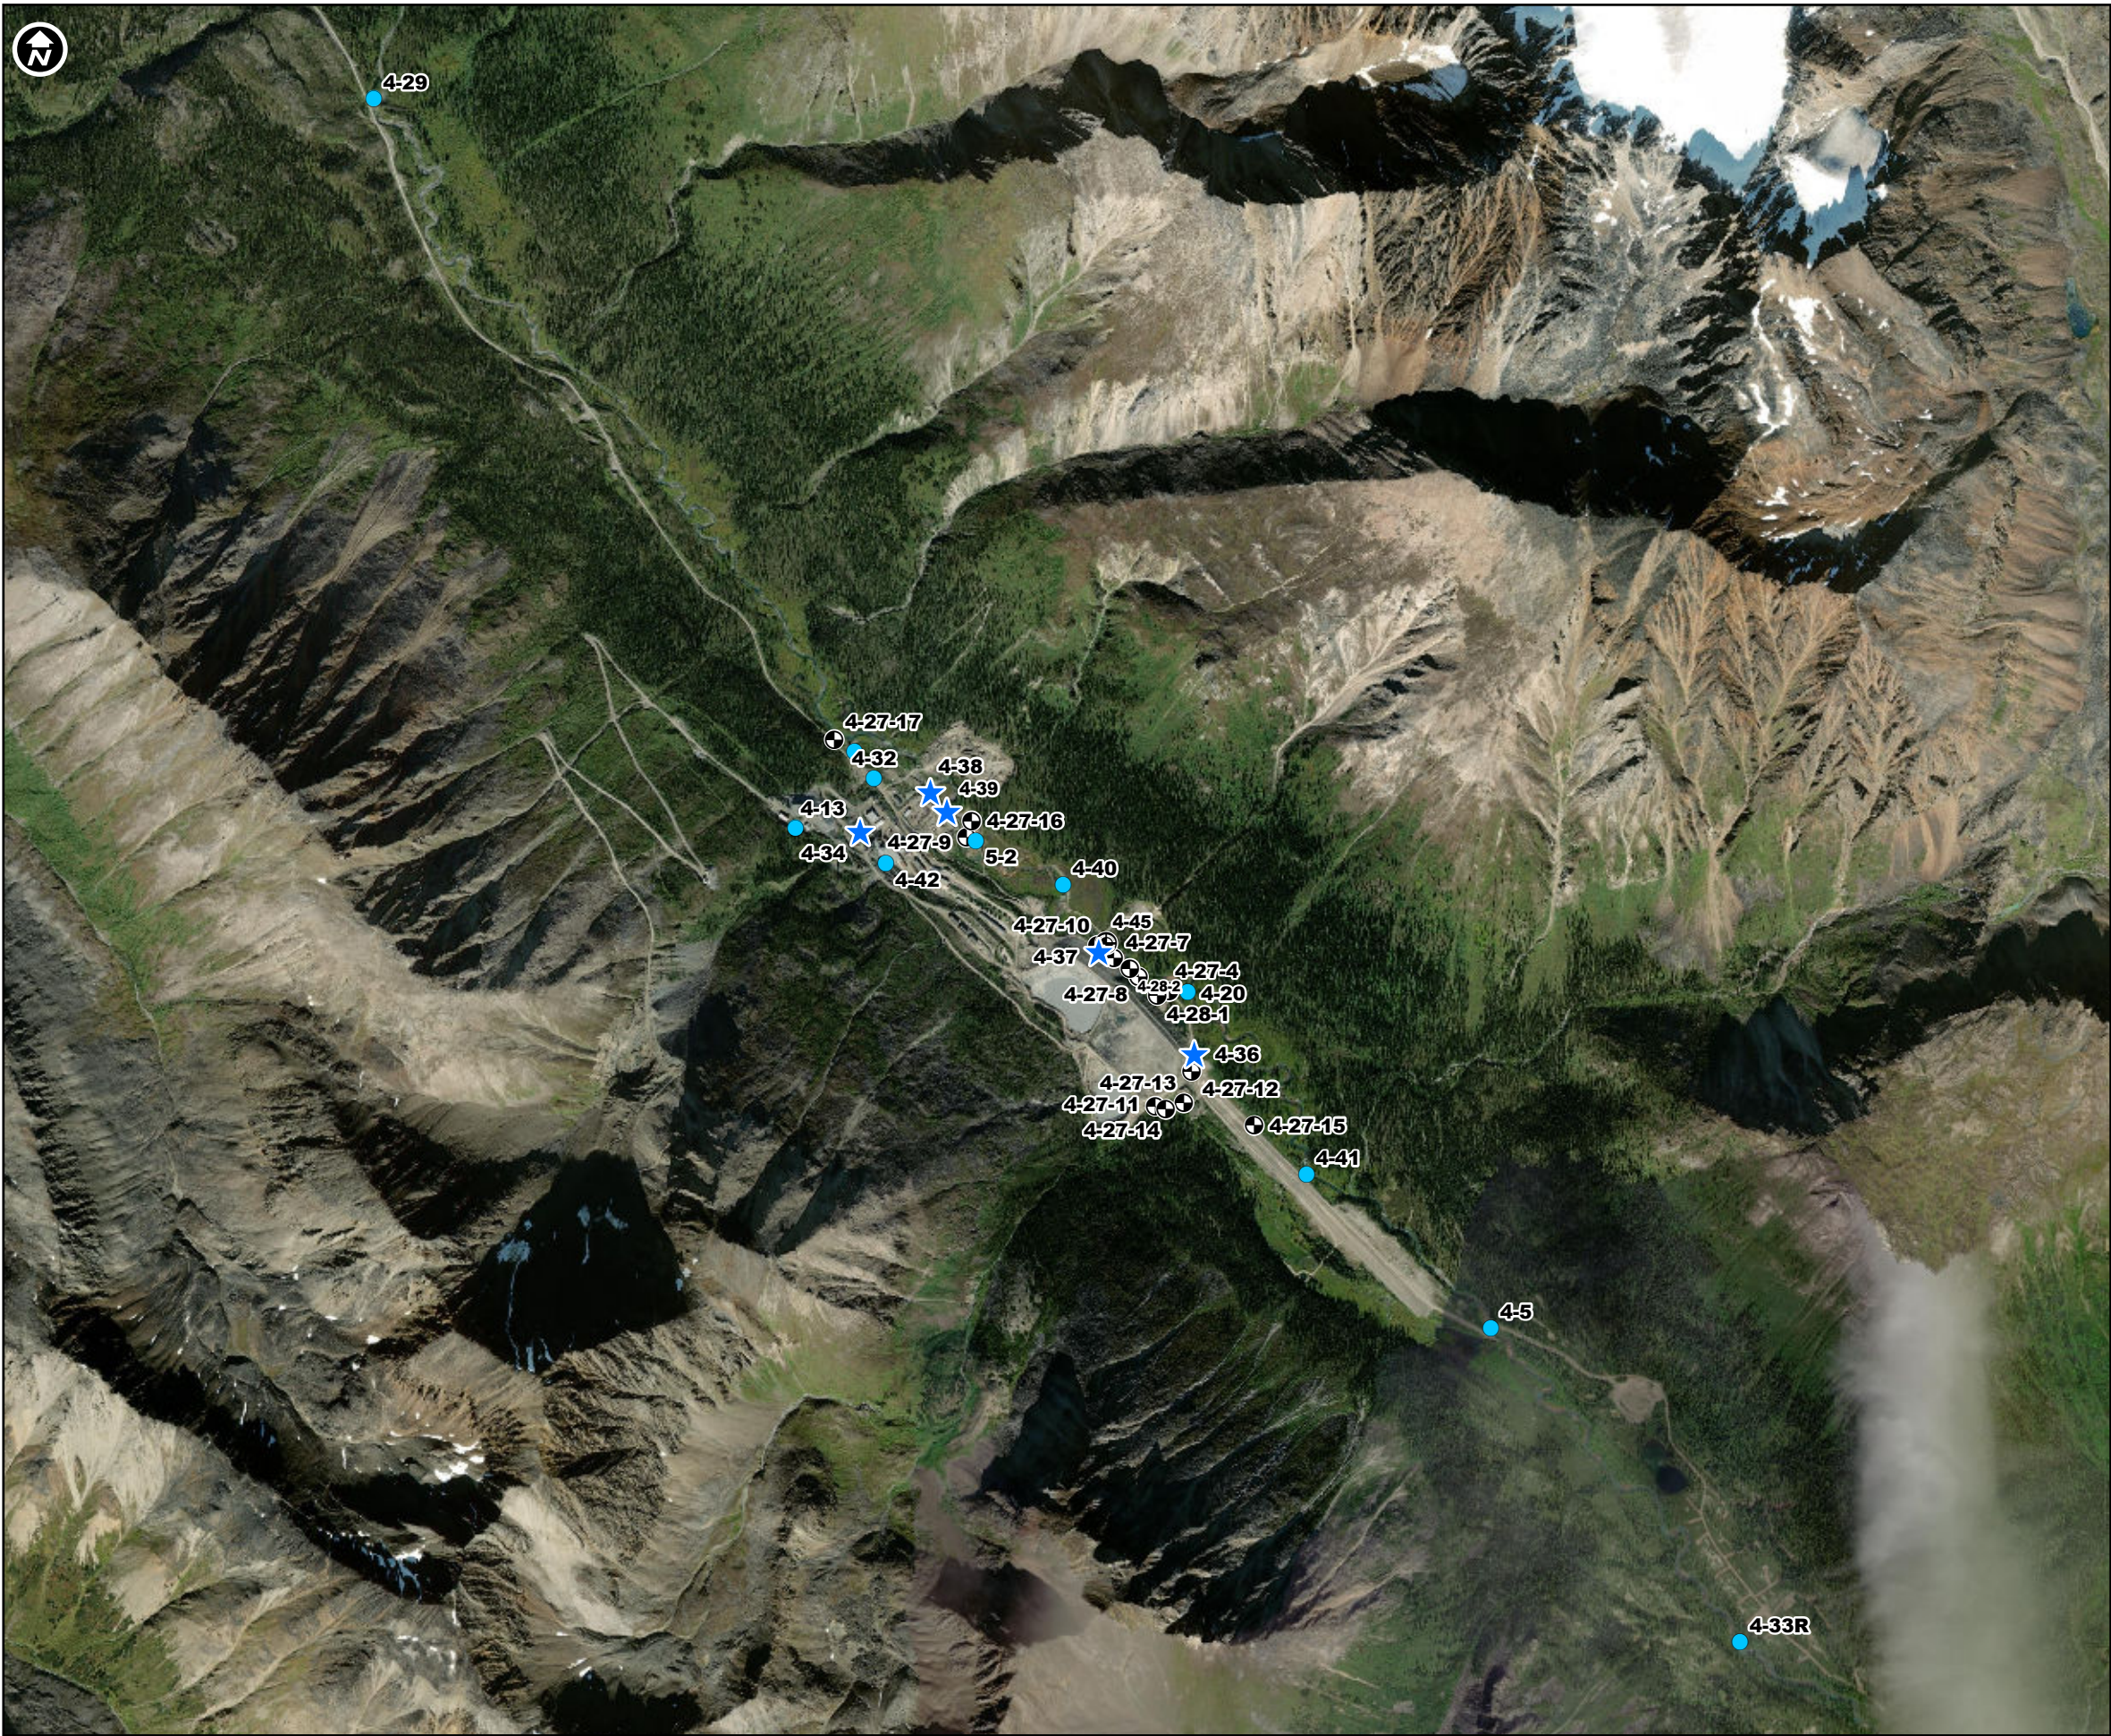
Drawing No.:
1

- Groundwater Station
- Flow
- Seepage
- Surface Water

Monitoring Locations
CANTUNG MINE, NT

The active monitoring stations are listed in Table 1, including rationale for sampling this month, and illustrated in Figures A, B and C.

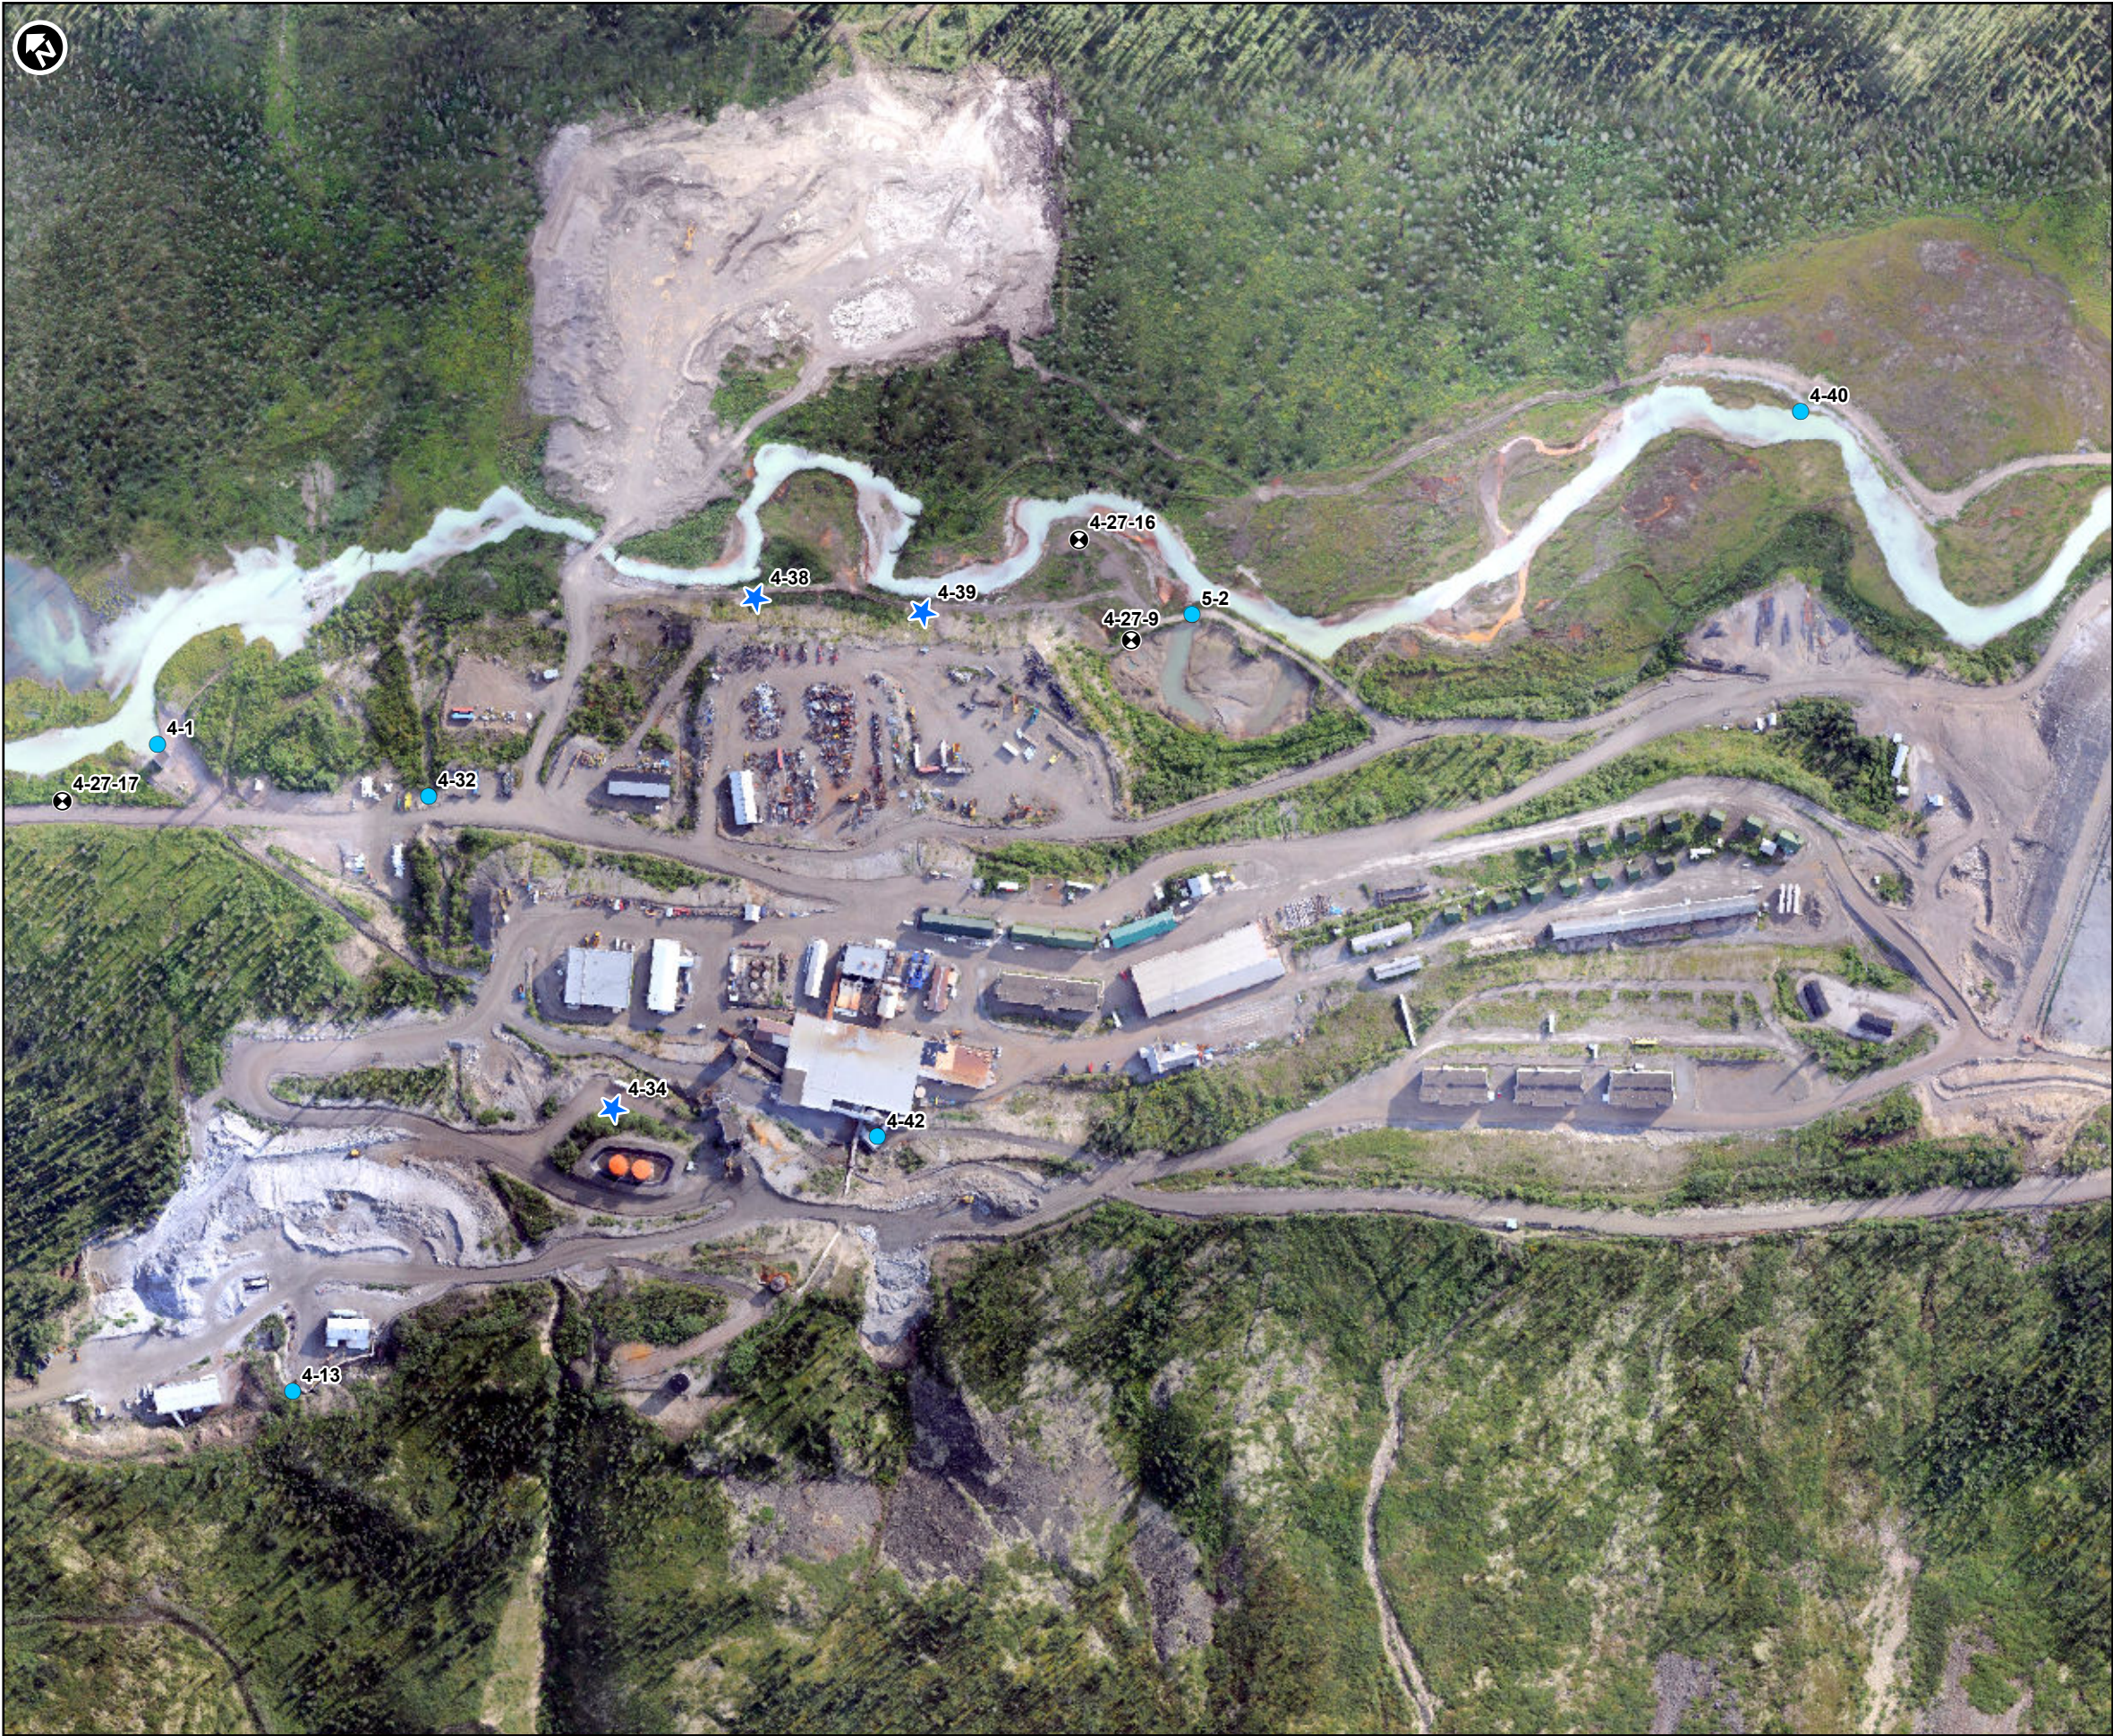
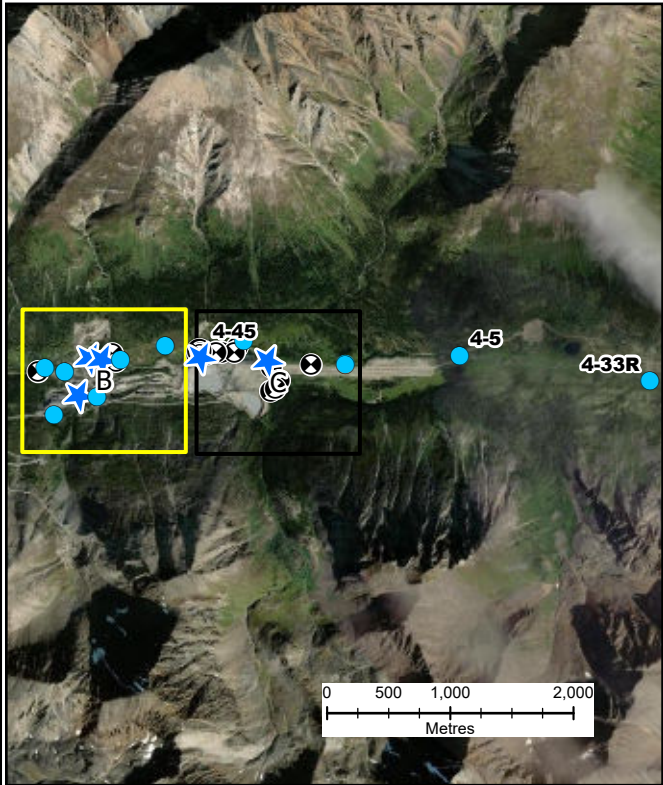
Surveillance Network Program (SNP) Stations

- Groundwater Station
- Flow
- Seepage
- Surface Water

Monitoring Locations

CANTUNG MINE, NT

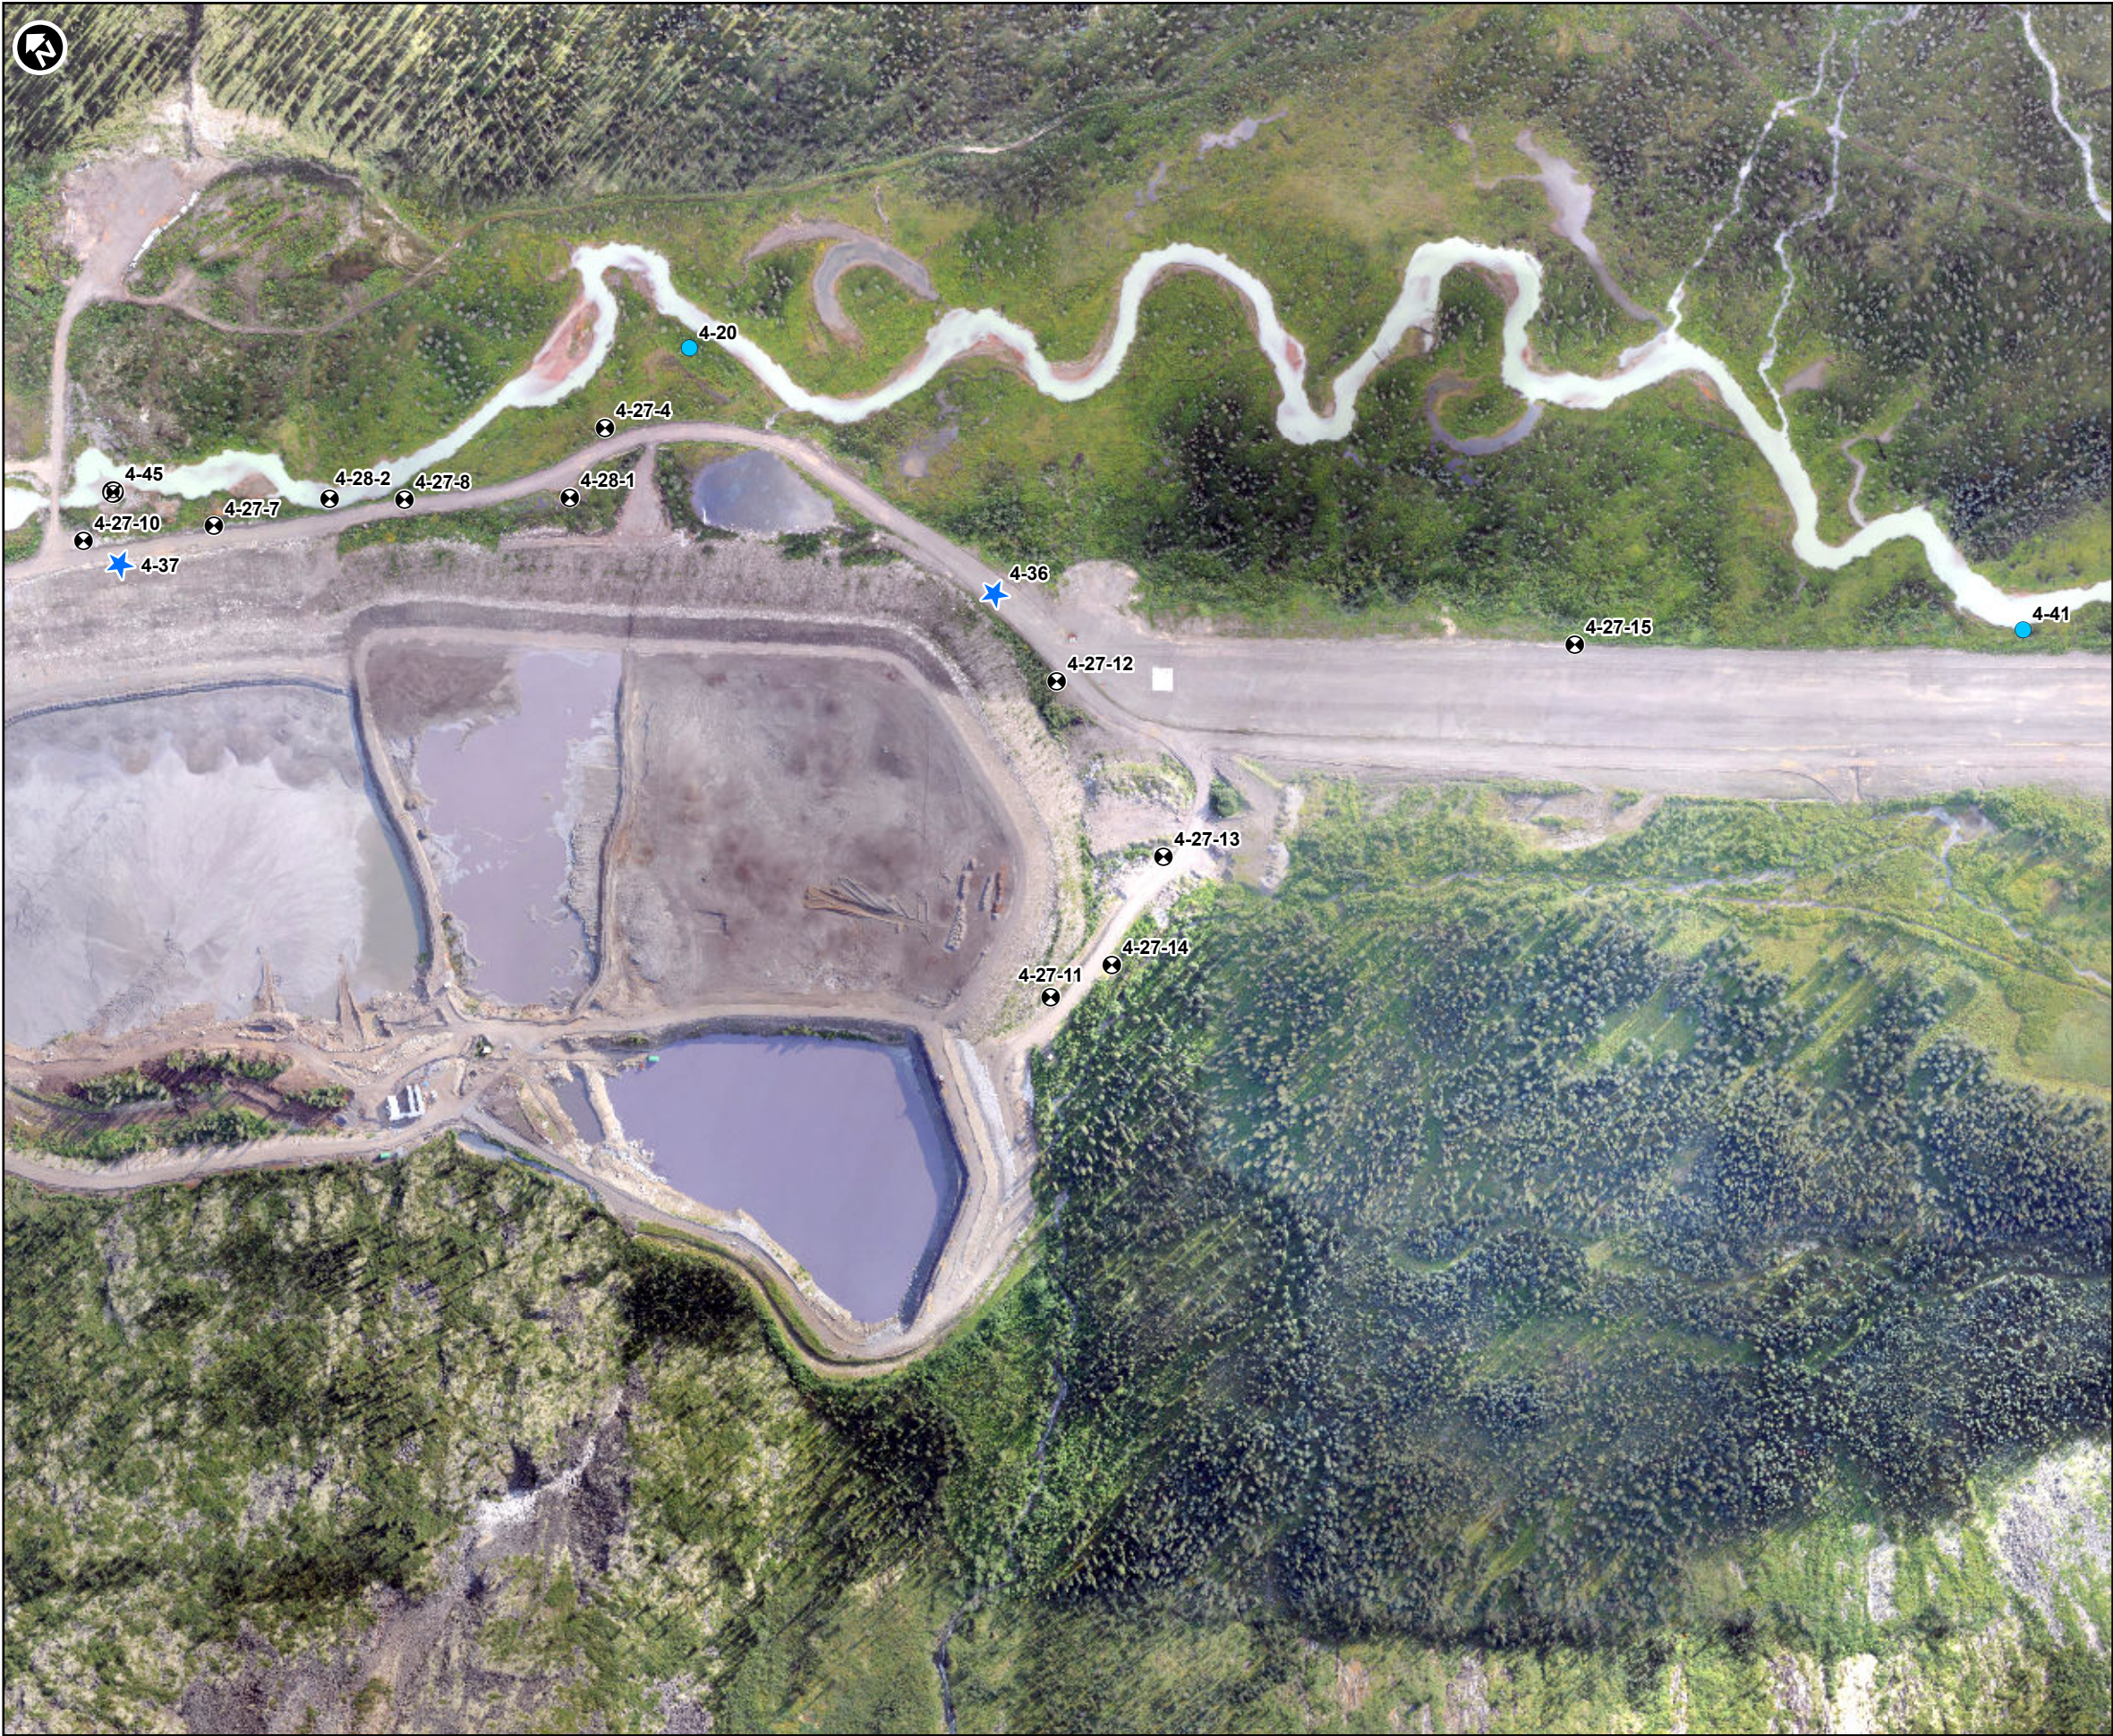
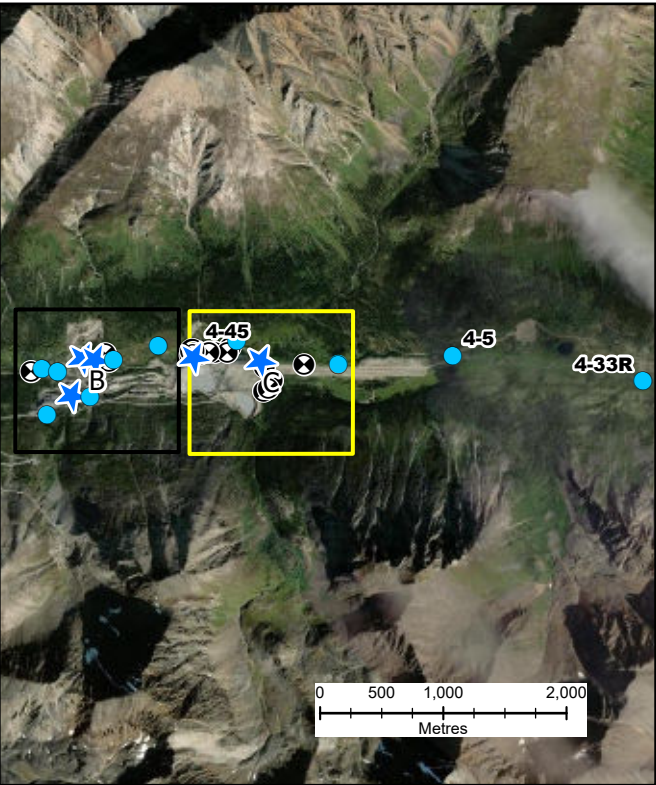
Surveillance Network Program (SNP) Stations

- Groundwater Station
- Flow
- Seepage
- Surface Water

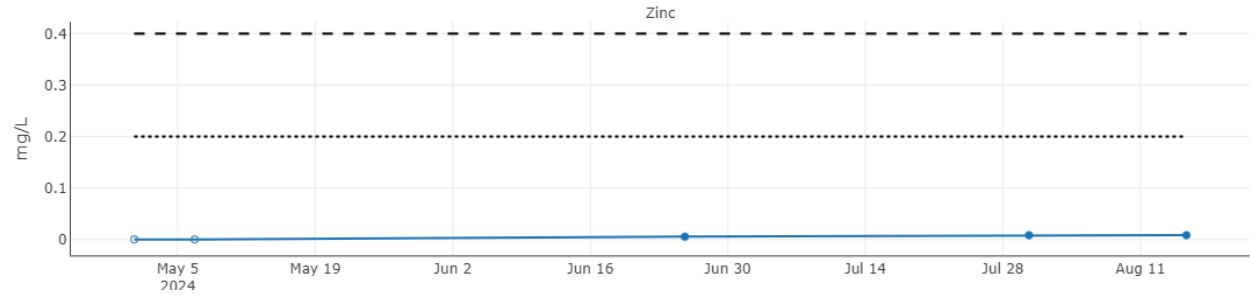
Chemistry Graph

WATER QUALITY TREND CHARTS
