Water License MV2023L2-0006
Surveillance Network Program (SNP) Monthly Reporting
July 2024

Parsons Inc. (Parsons) was retained by North American Tungsten Corporation Ltd. (NATC) to complete the monthly SNP inspection, sampling and reporting for NATC's Cantung Mine as per Water Licence MV2023L2-0006 (the Licence). NATC carried out its obligations under the License during the July field activities.

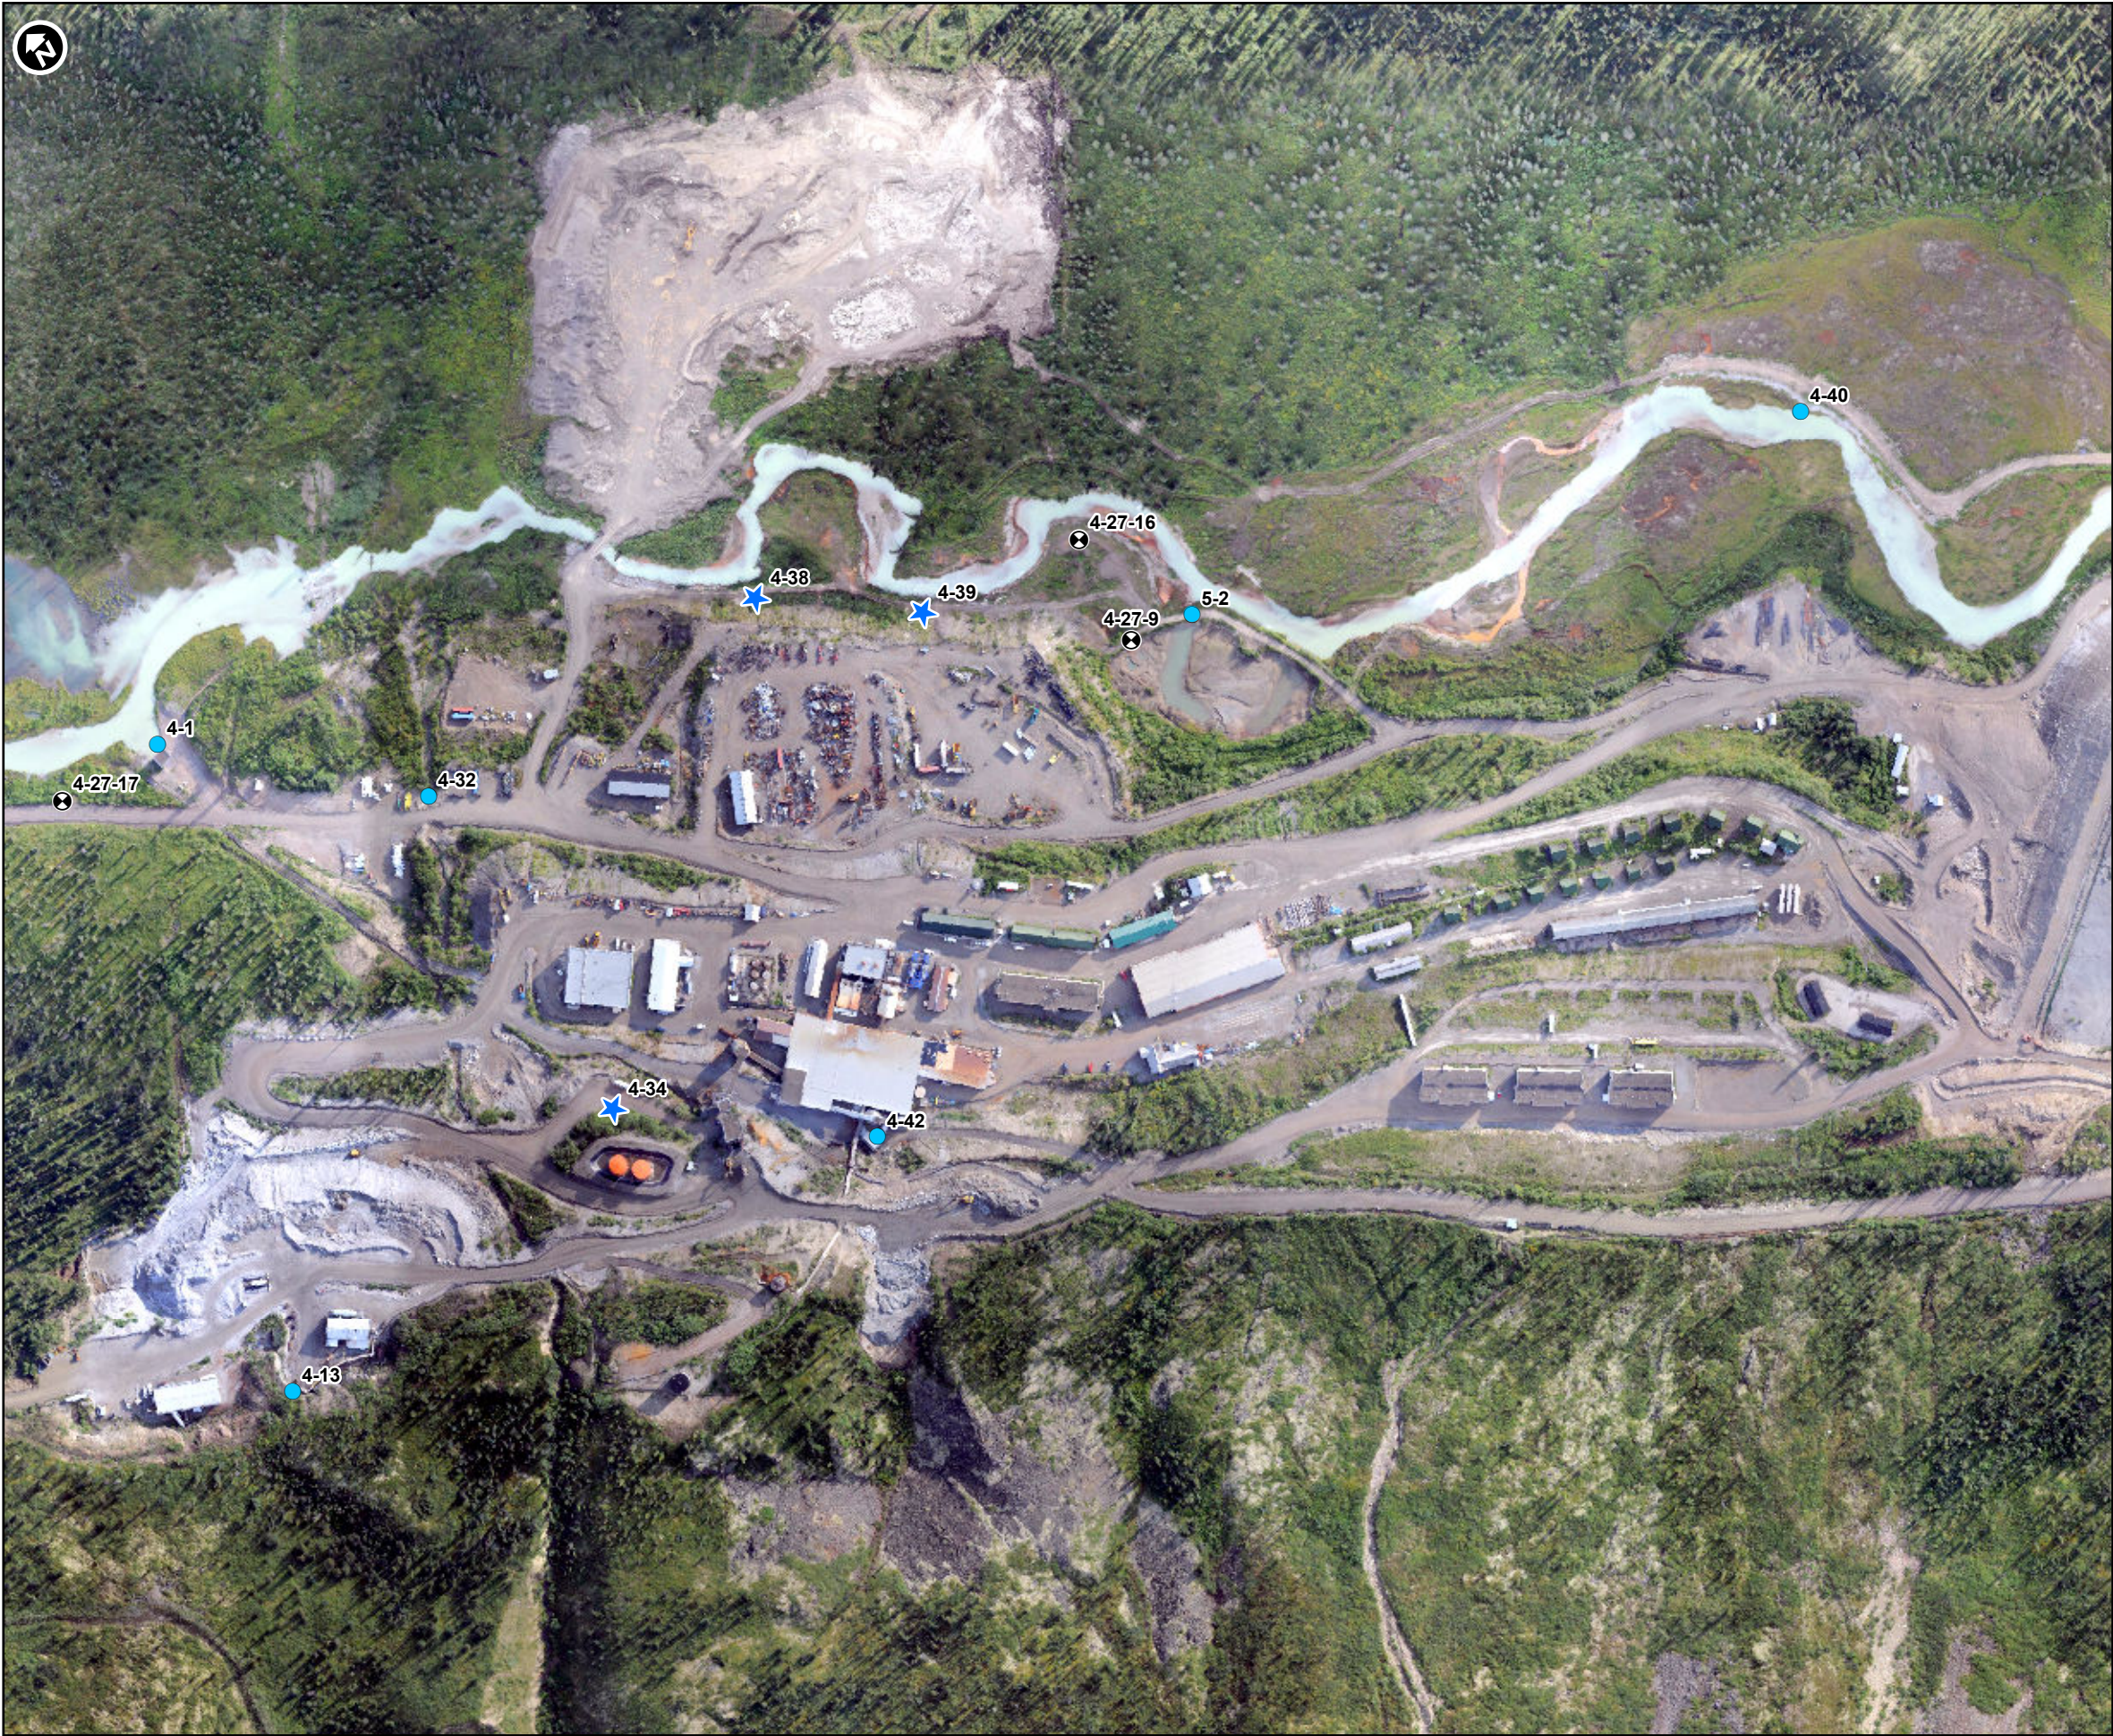
Reference: Tetra Tech, 2024	Drawn By: JDC Reviewed By: MFT	Ref. No.: 10-13166 Date: 23-Sep-2024 Drawing No.:
PARSONS		2

- LEGEND
- Surveillance Network Program (SNP) Stations**
- Groundwater Station
 - Flow
 - Seepage
 - Surface Water

The active monitoring stations are listed in Table 1, including rationale for sampling this month, and illustrated in Figures A, B and C.

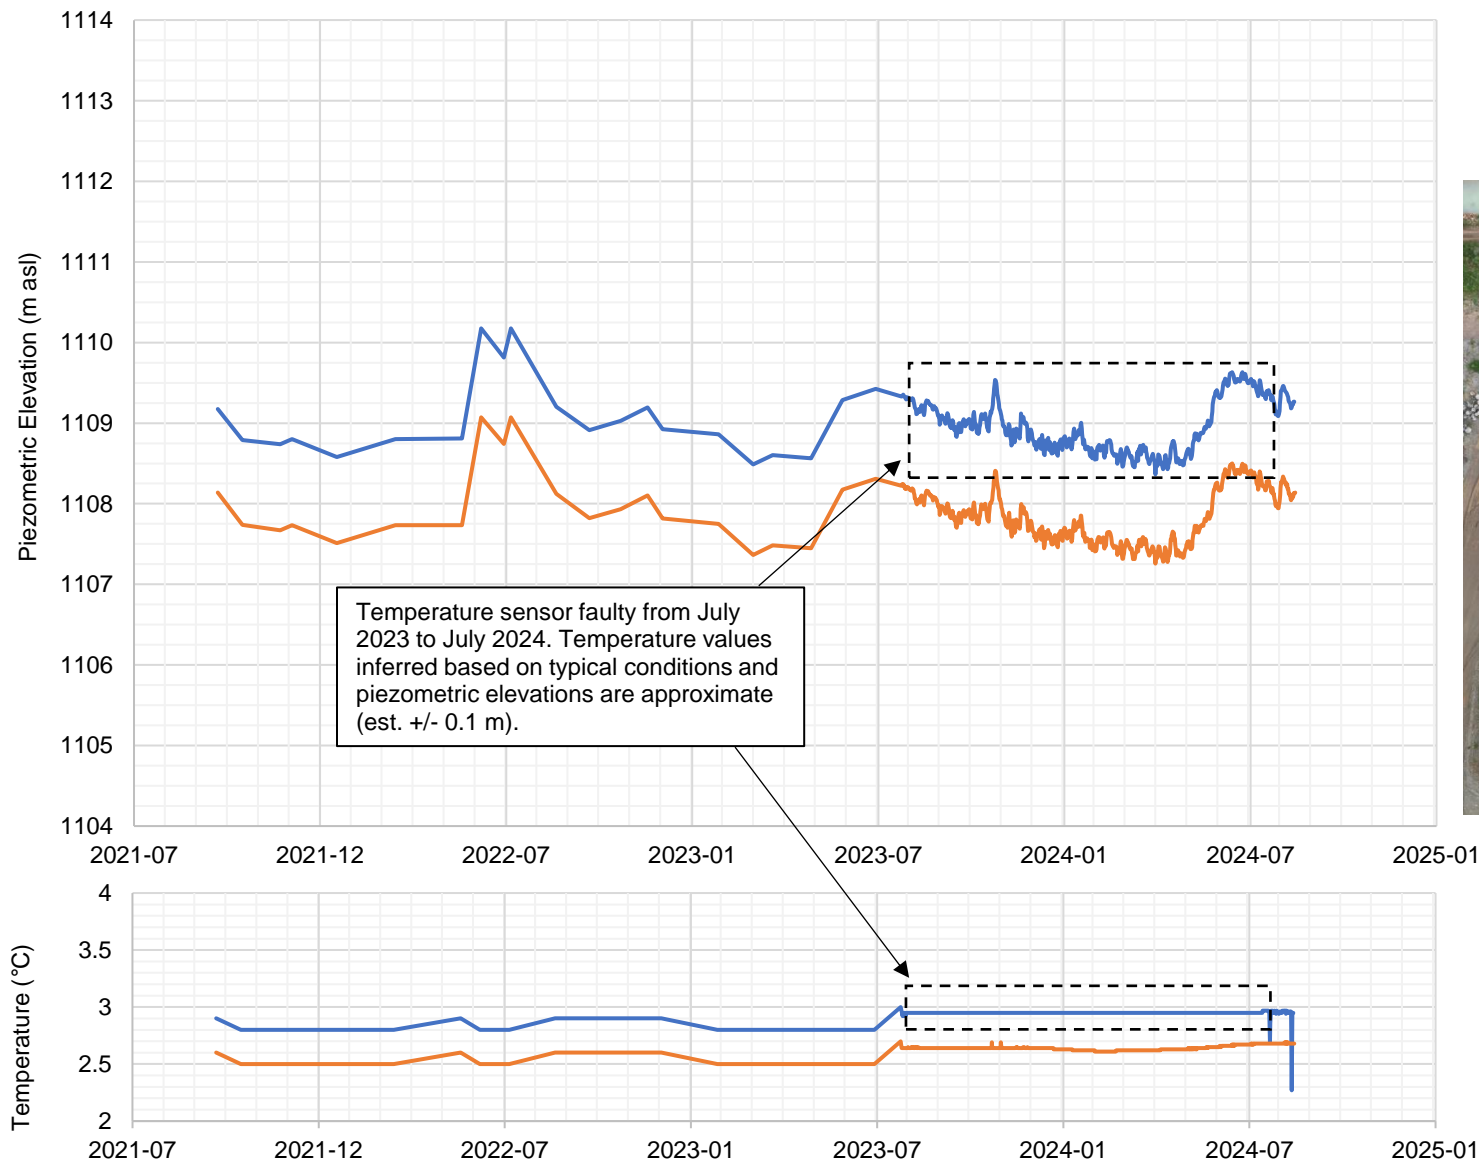
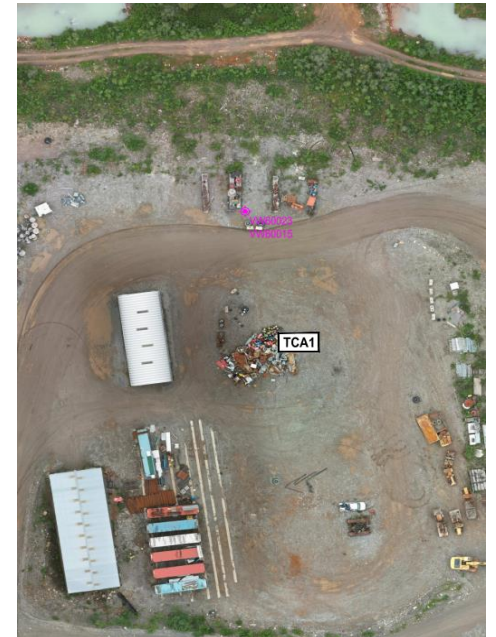
FIGURE 1

VWP ID	TIP EL. (masl)
VW60015	1090.8
VW60023	1100.8

NOTE:
IMAGERY COLLECTED JULY 2023

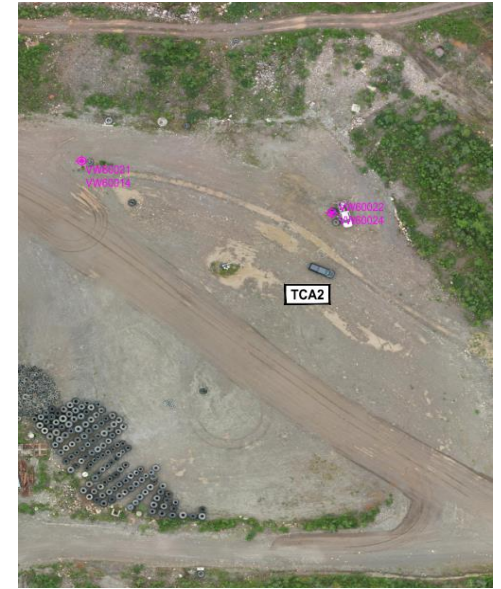
FIGURE 2

VWP ID	TIP EL. (masl)
VW60014	1088.3
VW60021	1097.5
VW60024	1087.2
VW60025	1114.3

NOTE:
IMAGERY COLLECTED JULY 2023

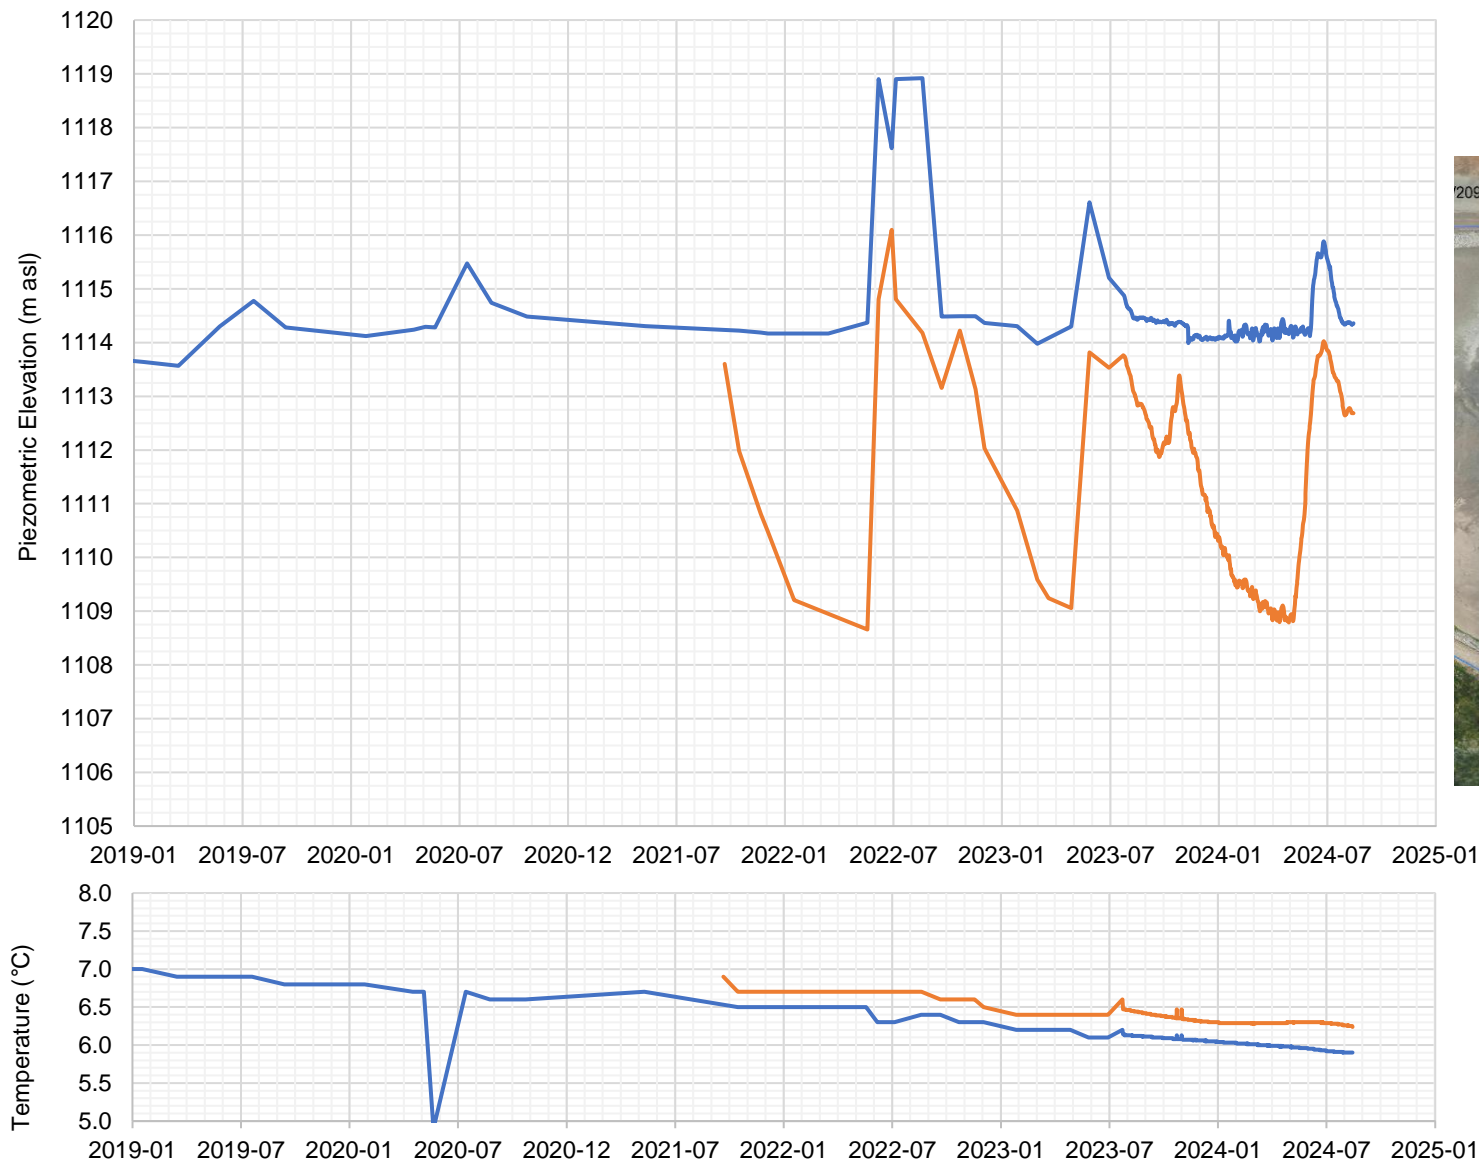
VWP ID	TIP EL. (masl)
VW20925	1114.3
VW60018	1101.7

NOTE:
IMAGERY COLLECTED JULY 2023
