# Dempster Fibre Line Wildlife Management and Monitoring Plan (WMMP)

Project No. 106033-01

April 13, 2022

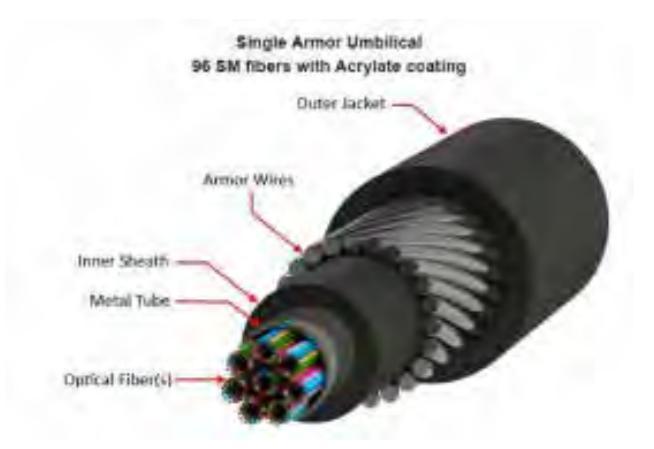
# Plate 2-1 Typical Cable Considered for Direct-buried or Surface-laid installation

The cables will be roughly 15 mm in outside diameter. A sample of the type of cable which will be considered for direct-buried or surface-laid application is shown in **Plate 2-1**.

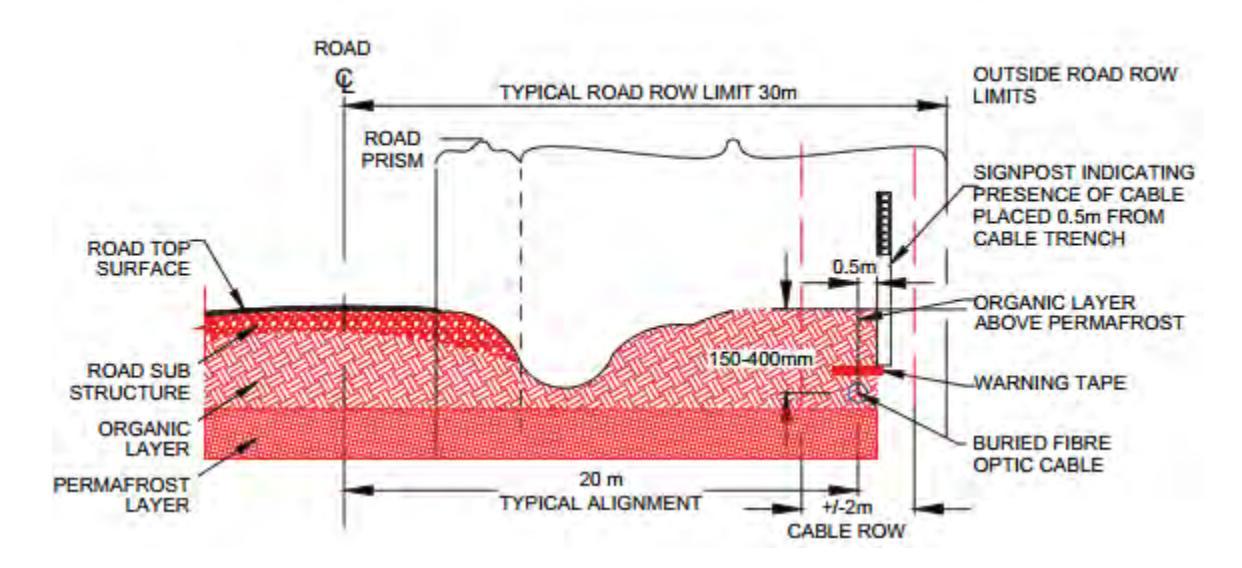
Plate 3-1 Typical Shallow Burial Installation - Negligible Permafrost

Cables are buried up to a depth of 1,000 mm for conventional burial and 150 mm to 400 mm for shallow burial, depending on the depth of the organic layer.

Typical shallow-buried installation is shown in Plate 3-1 and Plate 3-2.

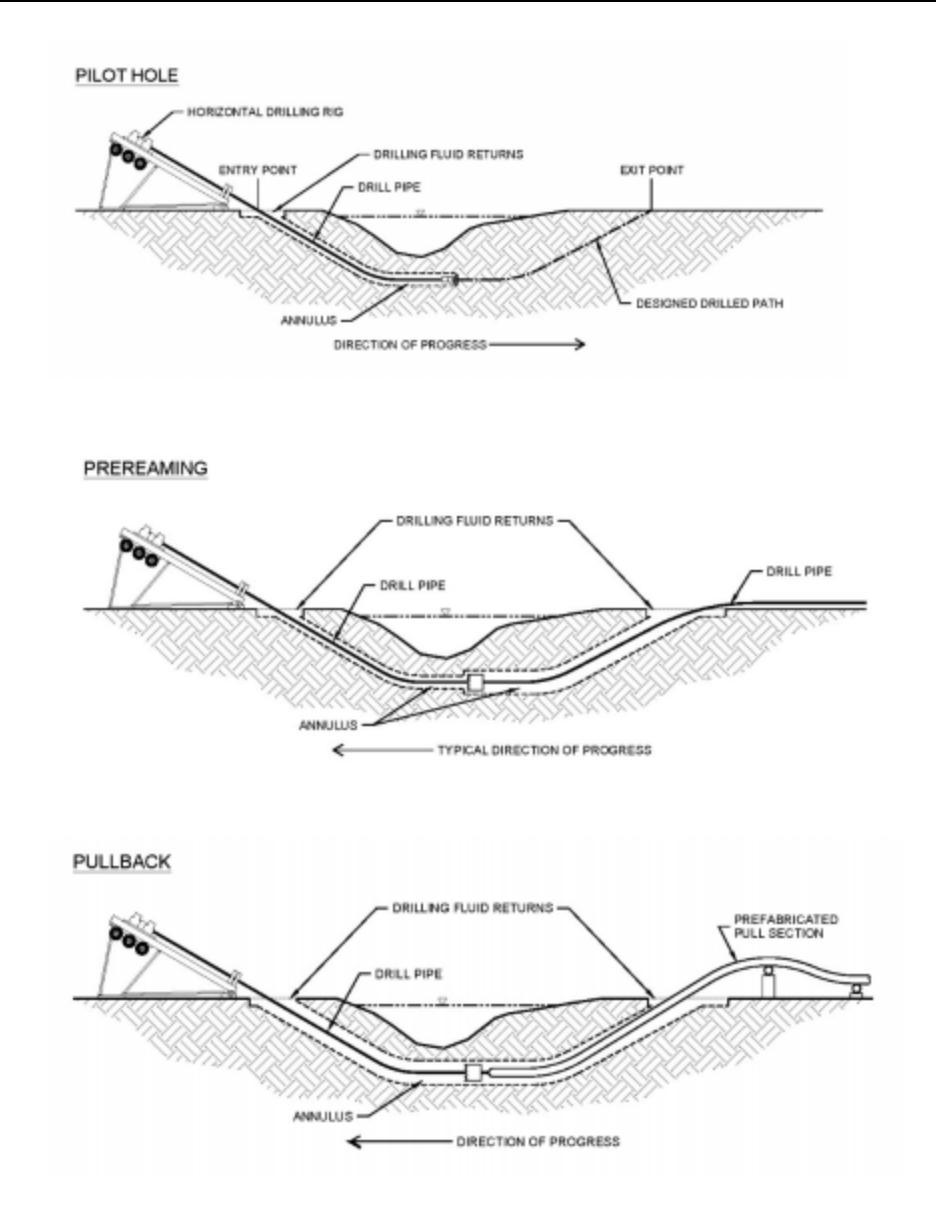
## Plate 3-5 Typical HDD Components

All material excavated for development of the entry pits will be side-casted for replacement once the conduit connection is complete. In upland areas, the disturbed terrain will be allowed to vegetate naturally. In riparian and wetland areas, if willows naturally occur in the area, willow cuttings will be applied to the backfilled pits to facilitate natural regrowth. Boughs and branches may also be placed over top of the drill site to decrease the likelihood of erosion. Upon the successful completion of each HDD, all equipment and materials will be removed from the site and the area will be cleaned up.

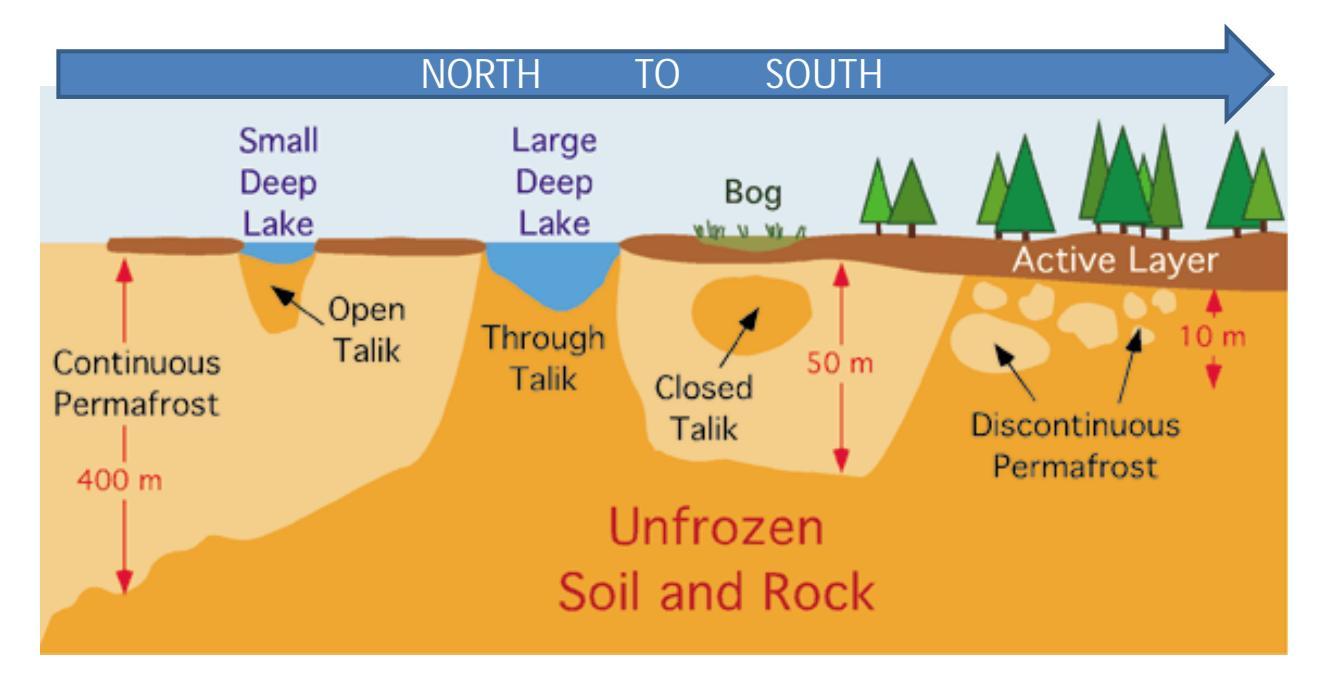
Permafrost occurs in all of Yukon's ecoregions (Smith et al. 2004), but its thickness and extent generally increase northward (Burn 2004). **Plate 7-1** provides a schematic representation of the variability in the approximate distribution and thickness of permafrost and overlying active layer, analogous to a north-south subsurface profile beneath the Dempster Highway corridor. Understanding of the distribution and characteristics of permafrost along the Dempster Highway corridor is based a number of sources of information, representing conditions from a national to a site scale (**Table 7-1**).

# Plate 7-1 Schematic representation of the variable distribution and thickness of permafrost and the overlying active layer (modified from Pidwirny 2006). The profile can be visualized as illustrating the idealized trends along the Dempster Highway corridor, from the Richardson Mountains (left) to the turn-off at the North Fork River valley (right).

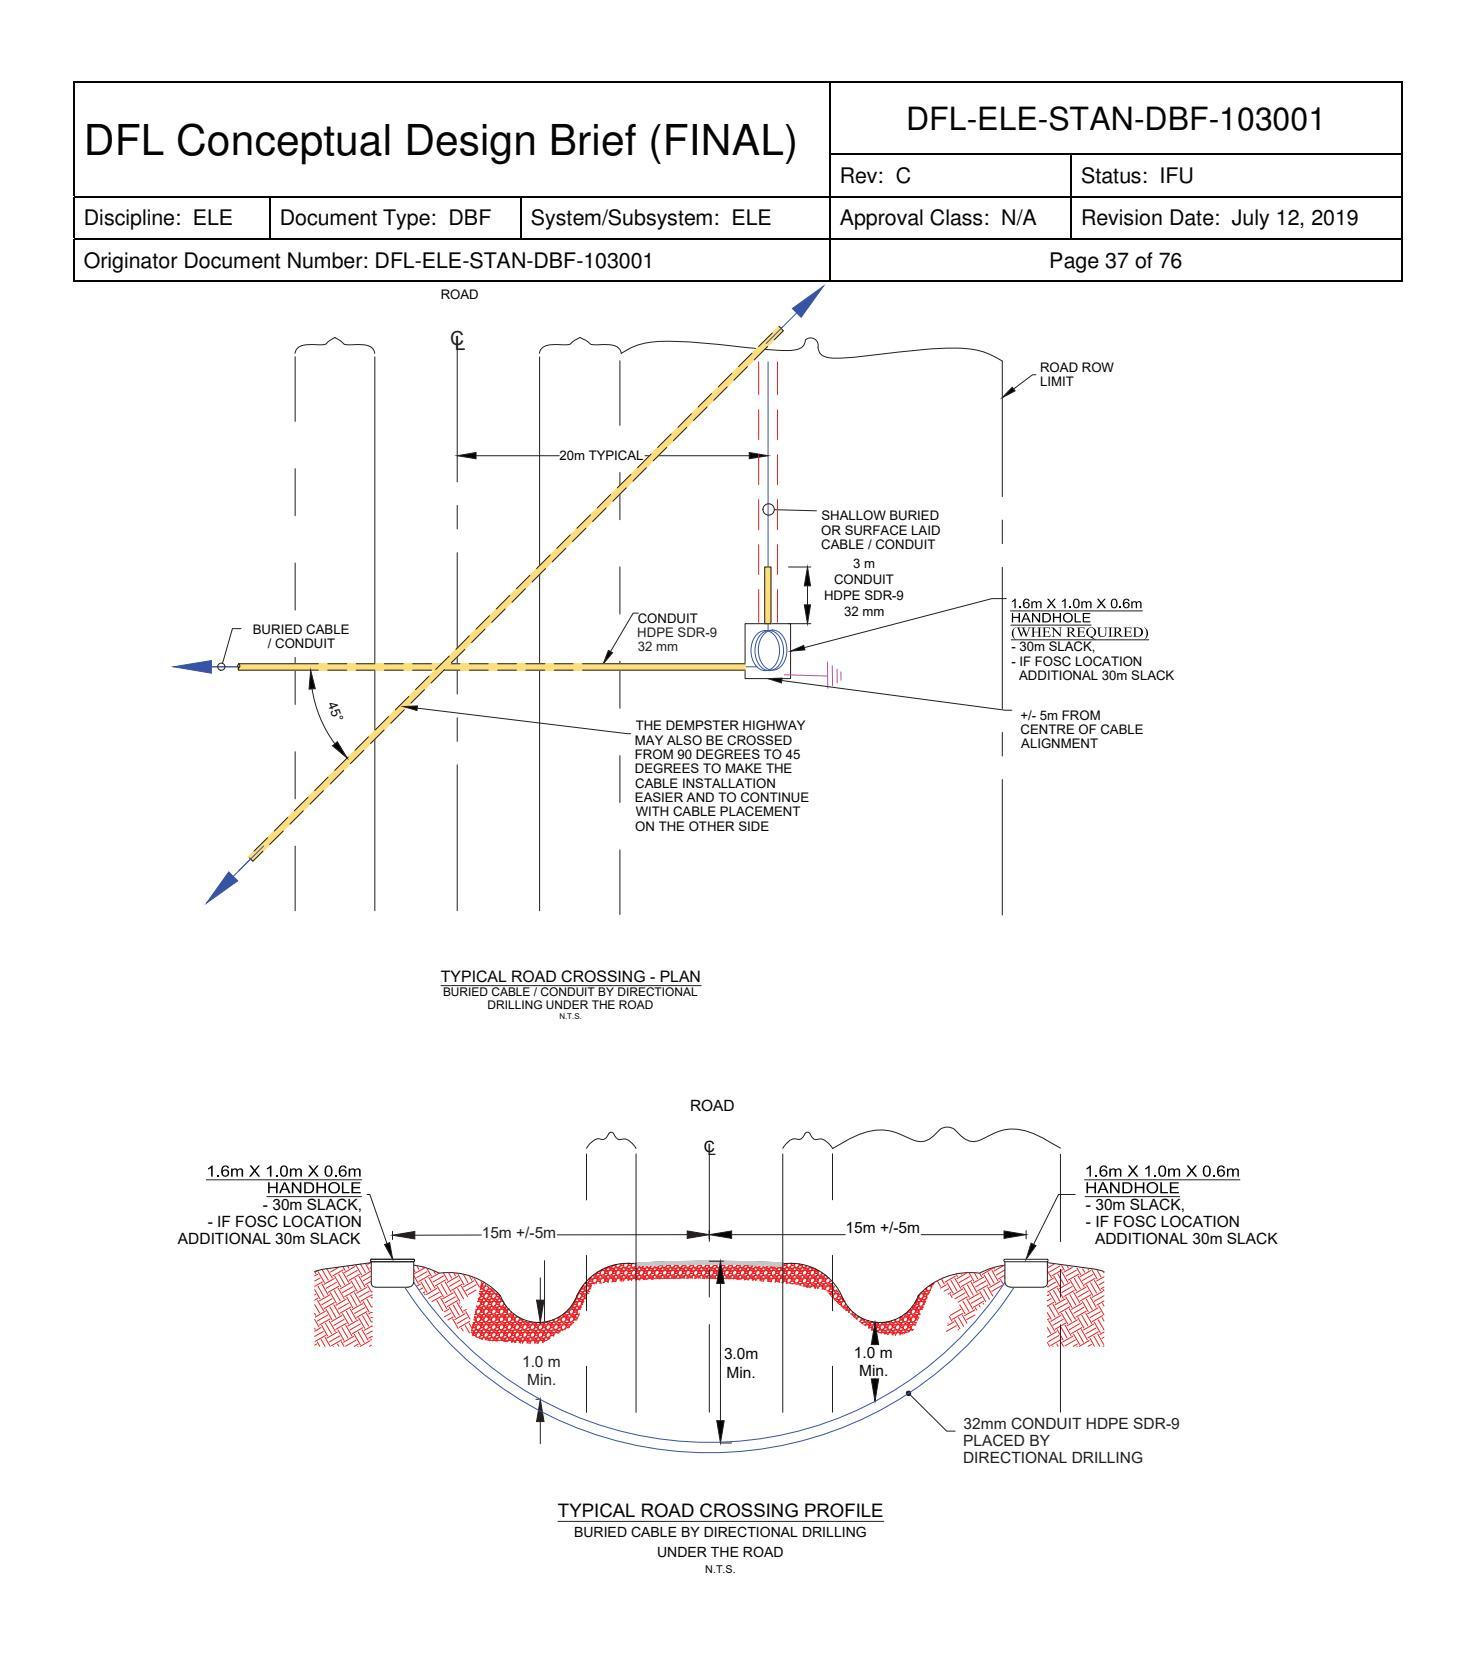
Figure 7 – Typical DFL HDD Roadway Crossings

The Dempster highway HDD road crossings can be made using crossing angles from 45<sup>o</sup> to 90<sup>o</sup> and 1m-2m below the road prism toe to minimize installation friction and cable bend stresses. This will lengthen the crossings but will simplify the cable installation process and minimize schedule delays. The following Figure details typical road crossings for this project.

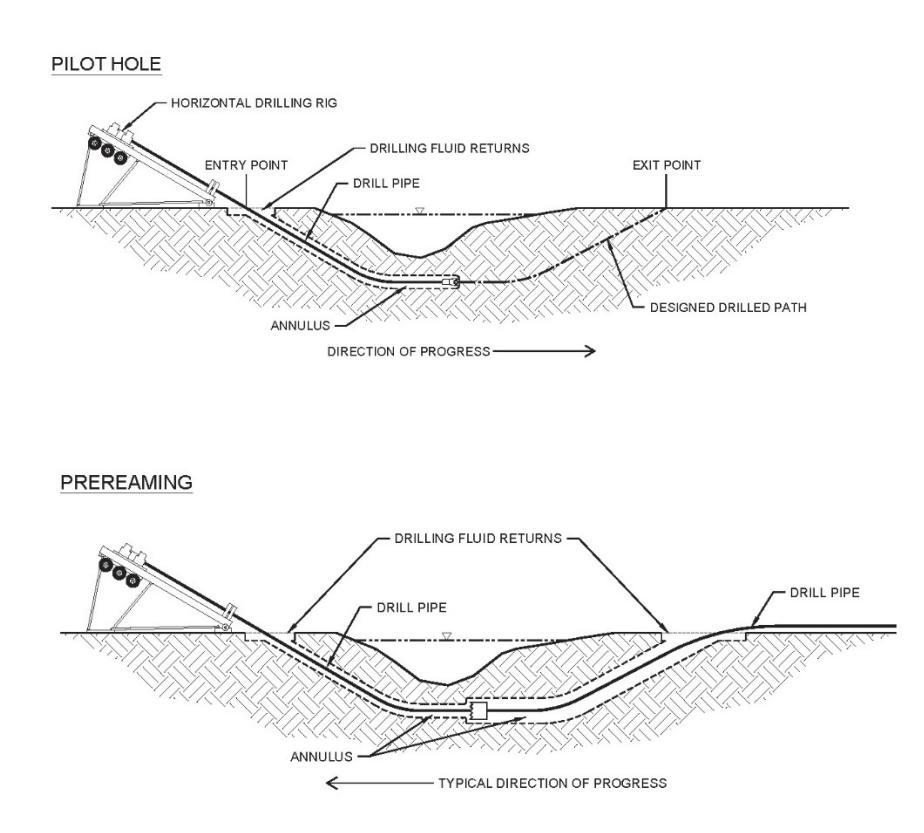
To provide some perspective of what is involved in the HDD process, consider the following sketches:

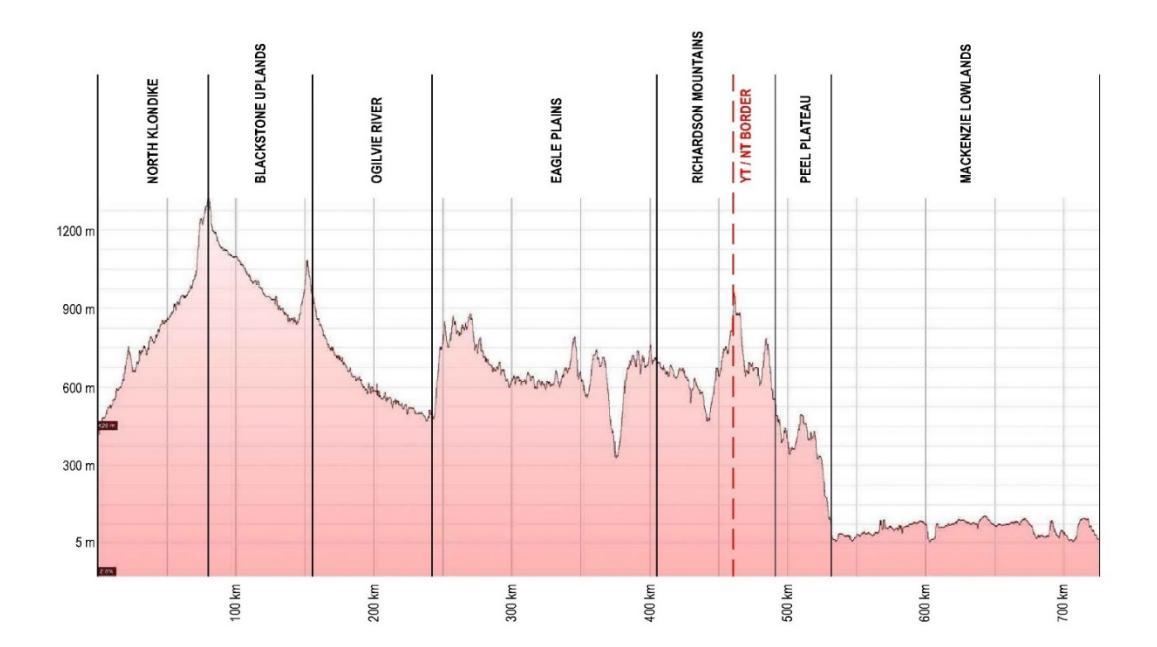
An elevation profile of the Dempster Highway is presented in Figure 1 (Refer to Tetra Tech EBA 2015). As can be seen from this information, there is a significant amount of relief along the highway that affects air temperature, precipitation, and ground temperature. The nature of the slopes, soil type and permafrost conditions are all climate related and vary substantially in response to the terrain elements. As shown on Figure 1, the elevation of the Dempster Highway ranges from just above sea level to over 1200 m at its highest point in the Yukon.
