Water License MV2015L2-0003 Surveillance Network Program (SNP) Monthly Reporting December 2023

Parsons Inc. (Parsons) was retained by North American Tungsten Corporation Ltd. (NATC) to complete the monthly SNP inspection, sampling and reporting for NATC's Cantung Mine as per Water Licence MV2015L2-0003 (the Licence.)

CANTUNG MINE, NT

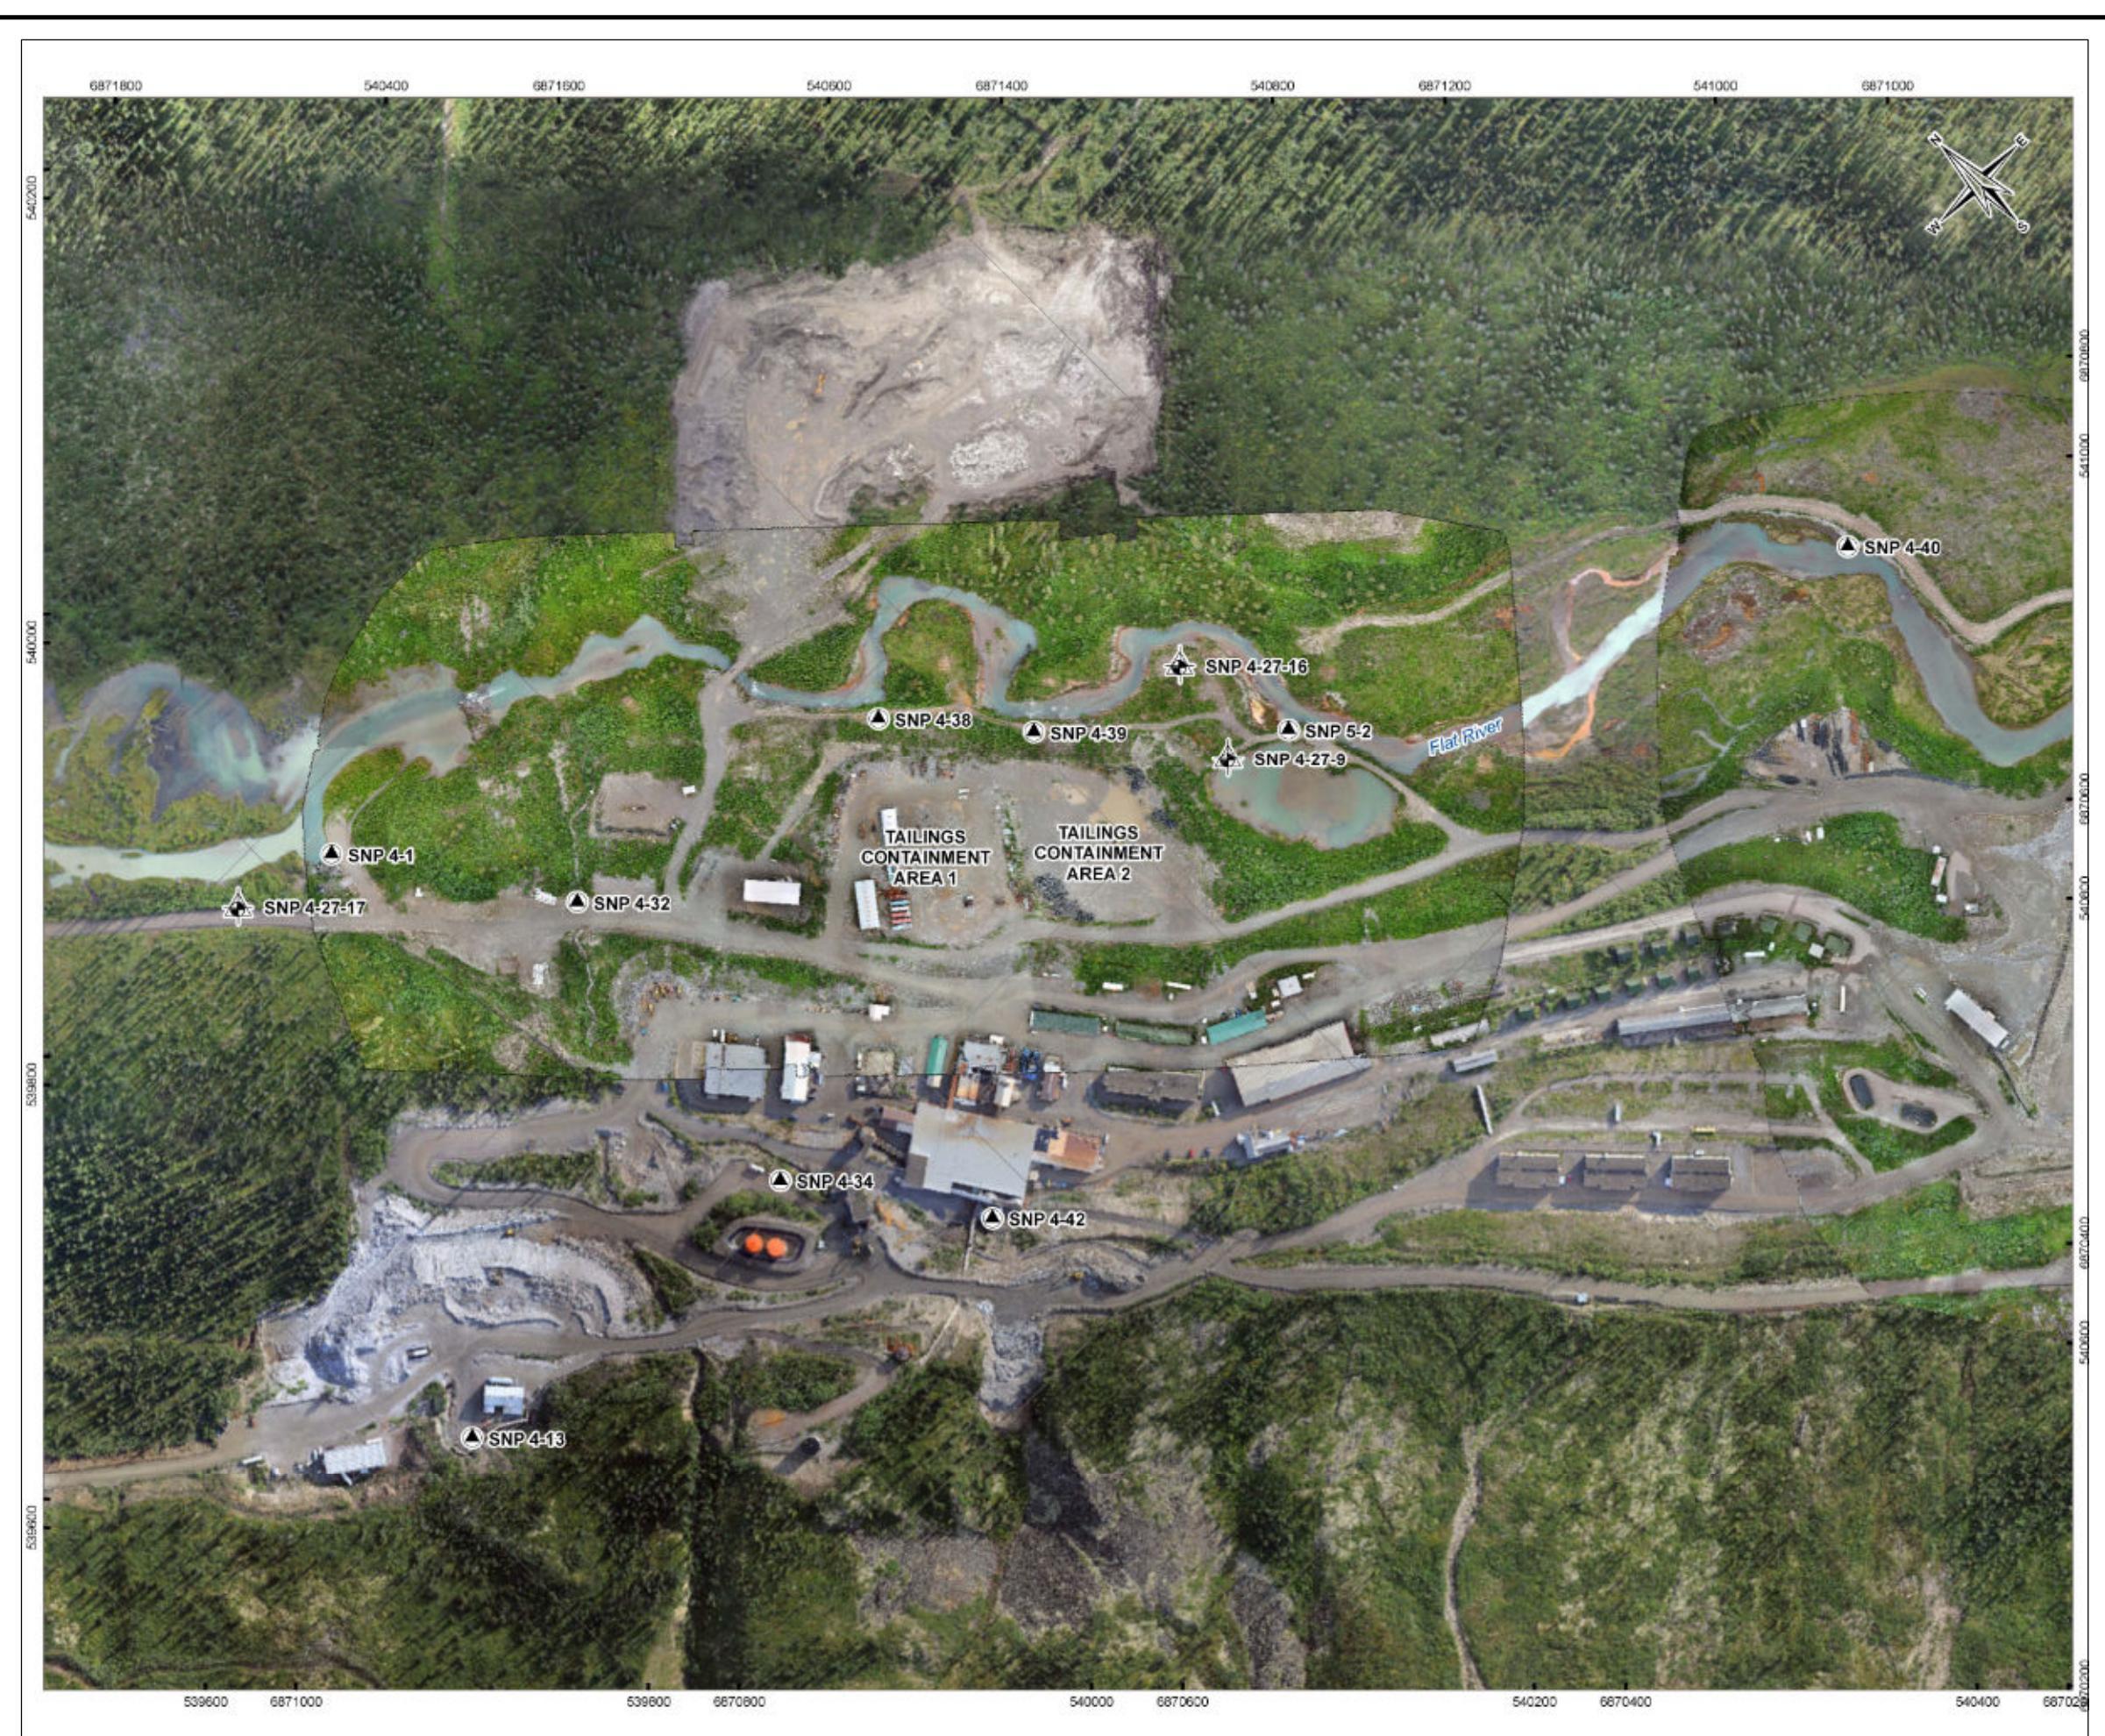
Monitoring Locations

The active monitoring stations are listed in Table 1, including rationale for sampling this month, and illustrated in Figures A, B and C.
