Memo

To:	MGM Energy	From:	James Hymers, Project Manager K'alo-Stantec Ltd.
	2800, 421 - 7 Avenue SW Calgary, AB T2P 4K9		Tulita, NT, Canada, X0E 0T0
File:	123514551	Date:	January 22, 2024

Reference: 2023 Environmental Site Monitoring Report: Maunoir L-80 Wellsite Area, Drilling Sump Area, and Camp Sump Area

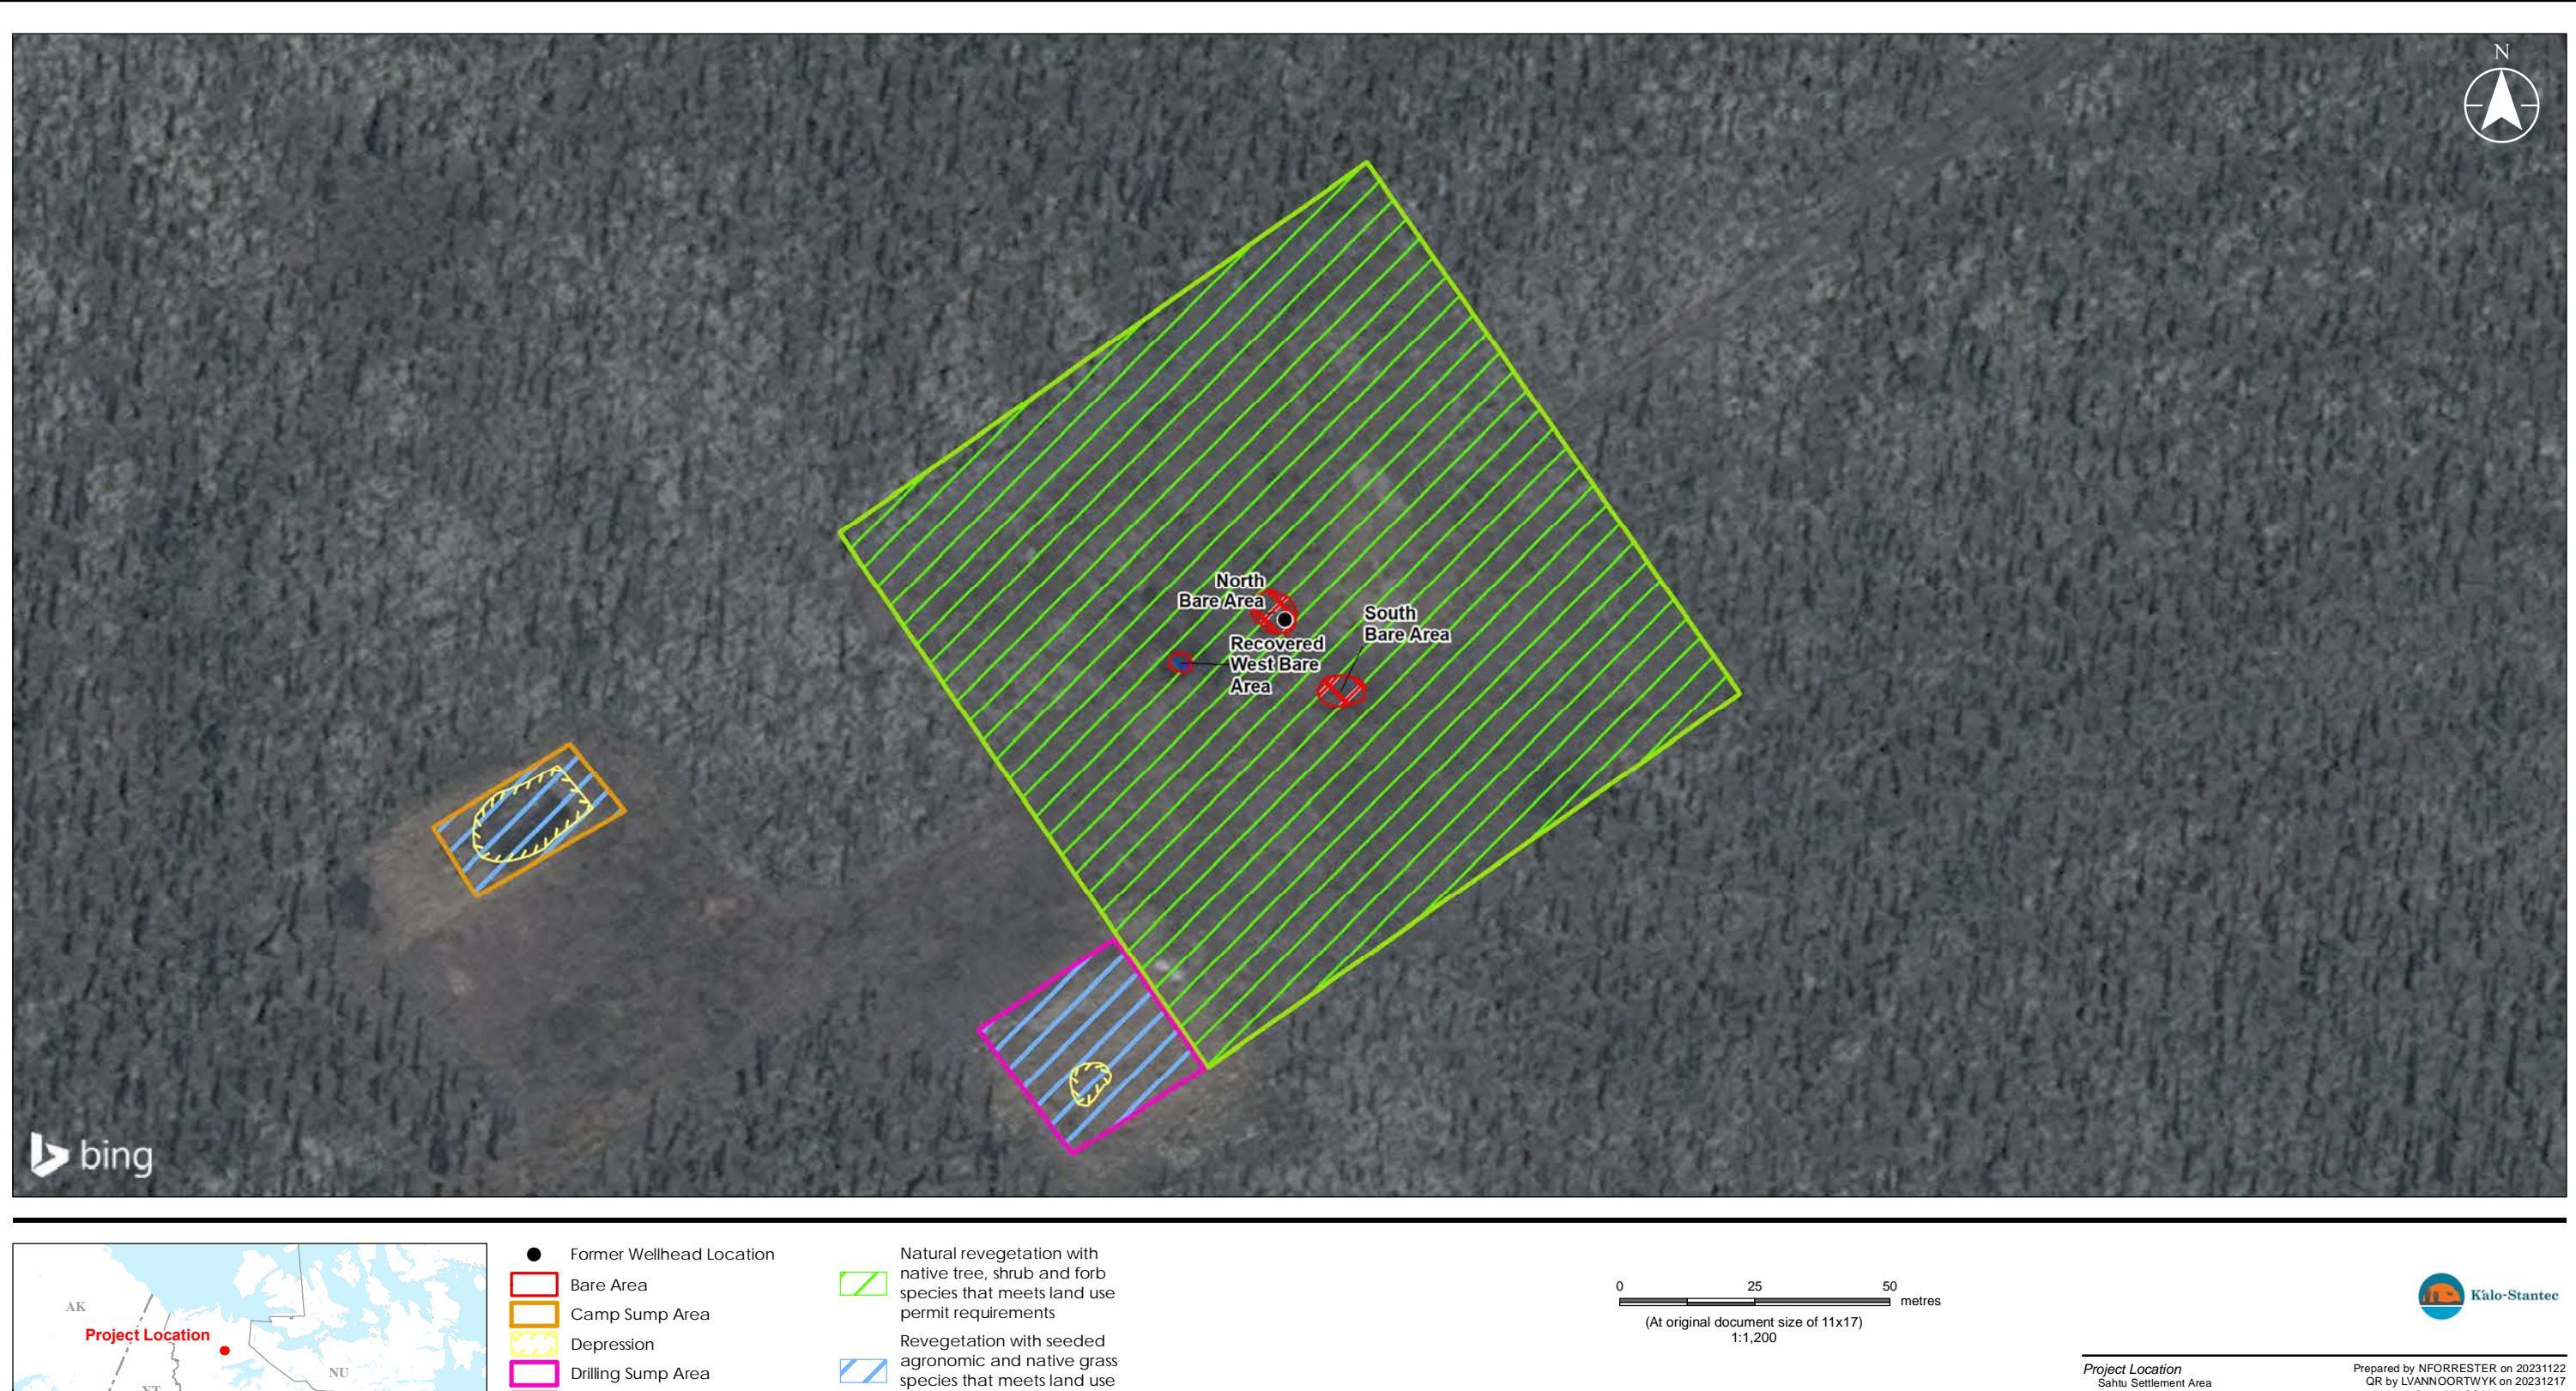
Maunoir L-80 Wellsite Area and Sump Area - Reclamation Assessment

Sump Areas (Attachment A, Figure A.3):		
•	 Vegetation cover on the Drilling Sump Area and Camp Sump Area met the land use permit requirements for >70% vegetation cover and in healthy condition. The Drilling Sump Area and Camp Sump Area had revegetated 		 No reclamation treatments recommended for Drilling Sump Area and Camp Sump Area at this
	with seeded grasses and naturally established tree, shrub, and forb species (Attachment B: Photo B.8 and Photo B.9).		time. Reconnaissance level vegetation
	 No invasive plants/weeds were observed within the Sump Areas during the 2023 site visit. 		issues arise.

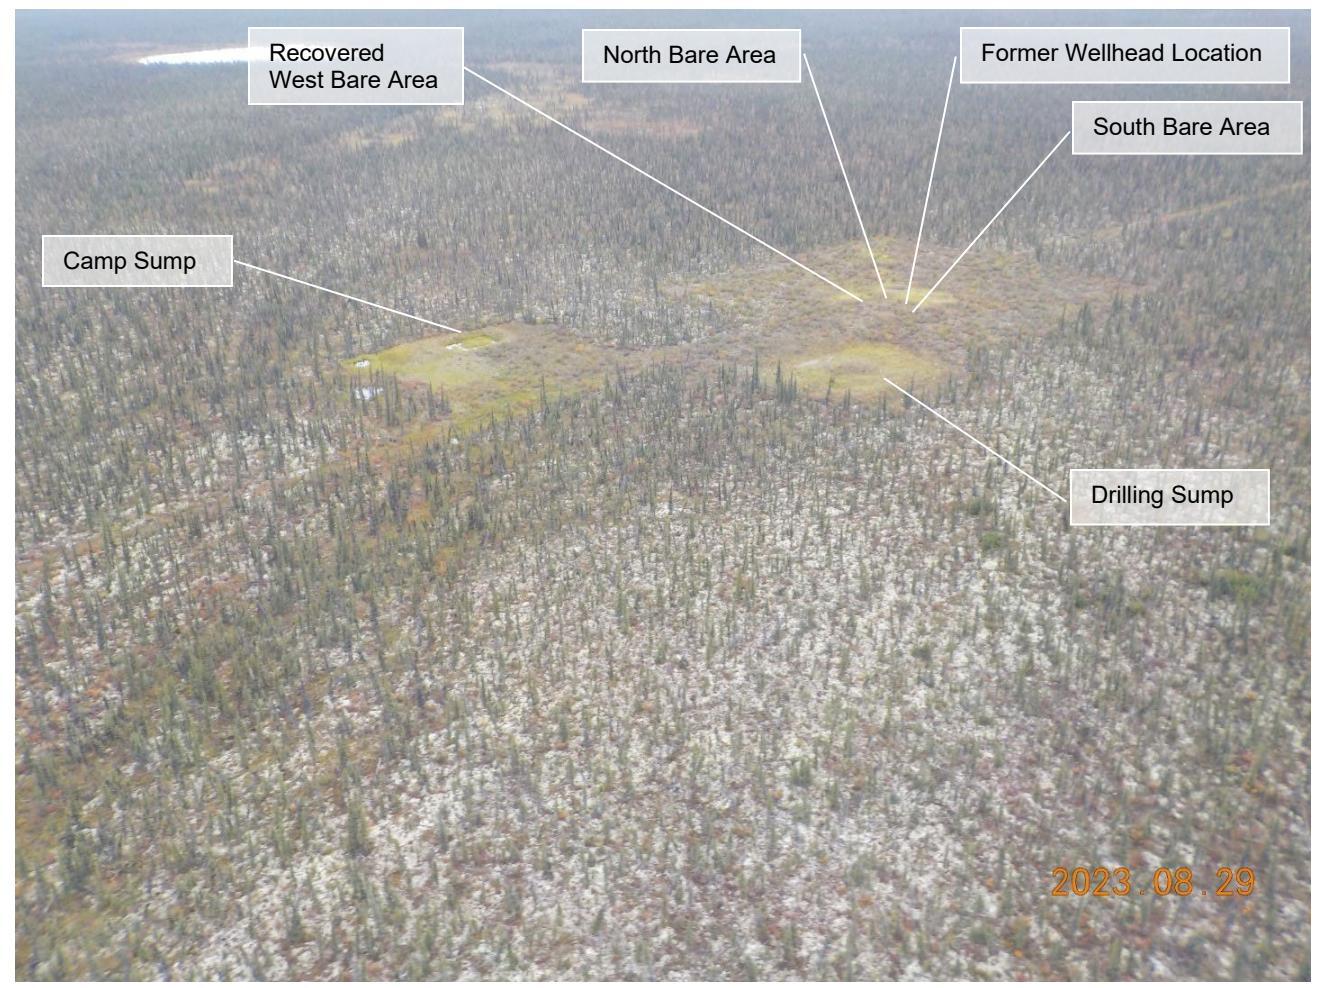
Photo B.1 L-80 Wellsite Area, Drilling Sump Area, and Camp Sump Area: Overview

Note: Overview facing northeast toward the Wellsite Area and Sump Areas, and surrounding area showing overall terrain, water, and vegetation conditions (August 29, 2023).

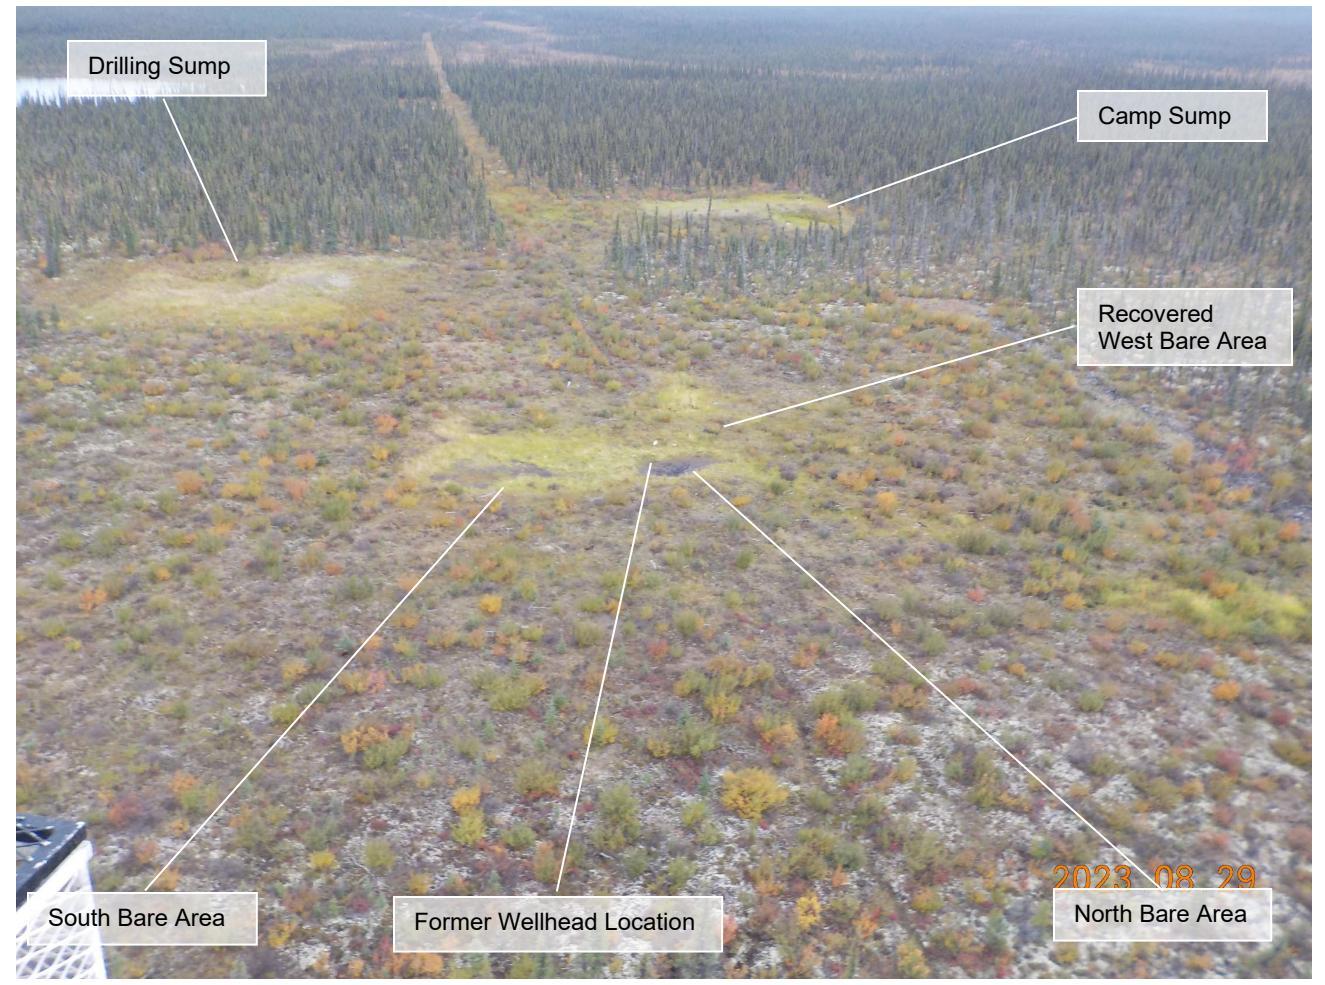
Photo B.2 L-80 Wellsite Area, Drilling Sump Area, and Camp Sump Area: Overview

Note: Overview facing southwest showing the Wellsite Area, Drilling Sump Area, Camp Sump Area, Former Wellhead Location, the North Bare Area, South Bare Area, and Recovered West Bare Area (August 29, 2023).

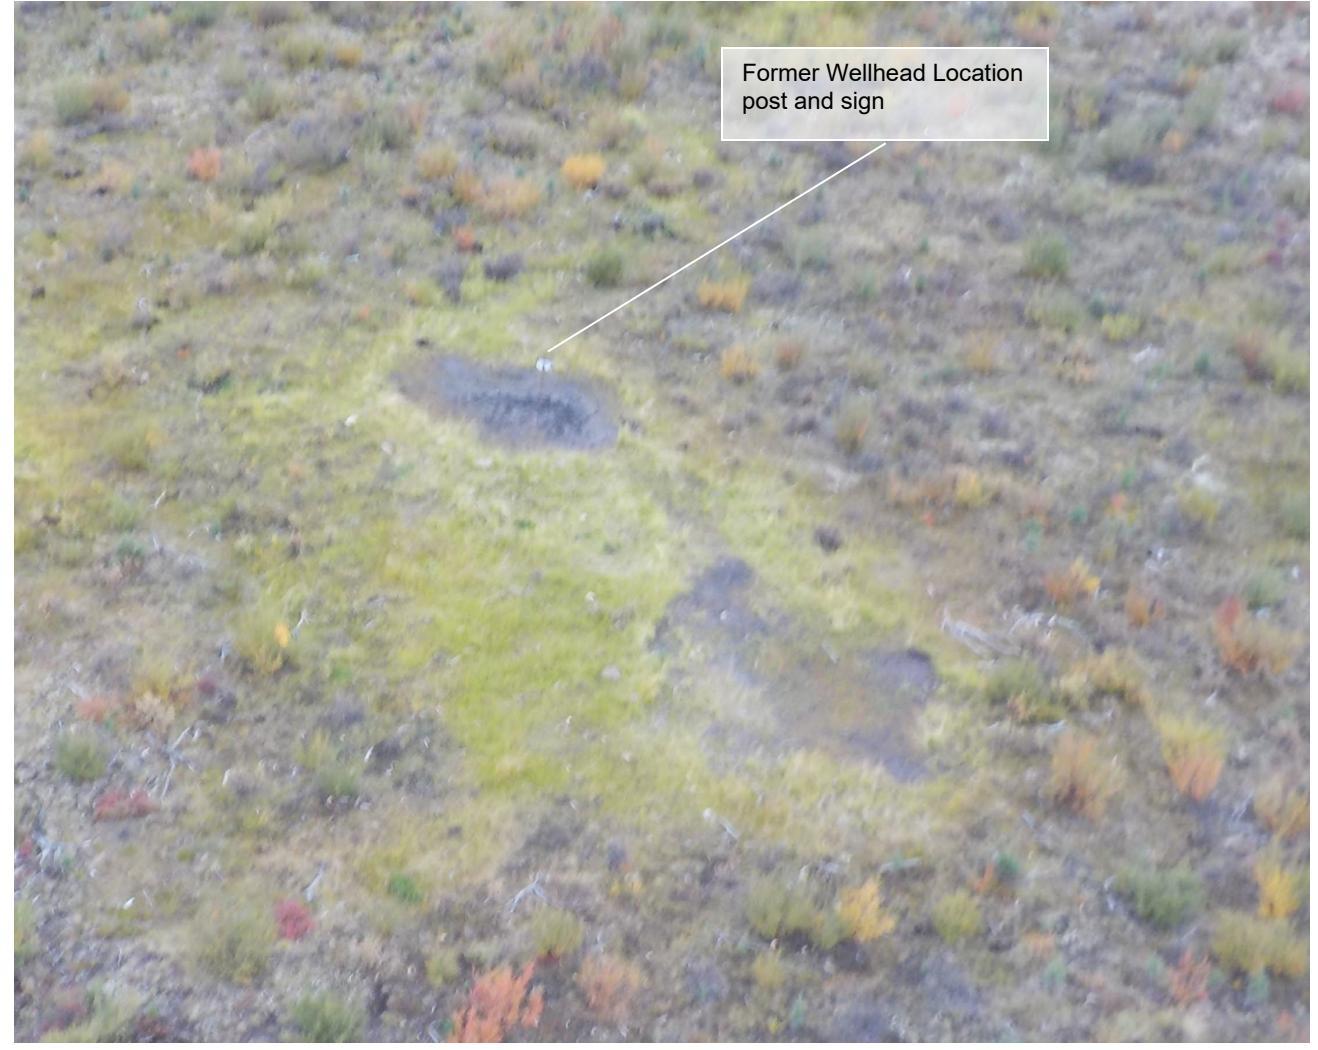
Photo B.3 L-80 Wellsite Area, Drilling Sump Area, and Camp Sump Area: On-Site Materials

Parameters	Monitoring Observations and Results	Soil and Water Analytical Results (if exceedances)	Future Recommended Work
On-Site Materials	 A steel well marker post and sign at the Former Wellhead Location were the only structures observed at the Site during the 2023 site visit (Attachment A: Figure A.2 and Figure A.3; Attachment B: Photo B.3). No other surface structures, materials, or waste were observed within the Site during the site visit. 	 Not applicable for this parameter. 	No further work related to on-site materials recommended at this time.
Terrain	 No erosion issues were observed at the Site during the 2023 site visit. The two sumps (drilling sump and camp sump) were observed to have the same irregular profiles as previously observed^{4,5,6}. The uneven topography is assumed to be related to the settlement/subsidence of the sump cap. This process is expected to have occurred prior to the beginning of the site monitoring by Stantec in 2017. Drilling Sump and Camp Sump depressions and edges/perimeters remained unchanged from previous monitoring observations. No new tension cracks and no evidence of additional subsidence were observed (Attachment B: Photo B.4 and Photo B.5). 	Not applicable for this parameter.	 Continue visual monitoring for potential signs of stress and/or ground movement during a future site visit. As the Drilling Sump does not contain waste materials, topography has not changed, and it has been revegetated; therefore, recommend no additional monitoring or decommissioning/reclamation treatments. Undertaking treatments would create new disturbances and would set back vegetation establishment. Recommend MGM Energy to discuss adjusting the permit requirements for the sump with the regulator.

Note: View facing north and looking at on-site materials showing Former Wellhead Location post and sign (August 29, 2023).

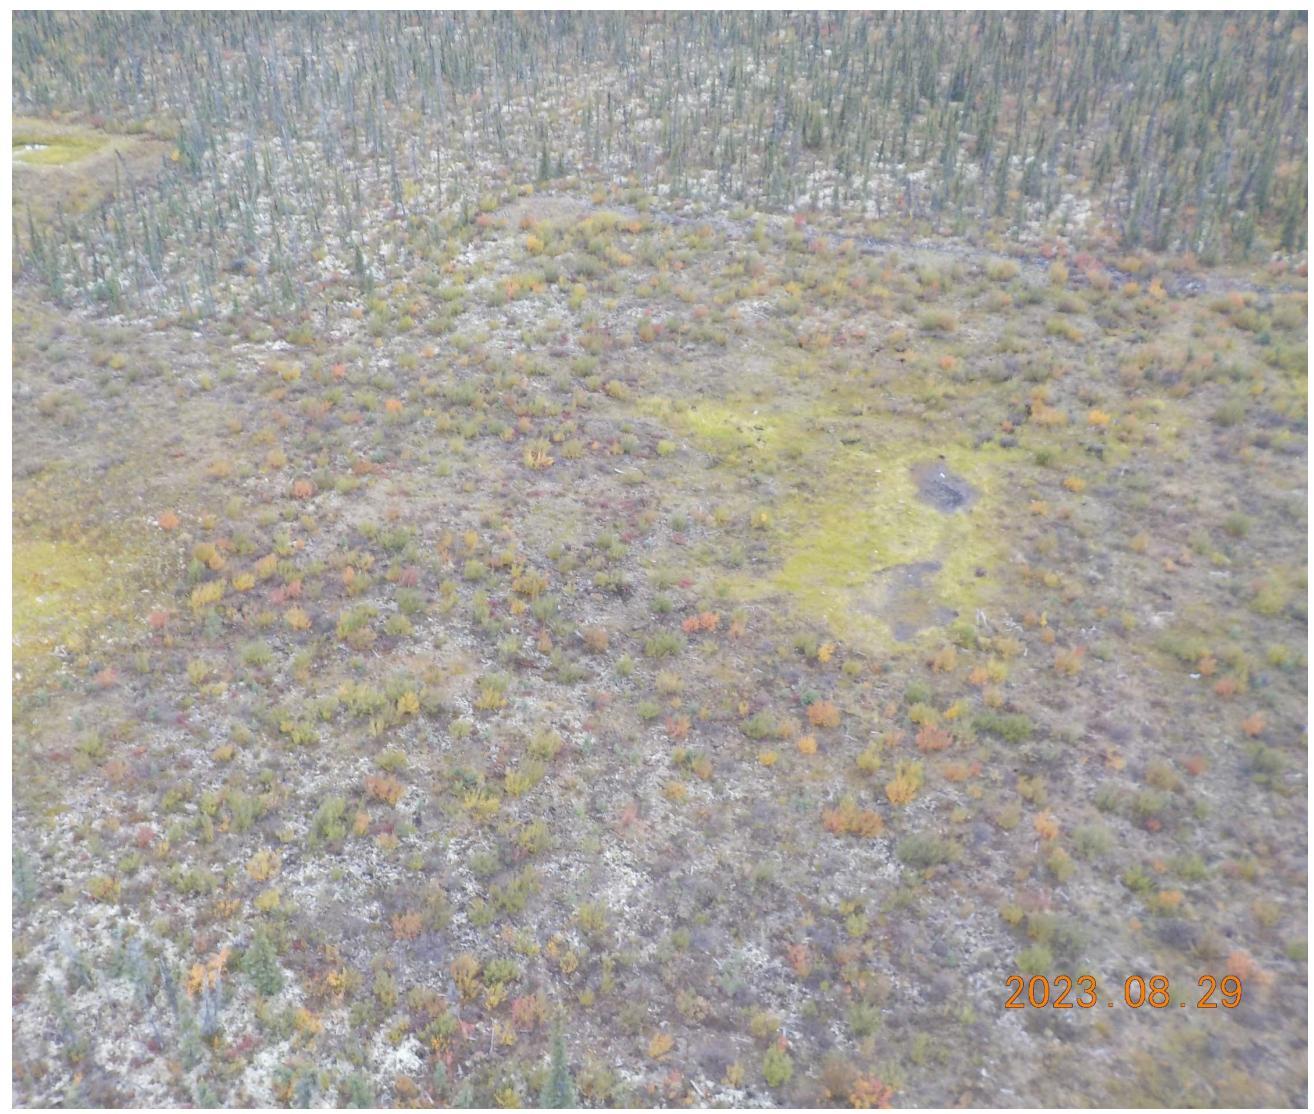
- Reference: 2023 Environmental Site Monitoring Report: Maunoir L-80 Wellsite Area, Drilling Sump Area, and Camp Sump Area
- Photo B.6 L-80 Wellsite Area, Drilling Sump Area, and Camp Sump Area: Vegetation Cover-Wellsite Area

and forbs around the Former Wellhead Location, North Bare Area, South Bare Area, and Recovered West Bare Area		only in this portion of the Wellsite Area.
	(Attachment B: Photo B.6).		Reconnaissance level vegetation monitoring recommended at North
	 The North Bare Area, South Bare Area, and West Bare Area underwent reclamation treatments in 2017 (organic mulch pellet application, ground tilling, application of native grass 		Bare Area, South Bare Area, and Recovered West Bare Area.
	seed and fertilizer).		Soil remediation/phytoremediation tractmenta recommended for North
	 The North and South Bare Areas subsequently were extremely grazed (>80% of plants grazed), the ground compacted and left bare due to suspected muskox (<i>Ovibos moschatus</i>) use. 		Bare Area and South Bare Area to address soil salinity and sodicity exceedances.
	requirements for percent cover and health condition (i.e., had <70% cover and in unhealthy condition).		 This treatment would be carried out based on the results of soil

Note: View facing northwest and looking at ground and vegetation conditions in the Wellsite Area. Majority of Wellsite Area was undisturbed and has revegetated with naturally established trees, shrubs, and forbs. Vegetation cover met the permit requirements (i.e., >70% cover and healthy condition) (August 29, 2023).

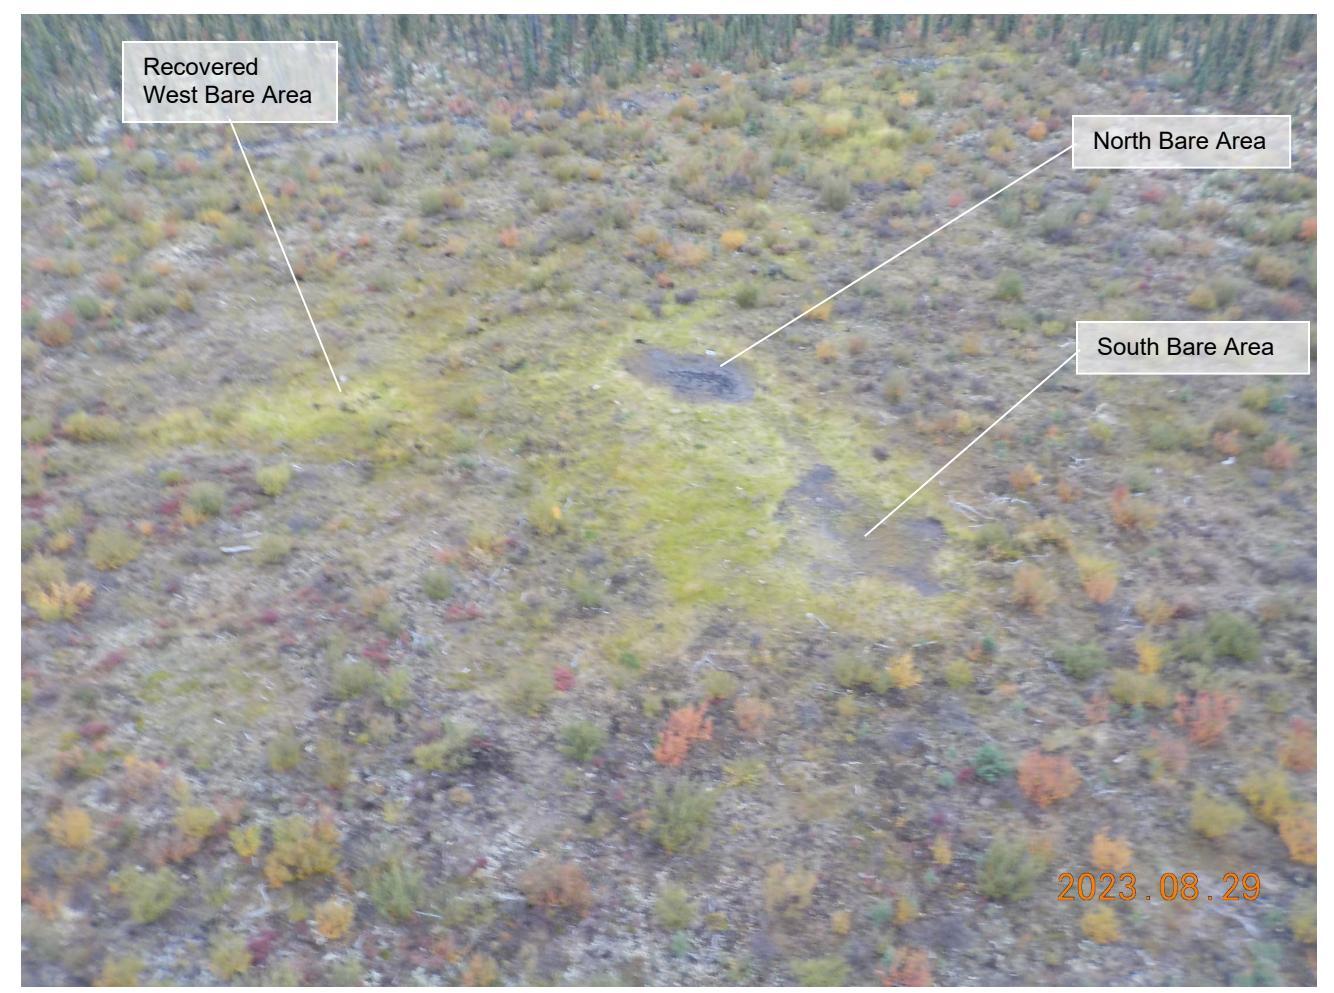
- Reference: 2023 Environmental Site Monitoring Report: Maunoir L-80 Wellsite Area, Drilling Sump Area, and Camp Sump Area
- Photo B.7 L-80 Wellsite Area, Drilling Sump Area, and Camp Sump Area: Vegetation Cover-Wellsite Area- North Bare Area, South Bare Area, and Recovered West Bare Area

North Bare Area: Overall vegetation cover was approximately 10% to 20% (Attachment B: Photo B.7). 		samples collected from the North and South Bare Areas
			 If treatments are carried out, they will include ground scarification

Parameters	Monitoring Observations and Results	Soil and Water Analytical Results (if exceedances)	Future Recommended Work
Parameters Vegetation (cont'd)	 Monitoring Observations and Results South Bare Area: Overall vegetation cover was approximately 30% to 35%, (Attachment B: Photo B.7). Although not visible from the air in 2023, it is suspected that the invasive plant prostrate knotweed (<i>Polygonum aviculare</i>) was still present in the area based on 2022 site visit ground observations This species is indicative of overgrazed and heavily compacted ground. Recovered West Bare Area (Vegetation Assessment: Vegetation was well established. Overall vegetation cover was approximately 75% to 80% consisting of seeded native grasses and naturally established vegetation (Attachment B: Photo B.7). Vegetation cover was meeting permit requirements of greater than 70% vegetation cover and in healthy condition at the time of the 2023 site visit. 	Soil and Water Analytical Results (if exceedances) See above	 Future Recommended Work Treatments must also include installation of grid deterrent structures and coarse wood debris to protect treated areas from muskox damage. Reconnaissance level monitoring for invasive plants whenever a site visit is carried out, particularly at the North Bare Area and South Bare Area. Carry out invasive plant/weed control treatments if infestations reach a density that prohibits vegetation establishment and growth, including pulling plants, storing in garbage bags, and disposing off-site at an approved

Note: View facing north and looking at ground and vegetation conditions in the North and South Bare Areas, and the Recovered West Bare Area (August 29, 2023). The three areas underwent reclamation treatments in July 2017. In North and South Bare Areas, vegetation was extremely grazed (>80% utilization) and ground was very heavily trampled and compacted by hoof traffic. Vegetation cover was approximately 10% to 35%, appeared unhealthy, and was not meeting permit requirements (i.e., had <70% cover and unhealthy condition). In the Recovered West Bare Area, vegetation had re-established well and did not appear grazed and the ground did not appear impacted by hoof traffic. Vegetation cover was approximately 75% to 80%, appeared healthy, and met the permit requirements (i.e., >70% cover and healthy condition).

• Although not visible from the air in 2023, it is suspected that the invasive plant prostrate knotweed (<i>Polygonum aviculare</i>) was still present in the area based on 2022 site visit ground observations. This species is indicative of overgrazed and heavily compacted ground.		application of amendment materials to address soil salinity and drainage, and application of native grass/legume/forb seed mix and fertilizer.

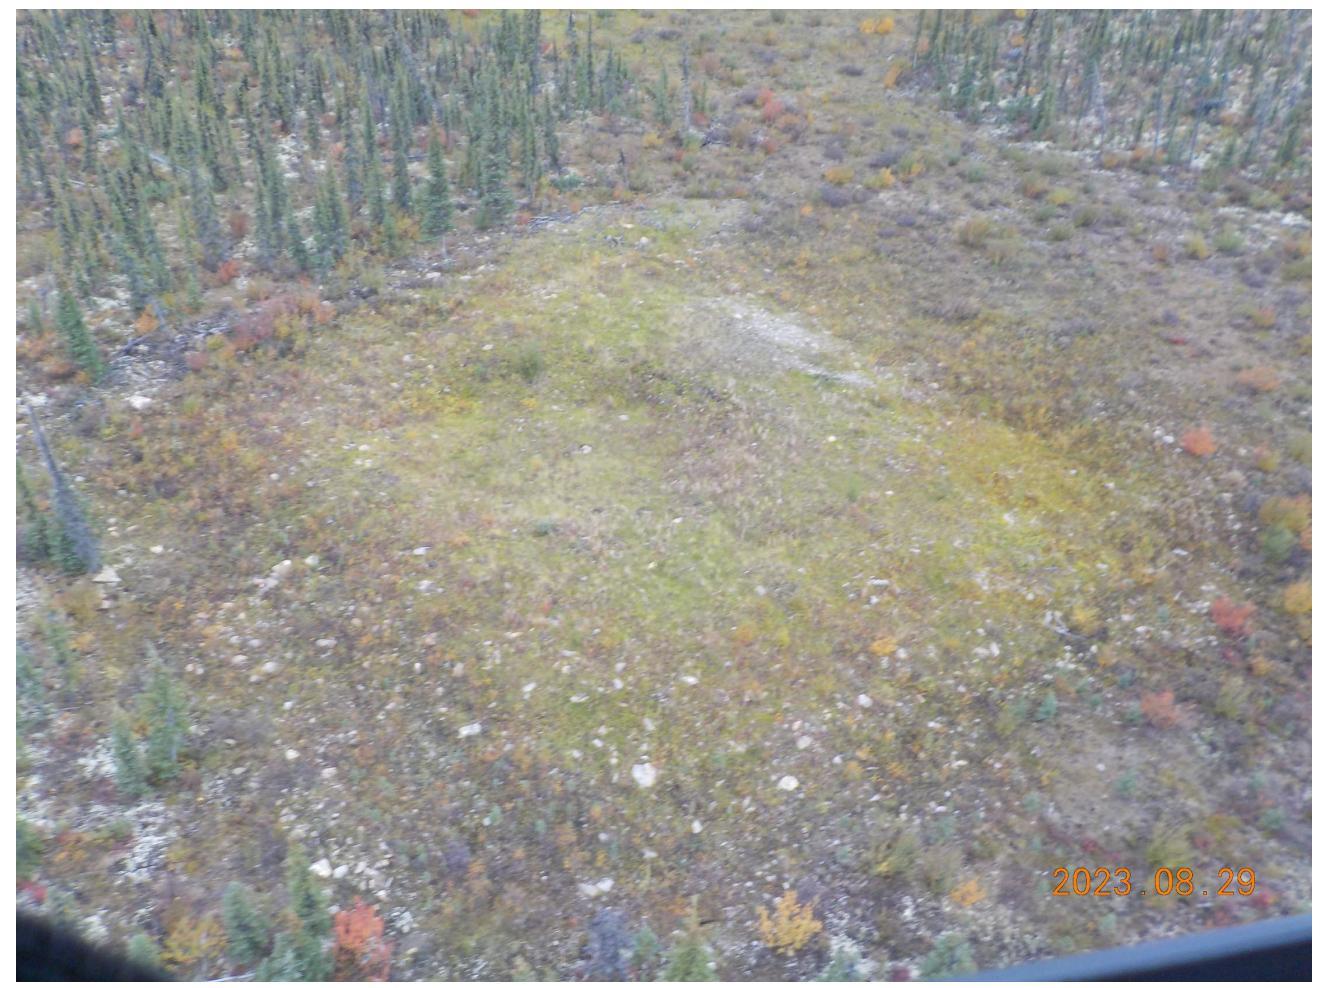
- Reference: 2023 Environmental Site Monitoring Report: Maunoir L-80 Wellsite Area, Drilling Sump Area, and Camp Sump Area
- Photo B.8 L-80 Wellsite Area, Drilling Sump Area, and Camp Sump Area: Vegetation Cover-Drilling Sump Area

Note: View facing west and looking at ground and vegetation conditions in the Drilling Sump Area which has revegetated with seeded grasses, and naturally established tree, shrub, and forb species. Vegetation cover met the permit requirements (i.e., >70% cover and healthy condition) (August 29, 2023).

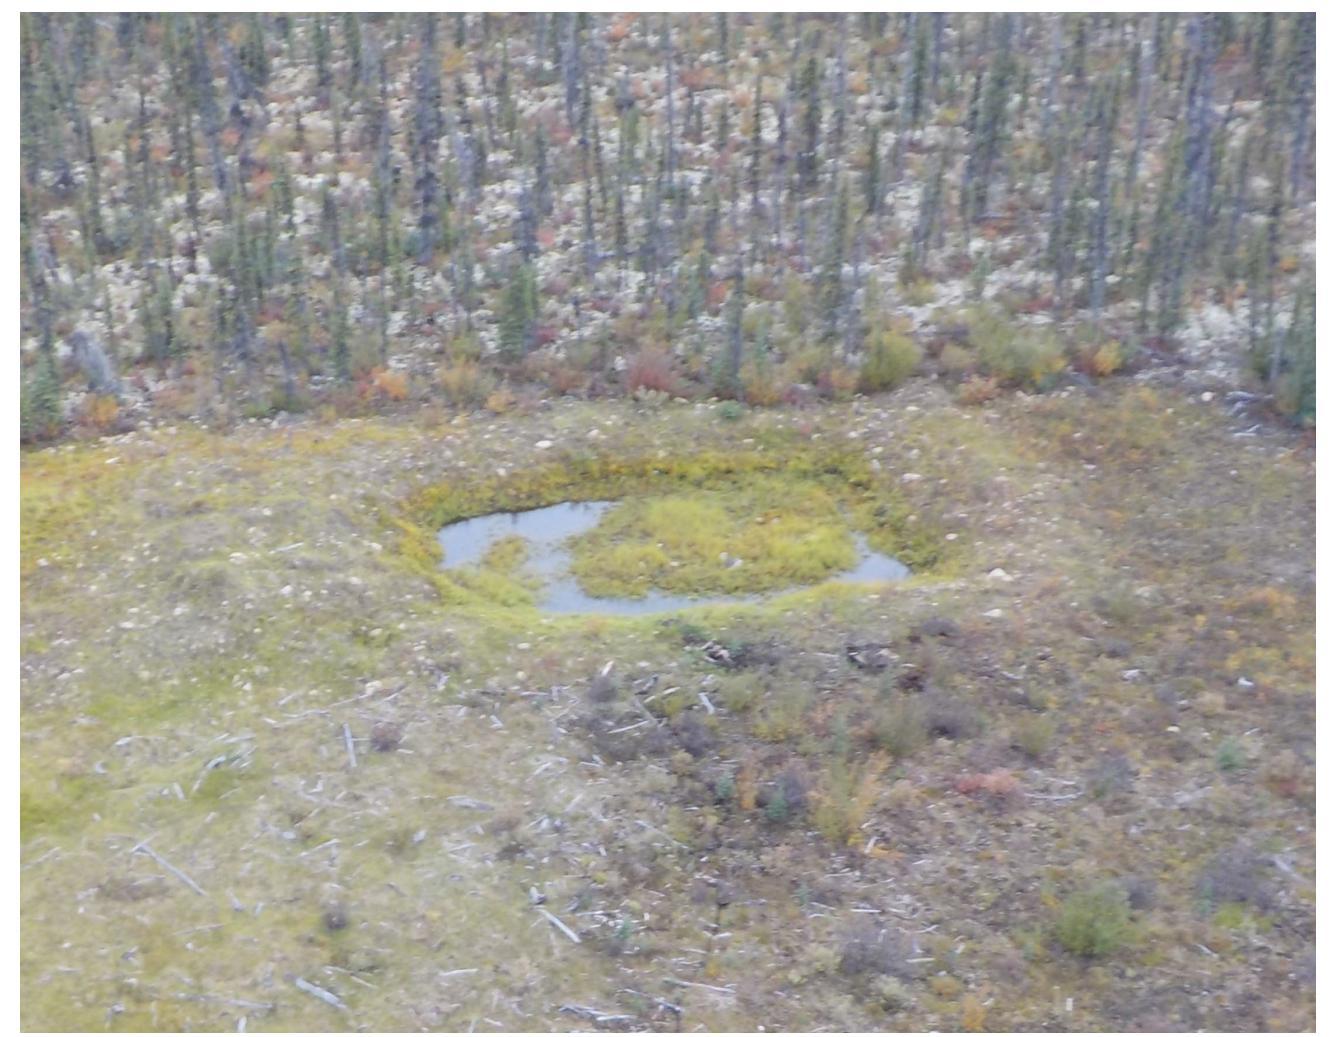
- Reference: 2023 Environmental Site Monitoring Report: Maunoir L-80 Wellsite Area, Drilling Sump Area, and Camp Sump Area
- Photo B.9 L-80 Wellsite Area, Drilling Sump Area, and Camp Sump Area: Vegetation Cover- Camp Sump Area

Note: View facing north and looking at the ground and vegetation conditions in the Camp Sump Area which has revegetated with seeded grasses, and naturally established tree, shrub, and forb species. Vegetation cover met the permit requirements (i.e., >70% cover and healthy condition) (August 29, 2023).
