Sahtu Land and Water Board Annual Water Licence Staff Report # 3

Applicant: Enbridge Pipelines (NW) Inc.		
Location: KP 158 Near Little Smith Creek	File Numbers: S20L1-001	
Date Prepared: August 22, 2023	Date of Board Meeting: November 7, 2023	
Subject/Project Name: Enbridge Pipeline – Little Smith Creek 2022 Annual Water Licence		
Report

Year 2 (2022) Post-Construction Environmental Monitoring Report

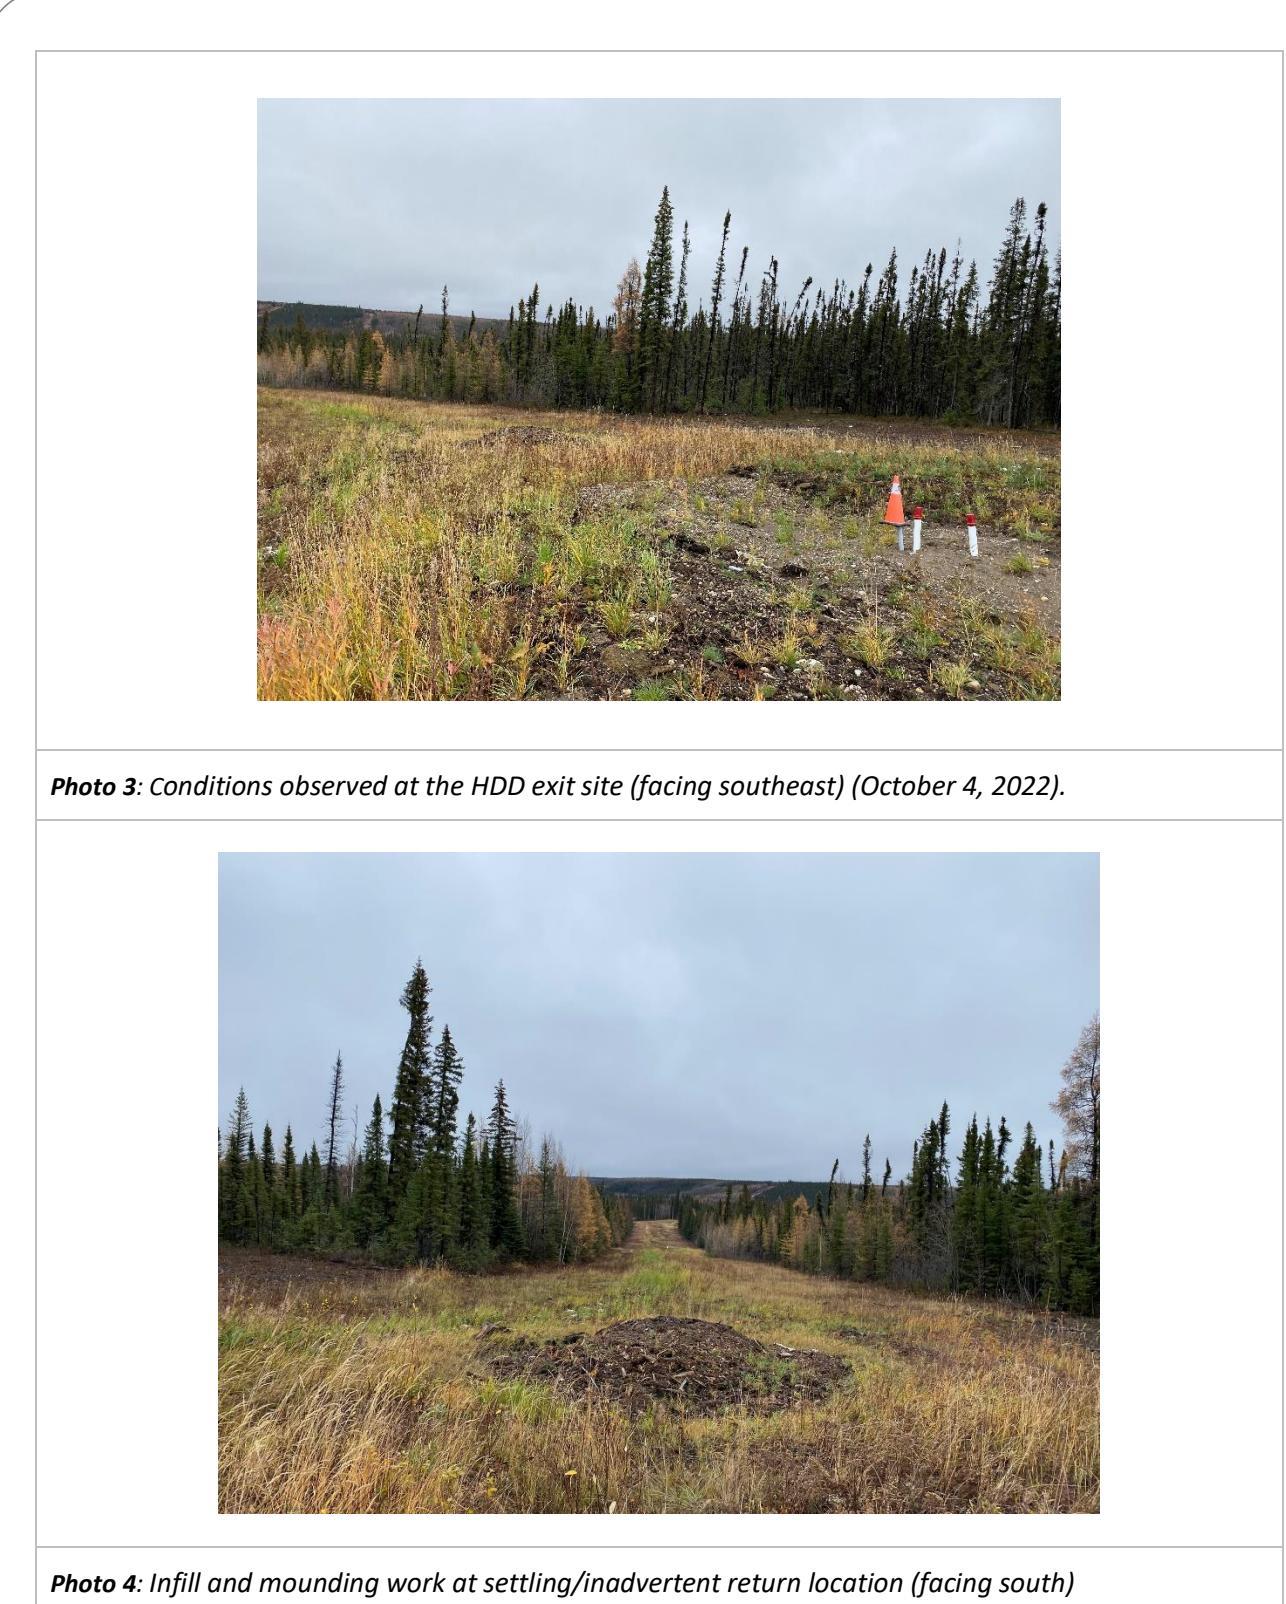
(October 4, 2022).

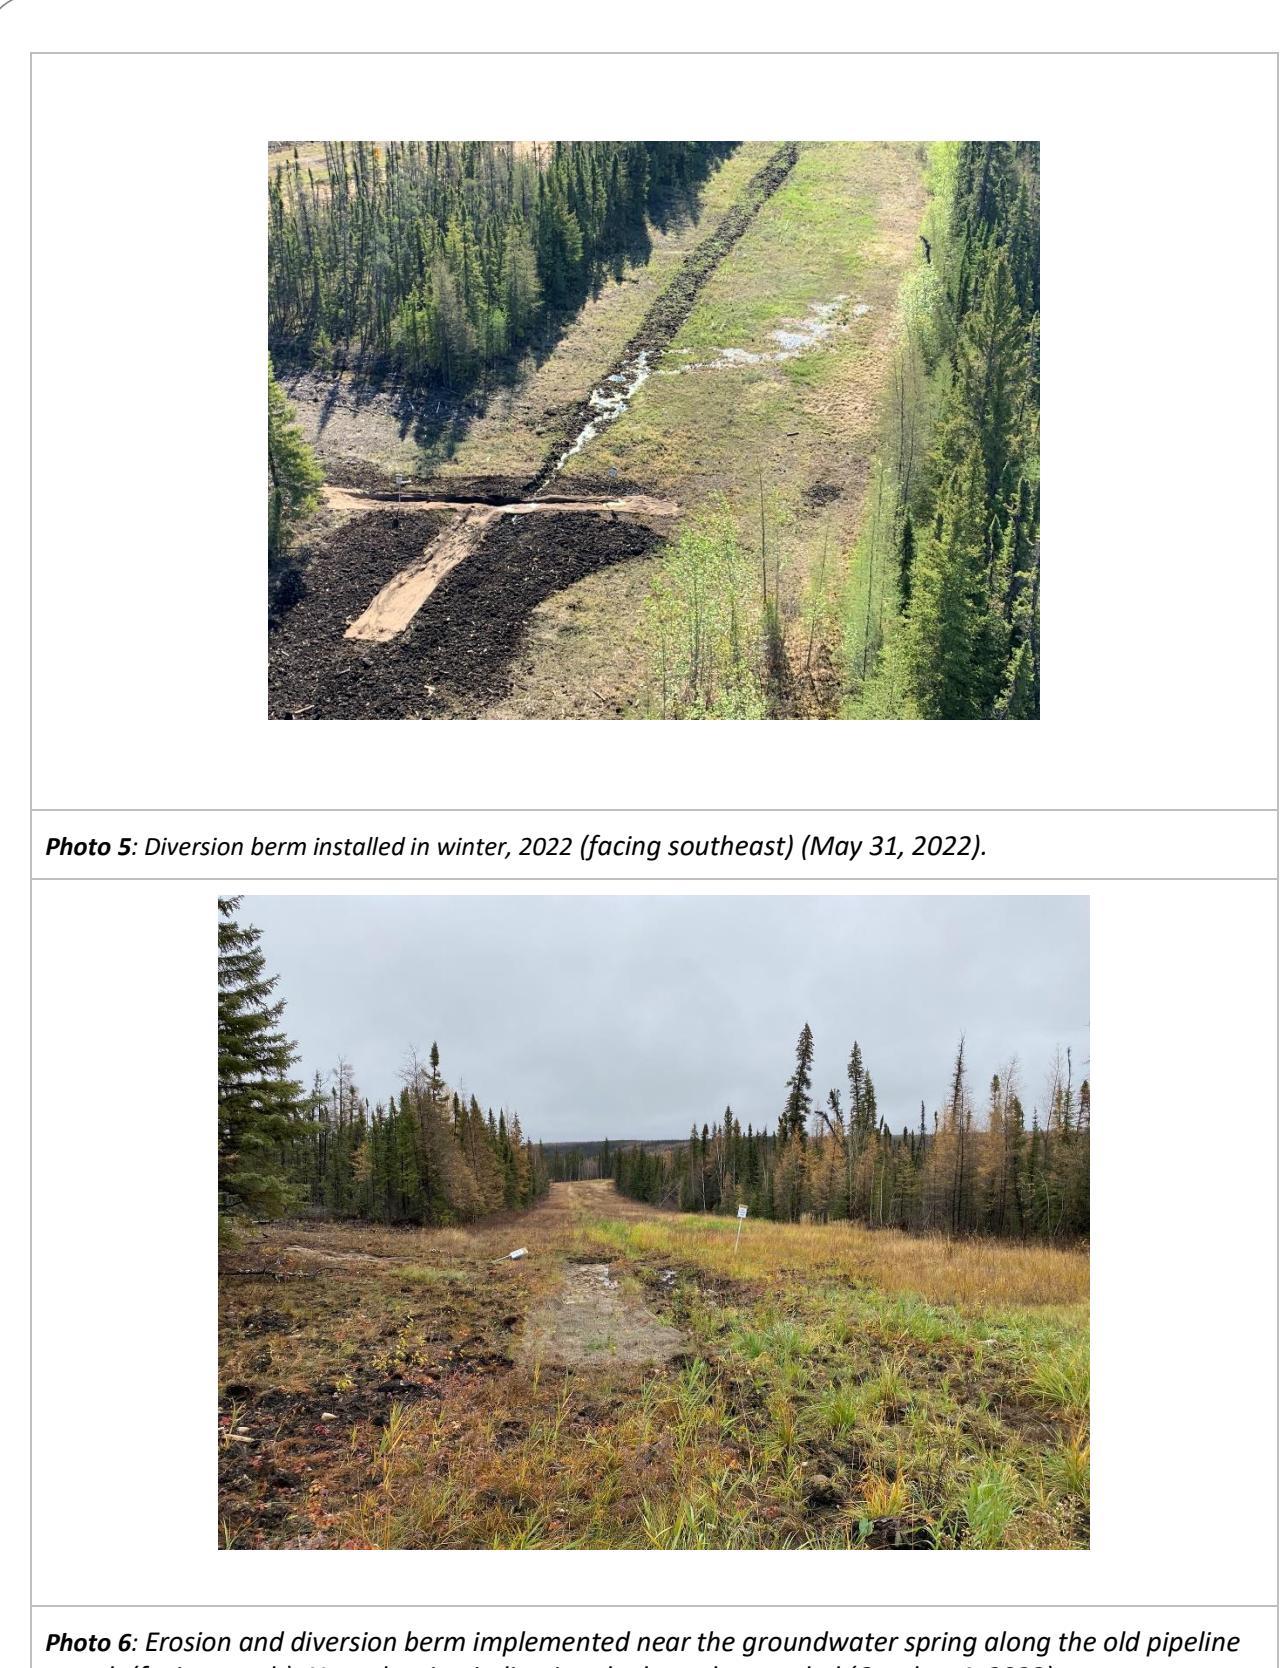
trench (facing south). Note the sign indicating the berm has settled (October 4, 2022).

Closure Objective	Closure Criteria	Year 2 PCEM Results	
	Pre-construction surface drainage is restored	Complete. A diversion berm was installed in 2022 to address surface drainage issues (see Photo 5 and Photo 6 in Appendix B). While the berm is still functional, Enbridge is conducting additional berm maintenance activities in winter 2023 based on field observations in 2022.	
	Surface stoniness is consistent with the representative area	Complete.	
	No ponding, subsidence, or slumping is observed	Complete. The settling observed near the HDD exit pit and the hole at the inadvertent return location were repaired in 2022. A diversion berm was installed to address surface drainage issues.	
Achieve soil stability	Erosion is not observed (beyond typical natural erosion in the Project area)	Complete. Minor erosion was observed from the spring near the removed pipeline in 2021. This erosion is still present but no further erosion was observed in 2022 following the installation of the diversion berm.

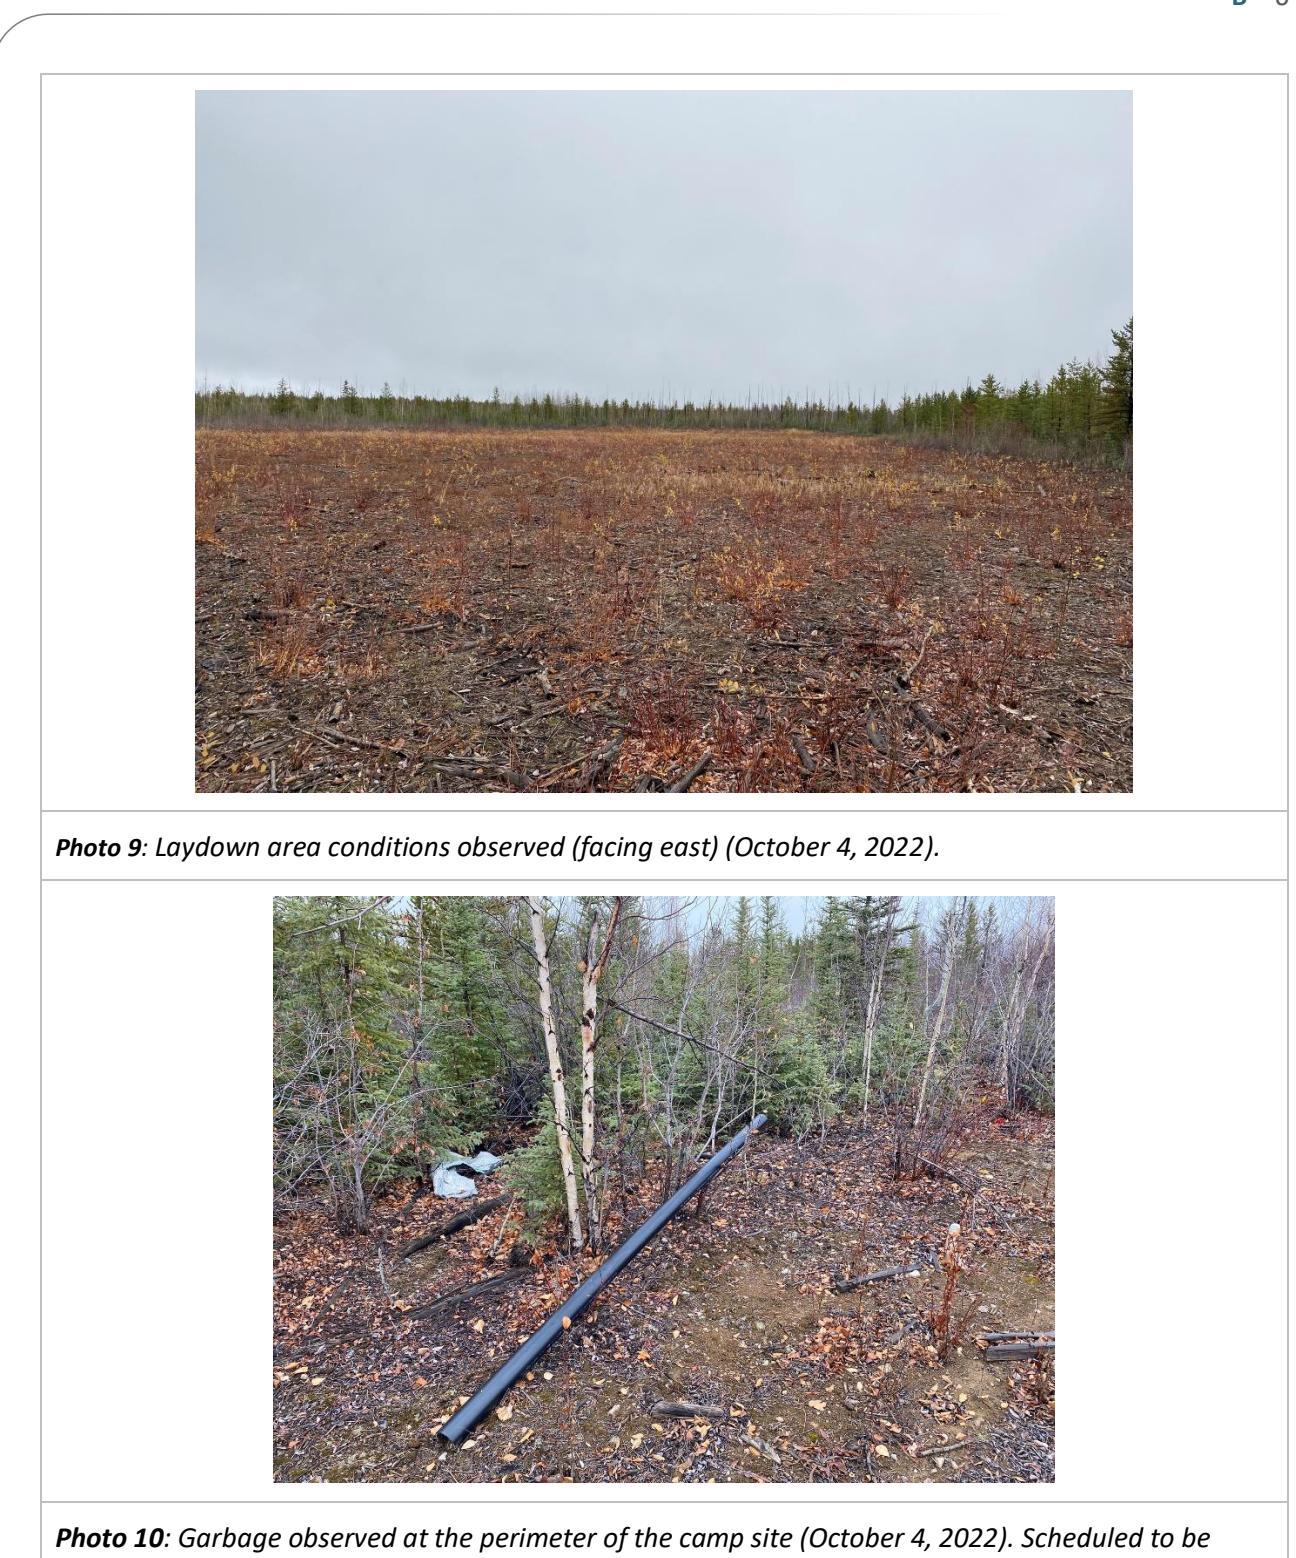
Photo 10: Garbage observed at the perimeter of the camp site (October 4, 2022). Scheduled to be removed Q2, 2023.

ltem				Observations and Recommendations	
#	Location	Issue(s) Observed (2021)	Repair Work Completed (2022)	(2022)	Status
1	HDD exit pit	Settling	Re-contouring to repair settling completed in 2022	The settling area observed near the exit pit was observed to be filled and mounded with a mixture of soil and mulch	Resolved
2	Vicinity of HDD exit pit	Hole created by inadvertent return during construction	Hole filled in 2022	The hold was observed to be filled and mounded with a mixture of soil and mulch	Resolved
3	Along removed pipe alignment	Water from a spring is creating surface erosion	Diversion berm installed in 2022	The diversion berm installed along and across the groundwater seepage was observed to be mitigating further erosion	Resolved
4	HDD entry pit, HDD exit put, camp site	N/A	N/A	Small items of garbage observed that require removal	To be resolved Q2 2023
