APPENDIX A INSTRUMENTATION DRAWINGS

APPENDIX B PHOTOGRAPHIC RECORD

CLIENT:	BIGIC	REPORT TITLE: A21 DIKE 2024 ANNUAL PERFORMANCE REPORT		
Diavik Diamond Mine		PROJECT No.: 1207018	DATE: NOVEMBER 2024

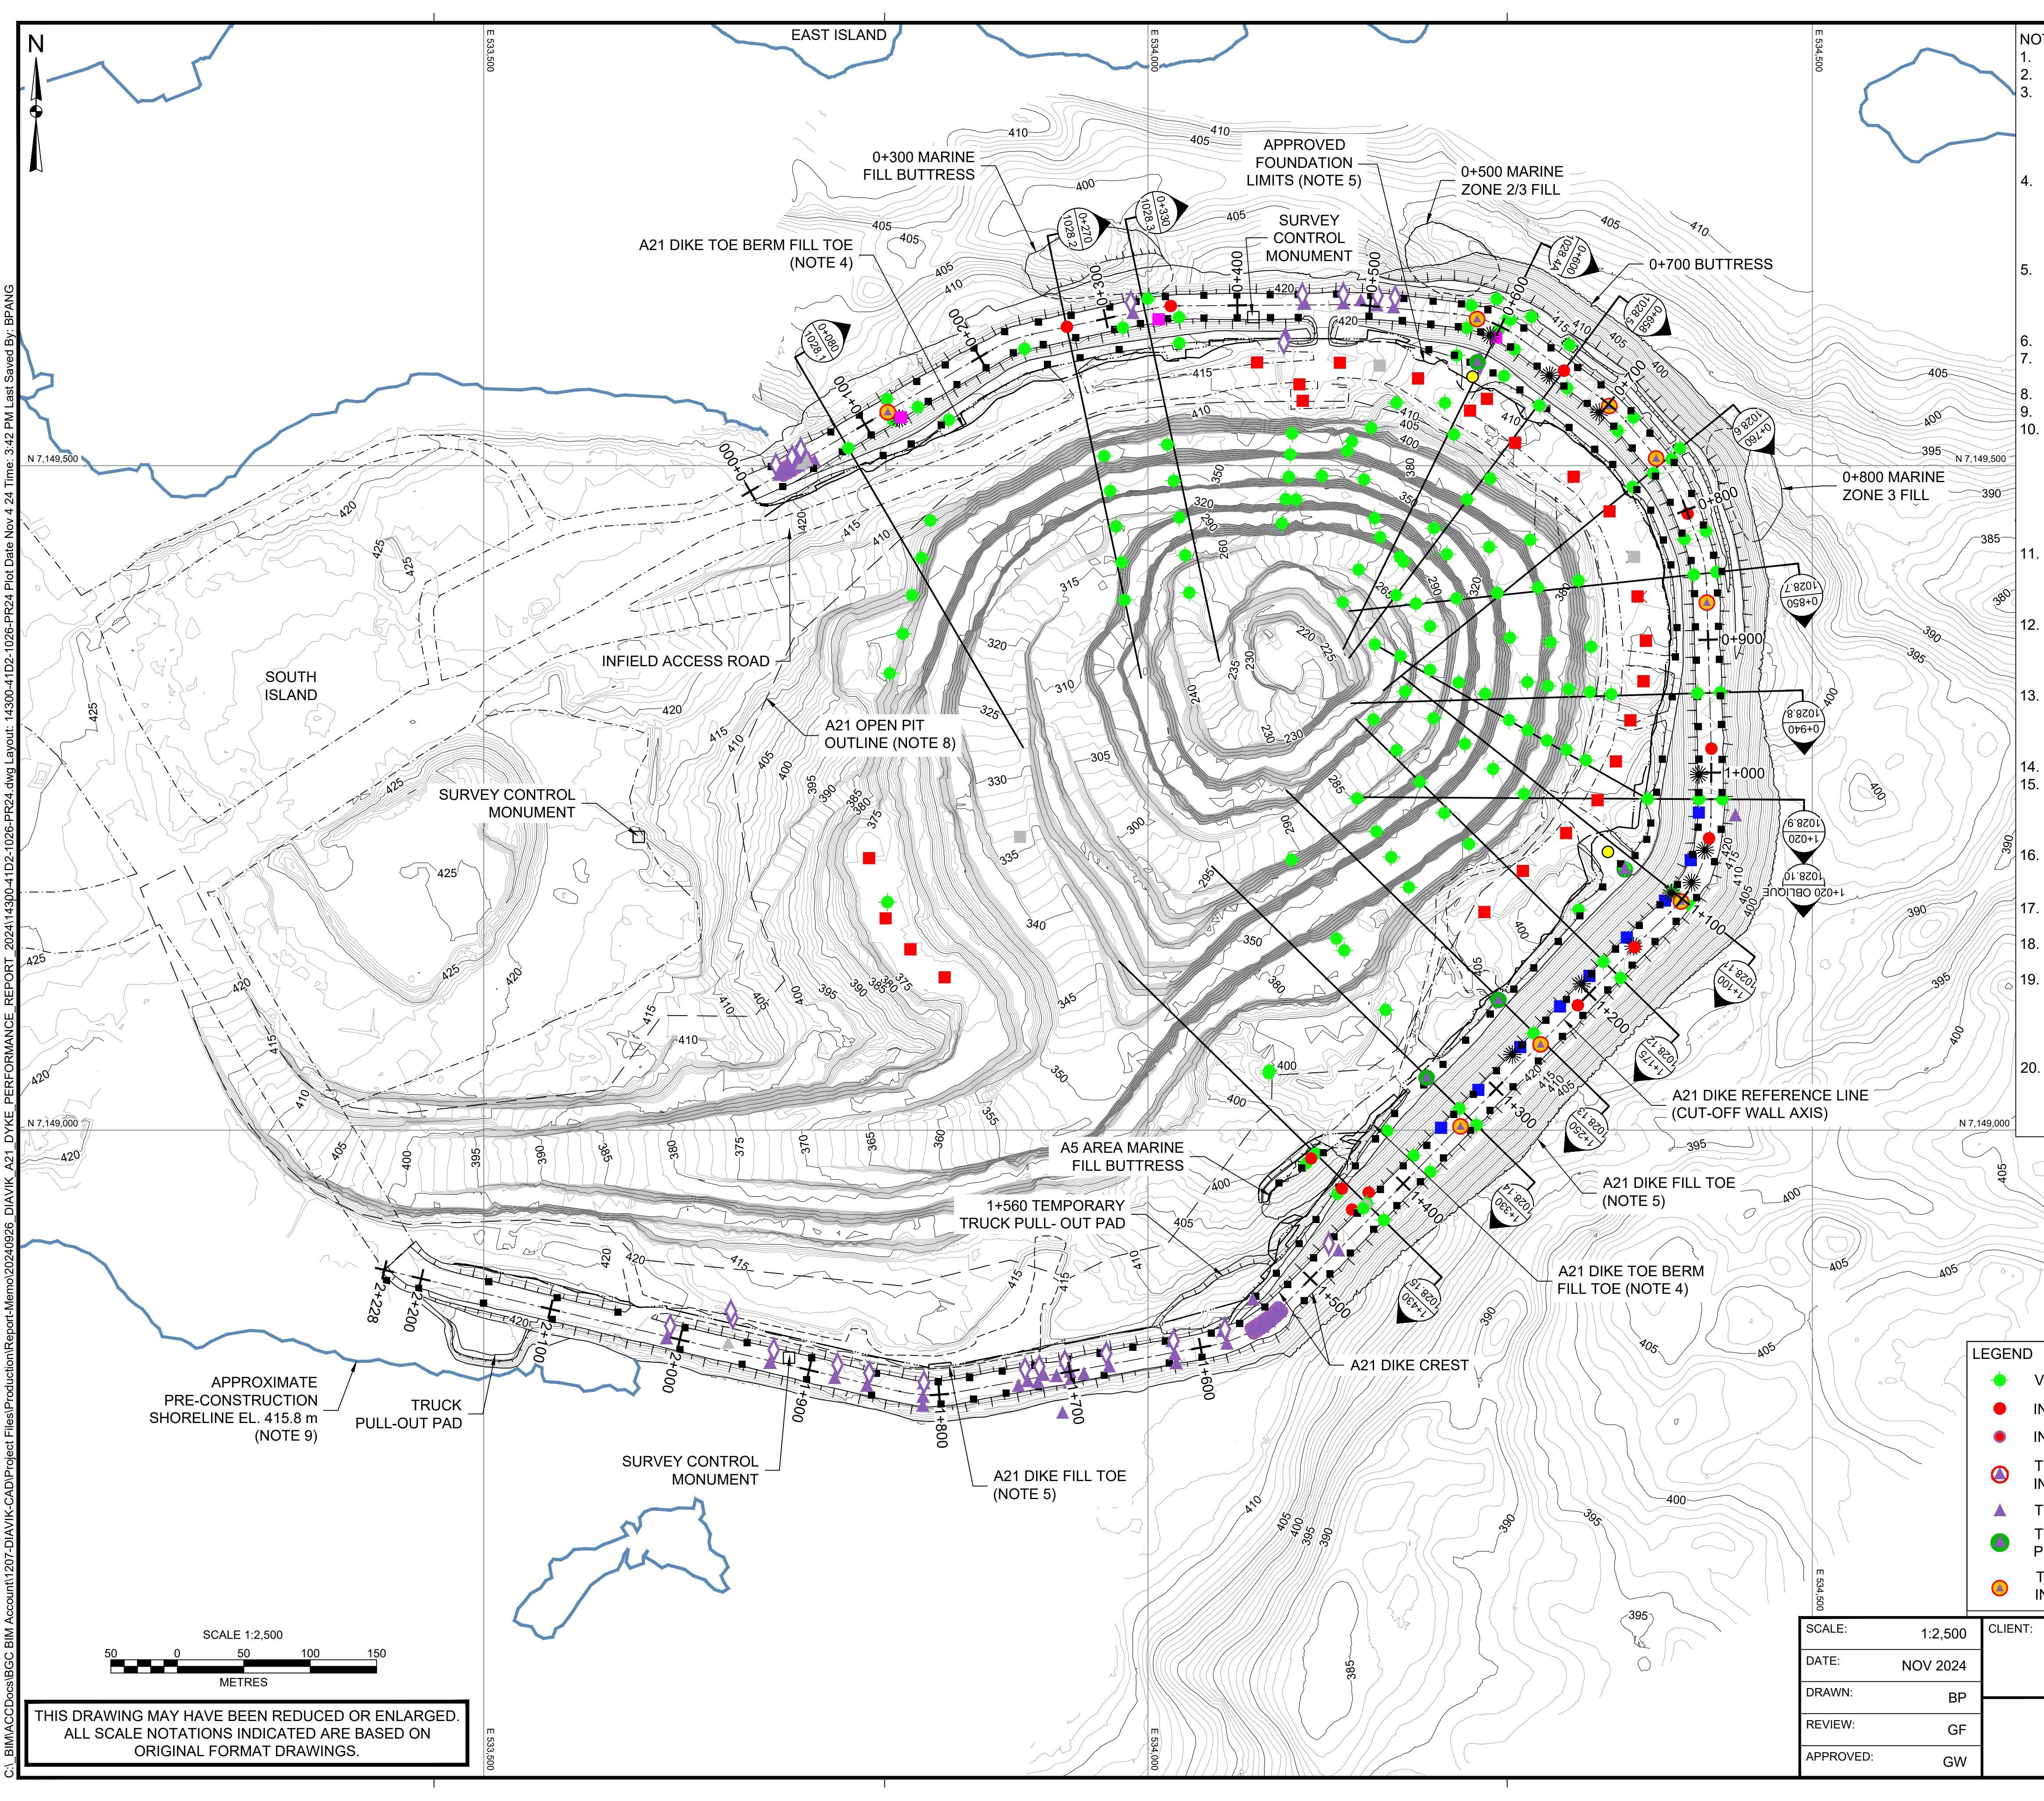
Detailed instrumentation locations on plan and profile are shown on Construction Record Drawings 14300-41D2-1026.1C-CRR through 14300-41D2-1026.6C-CRR. Installation stations and offsets are provided in Construction Record Drawings 14300-41D2-1027.1C-CRR through

Connection of A21 Dike vibrating wire piezometers (VWP) to automated data acquisition systems (ADAS) and permanent trenching of multiconductor cables were completed during the 2017 and 2018 Construction Seasons. Instrument cable layout and data logger locations were designed by RST, Tetra Tech and DDMI. Completed cable and trenching survey data were supplied by DDMI. . Survey data for instrument locations, survey control monuments, permanently trenched multi-conductor cables, pipe and culvert crossings, A21 Pit depressurization wells, and ADAS shacks were supplied by DDMI. Pit piezometers and depressurization wells locations provided by DDMI on October 16, 2020 and November 12, 2020.

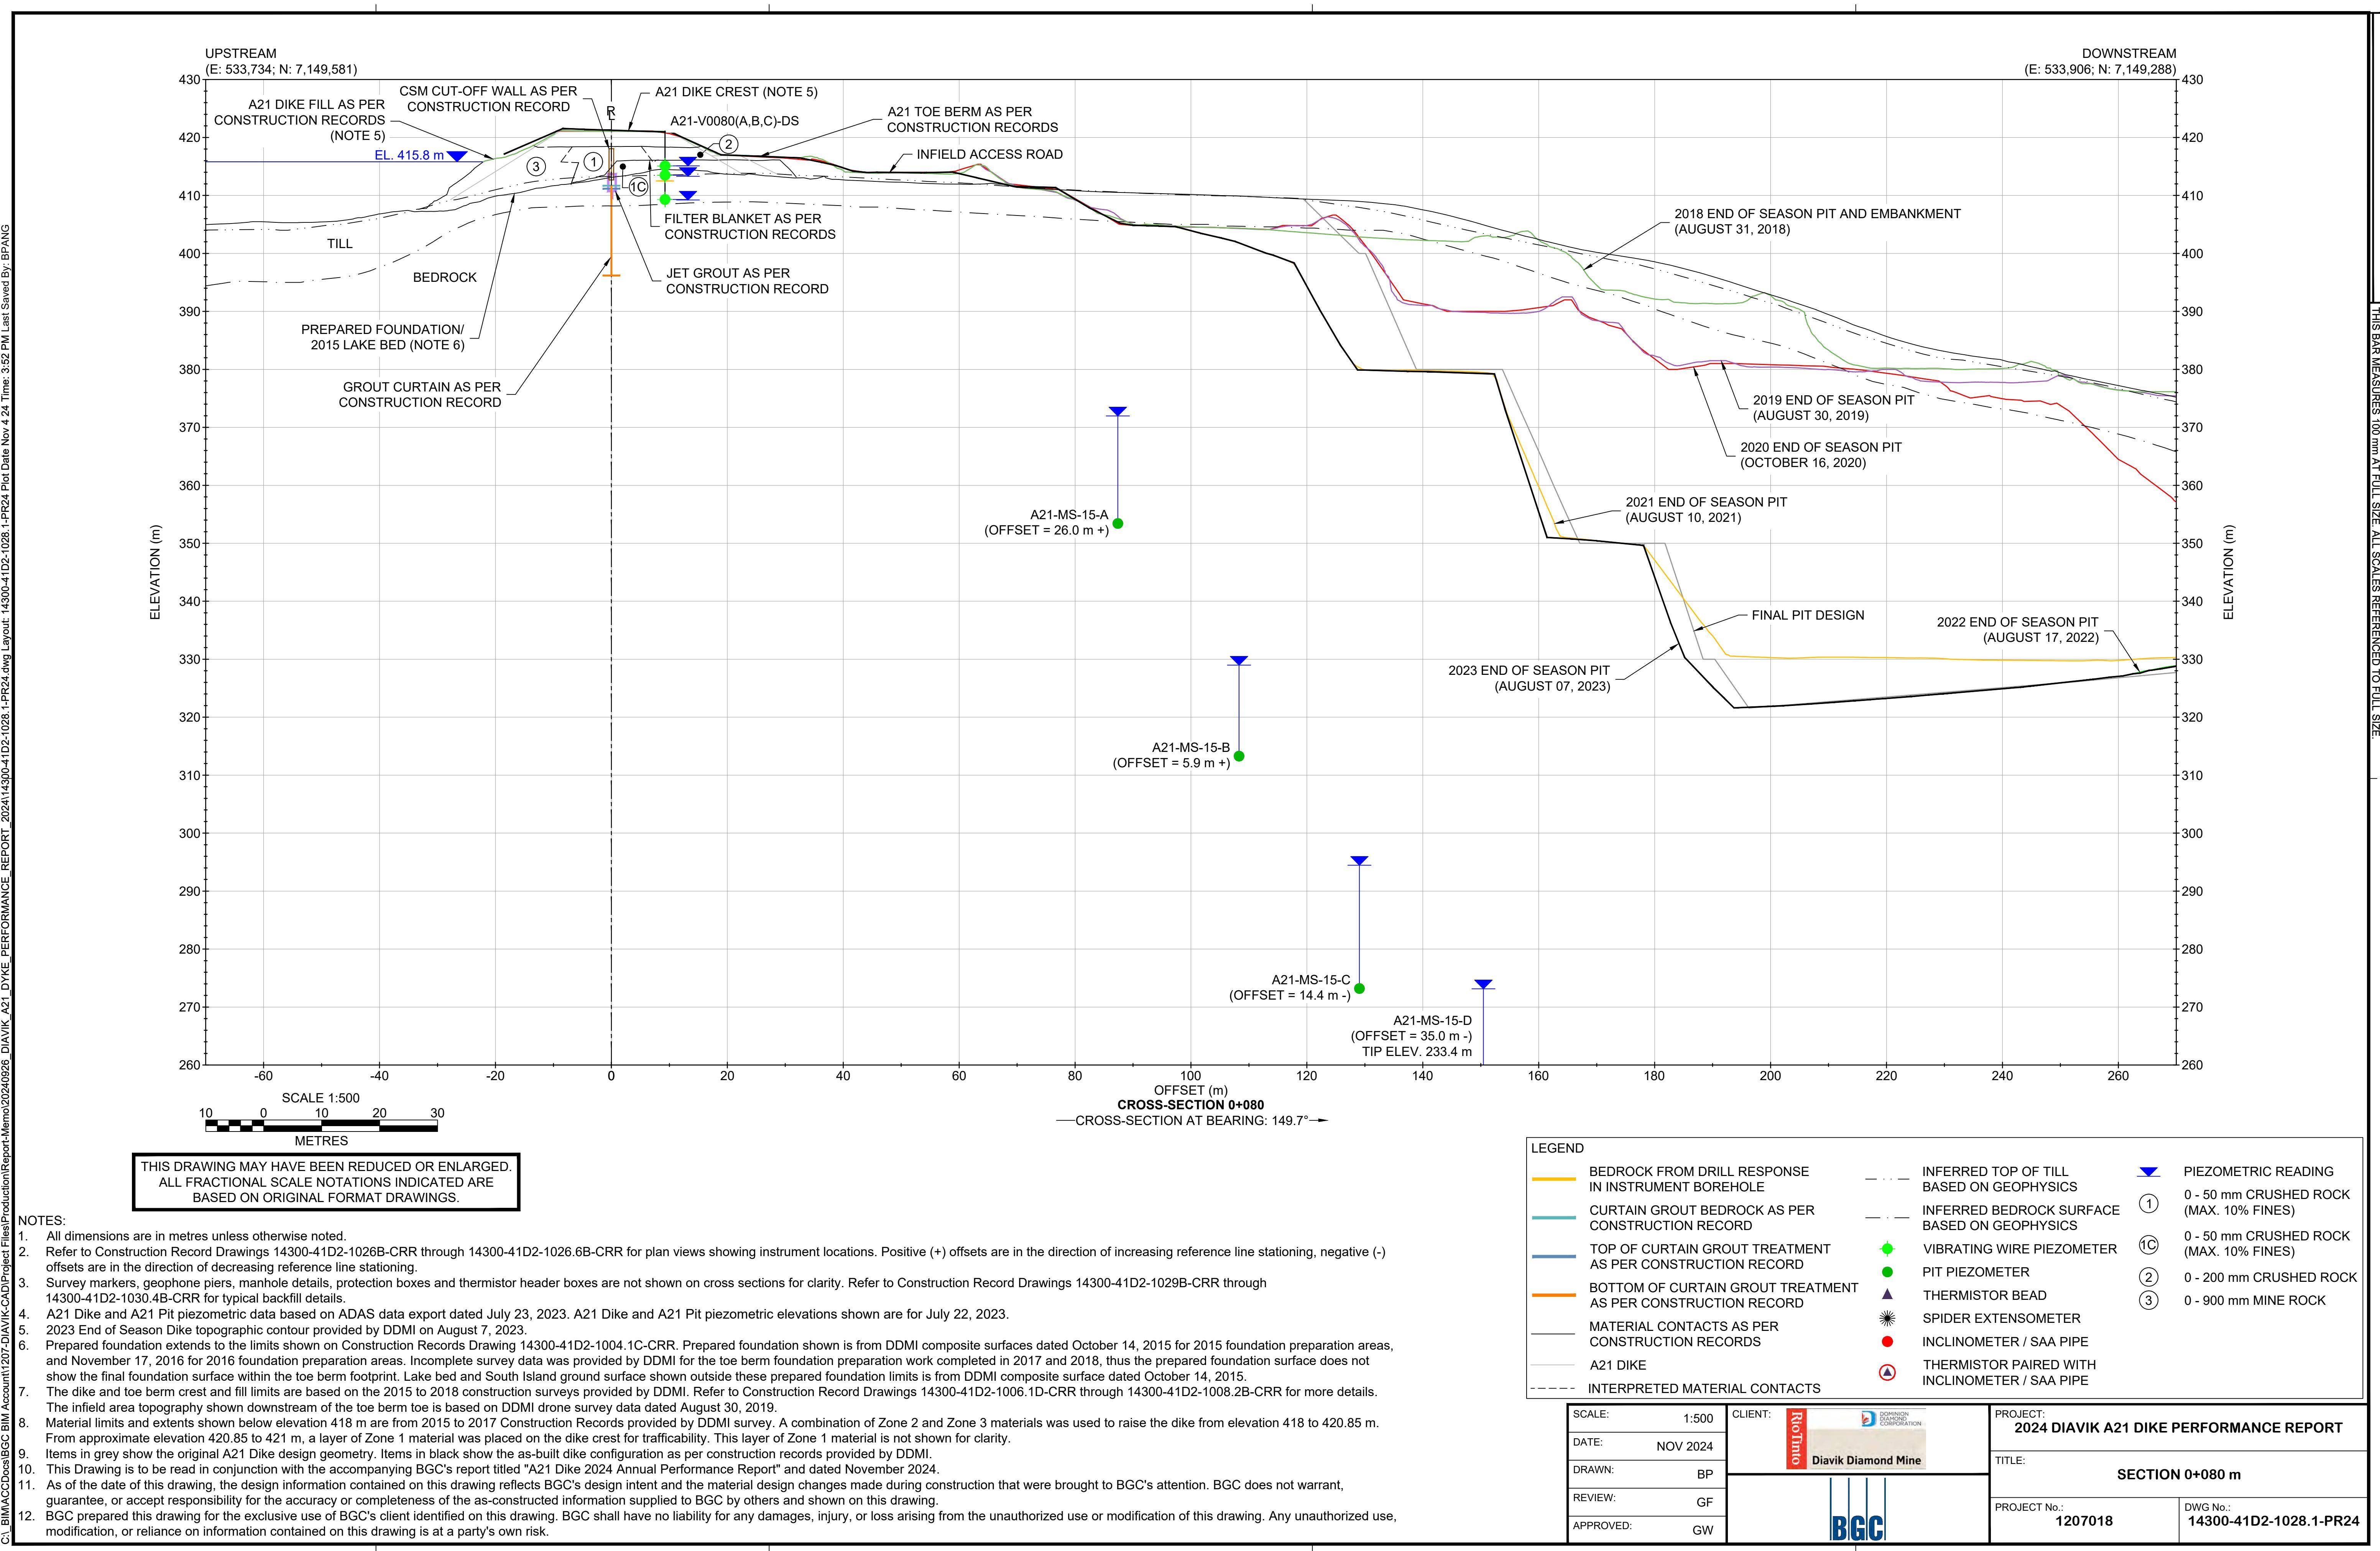
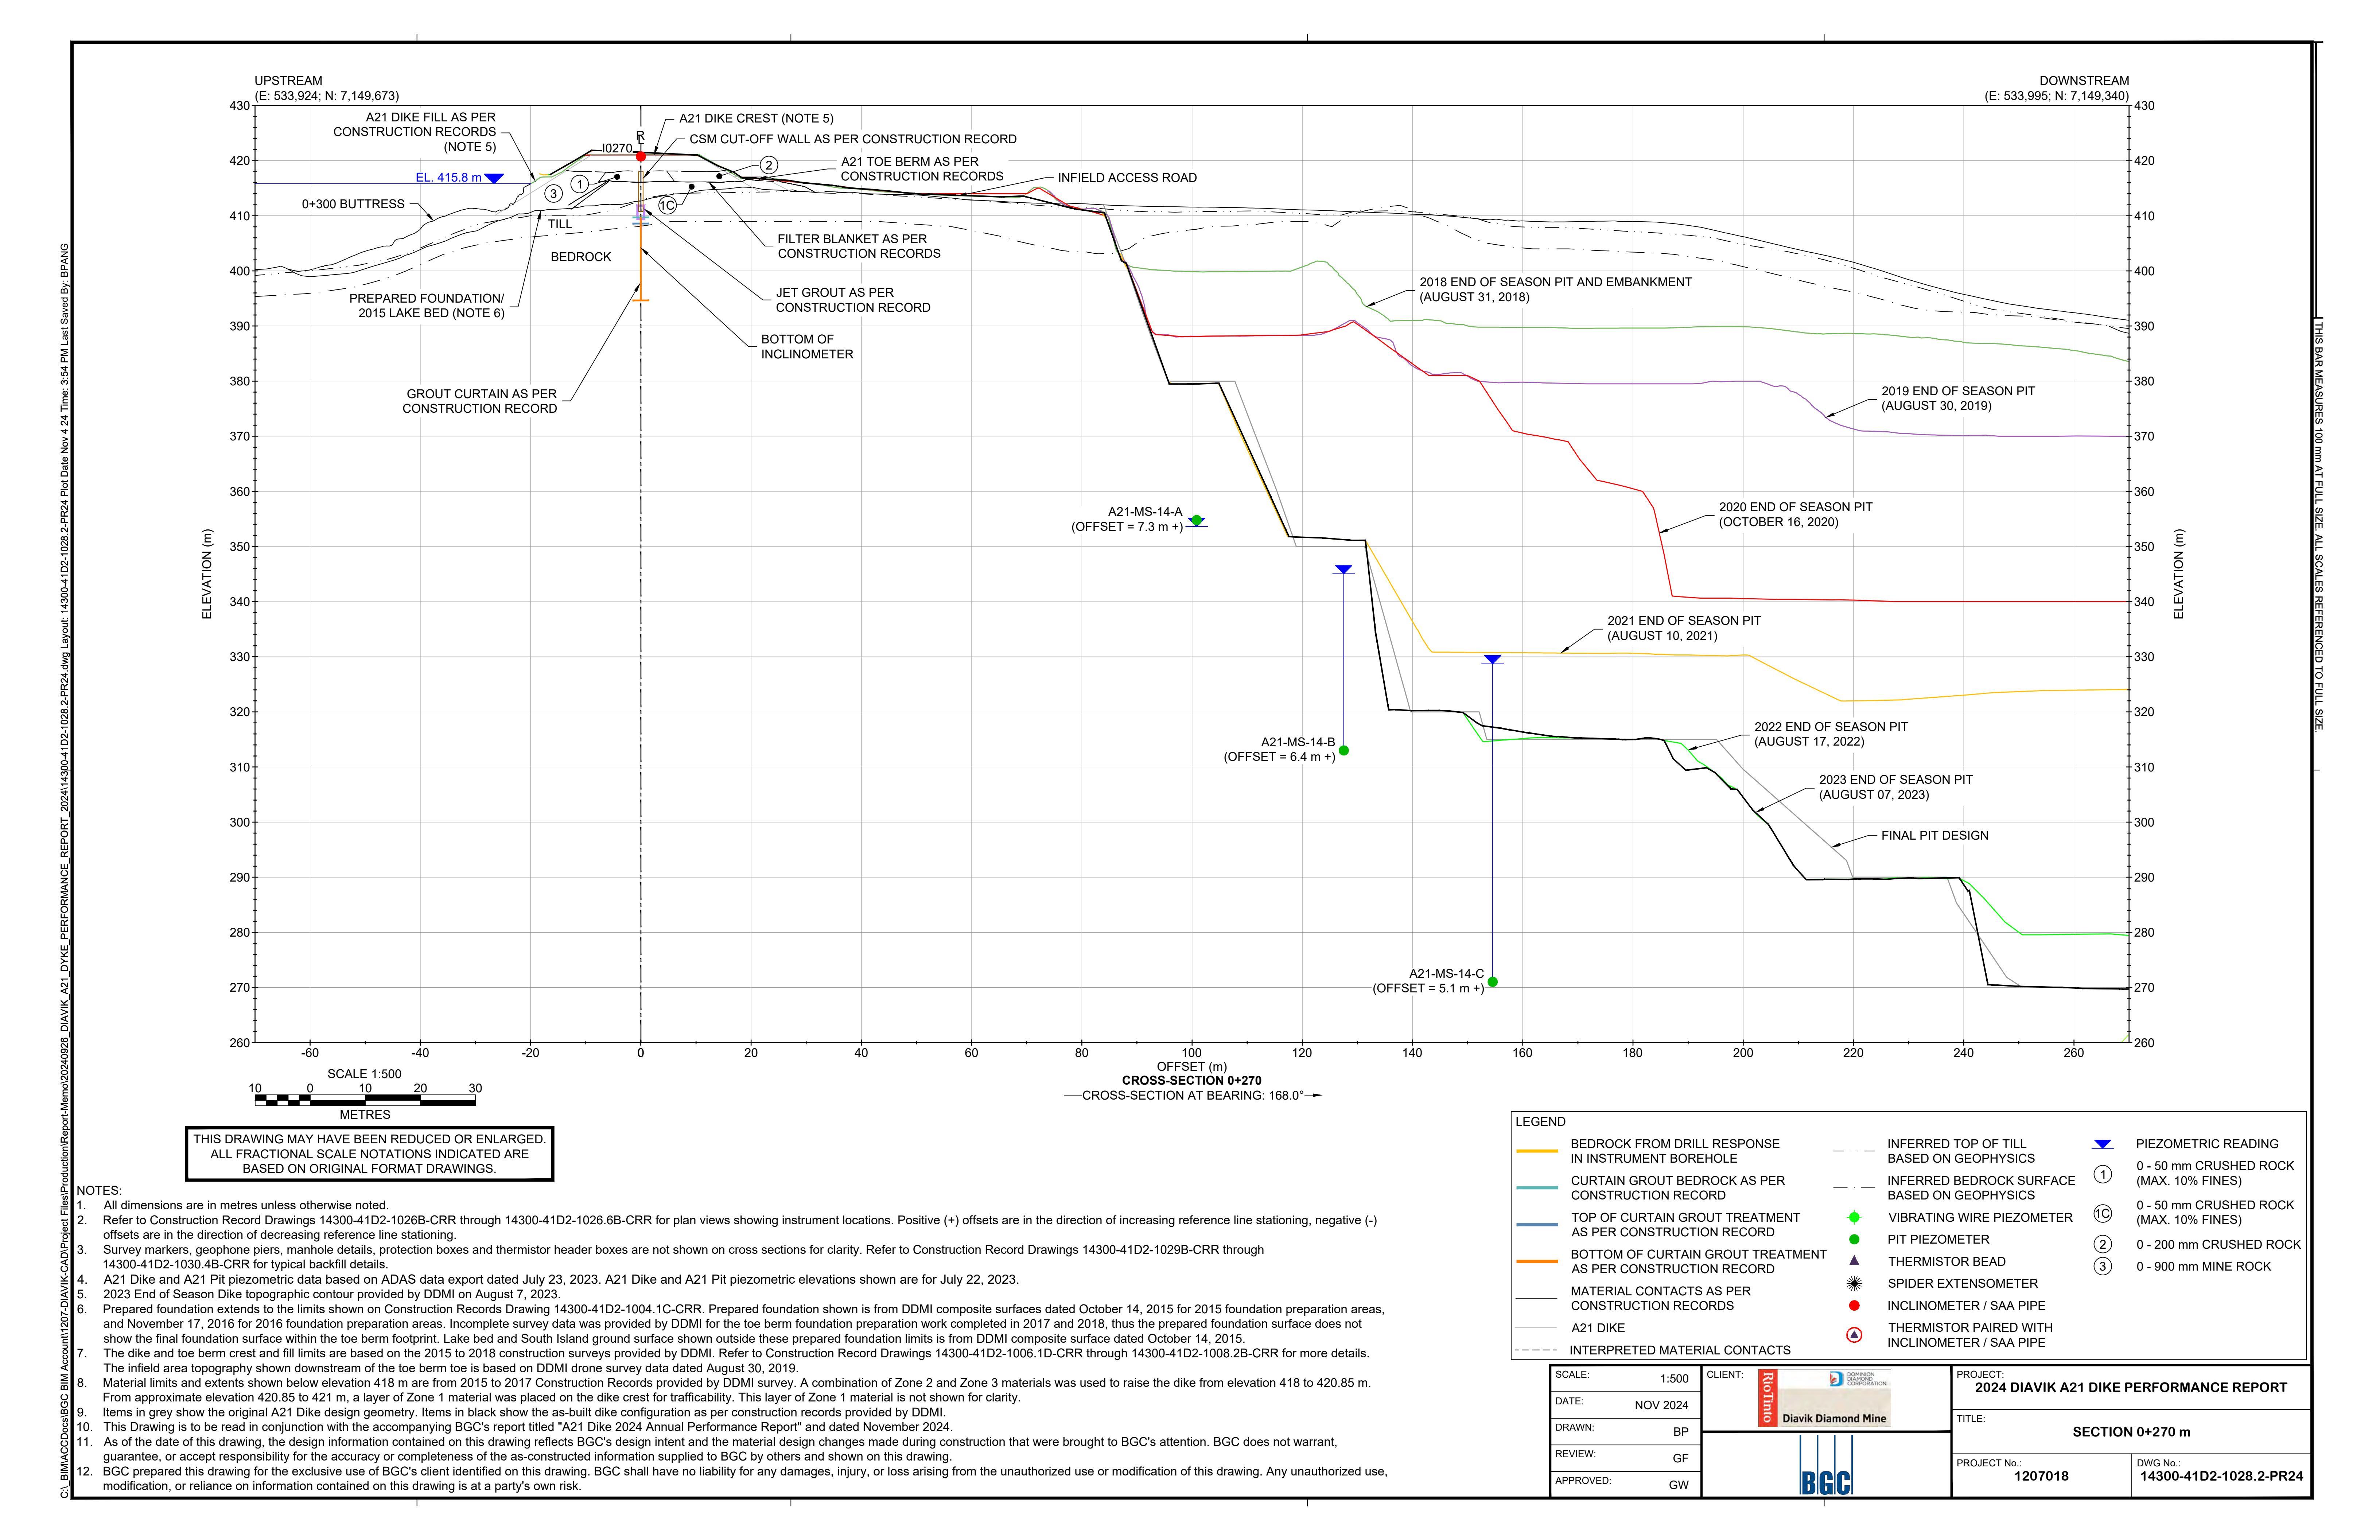
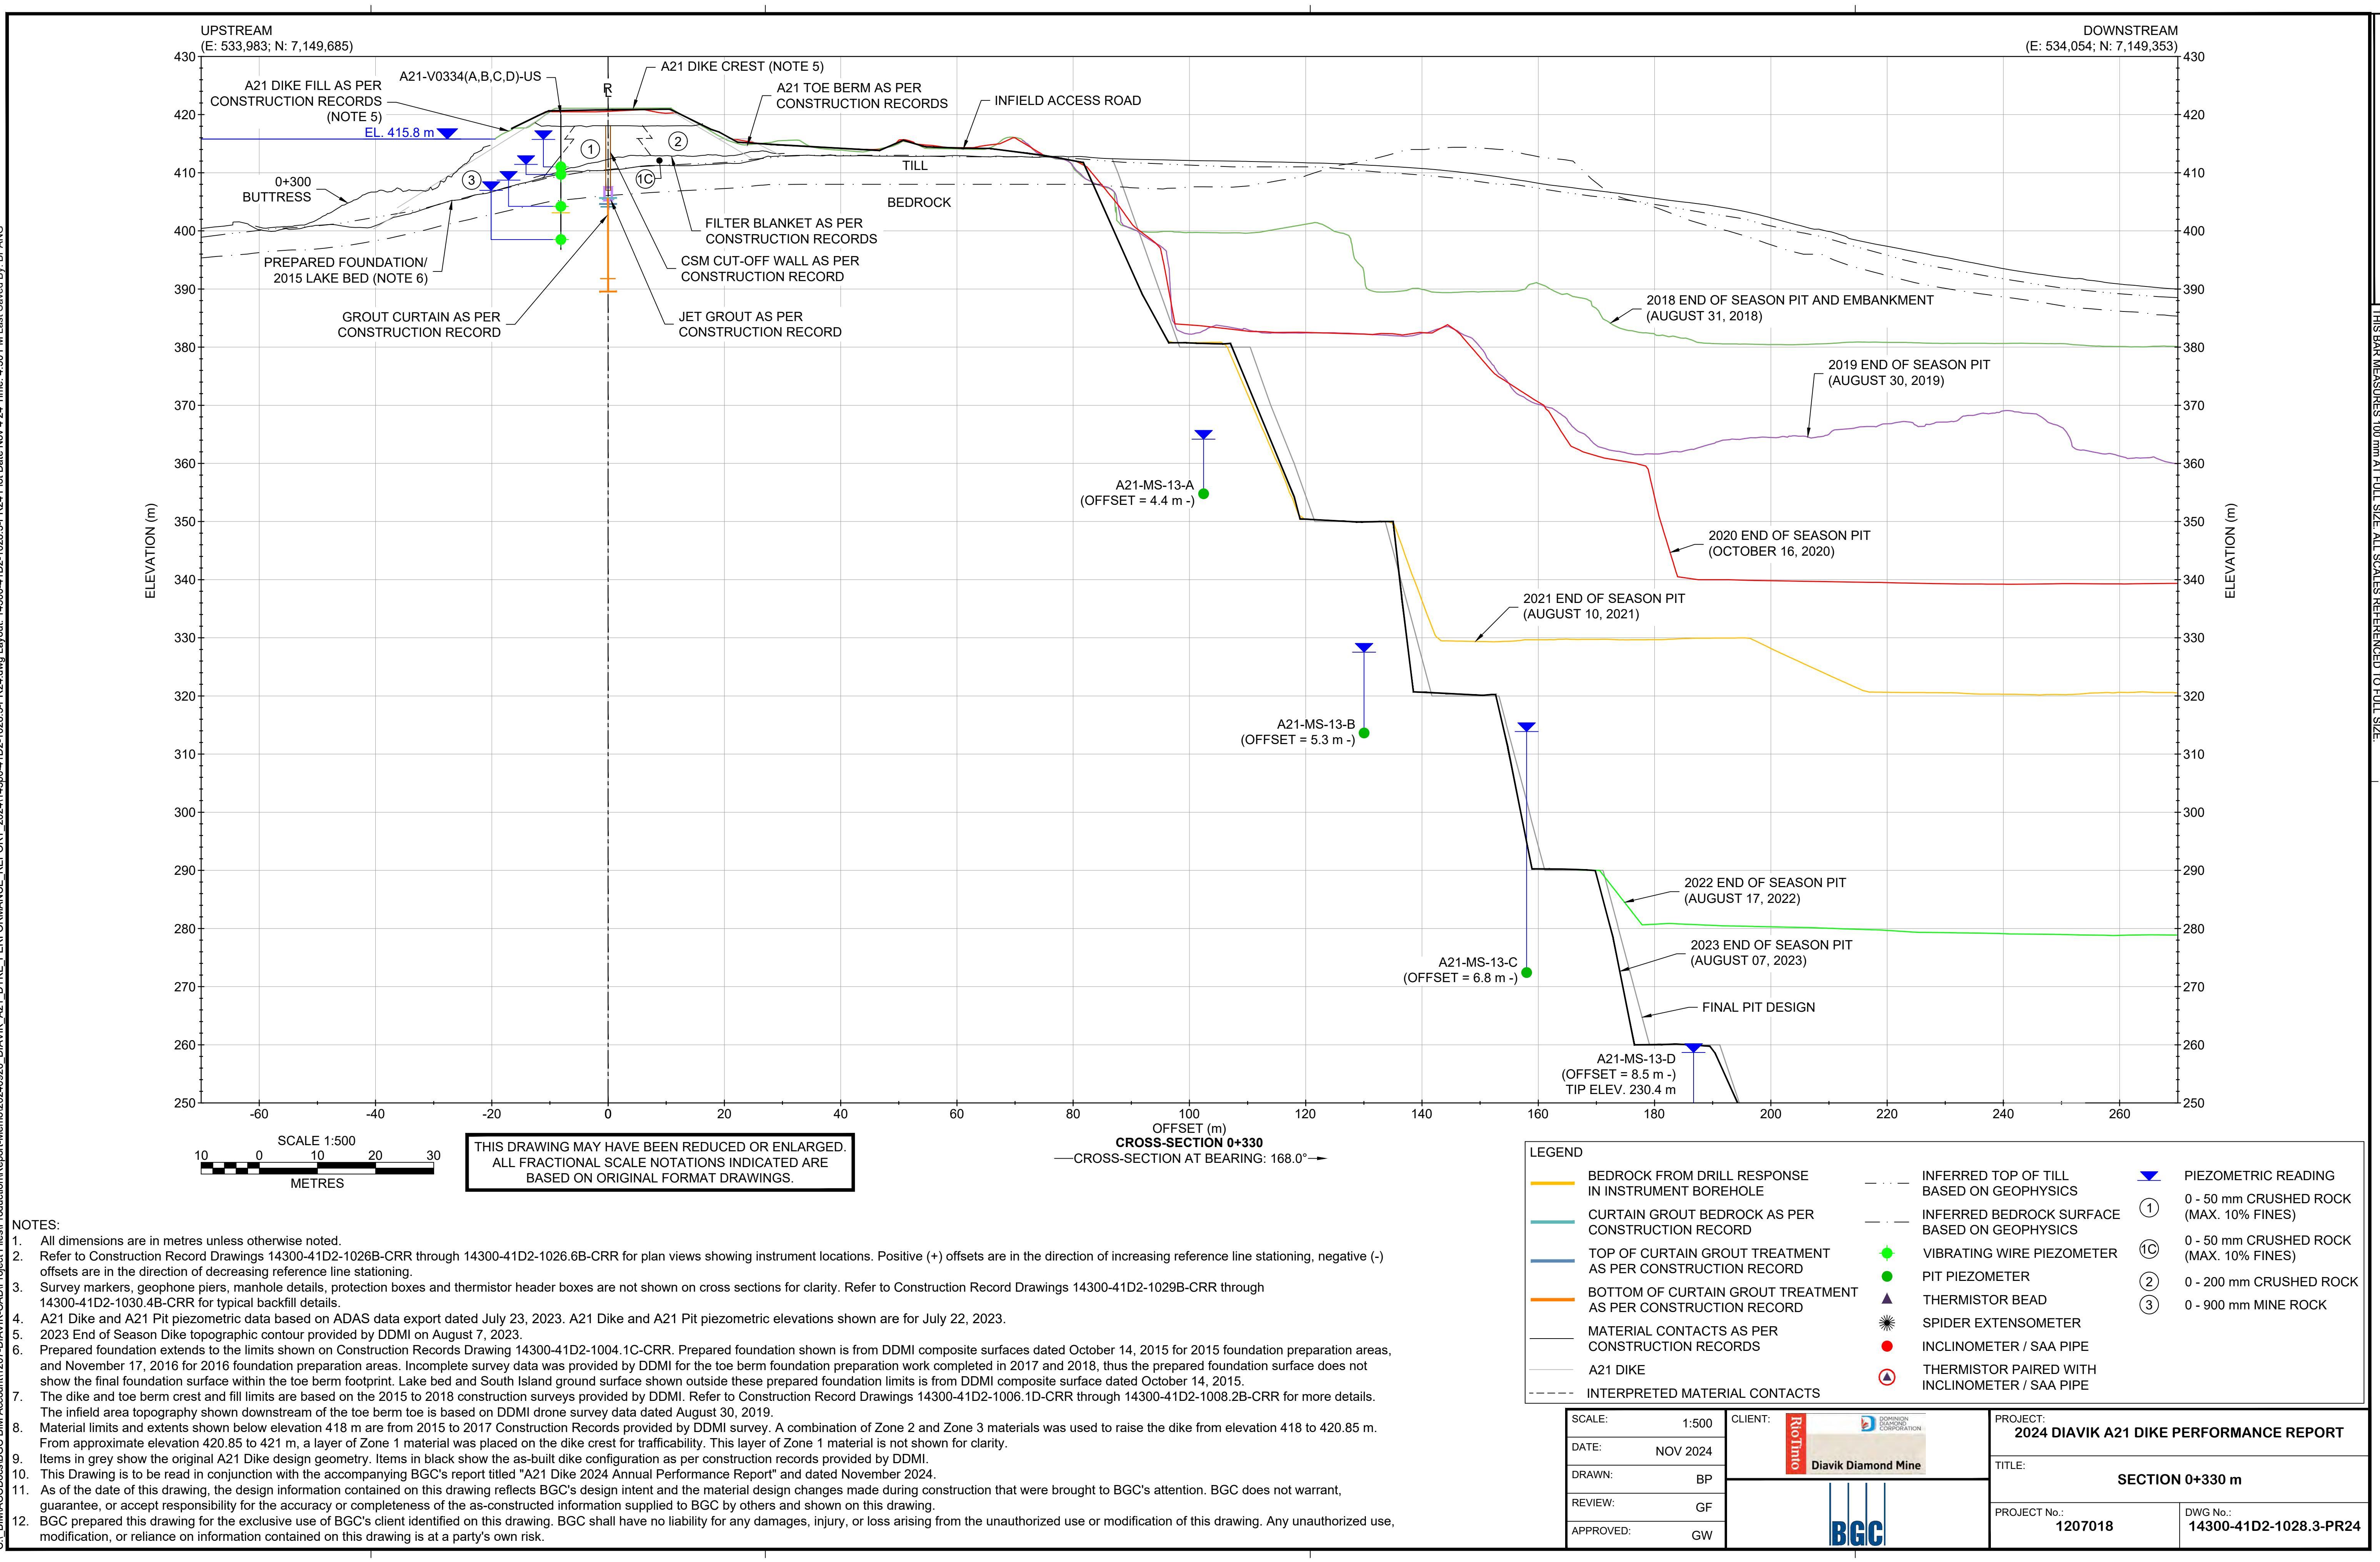
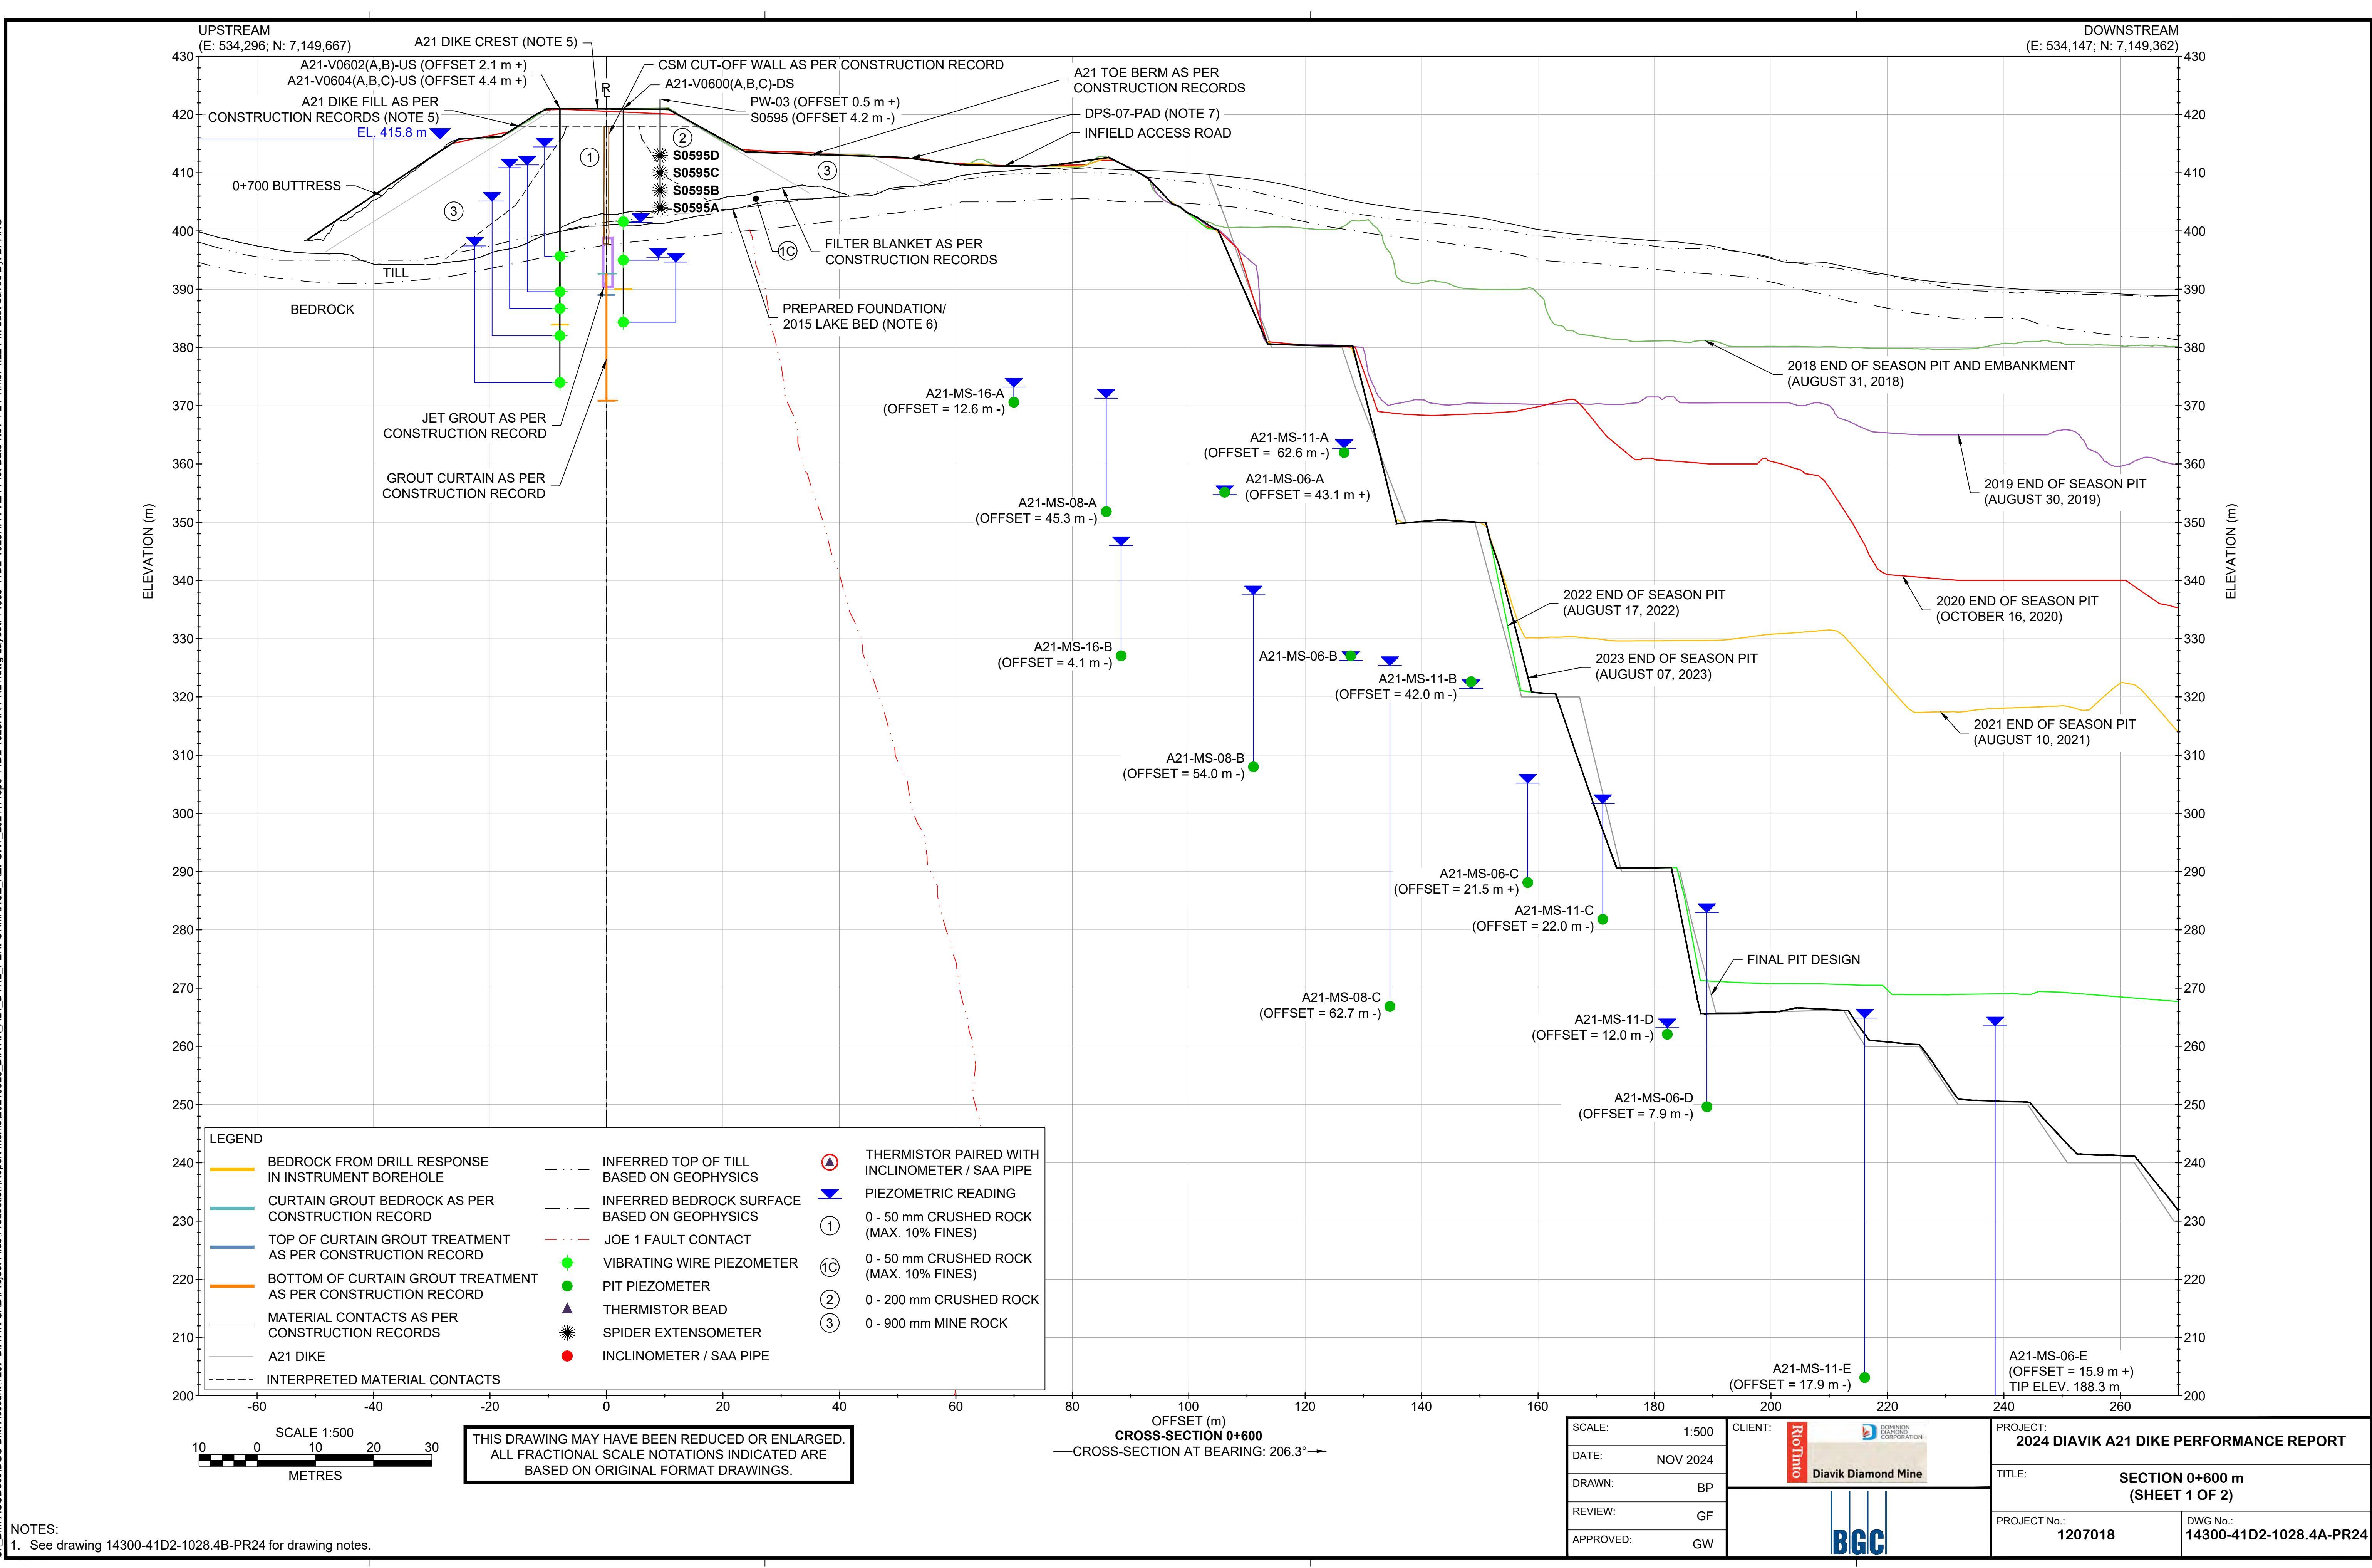
The infield area topography shown downstream of the toe berm toe is based on DDMI drone survey data dated August 30, 2019. 8. Material limits and extents shown below elevation 418 m are from 2015 to 2017 Construction Records provided by DDMI survey. A combination of Zone 2 and Zone 3 materials was used to raise the dike from elevation 418 to 420.85 m. From approximate elevation 420.85 to 421 m, a layer of Zone 1 material was placed on the dike crest for trafficability. This layer of Zone 1 material is not shown for clarity.

- 9. Items in grey show the original A21 Dike design geometry. Items in black show the as-built dike configuration as per construction records provided by DDMI.
