File Number G23H002
Type of Operation CAMPS - < 50 Man Camp
Location James Creek Km 14.2

An inspection of the above noted operation was conducted on February 13, 2024 by Manager, Resource Management Herbert Allen and Resource Management Officer I Bradley Voudrach.

ENVIRONMENTAL INSPECTION REPORT

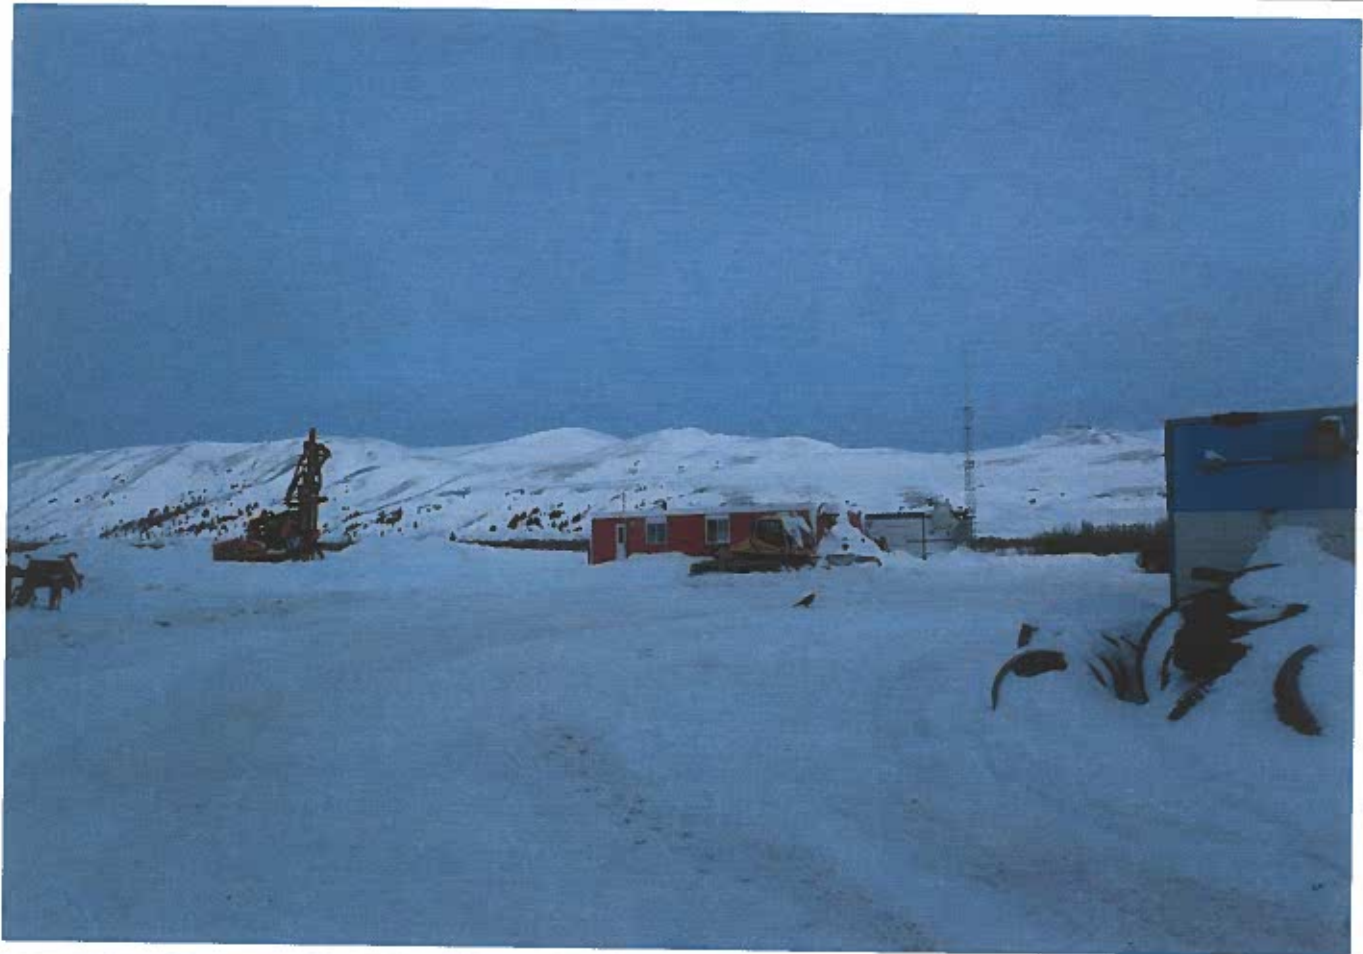
Inspection Images:
Figure 1

There was hydraulic fluid leak on the snow cat that was parked at the site and there was also hydraulic fluid on the ground in front of the bay door of the shop. The spills should be cleaned up and spill tray should be put under the leaks on the snow cat and leak should be repaired.
