#### Reference: 2020 Annual Geotechnical Inspection – Water License MV2017L2-0007

• Pine Point Mine Tailings Impoundment Area 2020 Annual Inspection, dated December 16 2020 prepared by Golder Associates

Reference No. 20140895-279-R-Rev0-1000

16 December 2020

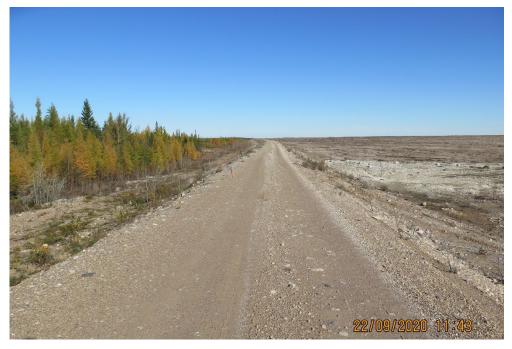
Photograph 7: West Dyke – South End – Crest, Upstream Slope and Toe Area, Looking North, 22 September 2020

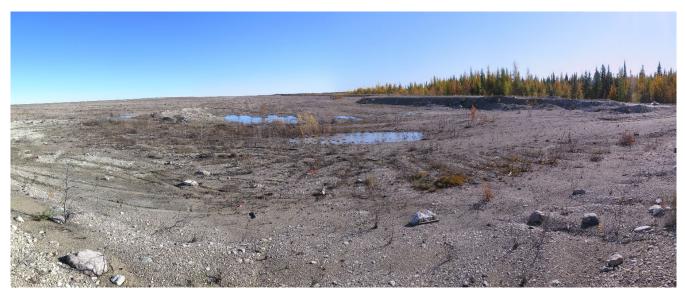
Photograph 8: West Dyke – South End - Ponding in Impoundment, Looking Southeast, 22 September 2020

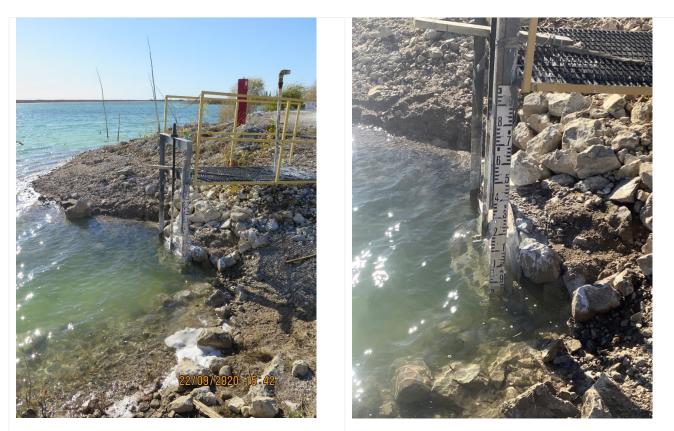
- The impoundment water level was at an elevation of 200.922 m, calculated based on a reading of 0.890 m at the staff gauge at the culvert through the polishing pond dyke (Photograph 25), which was 0.11 m below the datum of elevation 201.032 m.

Photograph 25: Main Pond Water Level Gauge at Culvert Intake to Polishing Pond, 22 September 2020
