Reference: 2019 Annual Geotechnical Inspection – Water License MV2017L2-0007

REPORT

2019 Dam Safety Inspection

Reference No. 18114183-209-R-Rev0-3000

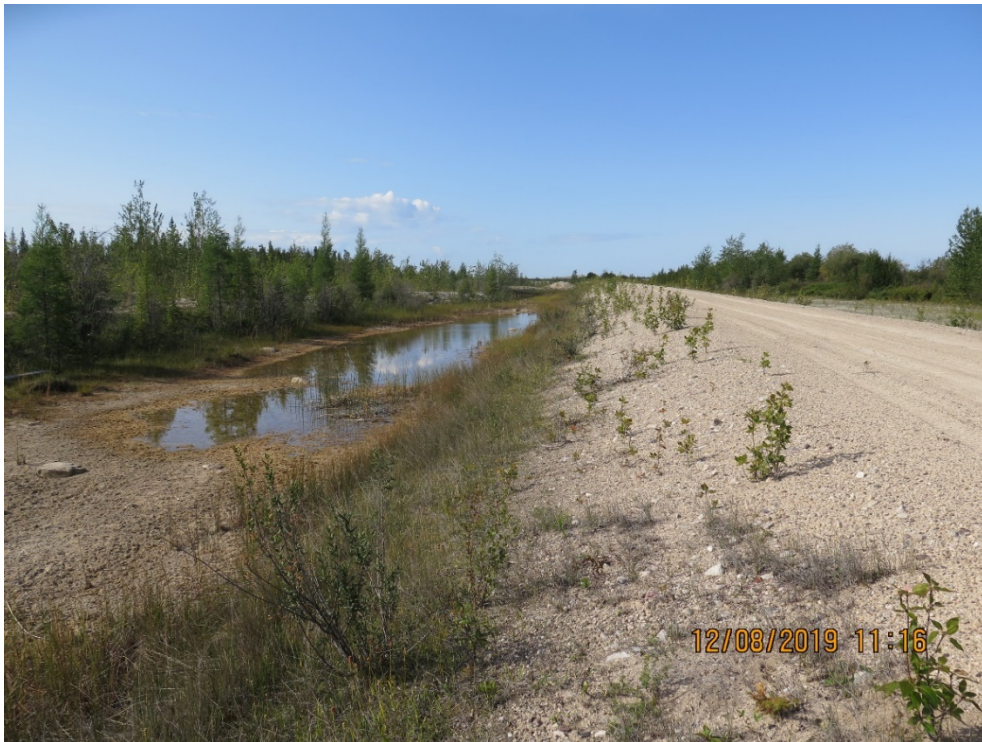
Photograph 1: South Dyke – Downstream Toe Area and Dam Slope at East End, Looking Southwest, 12 August 2019

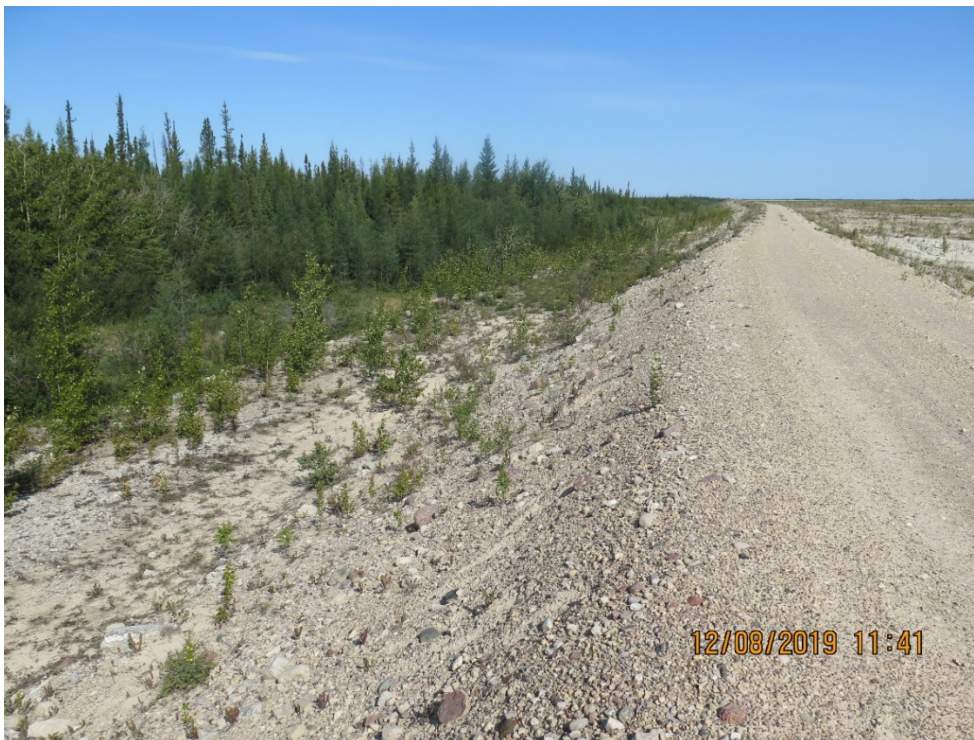
Photograph 4: West Dyke – Downstream Slope and Toe Area Near South End, Looking North, 12 August 2019

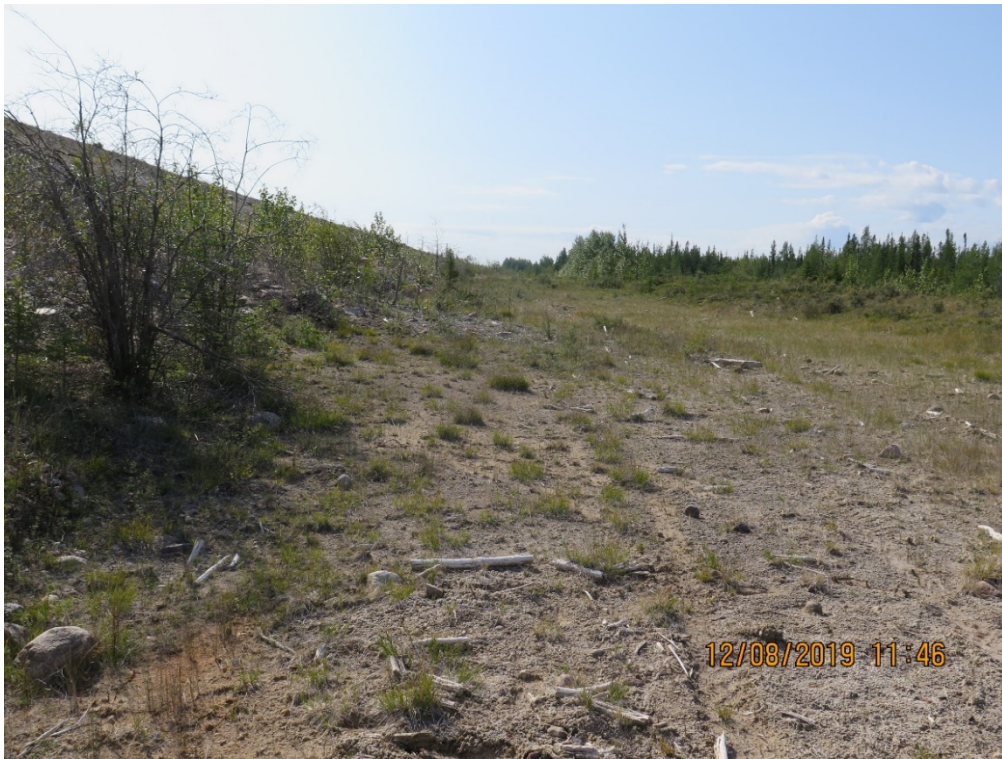
Photograph 5: West Dyke – Downstream Slope and Toe at Central Area, Looking South, 12 August 2019

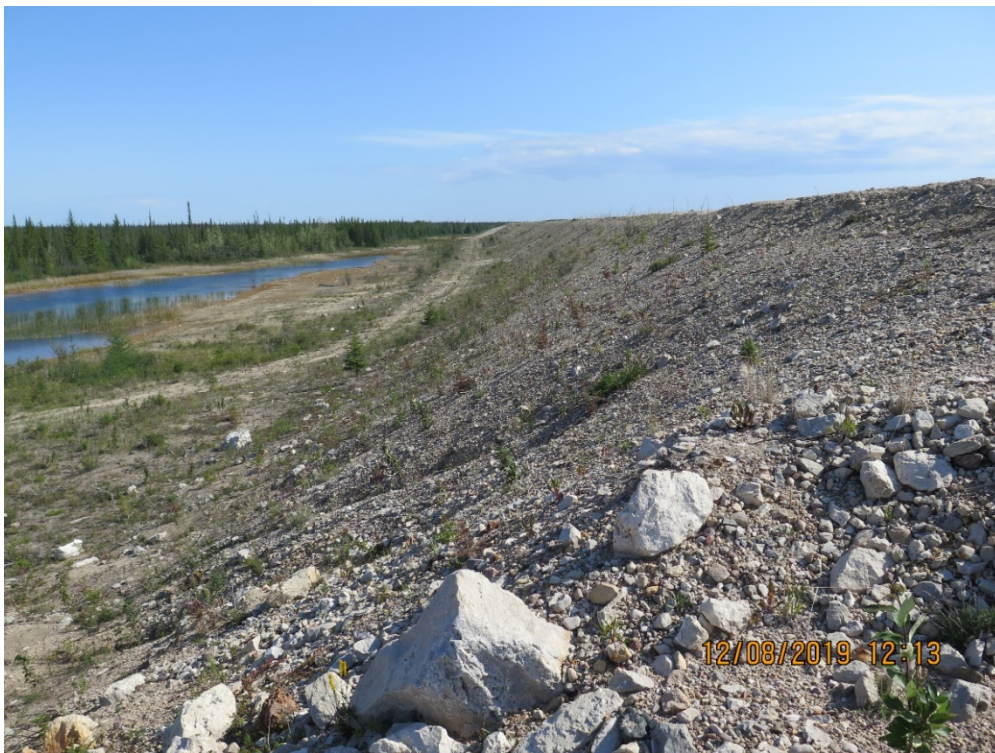
Photograph 8: North Dyke – Downstream Slope, Near West End, Looking East, 12 August 2019

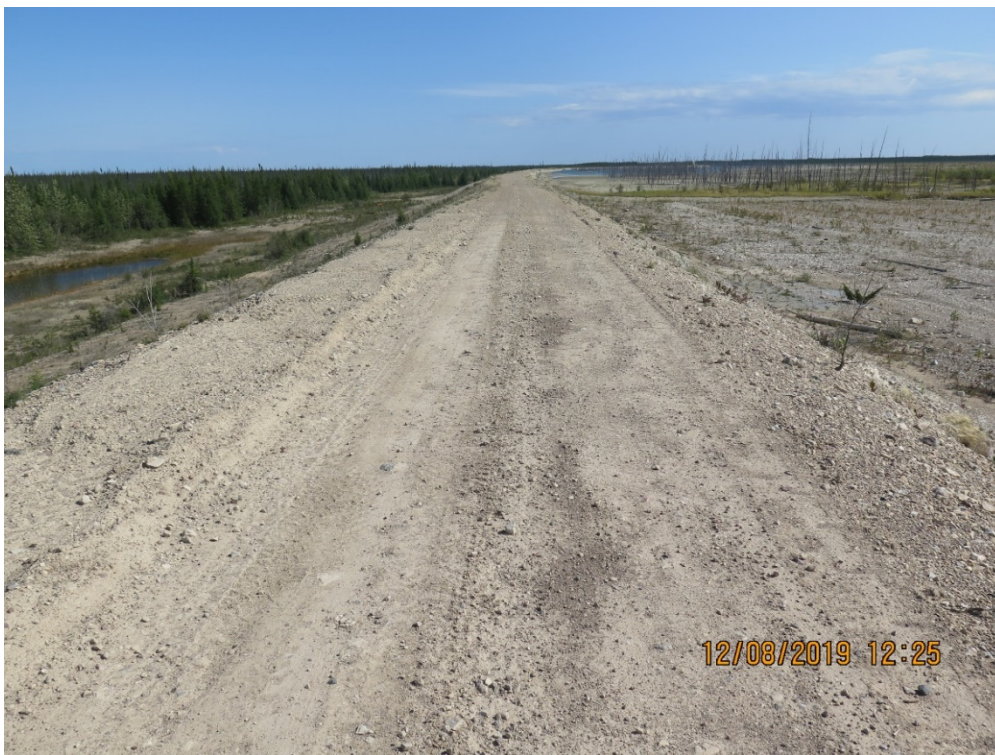
Photograph 10: North Dyke – Crest Near West End, Looking Northeast, 12 August 2019

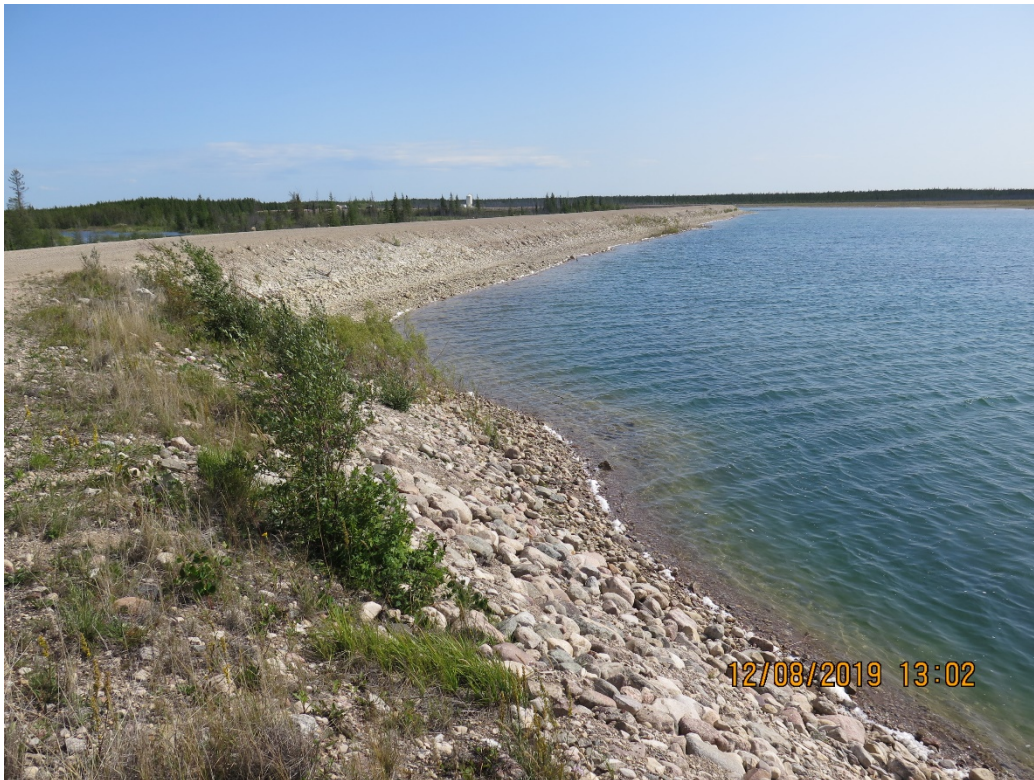
- Wave cut erosion
 - An erosion bench or scarp approximately 0.3 to 0.5 m high was observed on the upstream face of the north dyke, over a 700 m long section west of the dogleg. This erosion was immediately below the riprap placed on the slope in 2018 and above a bench in the slope. The erosion was attributed to wave and/or ice action. The maintenance repairs made in 2018 otherwise appeared to be in good condition, and should continue to be monitored.

- Erosion of the upstream face of the north dyke, approximately 0.3 m to 0.5 m deep, over a 700 m length west of the dogleg. The erosion was on the slope below the riprap placed in 2018. Monitoring for wave erosion should continue.
- Erosion rills with depths between approximately 0.10 and 0.25 m were observed on the north, east, and west dykes. Monitoring of the dykes for erosion rills should continue.
- Vegetation was present on the south dyke and should be removed following dam maintenance requirements.
 - vegetation clearance works were completed between 1 and 5 October 2019

Photograph 13: North Dyke – Upstream Slope West of Dogleg, Looking East, 12 August 2019

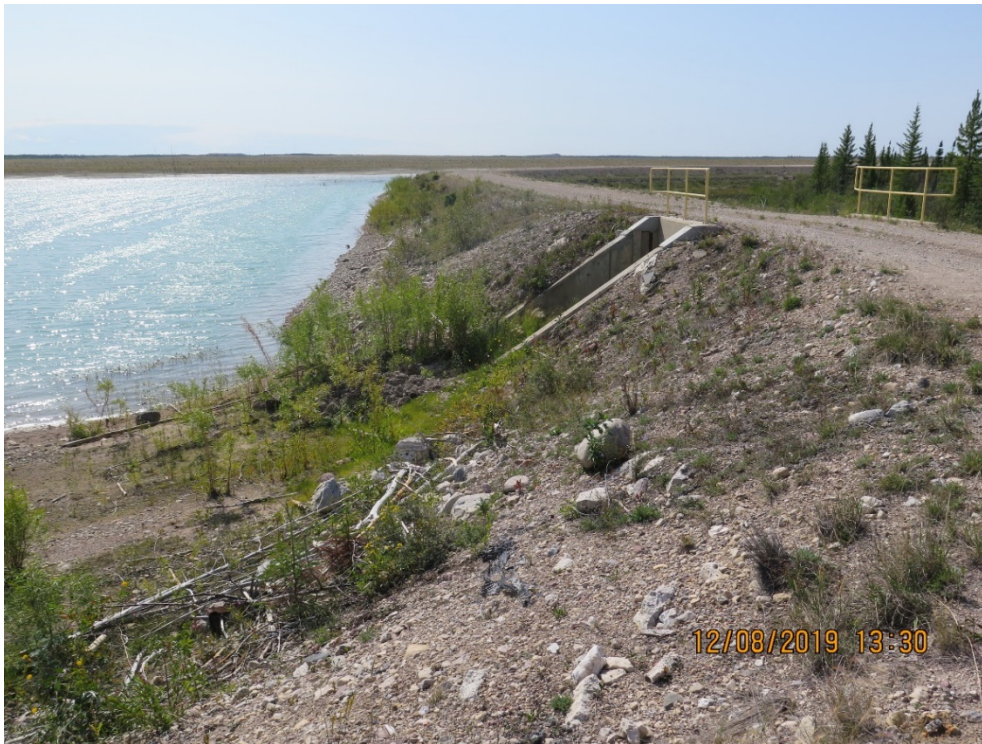
Photograph 15: Main Pond Spillway (Spillway No. 1) – Upstream Side, Looking South, 12 August 2019

Main Pond Spillway	<input checked="" type="checkbox"/>	New excavation up to 50 cm depth around the base of the concrete wing wall on the upstream side of the spillway
Treatment Spillway	<input checked="" type="checkbox"/>	Siphons in place
Other -(photos)	N/A	Photographs – 8 to 19 (Attachment 1)
Notes:		Seepage with red staining in area downstream of dogleg
East Dyke		
Ponded Water	<input checked="" type="checkbox"/>	Dyke not retaining water Tailings upstream of dyke in non-vegetated area
Erosion	<input checked="" type="checkbox"/>	Minor rilling on upstream and downstream slopes up to 10 cm deep
Settlement/Depressions	<input checked="" type="checkbox"/>	None
Sinkholes	<input checked="" type="checkbox"/>	None
Cracks/Movement	<input checked="" type="checkbox"/>	None
Debris	<input checked="" type="checkbox"/>	None
Vegetation	<input checked="" type="checkbox"/>	On upstream and downstream slopes
Other -(photos)	N/A	Photograph 20 (Attachment 1)

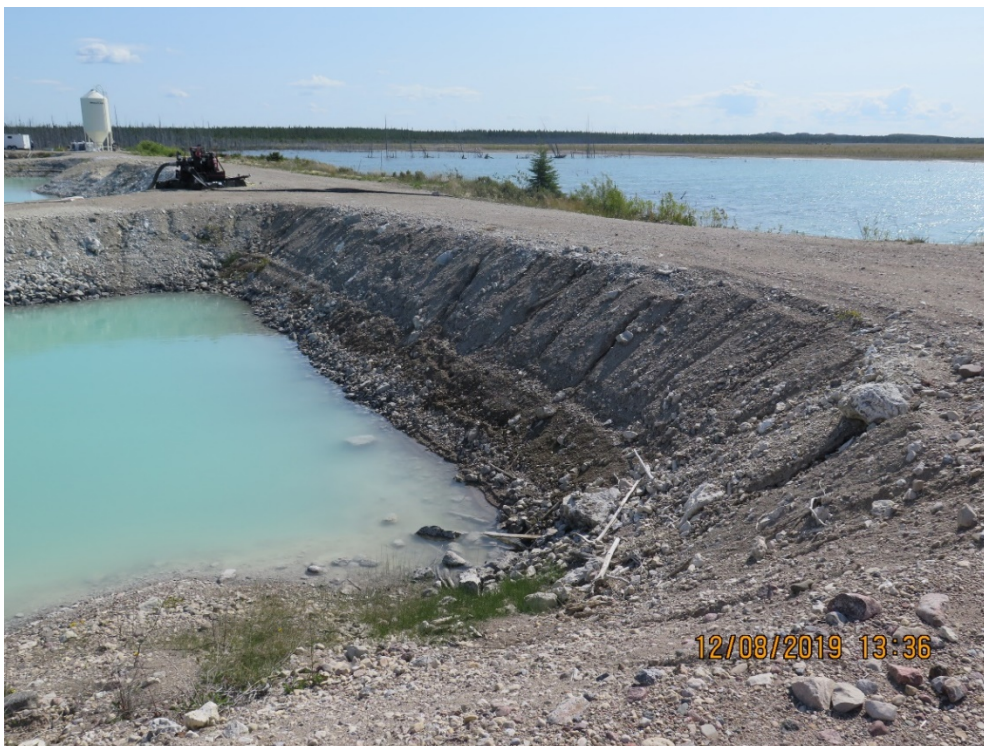
Photograph 18: Polishing Pond – Crest and Slope of Dyke (Polishing Pond on left), Looking East, 12 August 2019

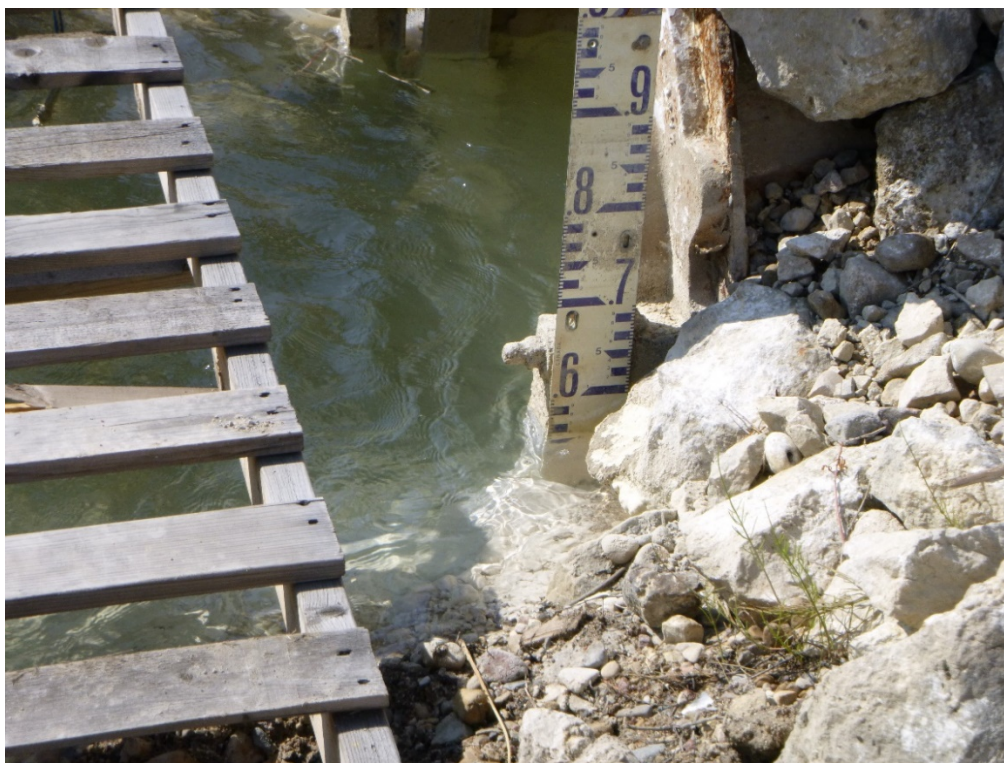
- The impoundment water level was 0.558 m at the staff gauge at the culvert through the polishing pond dyke (Photograph 19), interpreted to be elevation 200.558 m.

Photograph 19: Main Pond Water Level Gauge at Culvert Intake to Polishing Pond (Elevation 200.558 m), 12 August 2019

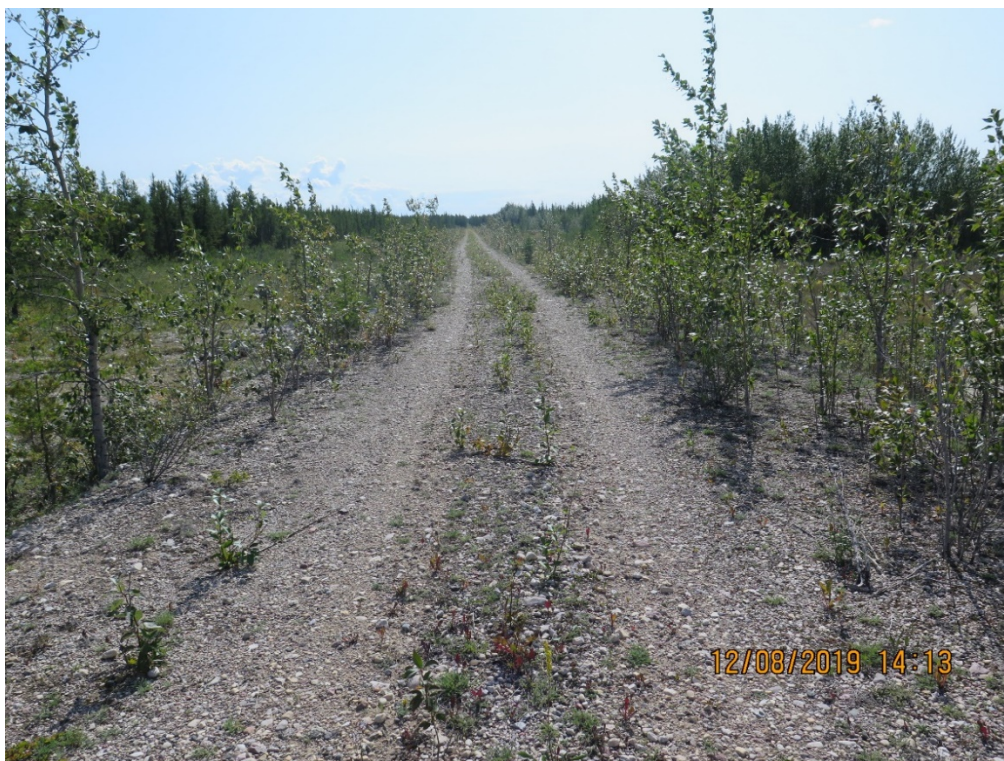
- Rills up to 0.10 m deep on the downstream slope of the east dyke, similar to previous years
 - No rills were observed to extend into the dyke crest and the crest width was intact

Photograph 20: East Dyke – Crest, looking South, 12 August 2019
