File Number	MV2020X0004
Type of Operation	Miscellaneous
Location	Taltson Dam

ENVIRONMENTAL INSPECTION REPORT

Permittee:	Northwest Territories Power Corporation (NTPC)	Permit Expiry Date:	July 01, 2025
Land Use Permit No.	MV2020X0004	Previous Inspection:	May 26, 2022
Quarrying Permit No.	2022QP0006	Inspection Date:	July 13, 2023
Contractor:	Litostroj Hydro	Subcontractor:	DB Consultant
Location(s) Inspected:	Taltson Dam		
Current Stage of Operation:	Active – Overhaul Construction		
Program Modifications Approved:	N/A

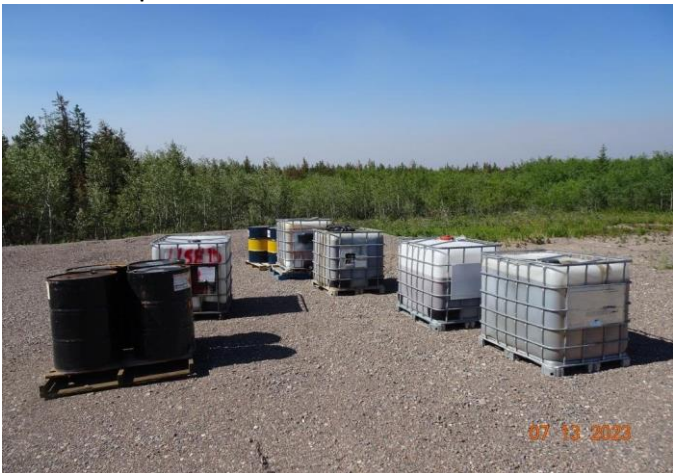
Figure 4
Fuel storage shed located at the airstrip.

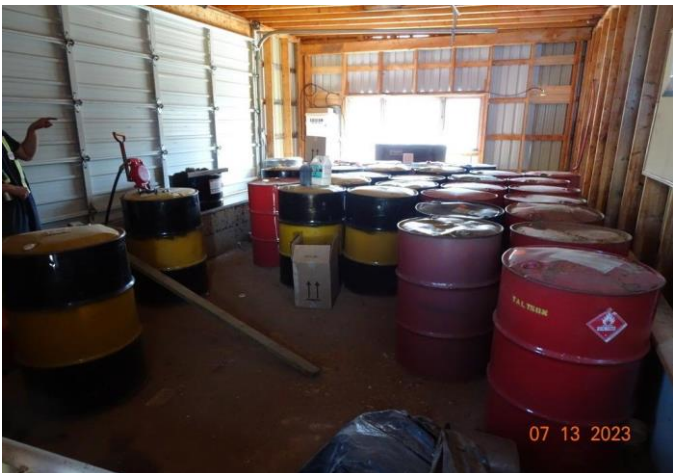
There are 32 x 45G fuel drums located inside the fuel shed (Figures 4-5). There are 24 empty 45G drums located along the southeast side of the runway (Figures 6-7). It is recommended that empty 45G drums be stored on pallets and hauled out during the next winter road season (2023/24) and disposed of to an authorized waste facility.

Figure 6
Empty 45G fuel drums along the southeast side of the airstrip.

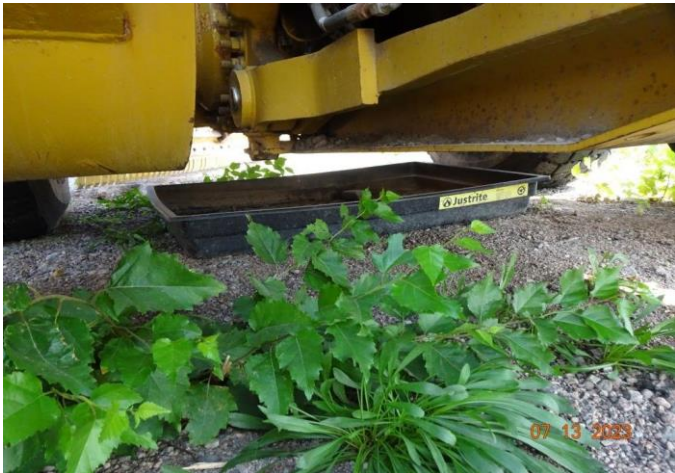
Parked in the storage and distribution area is the 160 Finning grader with a drip tray and 938K Cat loader without a drip tray (Figures 14 & 17-19); additional items observed include a new 500-kilowatt generator, existing generator, 1172 cu ft sea can, and metal scaffolding (Figures 15-16 & 20).

Figure 19
938K Cat Loader located in the storage and distribution area.

Equipment parked for 2 hours or greater must have a drip tray underneath it. Leaky equipment needs to be repaired immediately, and full drip trays need to be emptied into a labelled waste container to be hauled out and disposed of to an authorized waste facility.

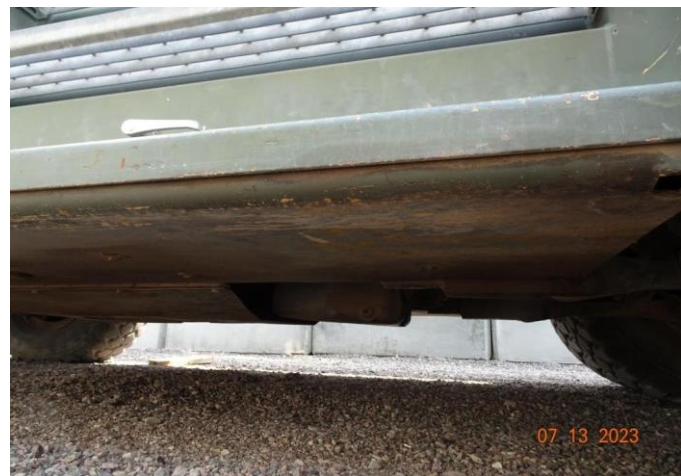
Storage area B has a gravel pad and is being used to store material and heavy equipment for the overhaul (Figures 26-39). Hydrocarbon staining and full drip trays were observed under the AMMANN single drum roller (Figures 26-27) and the old NTPC dump truck #3027 (Figures 26-29). The new NTPC dump truck #3081, Genie articulating boom lift, RT780 Terex crane, and Freightliner semi-truck did not have drip trays underneath them (Figures 26, 28, 30 & 36-37).

Figure 26
Heavy equipment located in storage B area.

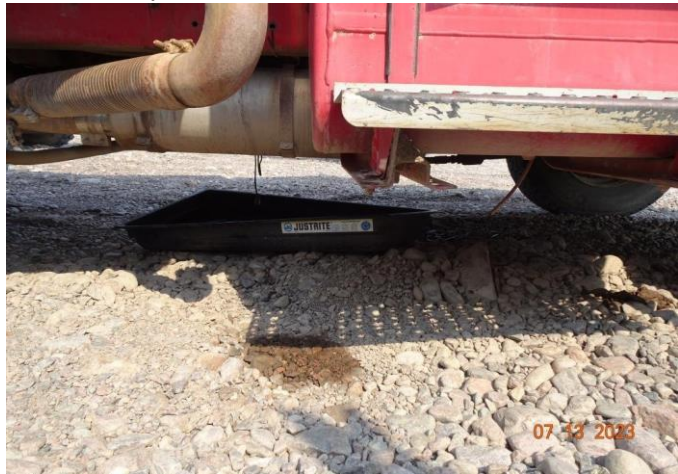
Figure 30
RT780 Terex crane.

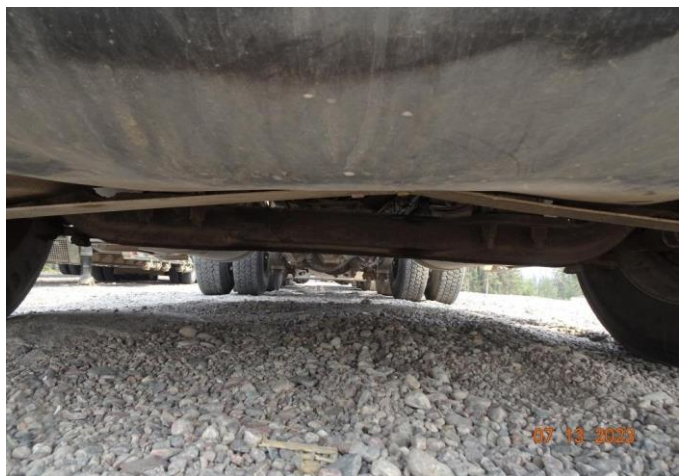
Figure 38
Metal material and electrical spools located in storage area B.

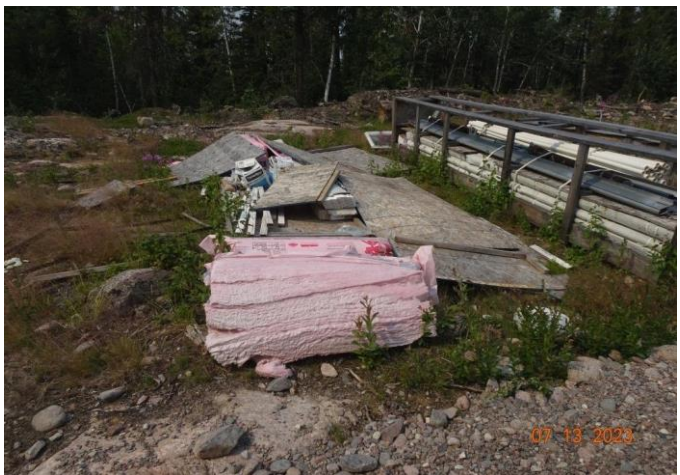
Figure 40
Storage shed and miscellaneous items in the bone yard.

The boneyard has two storage sheds and miscellaneous items throughout the area (Figures 40-55). It is recommended that items be pulled out from the tree line and sorted through; items that are no longer of use need to be hauled out during the 2023/24 winter road and disposed of at an authorized waste facility.

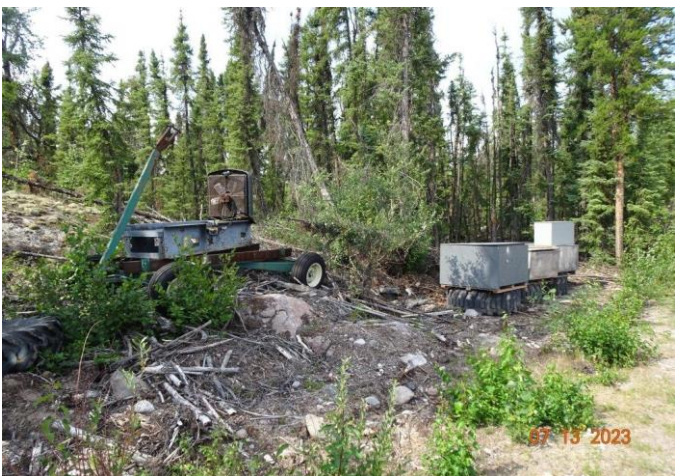
Figure 42
Miscellaneous items are stored along the south tree line of the boneyard.

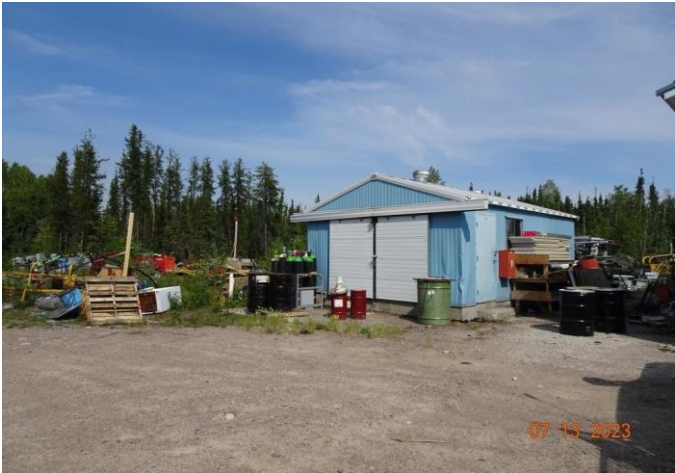
Figure 43
Storage shed and miscellaneous items in the boneyard.

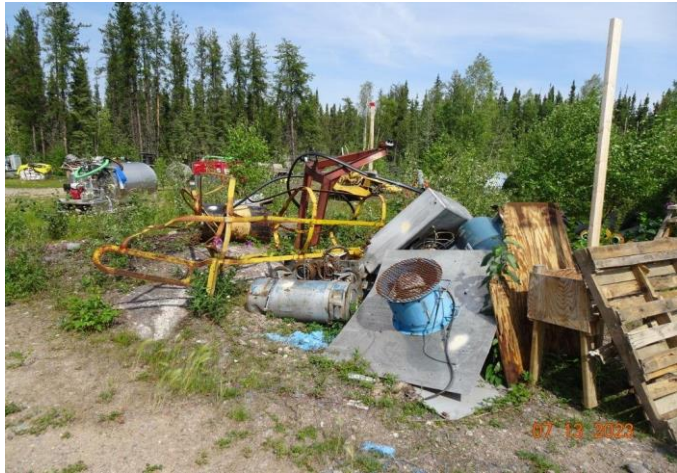
Figure 44
Miscellaneous items located in the boneyard.

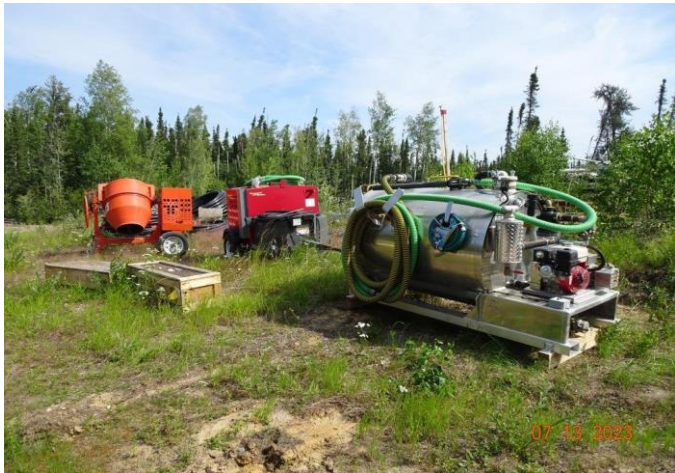
Figure 45
New generator, concrete mixer, and water pump located in the boneyard.

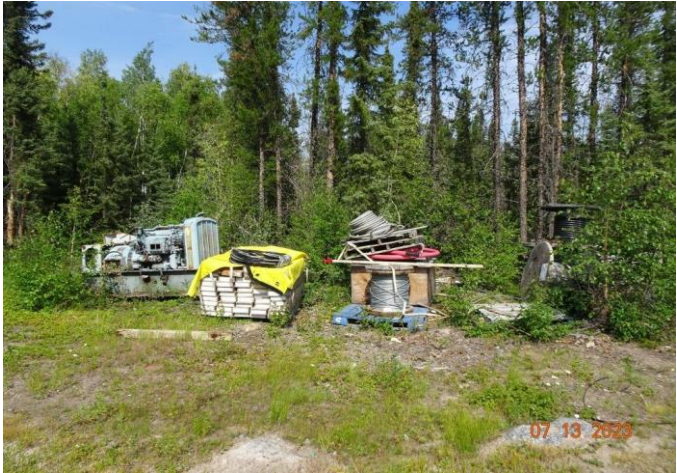
Figure 46
Miscellaneous items are located along the northwest tree line of the boneyard.

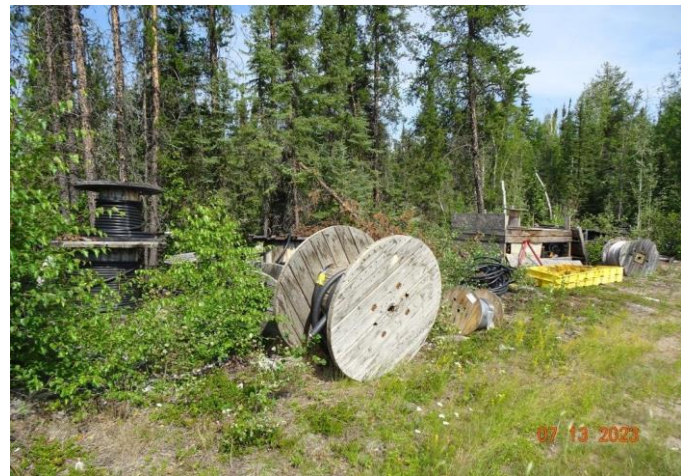
Figure 47
Miscellaneous items located along the northwest tree line of the boneyard.

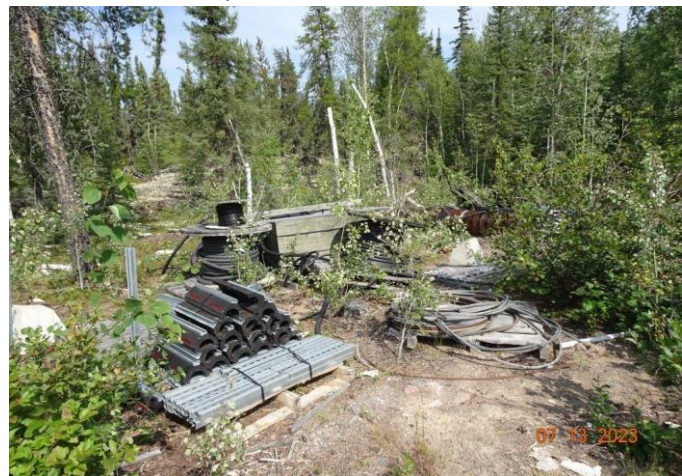
Figure 48
Miscellaneous items located along the north tree line of the boneyard.

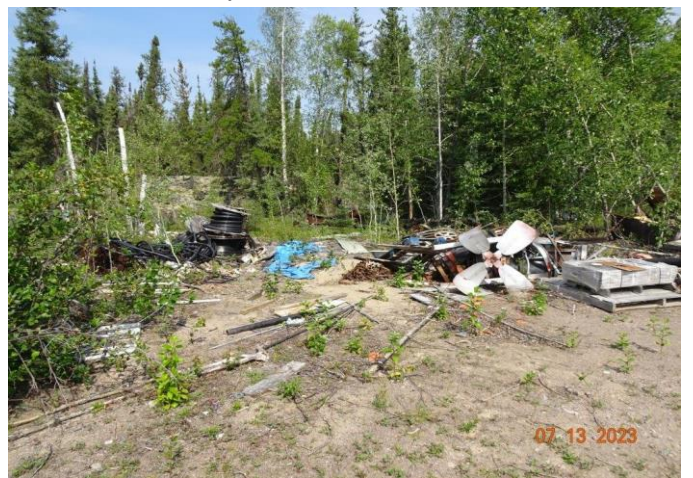
Figure 49
Miscellaneous items located along the north tree line of the boneyard.

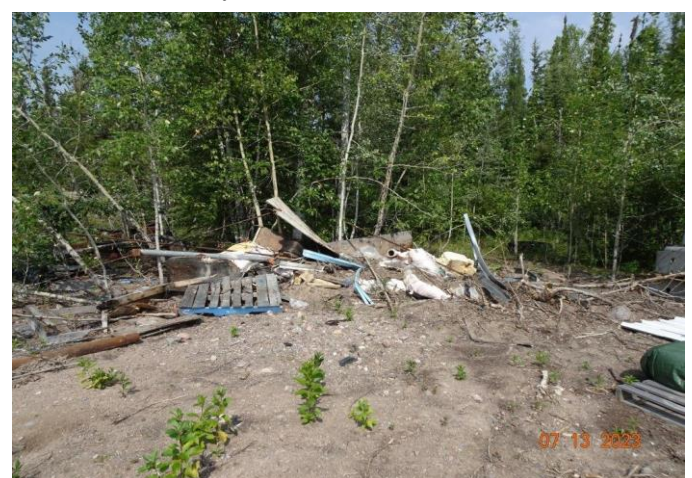
Figure 50
Miscellaneous items located along the north tree line of the boneyard.

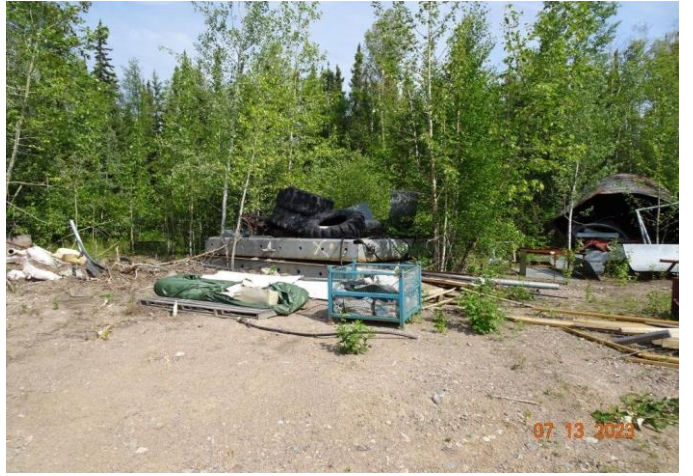
Figure 51
Miscellaneous items located along the northeast tree line of the boneyard.

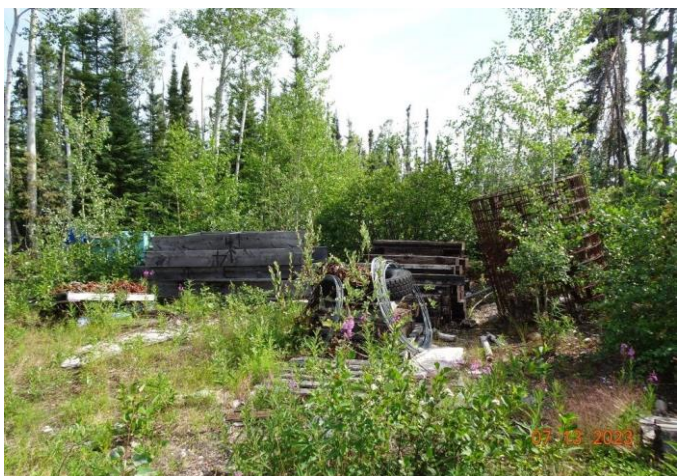
Figure 52
Miscellaneous items located along the northeast tree line of the boneyard.

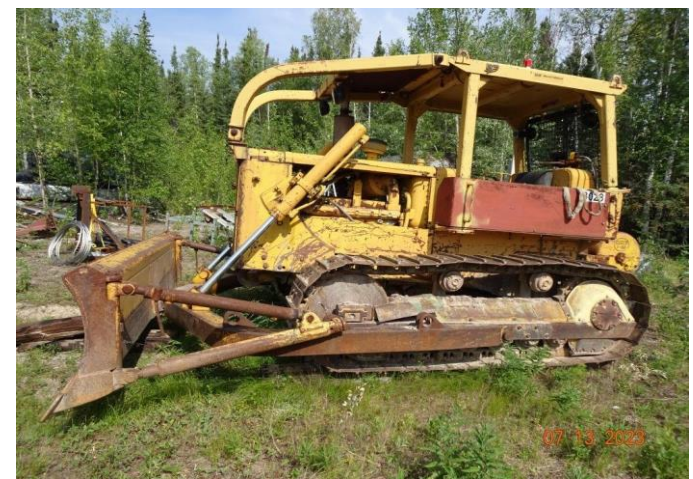
Figure 53
Old dozer located in the boneyard.

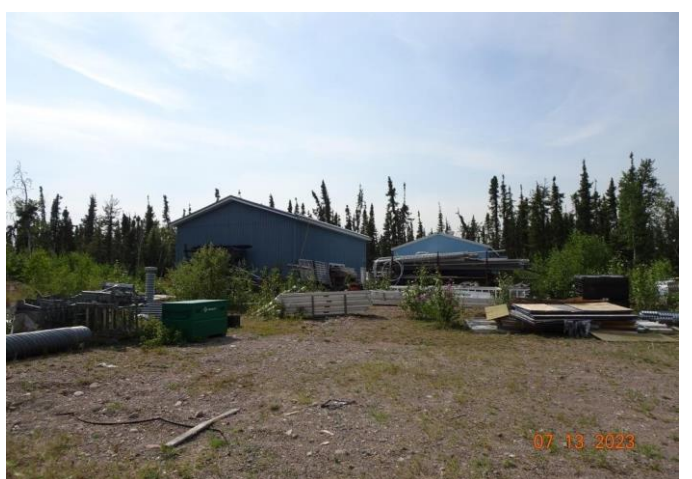
Figure 54
View of the north side of the storage shed in the boneyard.

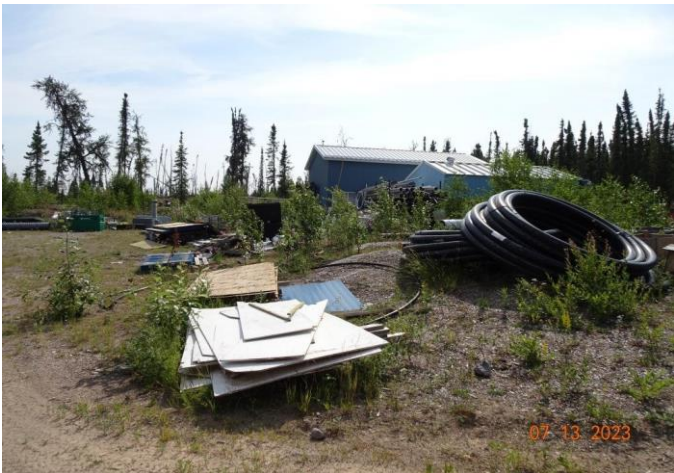
Figure 55
Miscellaneous items located in the center of the boneyard.

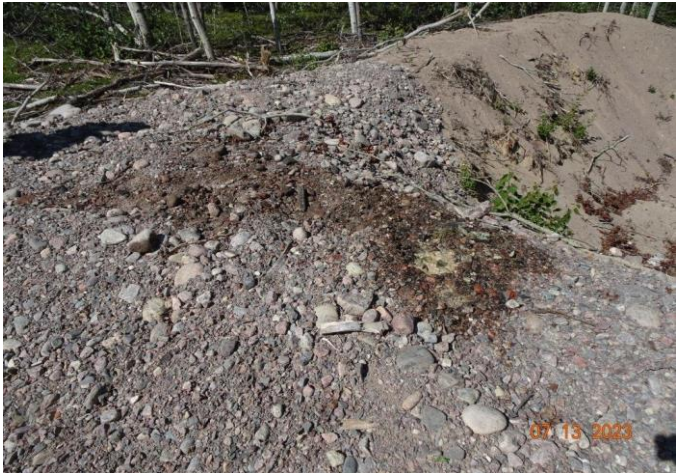
Figure 64
Kitchen grease trap waste dumped on berm.

The new septic field is operational (Figures 59-61). A temporary sewage lagoon for dumping porta-potti waste has been developed along the spillway access road (Figures 62-63). The grease trap from the kitchen was dumped on the berm of the pit (Figure 64). Domestic waste cannot be dumped in the pit. Please clean up contaminated granular material by shoveling it into the pit and covering it with fresh granular material.

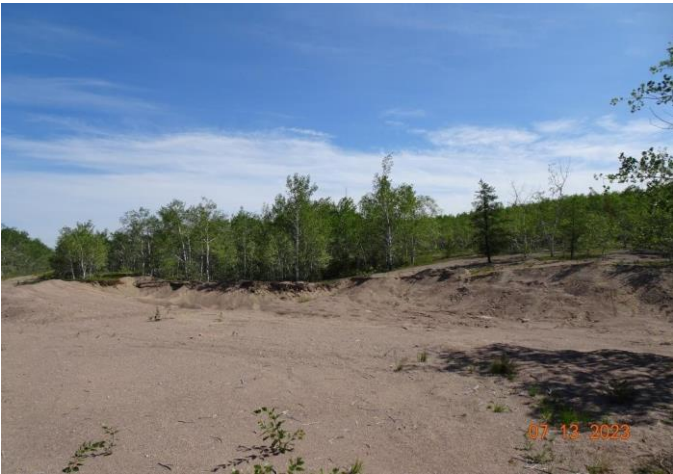
Pit B is an active sand quarry north of the airstrip; please note the quarry is very close to the access road (Figures 73-75). It is recommended that quarrying occurs in the east side of the pit.

Figure 73
Pit B facing northeast.

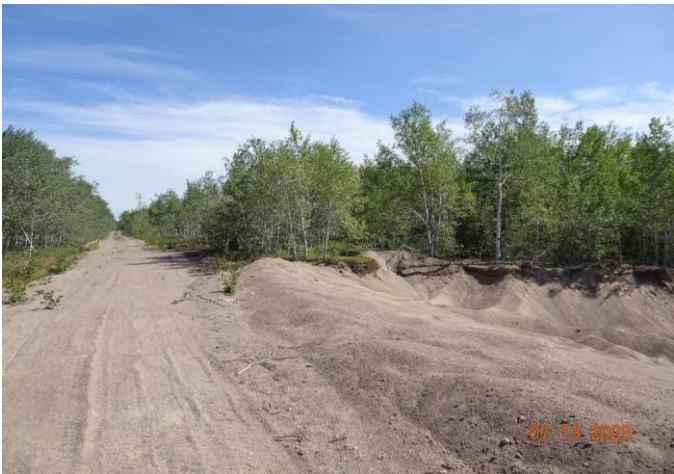
Figure 74
Pit B shows sand berm and spillway access road.

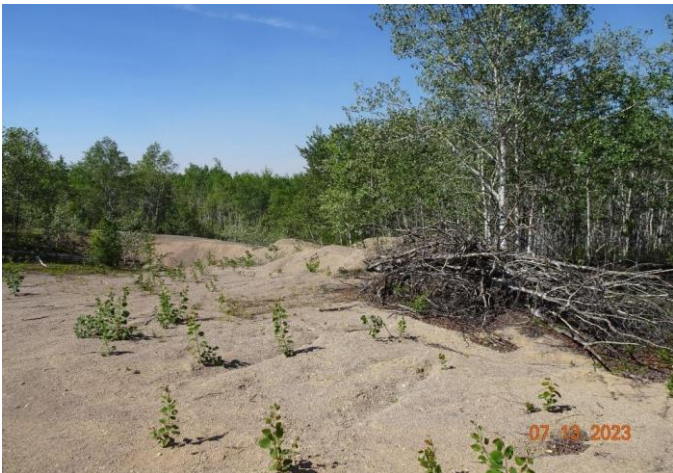
Figure 75
Pit B facing west.

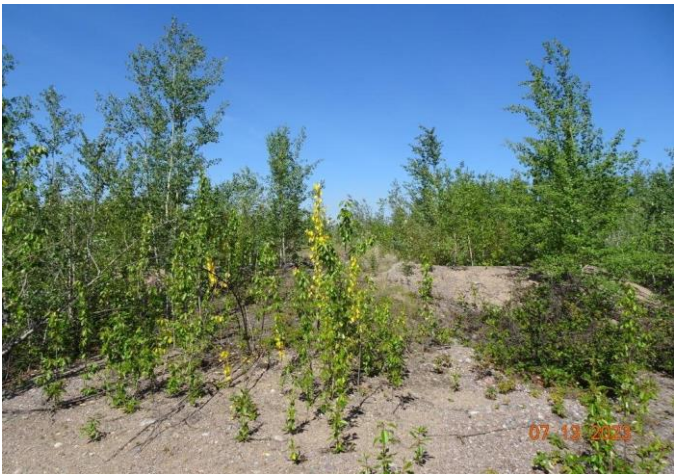
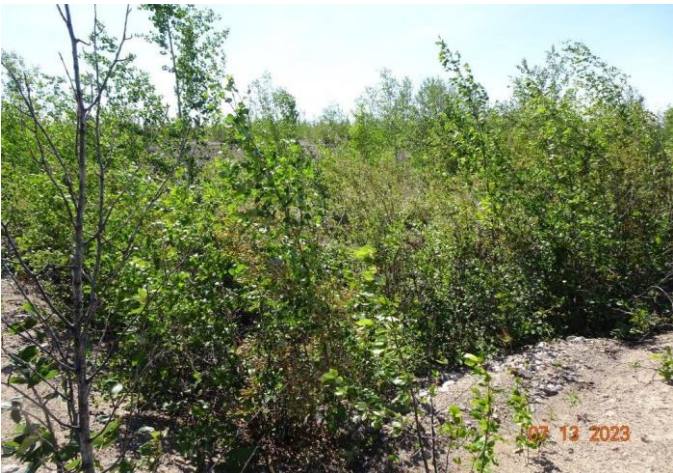
Figure 76
Overgrown contaminated soil containment area in Pit V.

There has been no activity in Pit V since the last inspection report. If the contaminated soil containment area is to be used again, the vegetation needs to be removed and the HDPE liner needs to be in good condition before use.
