File Number	MV2022X0018
Type of Operation	Cameron Hills Oil and Gas Field Abandonment
Location	Cameron Hills, NT

ENVIRONMENTAL INSPECTION REPORT

Permittee:	Strategic Oil and Gas Ltd. c/o Alvarez & Marsal Canada Inc.	Permit Expiry Date:	January 02, 2028
Land Use Permit No.	MV2022X0018	Previous Inspection:	February 21, 2024
Quarrying Permit No.		Inspection Date:	September 17, 2024
Contractor:	ELM Inc.	Subcontractor:	
Location(s) Inspected:	Cameron Hills Oil and Gas Field		
Current Stage of Operation:	The abandonment of the H-03 Battery, forty-four (44) oil and gas wells was completed in the winter of 2023 and 2024.		
Program Modifications Approved:

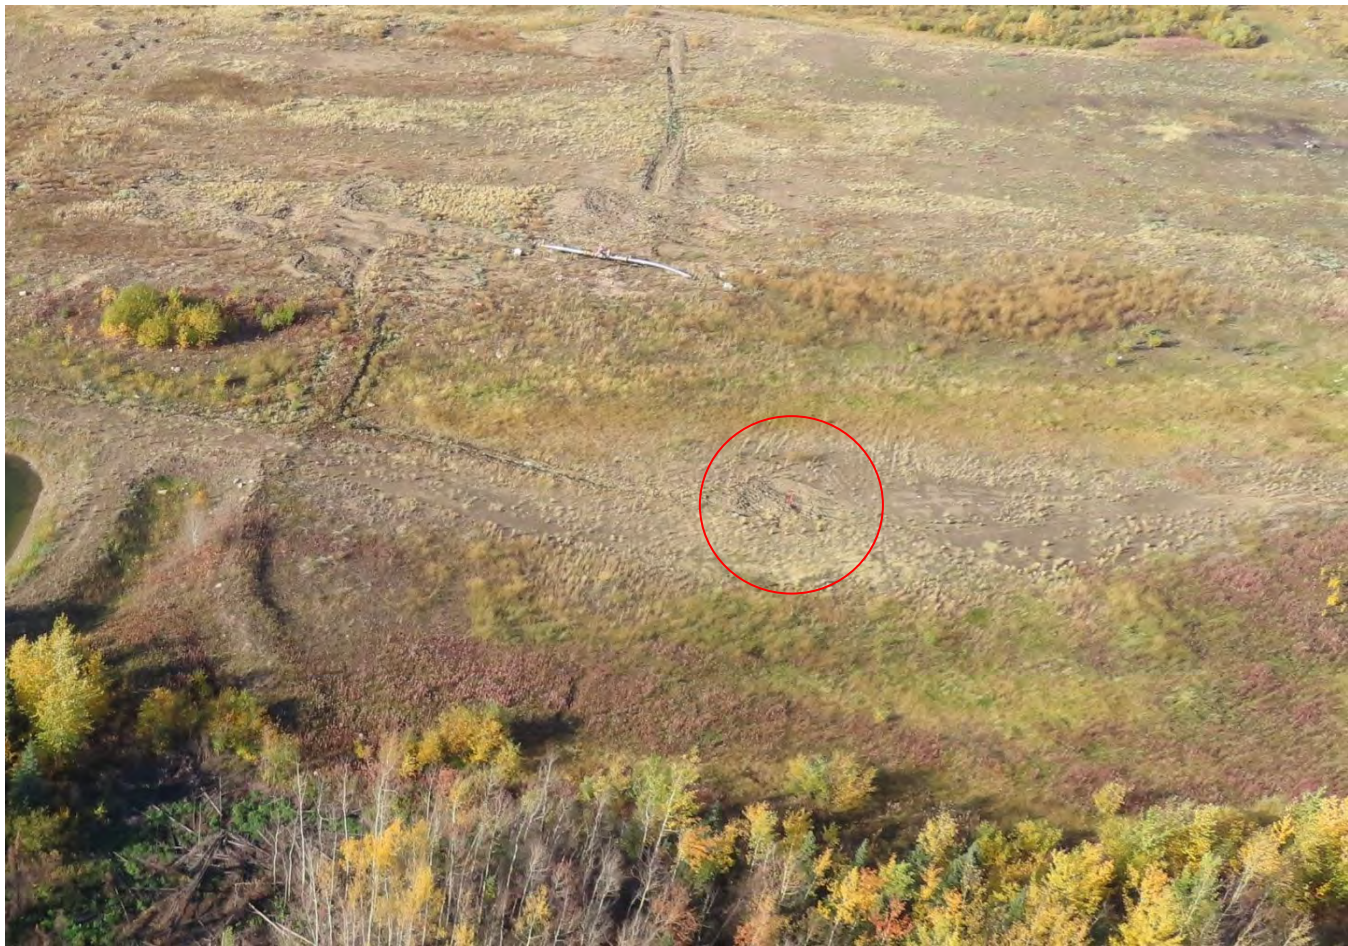
Figure 1

A-03: Aerial view of the wellsite. Well abandoned on February 26, 2023. Pipeline riser located on H-03 Battery Site. No further remediation work required at A-03.

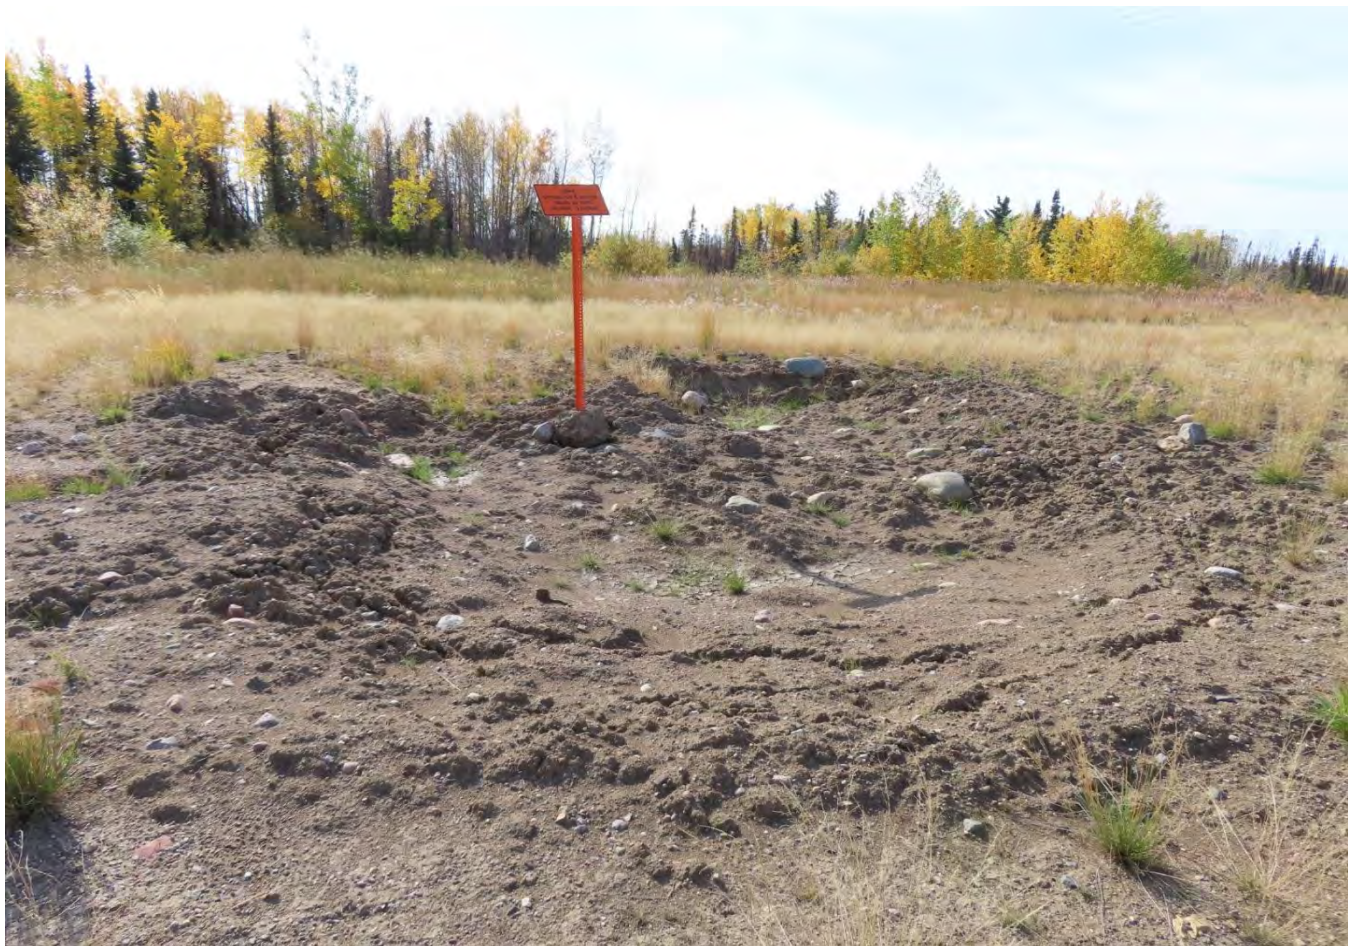
Figure 2

A-03: Backfill of well center appears satisfactory. Well abandonment signs have been installed at all abandoned wells.

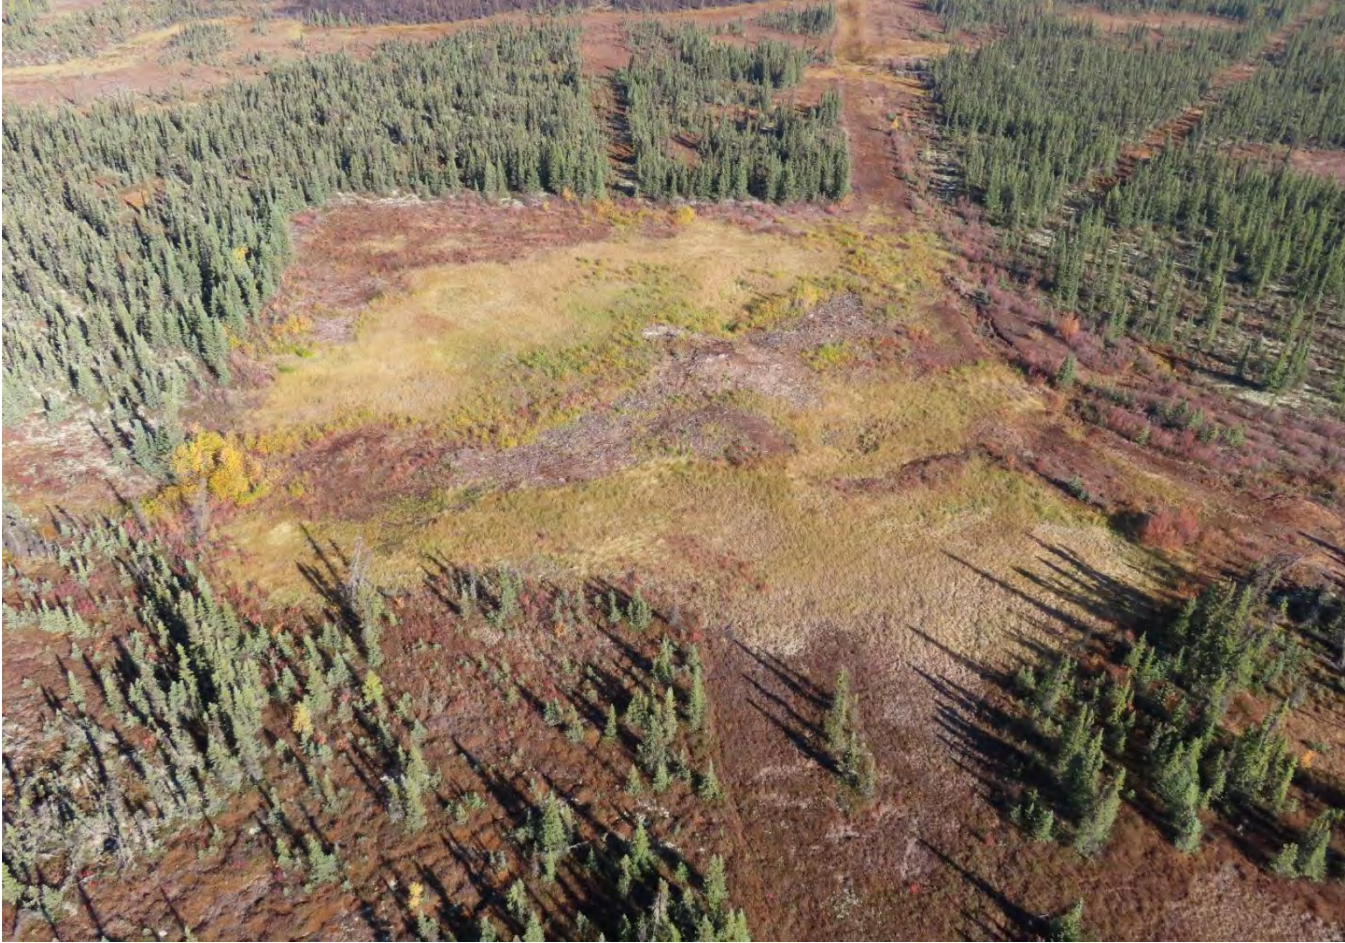
Figure 3

A-05: Aerial view of the wellsite. Well abandoned on February 15, 2023. No further remediation work required at A-05.

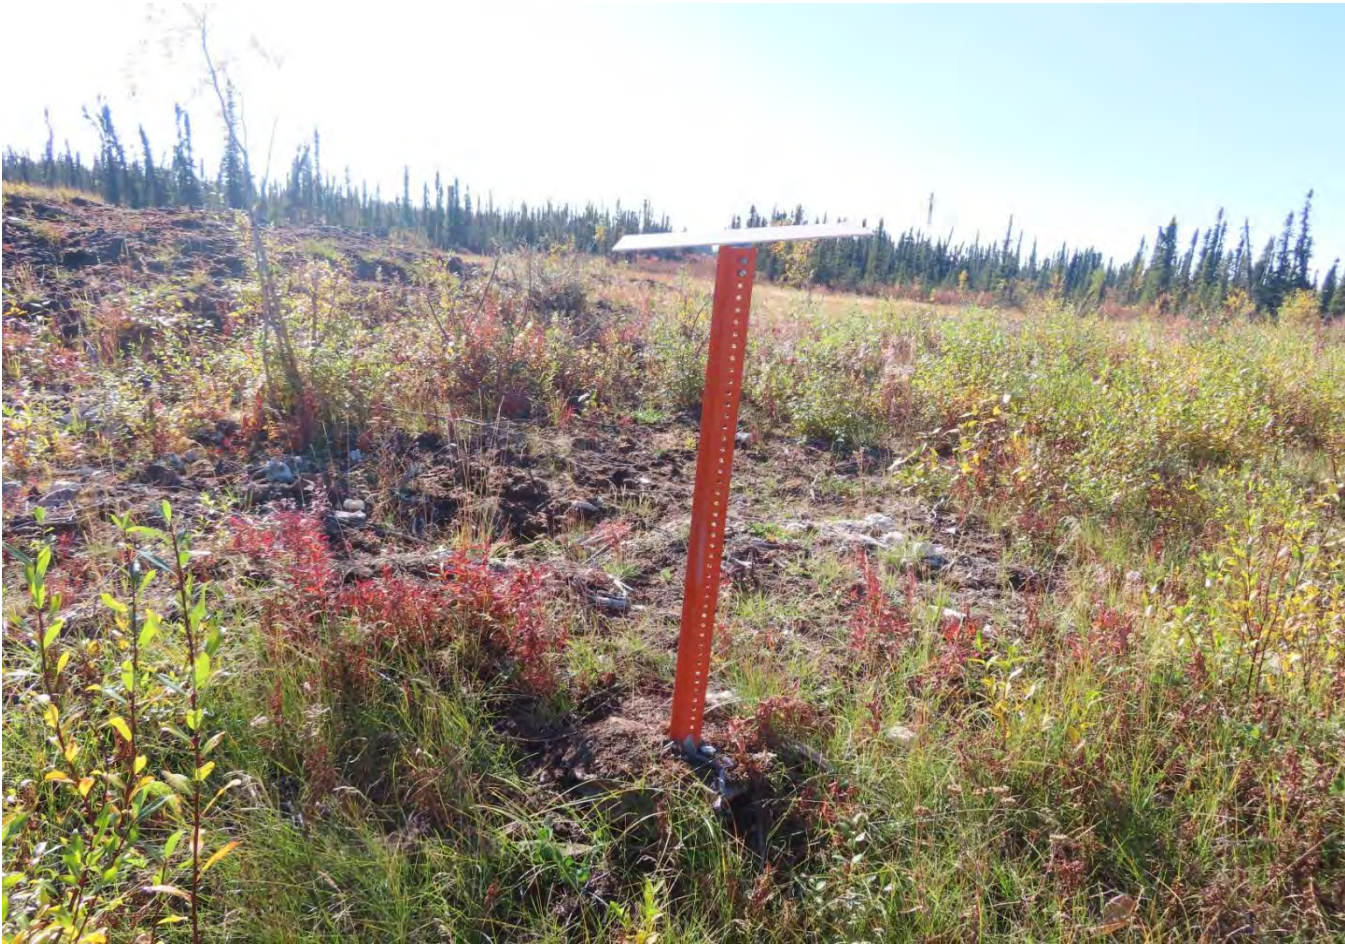
Figure 4

A-05: Backfill of well center appears satisfactory.

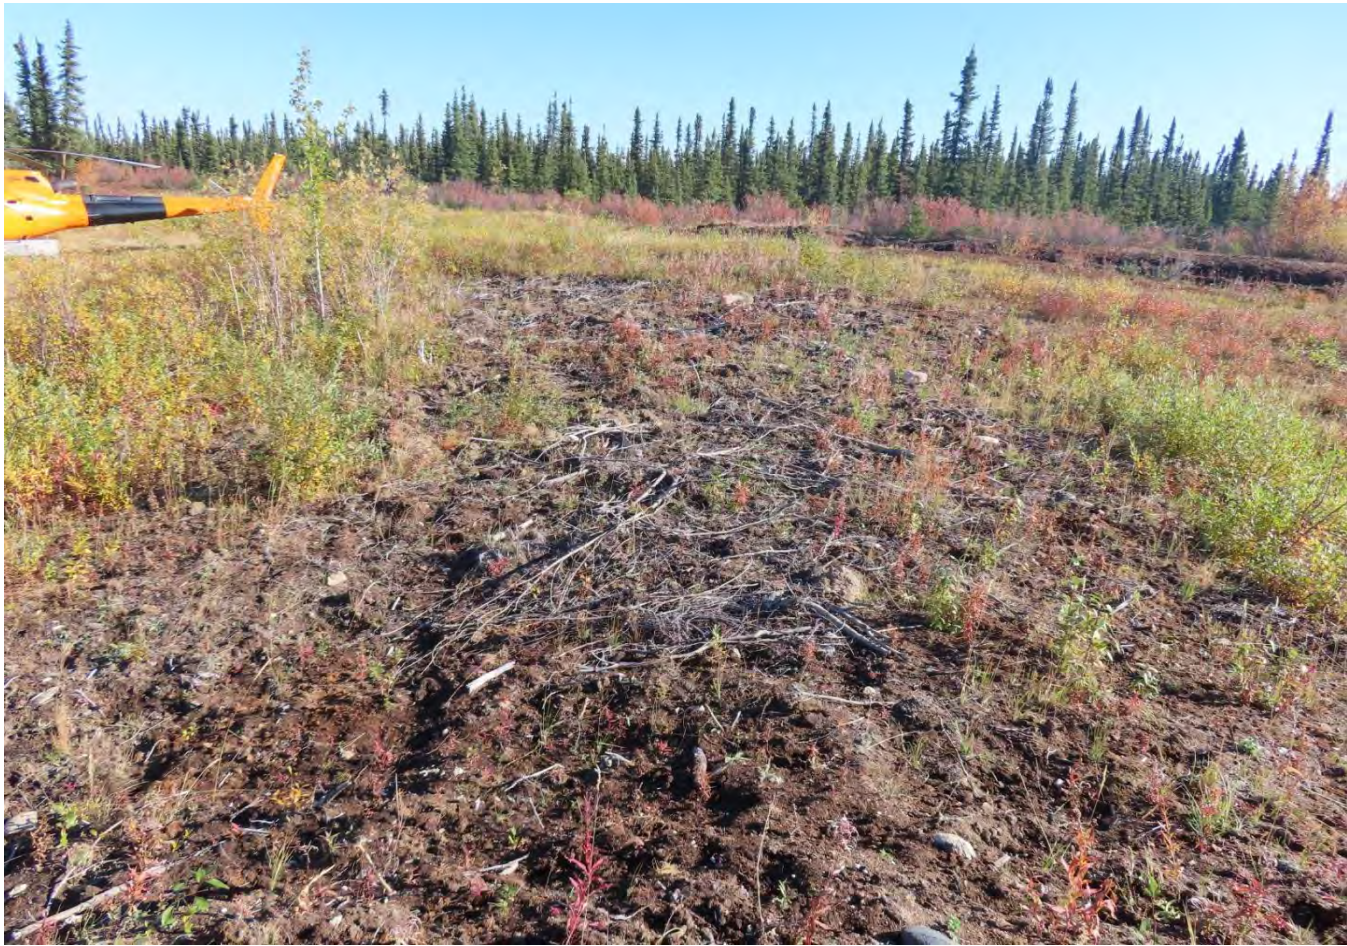
Figure 5

A-05: All production infrastructure was removed from the wellsite in the winter of 2023.

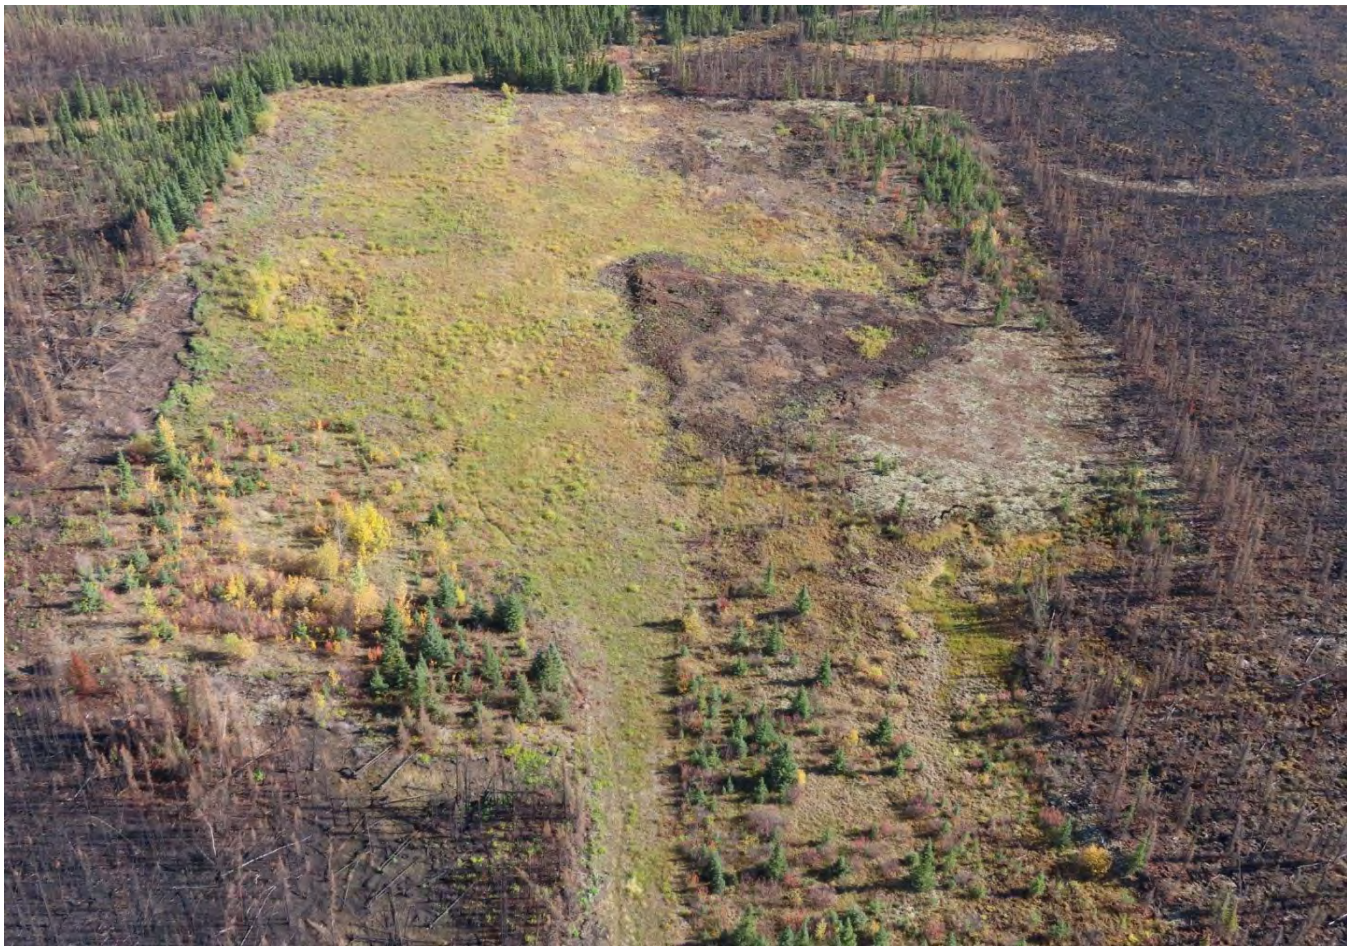
Figure 6

A-68: Aerial view of the wellsite. Well abandoned on January 17, 2023.

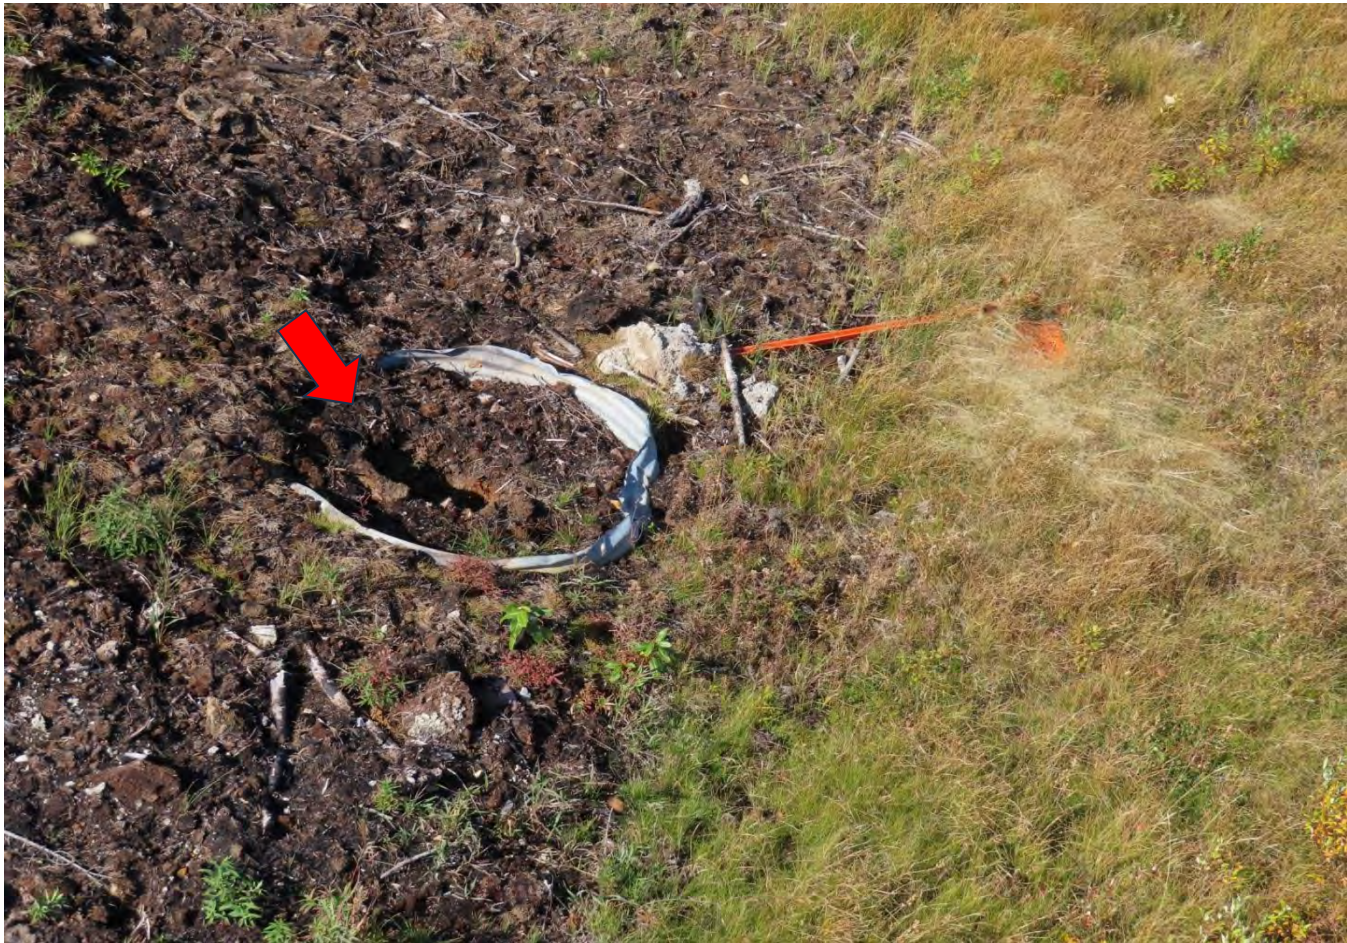
Figure 7

A-68: Cellar not removed and well center not backfilled. Well abandonment sign on the ground.

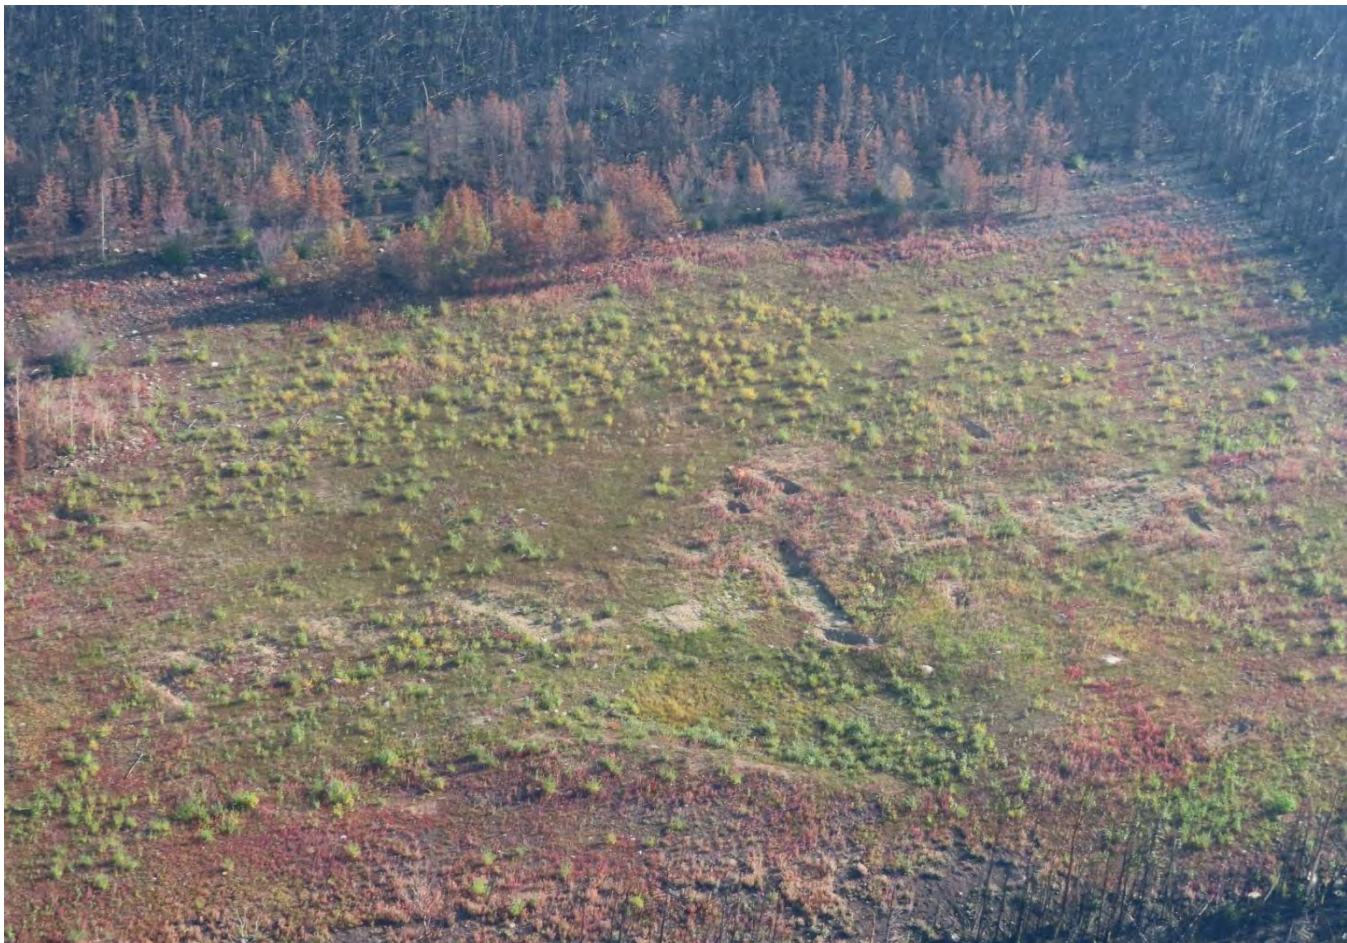
Figure 8

A-73: Aerial view of the wellsite. Well abandoned on February 15, 2023.

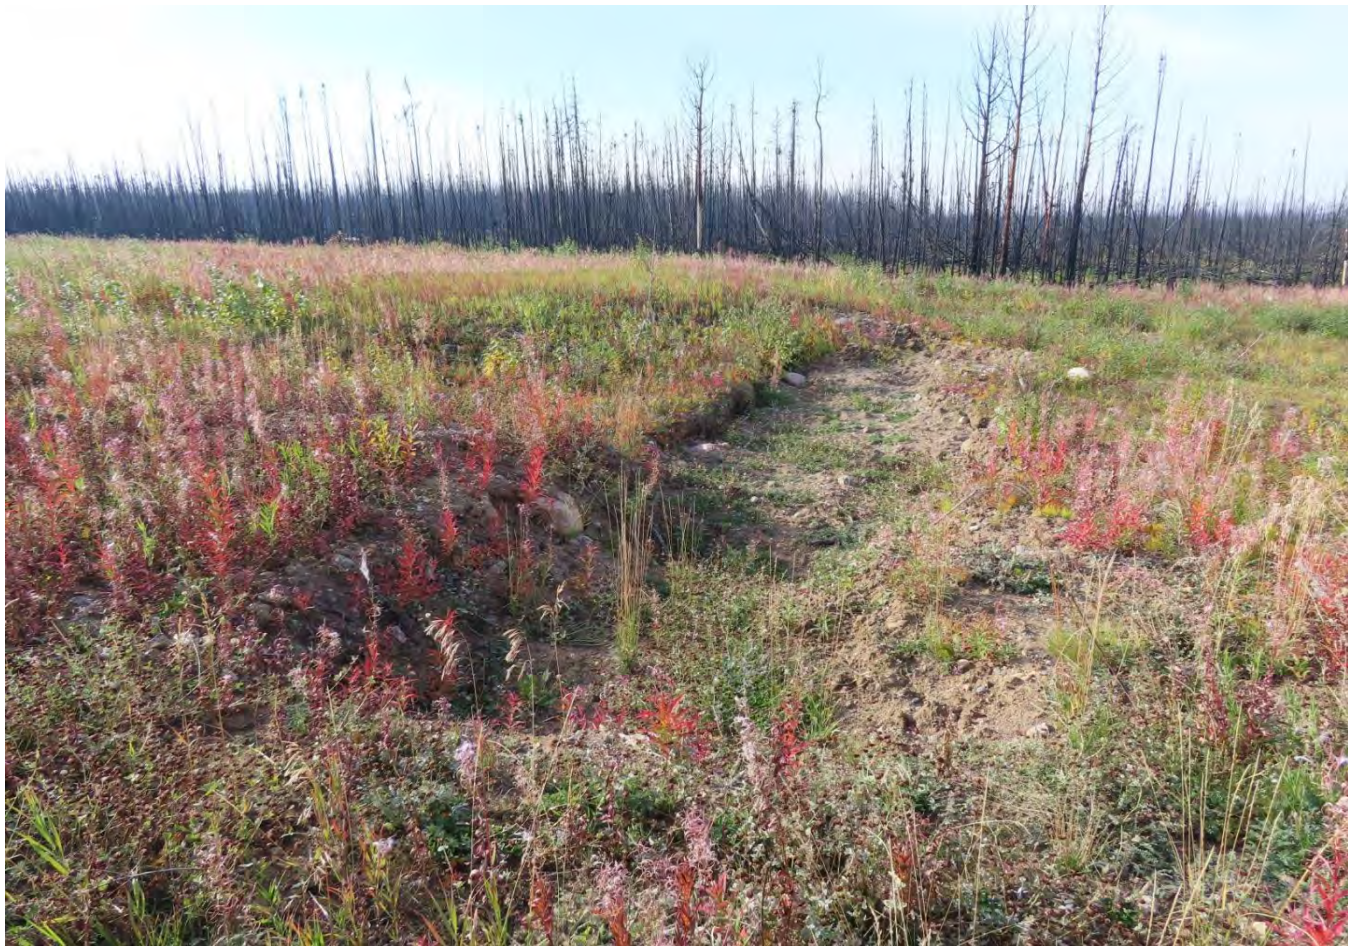
Figure 10

A-73: All production infrastructure was removed from the wellsite in the winter of 2023.

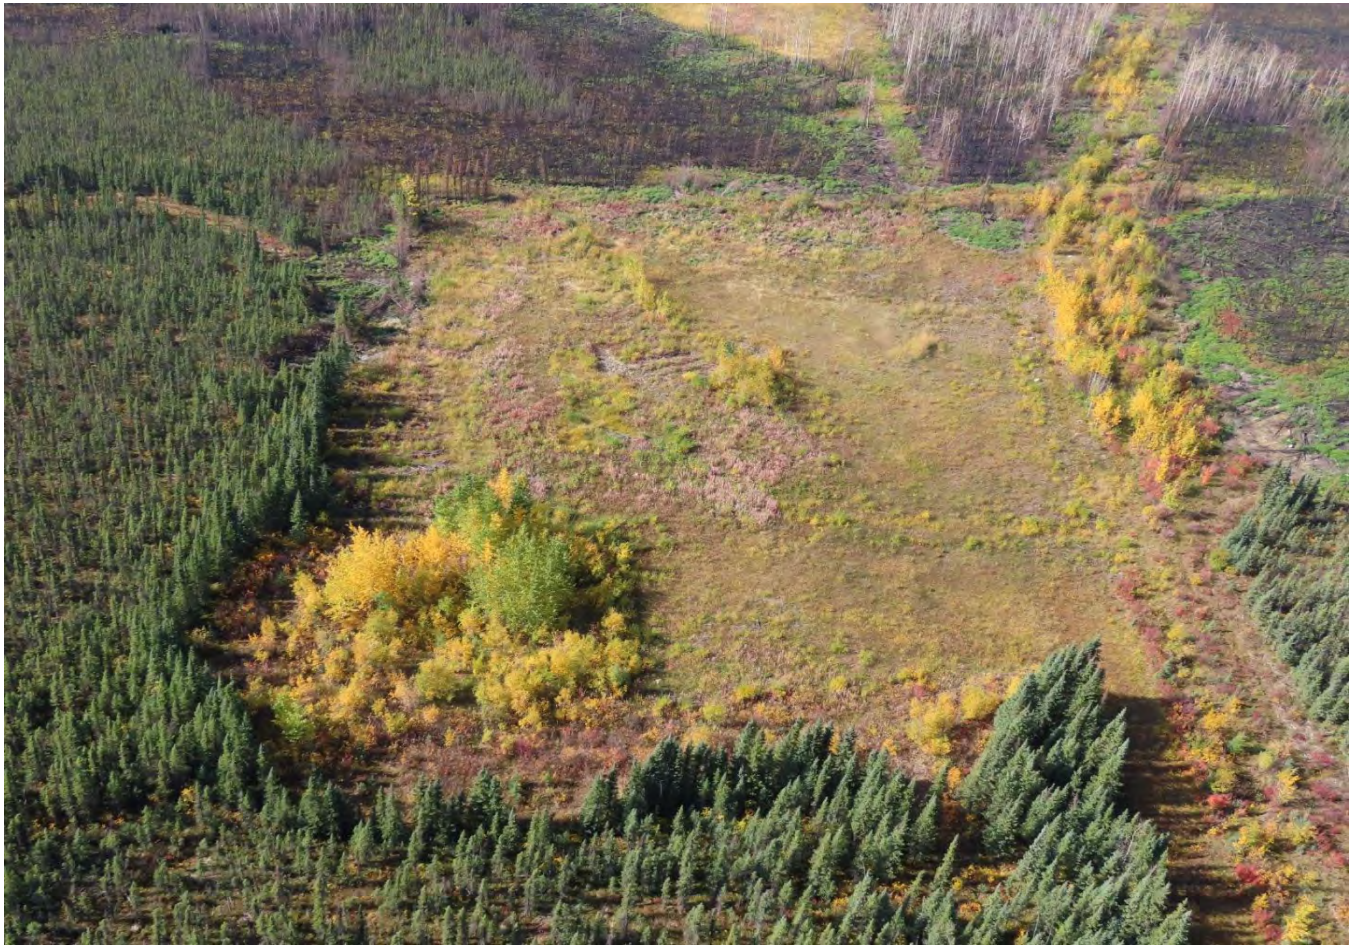
Figure 11

B-08: Aerial view of the wellsite. Well abandoned on February 20, 2023. No further remediation work required at B-08.

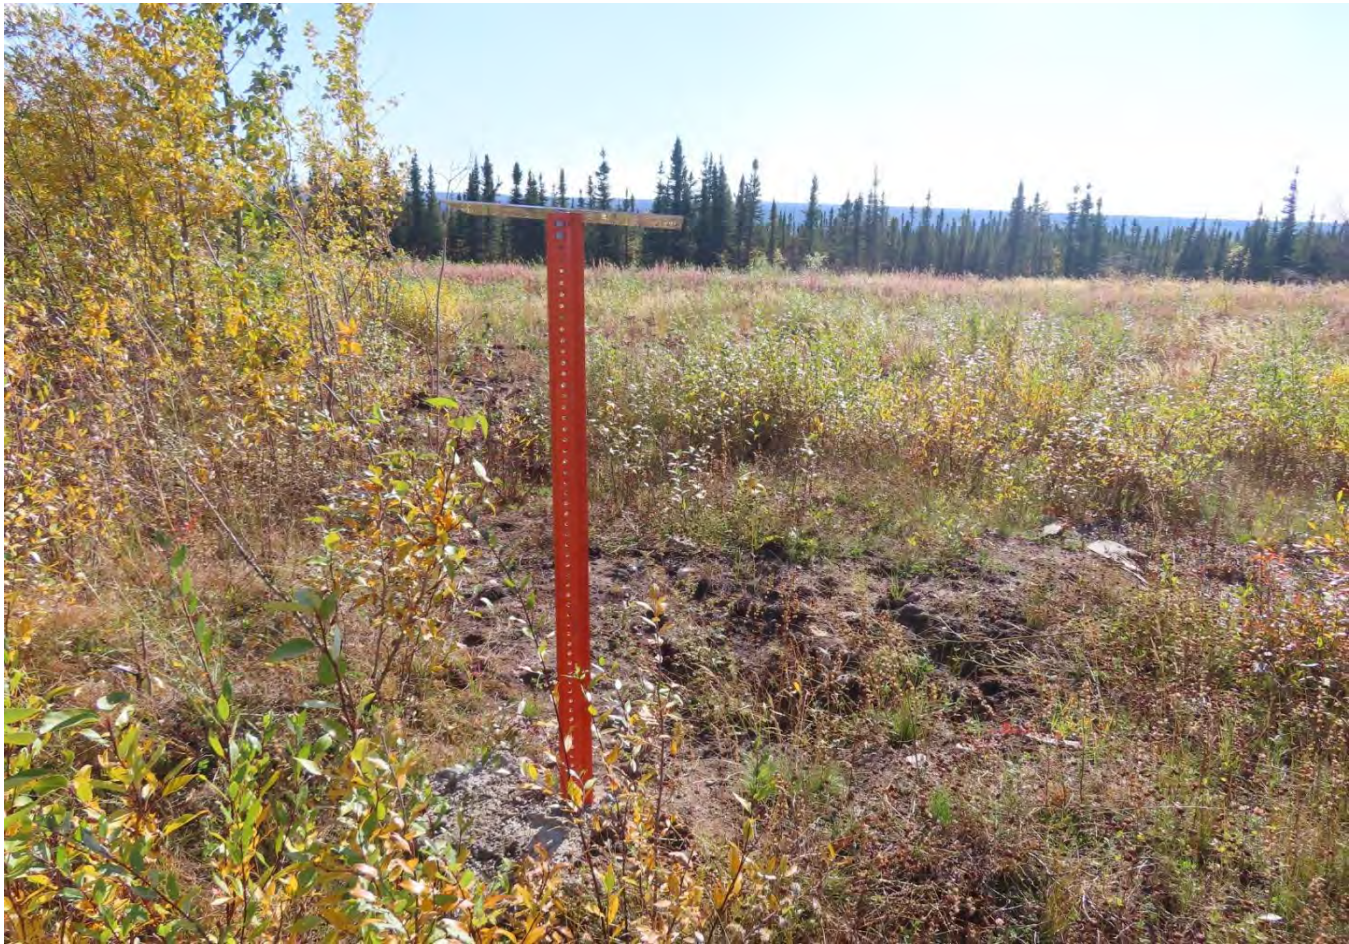
Figure 12

B-08: Backfill of well center appears satisfactory.

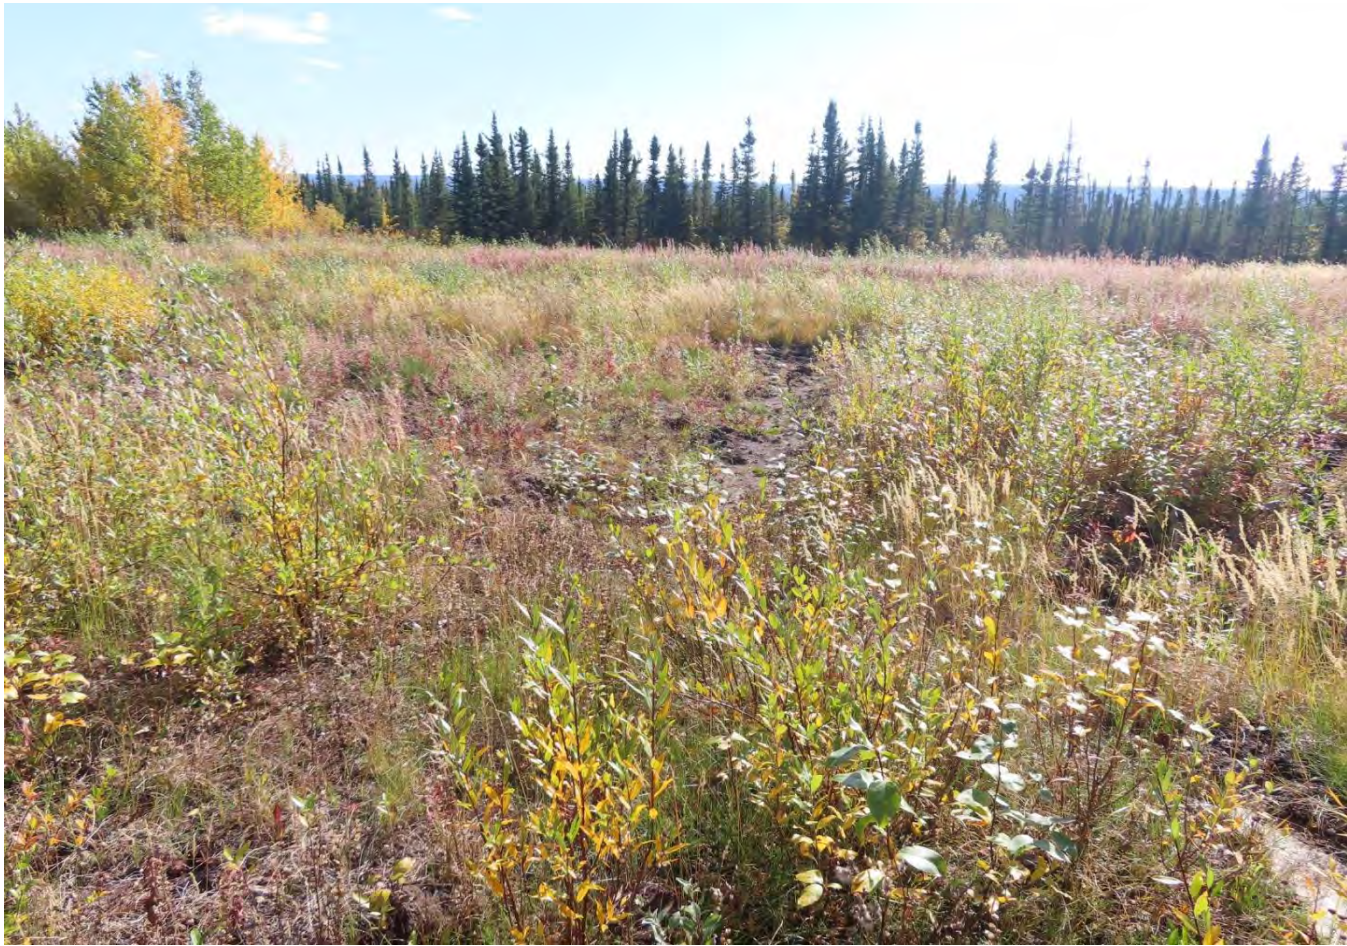
Figure 13

B-08: All production infrastructure was removed from the wellsite in the winter of 2023.

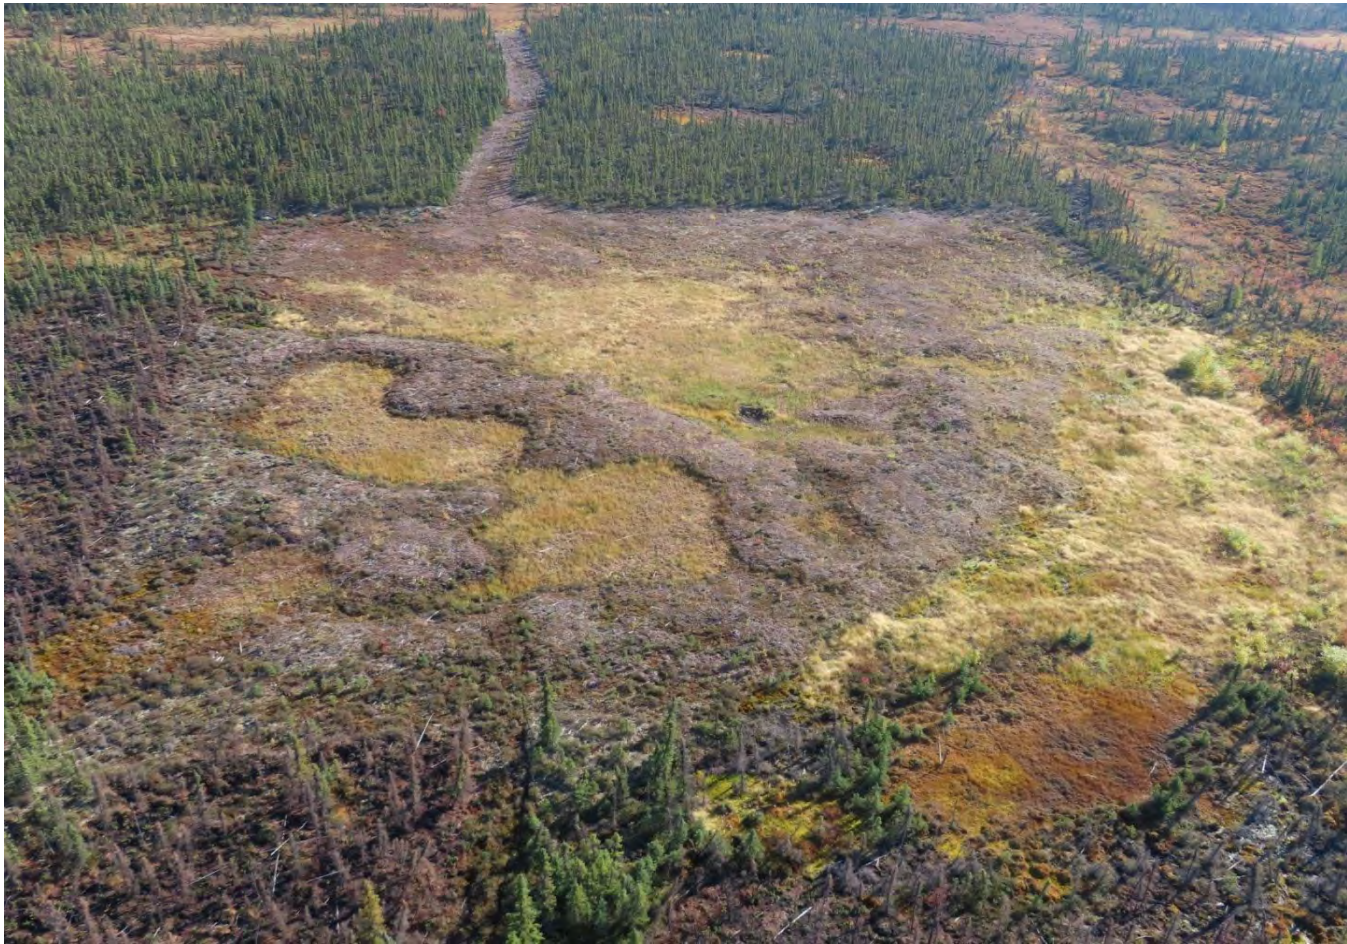
Figure 14

B-09: Aerial view of the wellsite. Well abandoned on February 27, 2023. No further remediation work required at B-09.

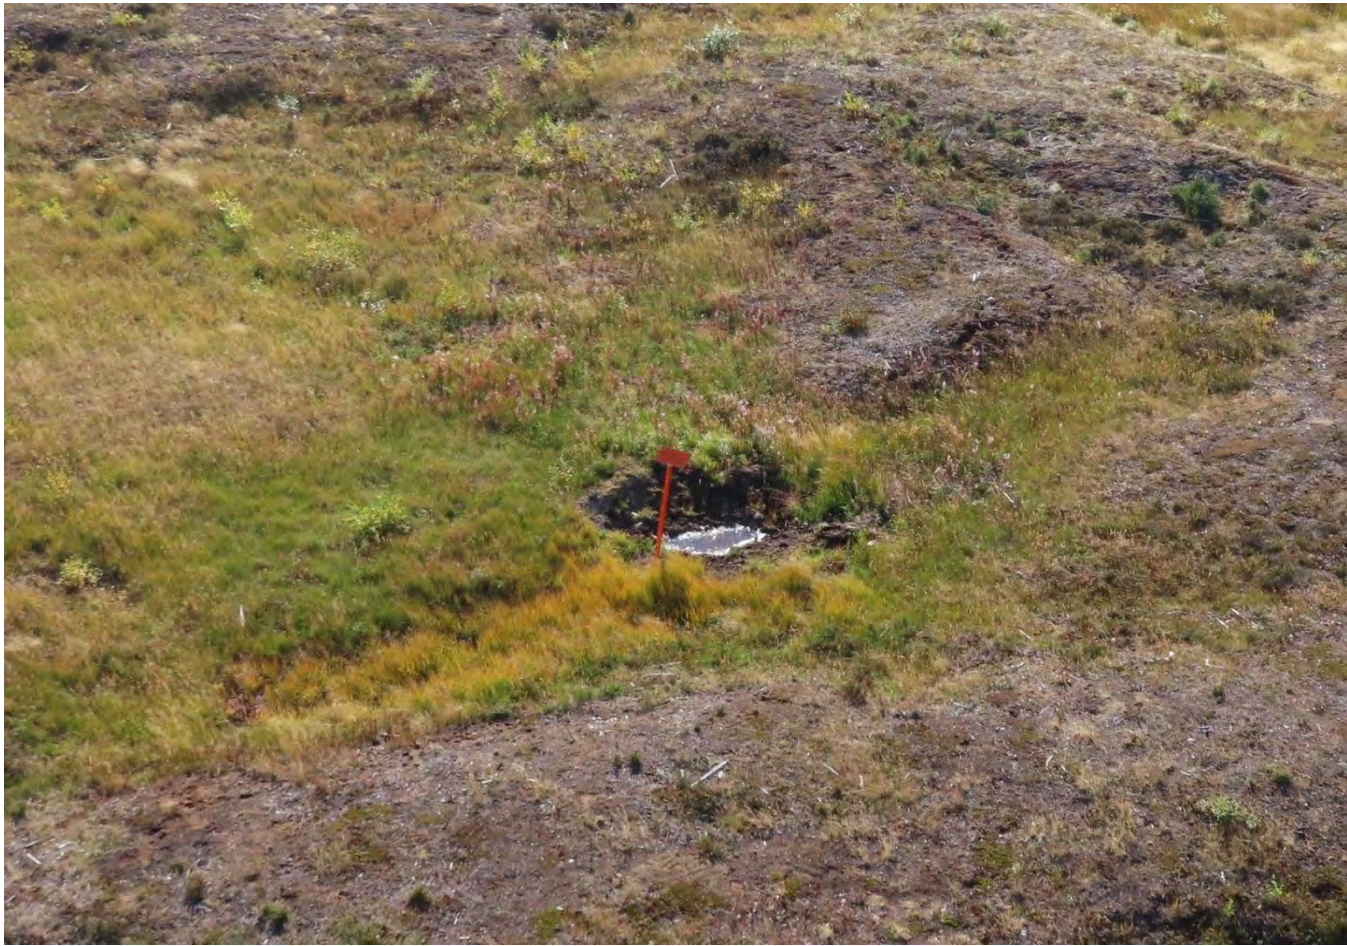
Figure 15

B-09: Minor ponding observed at well center. No concerns with abandonment.

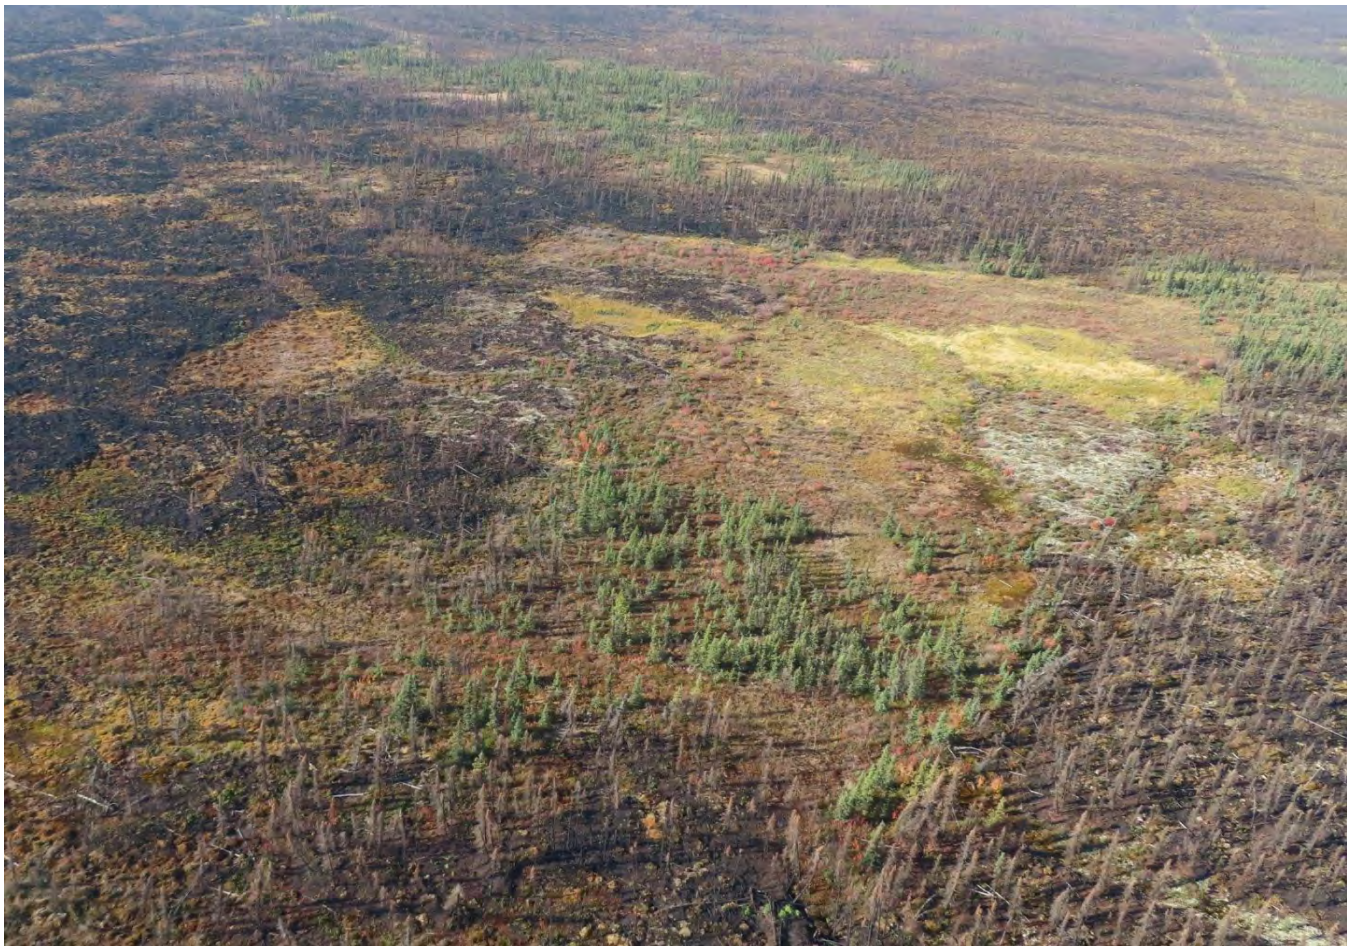
Figure 16

B-11: Aerial view of the wellsite. Site was cleared in 2010 but was never drilled.

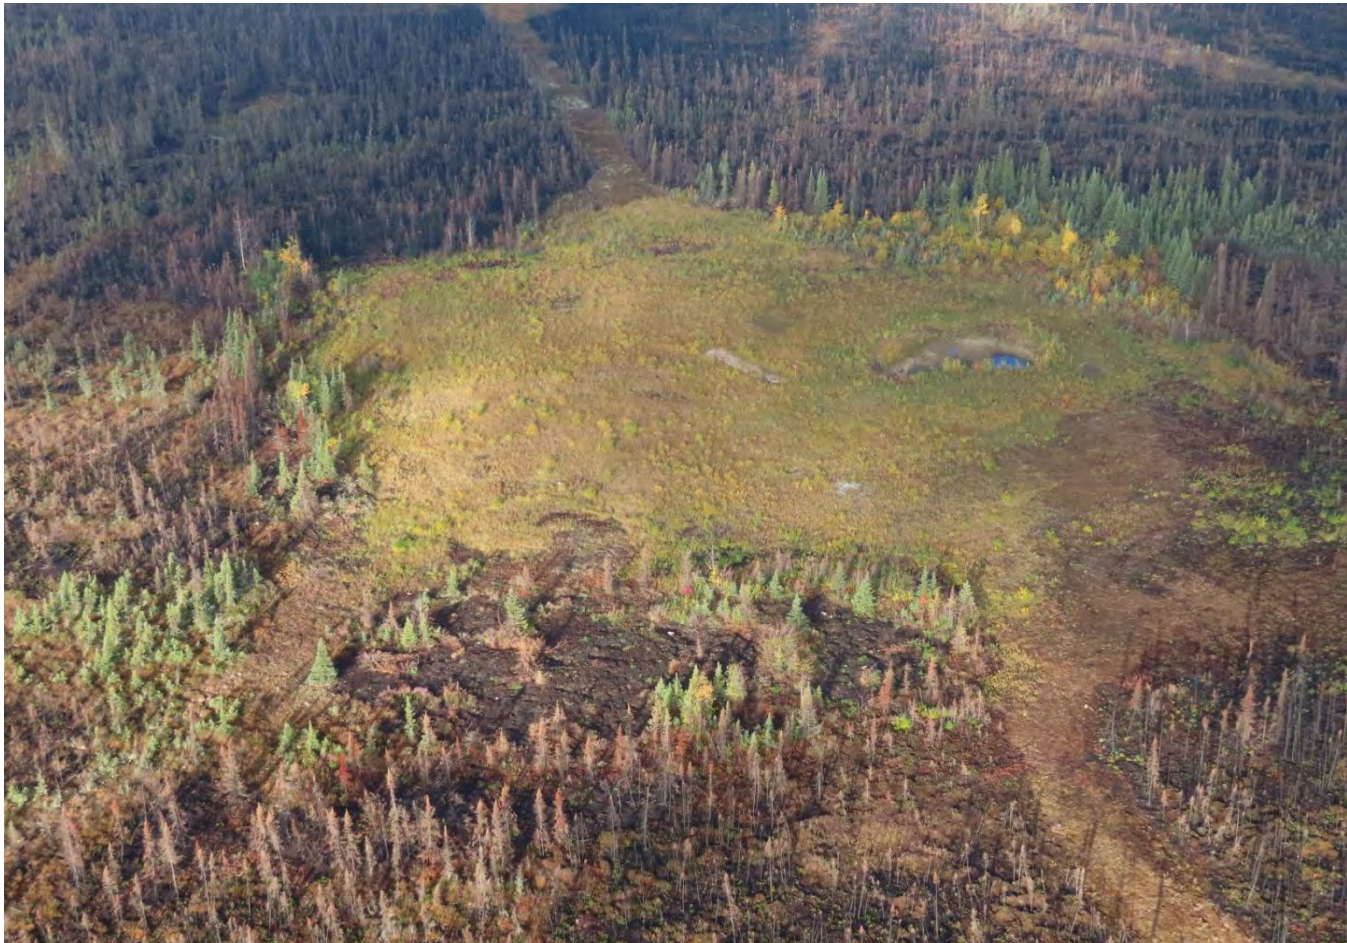
Figure 17

B-25: Aerial view of the wellsite. Well abandoned on January 31, 2023.

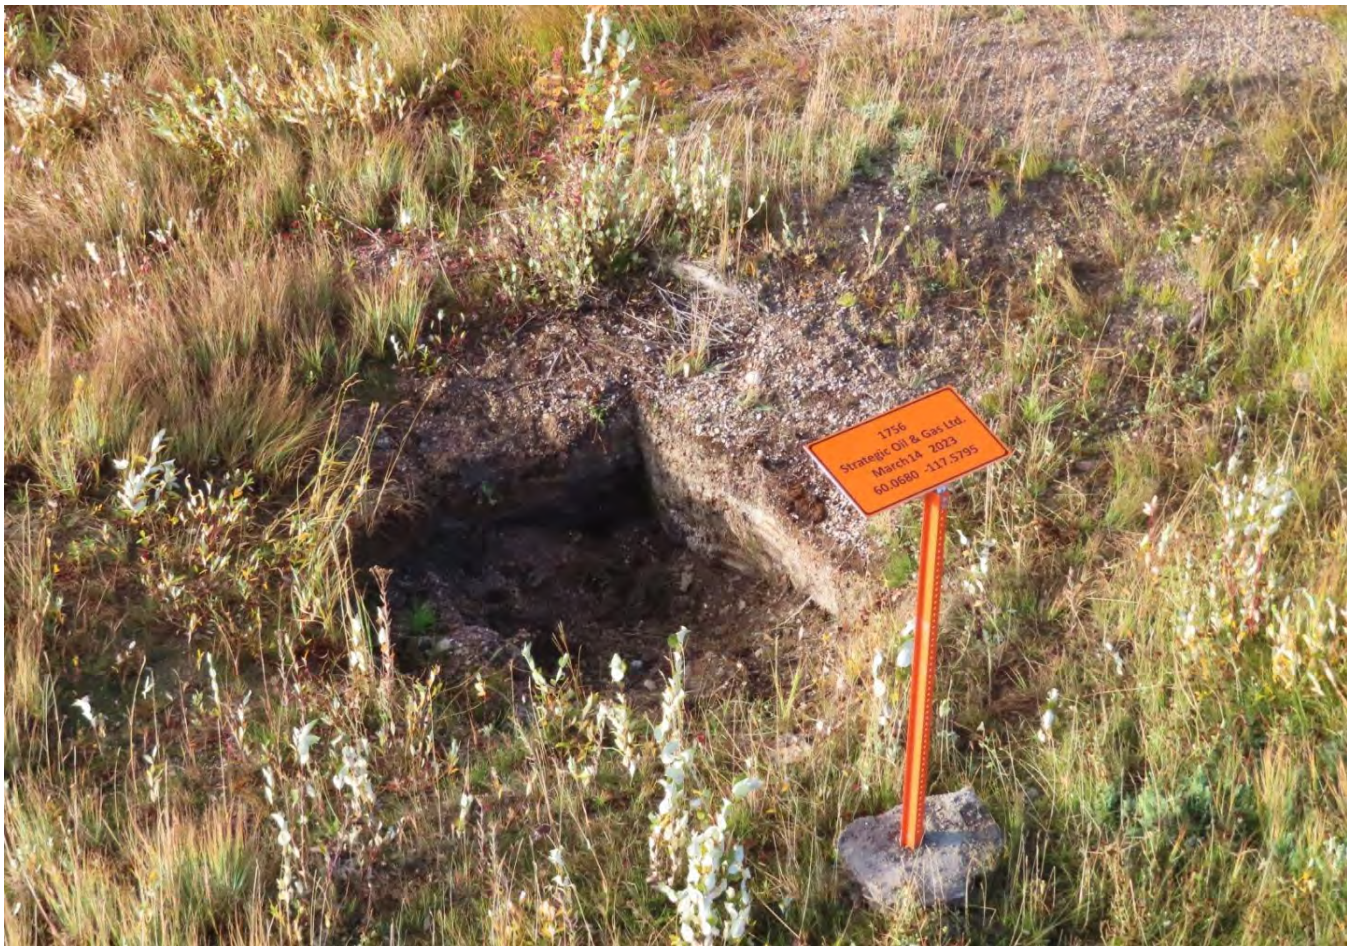
Figure 18

B-25: Backfill of B-25 well center not completed following abandonment operations.
