File Number	MV2022X0018
Type of Operation	Cameron Hills Oil and Gas Field Abandonment
Location	Cameron Hills, NT

ENVIRONMENTAL INSPECTION REPORT

Permittee:	Strategic Oil and Gas Ltd. c/o Alvarez & Marsal Canada Inc.	Permit Expiry Date:	January 02, 2028
Land Use Permit No.	MV2022X0018	Previous Inspection:	February 21, 2024
Quarrying Permit No.		Inspection Date:	September 17, 2024
Contractor:	ELM Inc.	Subcontractor:	
Location(s) Inspected:	Cameron Hills Oil and Gas Field		
Current Stage of Operation:	The abandonment of the H-03 Battery, forty-four (44) oil and gas wells was completed in the winter of 2023 and 2024.		
Program Modifications Approved:

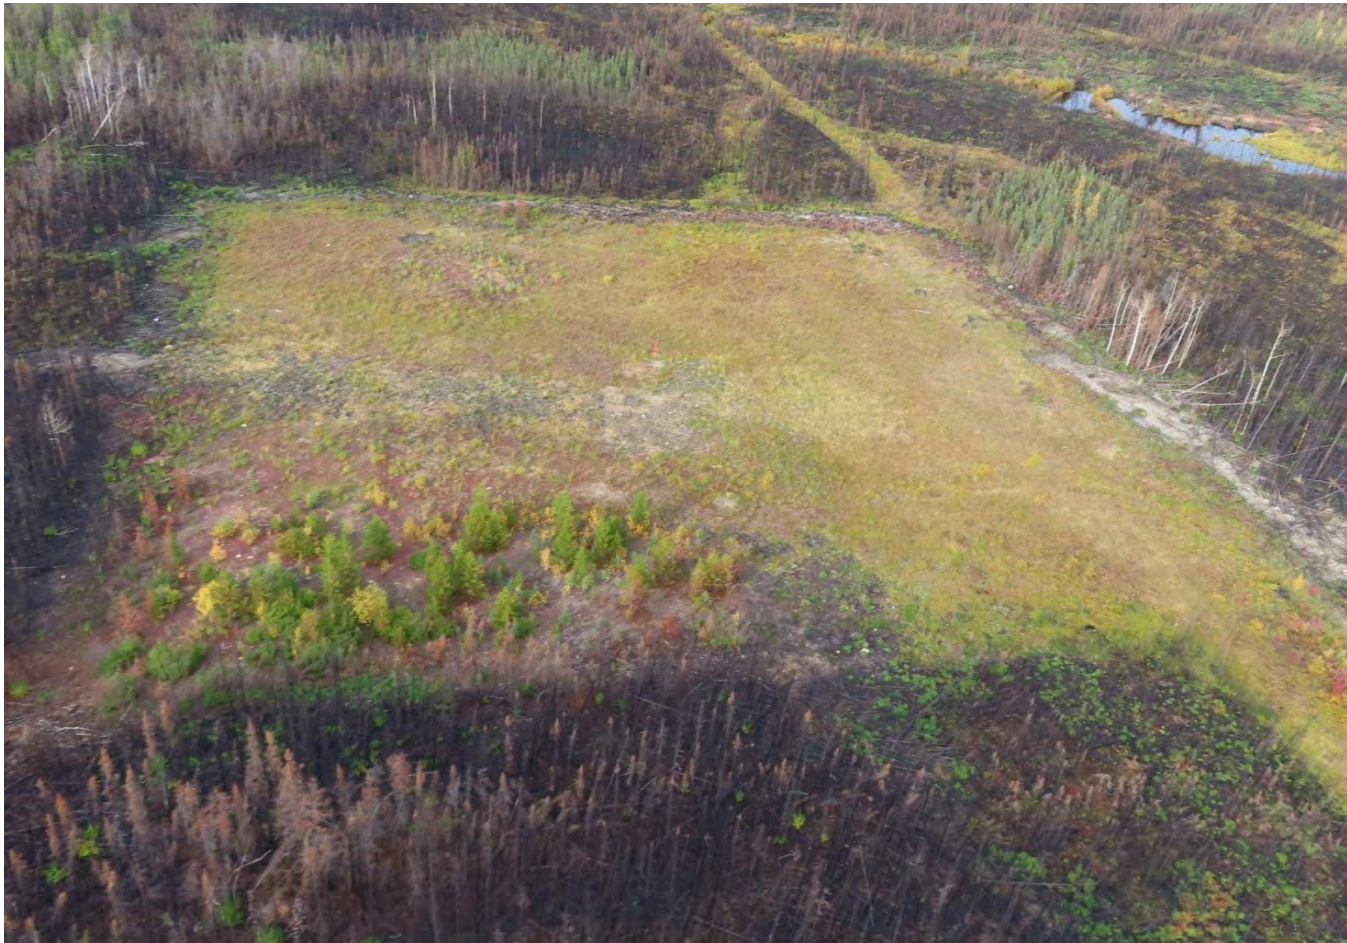
Figure 19

B-38: Aerial view of the wellsite. Well abandoned on January 31, 2023. No further remediation work required at B-38.

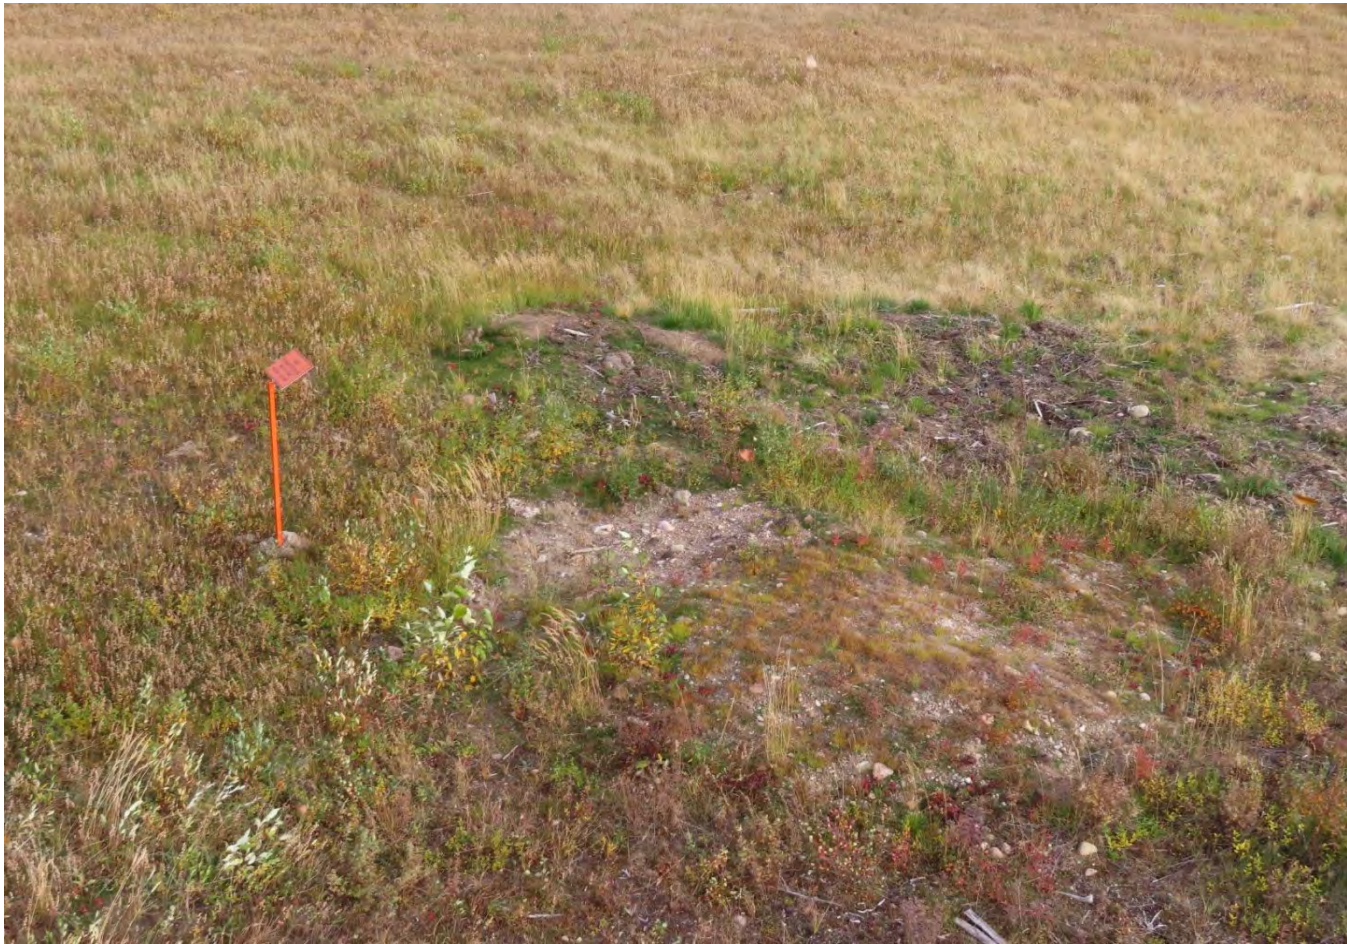
Figure 20

B-38: Backfill of well center appears satisfactory.

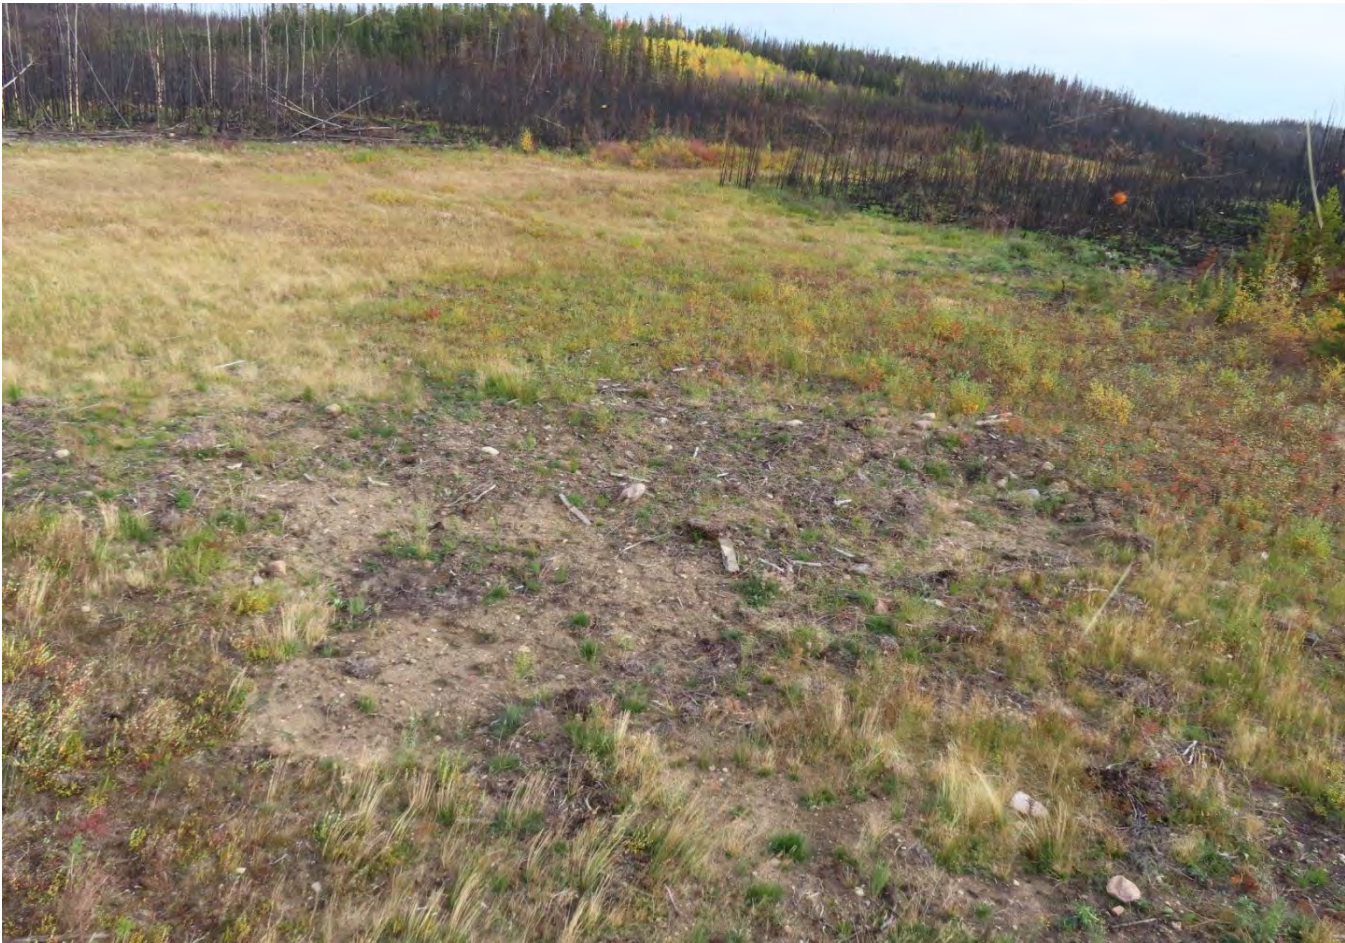
Figure 21

B-38: All production infrastructure was removed from the wellsite in the winter of 2023.

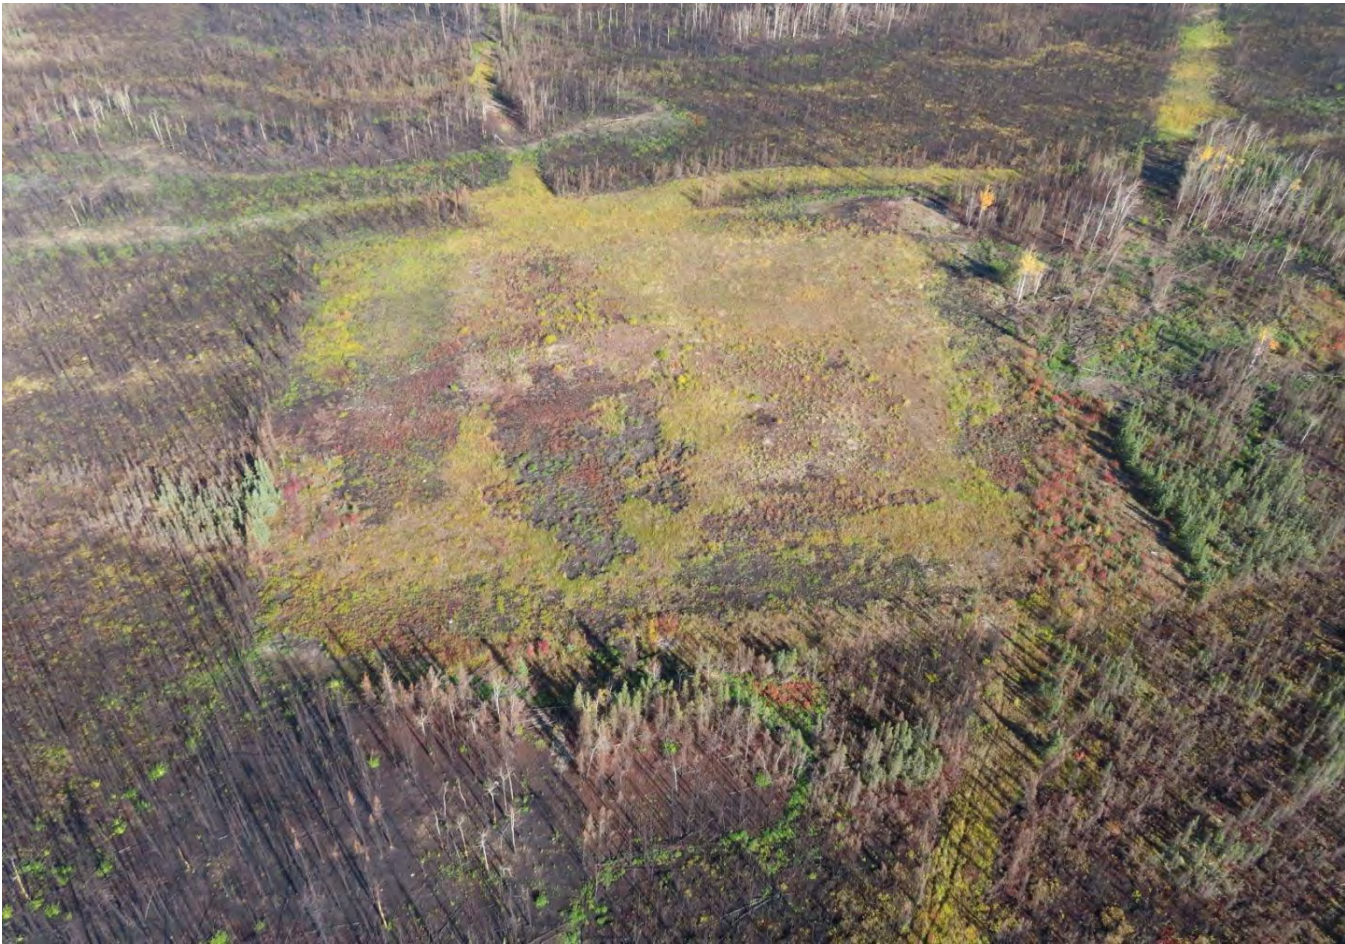
Figure 22

C-16: Aerial view of the wellsite. Well abandoned on January 11, 2023. No further remediation work required at C-16.

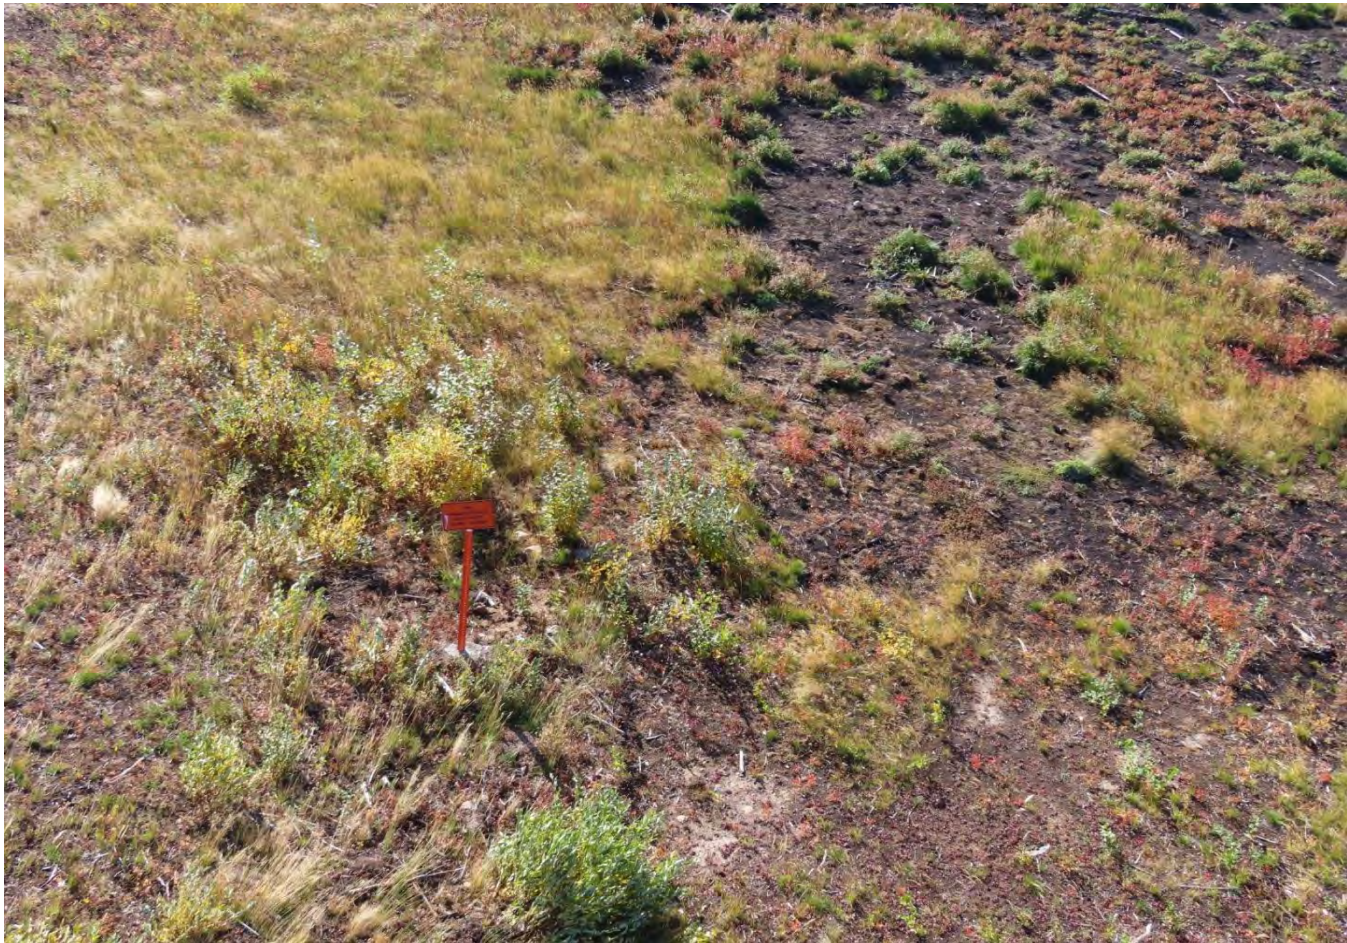
Figure 23

C-16: Backfill of well center appears satisfactory.

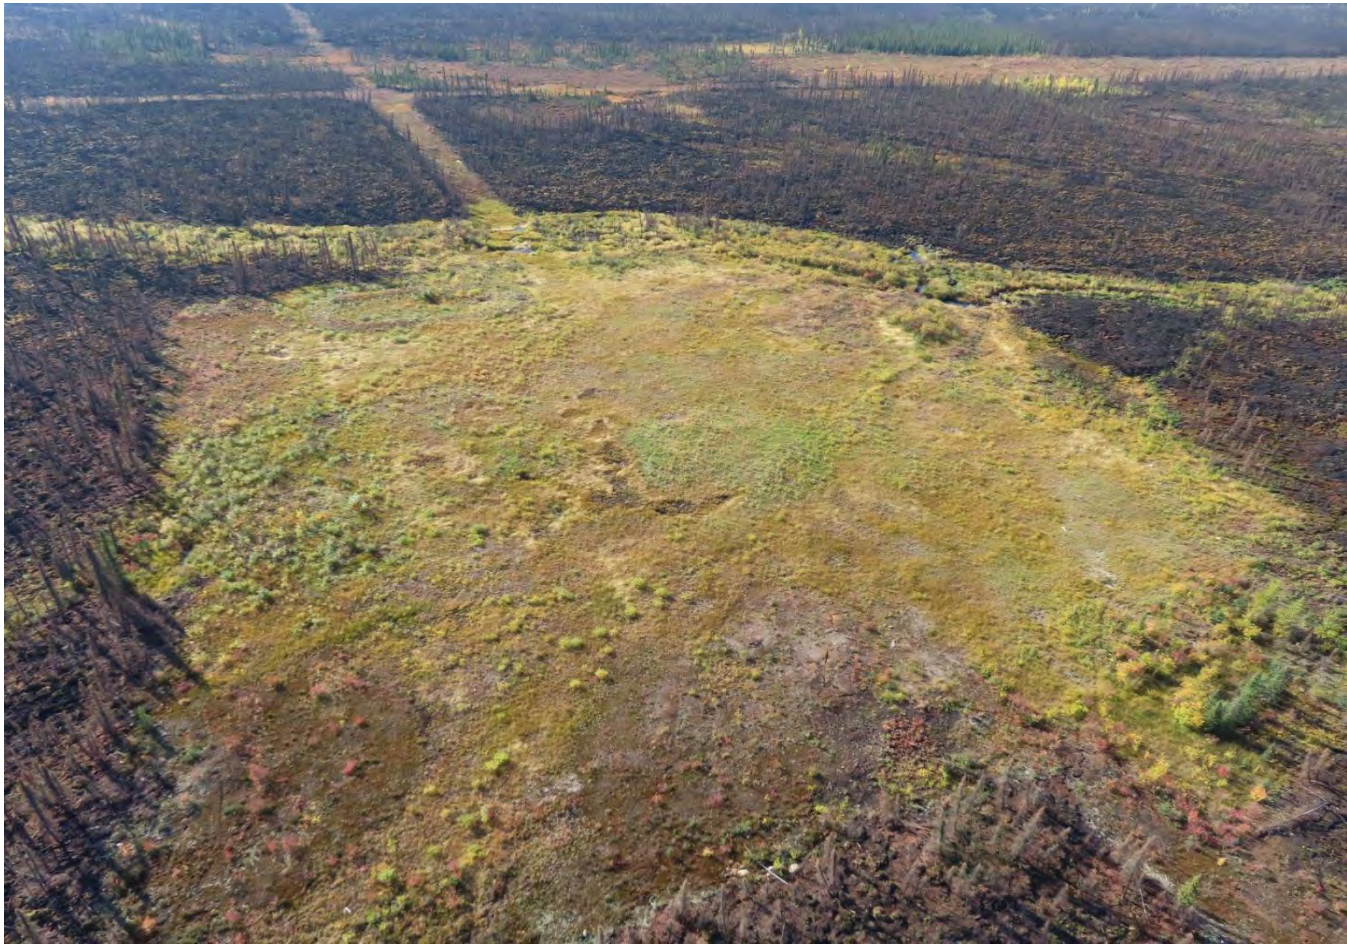
Figure 24

C-19: Aerial view of the wellsite. Well abandoned on March 02, 2023. No further remediation work required at C-19.

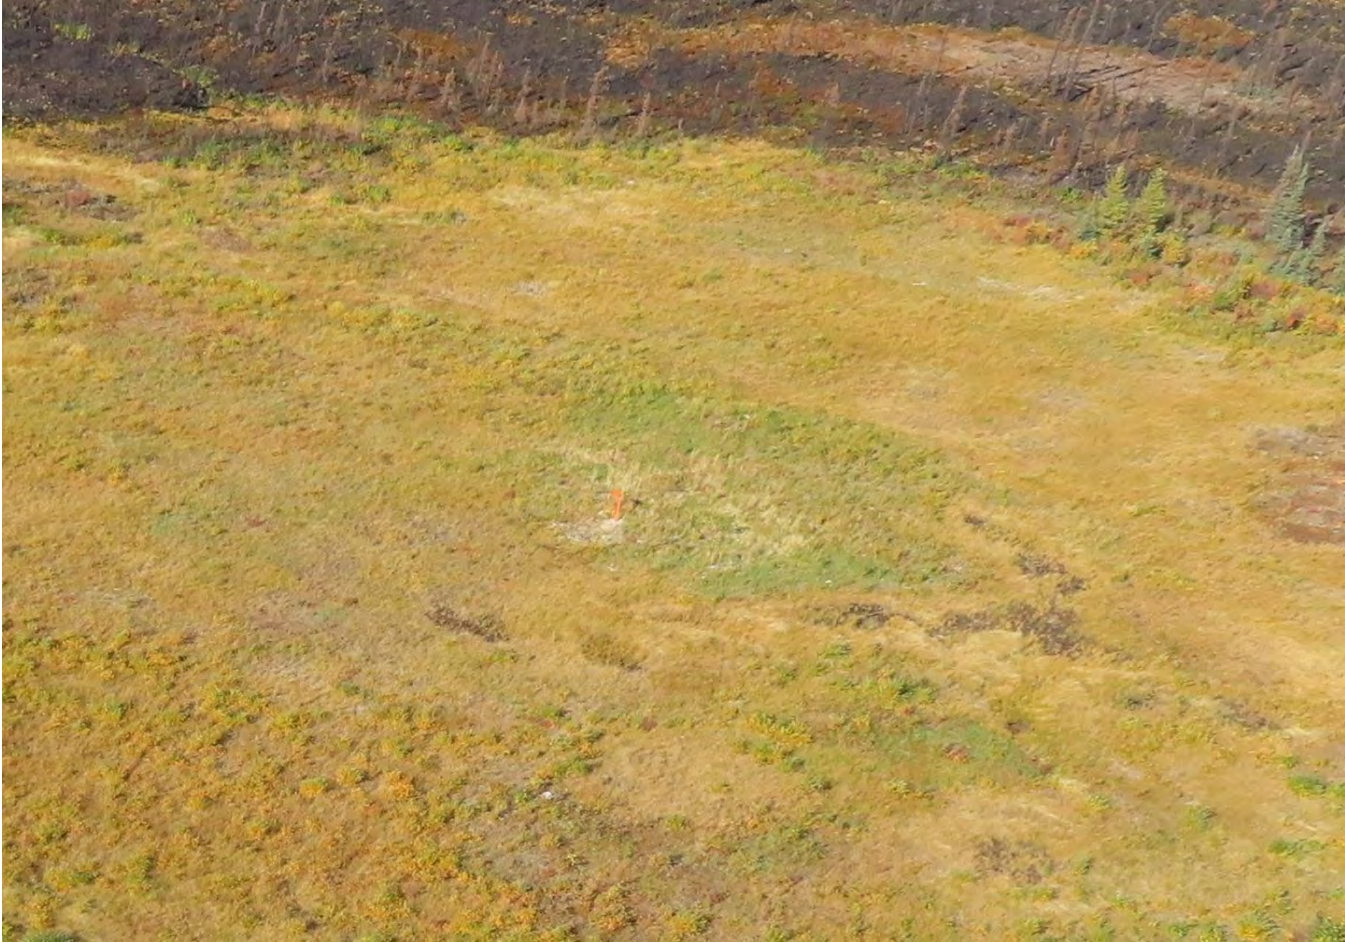
Figure 25

C-19: Backfill of well center appears satisfactory.

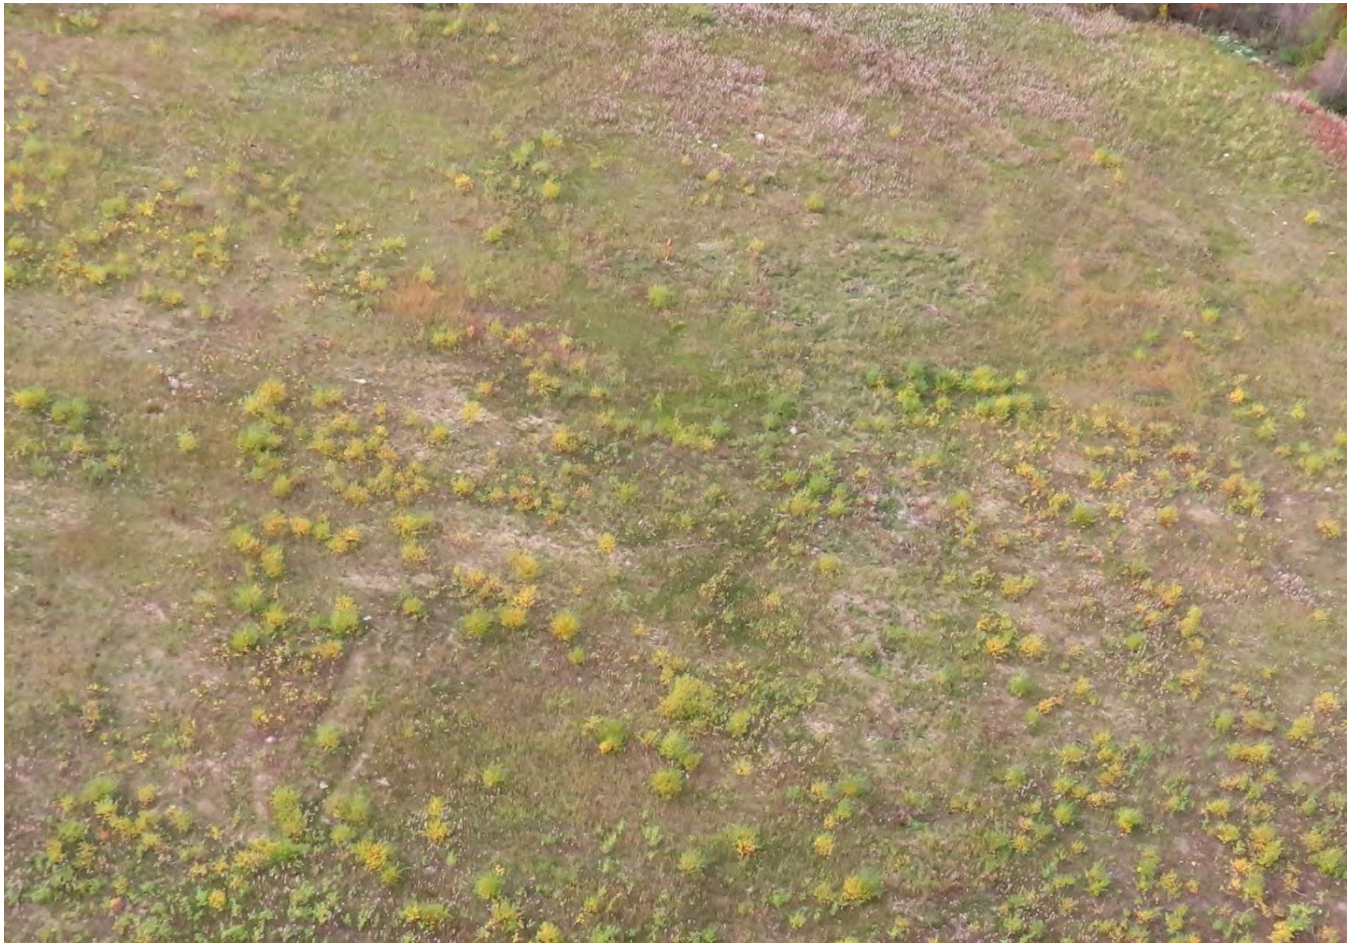
Figure 27

C-50: All production infrastructure was removed from the wellsite in the winter of 2023.

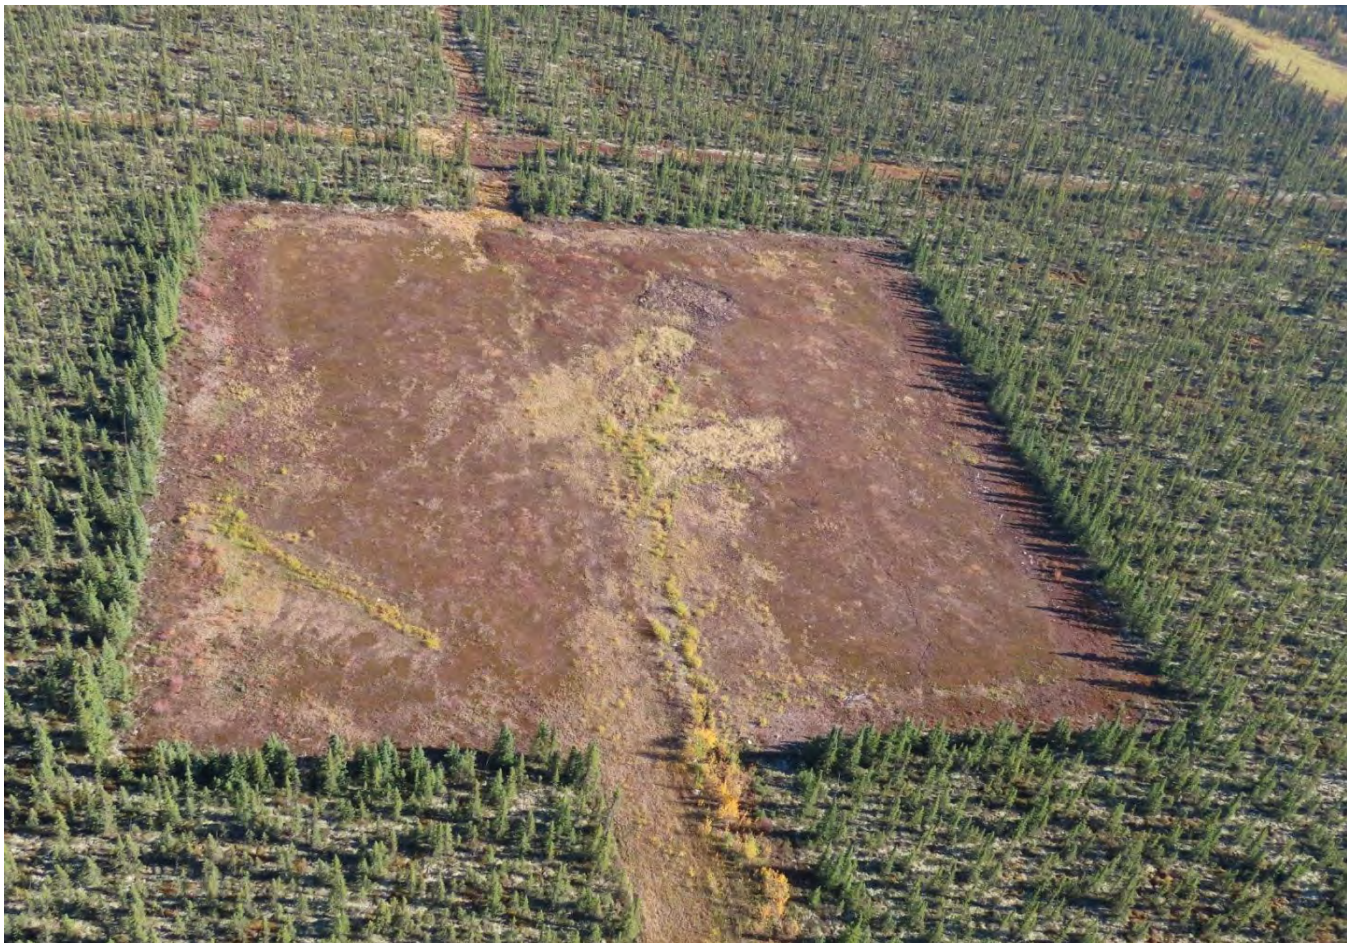
Figure 28

C-74: Aerial view of the Wellsite. Well abandoned on February 22, 2023.

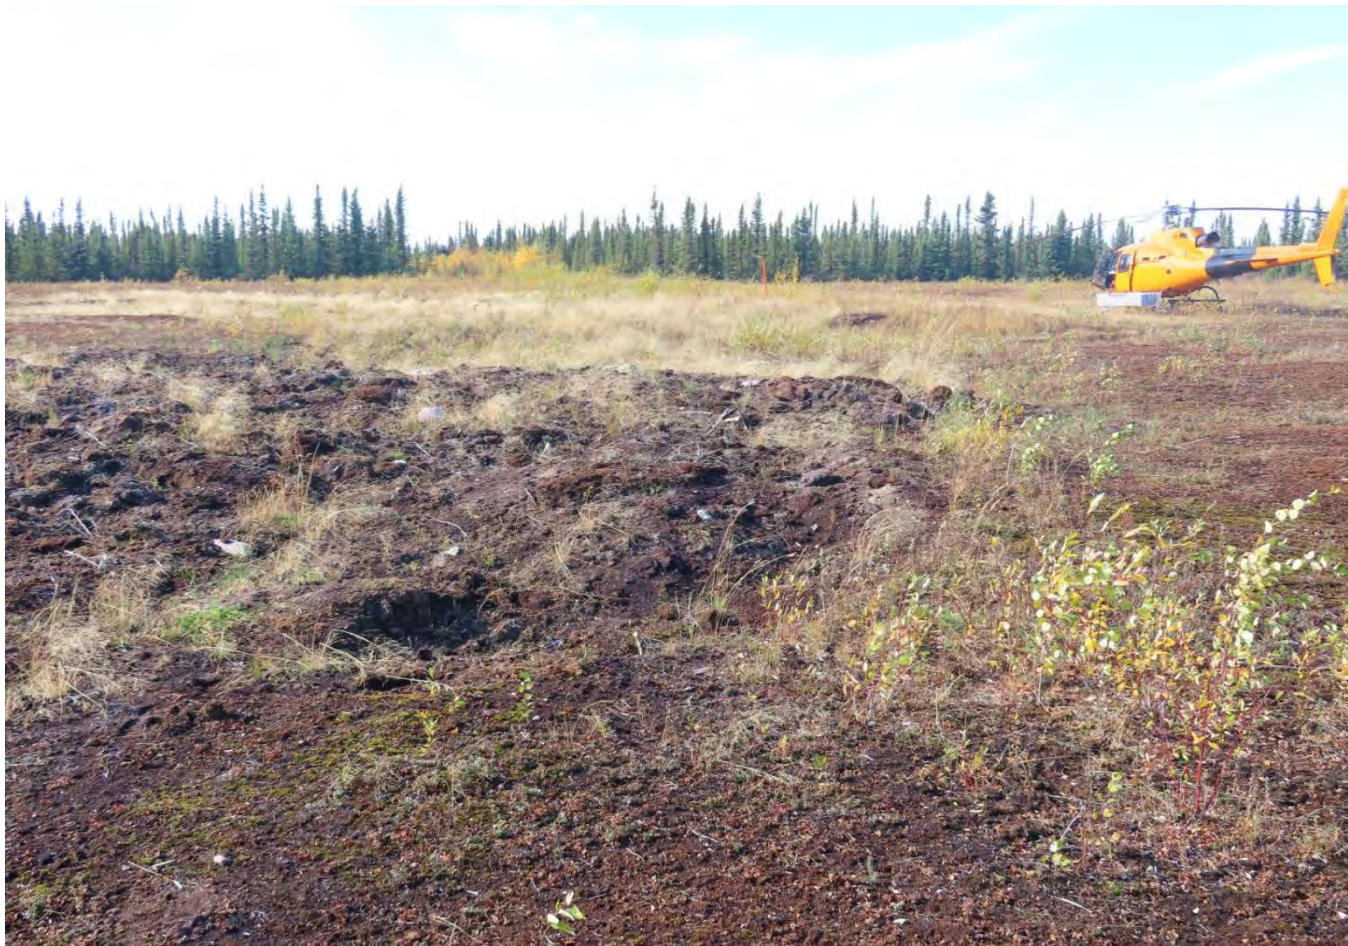
Figure 30

C-74: All production infrastructure was removed from the wellsite in the winter of 2023.

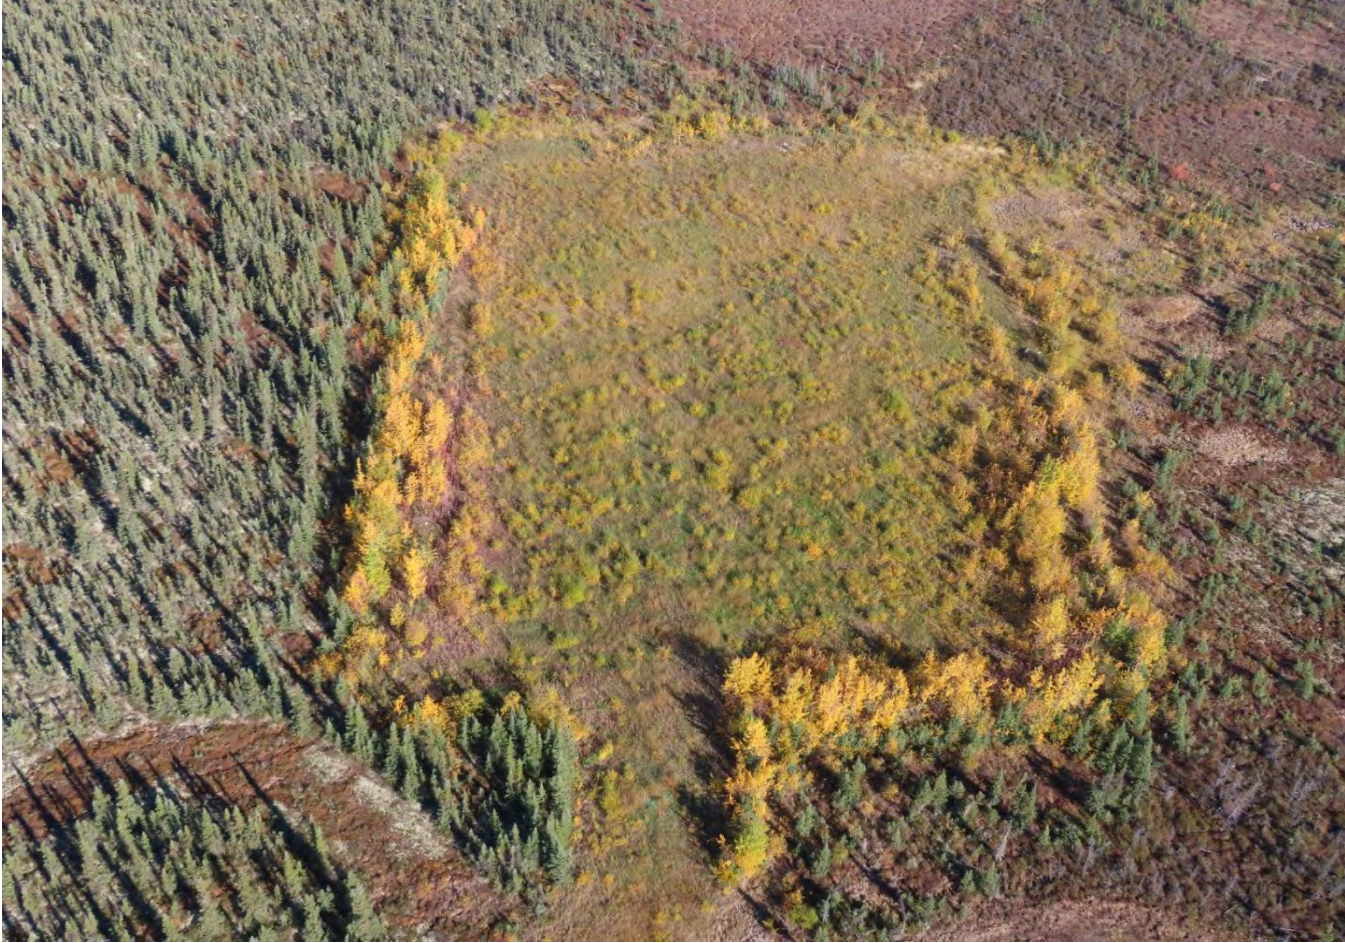
Figure 31

C-75: Aerial view of the wellsite. Well abandoned on February 20, 2023. No further remediation work required at C-75.

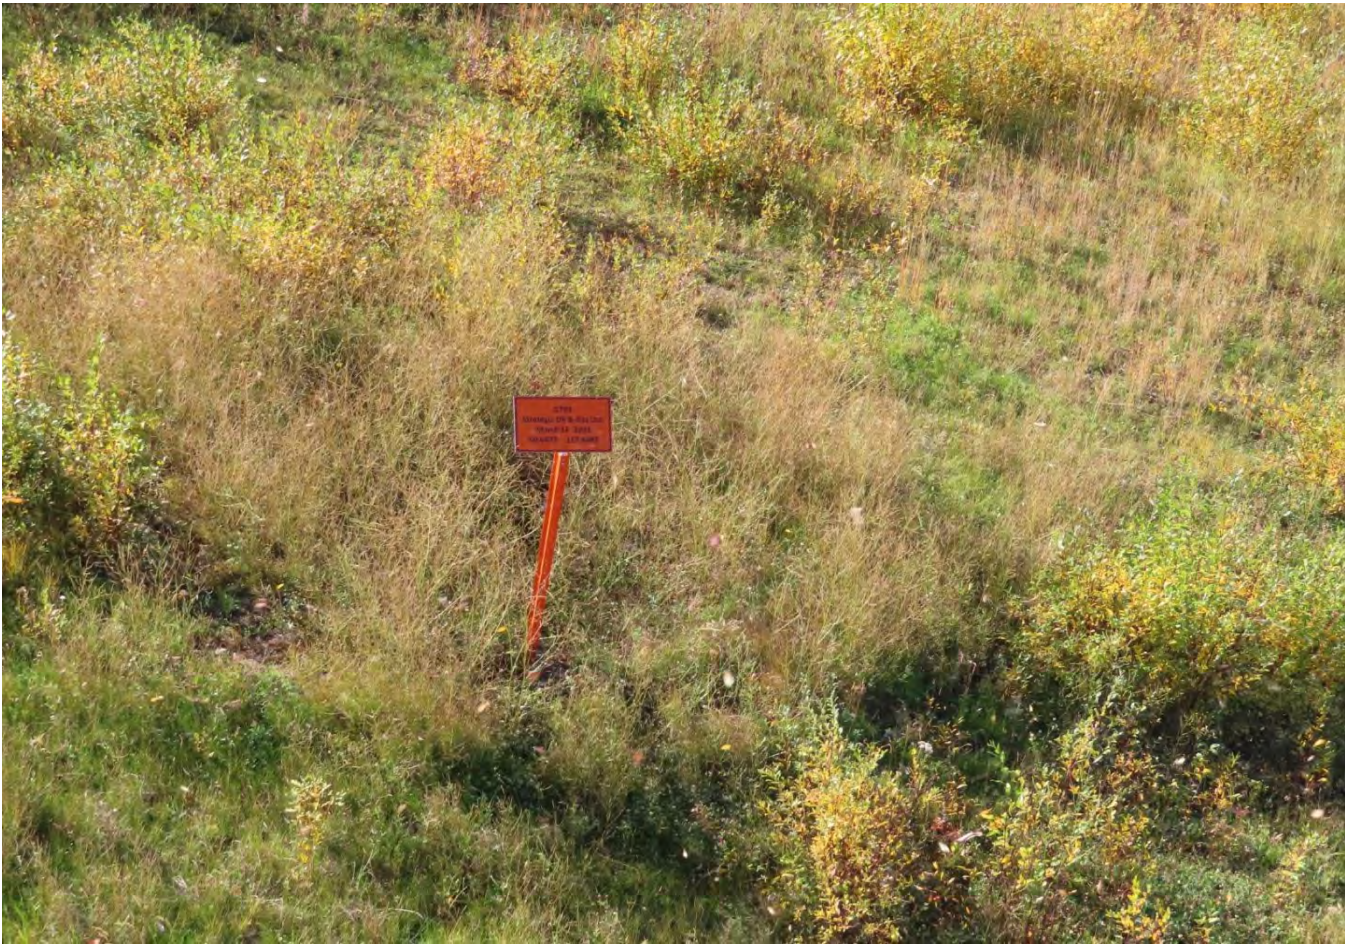
Figure 32

C-75: Backfill of well center appears satisfactory.

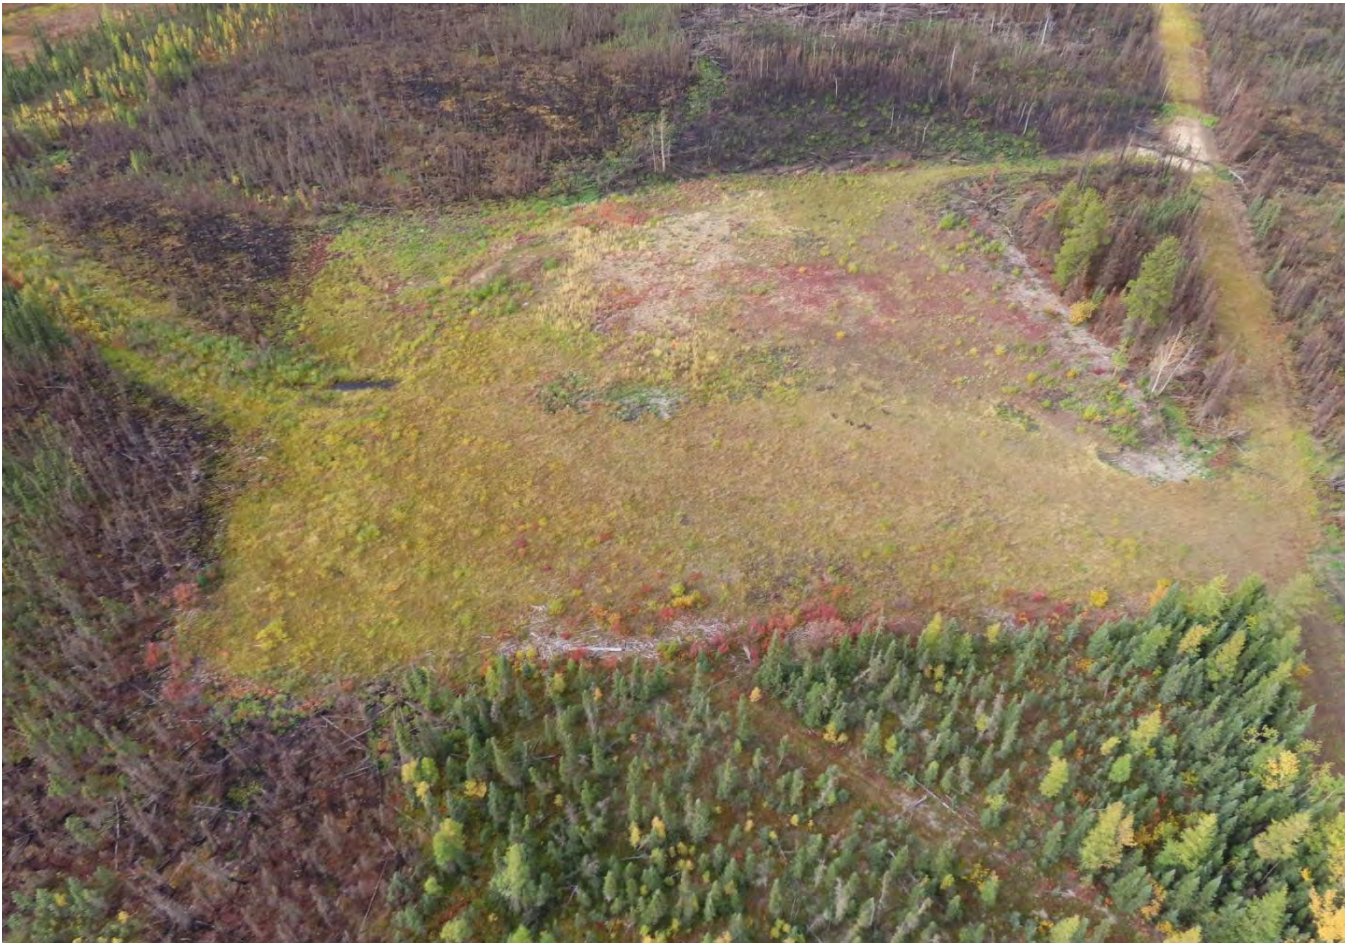
Figure 33

D-49: Aerial view of the wellsite. Well abandoned on February 21, 2023.

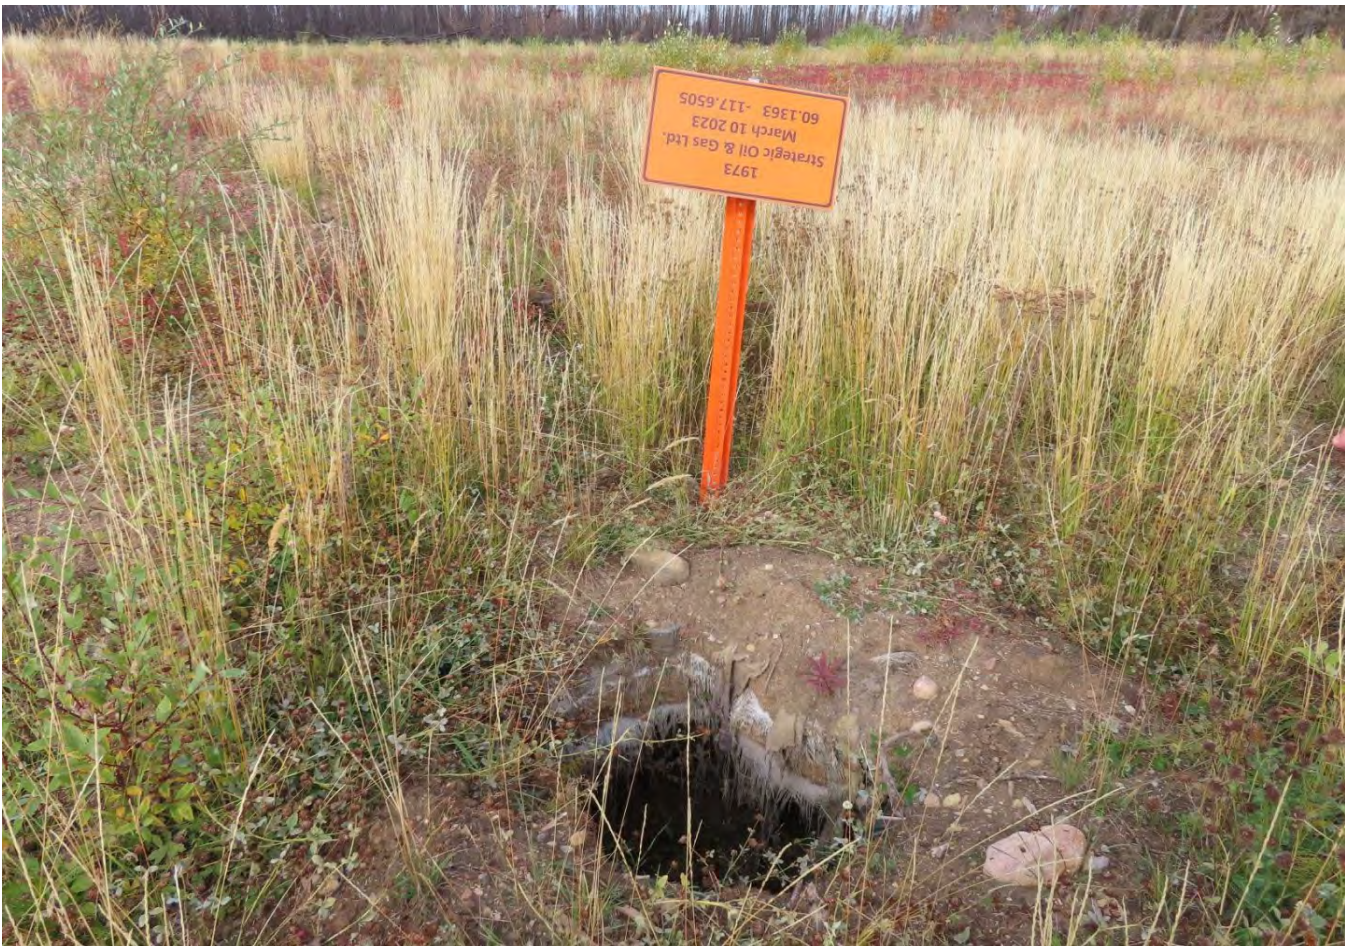
Figure 34

D-49: Well center not backfilled following abandonment operations.

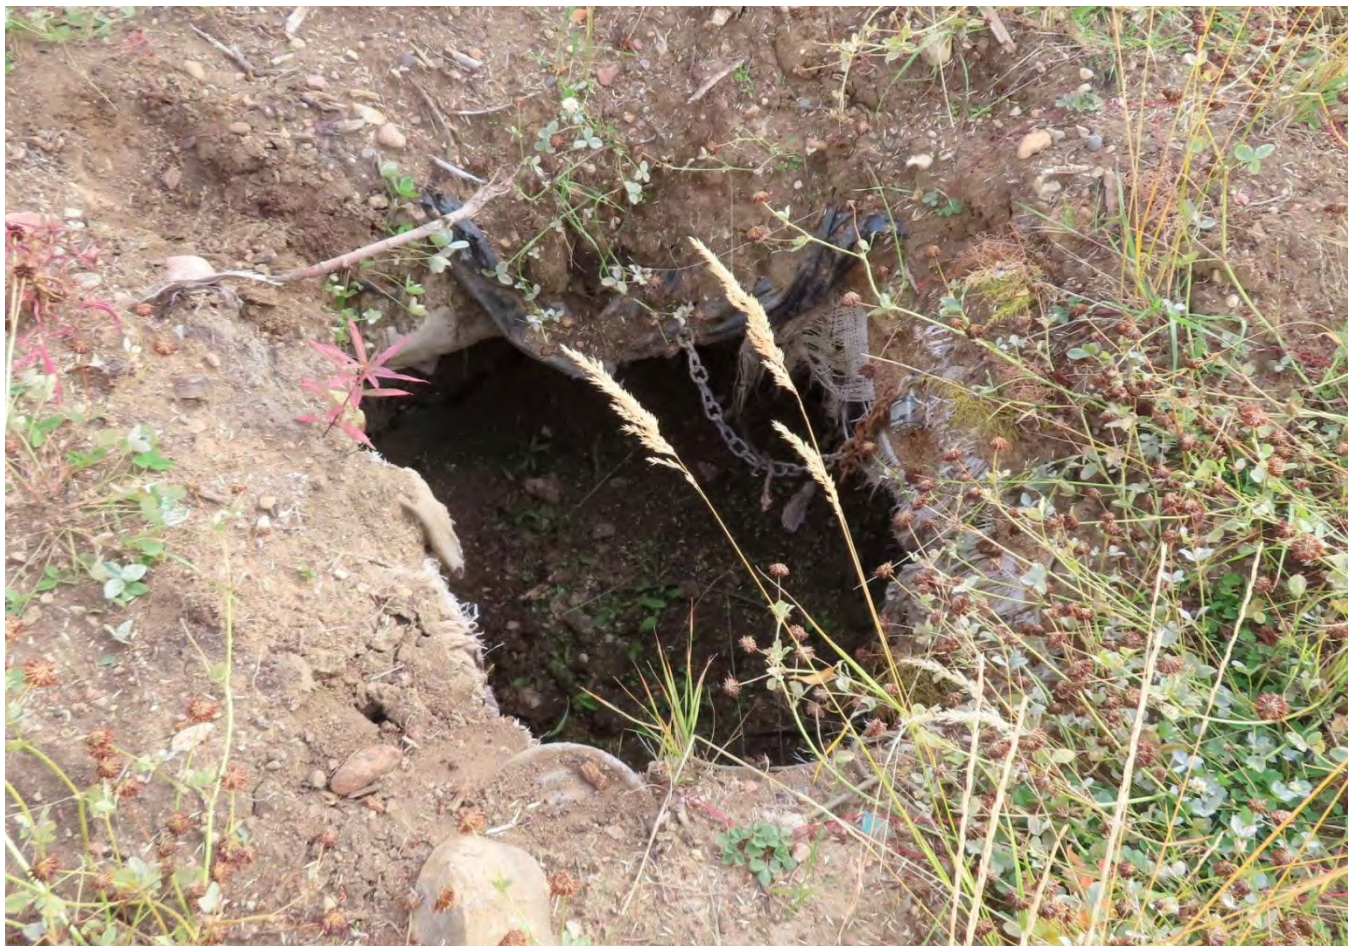
Figure 35

D-49: Length of chain and plastic to be removed from the excavation prior to backfill.

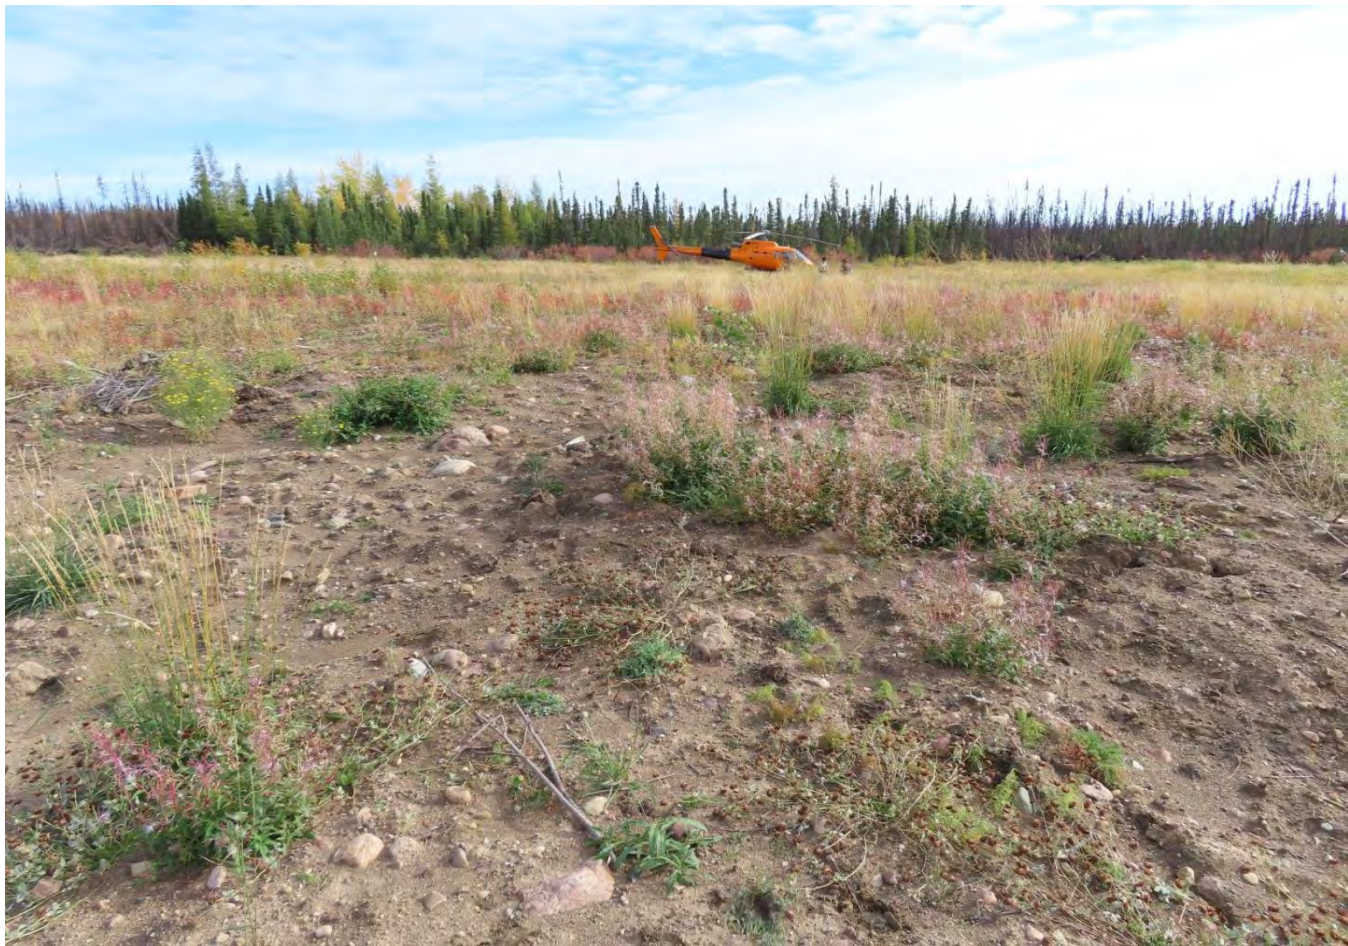
Figure 36

D-49: All production infrastructure was removed from the wellsite in the winter of 2023.

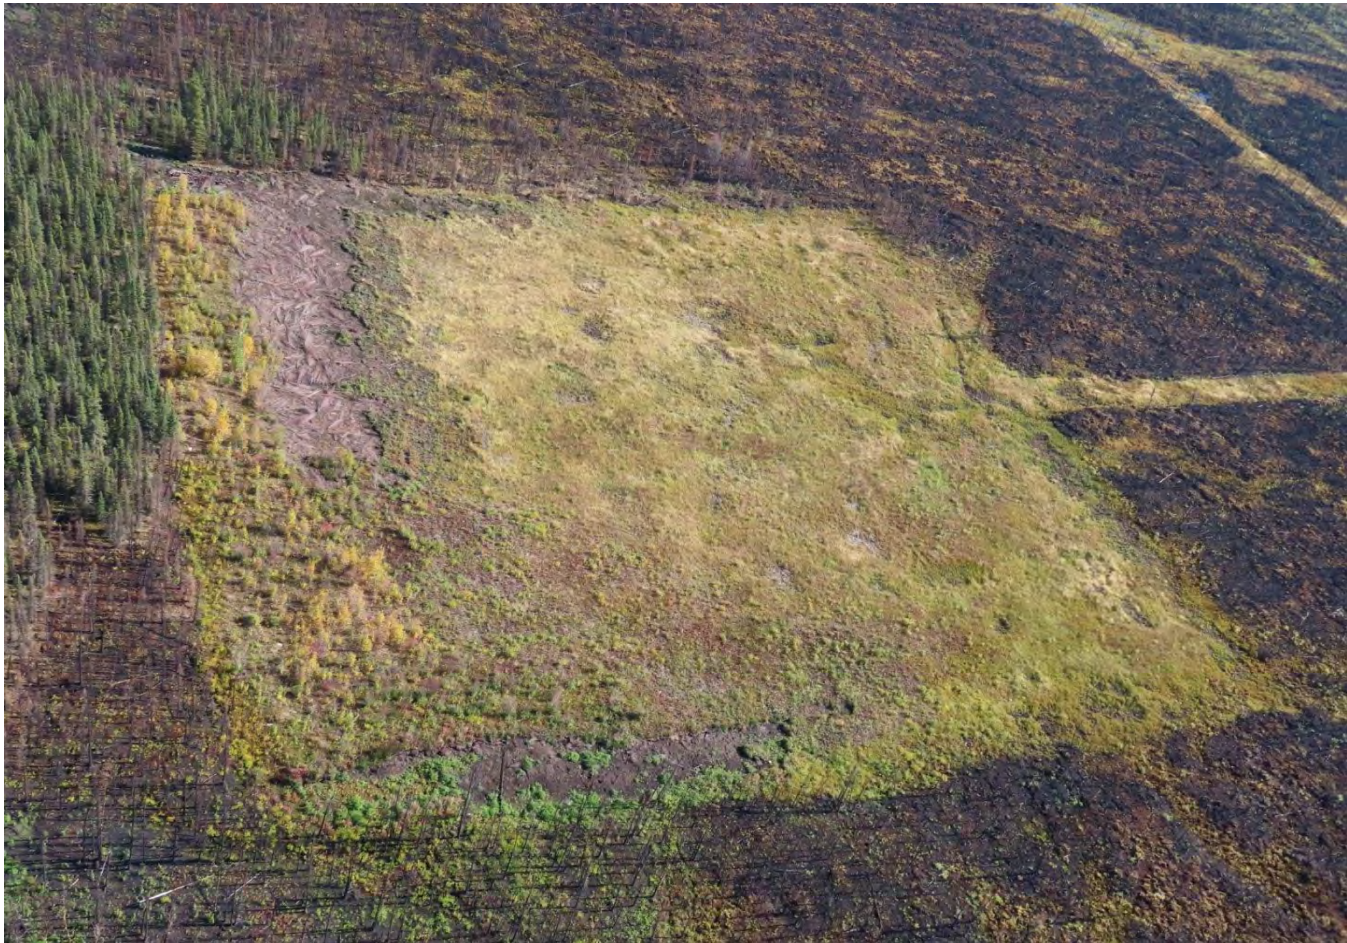
Figure 37

E-07: Aerial view of the wellsite. Well abandoned on February 20, 2023. No further remediation work required at E-07.
