File Number	MV2022X0018
Type of Operation	Cameron Hills Oil and Gas Field Abandonment
Location	Cameron Hills, NT

ENVIRONMENTAL INSPECTION REPORT

Permittee:	Strategic Oil and Gas Ltd. c/o Alvarez & Marsal Canada Inc.	Permit Expiry Date:	January 02, 2028
Land Use Permit No.	MV2022X0018	Previous Inspection:	February 21, 2024
Quarrying Permit No.		Inspection Date:	September 17, 2024
Contractor:	ELM Inc.	Subcontractor:	
Location(s) Inspected:	Cameron Hills Oil and Gas Field		
Current Stage of Operation:	The abandonment of the H-03 Battery, forty-four (44) oil and gas wells was completed in the winter of 2023 and 2024.		
Program Modifications Approved:

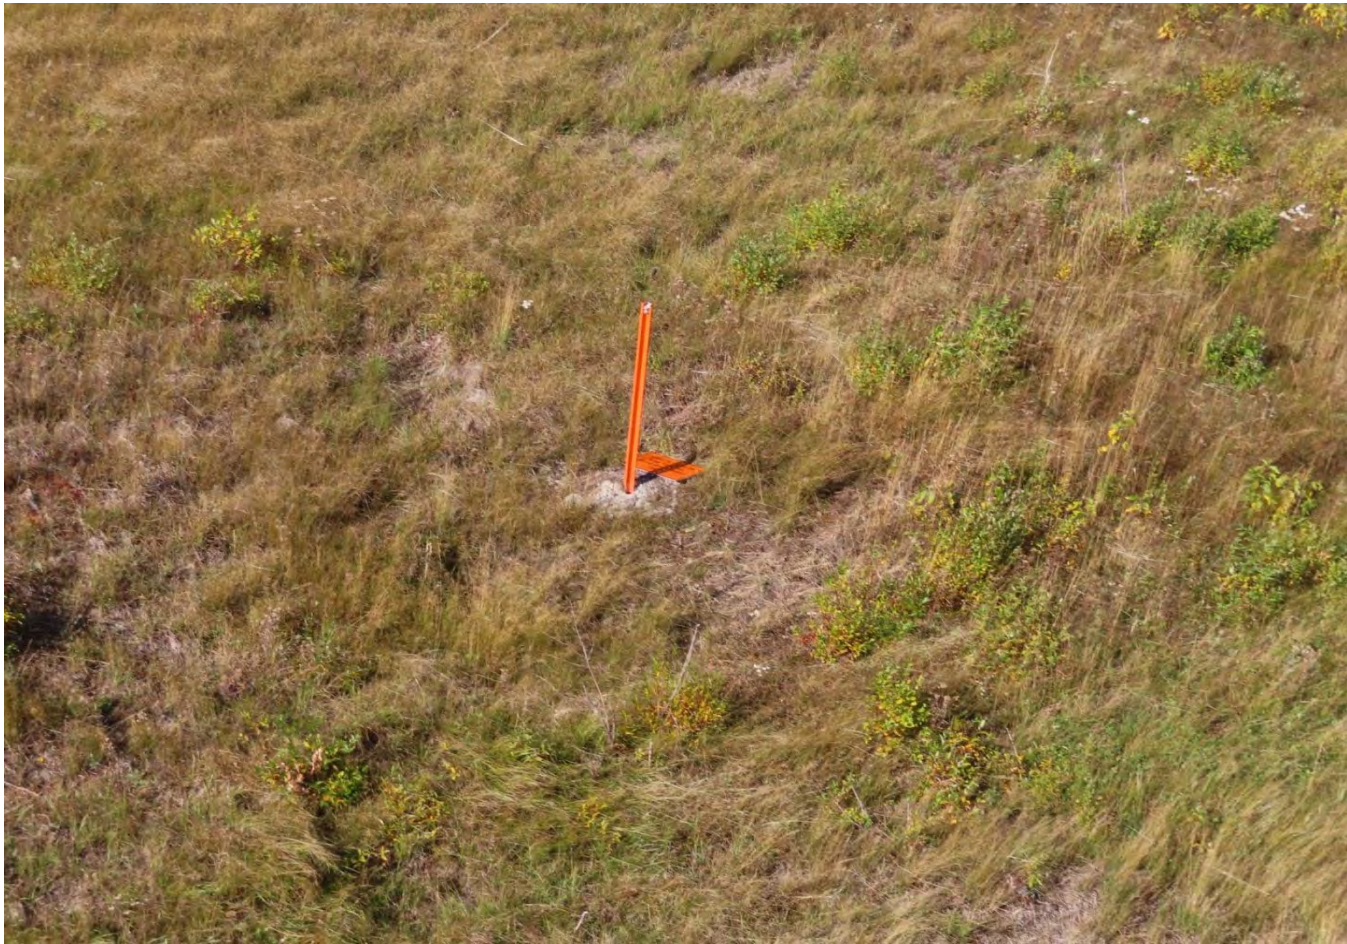
Figure 38

E-07: Backfill of well center appears satisfactory. Well abandonment sign detached from post.

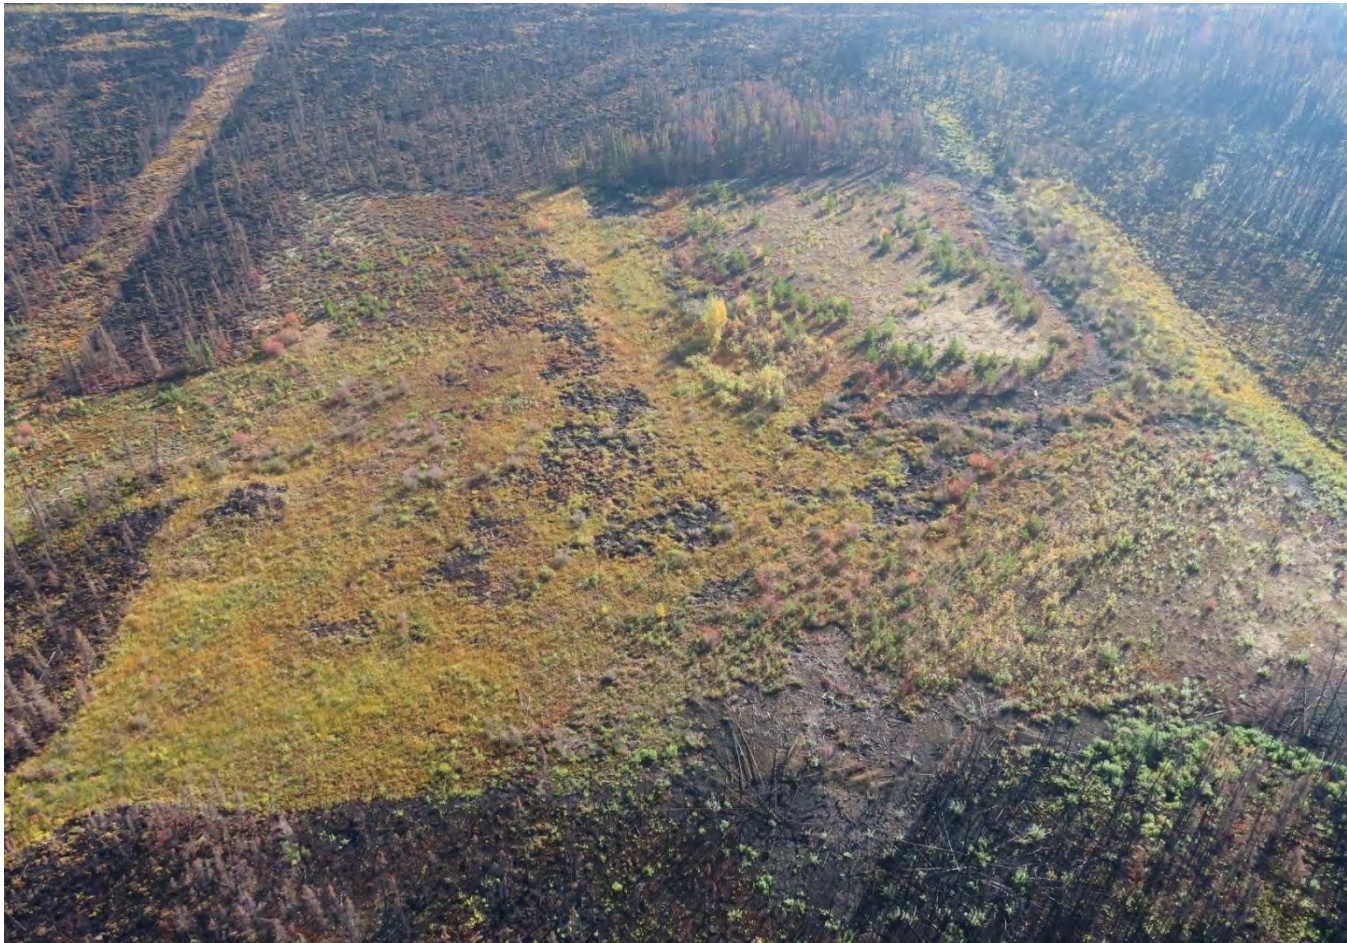
Figure 39

E-52: Aerial view of the wellsite. Well abandoned in 2012.

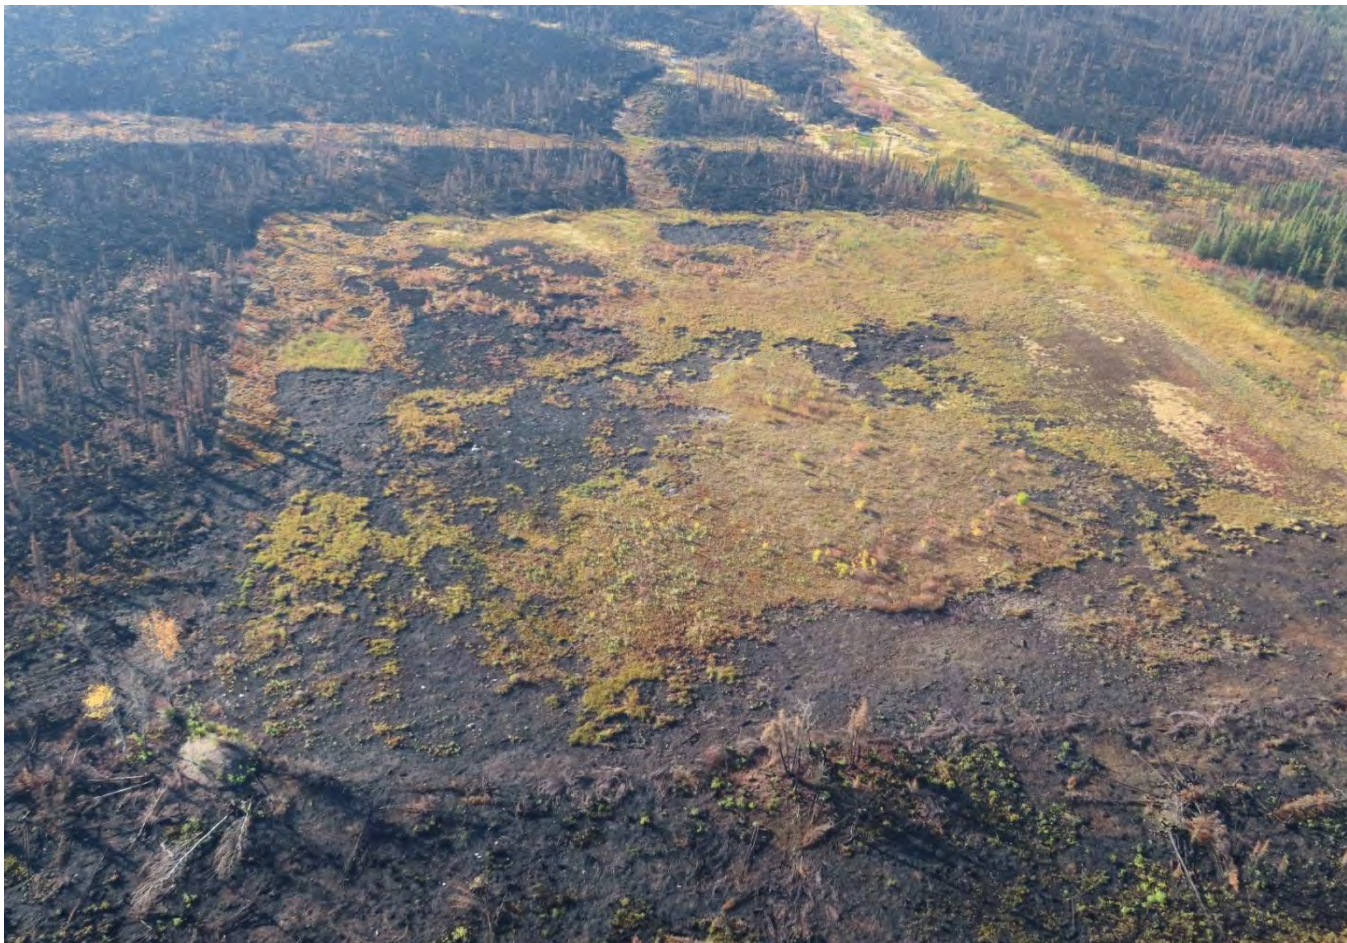
Figure 40

E-72: Aerial view of the wellsite. Well abandoned in 2019.

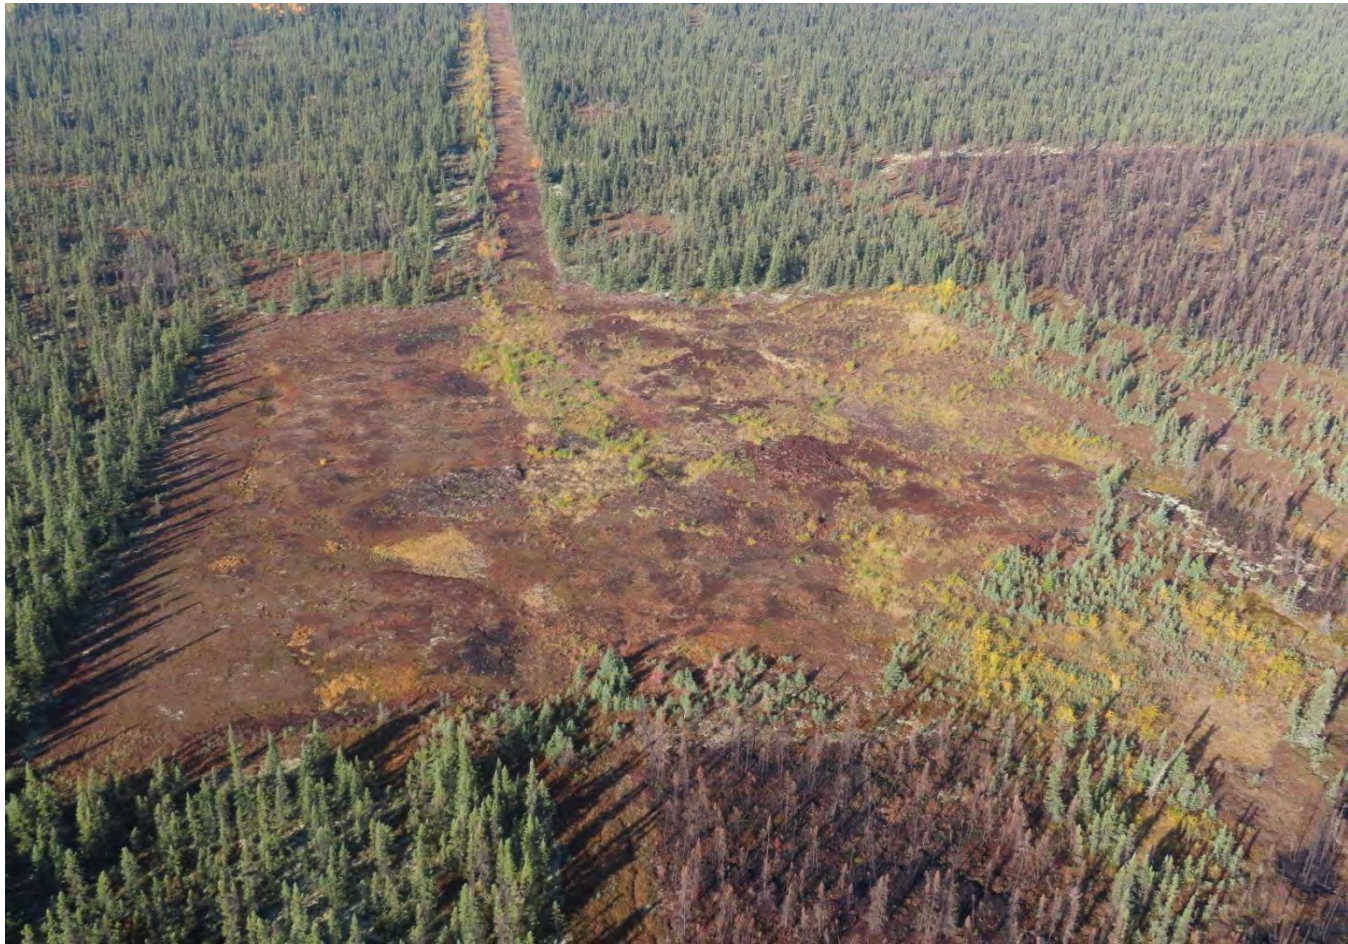
Figure 42

F-73/2F-73: Aerial view of the wellsite. Wells abandoned on February 20, 2023. No further remediation work required F-73/2F-73.

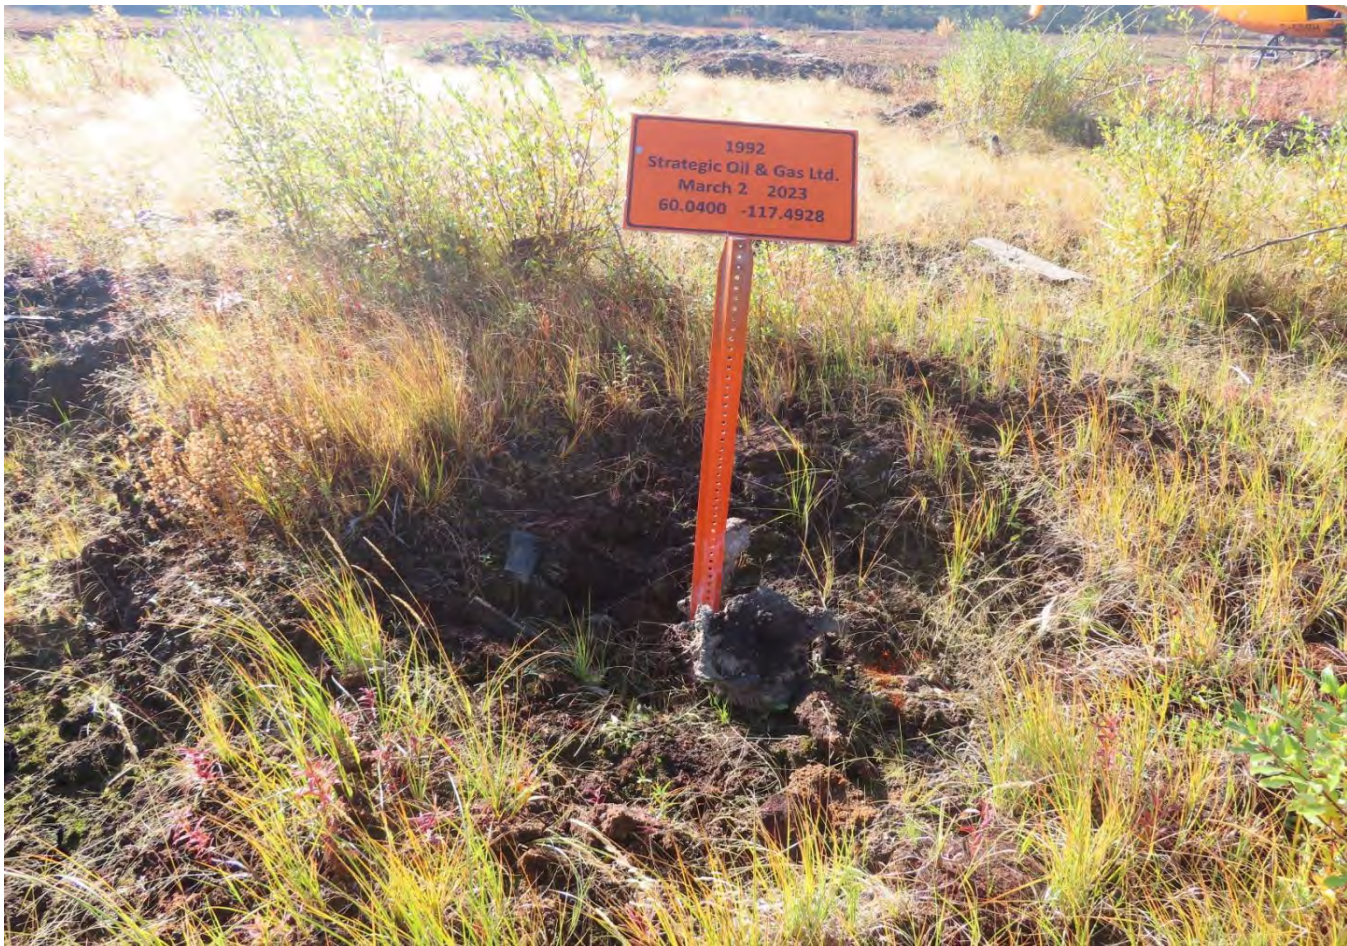
Figure 44
F-73: Backfill of F-73 well center appears satisfactory.

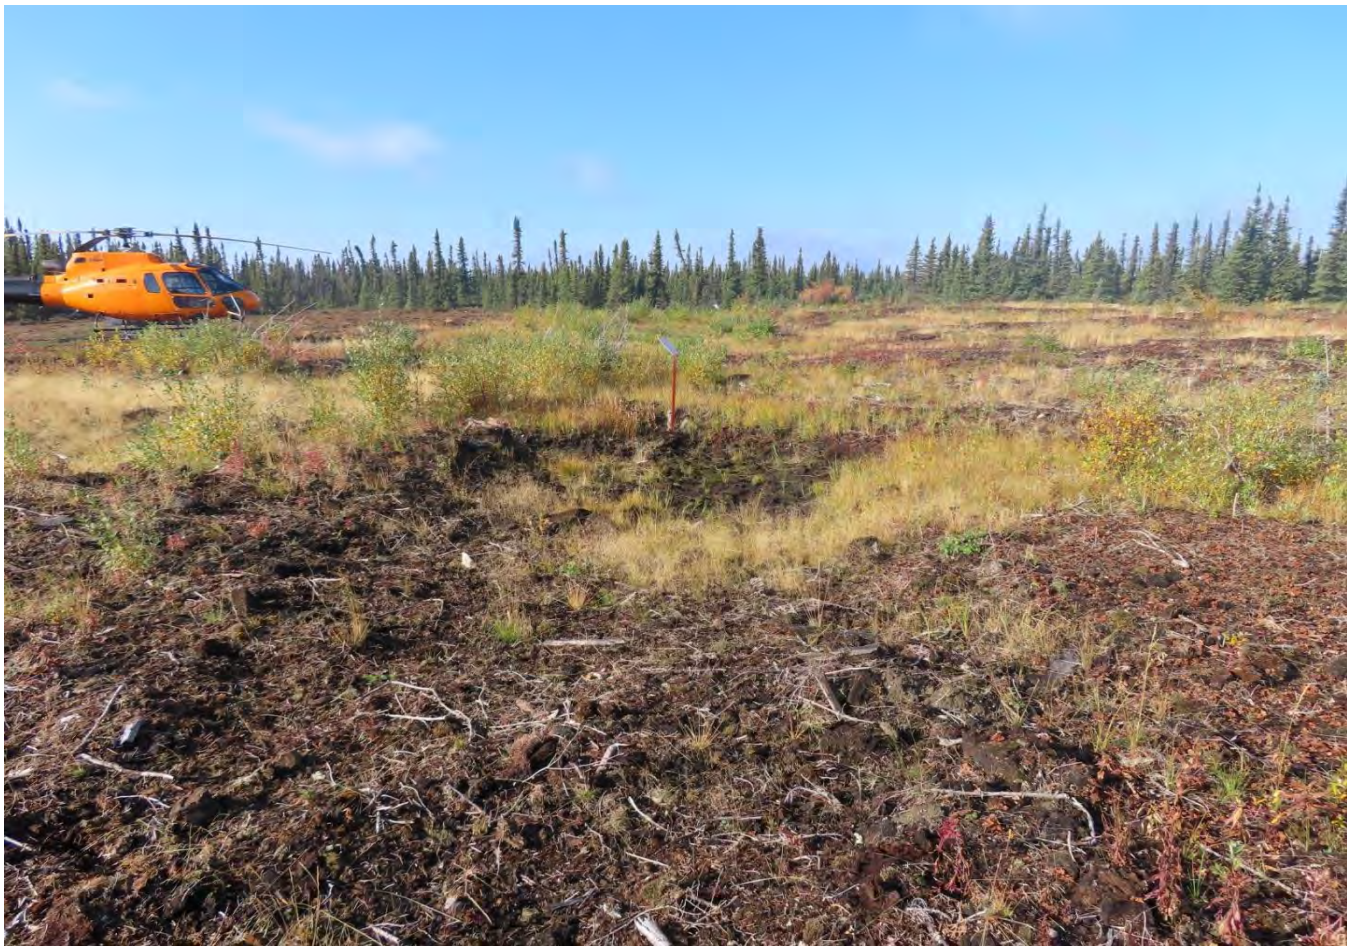
Figure 46

F-73/2F-73: All production infrastructure was removed from the wellsite in the winter of 2023.

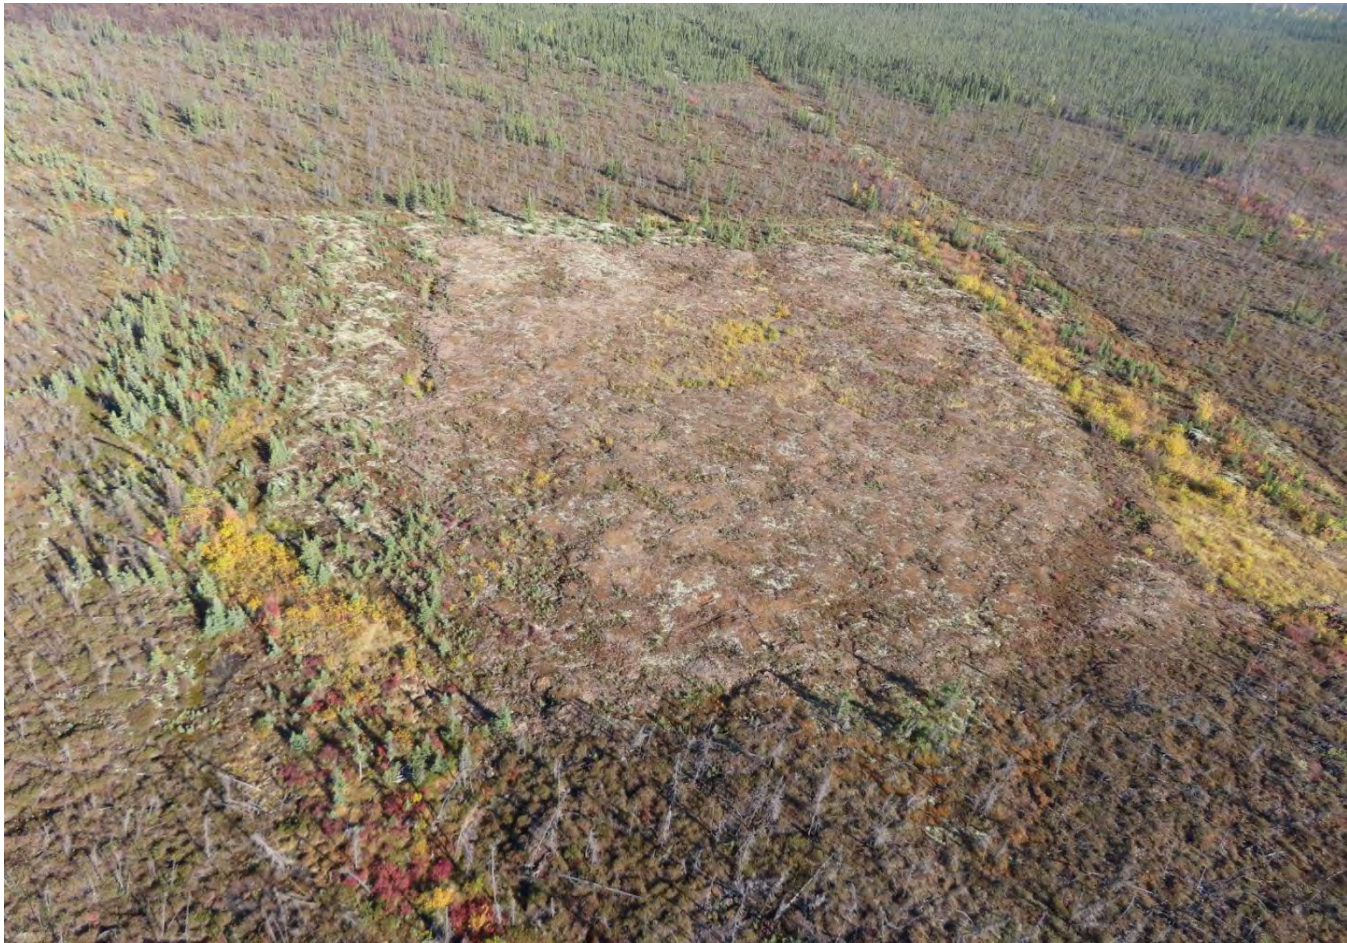
Figure 47

F-75: Aerial view of the wellsite. Well abandoned on February 09, 2023. The backfill of the rathole and mousehole not confirmed on the inspection.

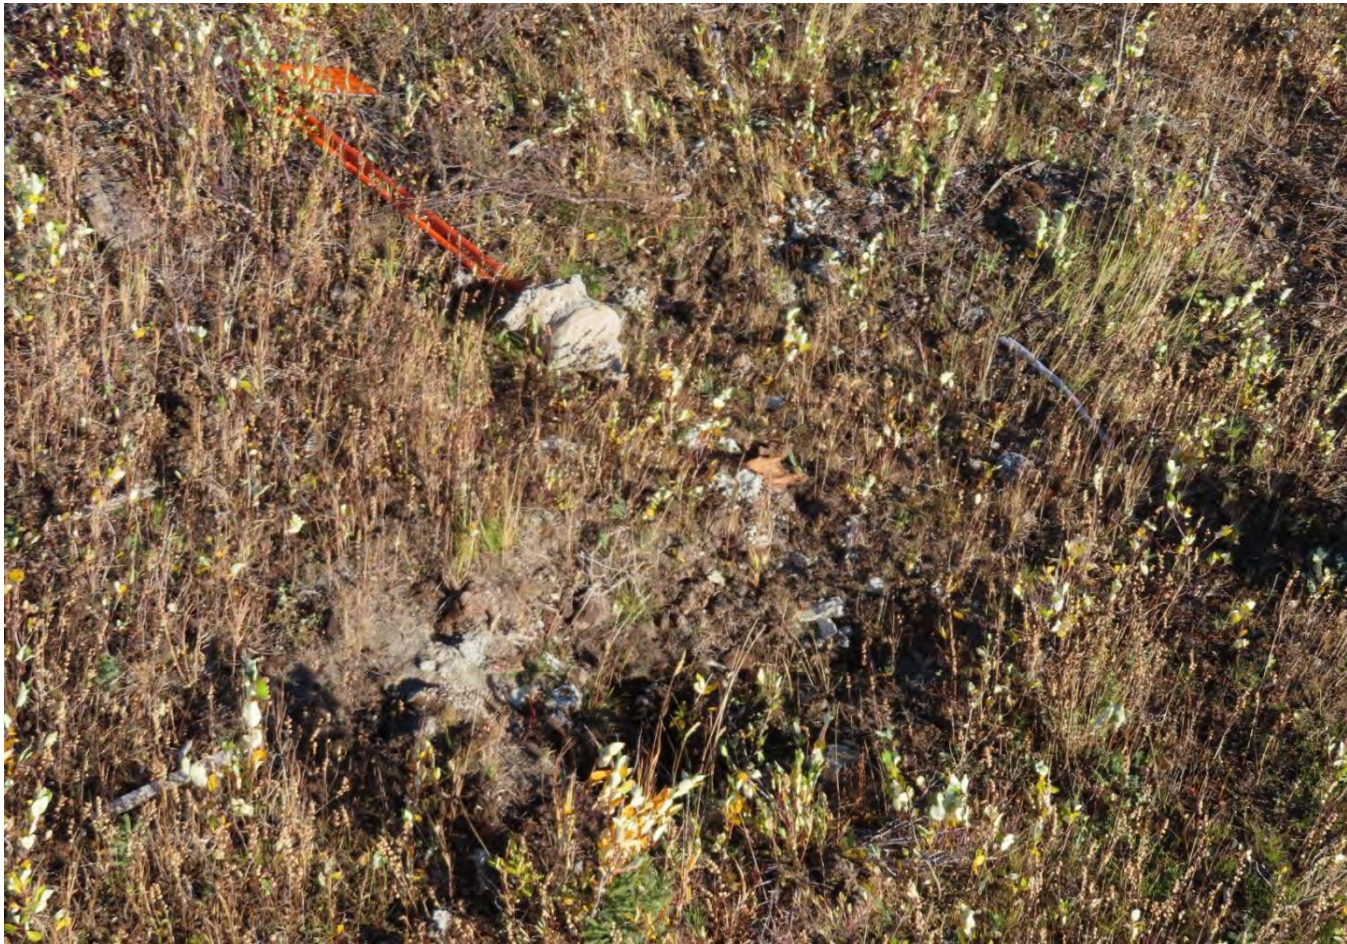
Figure 48

F-75: Backfill of well center appears satisfactory. Well abandonment sign on the ground.

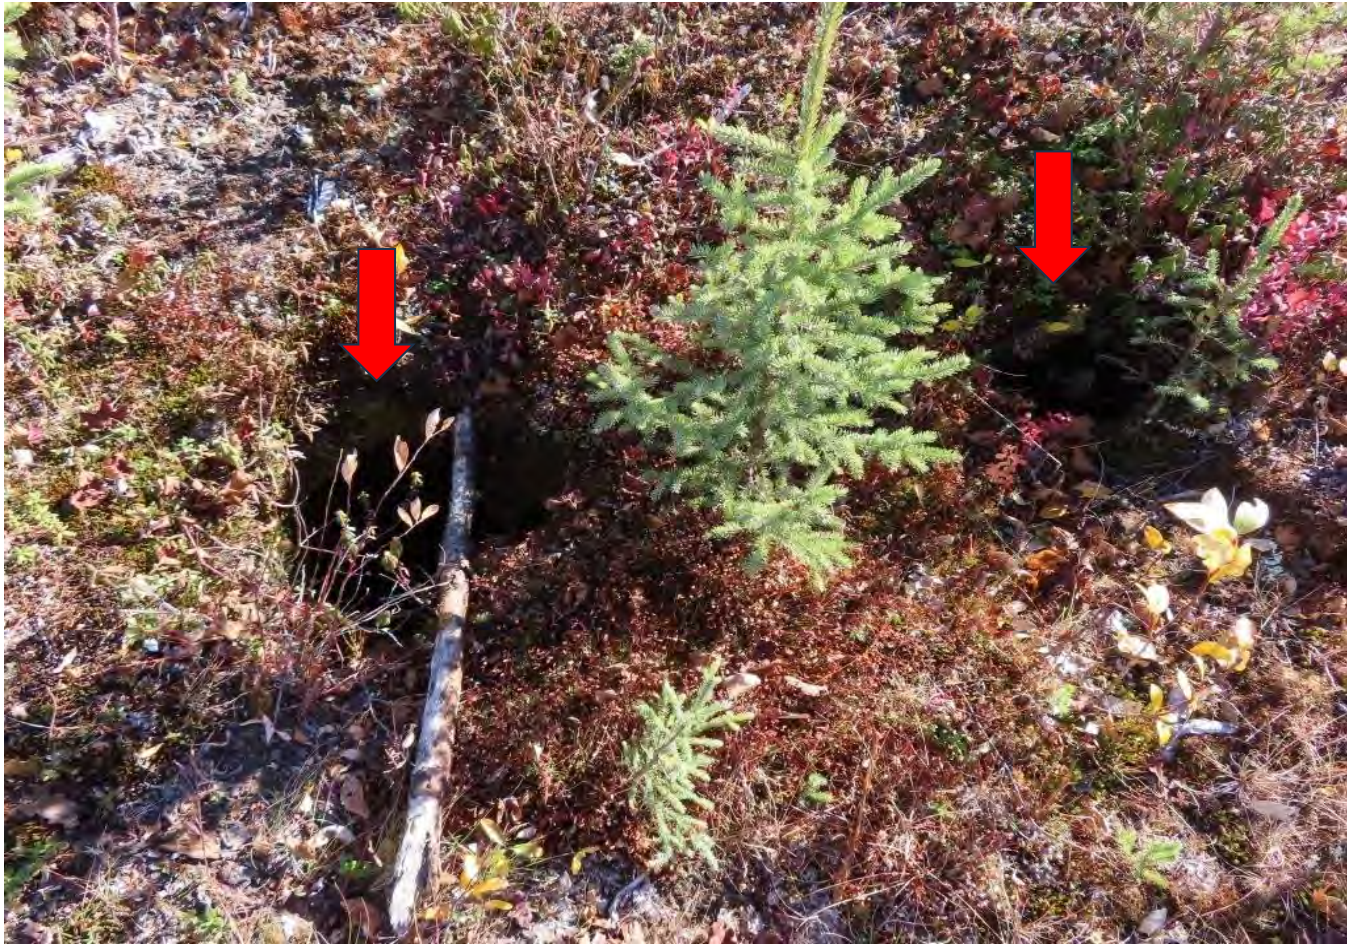
Figure 50

F-75: Photo taken September 23, 2022 showing the rathole and mousehole. Inspectors did not land at F-75 to confirm the holes were backfilled.

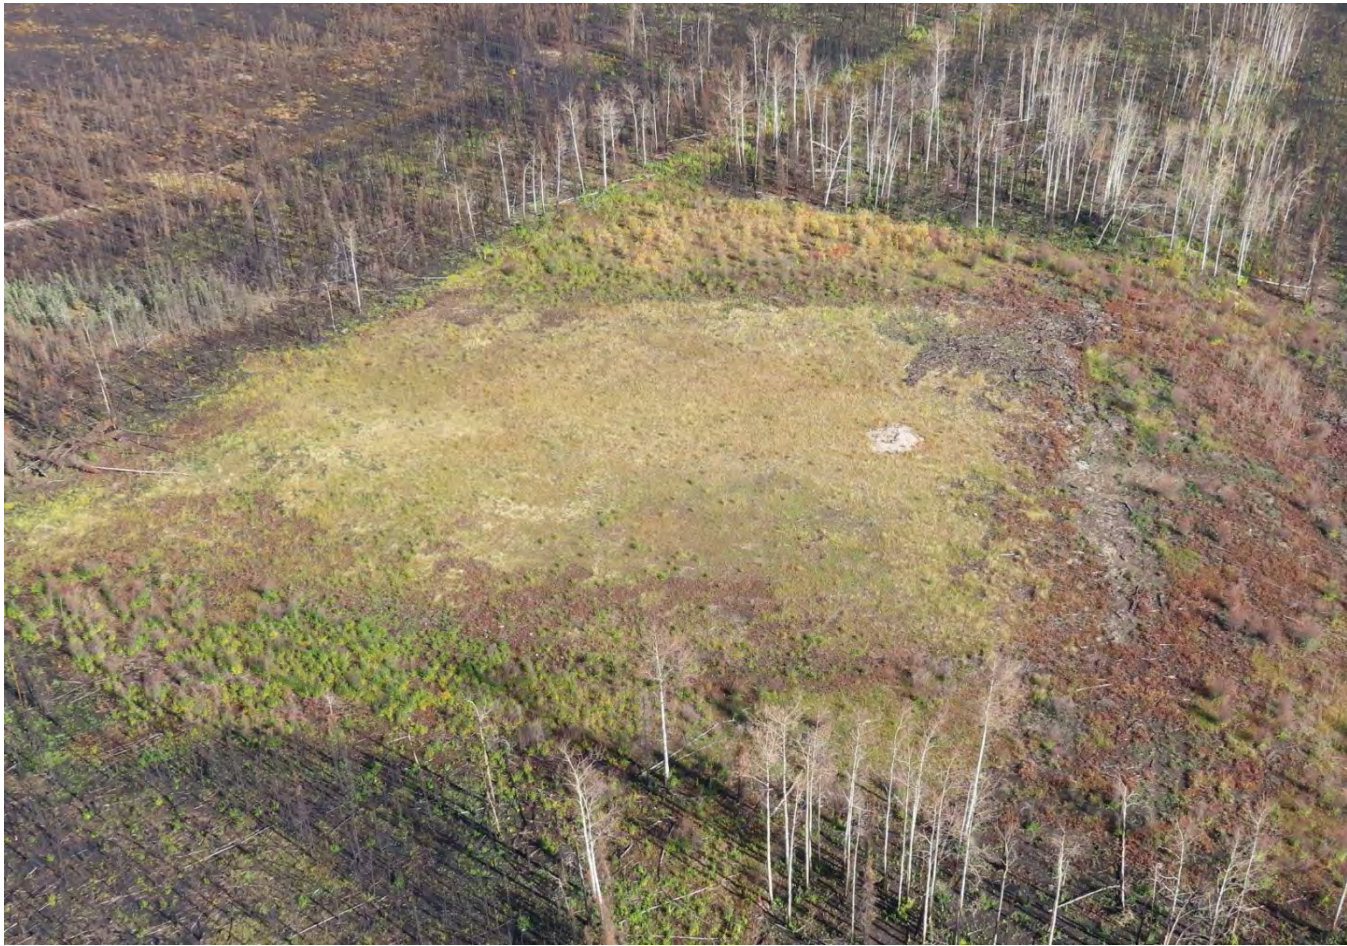
Figure 51

F-77: Aerial view of the wellsite. Well abandoned on February 20, 2023. No further remediation work required at F-77.

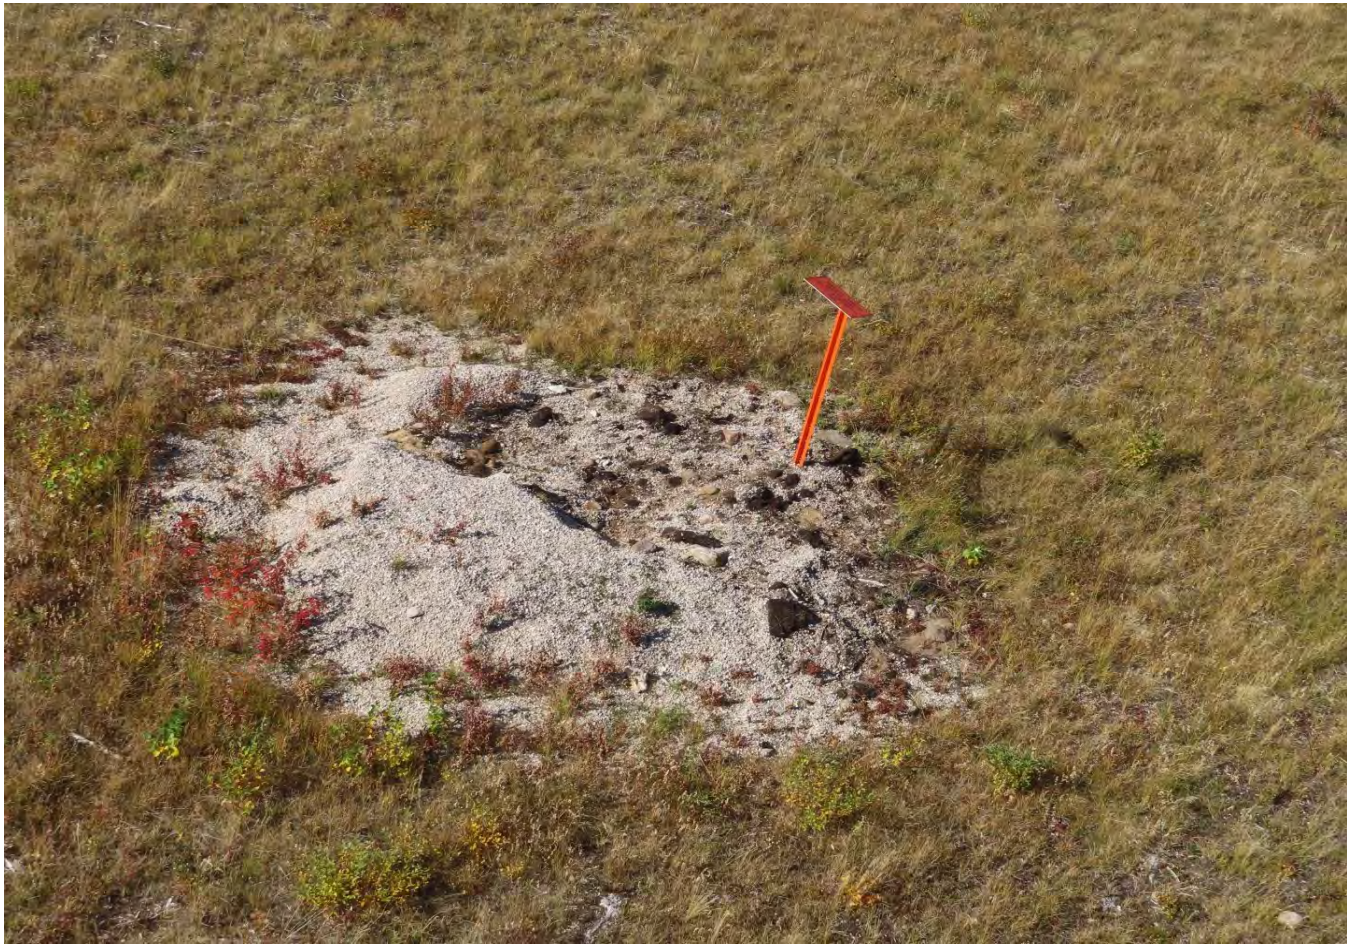
Figure 52

F-77: Backfill of well center appears satisfactory.

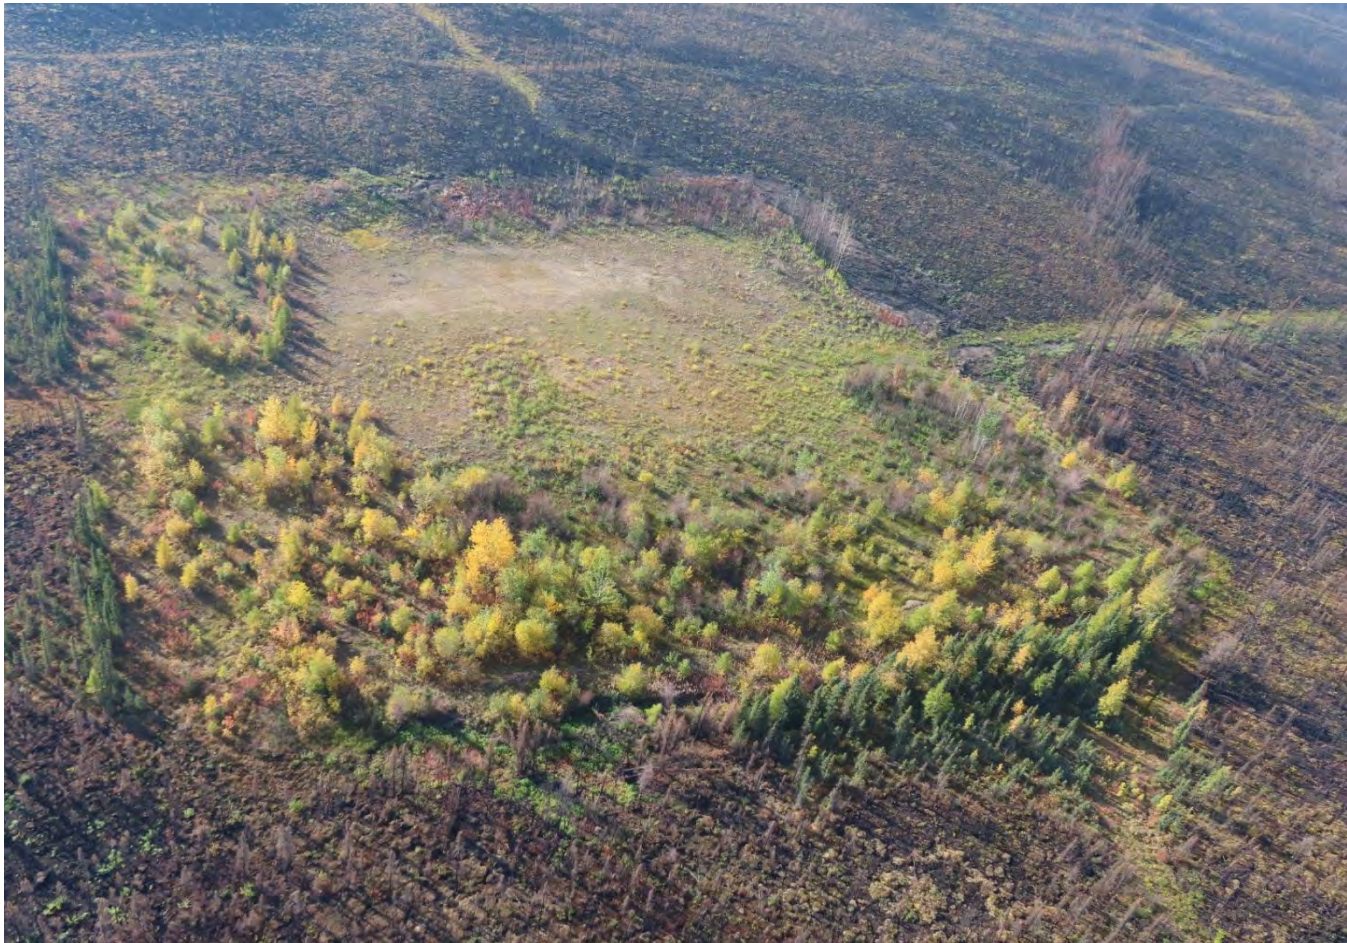
Figure 53

G-21: Aerial view of the wellsite. Well abandoned on February 15, 2023. No further remediation work required at G-21.

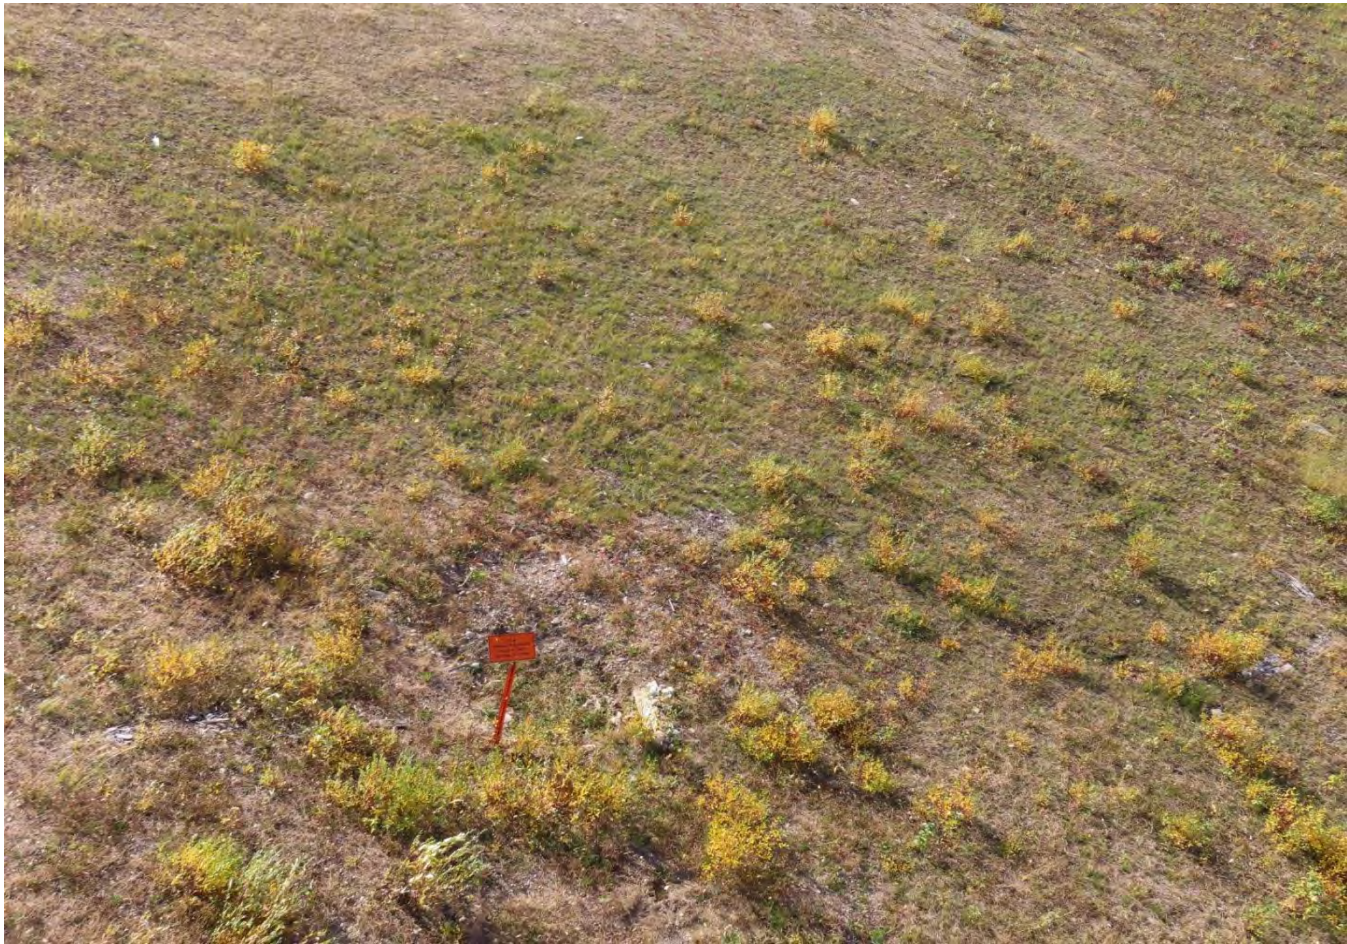
Figure 54

G-21: Backfill of well center appears satisfactory.

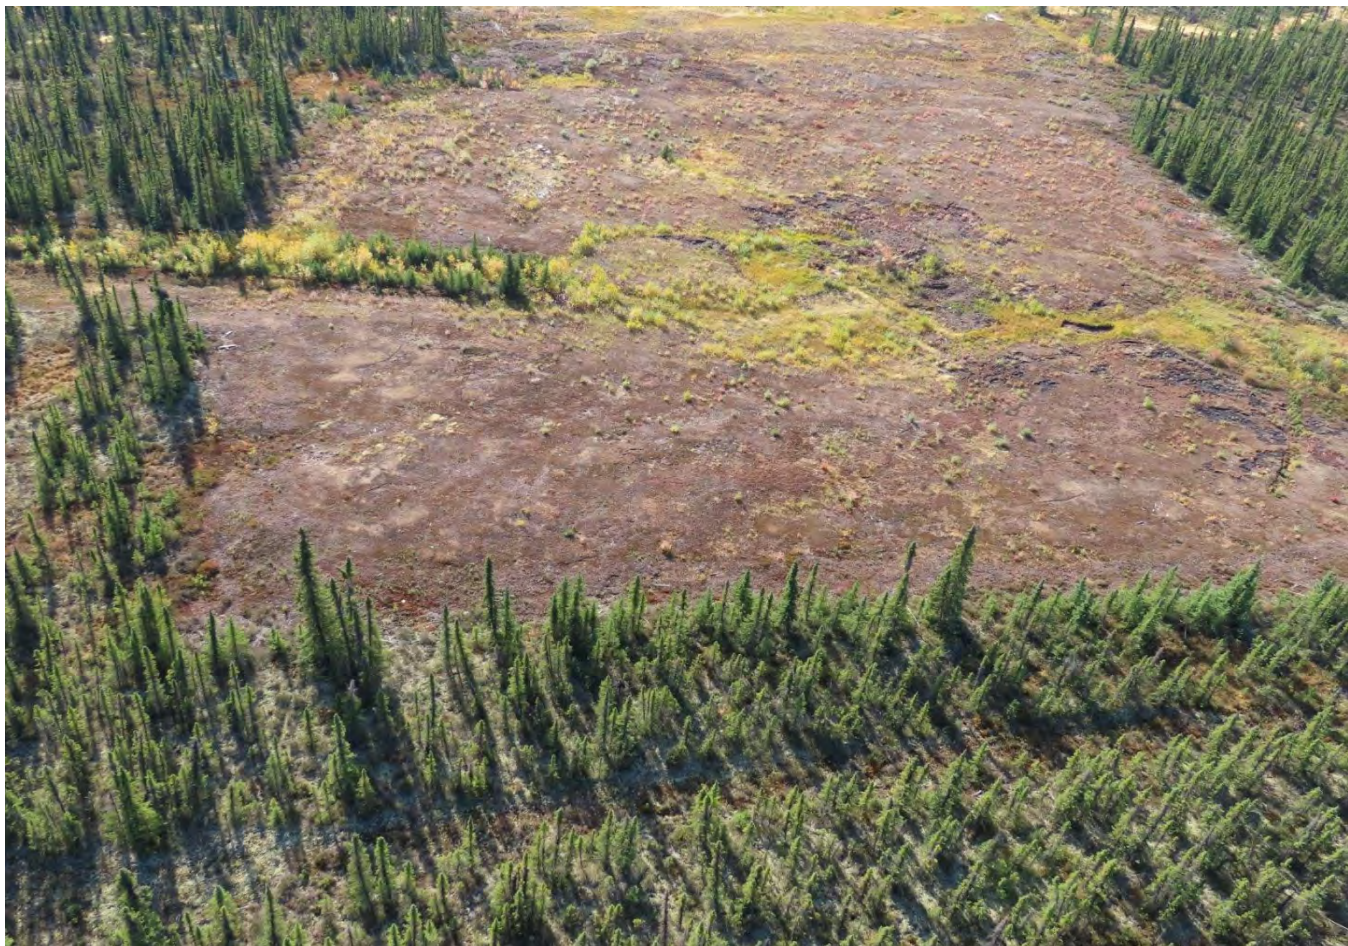
Figure 55

H-03: Aerial view of the wellsite. Well abandoned on February 26, 2023.

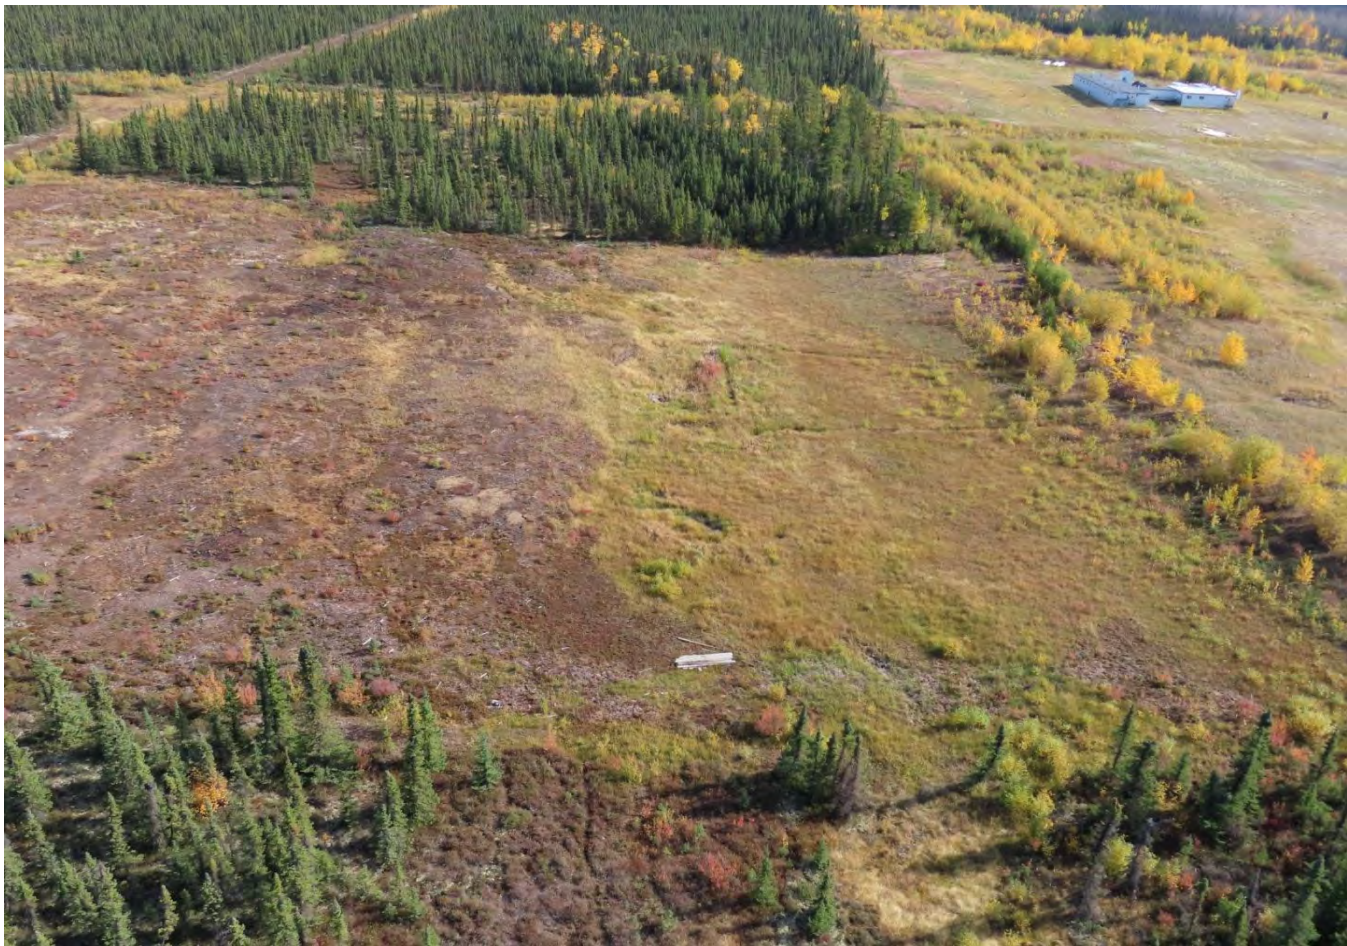
Figure 58

2H-03: Aerial view of the wellsite. Well abandoned on March 18, 2023.

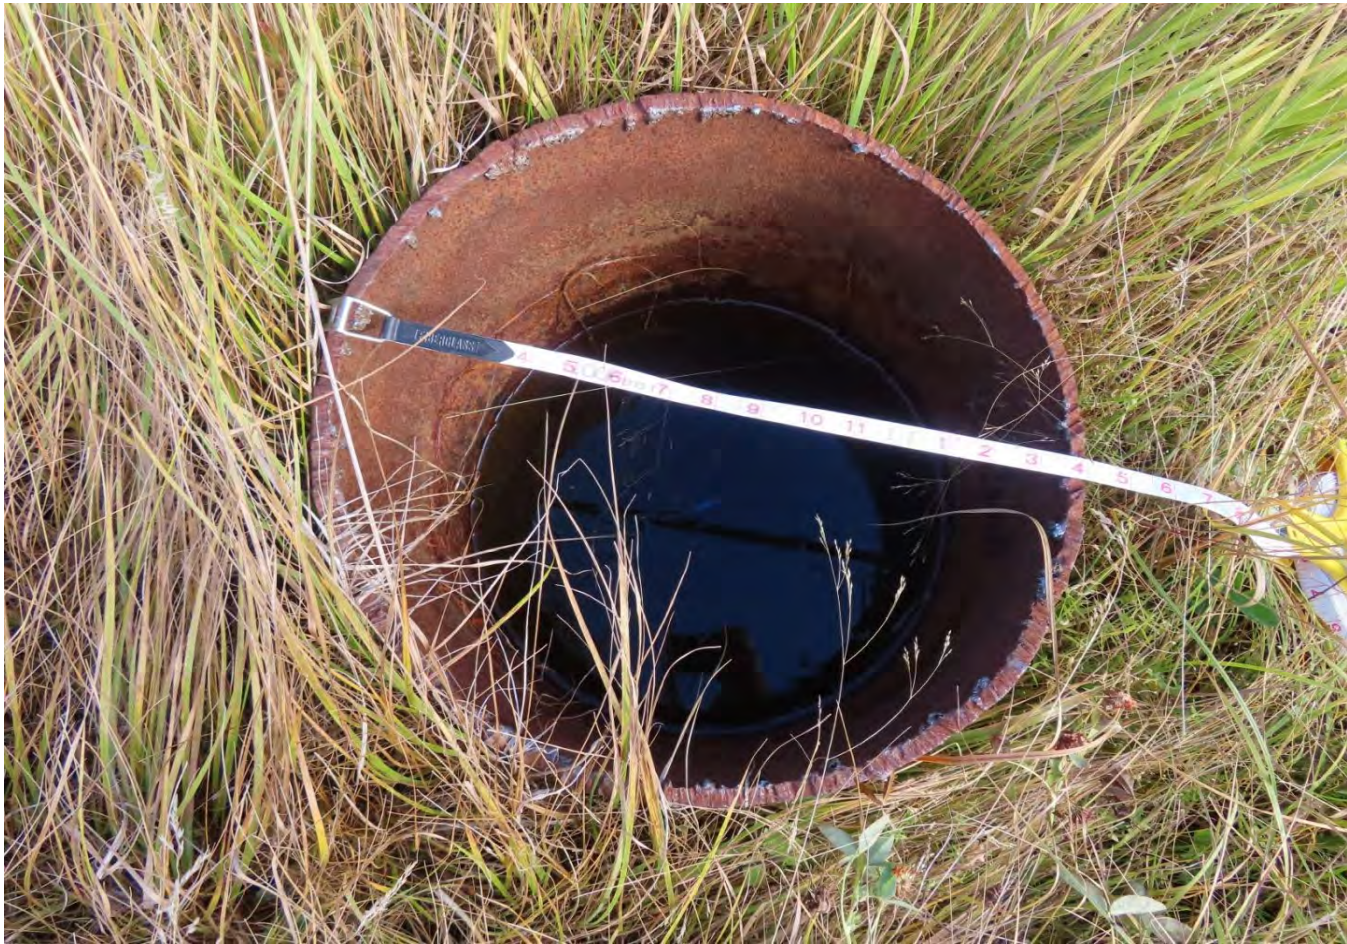
Figure 62

2H-03: Example of a 16” diameter piling left on the wellsite.

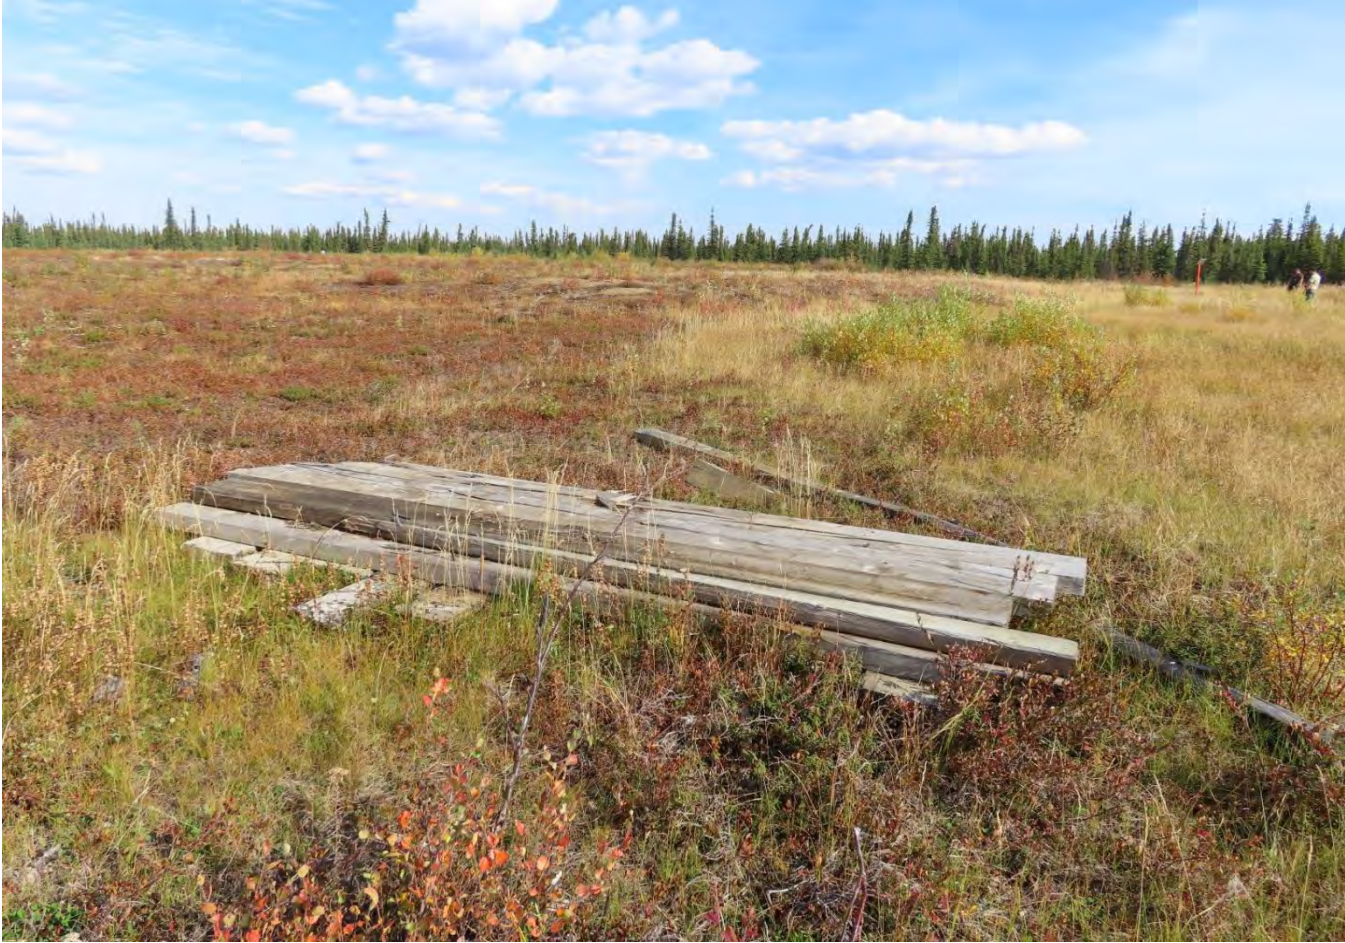
Figure 63

2H-03: Lumber left on the west side of the wellsite to be removed.
