File Number	MV2022X0018
Type of Operation	Cameron Hills Oil and Gas Field Abandonment
Location	Cameron Hills, NT

ENVIRONMENTAL INSPECTION REPORT

Permittee:	Strategic Oil and Gas Ltd. c/o Alvarez & Marsal Canada Inc.	Permit Expiry Date:	January 02, 2028
Land Use Permit No.	MV2022X0018	Previous Inspection:	February 21, 2024
Quarrying Permit No.		Inspection Date:	September 17, 2024
Contractor:	ELM Inc.	Subcontractor:	
Location(s) Inspected:	Cameron Hills Oil and Gas Field		
Current Stage of Operation:	The abandonment of the H-03 Battery, forty-four (44) oil and gas wells was completed in the winter of 2023 and 2024.		
Program Modifications Approved:

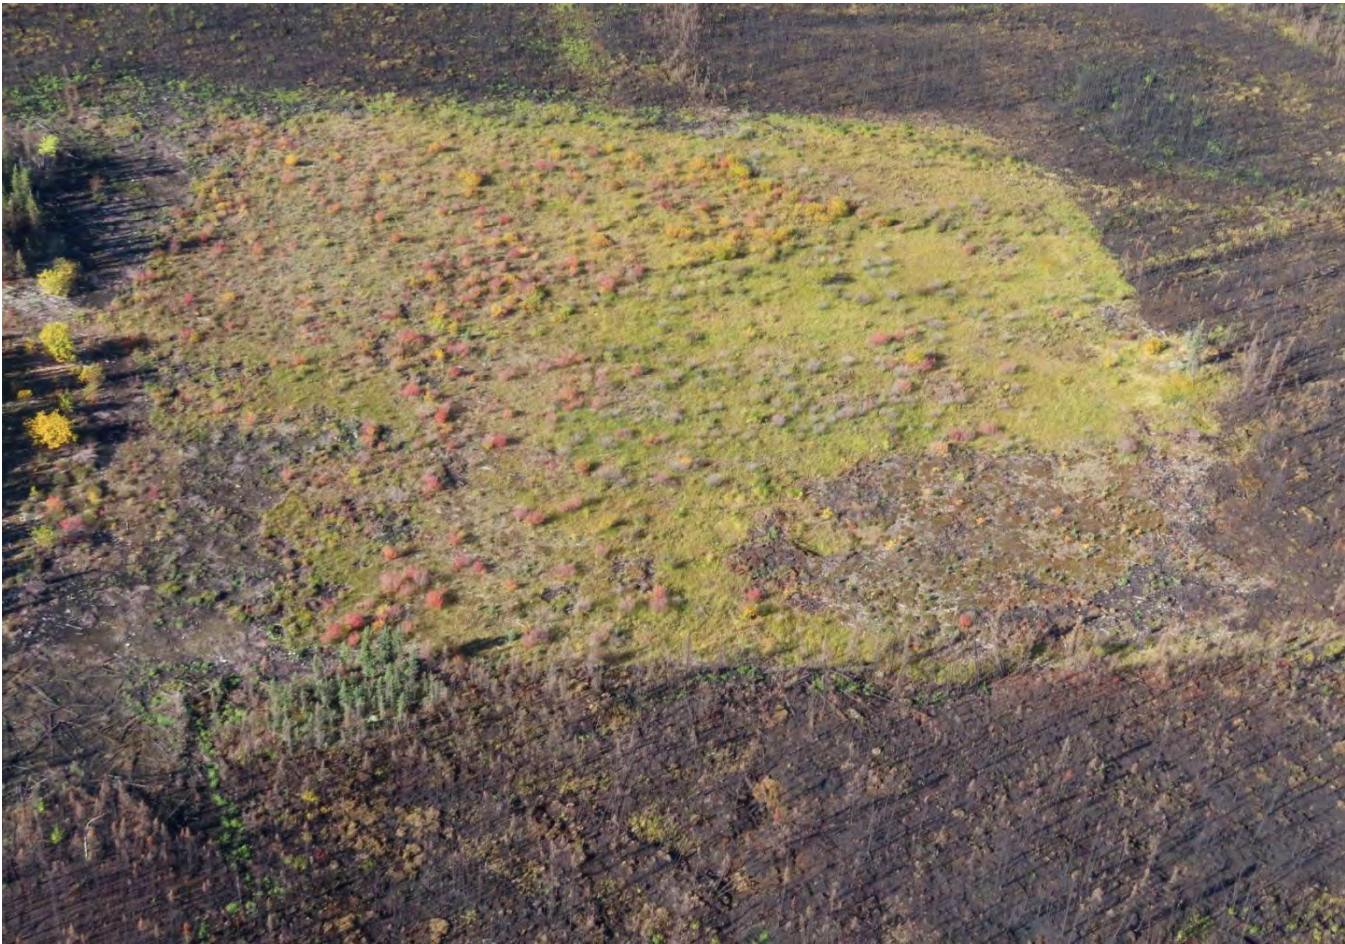
Wellsite: H-06 Figure 64
Year Drilled: 2010
Coordinates: 60° 05’ 18.78”N 117° 30’ 28.37”W
Production History: Well never produced, no production infrastructure.
Status: Well abandoned in 2016. No work done under this permit.
Date Inspected: September 19, 2024.
Comments:

H-06: Aerial view of the wellsite. Well abandoned in 2016. No further remediation work required at H-06.

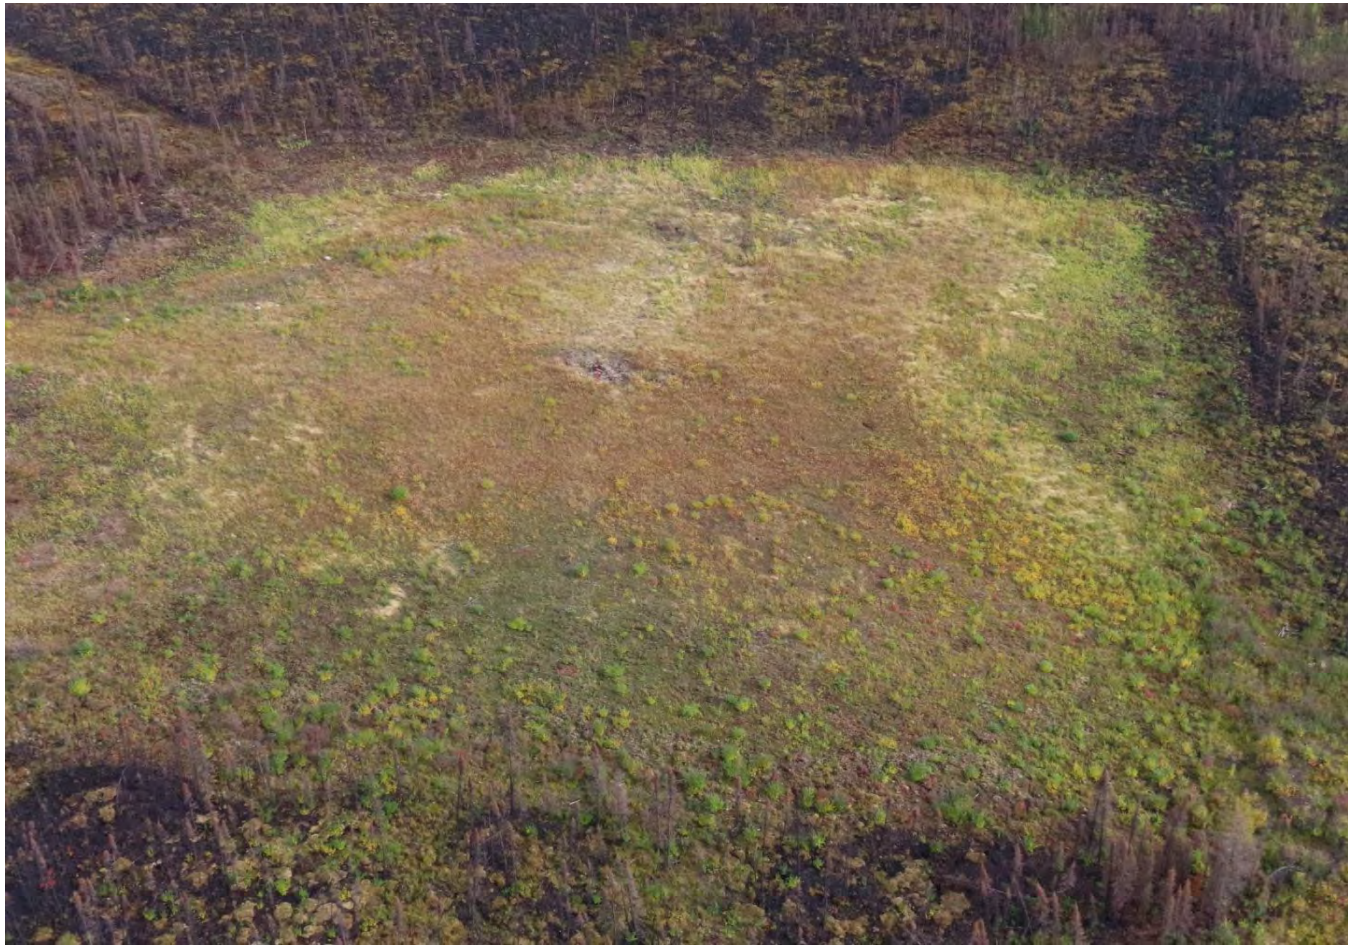
Figure 65

H-58: Aerial view of the wellsite. Well abandoned on March 02, 2023. No further remediation work required at H-58.

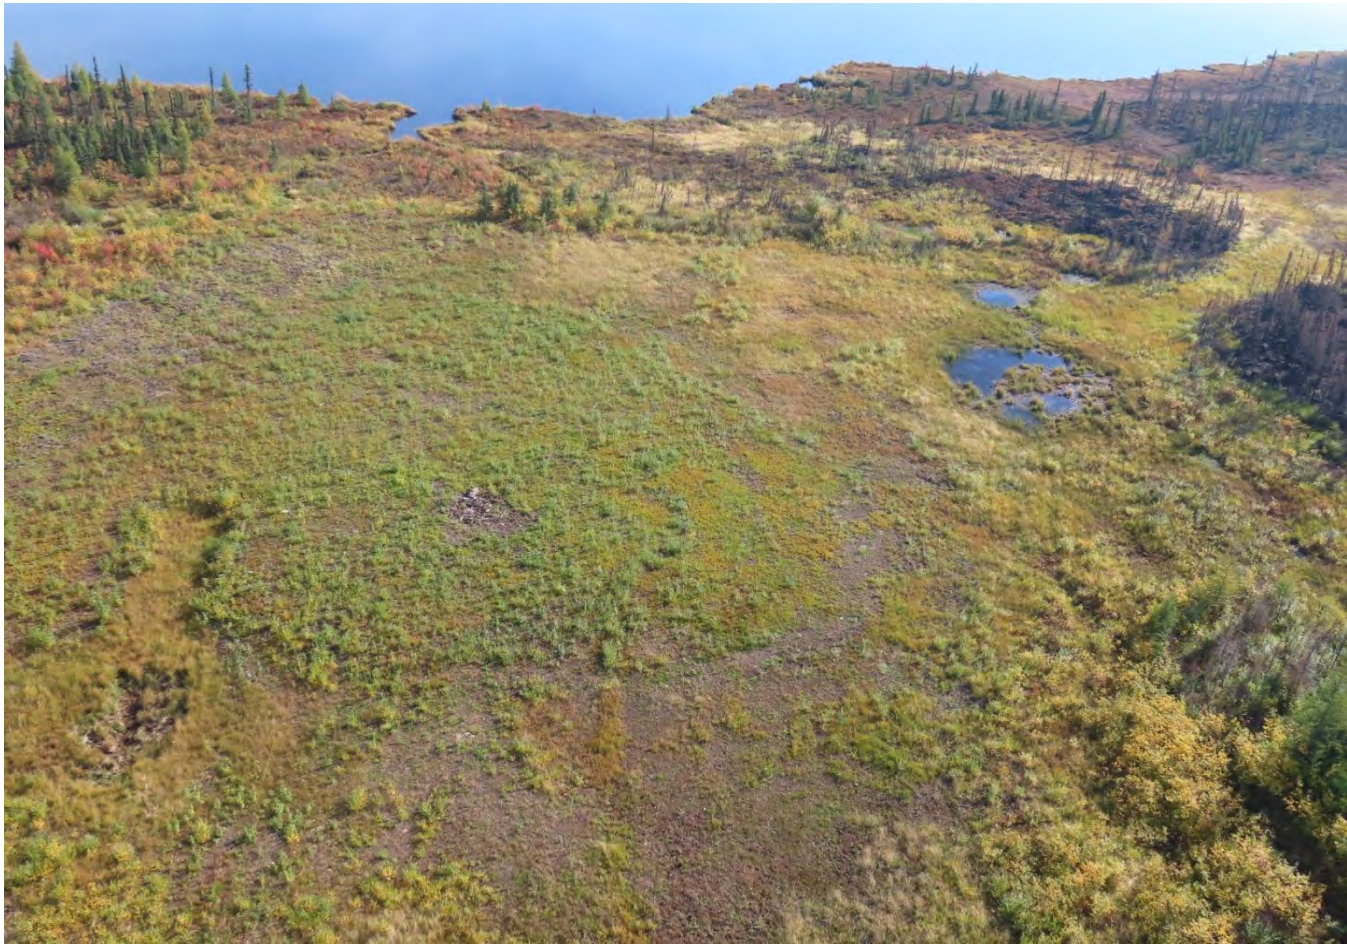
Figure 68

I-10: Aerial view of the wellsite. Well abandoned on March 20, 2023. No further remediation work required at I-10.

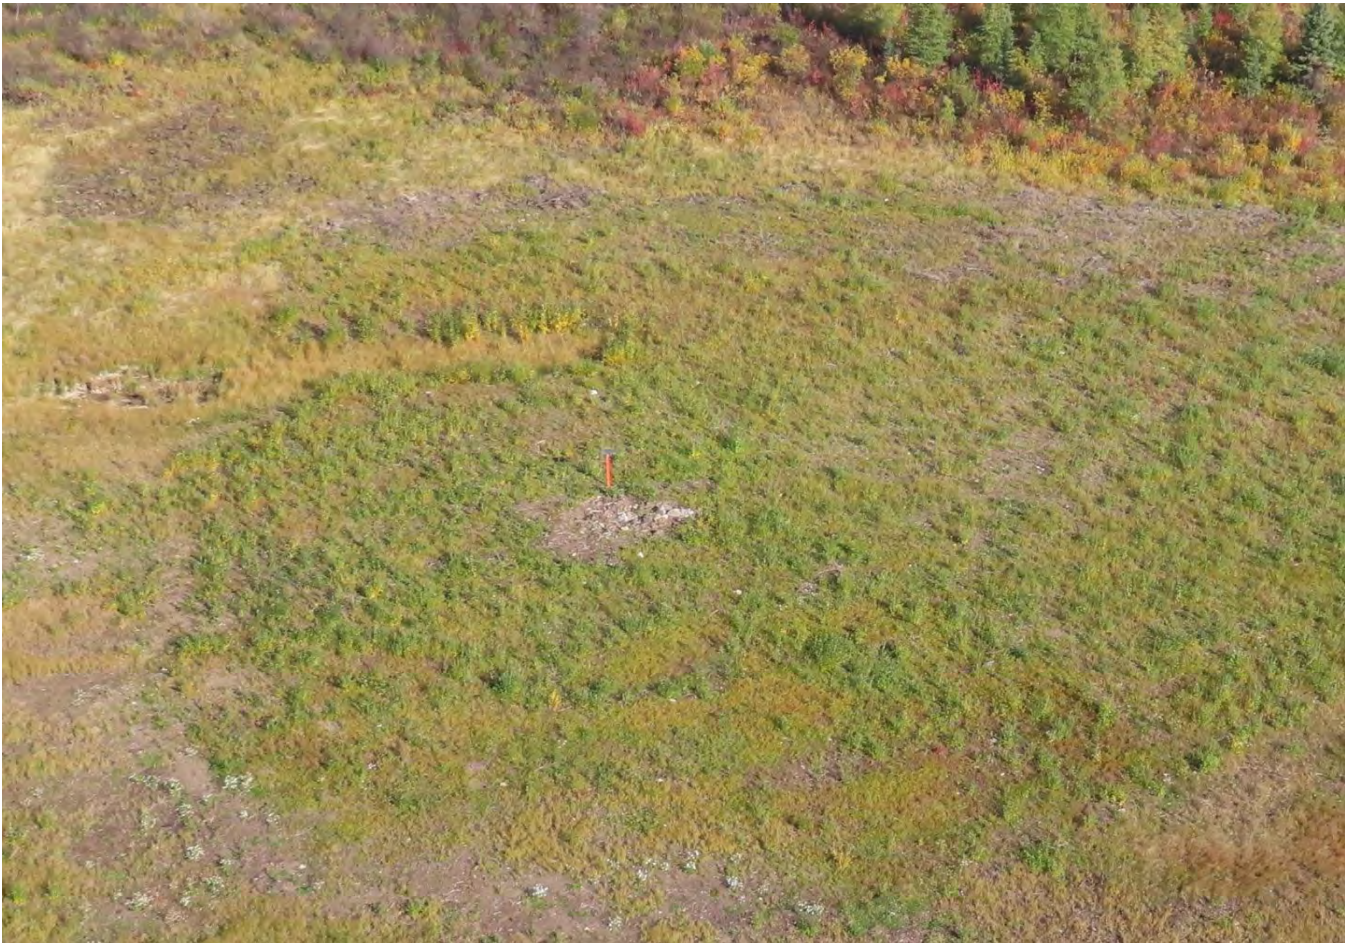
Figure 69

I-10: Backfill of well center appears satisfactory.

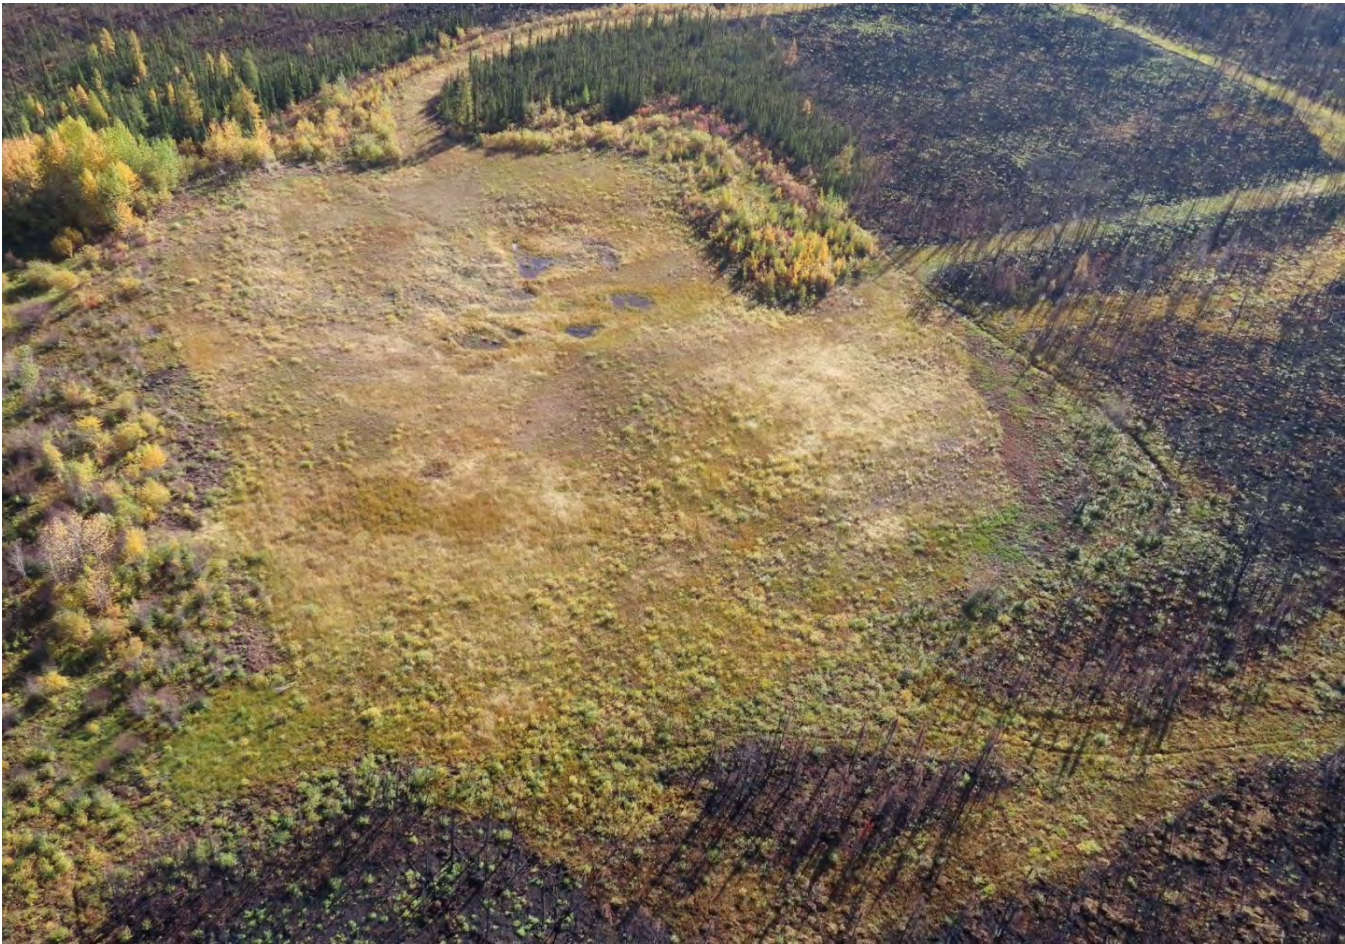
Figure 70

I-16: Aerial view of the wellsite. Well abandoned March 17, 2023. No further remediation work required at I-16.

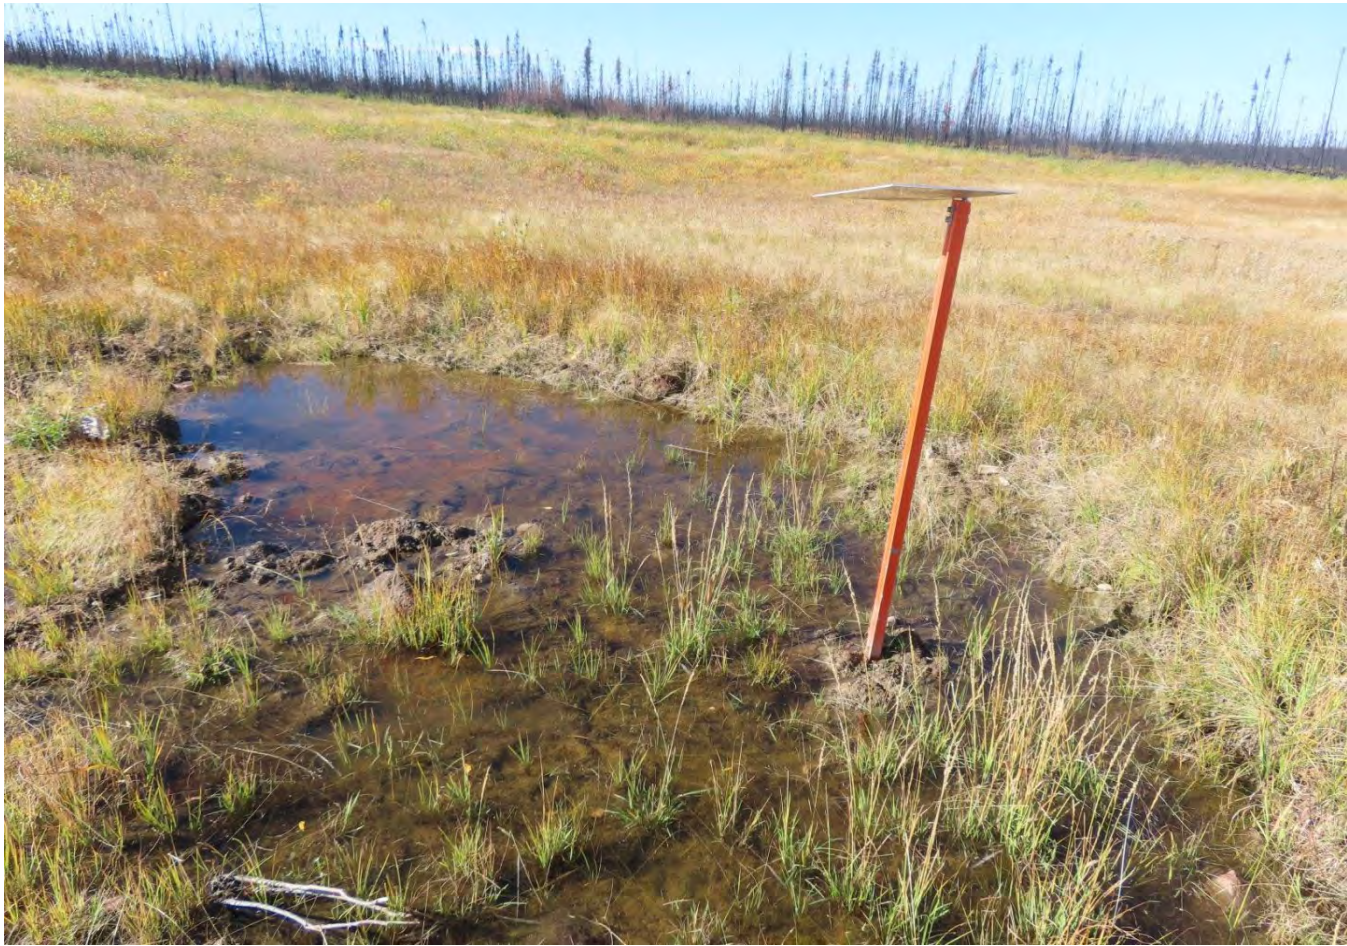
Figure 71

I-16: Backfill of well center appears satisfactory. Wet site with ponding water.

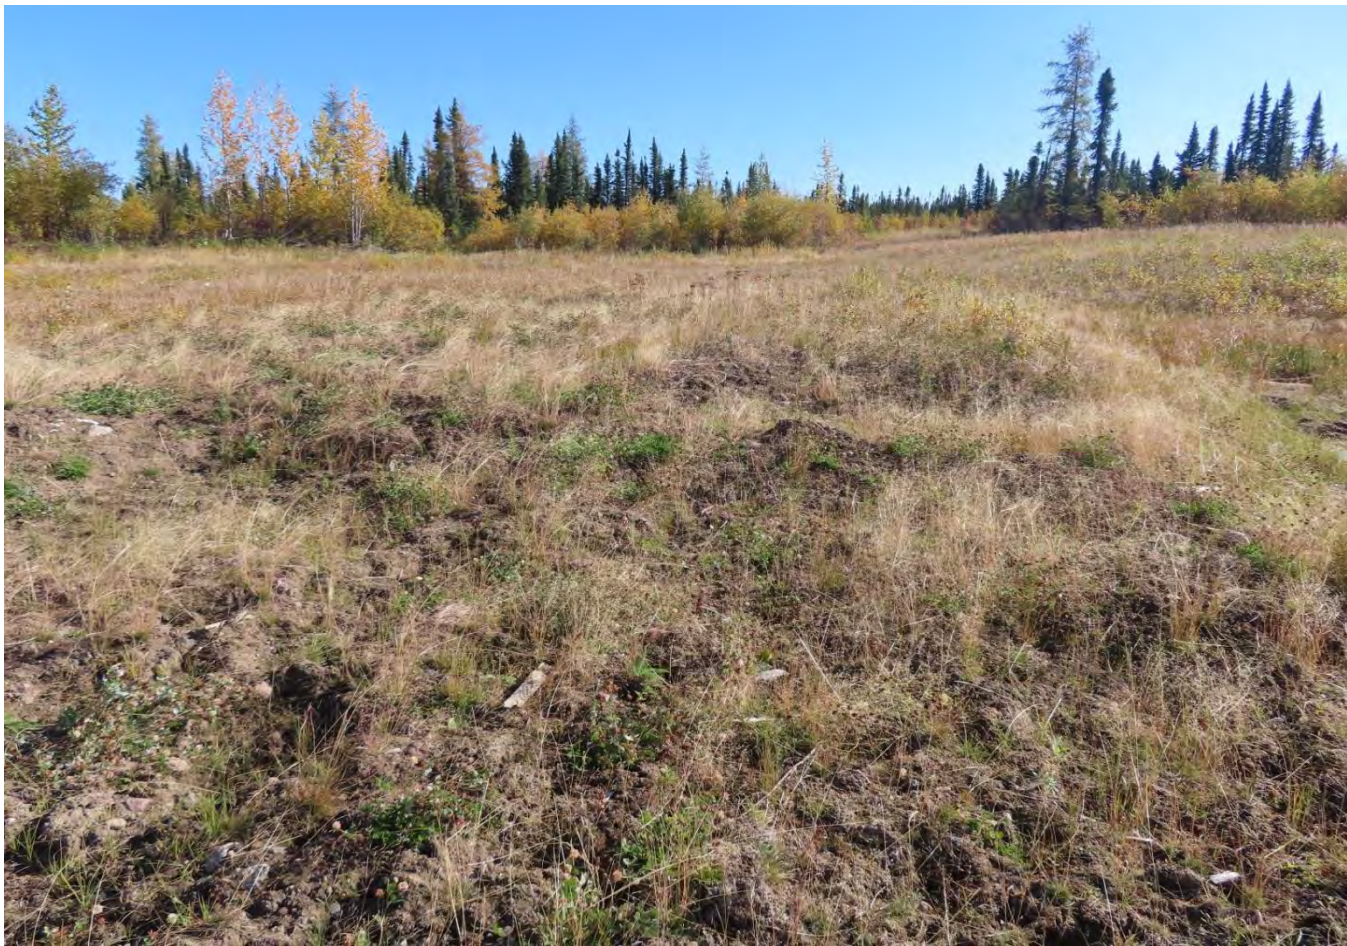
Figure 72

I-16: All production infrastructure was removed from the wellsite in the winter of 2023.

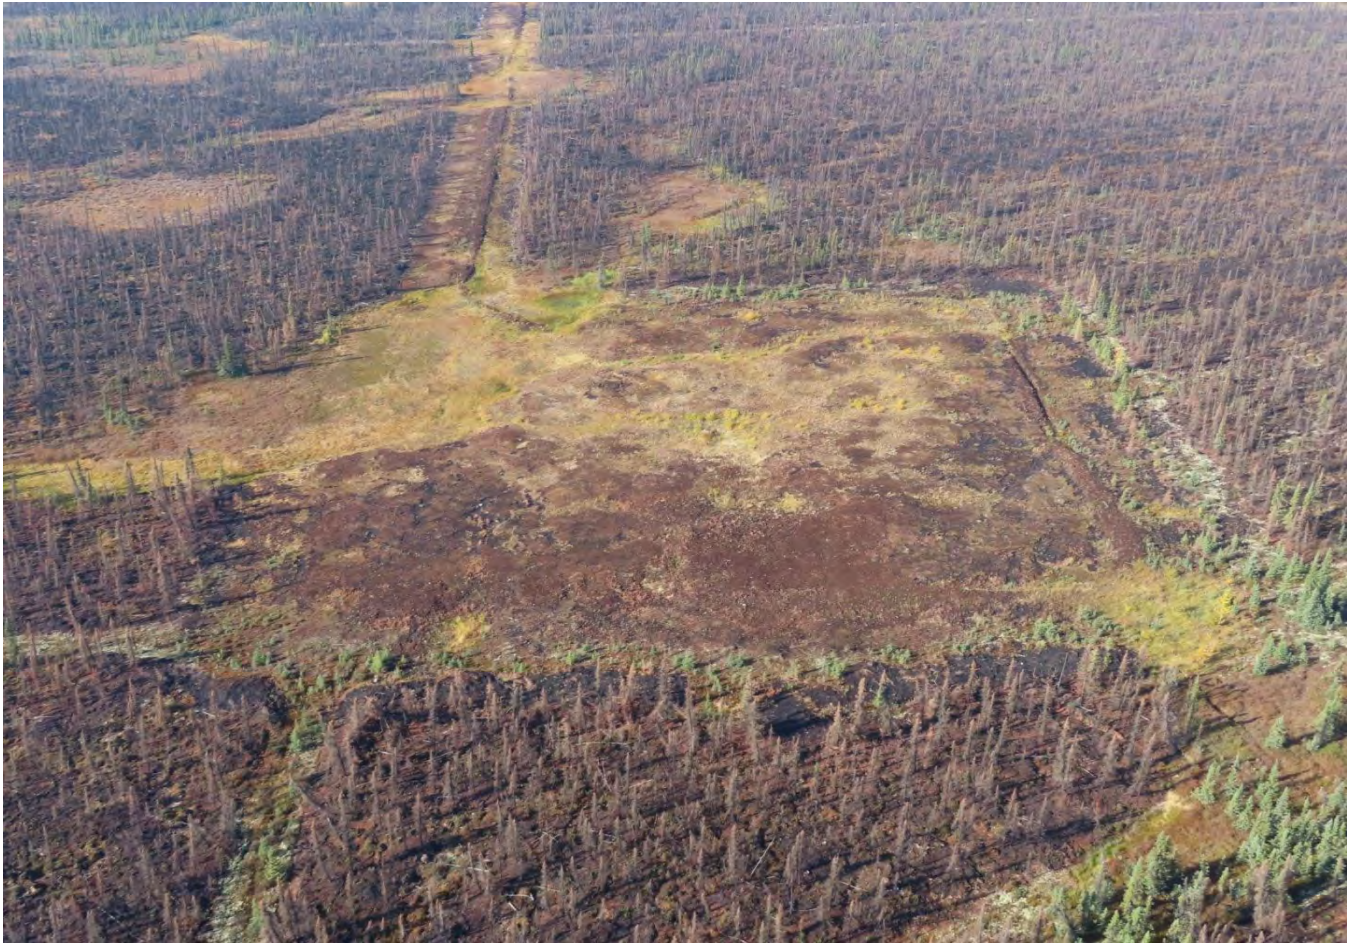
Figure 73

I-73: Aerial view of the wellsite. Well was abandoned on February 23, 2023.

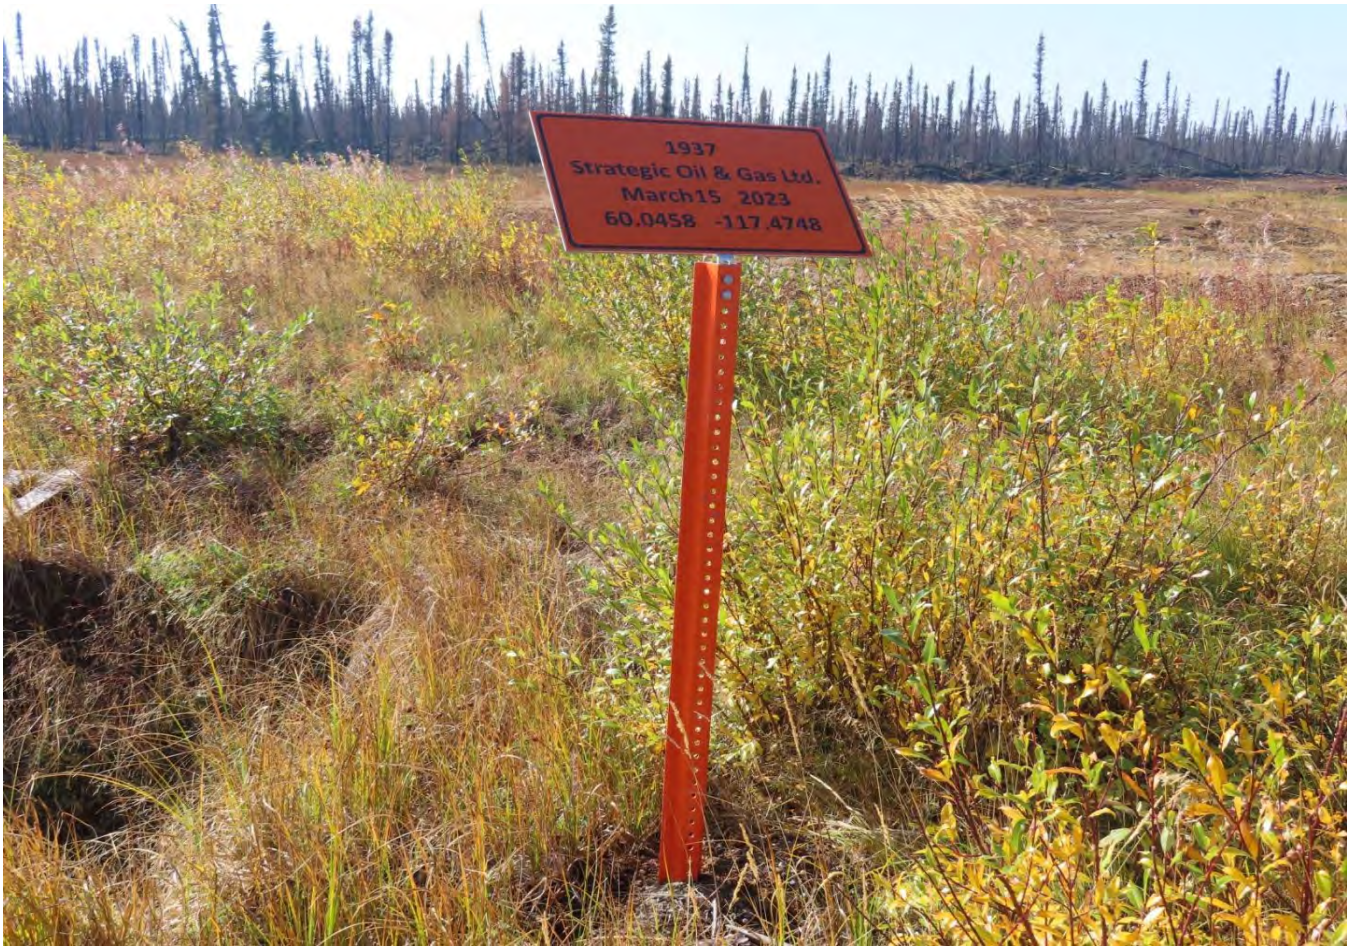
Figure 74

I-73: All production infrastructure was removed from the wellsite in the winter of 2023.

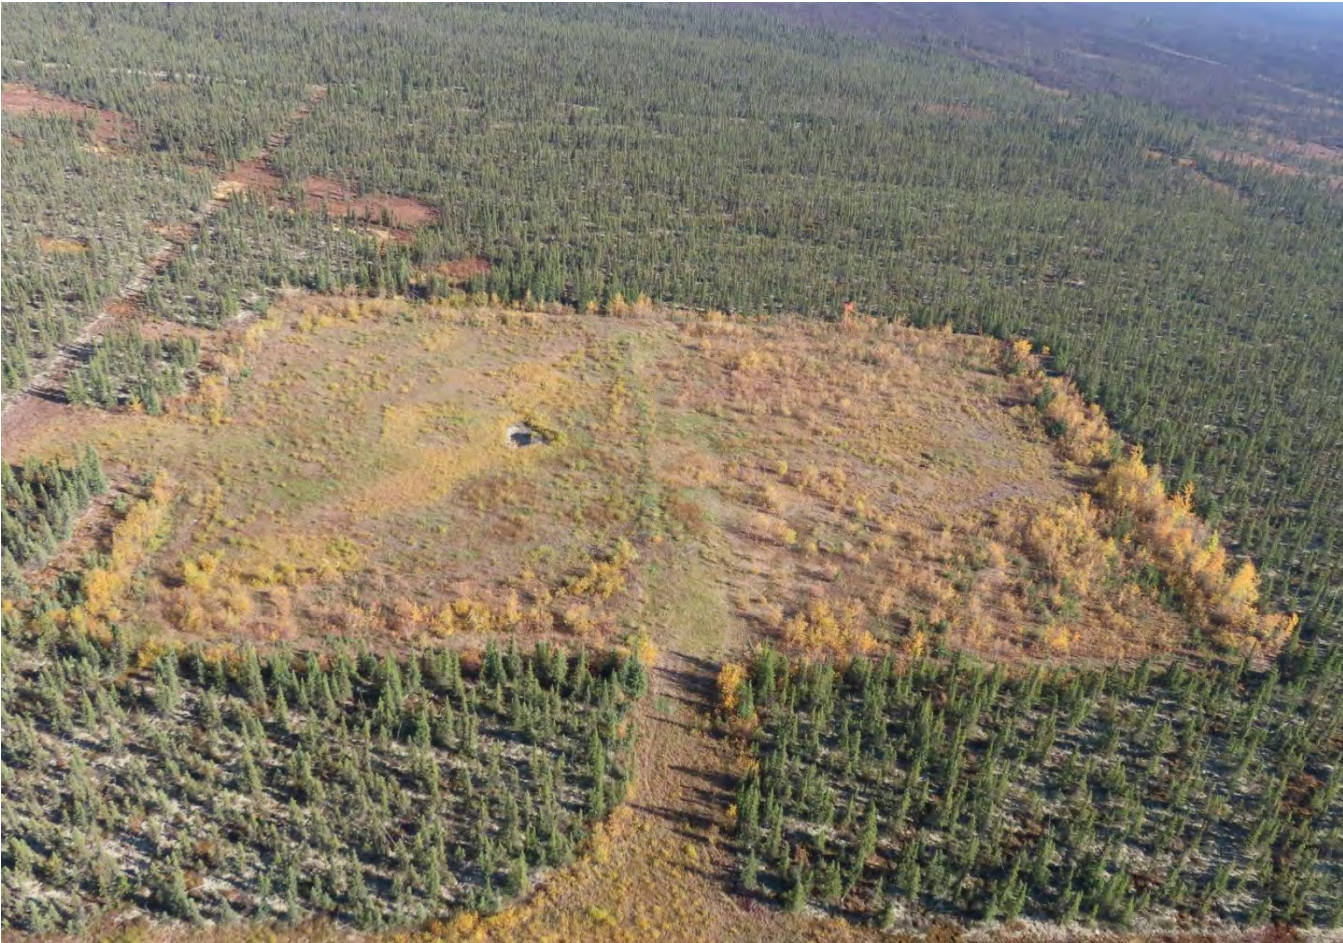
Figure 76

I-74/2I-74: Aerial view of the wellsite. I-74 (left) and 2I-74. I-74 was abandoned on January 23, 2023 and 2I-74 well was never drilled.

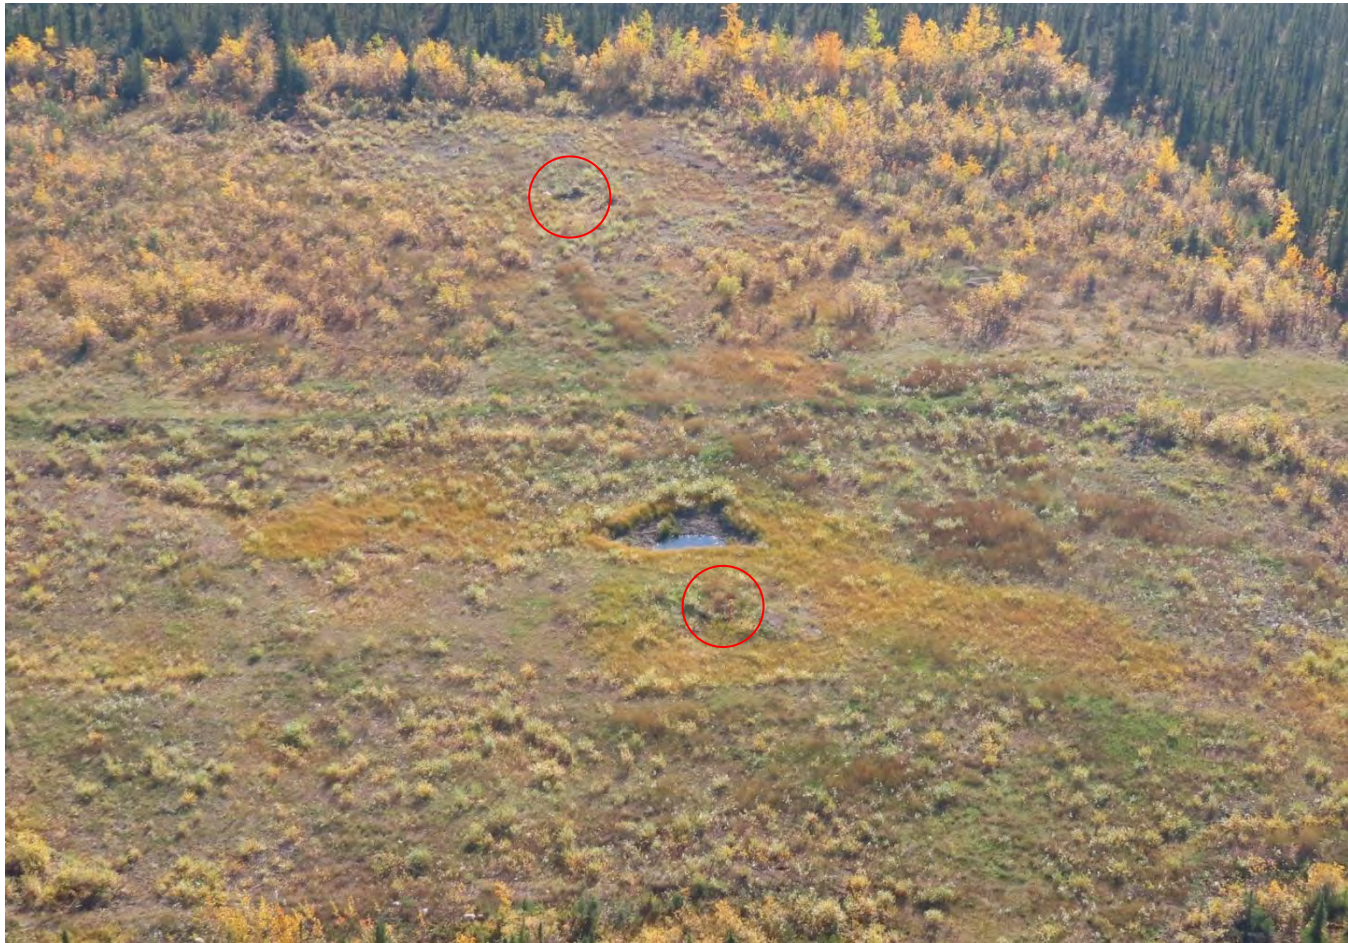
Figure 77

- 1. I-74 Well has been abandoned and cut/cap completed.
- 2. Backfill of I-74 well center not completed.
- 3. Cellar has not been removed.
- 4. Rathole not backfilled where proposed 2I-74 well was to be drilled (Figure 77 & 80). The rathole has a 20" diameter and is 30 feet deep. Rathole coordinates: 60°03'33.9"N 117°28'24.3"W. The rathole is a hazard to persons on site and wildlife. **ECC requires Alvarez and Marsal (A&M), the NWT receiver of Strategic Oil and Gas Ltd., to implement temporary mitigation of 2I-74 no later than October 31, 2024.**
- 5. A&M is required to submit a plan to OROGO and ECC on a timeframe and methodology for how these issues will be permanently addressed. The plan must be submitted to OROGO and ECC by December 15, 2024.
- 6. No drill waste observed on the site.
- 7. No hydrocarbon impacted soils were noted.
- 8. All other aspects of wellsite satisfactory.

I-74/2I-74: I-74 (bottom) and 2I-74 (top).

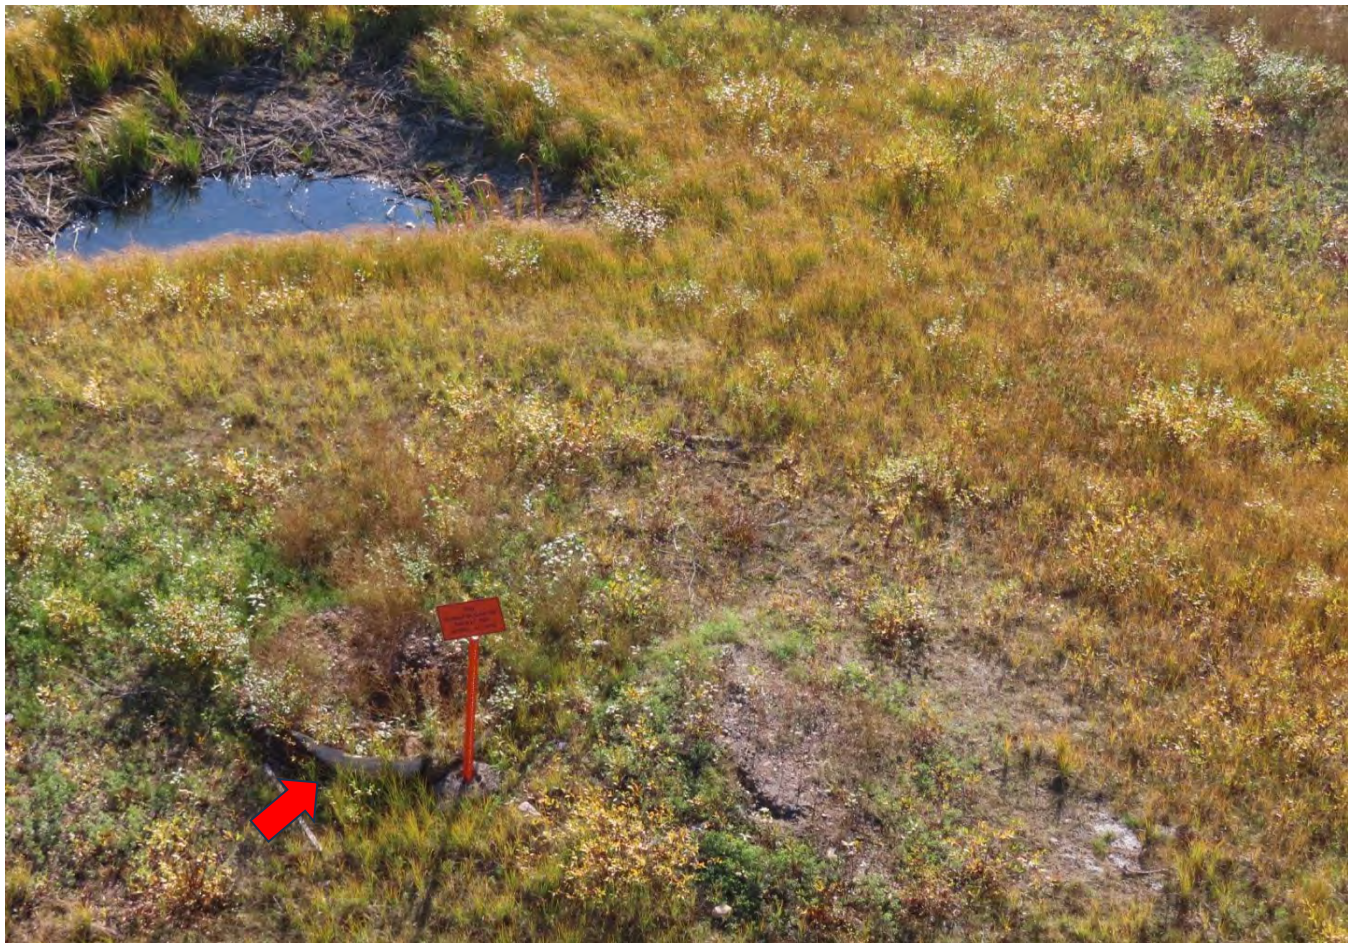
Figure 78

I-74: Cellar at I-74 was not removed during abandonment operations.

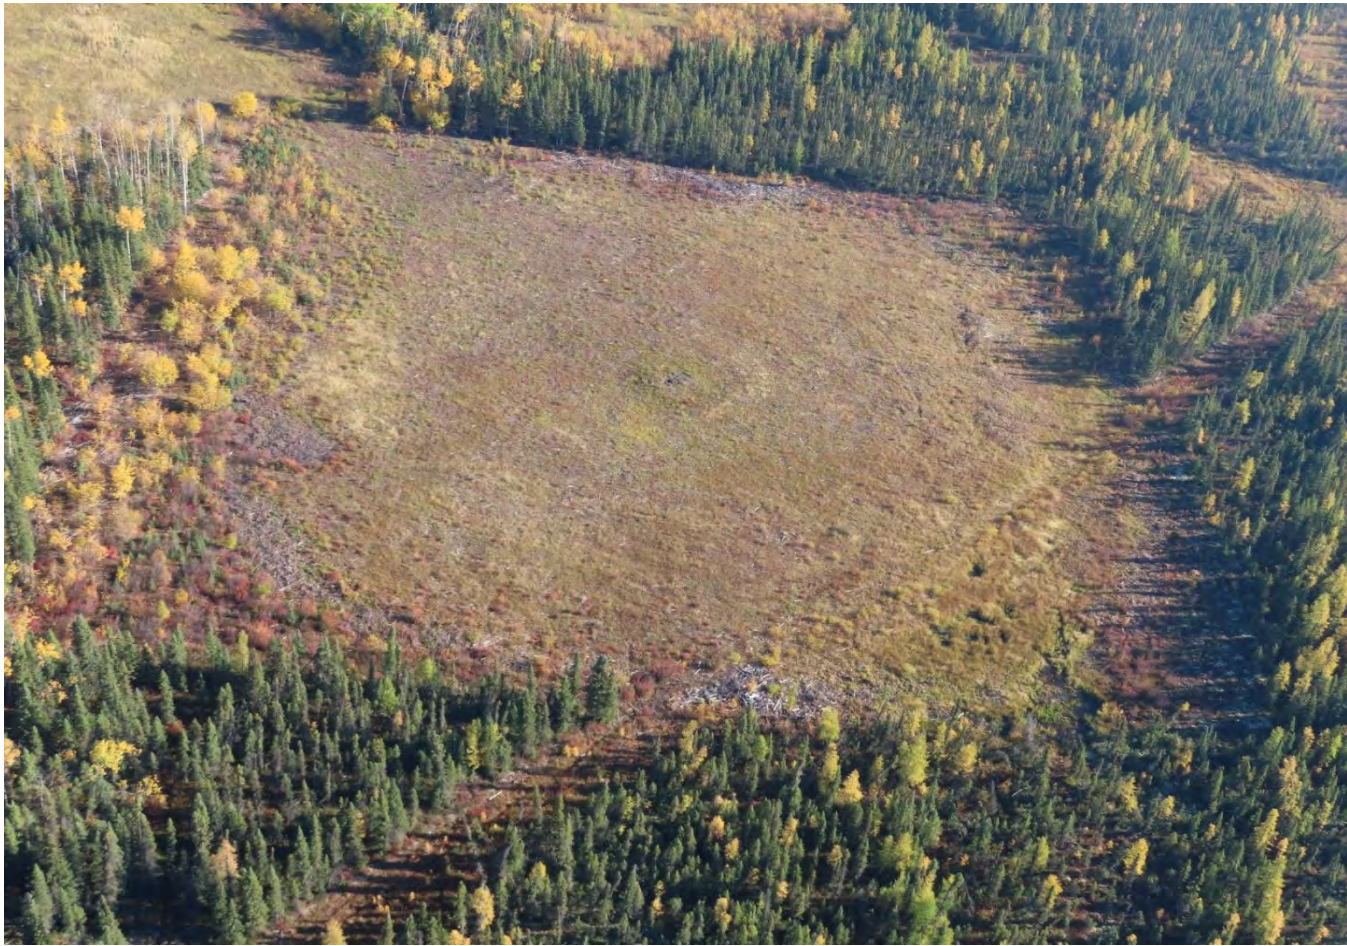
Figure 81

J-04: Aerial view of the wellsite. Well was abandoned on March 11, 2023.

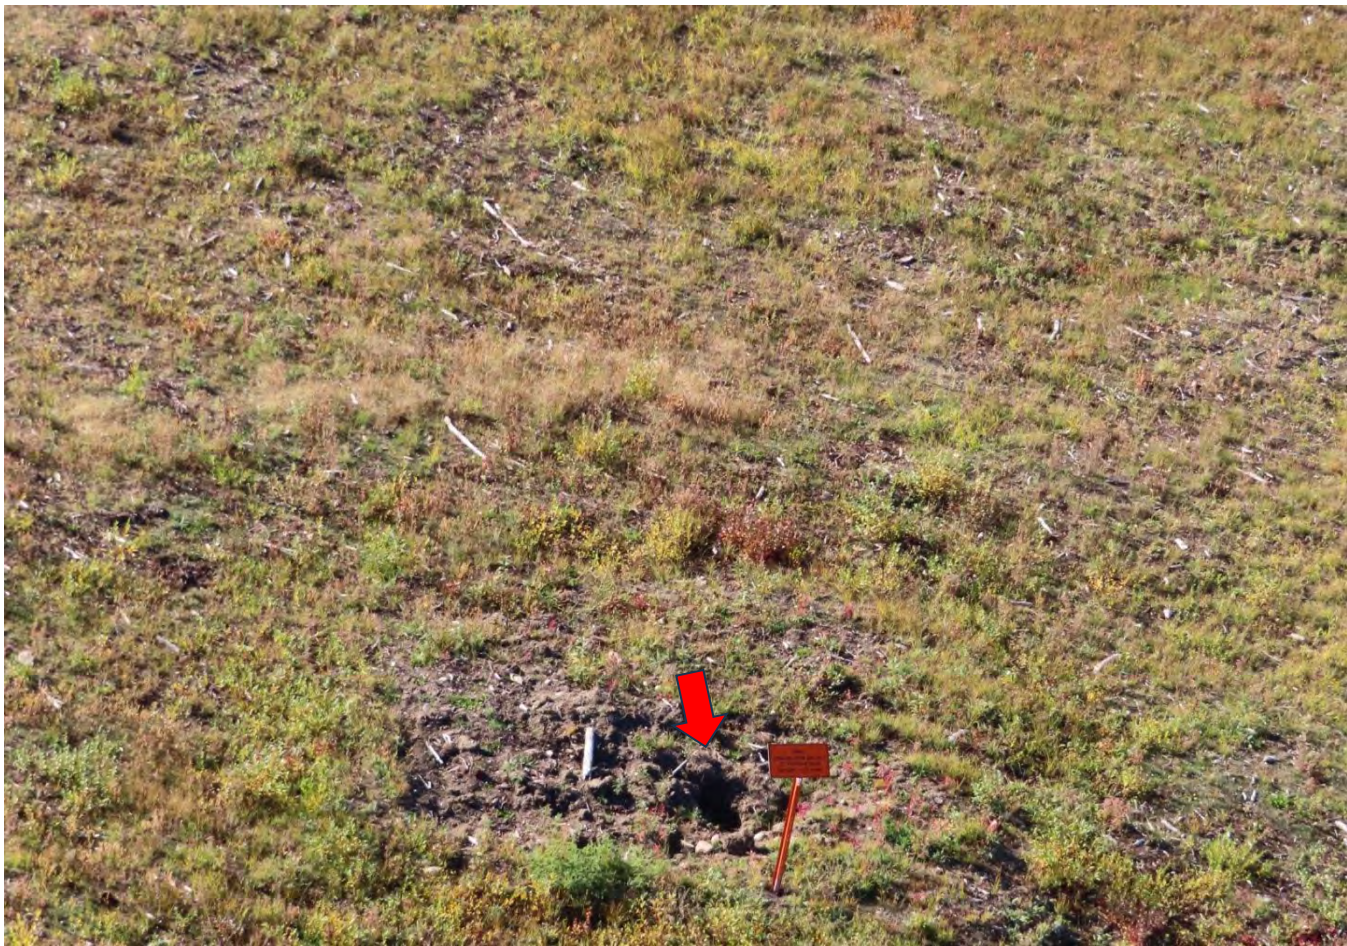
Figure 82

J-04: Well center not backfilled following abandonment operation.

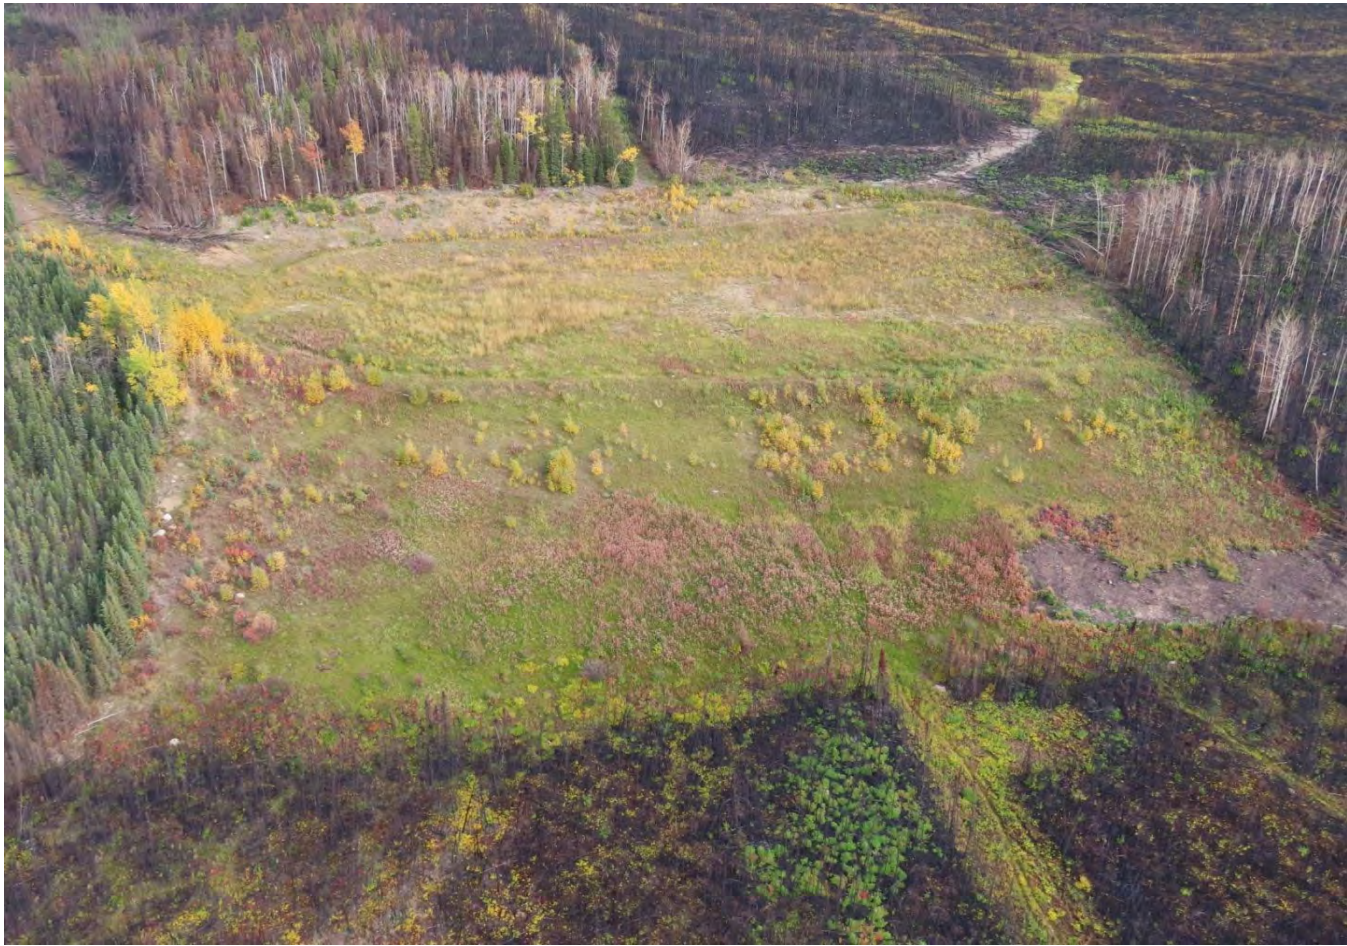
Figure 83

J-37: Aerial view of the wellsite. Well was abandoned on January 23, 2023. No further remediation work required at J-37.

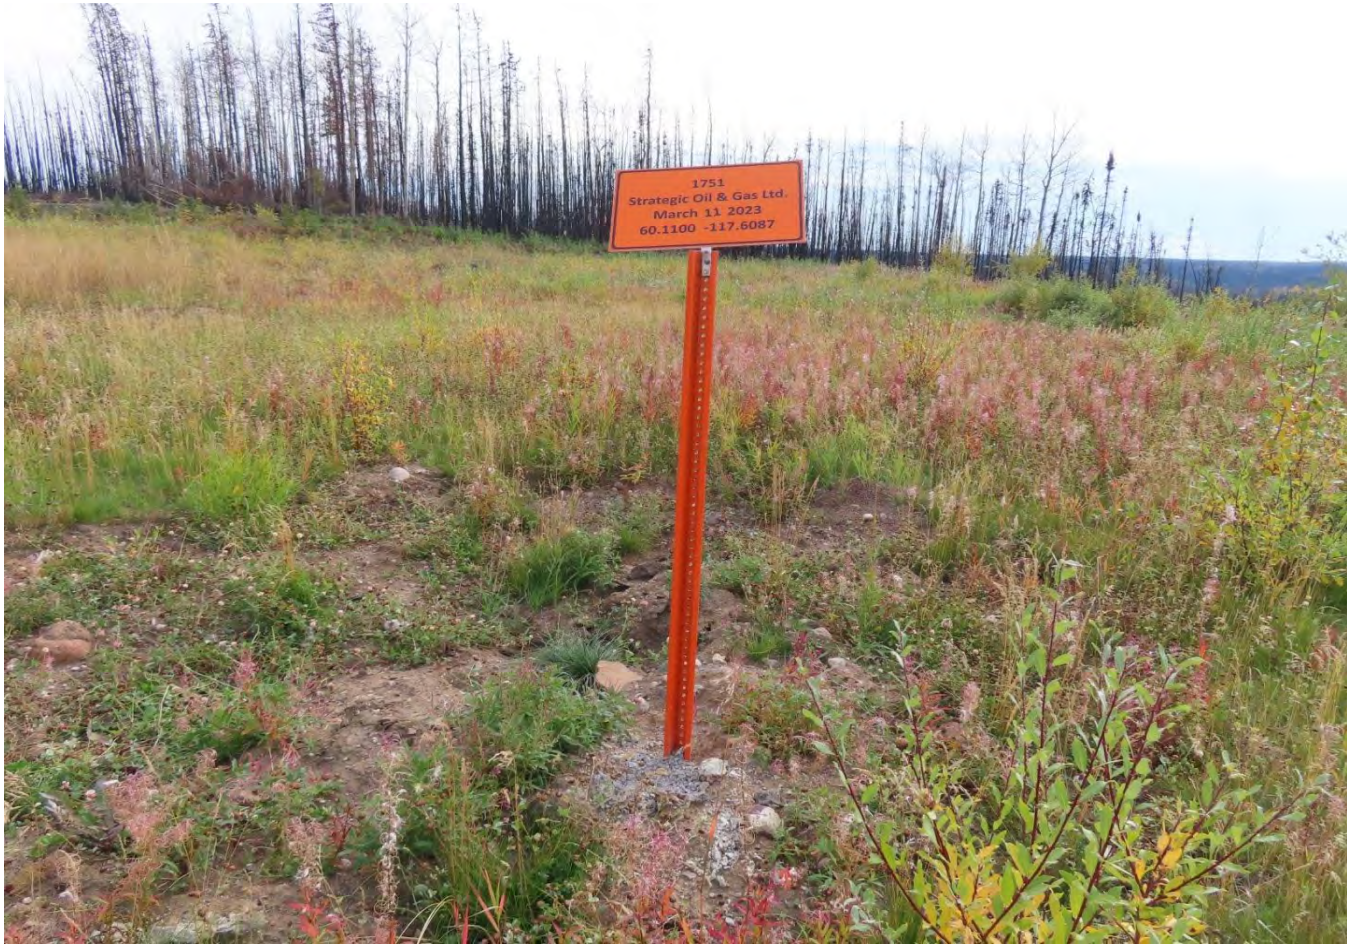
Figure 84

J-37: Backfill of well center appears satisfactory.

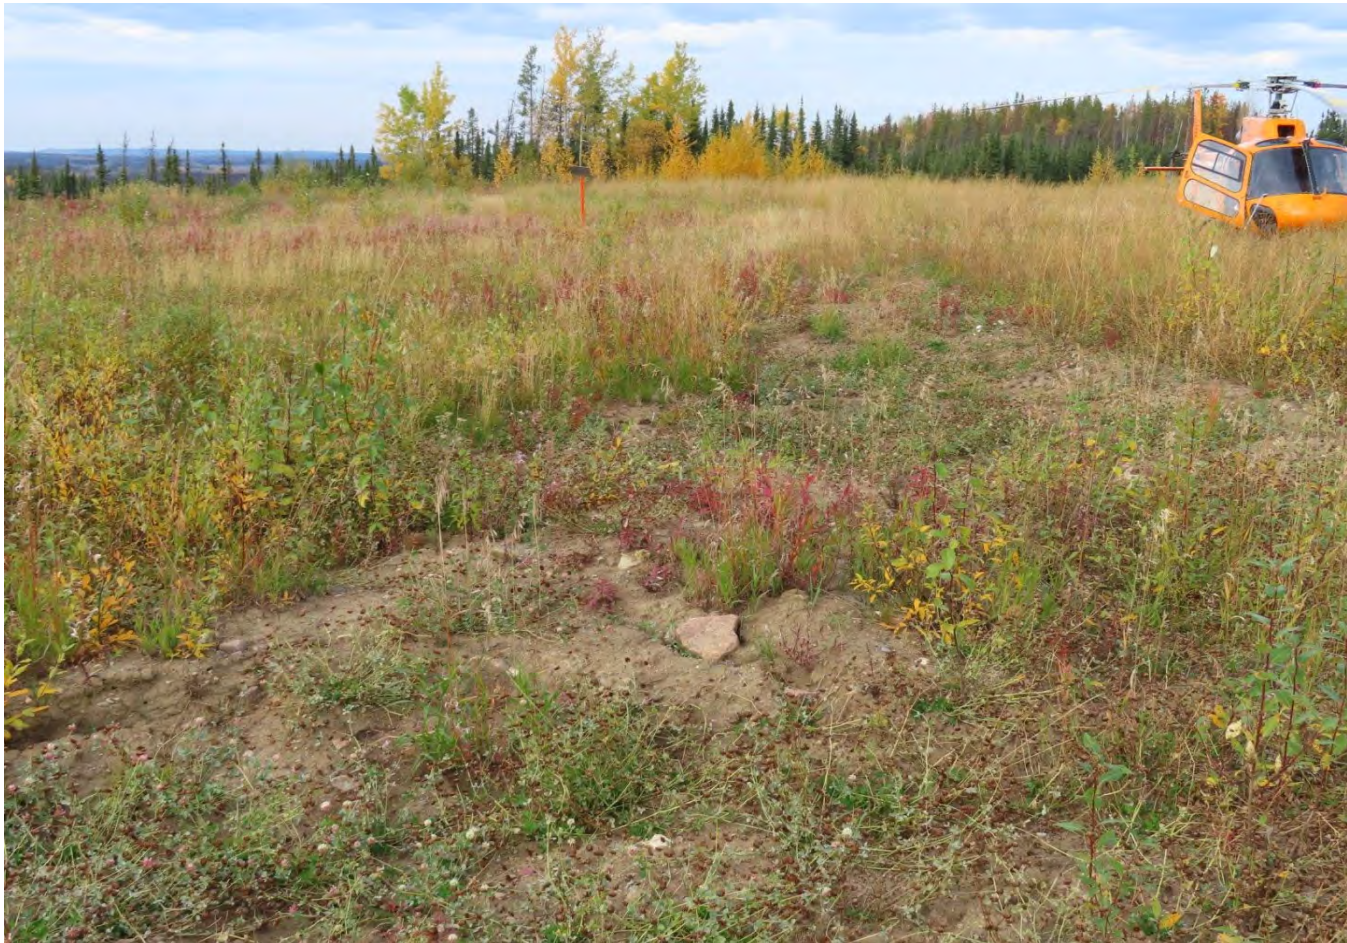
Figure 85

J-37: All pilings located on the wellsite were removed in the winter of 2023.
