File Number	MV2022X0018
Type of Operation	Cameron Hills Oil and Gas Field Abandonment
Location	Cameron Hills, NT

ENVIRONMENTAL INSPECTION REPORT

Permittee:	Strategic Oil and Gas Ltd. c/o Alvarez & Marsal Canada Inc.	Permit Expiry Date:	January 02, 2028
Land Use Permit No.	MV2022X0018	Previous Inspection:	February 21, 2024
Quarrying Permit No.		Inspection Date:	September 17, 2024
Contractor:	ELM Inc.	Subcontractor:	
Location(s) Inspected:	Cameron Hills Oil and Gas Field		
Current Stage of Operation:	The abandonment of the H-03 Battery, forty-four (44) oil and gas wells was completed in the winter of 2023 and 2024.		
Program Modifications Approved:

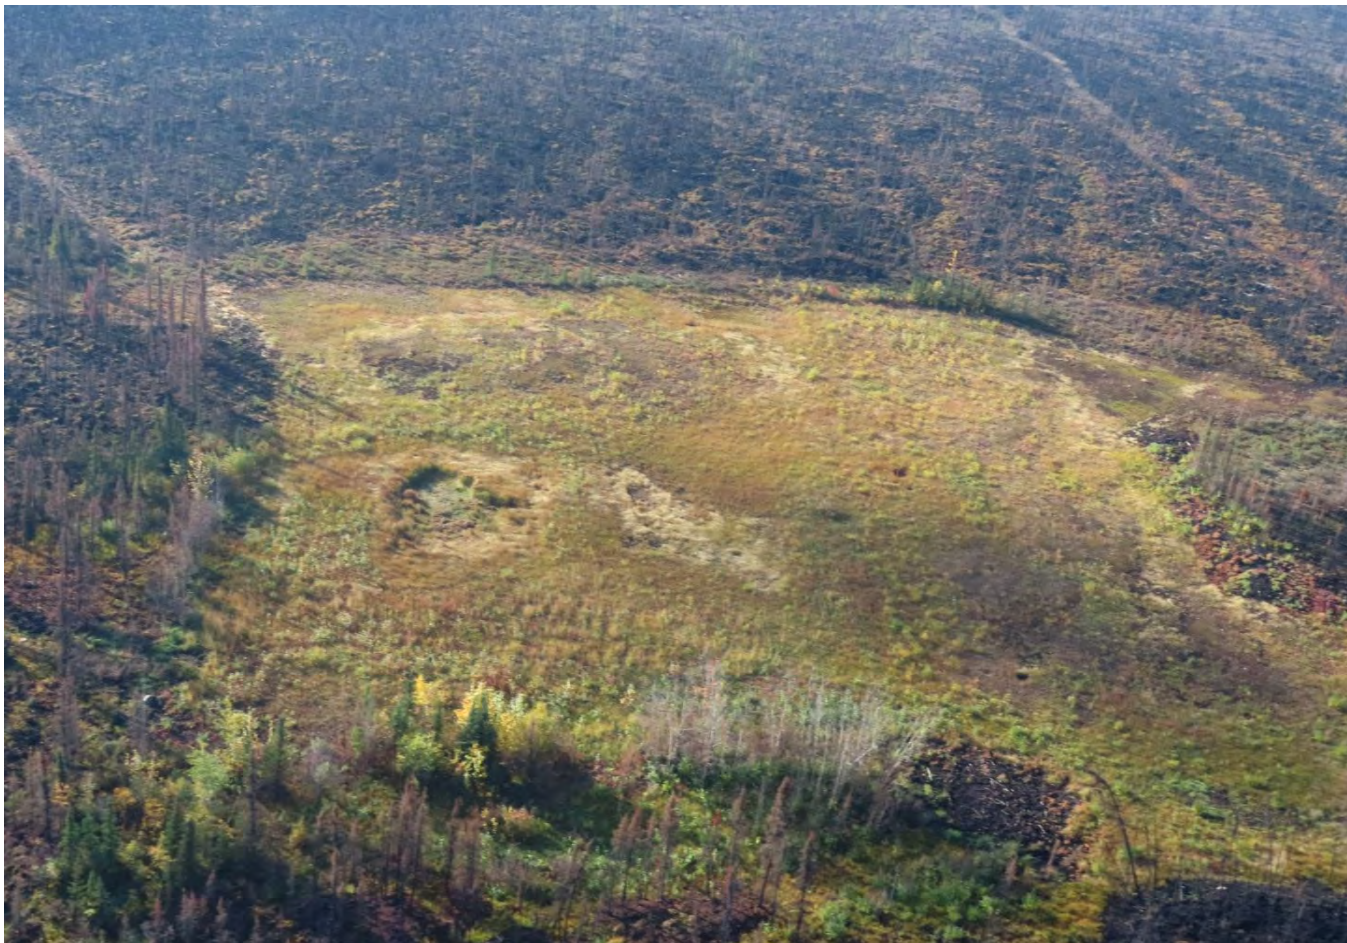
Figure 86

J-62: Aerial view of the wellsite. Well was abandoned on March 22, 2023.

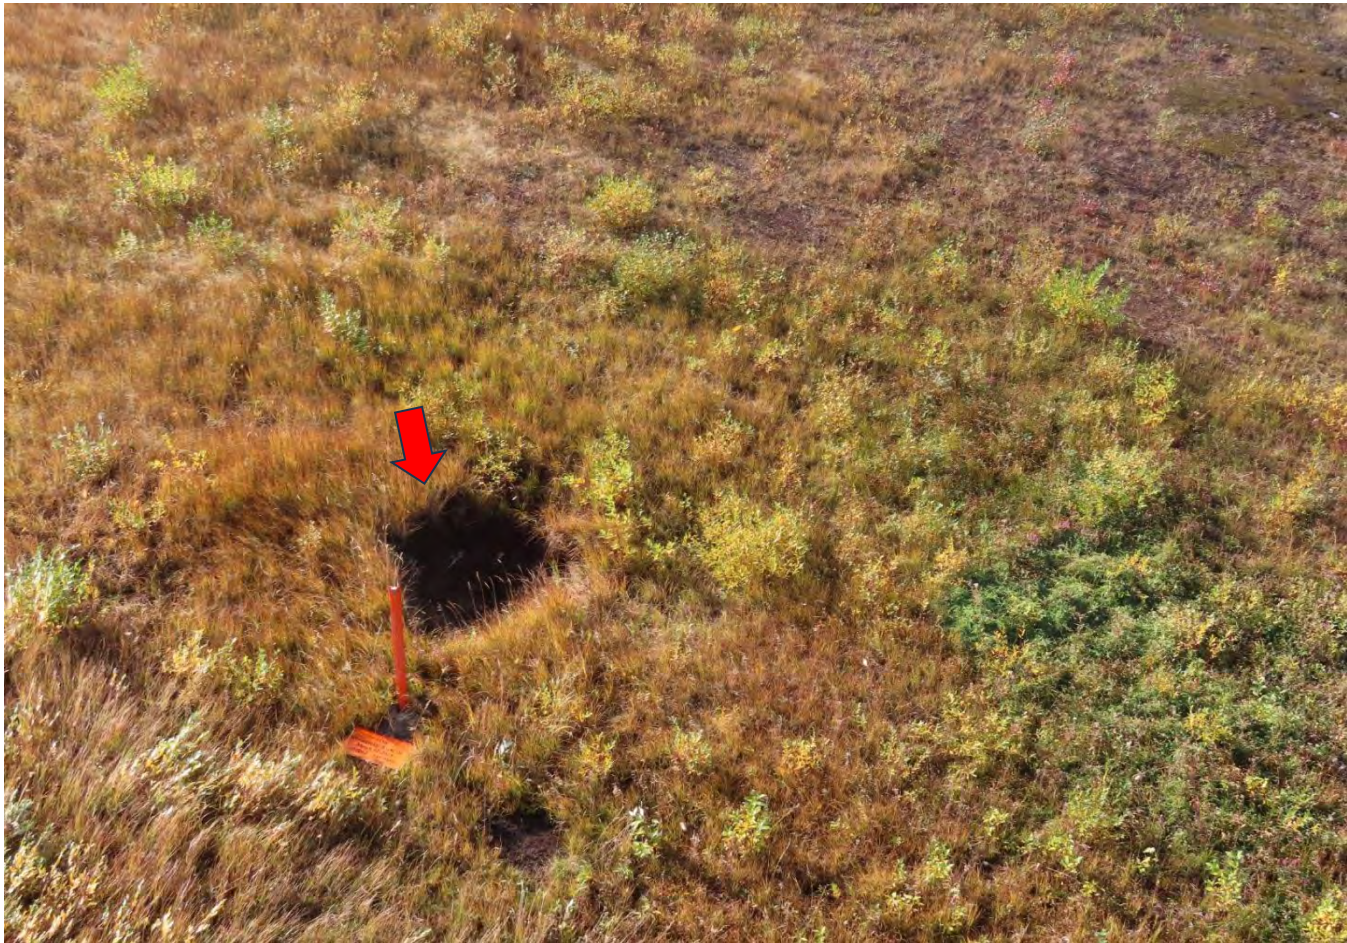
Figure 87

J-62: Well center not backfilled following abandonment operation.

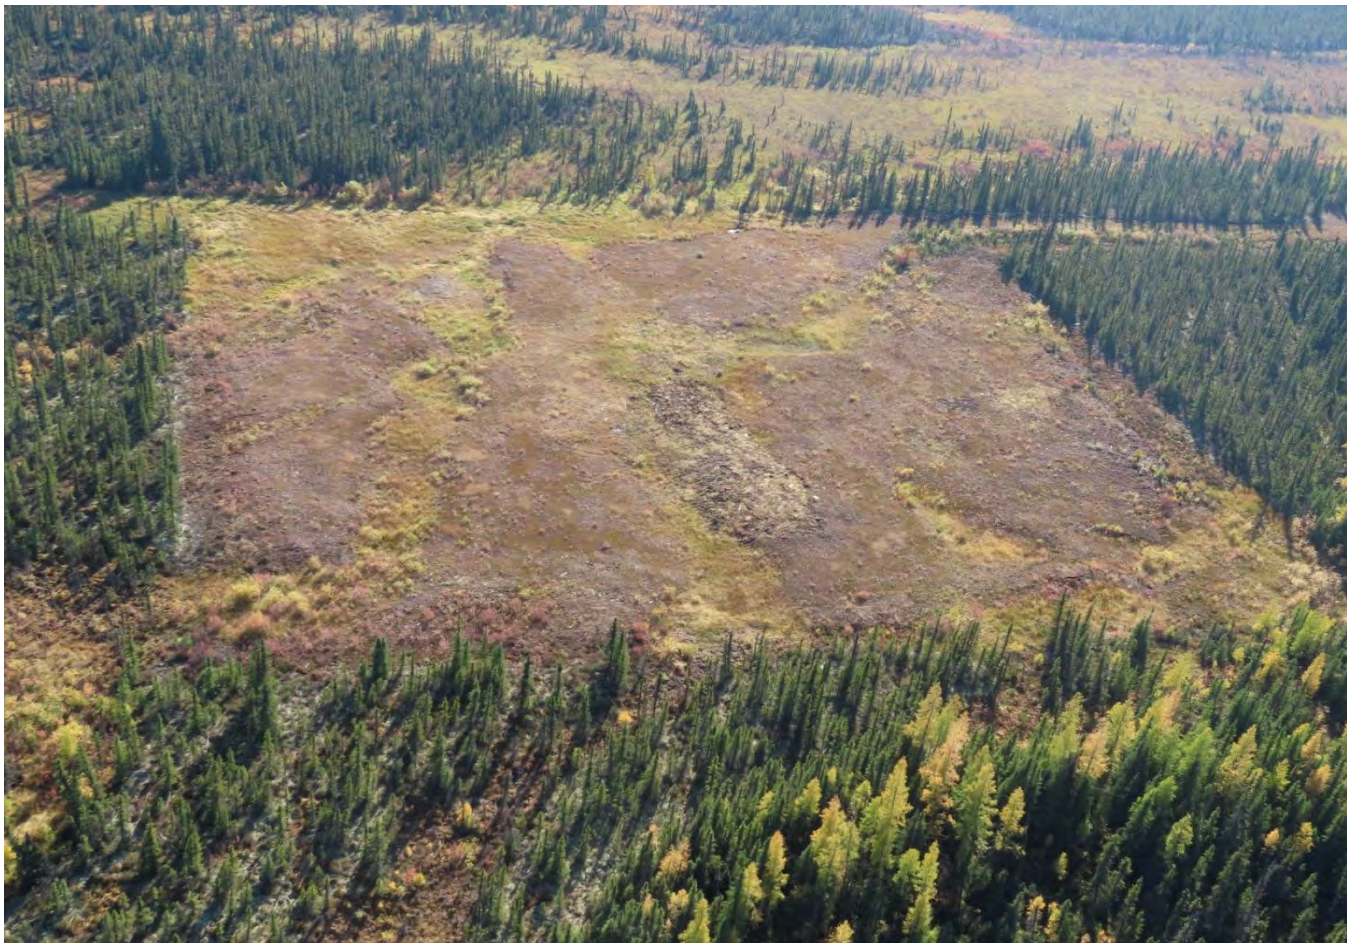
Figure 88

J-74: Aerial view of the wellsite. Well was abandoned on February 27, 2023.

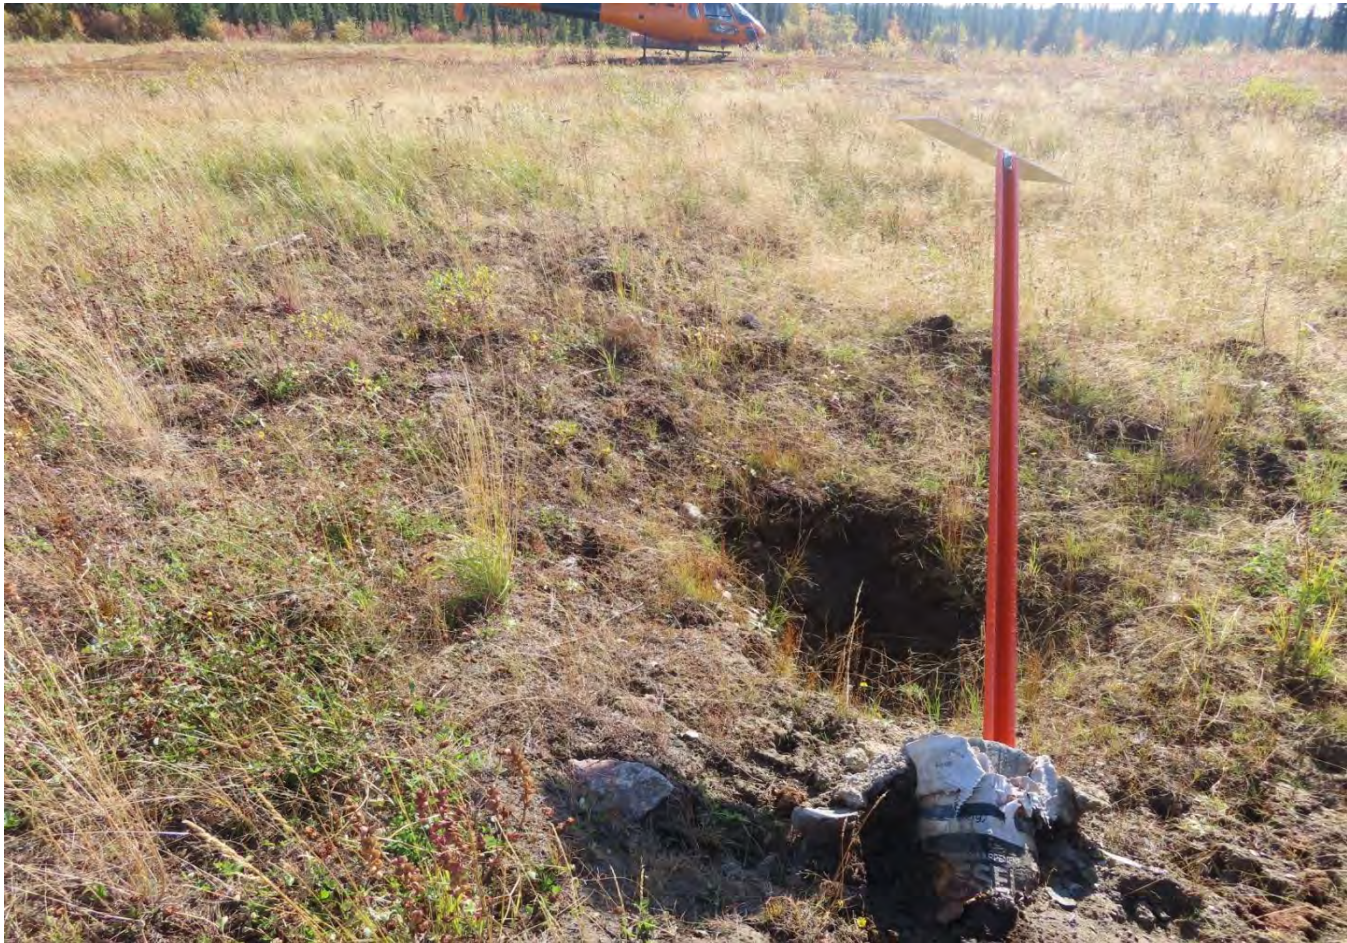
Figure 89

J-74: Well center not backfilled following abandonment operation.

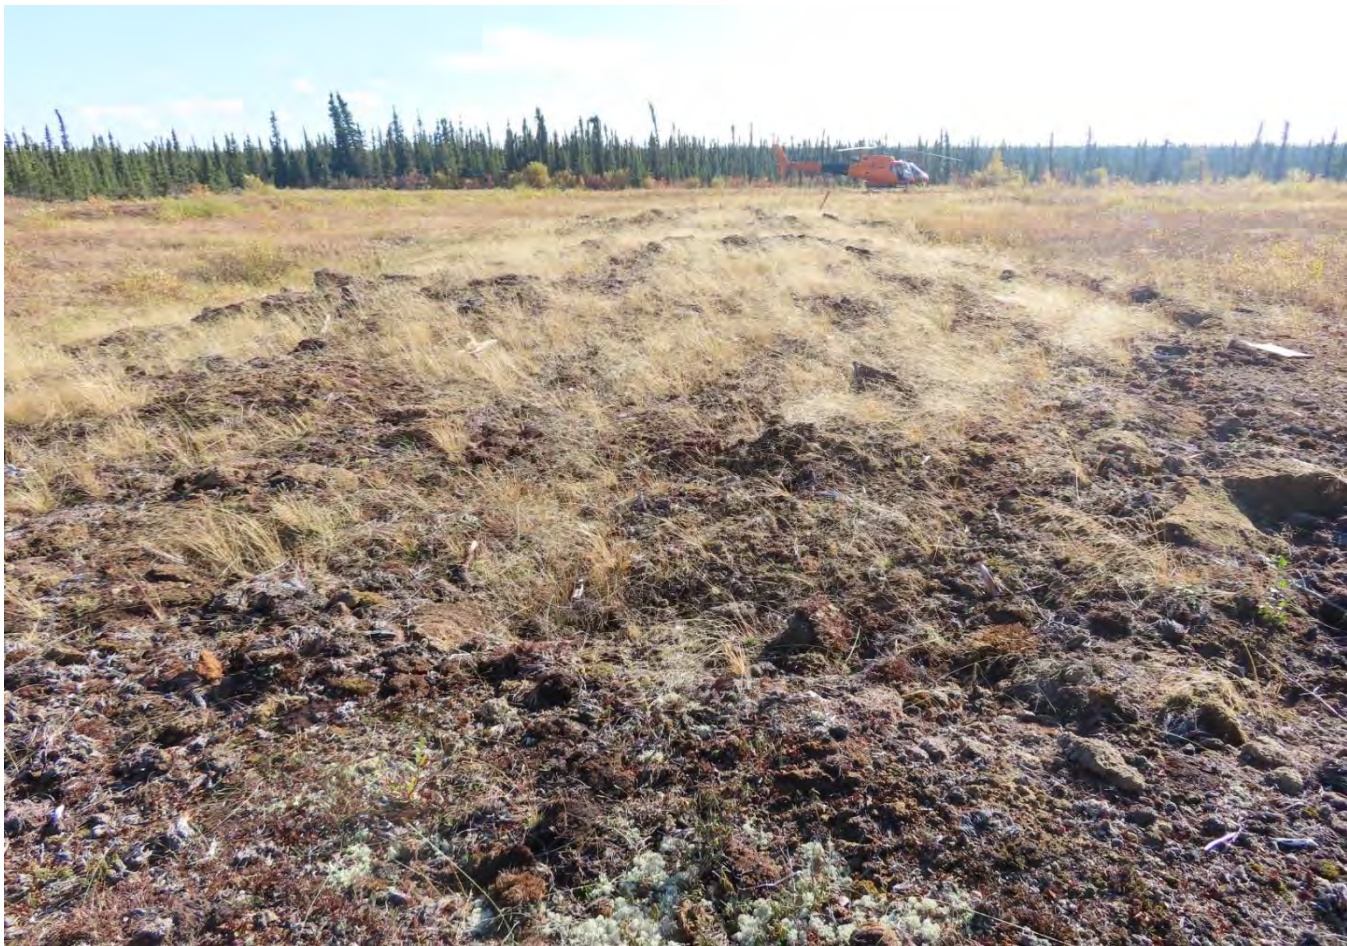
Figure 90

J-74: All production infrastructure was removed from the wellsite in the winter of 2023.

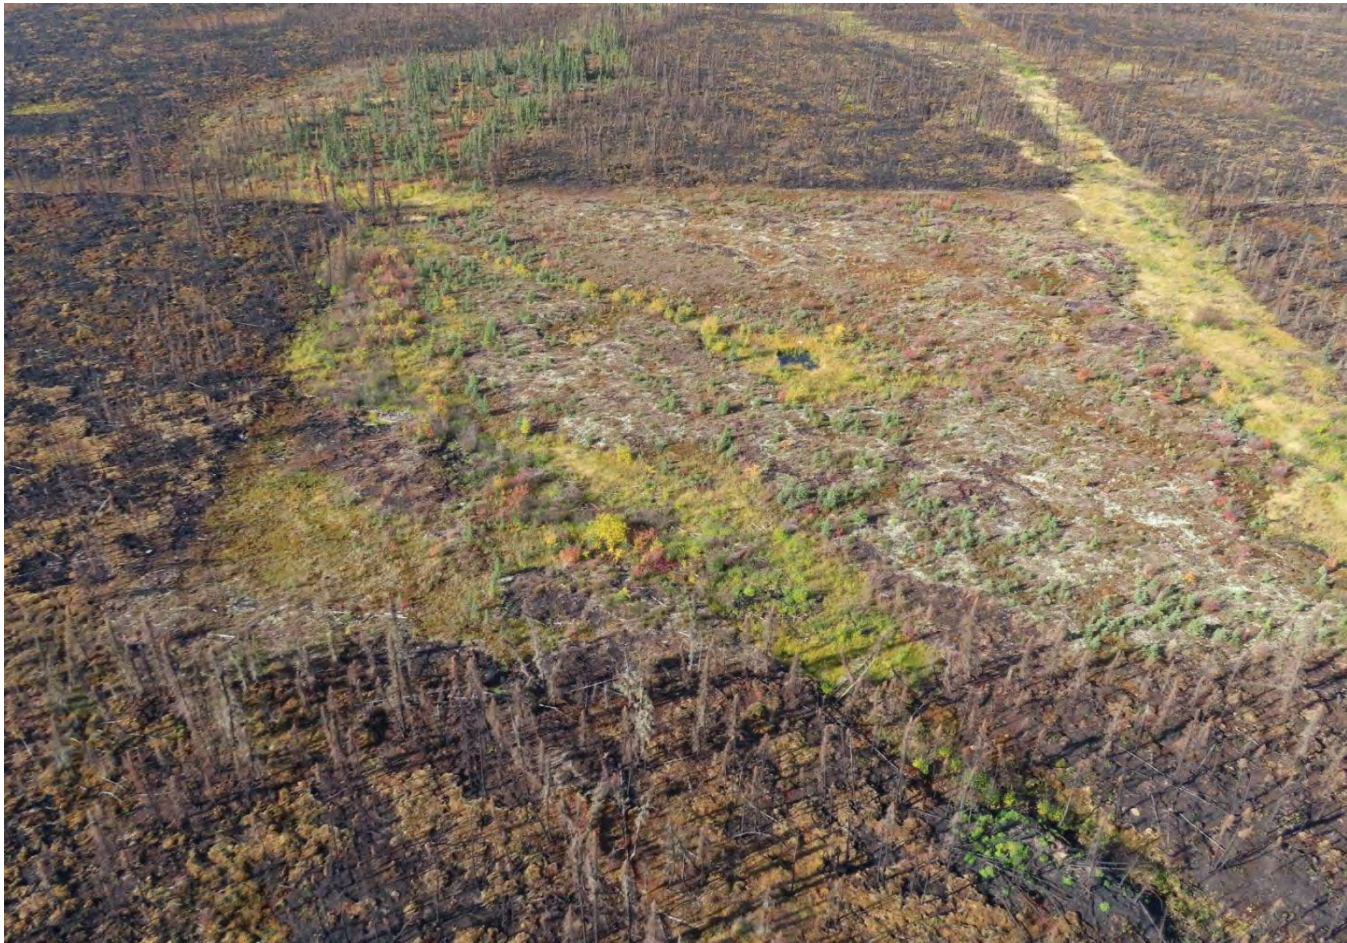
Figure 91

K-19: Aerial view of the wellsite. Well abandoned in 2012. No further remediation work required at K-19.

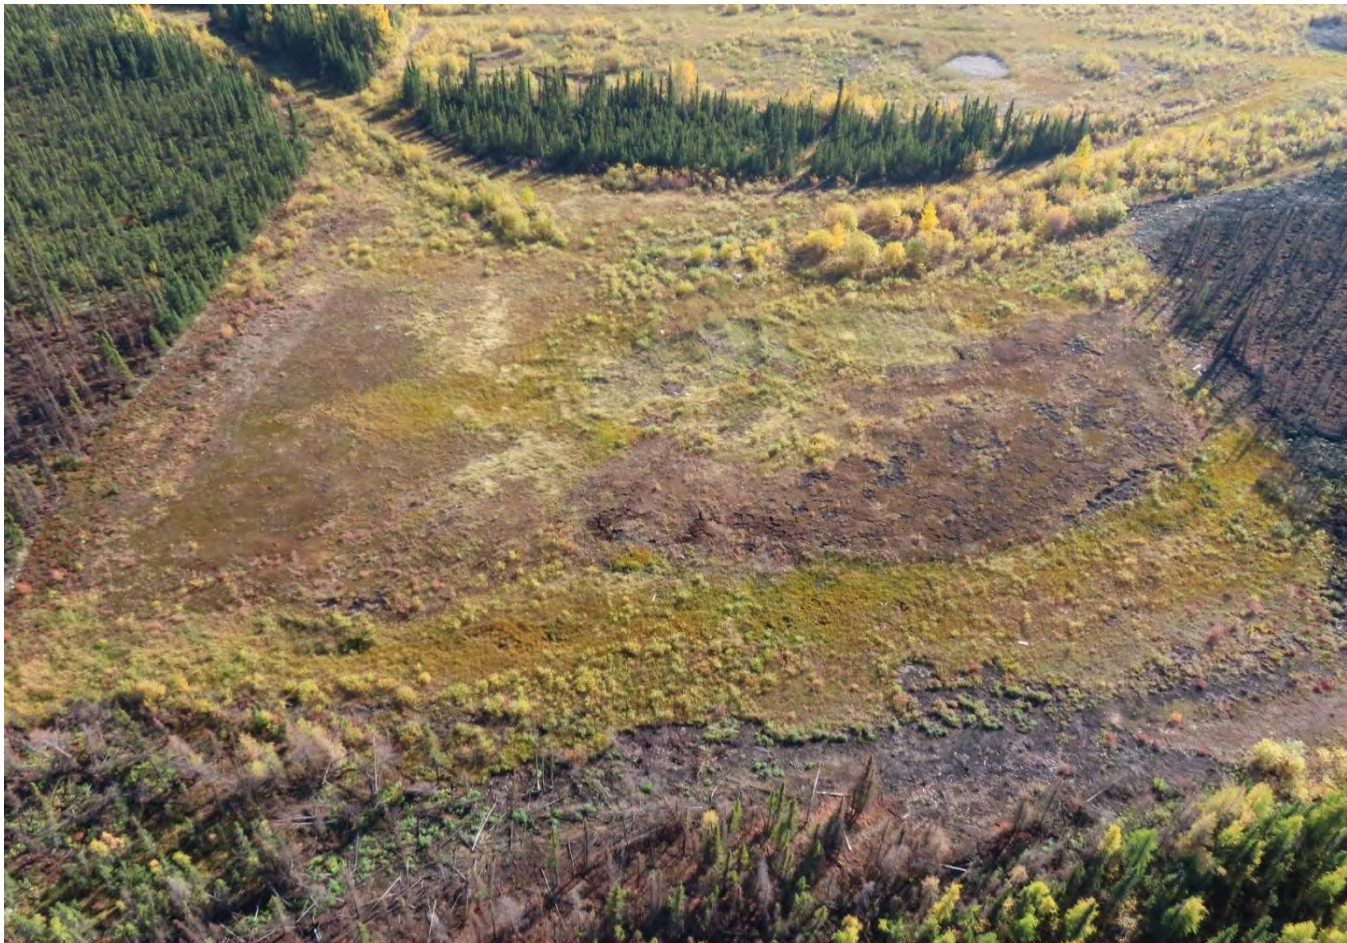
Figure 92

K-74: Aerial view of the wellsite. Well was abandoned on February 21, 2023. No further remediation work required at K-74.

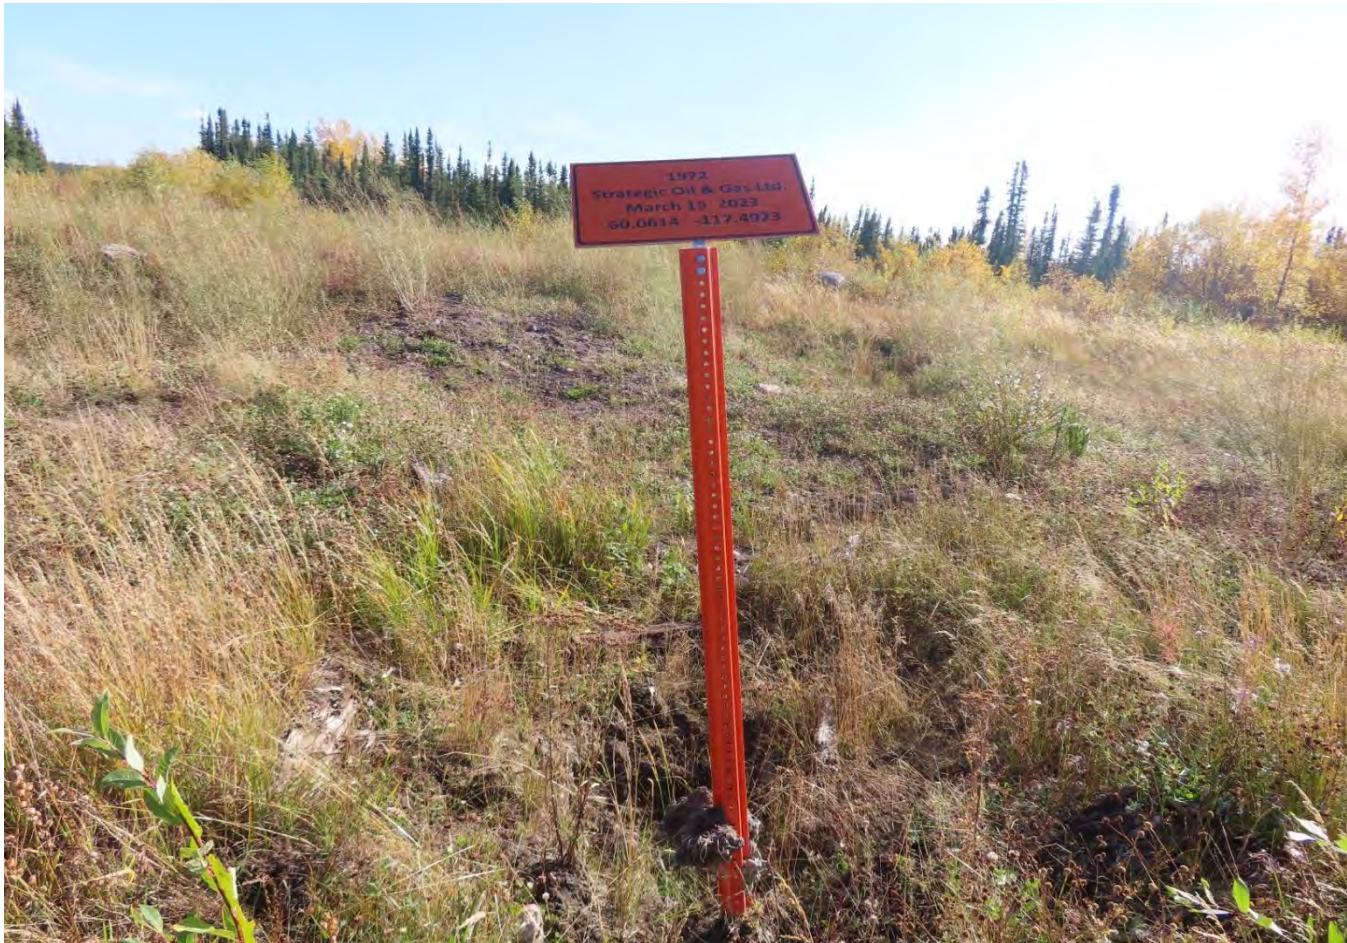
Figure 93

K-74: Backfill of well center appears satisfactory.

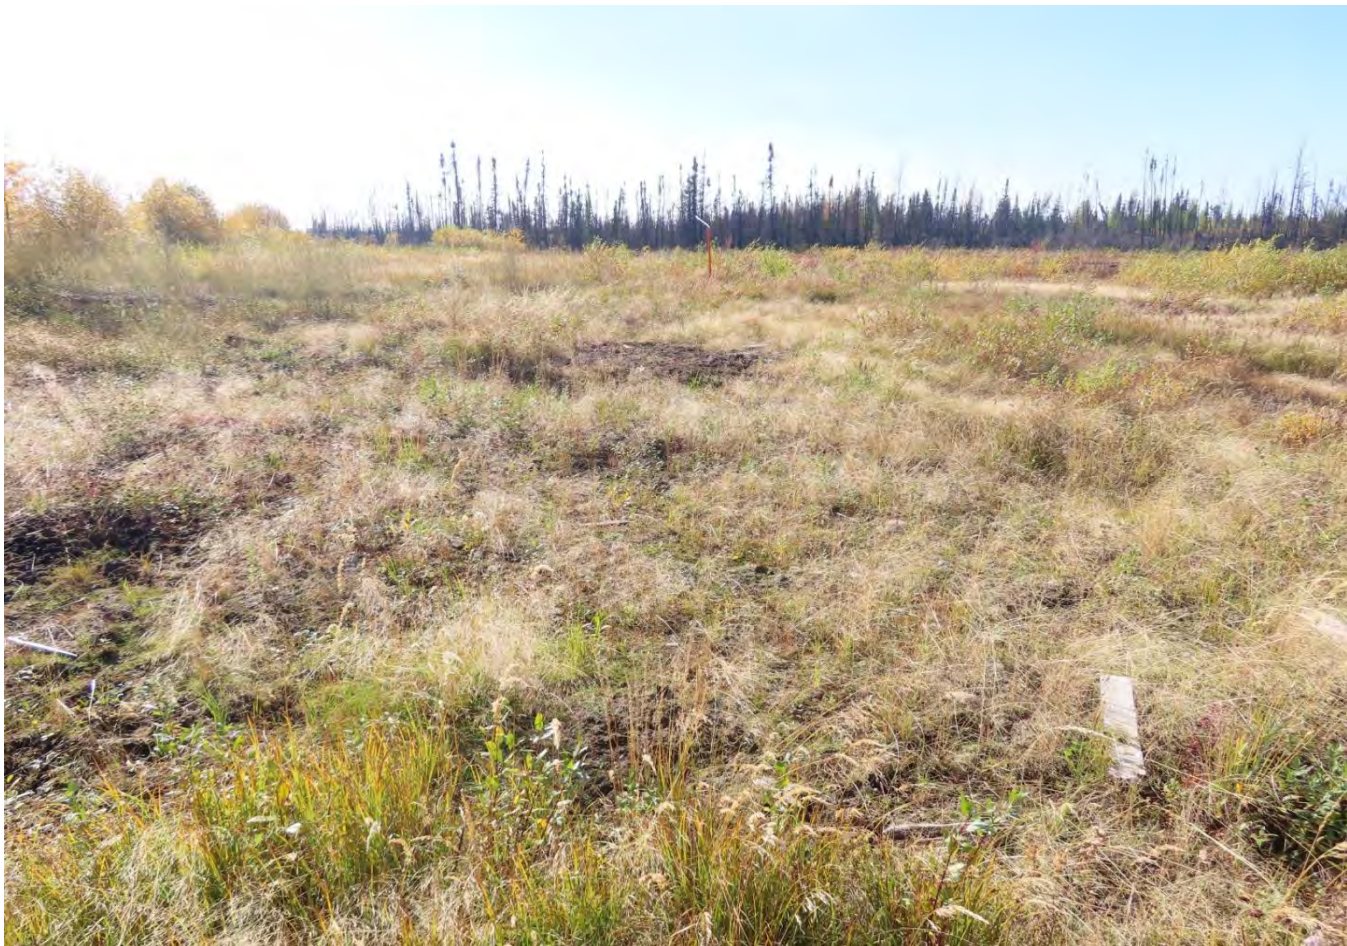
Figure 94

K-74: All production infrastructure was removed from the wellsite in the winter of 2023.

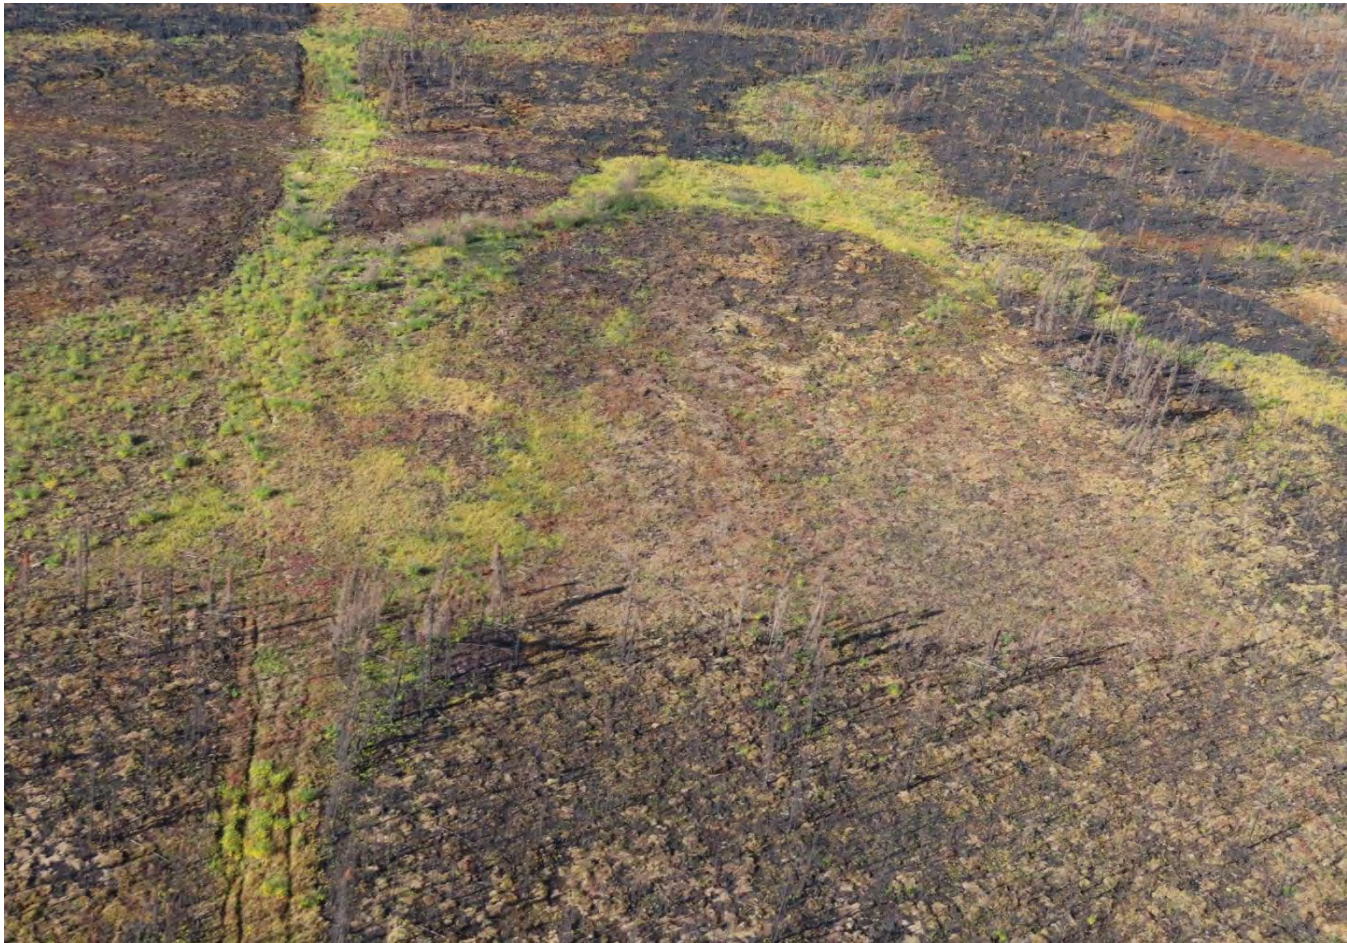
Figure 95

L-09: Aerial view of the wellsite. Site was cleared in 2010 but was never drilled. No further remediation work required at L-09.

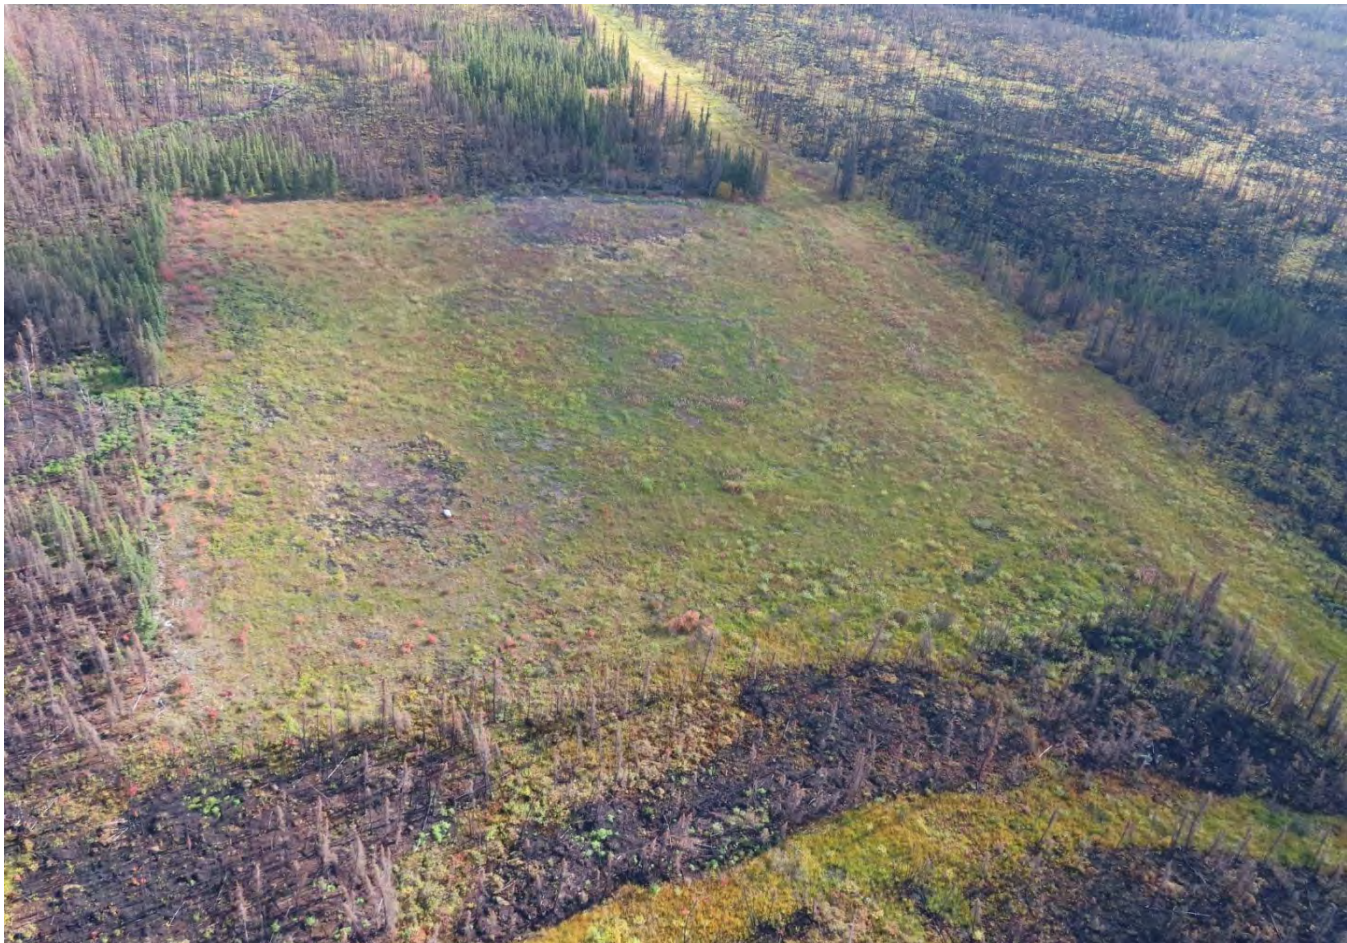
Figure 96

L-29: Aerial view of the wellsite. Well was abandoned on January 15, 2023. No further remediation work required at L-29.

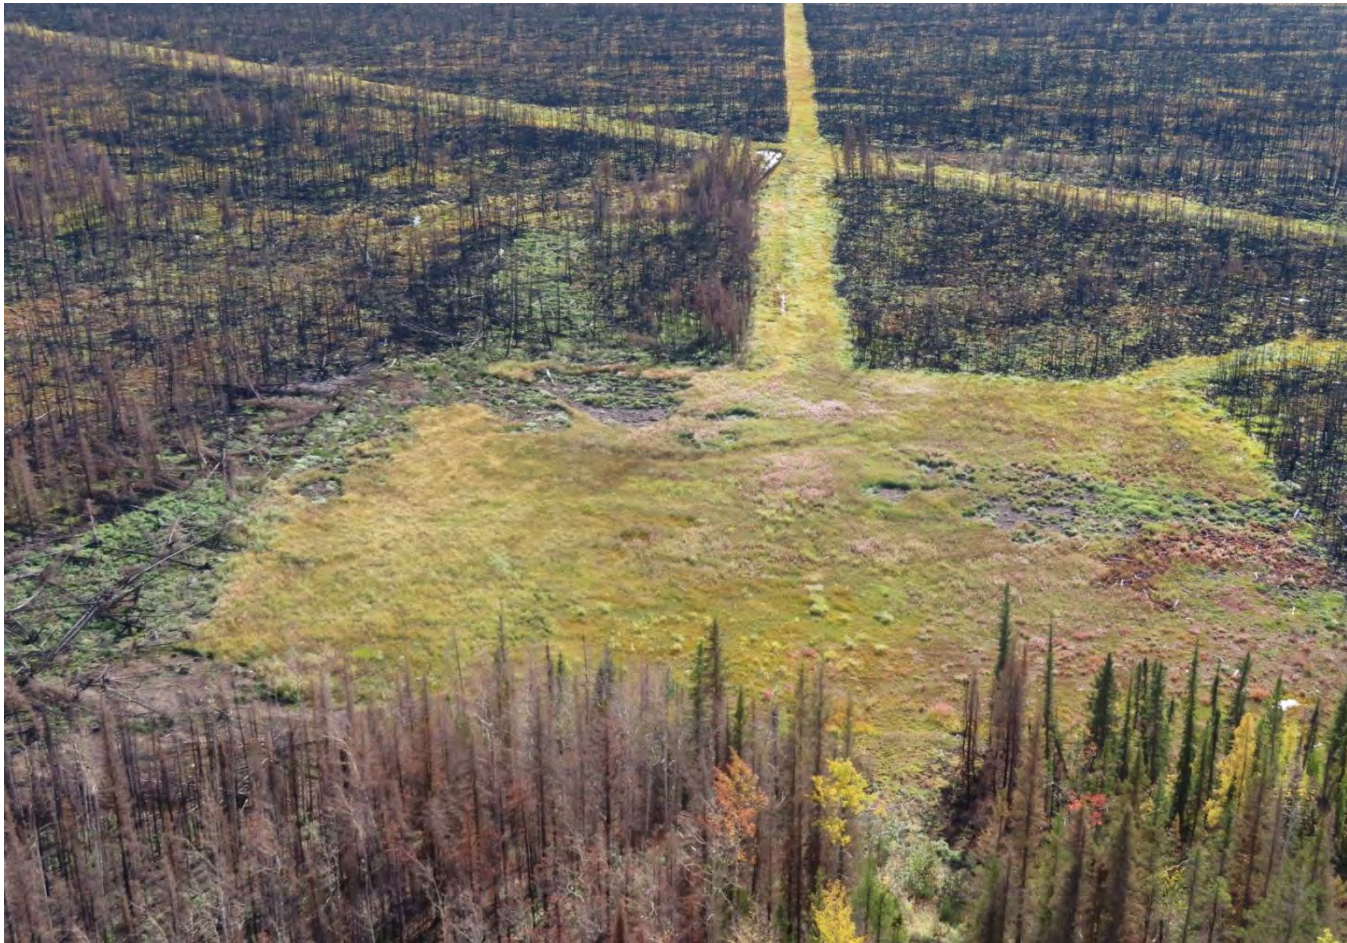
Figure 97

L-40: Aerial view of the wellsite. Well was abandoned on March 08, 2023. No further remediation work required at L-40.

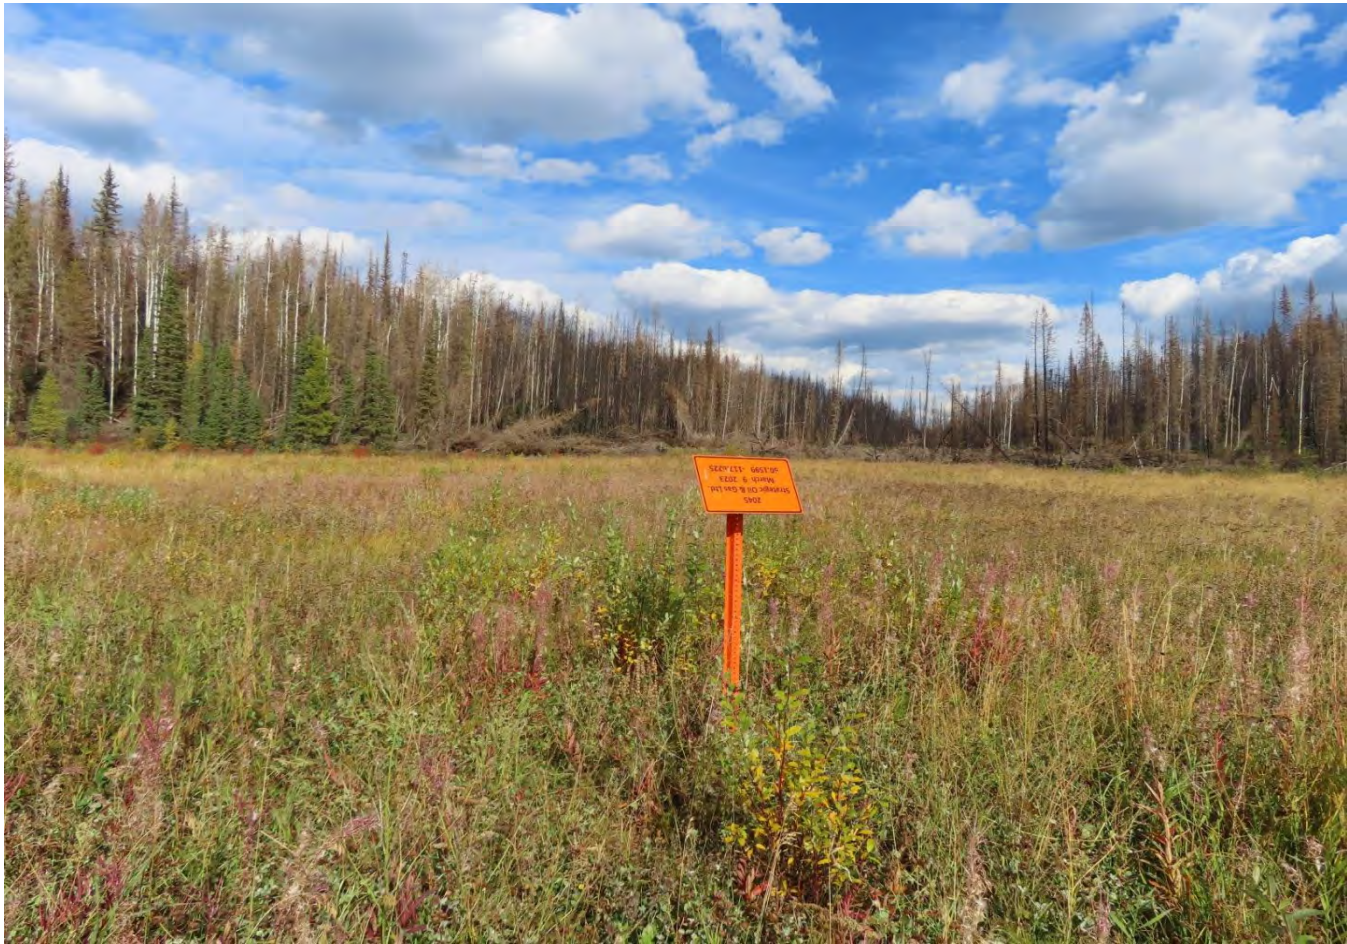
Figure 98

L-40: Backfill of well center appears satisfactory.

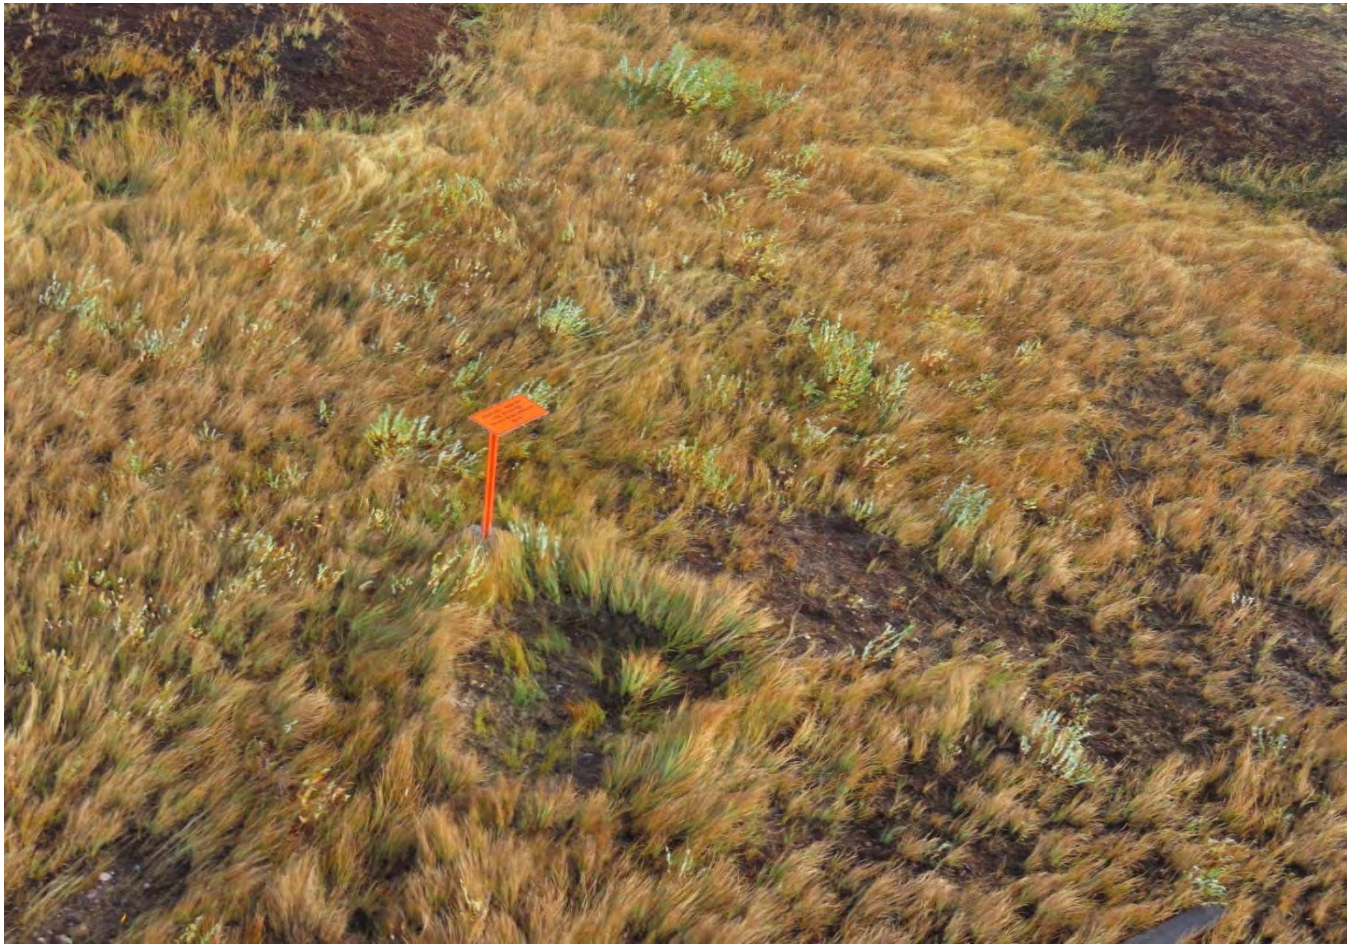
Figure 100

L-44: Backfill of well center appears satisfactory.

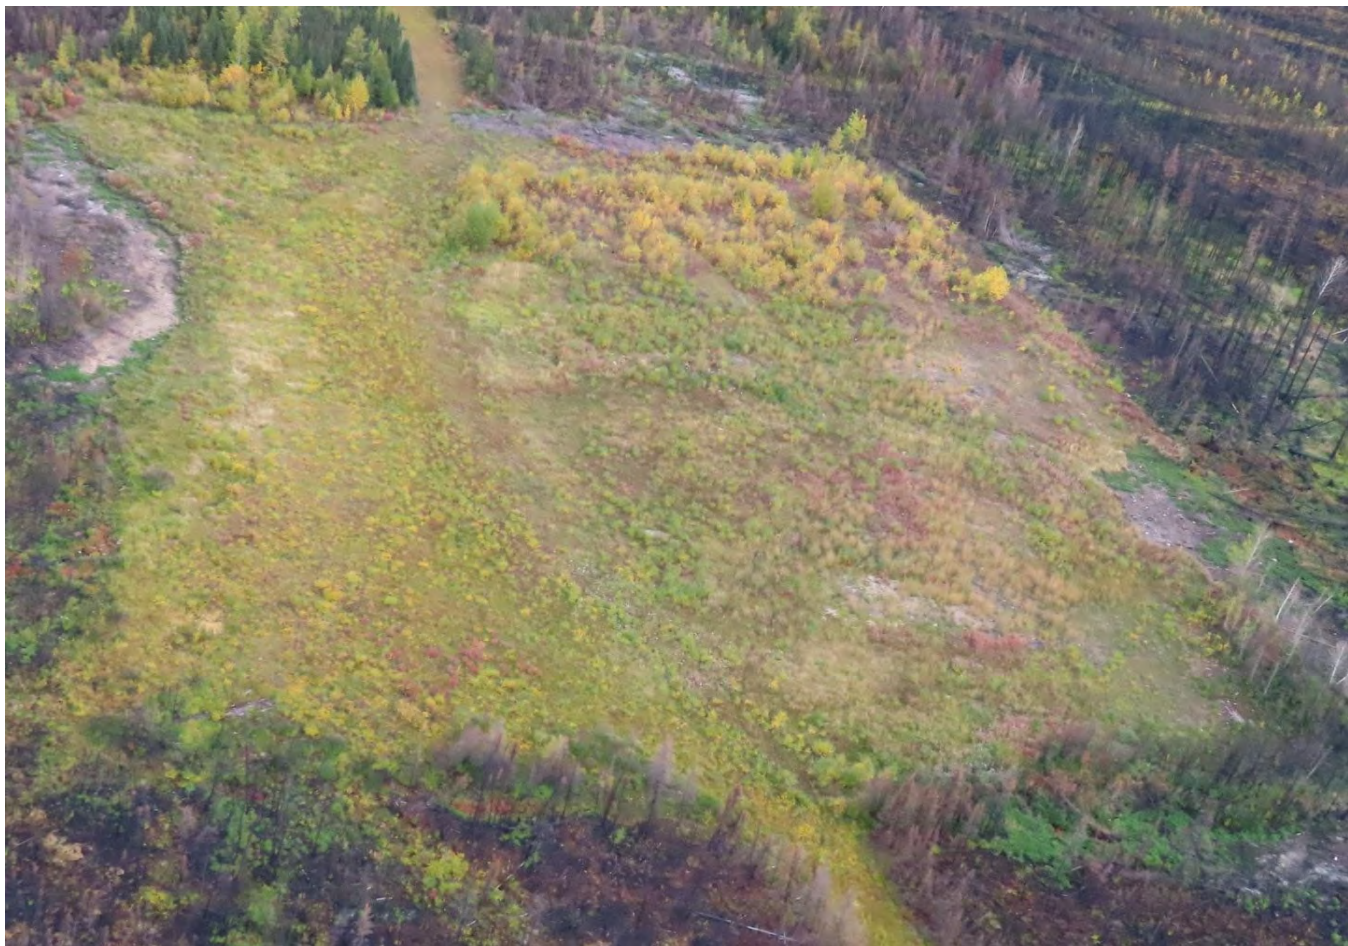
Figure 101

L-47: Aerial view of the wellsite. Well was abandoned on February 27, 2023.

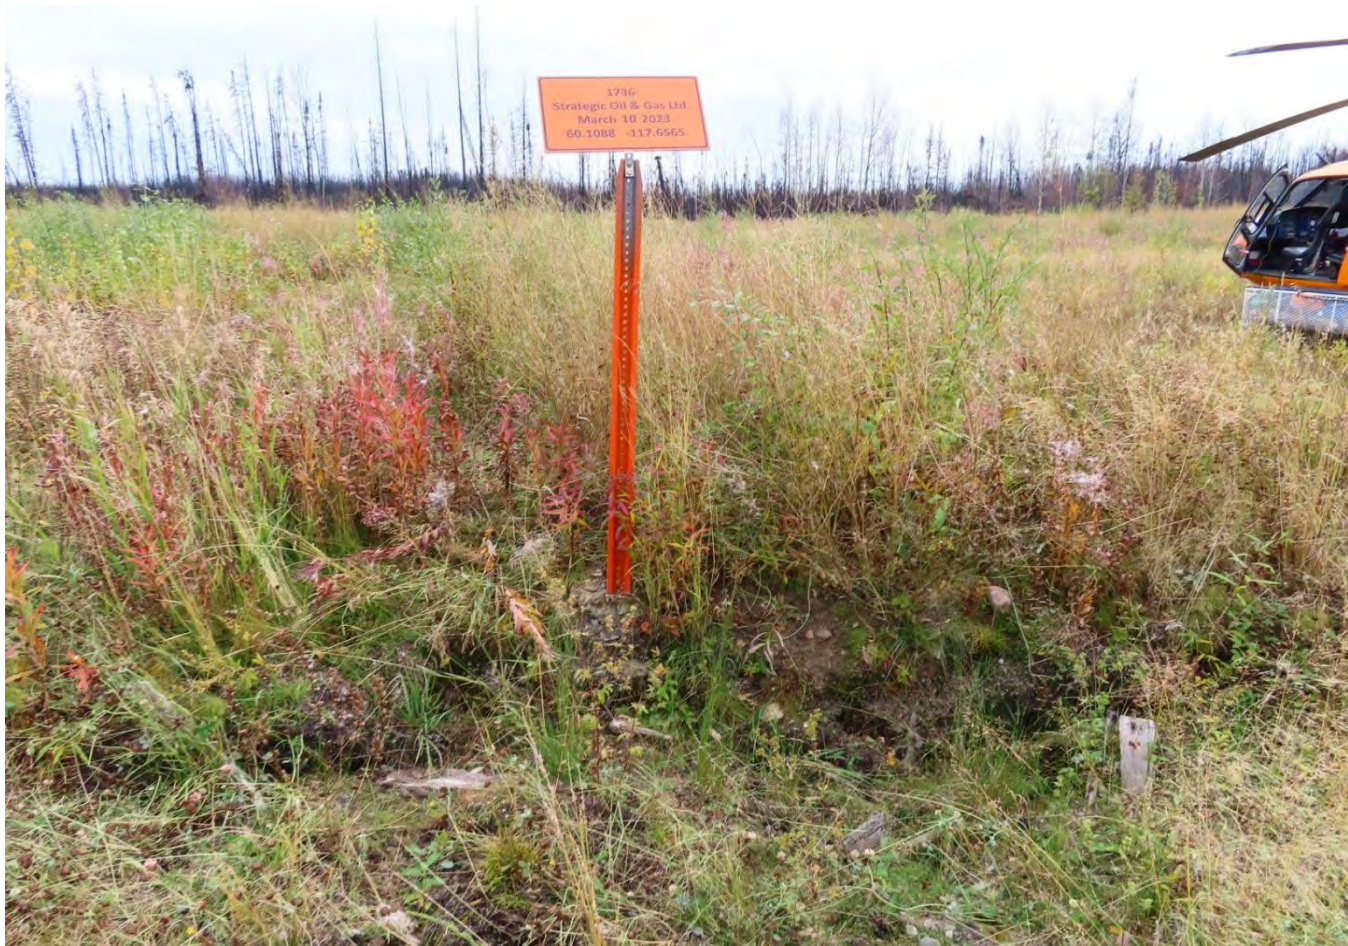
Figure 102

L-47: Backfill of well center appears satisfactory.

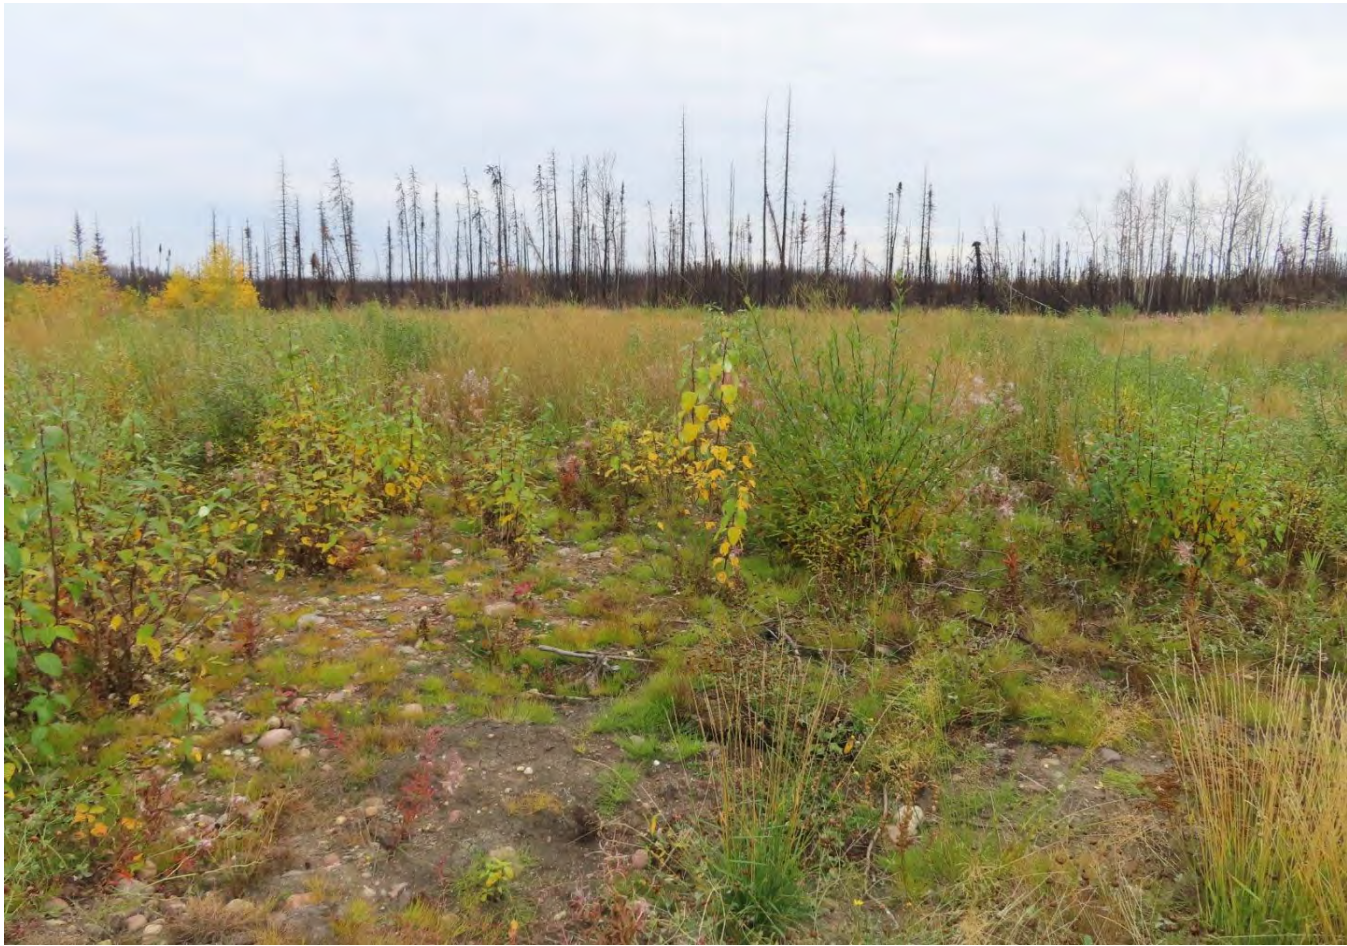
Figure 103

L-47: All production infrastructure was removed from the wellsite in the winter of 2023.
