File Number	MV2022X0018
Type of Operation	Cameron Hills Oil and Gas Field Abandonment
Location	Cameron Hills, NT

ENVIRONMENTAL INSPECTION REPORT

Permittee:	Strategic Oil and Gas Ltd. c/o Alvarez & Marsal Canada Inc.	Permit Expiry Date:	January 02, 2028
Land Use Permit No.	MV2022X0018	Previous Inspection:	February 21, 2024
Quarrying Permit No.		Inspection Date:	September 17, 2024
Contractor:	ELM Inc.	Subcontractor:	
Location(s) Inspected:	Cameron Hills Oil and Gas Field		
Current Stage of Operation:	The abandonment of the H-03 Battery, forty-four (44) oil and gas wells was completed in the winter of 2023 and 2024.		
Program Modifications Approved:

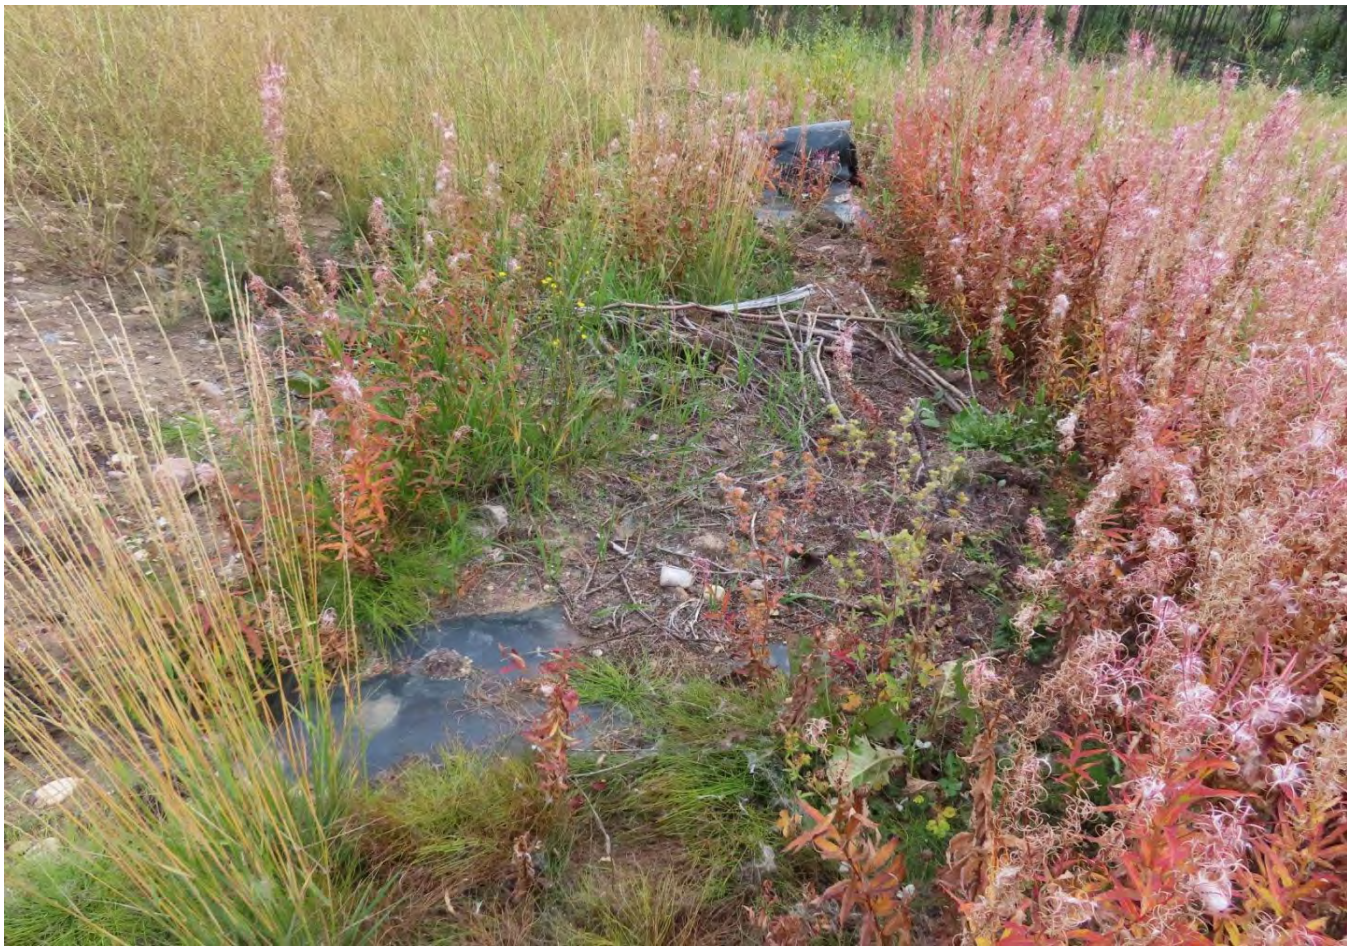
Figure 104

L-47: Bulk tank liner partially buried located near the southwest corner of the wellsite to be removed.

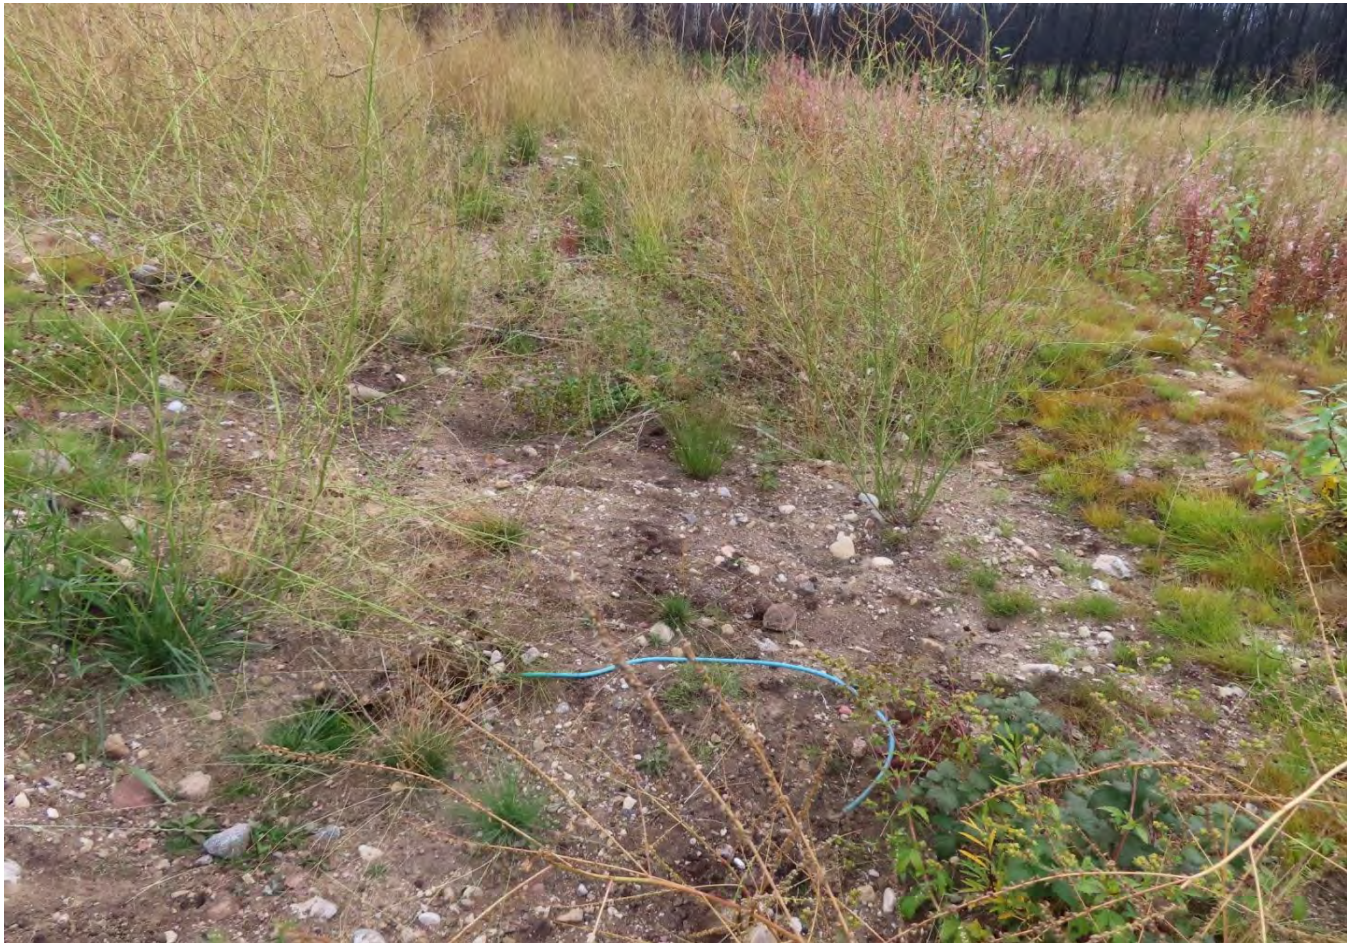
Figure 105

L-47: Grounding cable partially buried located near the southwest corner of the wellsite to be removed.

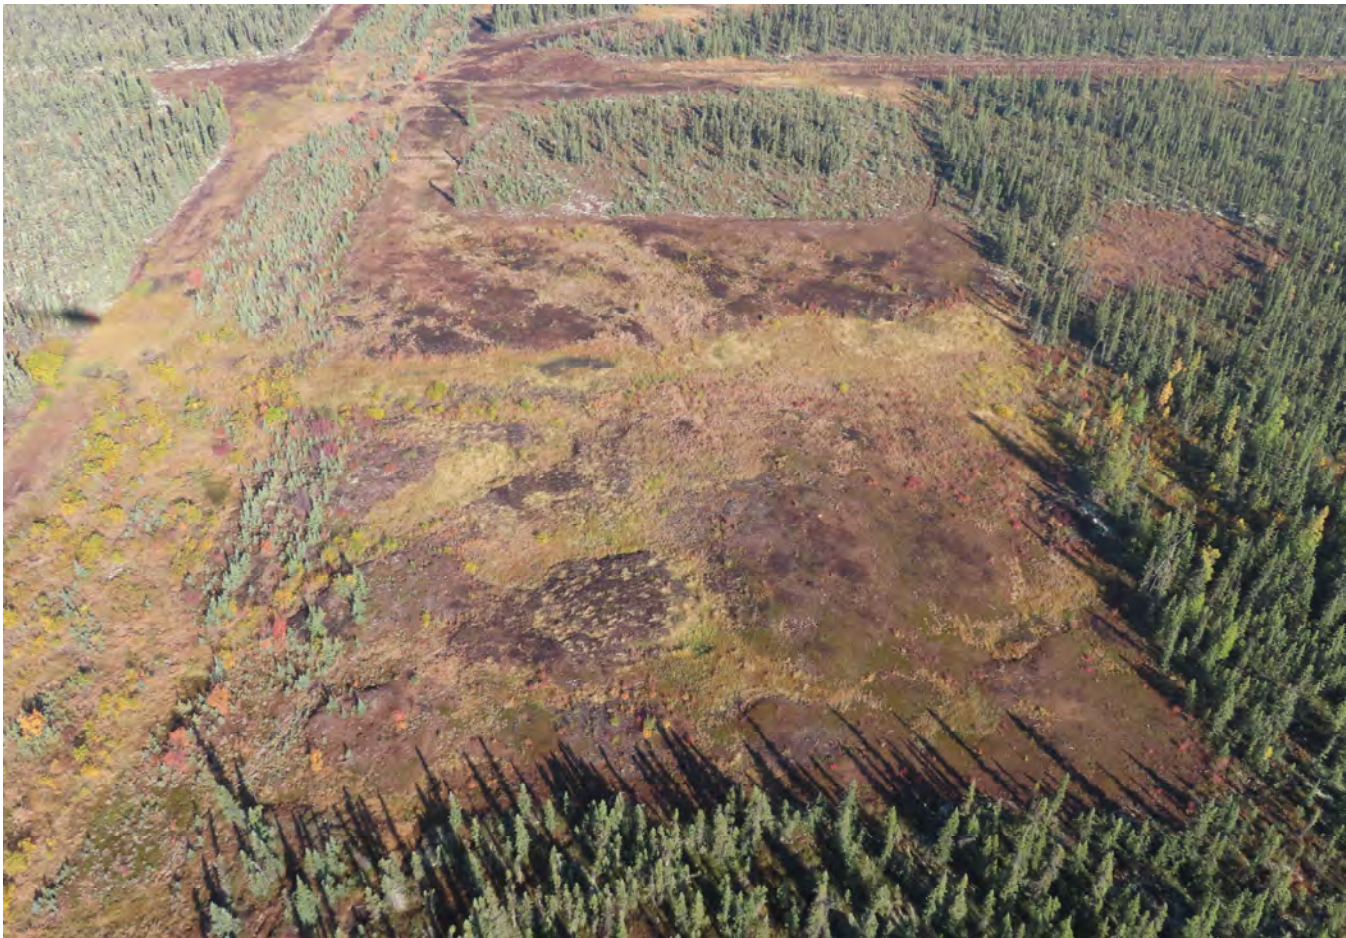
Figure 106

L-73: Aerial view of the wellsite. Well was abandoned on February 23, 2023. No further remediation work required at L-73.

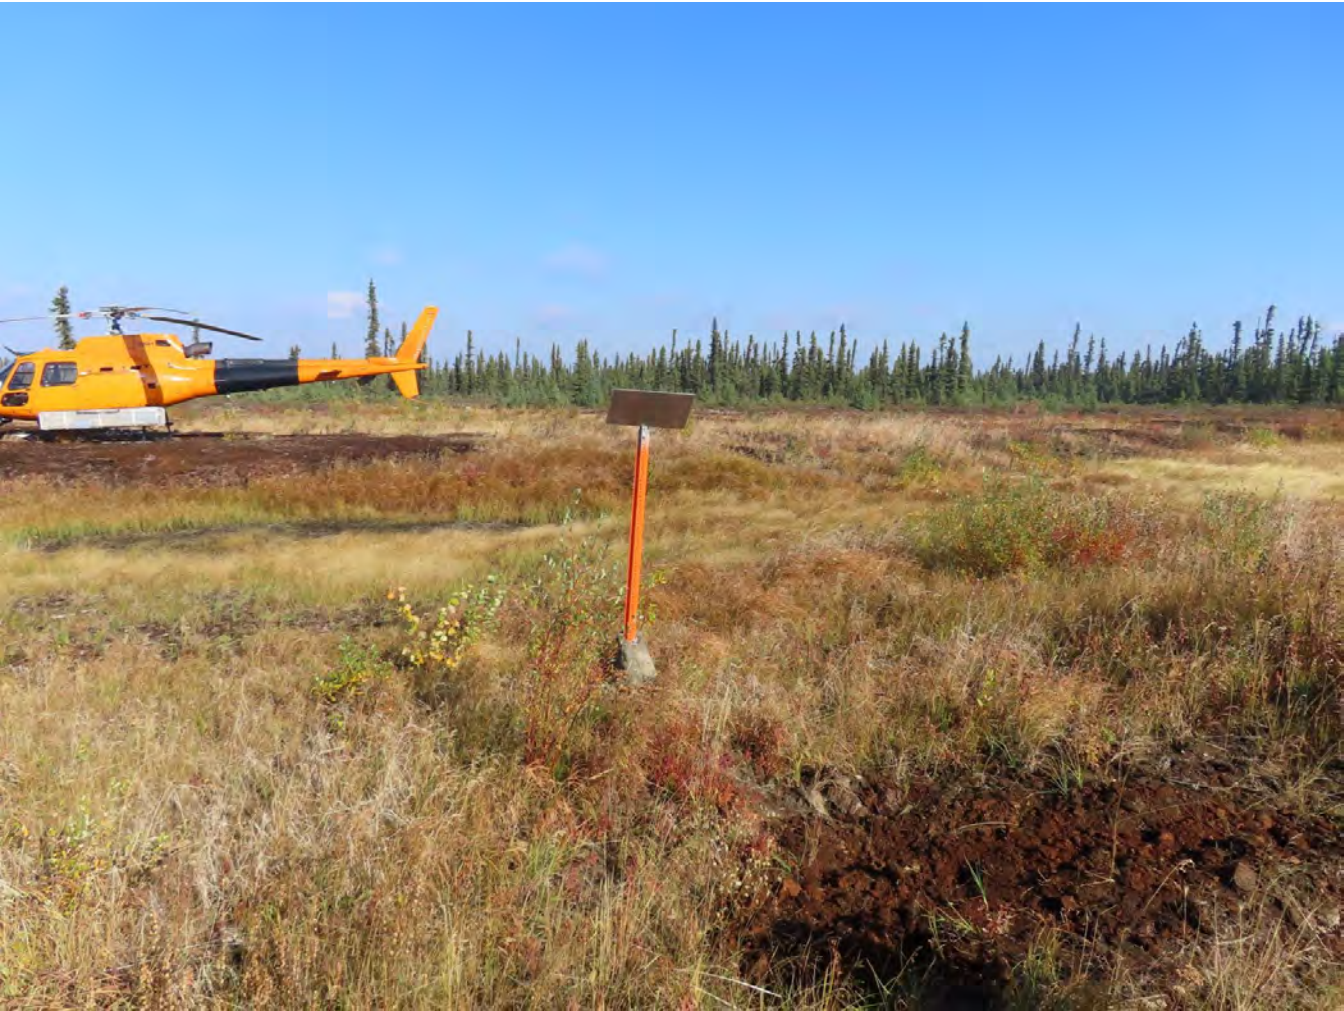
Figure 107

L-73: Backfill of well center appears satisfactory.

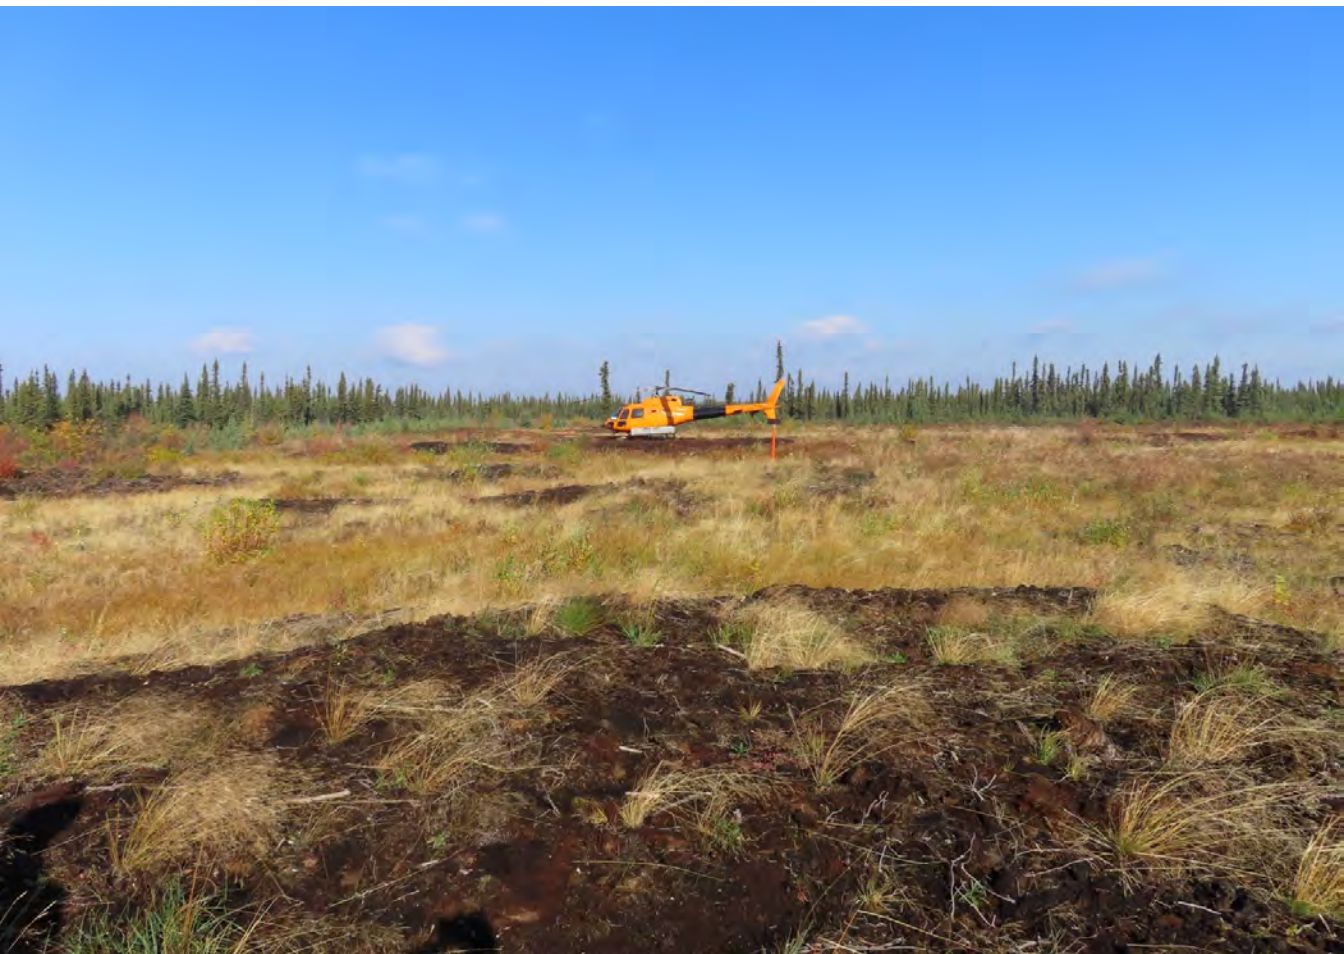
Figure 108

L-73: All production infrastructure was removed from the wellsite in the winter of 2023.

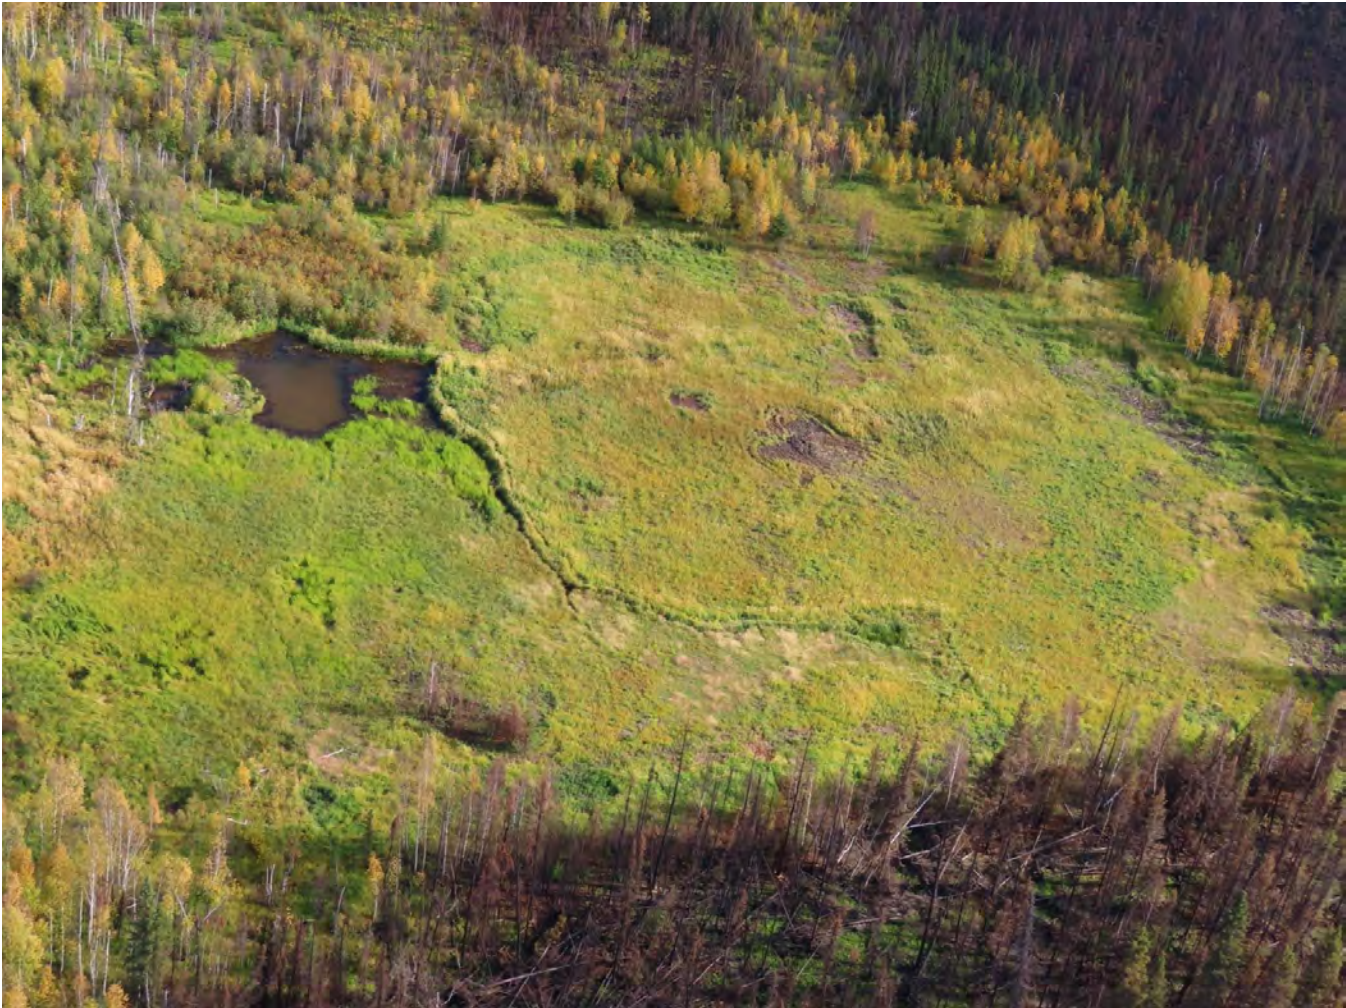
Figure 109

M-31: Aerial view of the wellsite. Well was abandoned on February 17, 2024. No further remediation work required at M-31.

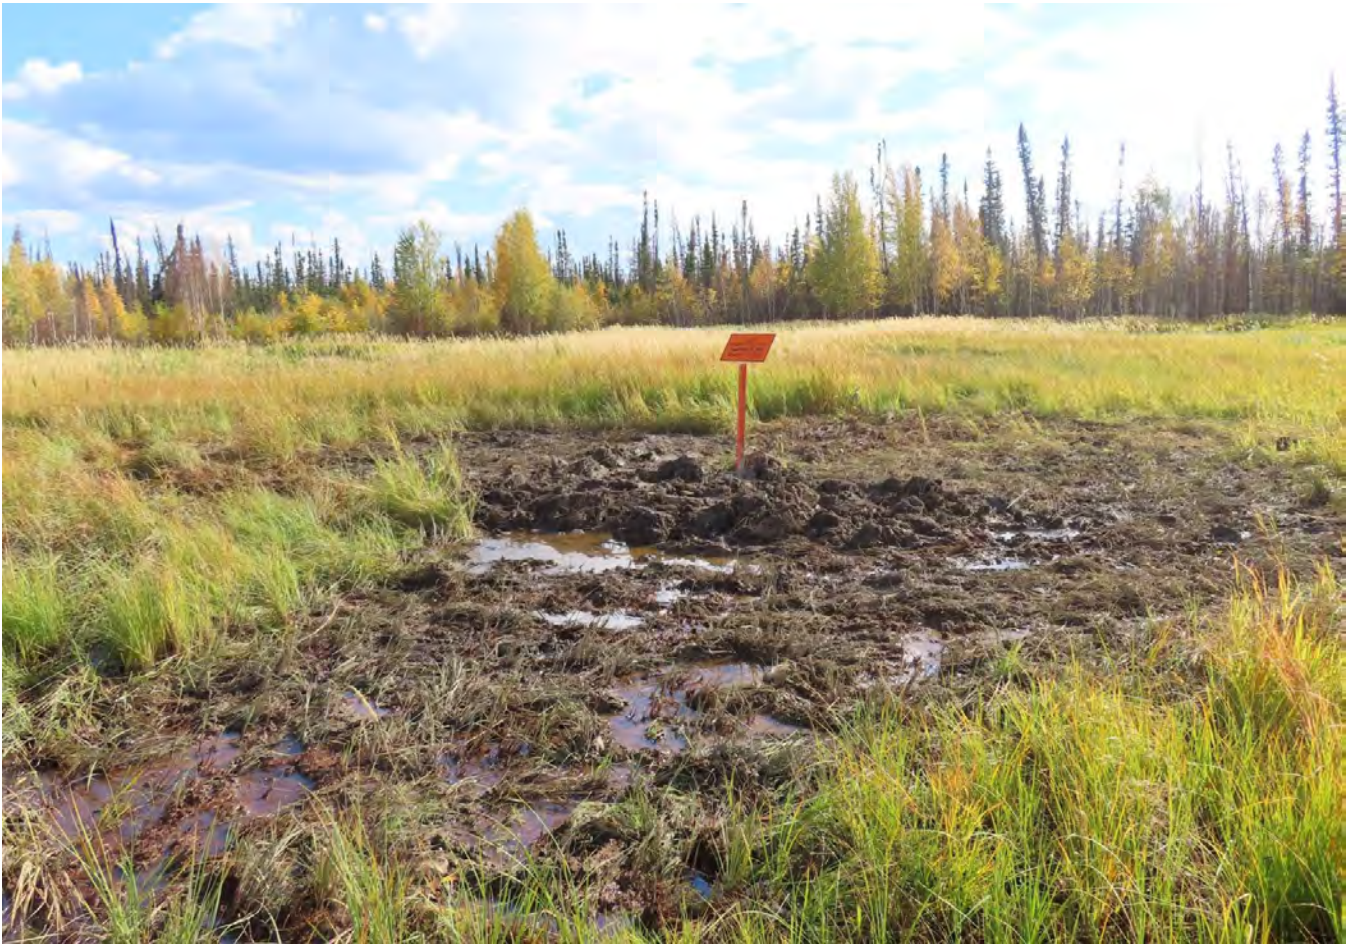
Figure 110

M-31: Backfill of well center appears satisfactory. Site noted to be very wet.

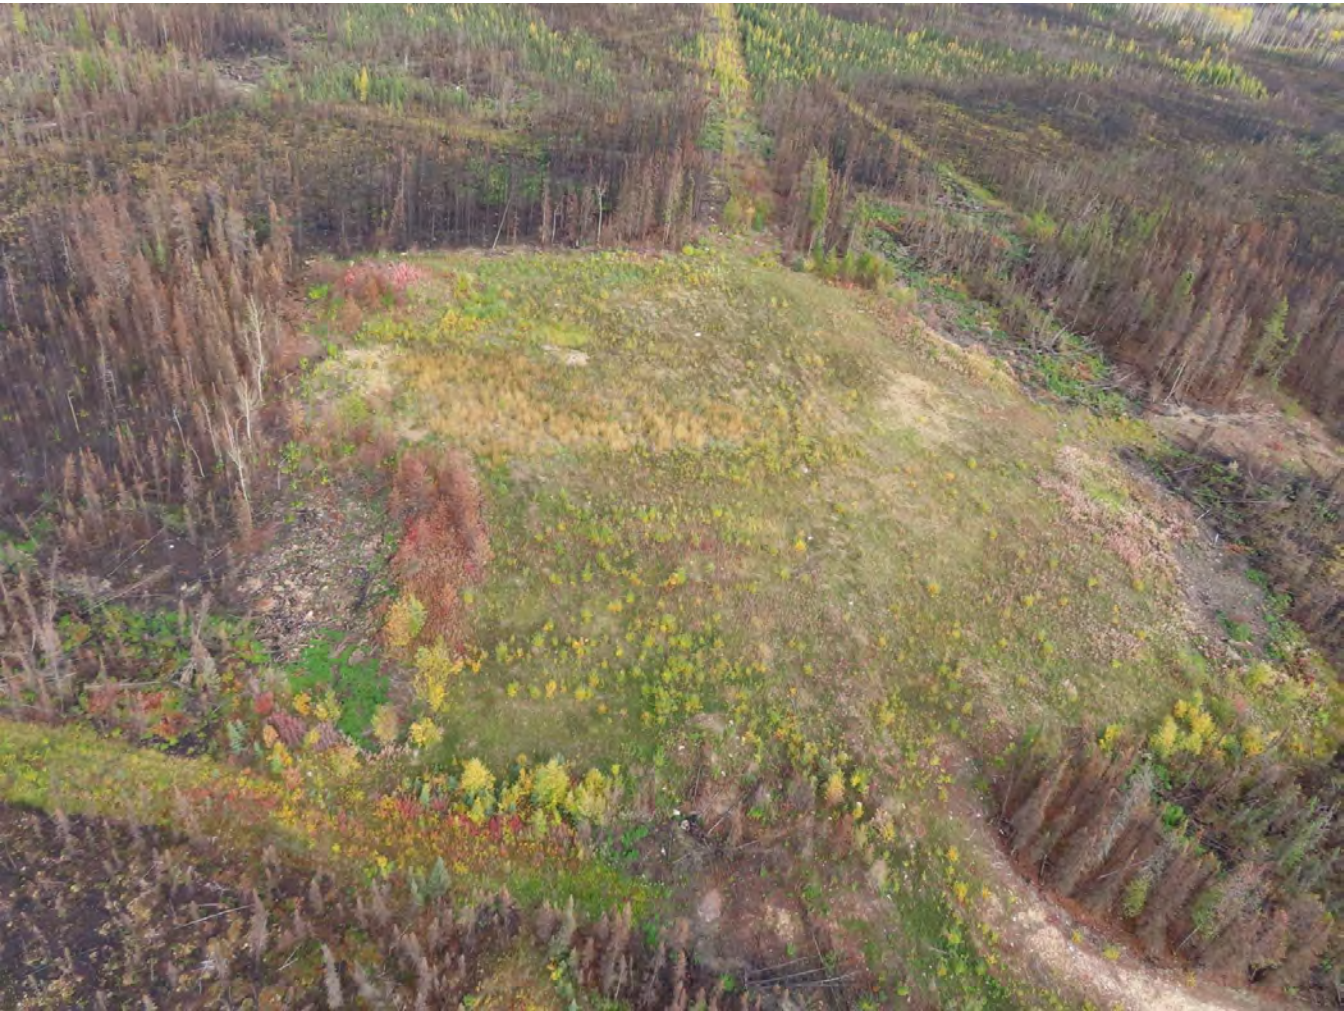
Figure 111

M-49: Aerial view of the wellsite. Well was abandoned on February 29, 2023.

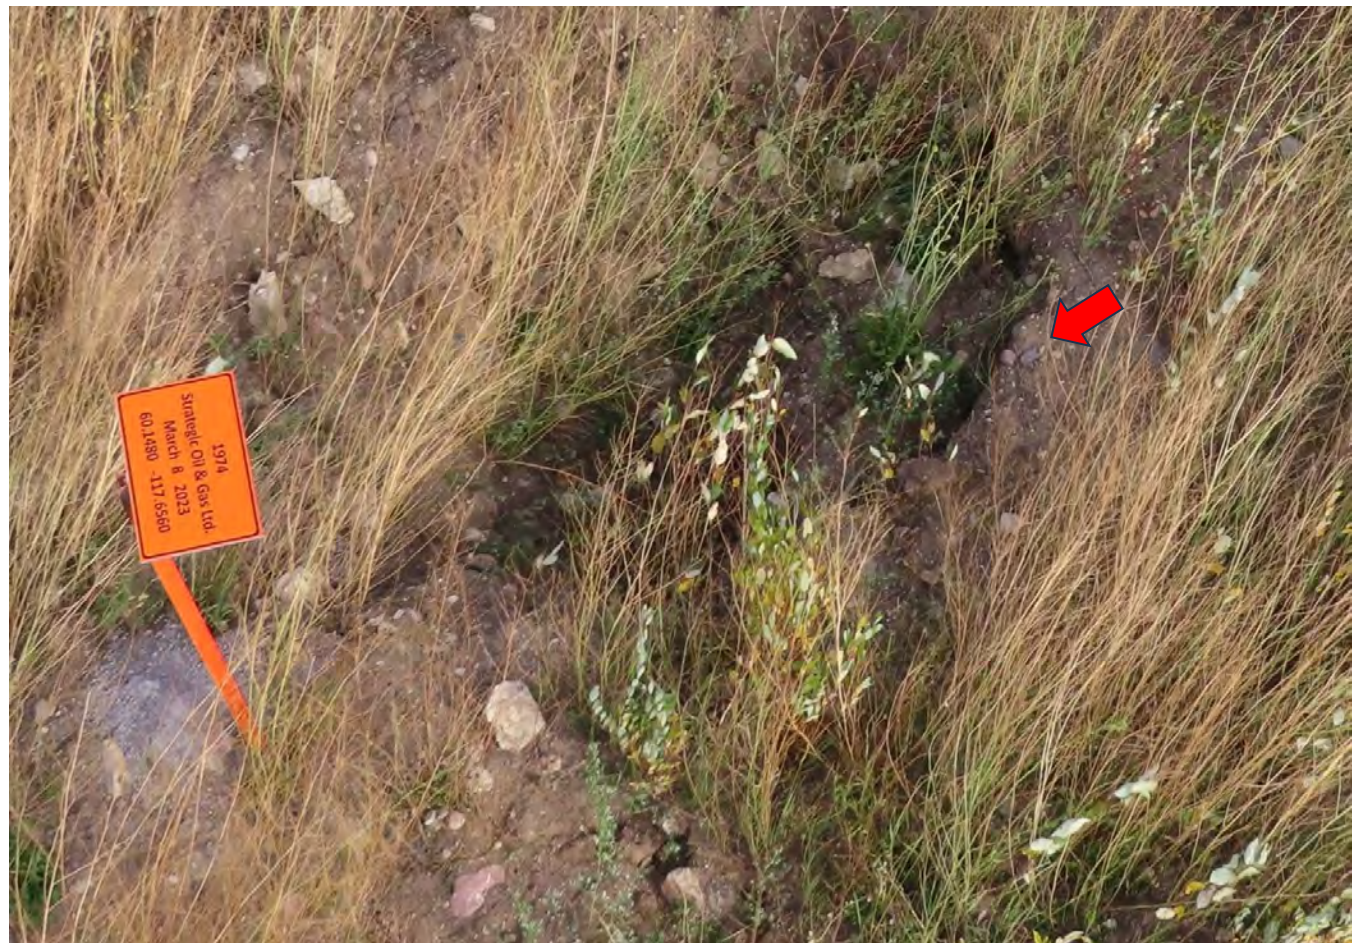
Figure 112

M-49: Backfill of well center not completed following abandonment operations.

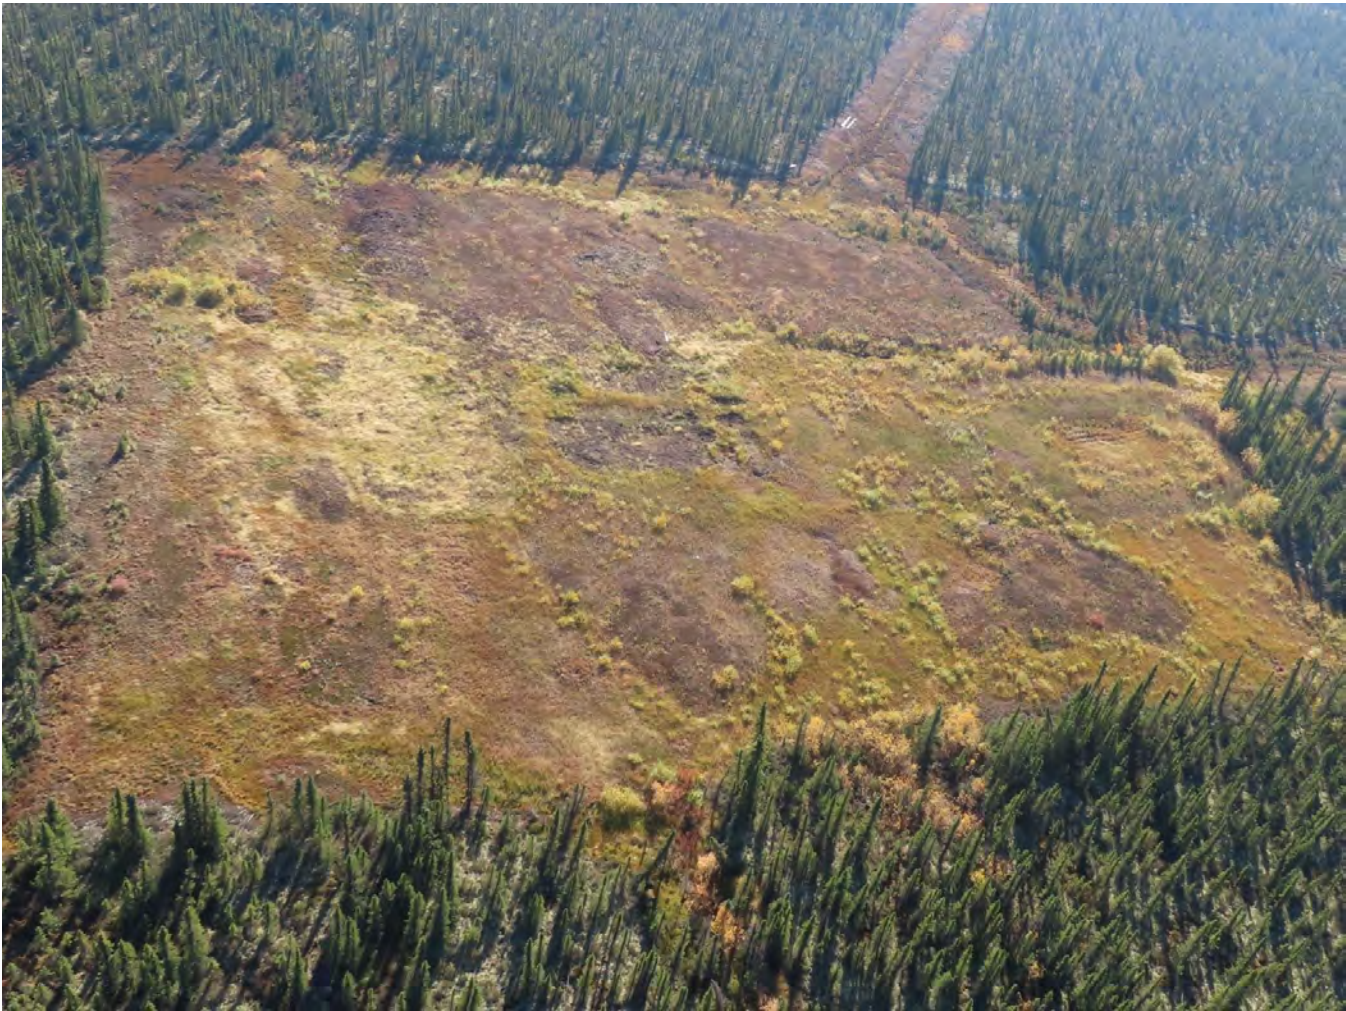
Figure 113

M-73/2M-73: Aerial view of the wellsite. M-73 was abandoned on March 15, 2023 and 2M-73 was abandoned on February 29, 2023.

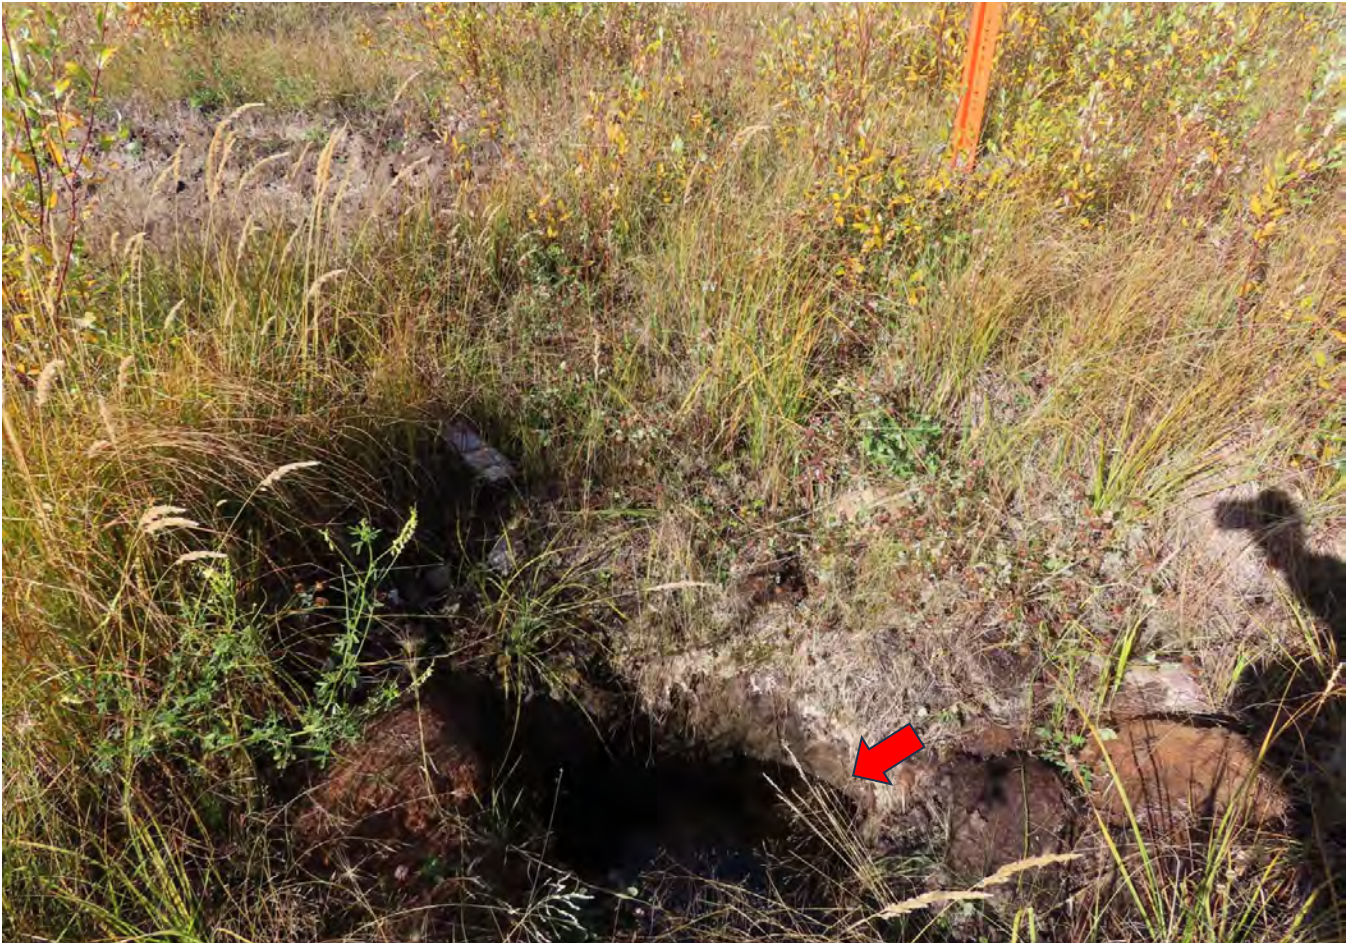
Figure 114

M-73: Backfill of M-73 well center not completed following abandonment operations.

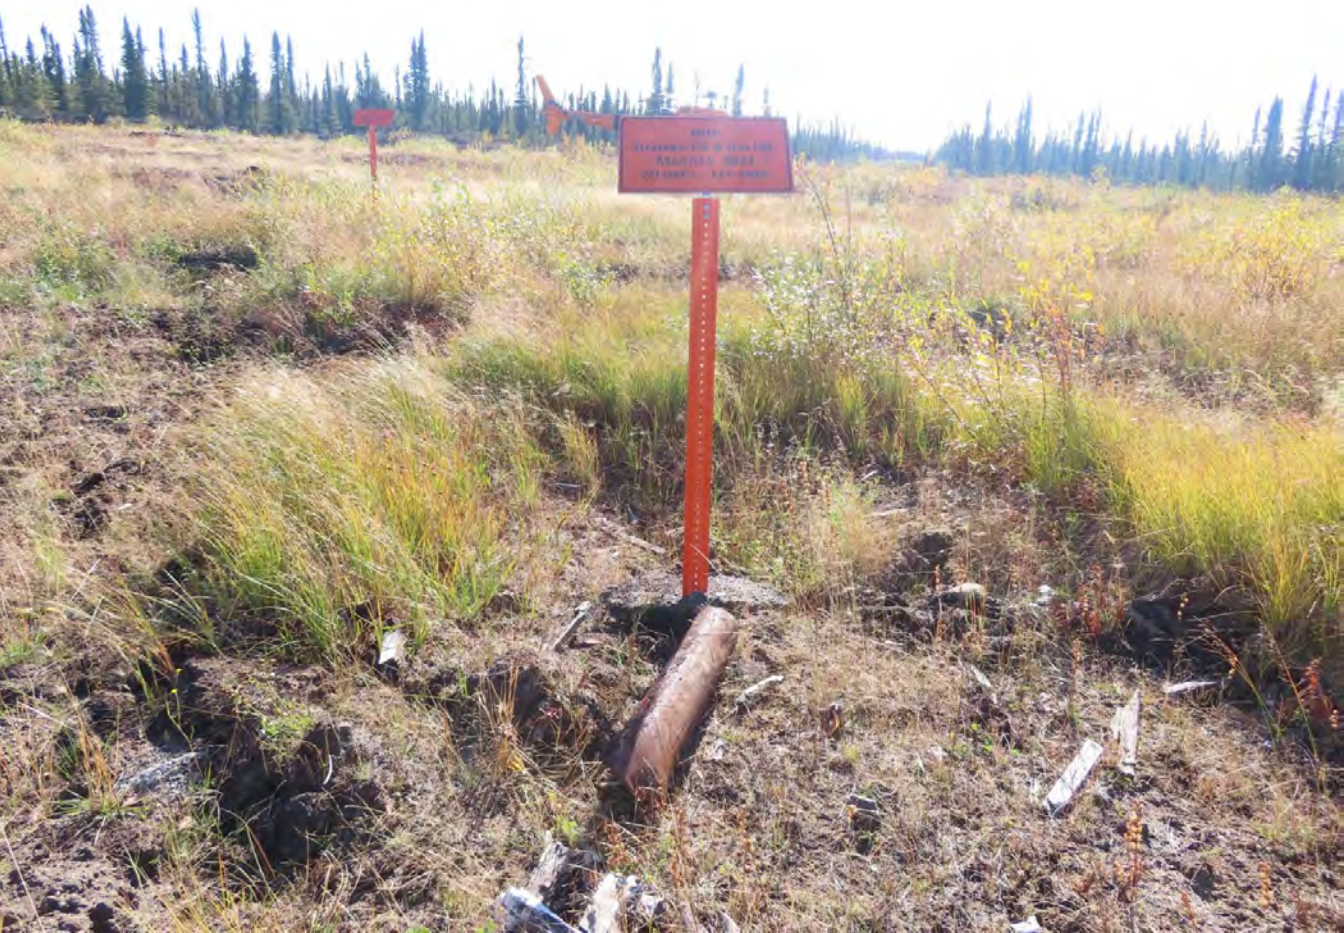
Figure 115

2M-73: Length of steel piling located at 2M-73 to be removed. Backfill of 2M-73 appeared satisfactory. *Insert:* A small amount of metal debris located on the wellsite to be removed.

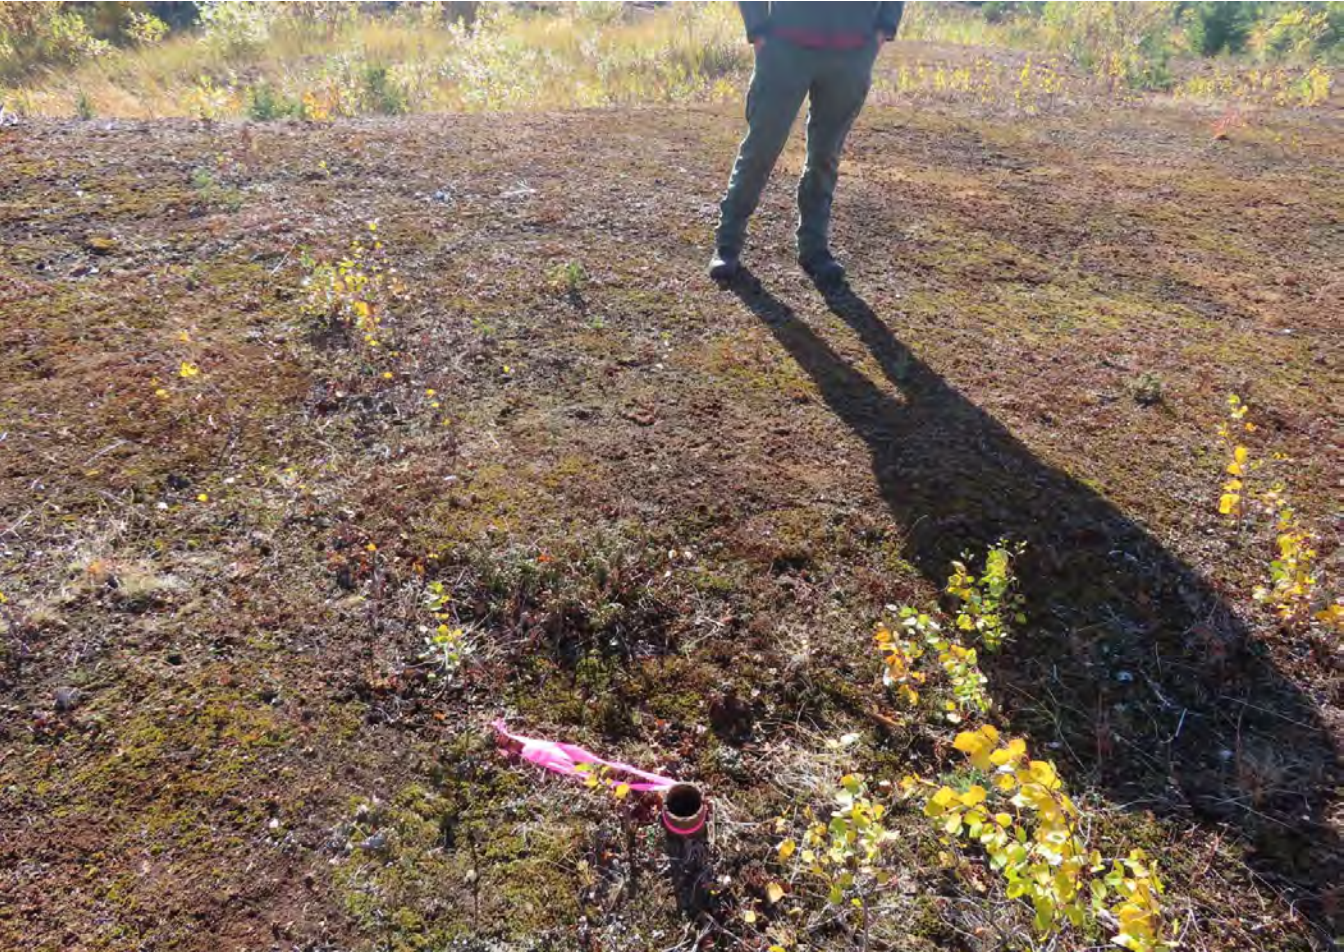
Figure 118

M-73/2M-73: Steel piling cut above ground level located on the wellsite to be removed.

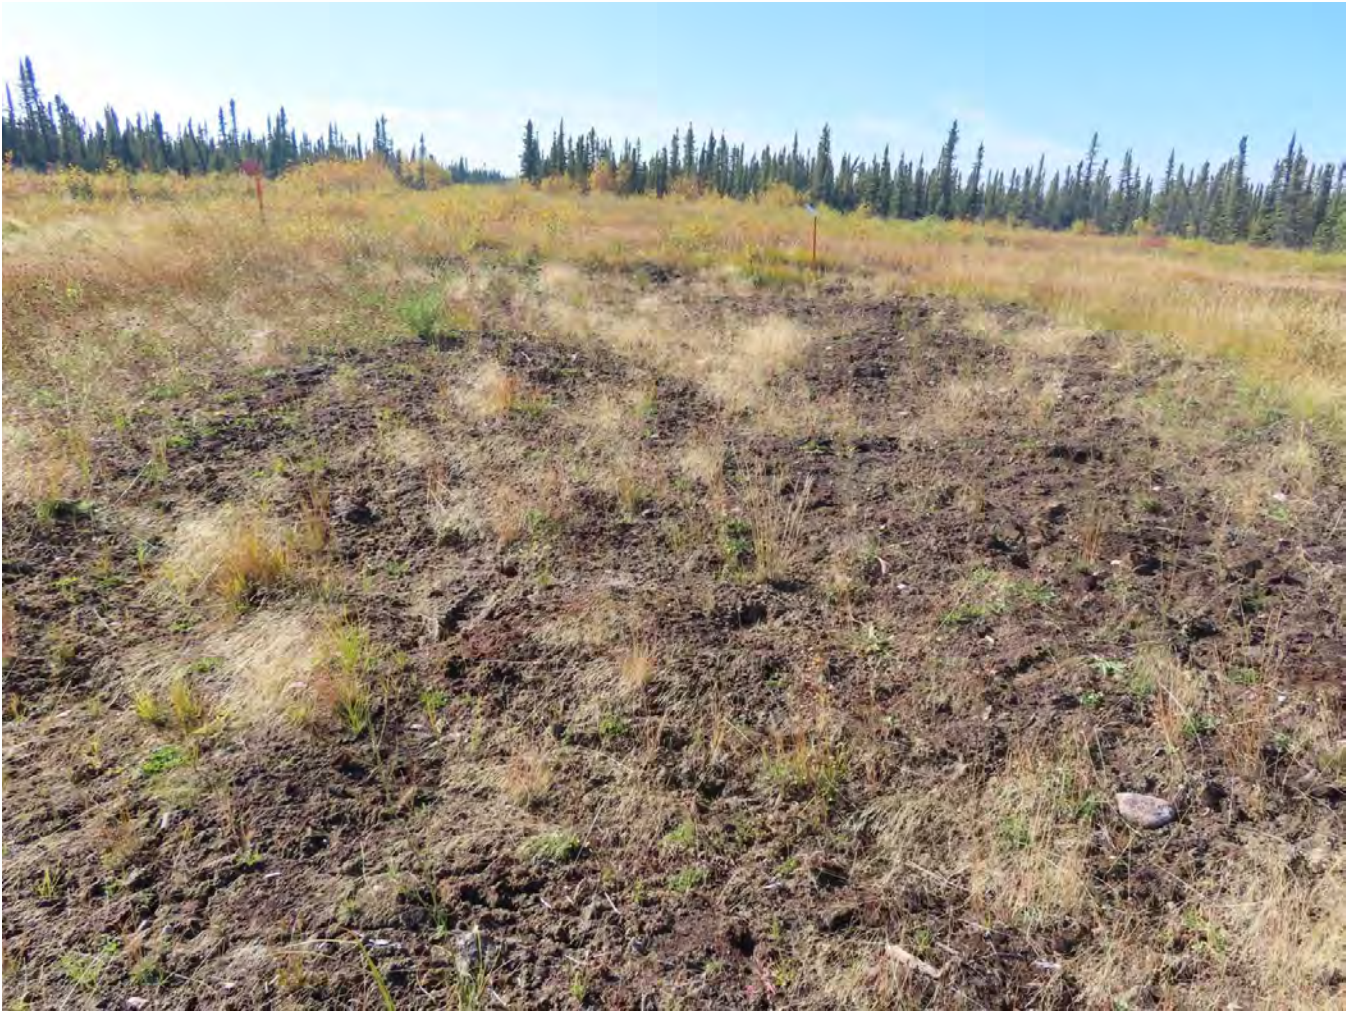
Figure 119

M-73/2M-73: All production infrastructure was removed from the wellsite in the winter of 2023.

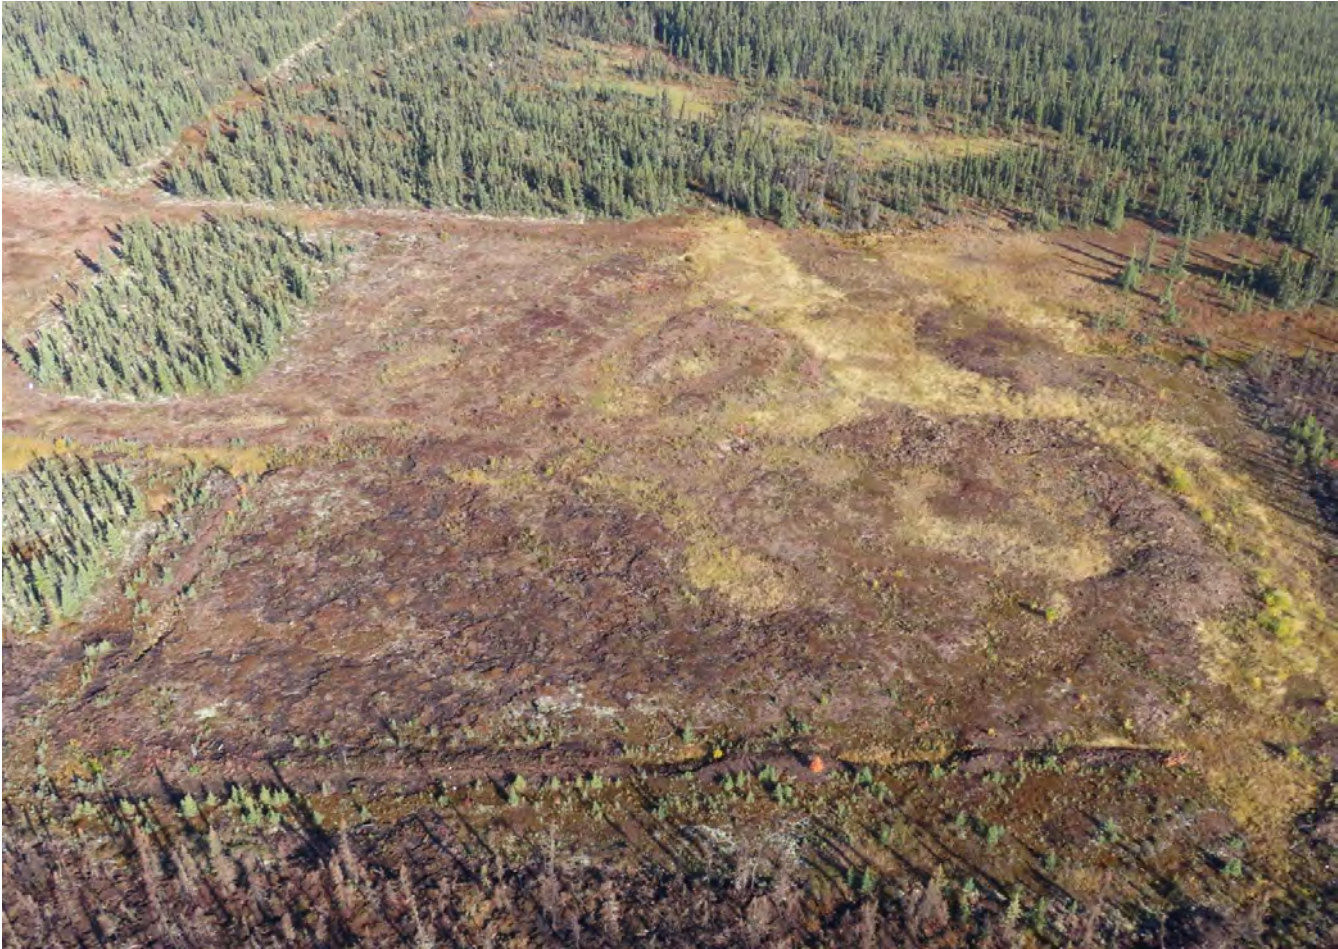
Figure 120

M-74: Aerial view of the wellsite. Well was abandoned on March 09, 2023.

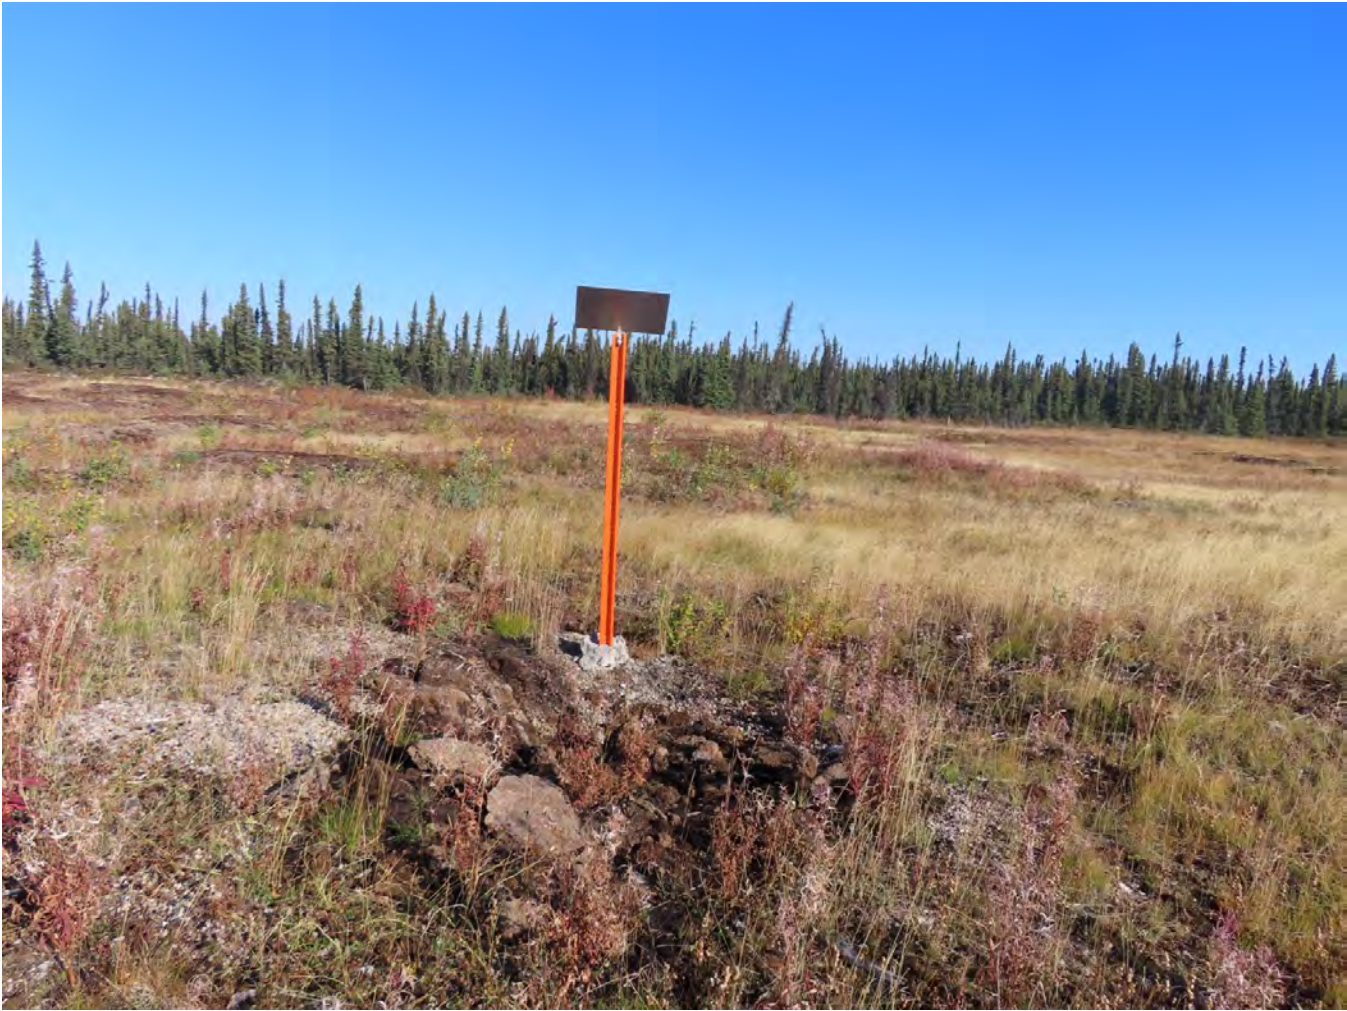
Figure 121

M-74: Backfill of well center appears satisfactory.

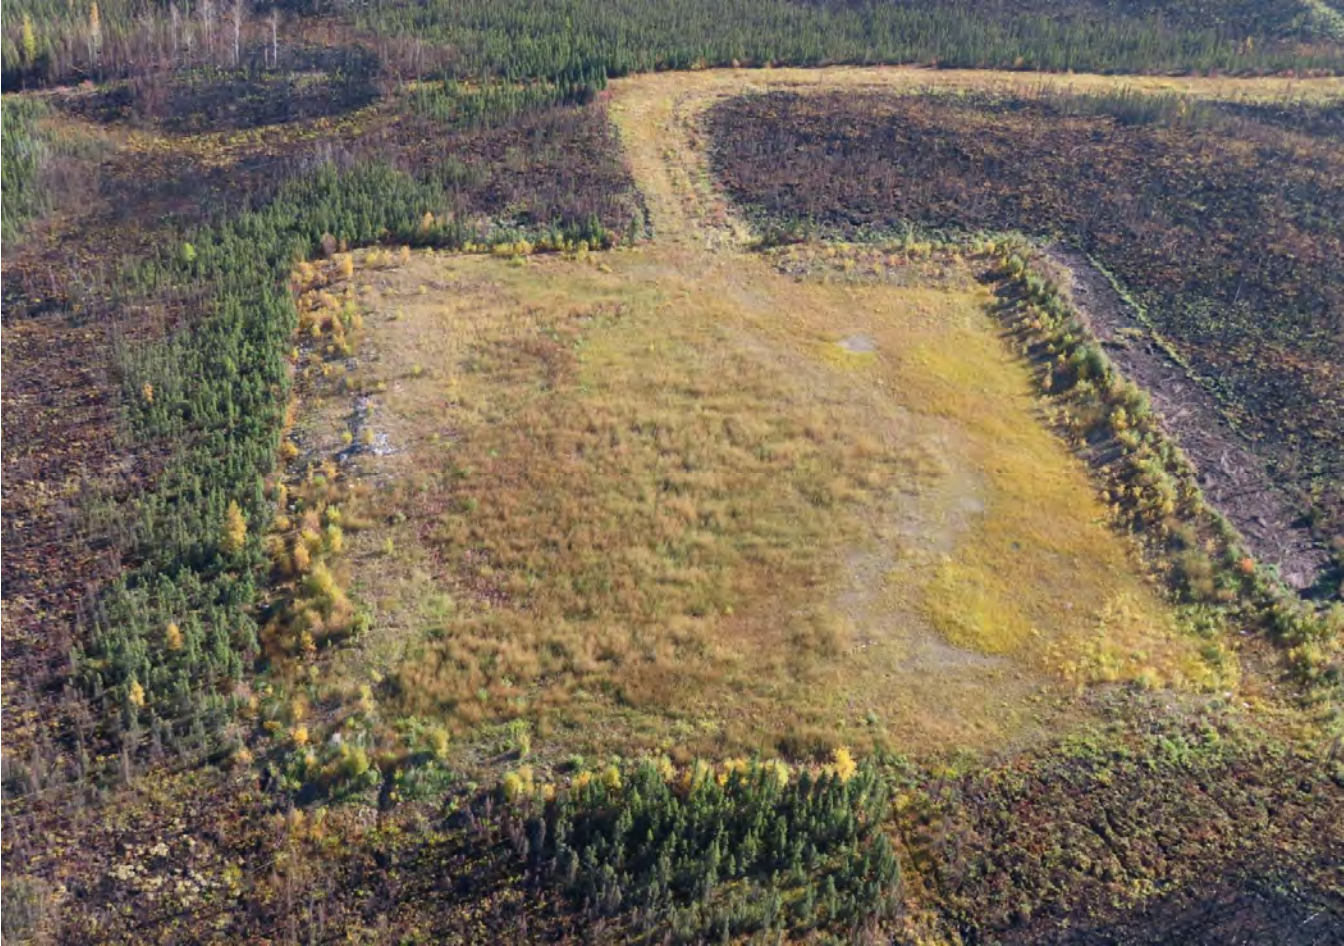
Figure 124

N-06: Aerial view of the wellsite. Well was abandoned on January 11, 2023. No further remediation work required at N-06.
