File Number	MV2022X0018
Type of Operation	Cameron Hills Oil and Gas Field Abandonment
Location	Cameron Hills, NT

ENVIRONMENTAL INSPECTION REPORT

Permittee:	Strategic Oil and Gas Ltd. c/o Alvarez & Marsal Canada Inc.	Permit Expiry Date:	January 02, 2028
Land Use Permit No.	MV2022X0018	Previous Inspection:	February 21, 2024
Quarrying Permit No.		Inspection Date:	September 17, 2024
Contractor:	ELM Inc.	Subcontractor:	
Location(s) Inspected:	Cameron Hills Oil and Gas Field		
Current Stage of Operation:	The abandonment of the H-03 Battery, forty-four (44) oil and gas wells was completed in the winter of 2023 and 2024.		
Program Modifications Approved:

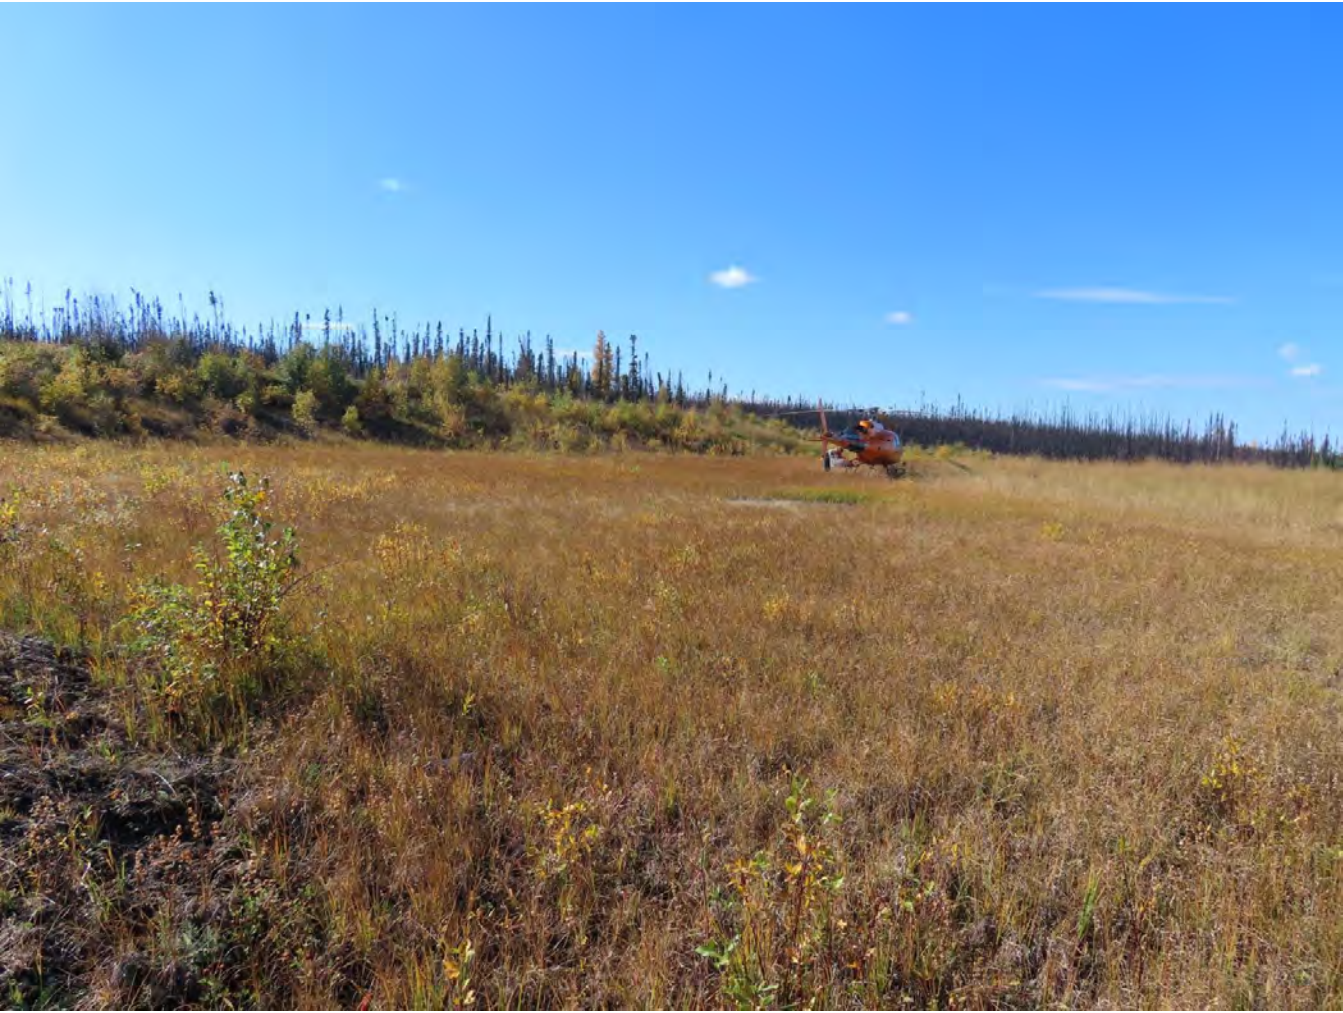
Figure 125

N-06: All production infrastructure was removed from the wellsite in the winter of 2023.

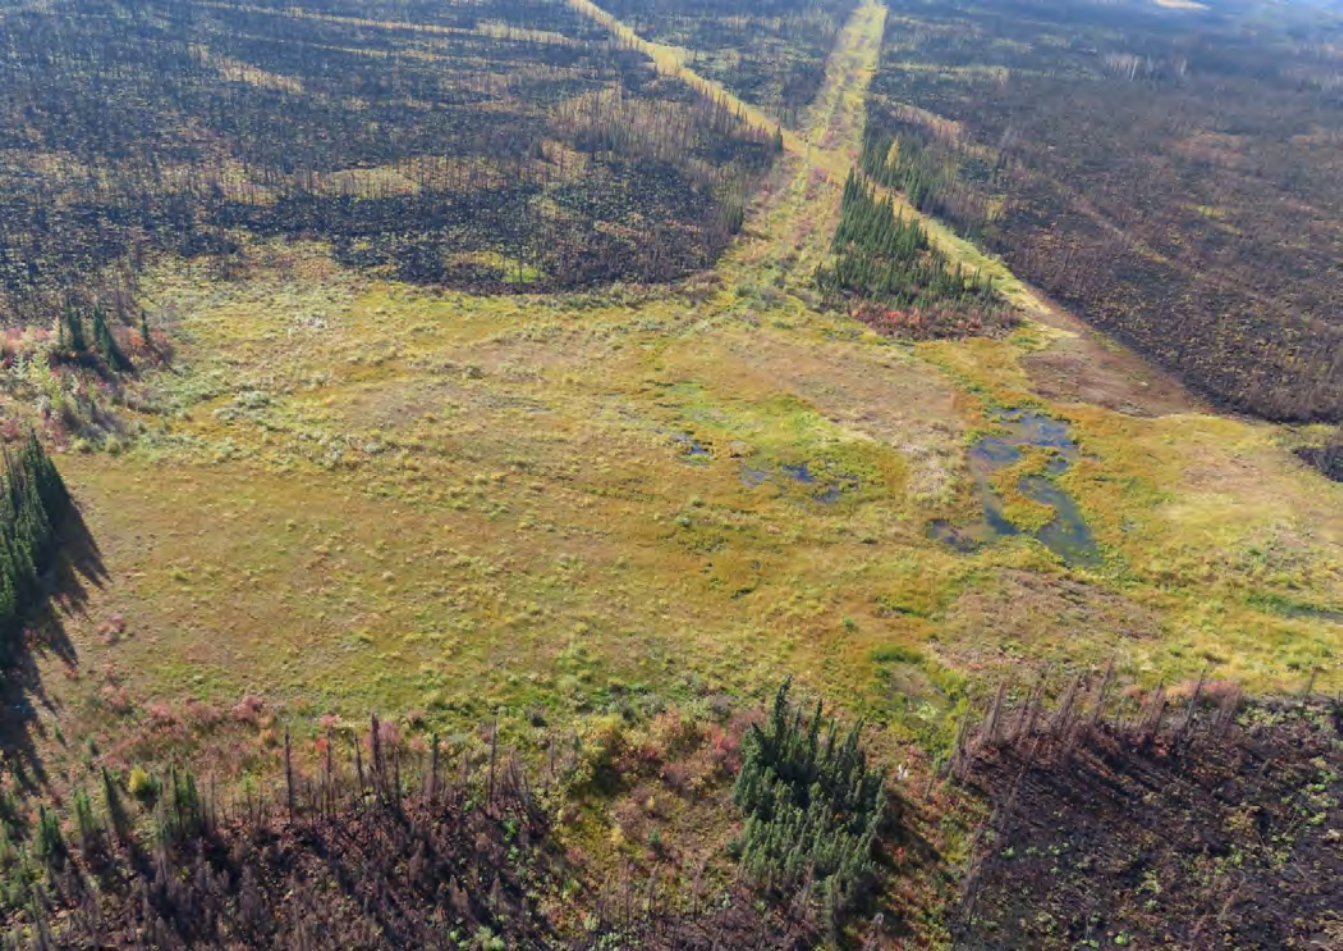
Figure 126

N-28: Aerial view of the wellsite. Well was abandoned on March 11, 2023. No further remediation work required at N-28.

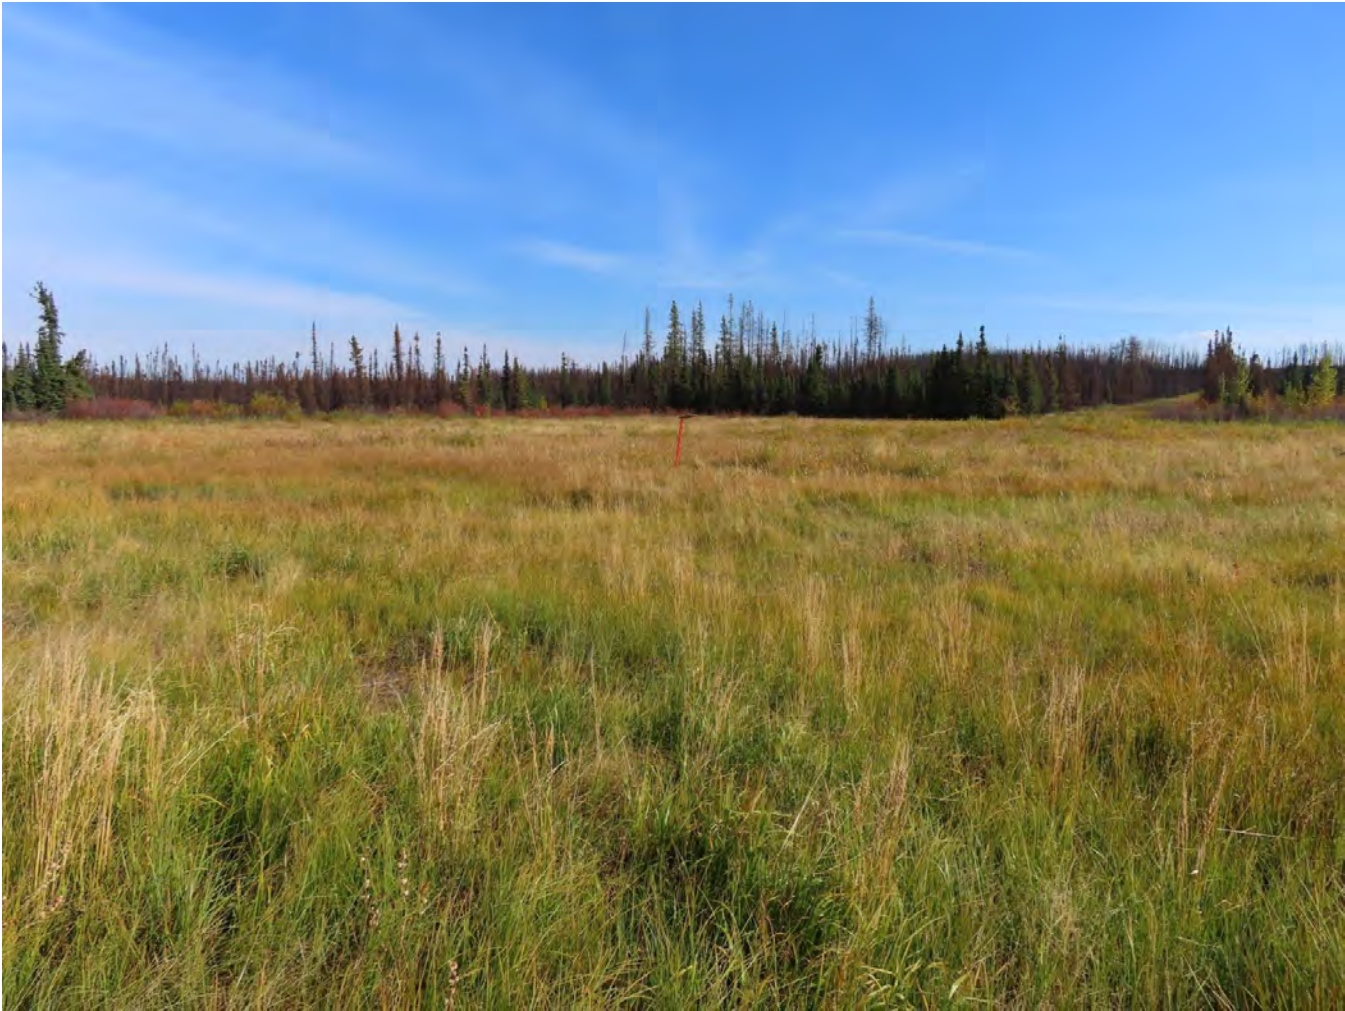
Figure 127

N-28: All production infrastructure was removed from the wellsite in the winter of 2023.

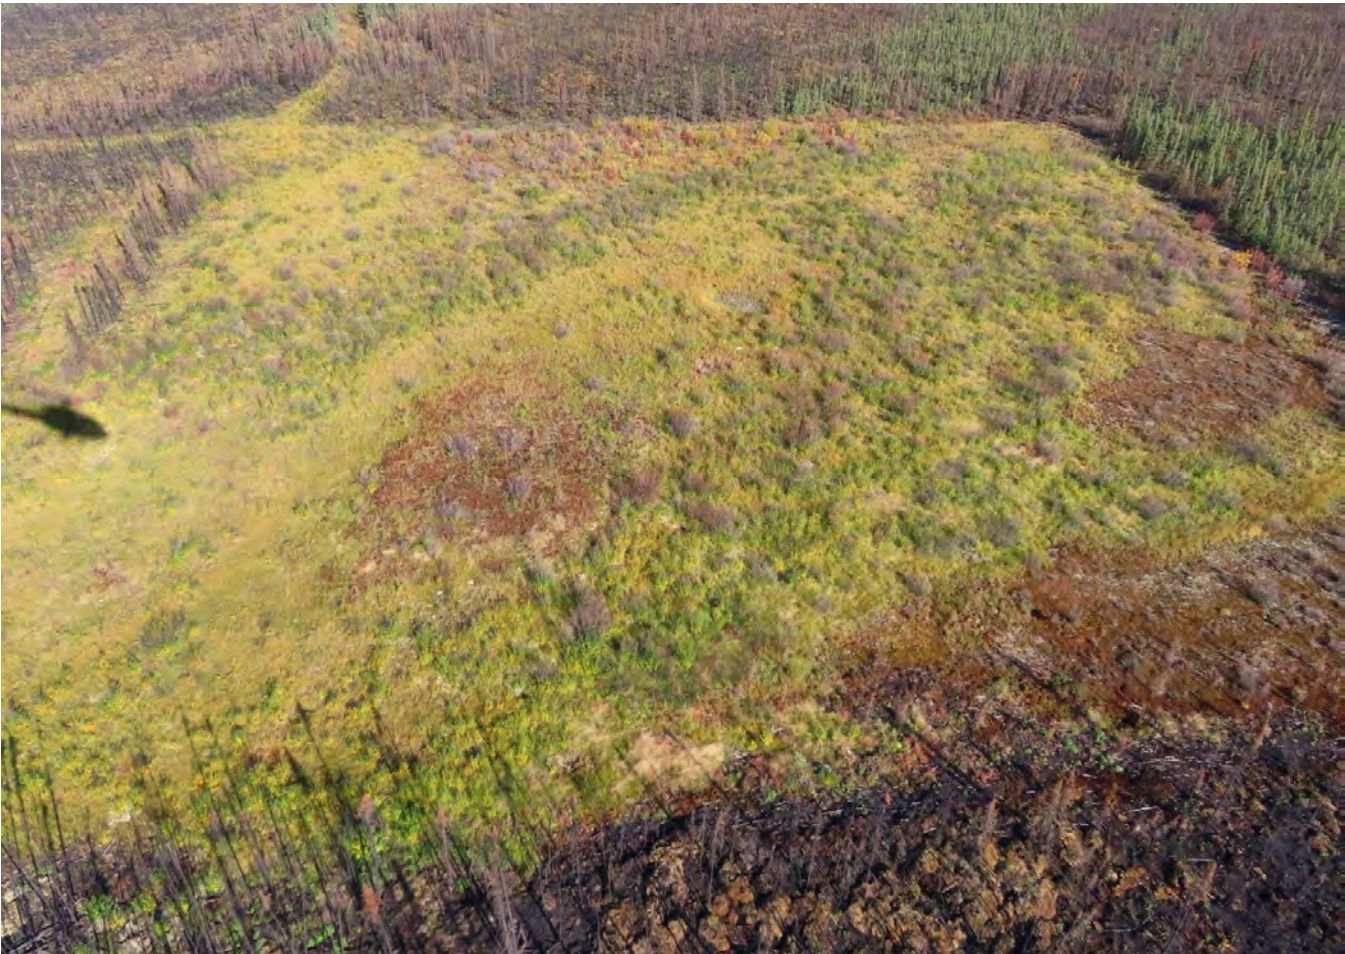
Figure 128

O-19: Aerial view of the wellsite. Well abandoned in 2012. No further remediation work required at O-19.

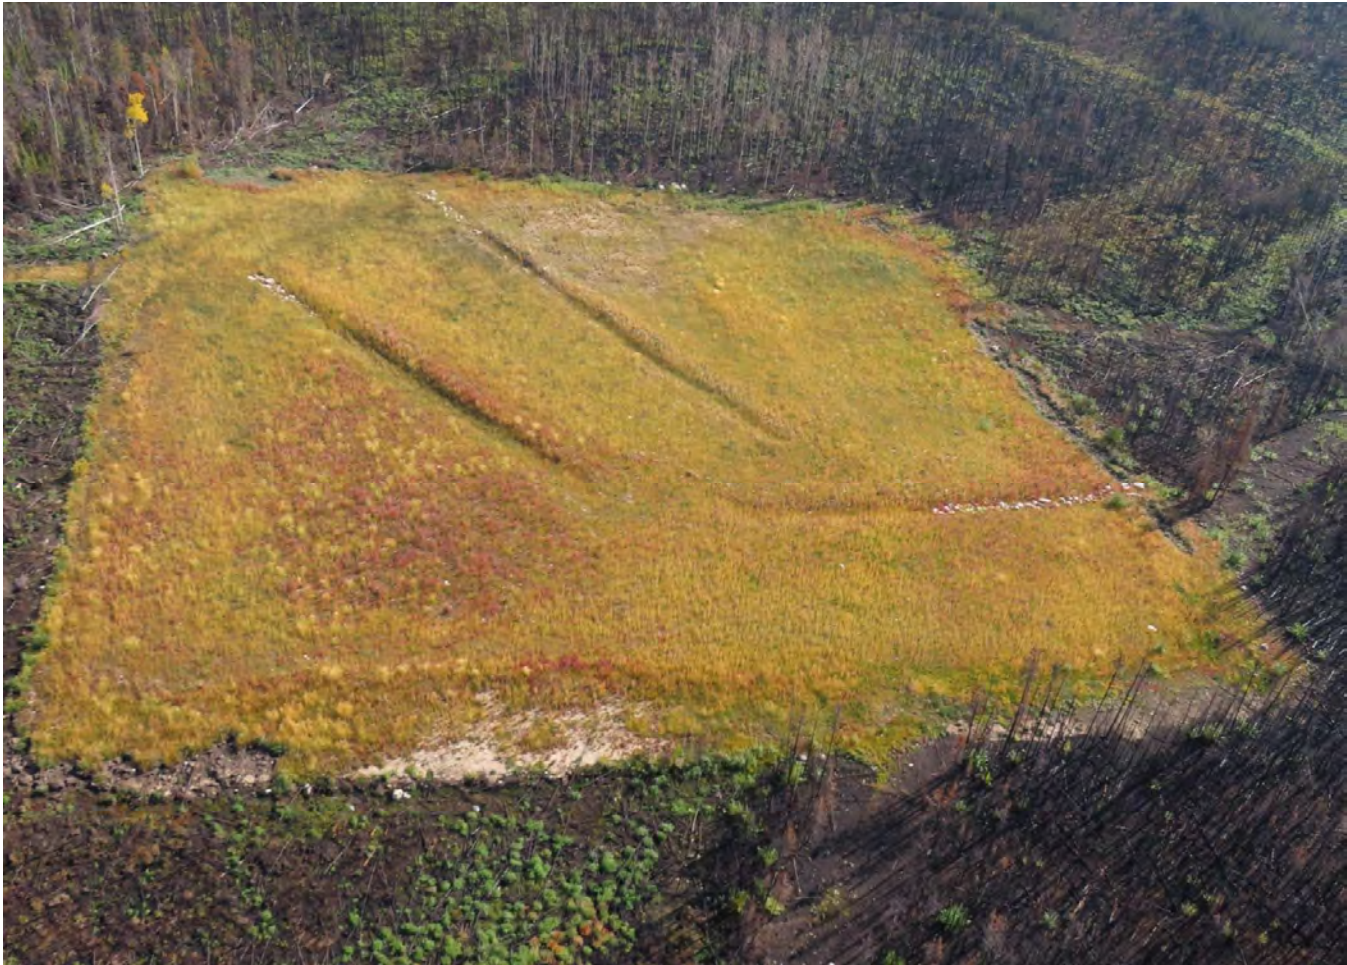
Figure 129

P-17: Aerial view of the wellsite. Site was cleared in 2010 but was never drilled. No further remediation work required at P-17.

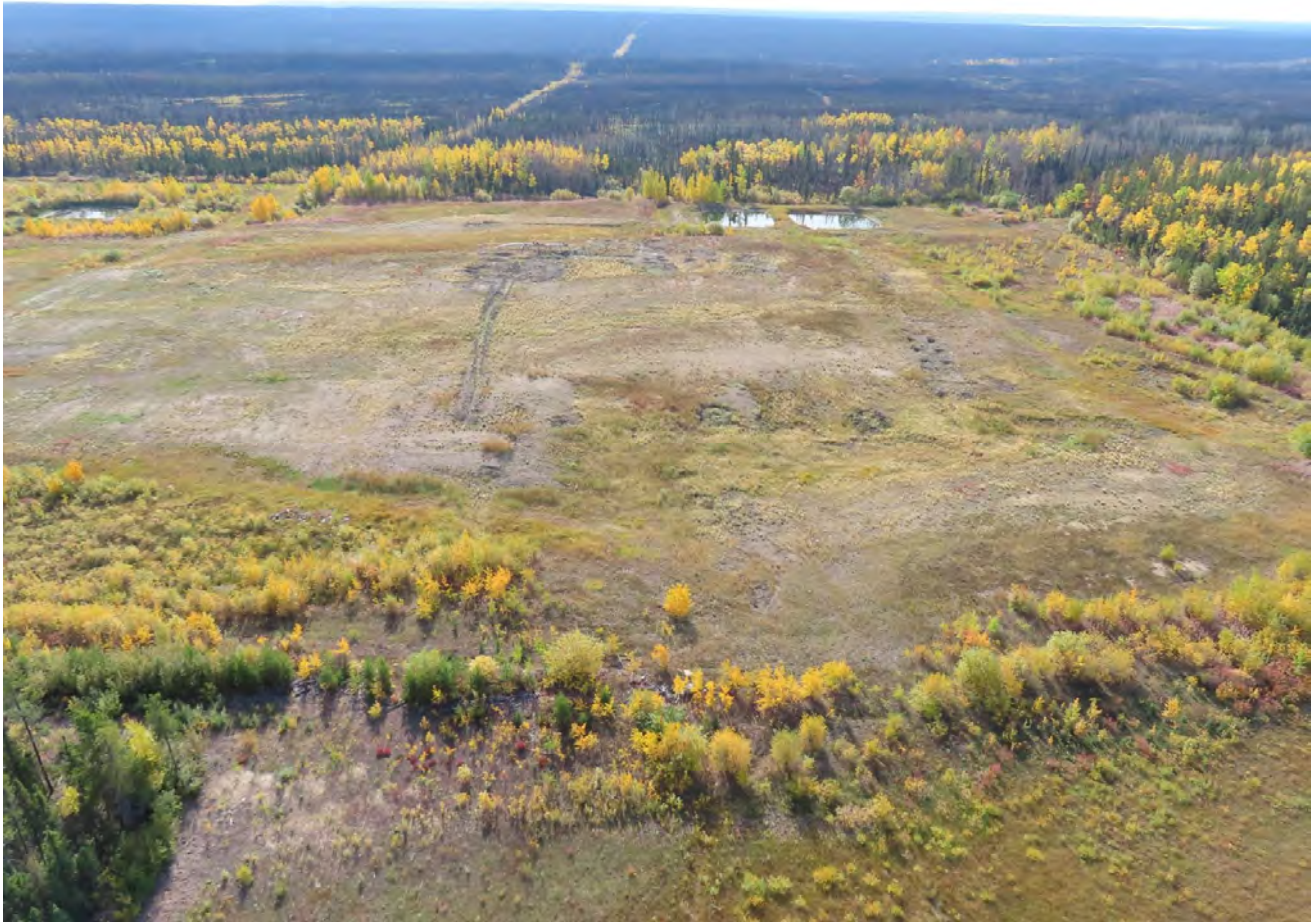
Figure 130

H-03 Battery: Aerial view of the H-03 Battery site. All infrastructure was removed in 2023.

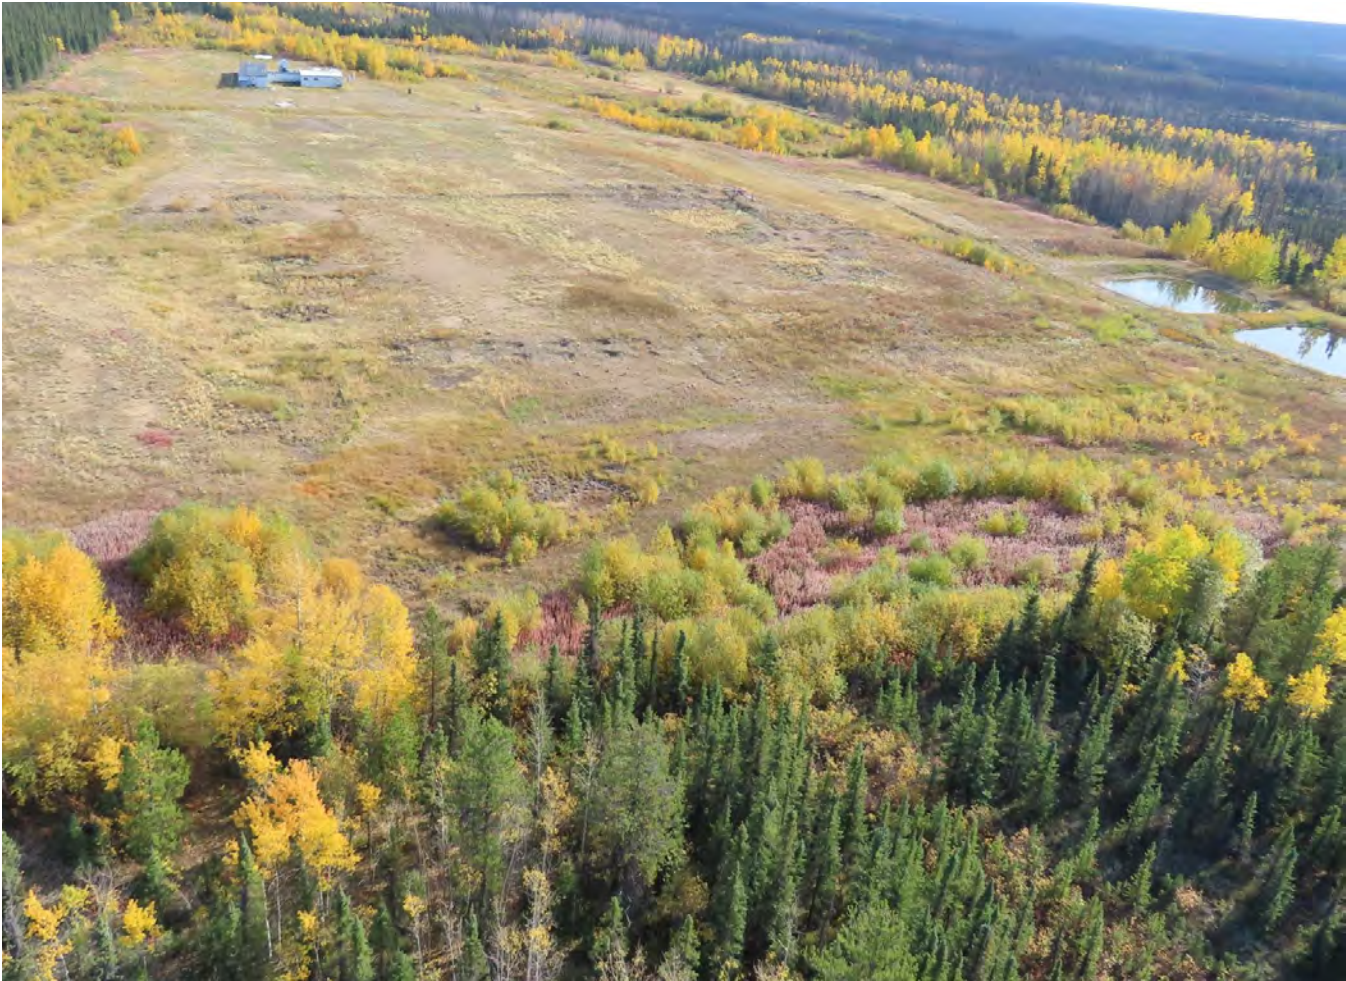
Figure 131

H-03 Battery: Aerial view of the H-03 Battery site facing east.

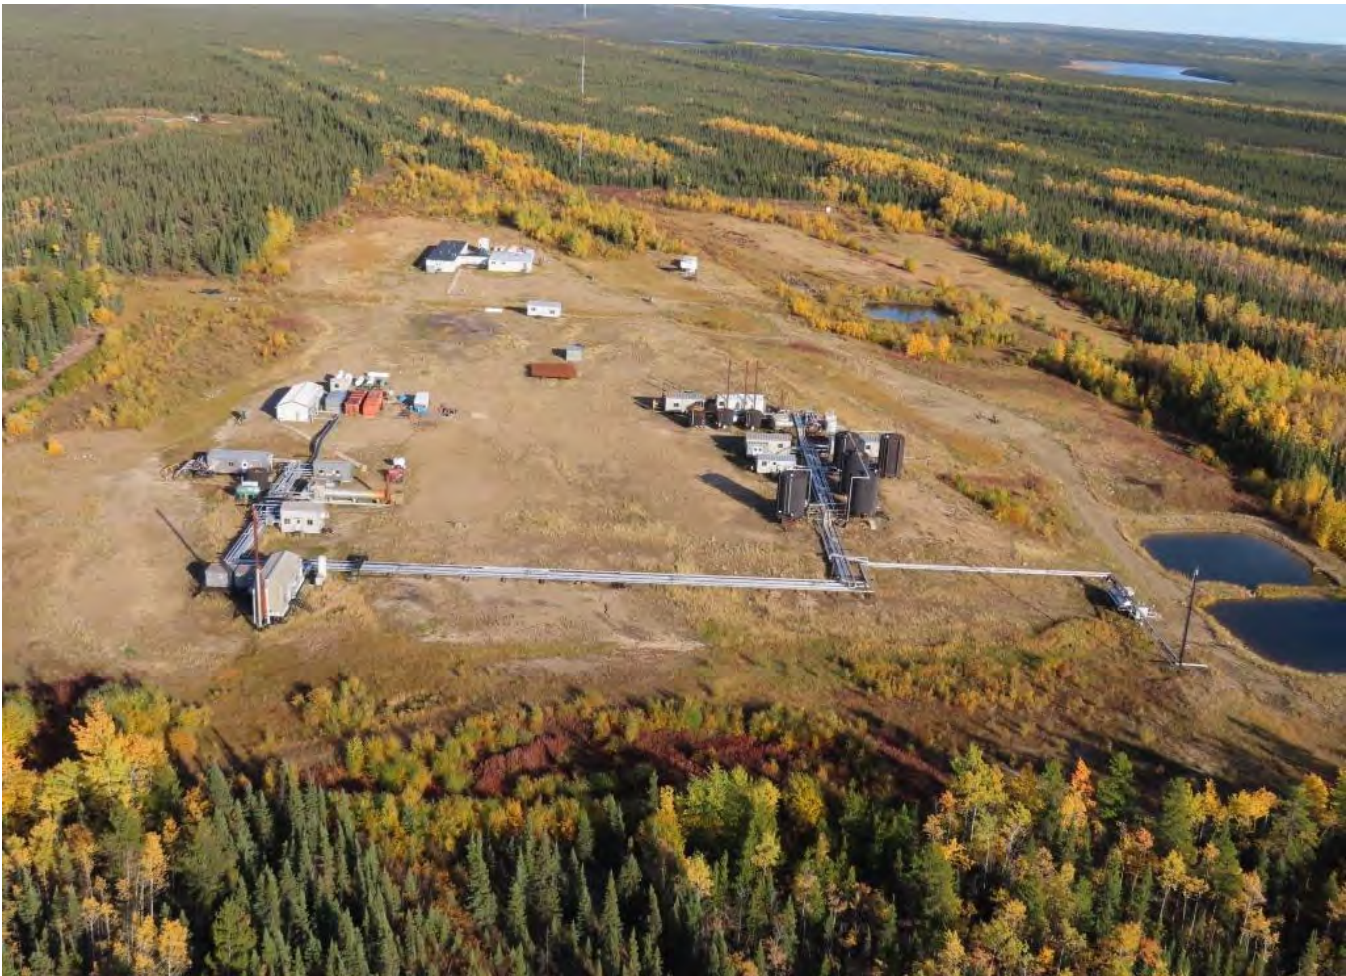
Figure 132

H-03 Battery: Aerial view of the H-03 Battery site facing east showing the site before abandonment. Photo taken September 20, 2022.

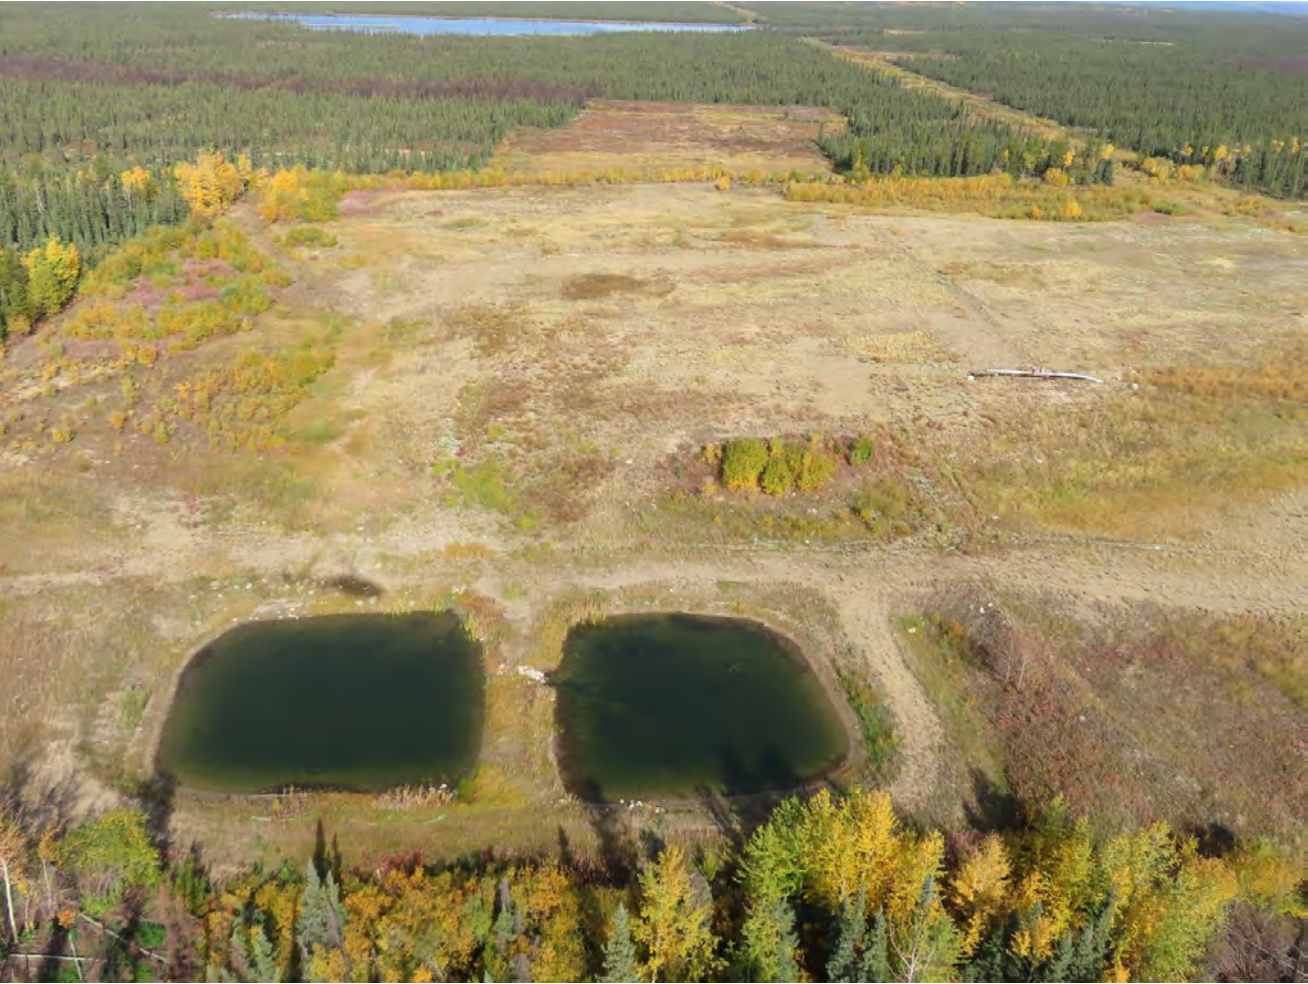
Figure 133

H-03 Battery: Aerial view of the H-03 Battery site facing north.

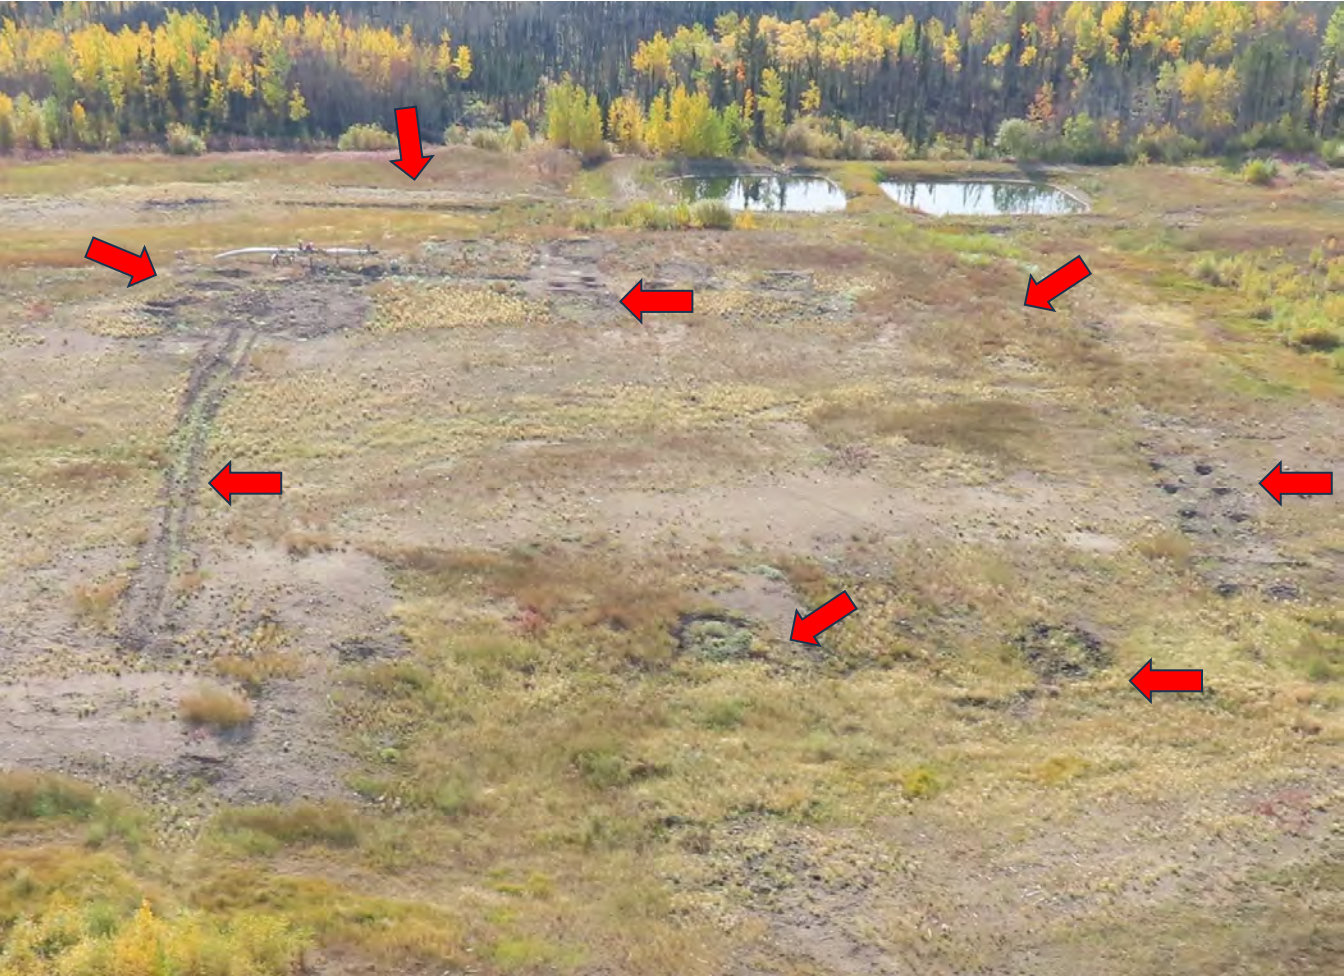
Figure 134

H-03 Battery: The ground surface at the H-03 Battery site requires contouring following the removal of the production infrastructure in 2023.

4. Ground disturbances were noted where the surface structures and buried facilities were excavated for removal. All areas affected by the removal activities must be stabilized and landscaped to their pre-construction profiles in accordance with Permit Condition #88. The areas requiring recontouring are shown in Figure 134. The remediation work can be completed when the retention ponds are reclaimed under the next phase of the abandonment program.

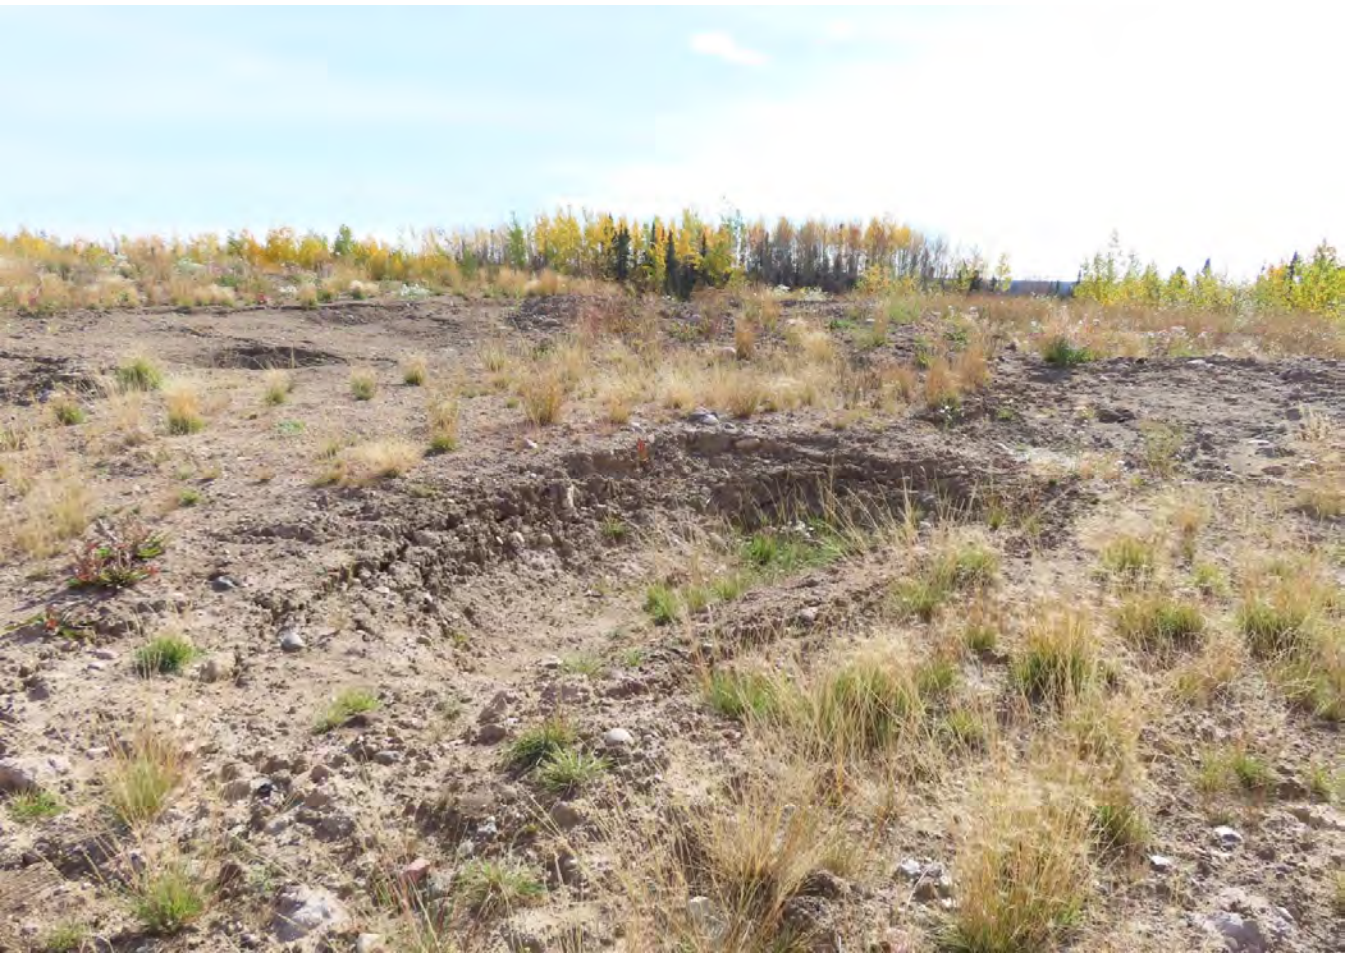
Figure 138

H-03 Battery: All areas affected by the removal activities at the H-03 Battery must be stabilized and landscaped to their pre-construction profiles.

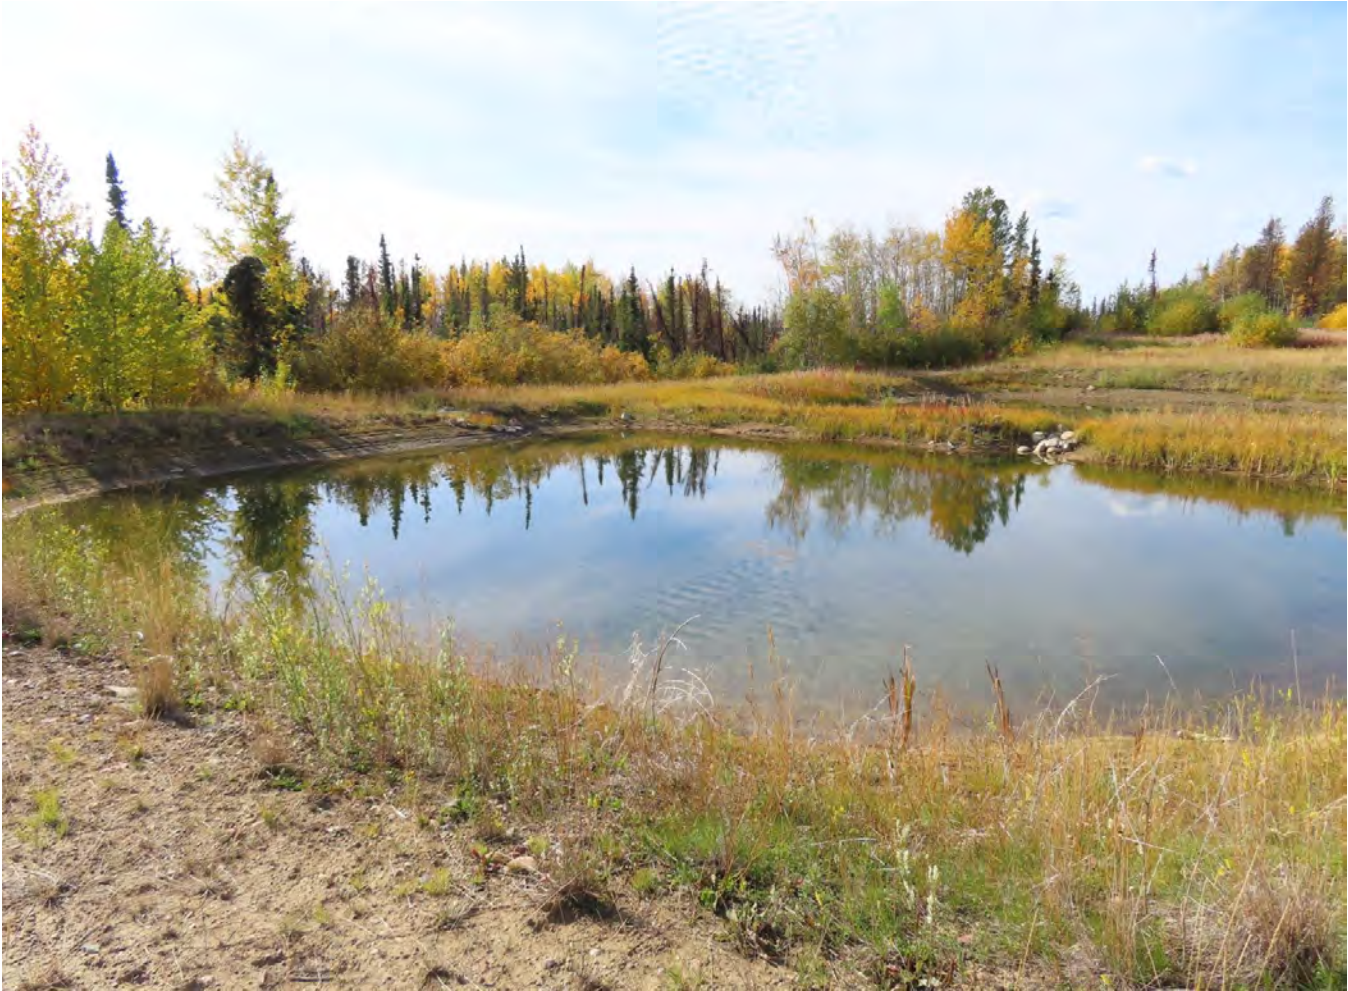
Figure 142

H-03 Battery: East Rention Pond.

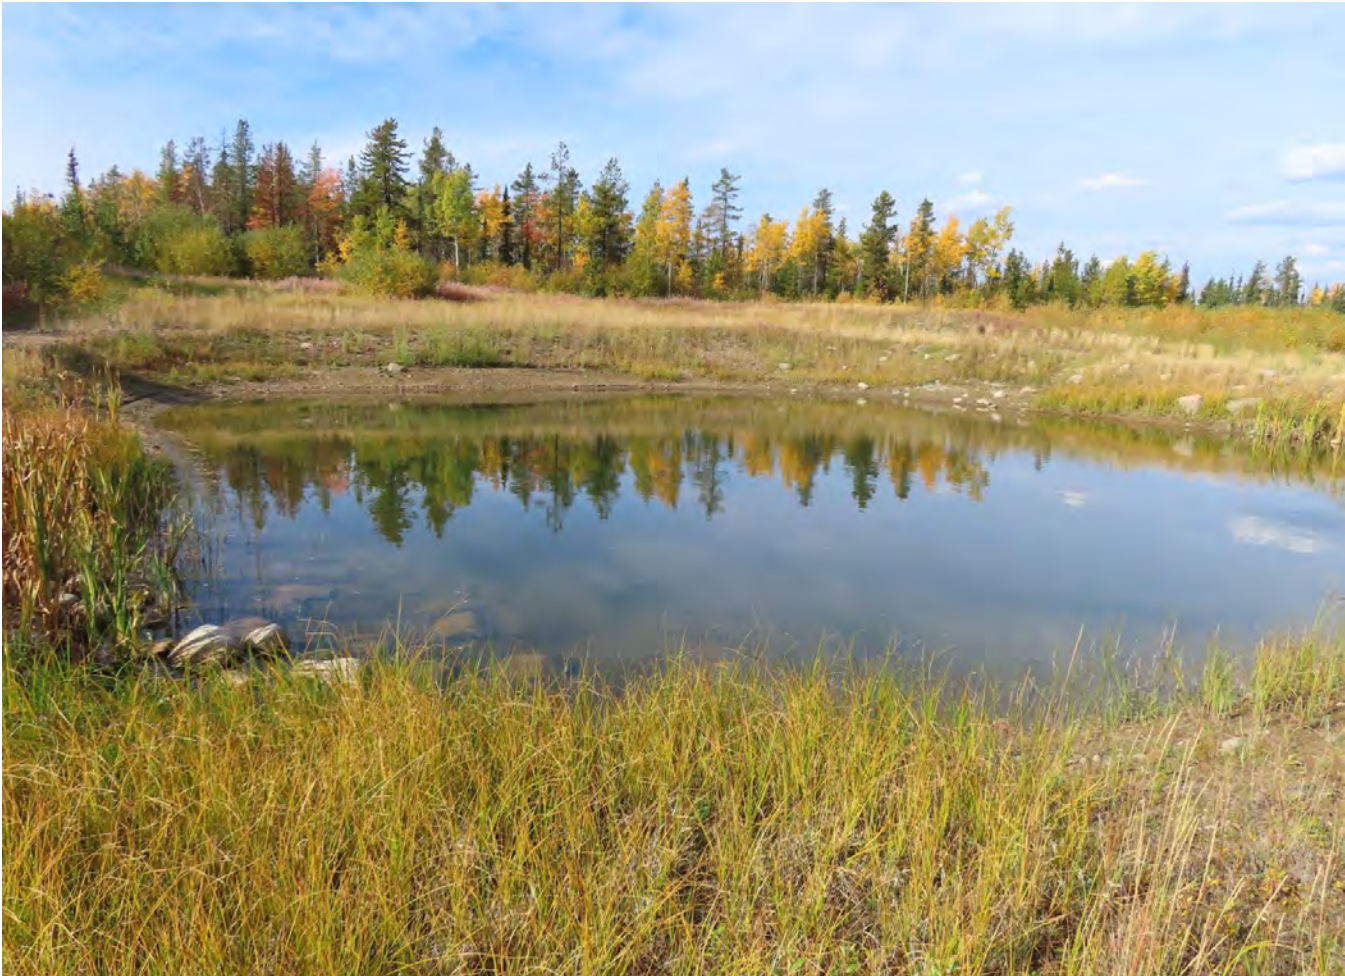
Figure 143
H-03 Battery: West Rention Pond.

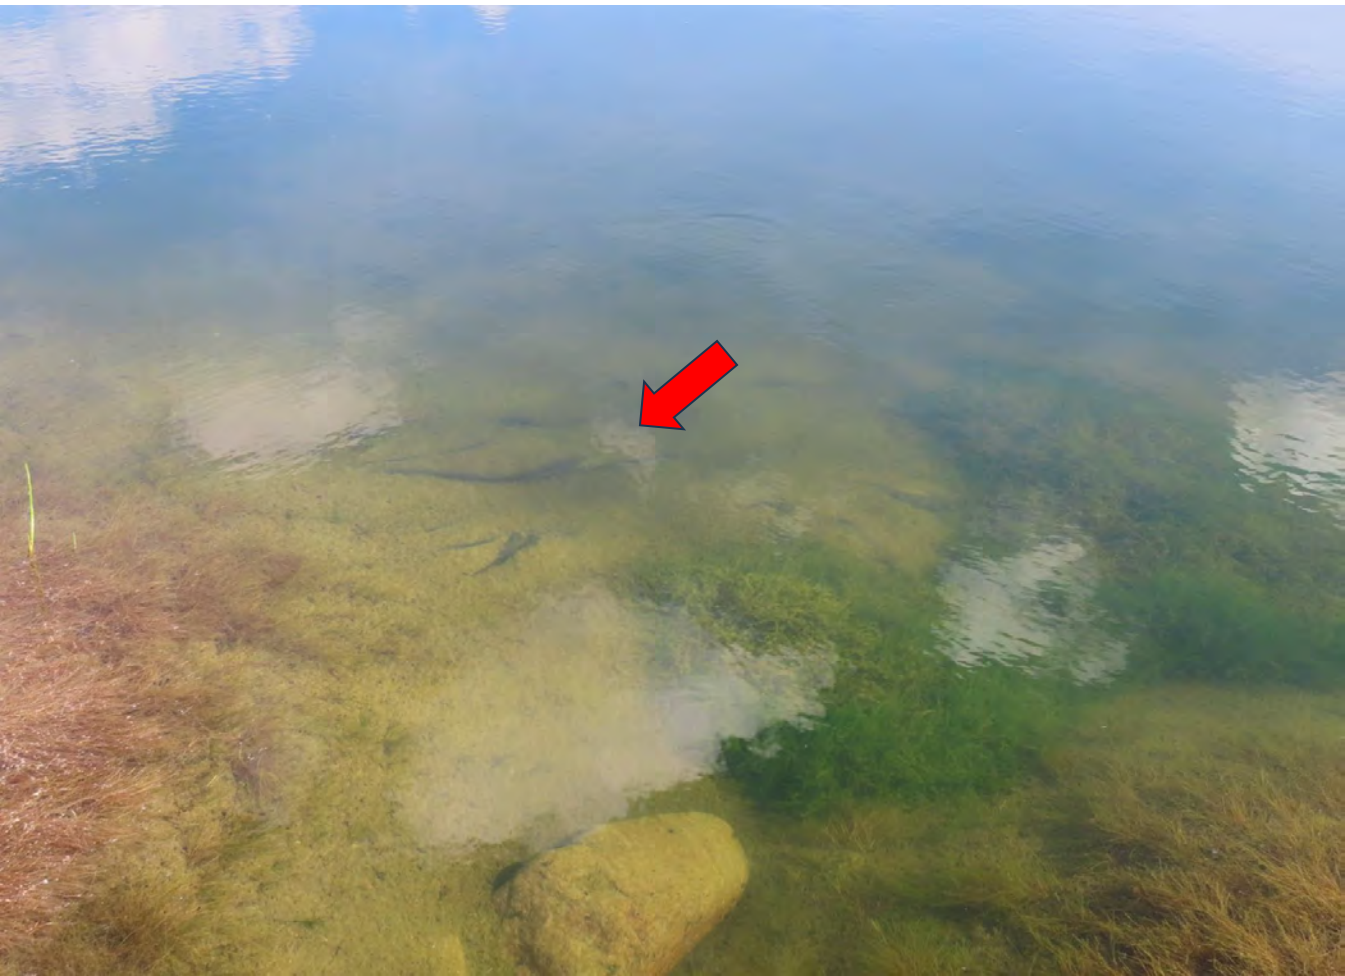
Figure 144
H-03 Battery: PVC liner located in retention pond.

5. The PVC liner found in the retention ponds must be removed when the ponds are reclaimed (Figure 144).
6. Water Officer Joshua Gauthier took water samples on September 18th, 2024 from the east and west surface run-off retention ponds to ensure compliance with water license effluent quality criteria (Water License #MV2010L1-0001).

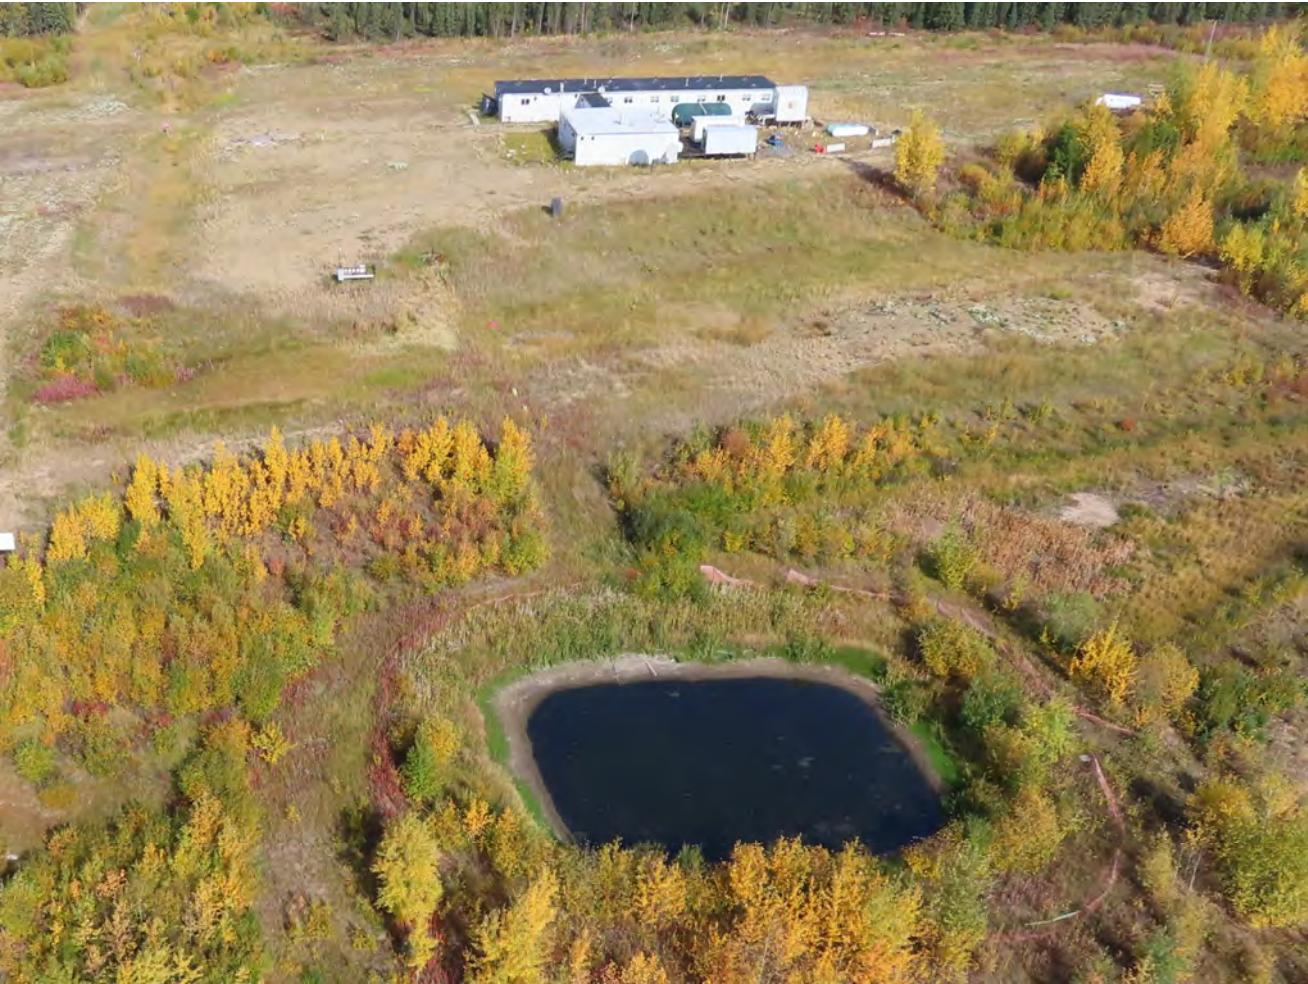
Figure 145

Main Camp: Aerial view of main campsite facing north. Sewage lagoon seen at bottom of photo.

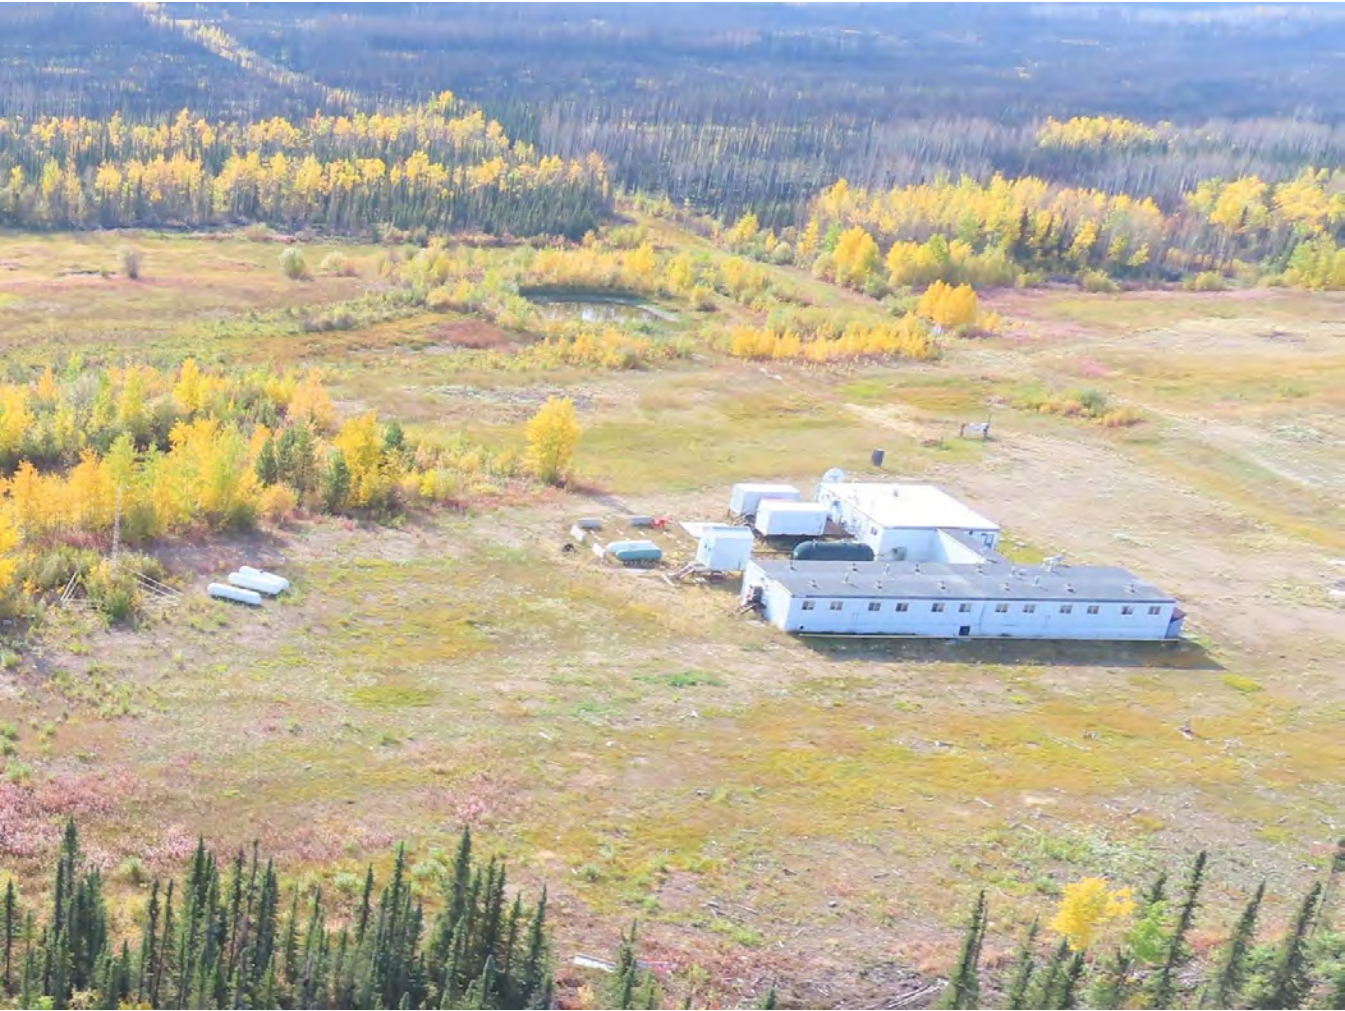
Figure 146

Main Camp: Aerial view of main campsite facing south.

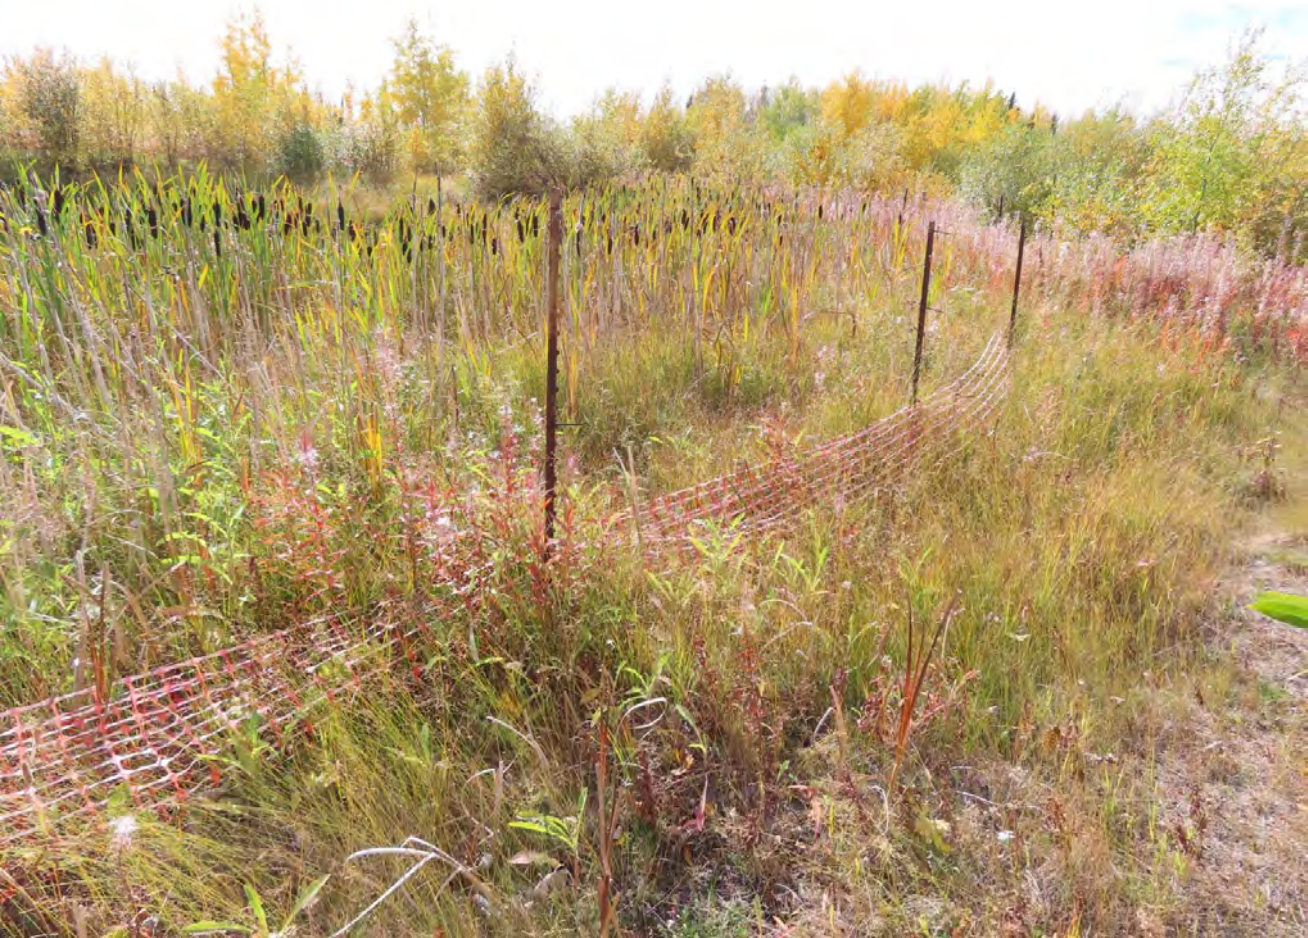
Figure 152

Main Camp: Snow fencing and metal posts around the sewage lagoon to be removed.
