File Number	MV2022X0018
Type of Operation	Cameron Hills Oil and Gas Field Abandonment
Location	Cameron Hills, NT

ENVIRONMENTAL INSPECTION REPORT

Permittee:	Strategic Oil and Gas Ltd. c/o Alvarez & Marsal Canada Inc.	Permit Expiry Date:	January 02, 2028
Land Use Permit No.	MV2022X0018	Previous Inspection:	February 21, 2024
Quarrying Permit No.		Inspection Date:	September 17, 2024
Contractor:	ELM Inc.	Subcontractor:	
Location(s) Inspected:	Cameron Hills Oil and Gas Field		
Current Stage of Operation:	The abandonment of the H-03 Battery, forty-four (44) oil and gas wells was completed in the winter of 2023 and 2024.		
Program Modifications Approved:

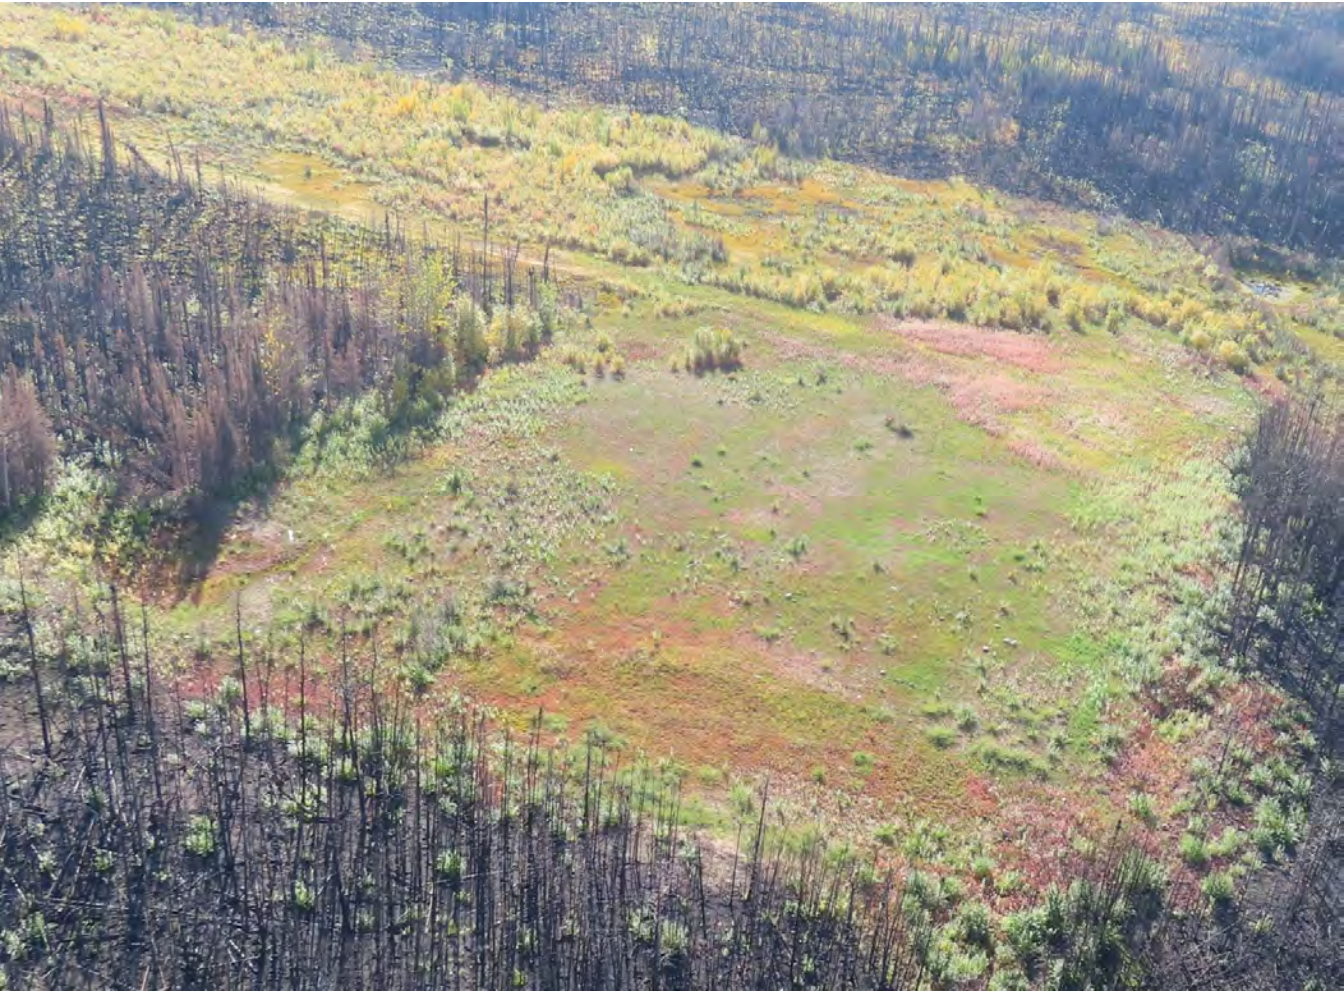
Figure 155

Camp: B-29 Campsite.

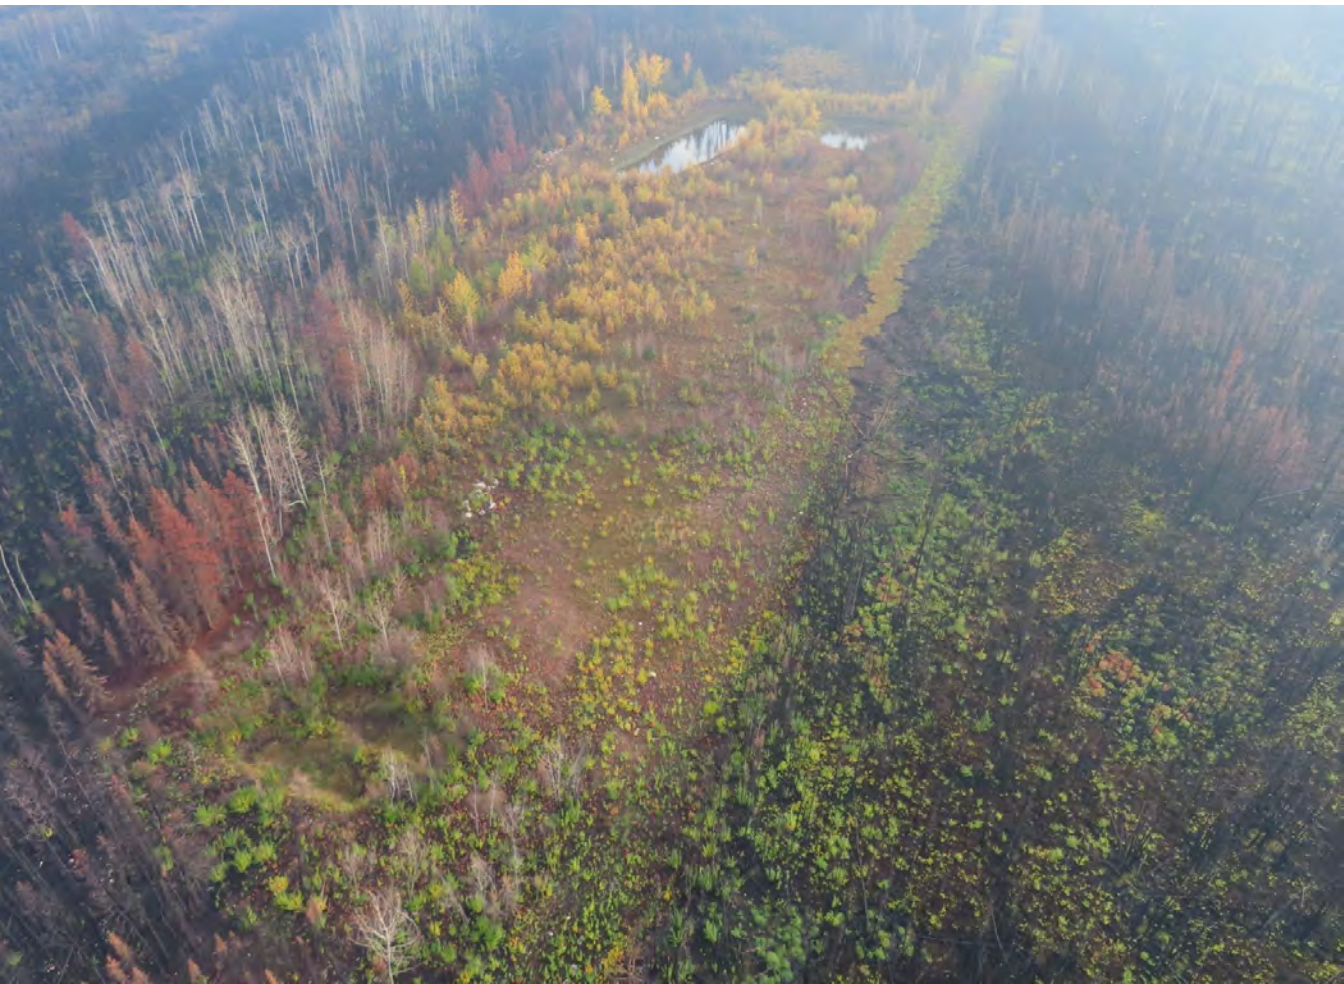
Figure 156

Camp: D-11 Campsite. Two (2) borrow pits are located on the east side of the site.

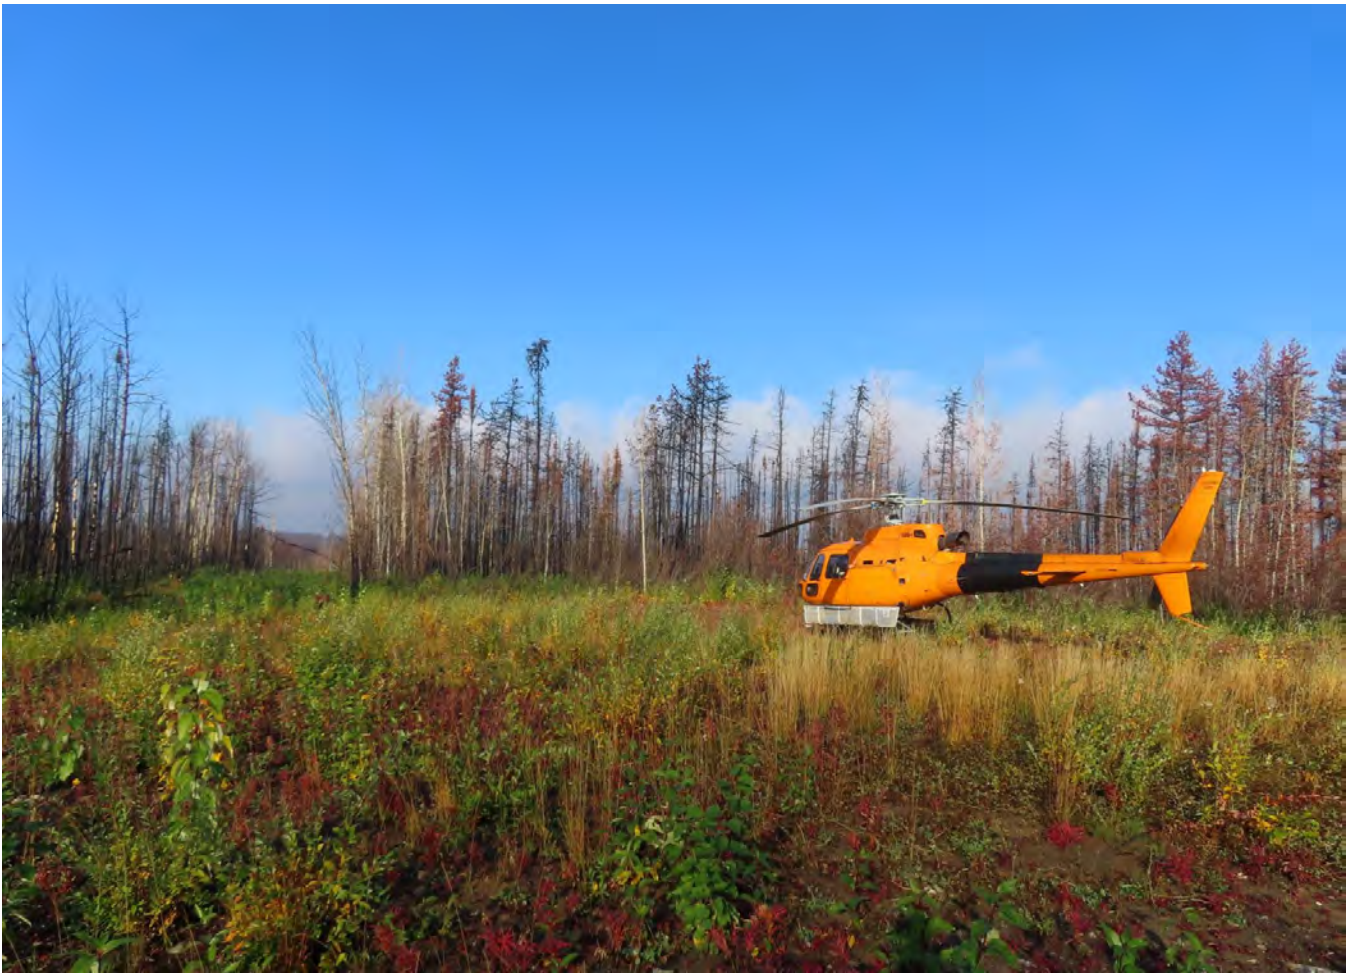
Figure 157

Camp: D-11 Campsite. No debris was located on the site. The water well was abandoned on March 02, 2023.

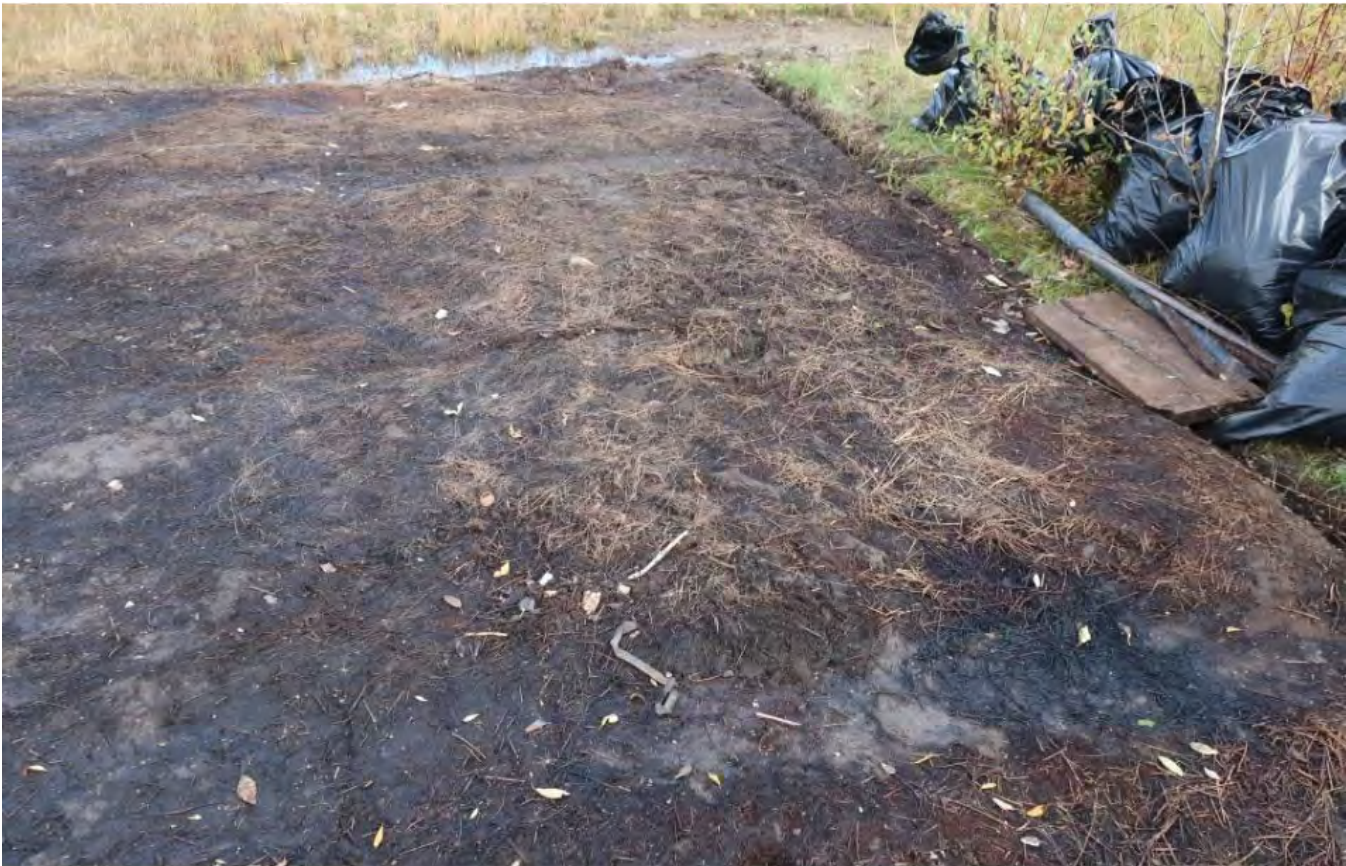
Figure 160

- 5. The 3.5m x 4.5m (15.75 m²) fuel berm located on the east side of the garage building at 60°03'37.46"N 117°29'32.64"W was removed in 2019. The soils appear to be impacted by hydrocarbons as vegetation growth was noted to be sparse. The site was not photographed but a photo taken on September 16th, 2021 is included in this report (Figure 160) for reference.

Camp: K-74 Campsite. Photo taken on September 16th, 2021 showing hydrocarbon impacted soils following removal of the fuel berm. Site has not been remediated to date.

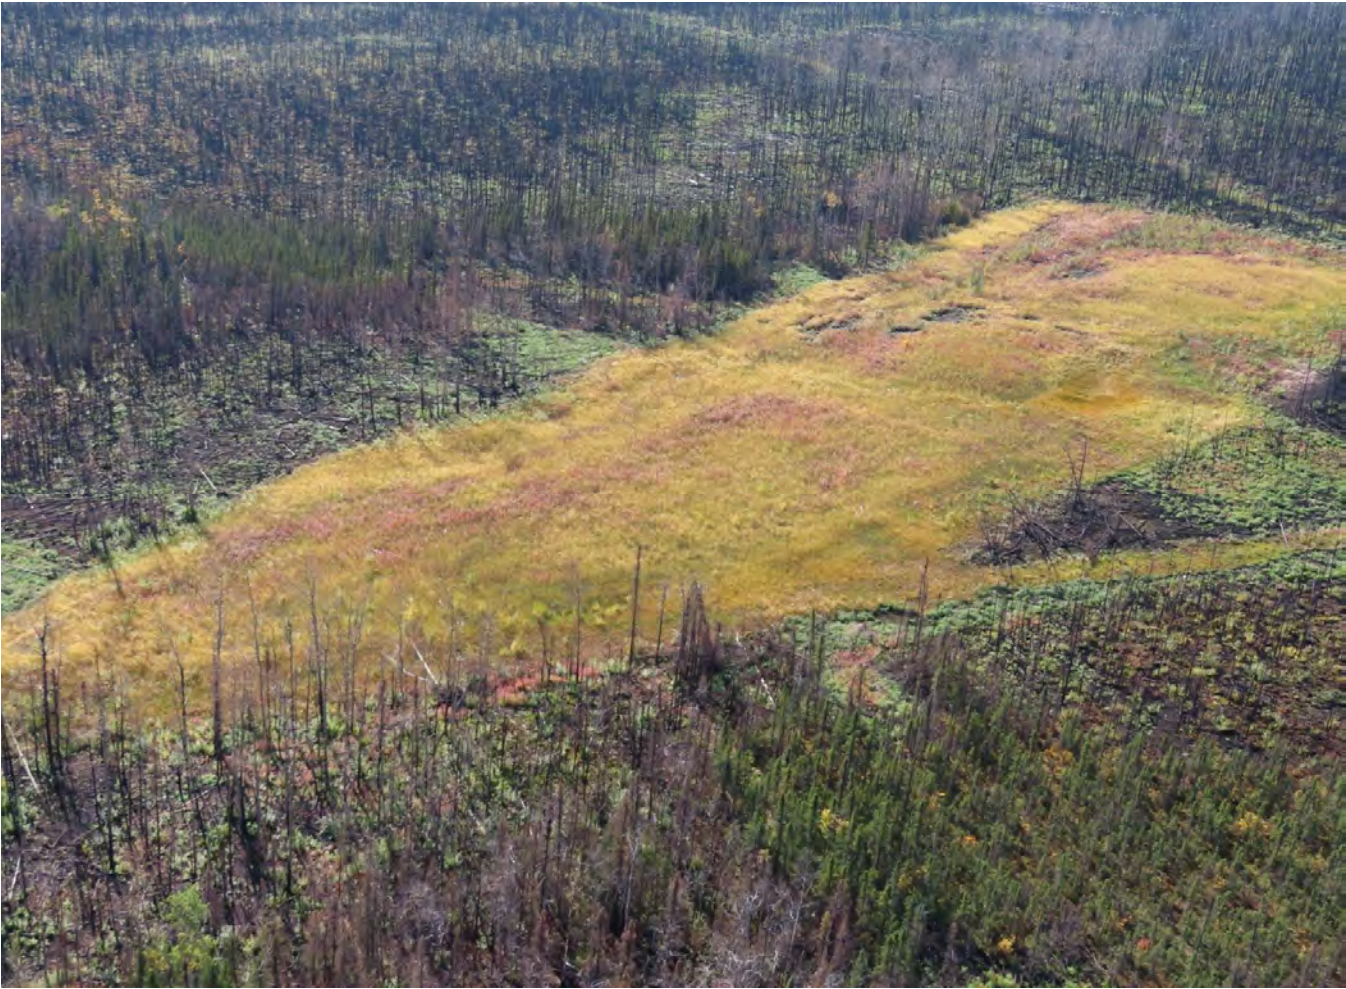
Figure 163

Remote Sump – W B-08. Remediation of the sump was completed in February 2019. Vegetation covering the sump appeared healthy with no signs of distressed or dead vegetation.

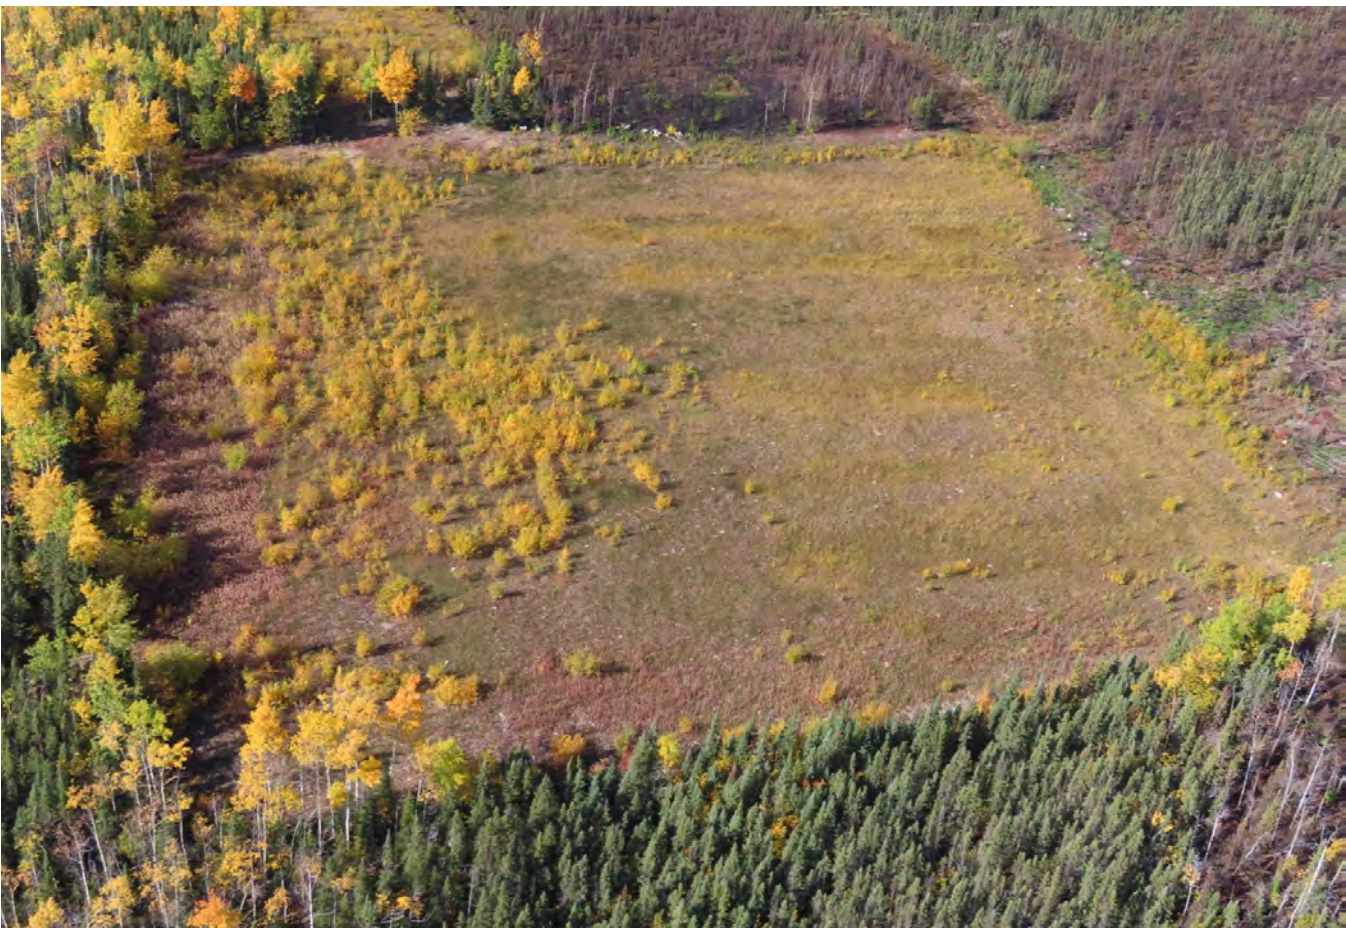
Figure 164

Remote Sump – E B-08. Remediation of the sump was completed in February 2019. Vegetation covering the sump appeared healthy with no signs of distressed or dead vegetation.

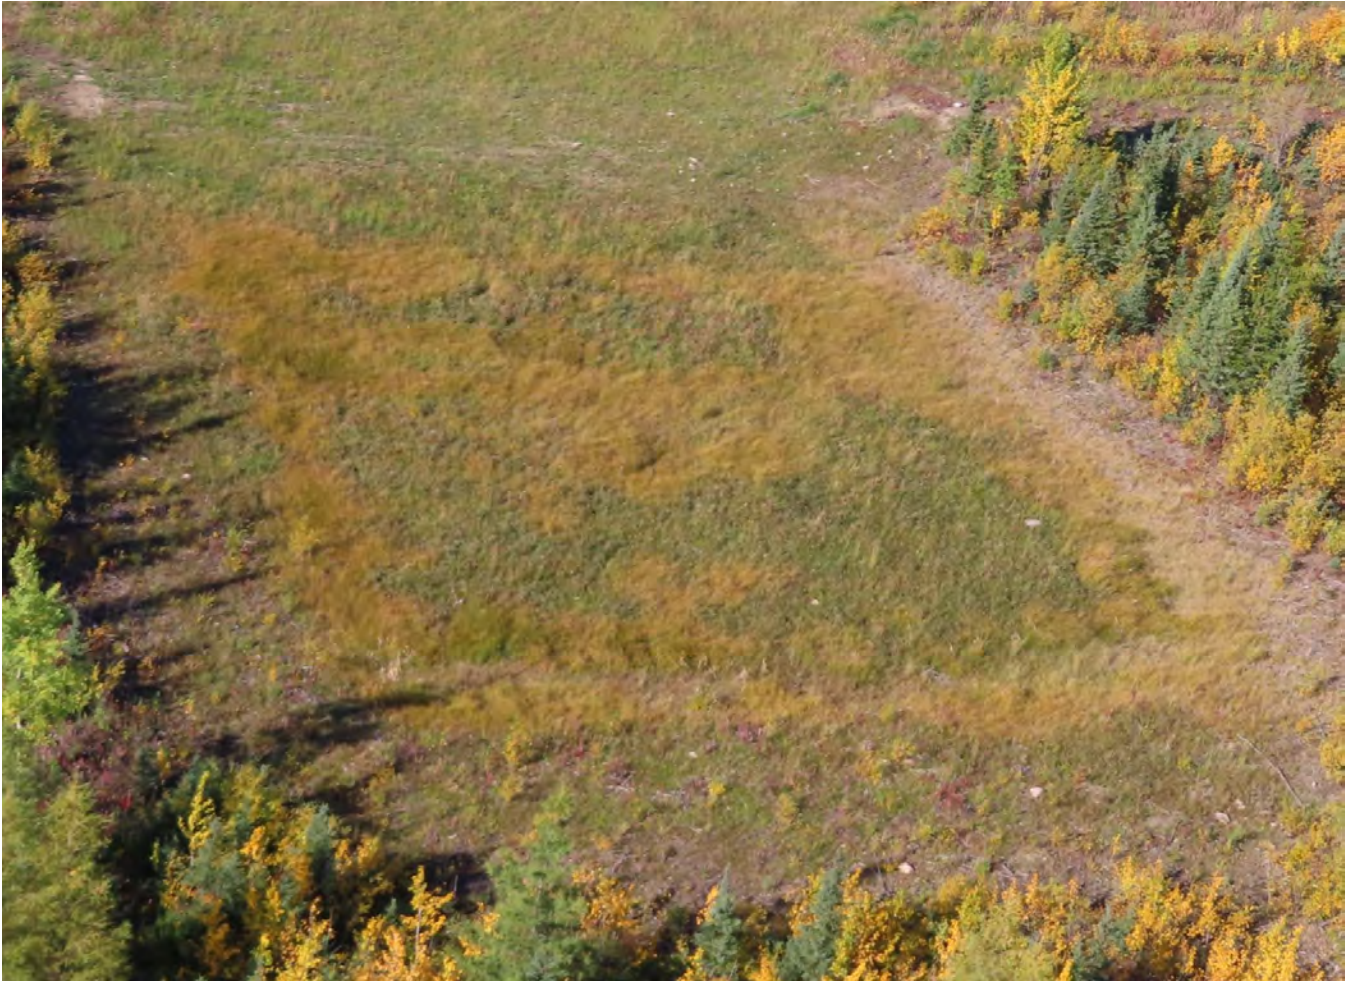
Figure 165

Remote Sump – E B-09. Remediation of the sump was completed in February 2019. Vegetation covering the sump appeared healthy with no signs of distressed or dead vegetation.

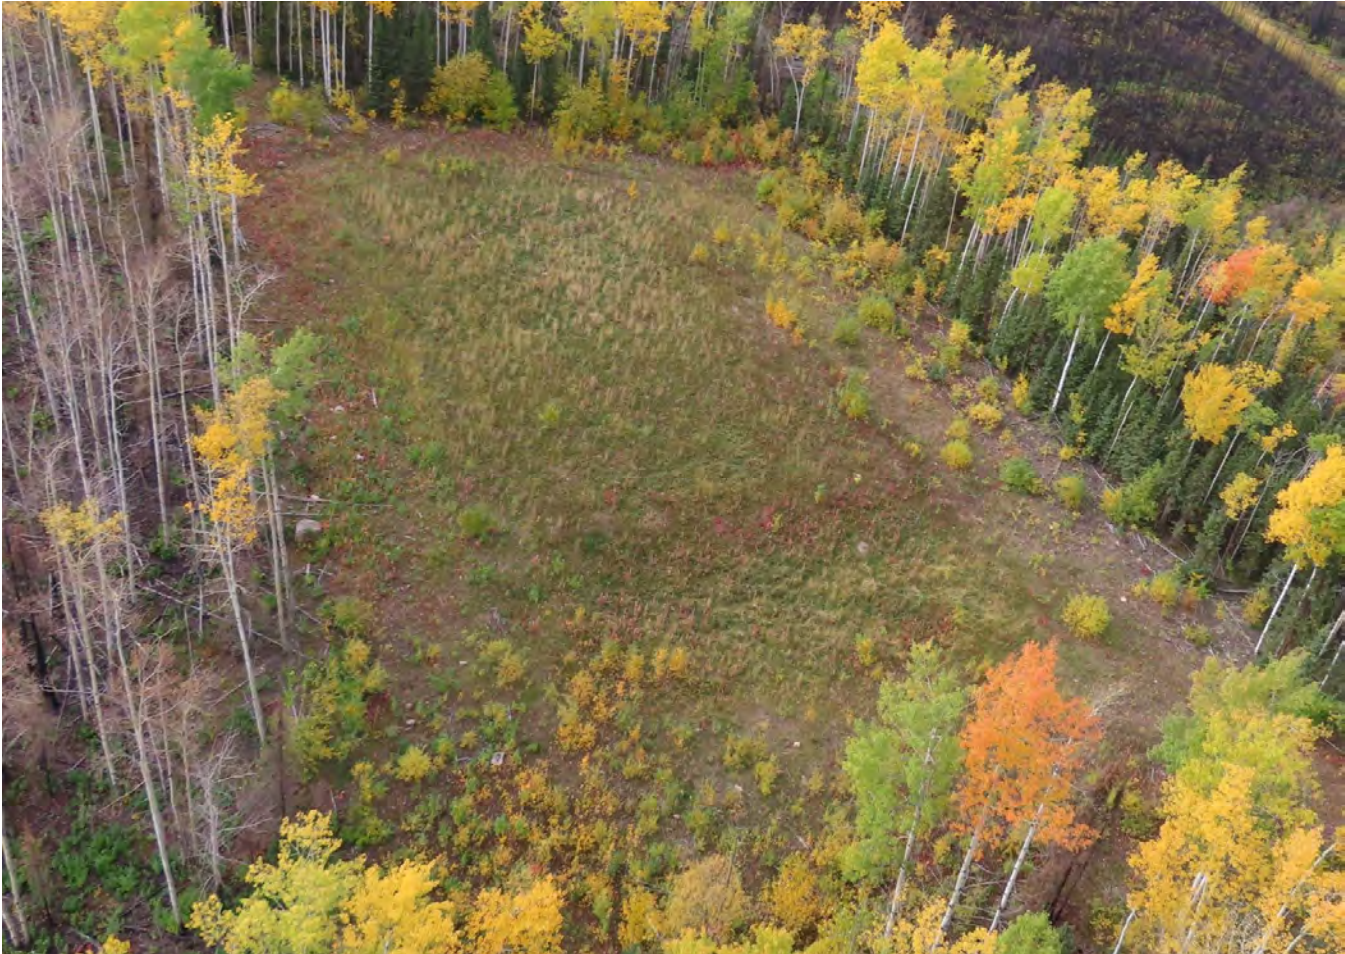
Figure 166

Remote Sump – S C-50. Remediation of the sump was completed in February 2019. Vegetation covering the sump appeared healthy with no signs of distressed or dead vegetation.

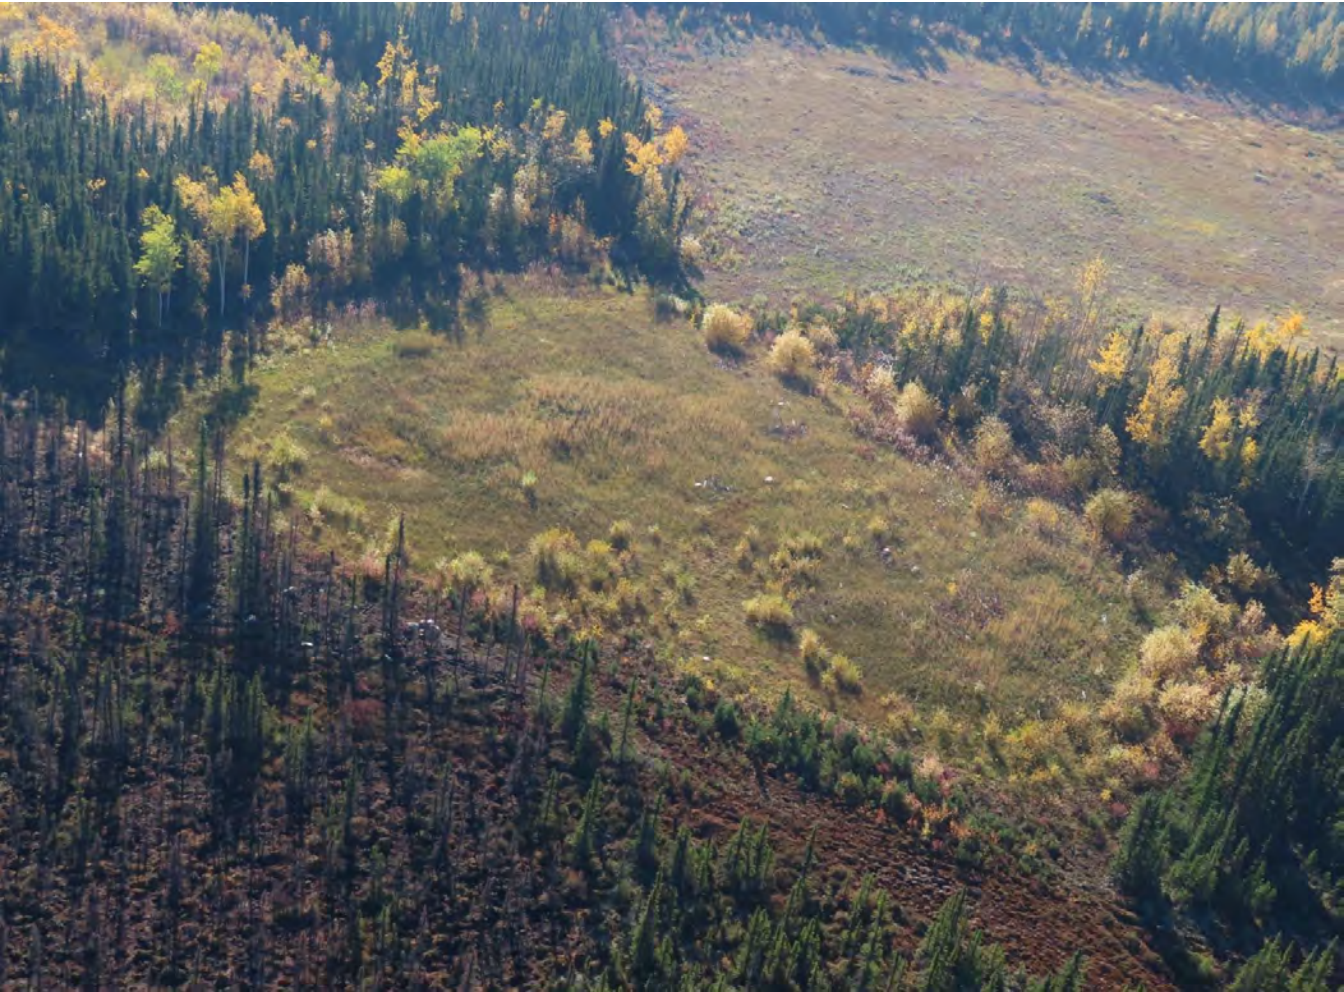
Figure 169

Remote Sump – E J-04. Site 1 (right) and 2 (top left). Vegetation covering both sumps appeared healthy with no signs of distressed or dead vegetation.

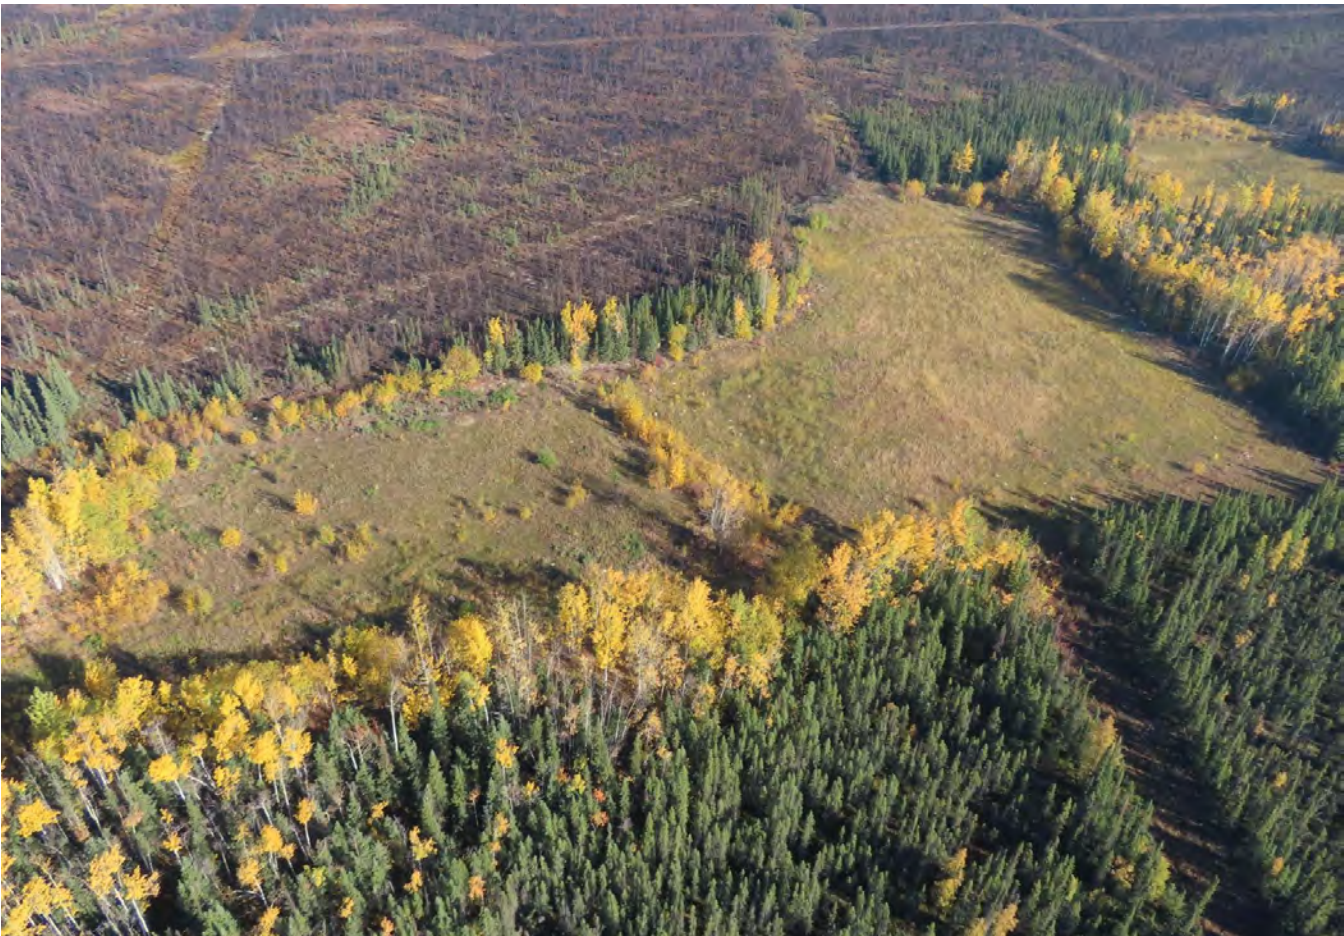
Figure 170

Remote Sump – E J-04. Site 3 (left) and 4 (right). Vegetation covering both sumps appeared healthy with no signs of distressed or dead vegetation.

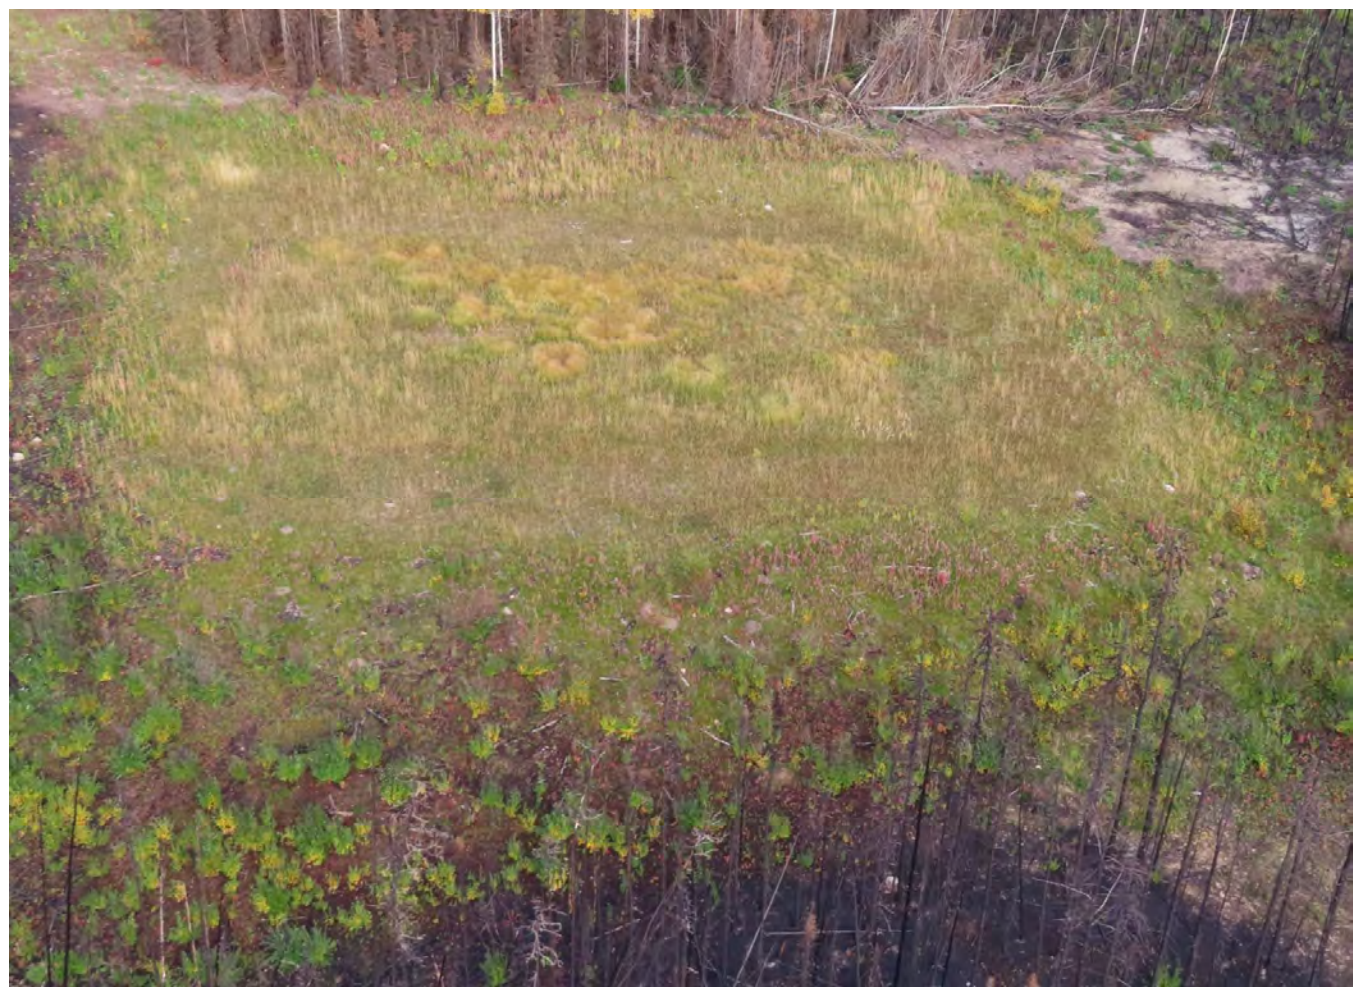
Figure 173

Remote Sump – E J-37. Site 1. Vegetation covering the sump appeared healthy with no signs of distressed or dead vegetation.

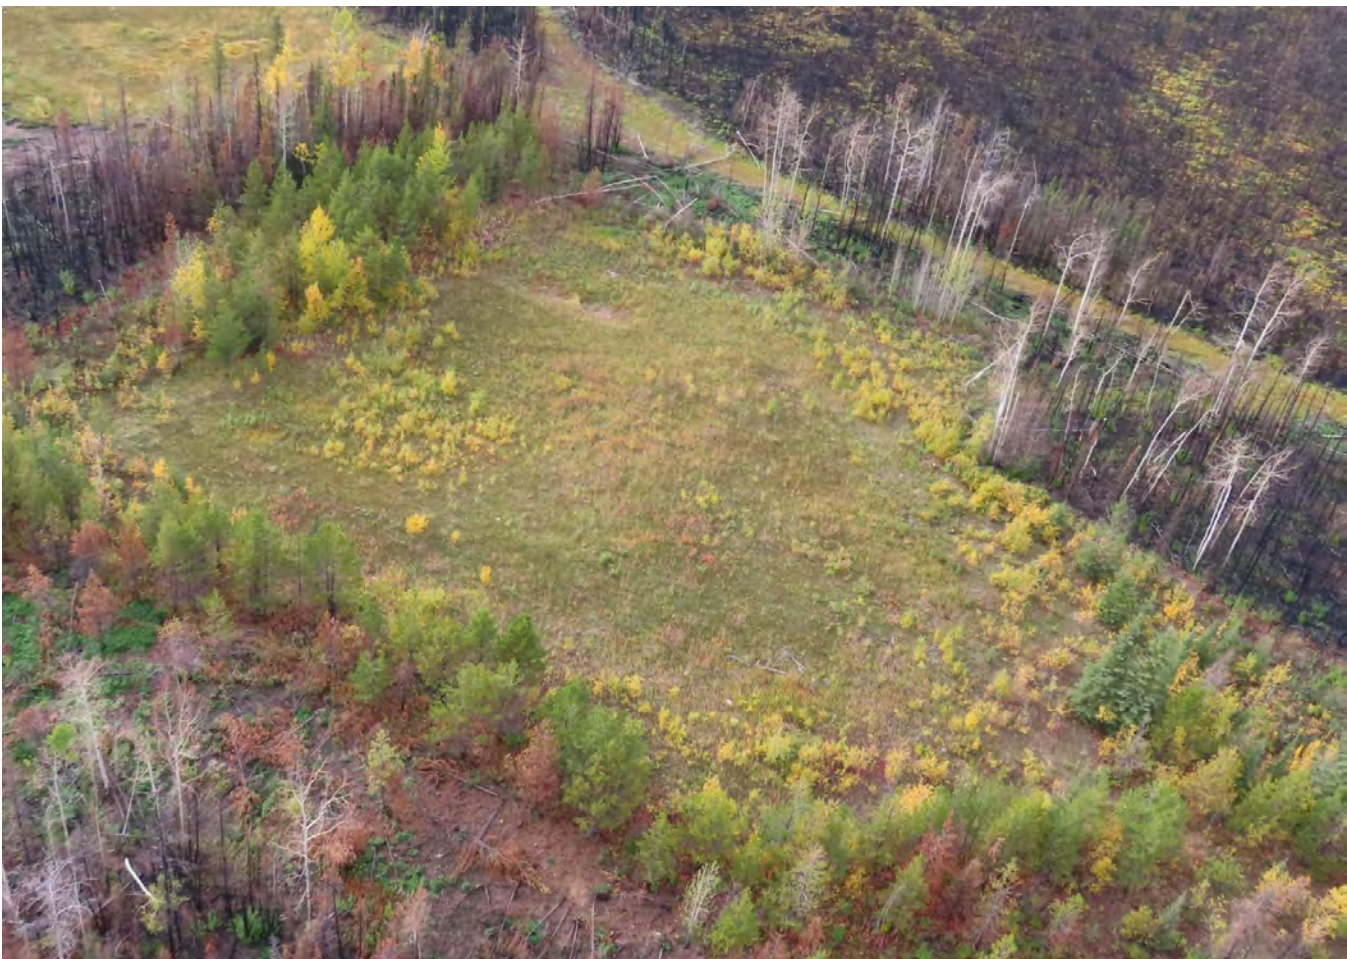
Figure 174

Remote Sump – E J-37. Site 2. Vegetation covering the sump appeared healthy with no signs of distressed or dead vegetation.

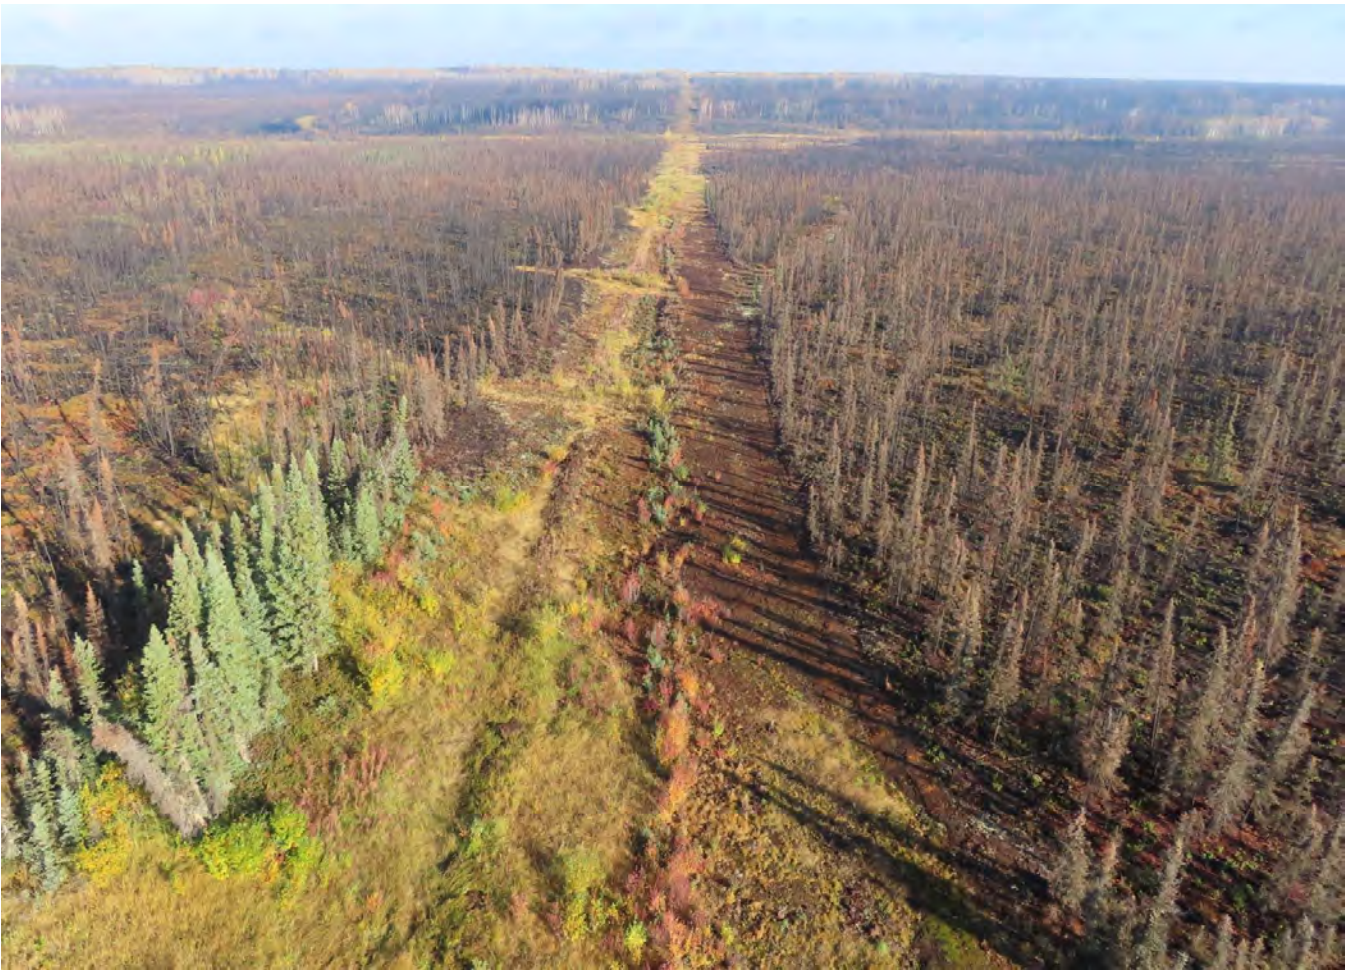
Figure 175

Pipeline – S E-72. South section of the pipeline appeared satisfactory with no signs of erosion observed. Pipeline was remediated in the winter of 2019.

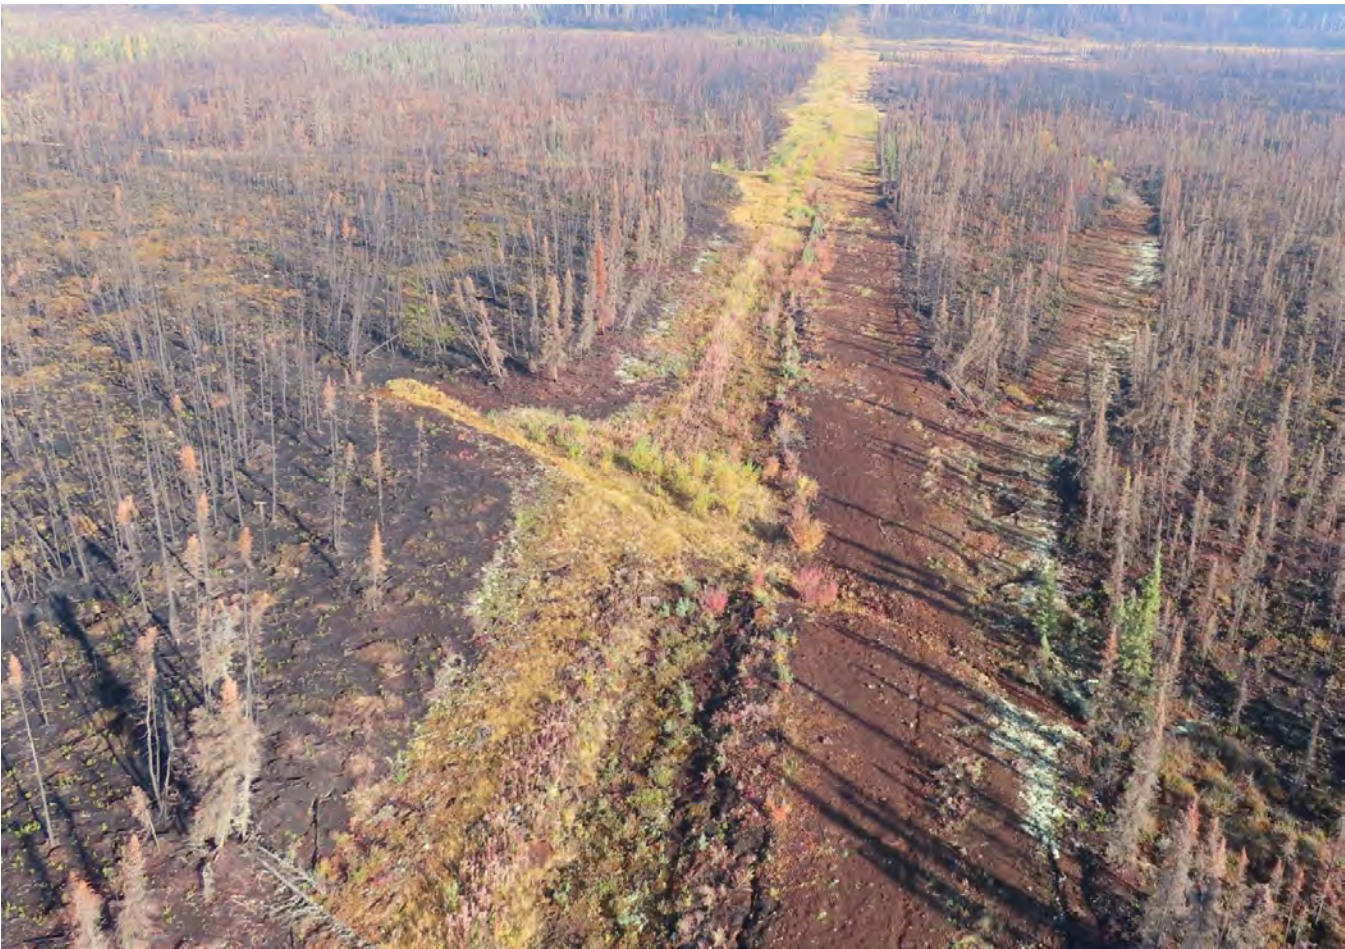
Figure 176

Pipeline – S E-72. North section of the pipeline appeared satisfactory with no environmental concerns noted. Pipeline was remediated in the winter of 2019.

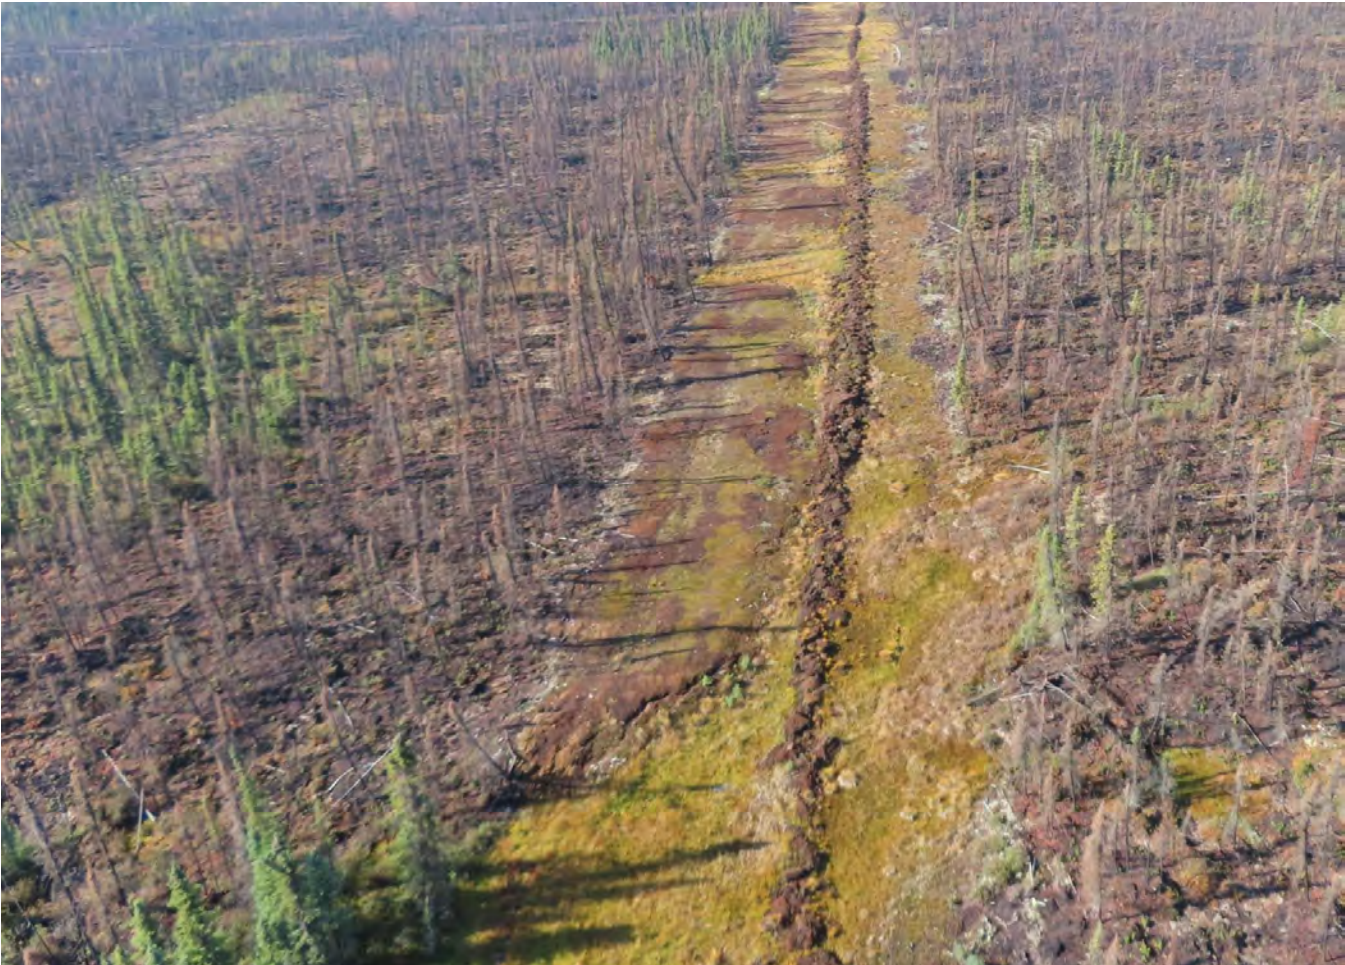
Figure 177

Pipeline – W I-73. Pipeline facing west (east section) appeared satisfactory with no signs of erosion observed. Pipeline was remediated in March 2019.

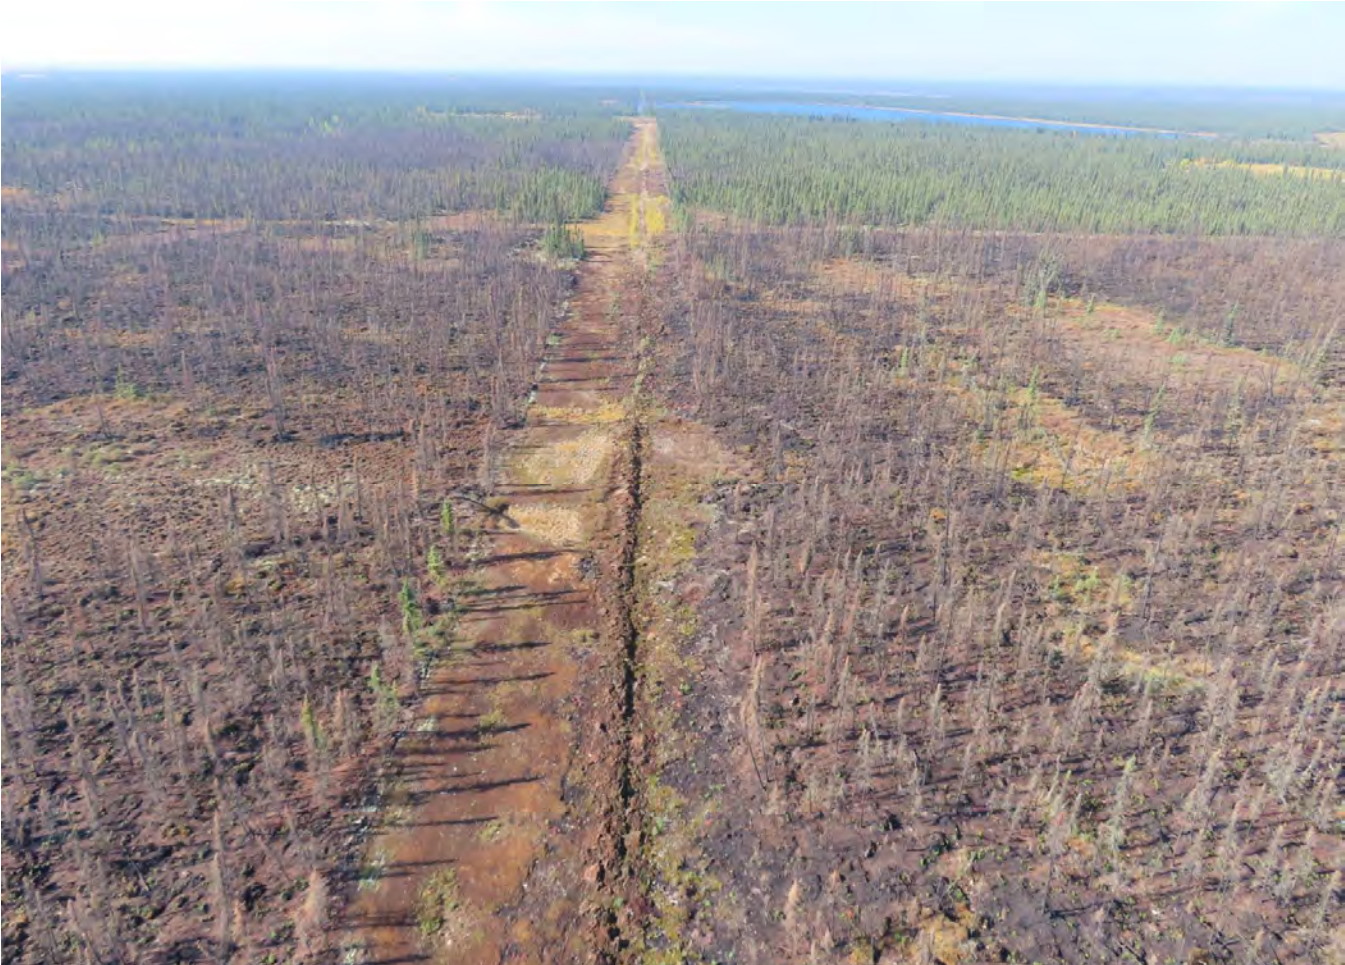
Figure 178

Pipeline – W I-73. Pipeline facing west (west section) appeared satisfactory with no environmental concerns noted. Pipeline was remediated in March 2019.

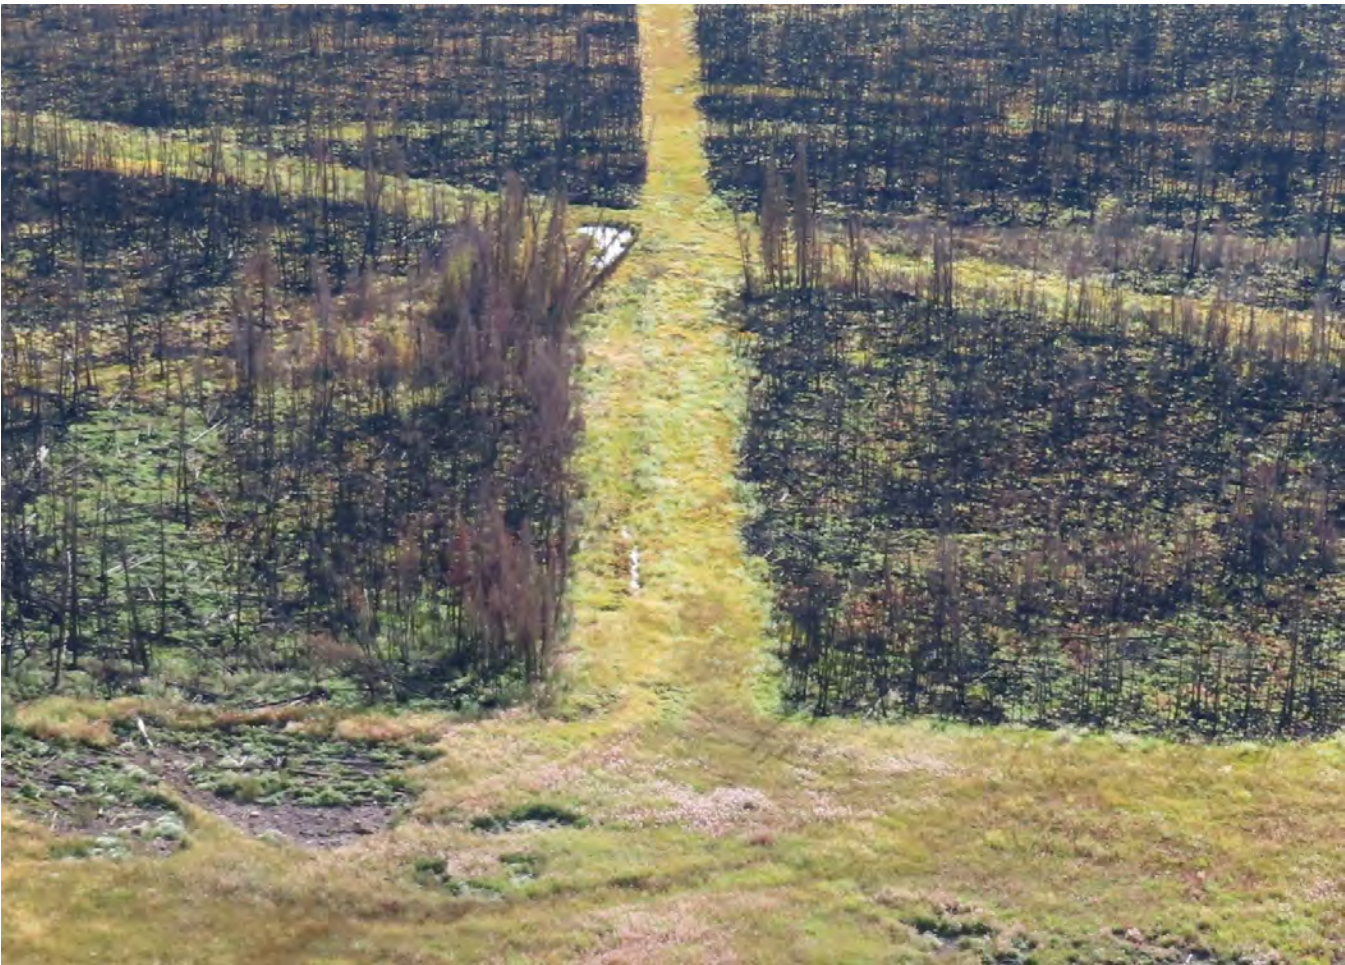
Figure 179

Pipeline – S L-40. Pipeline facing south appeared satisfactory with no signs of erosion observed. Pipeline was remediated in March 2019.
