File Number	MV2022X0018
Type of Operation	Cameron Hills Oil and Gas Field Abandonment
Location	Cameron Hills, NT

ENVIRONMENTAL INSPECTION REPORT

Permittee:	Strategic Oil and Gas Ltd. c/o Alvarez & Marsal Canada Inc.	Permit Expiry Date:	January 02, 2028
Land Use Permit No.	MV2022X0018	Previous Inspection:	February 21, 2024
Quarrying Permit No.		Inspection Date:	September 17, 2024
Contractor:	ELM Inc.	Subcontractor:	
Location(s) Inspected:	Cameron Hills Oil and Gas Field		
Current Stage of Operation:	The abandonment of the H-03 Battery, forty-four (44) oil and gas wells was completed in the winter of 2023 and 2024.		
Program Modifications Approved:

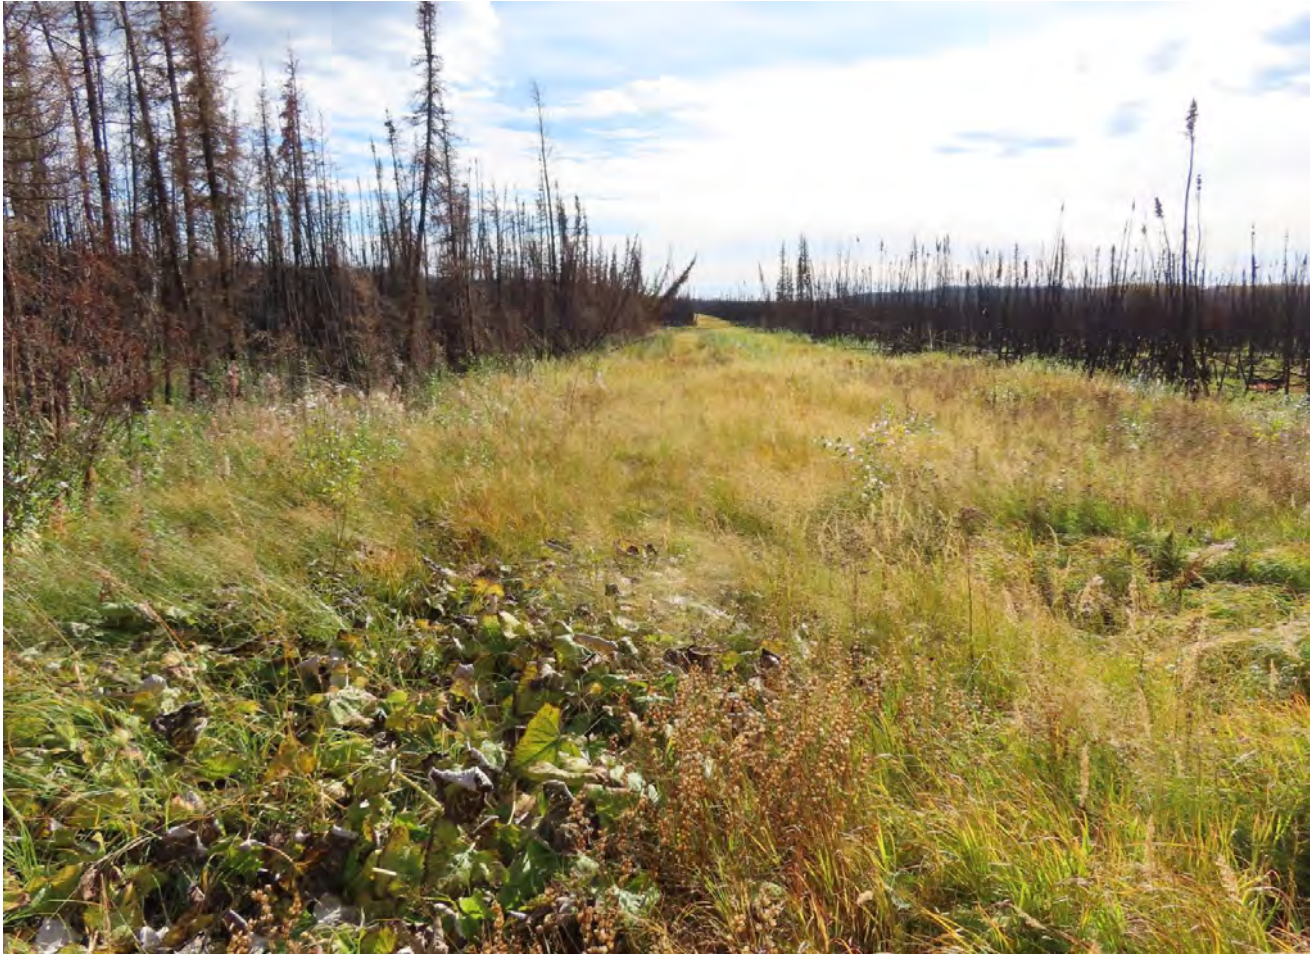
Figure 180

Pipeline – S L-40. Pipeline appeared satisfactory with no signs of erosion observed. Pipeline was remediated in March 2019.

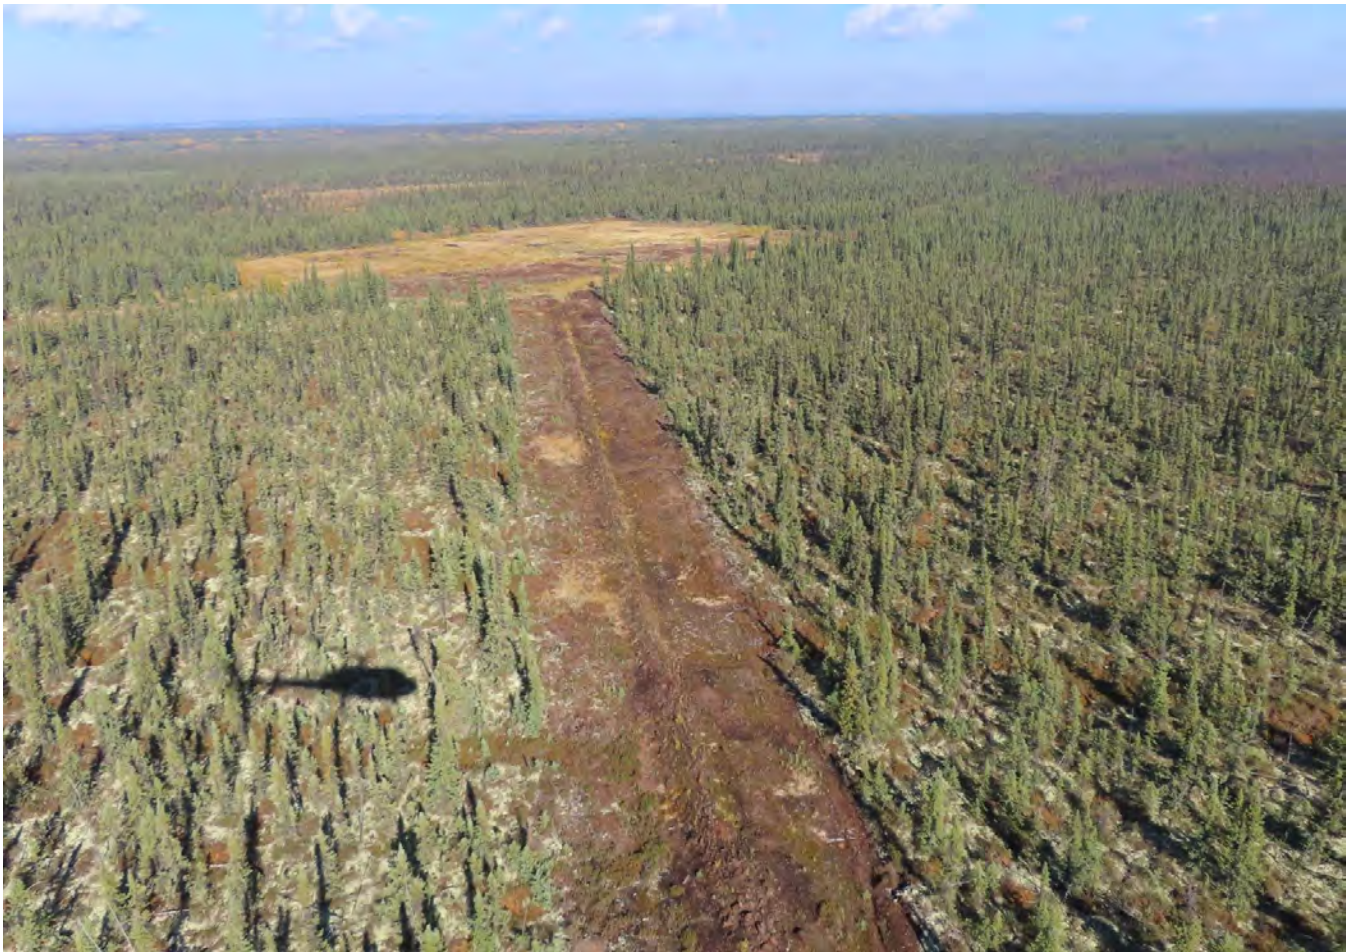
Figure 181

Pipeline – S M-73. Pipeline facing north appeared satisfactory with no signs of erosion observed. Pipeline was remediated in March 2019.

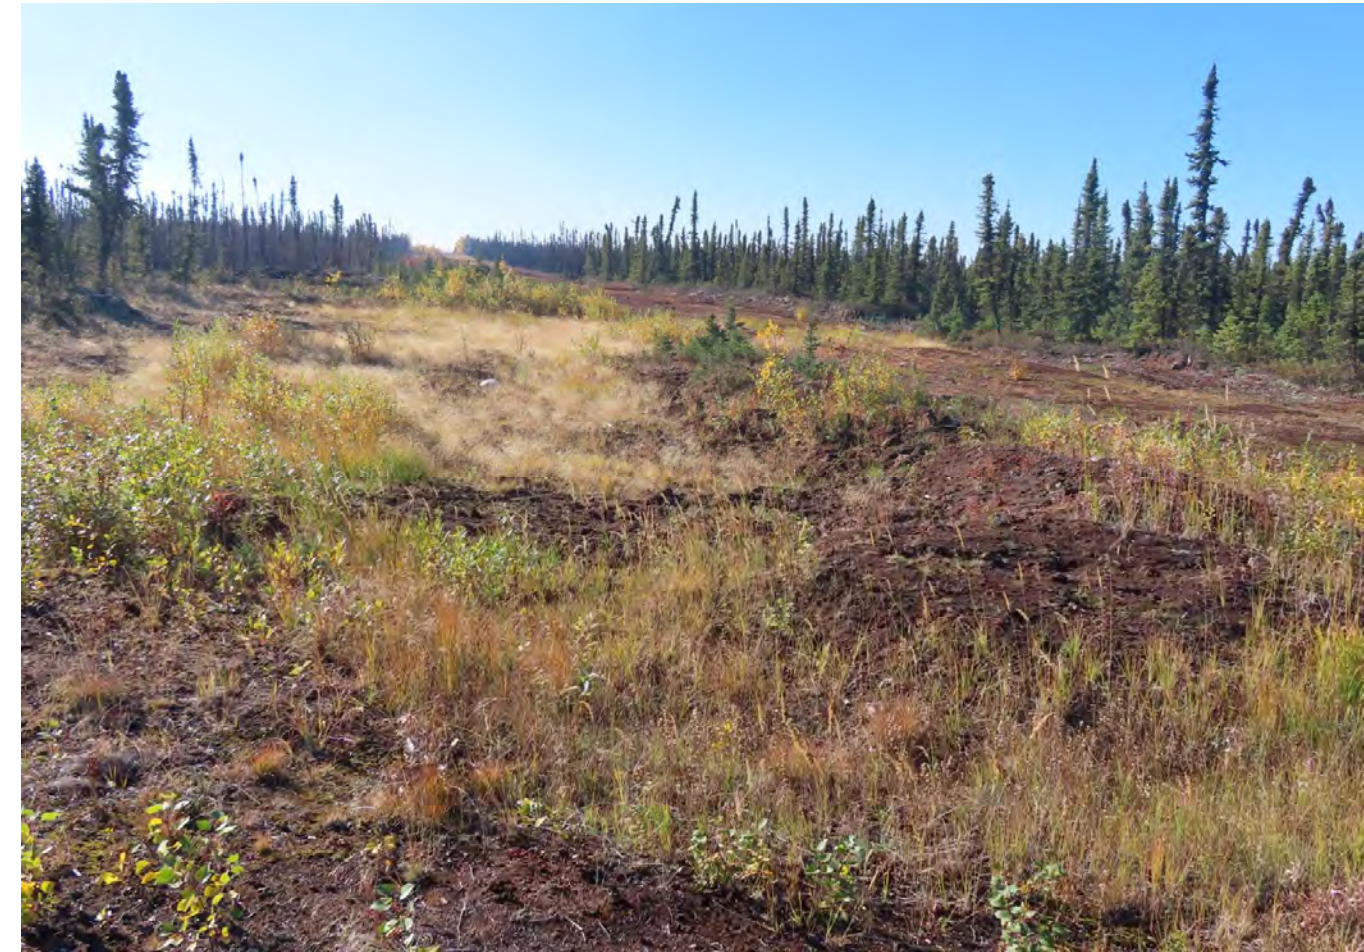
Figure 182

Pipeline – M-74. Facing south, the pipeline riser was removed in the winter of 2023. The area has been backfilled in a satisfactory manner and no environmental concerns were noted.

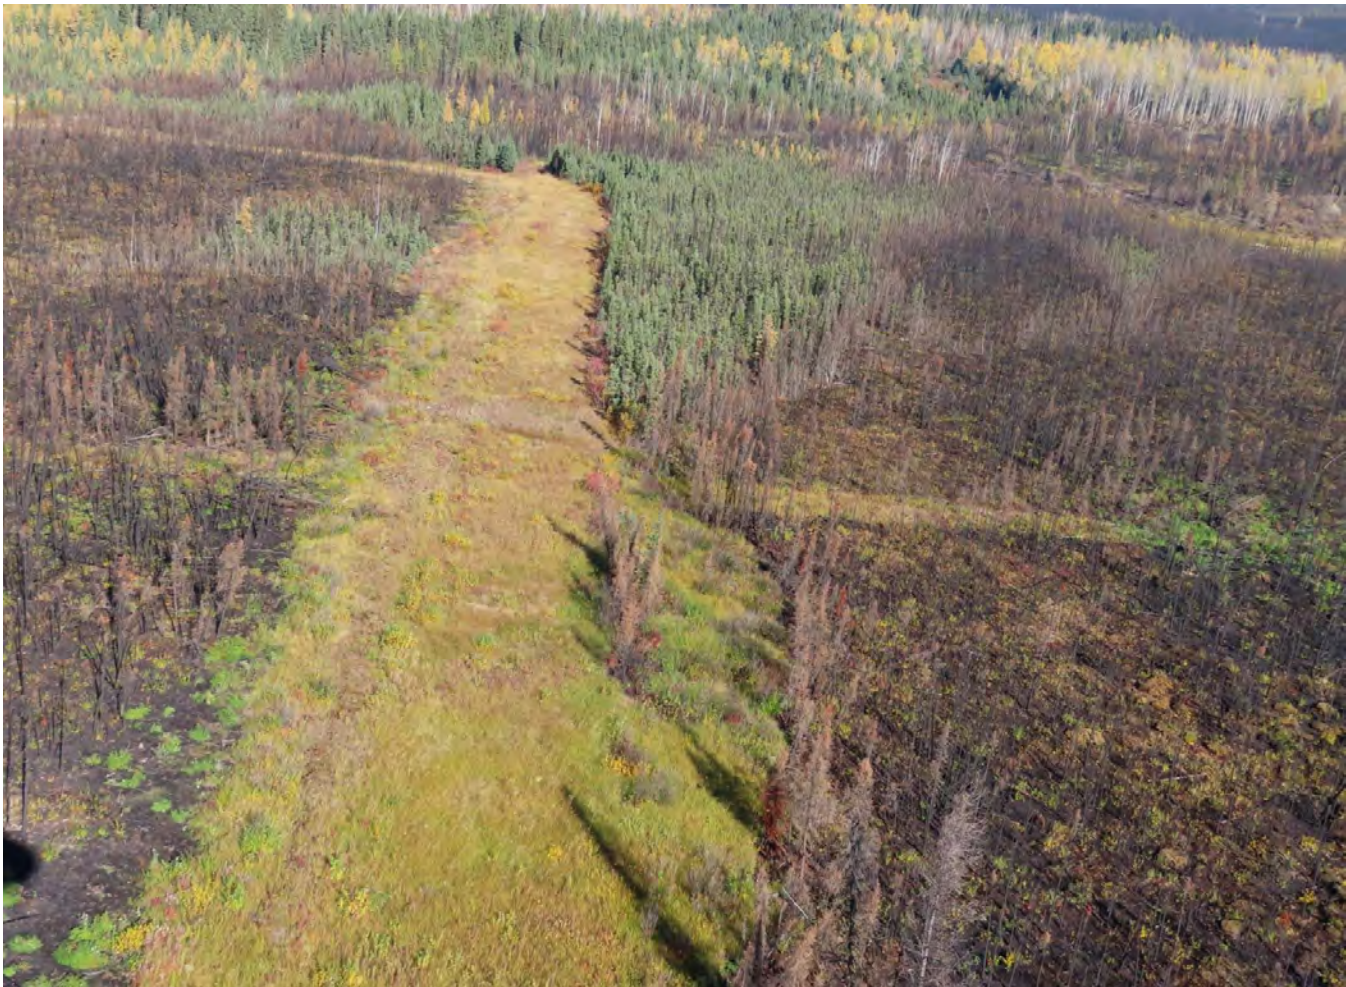
Figure 183

Pipeline – S N-06. Pipeline facing north appeared satisfactory with no signs of erosion observed. Pipeline was remediated in the winter of 2019.

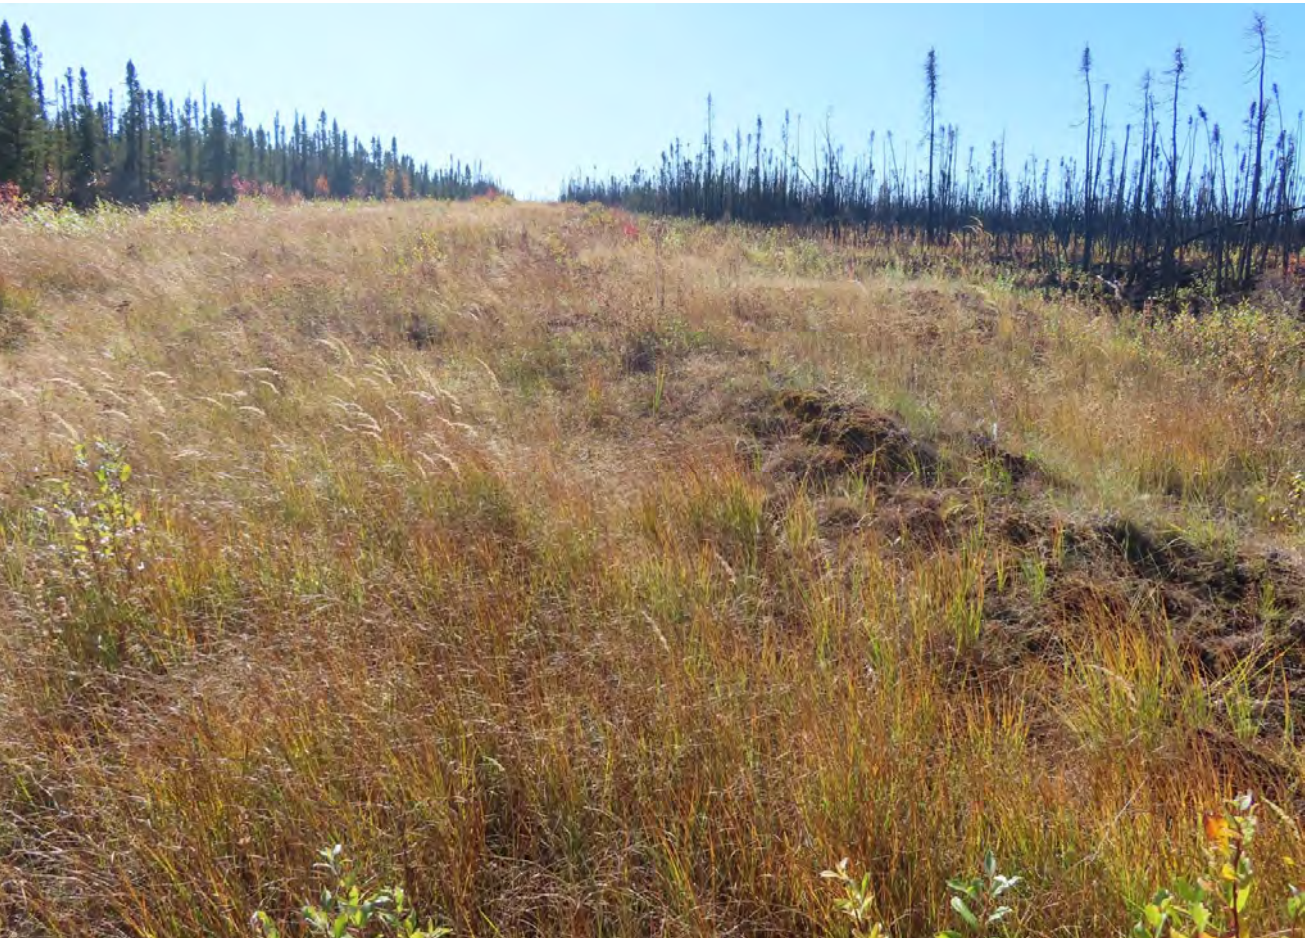
Figure 184

Pipeline – S N-06. Facing south, the pipeline right-of-way was well vegetated with no signs of erosion.

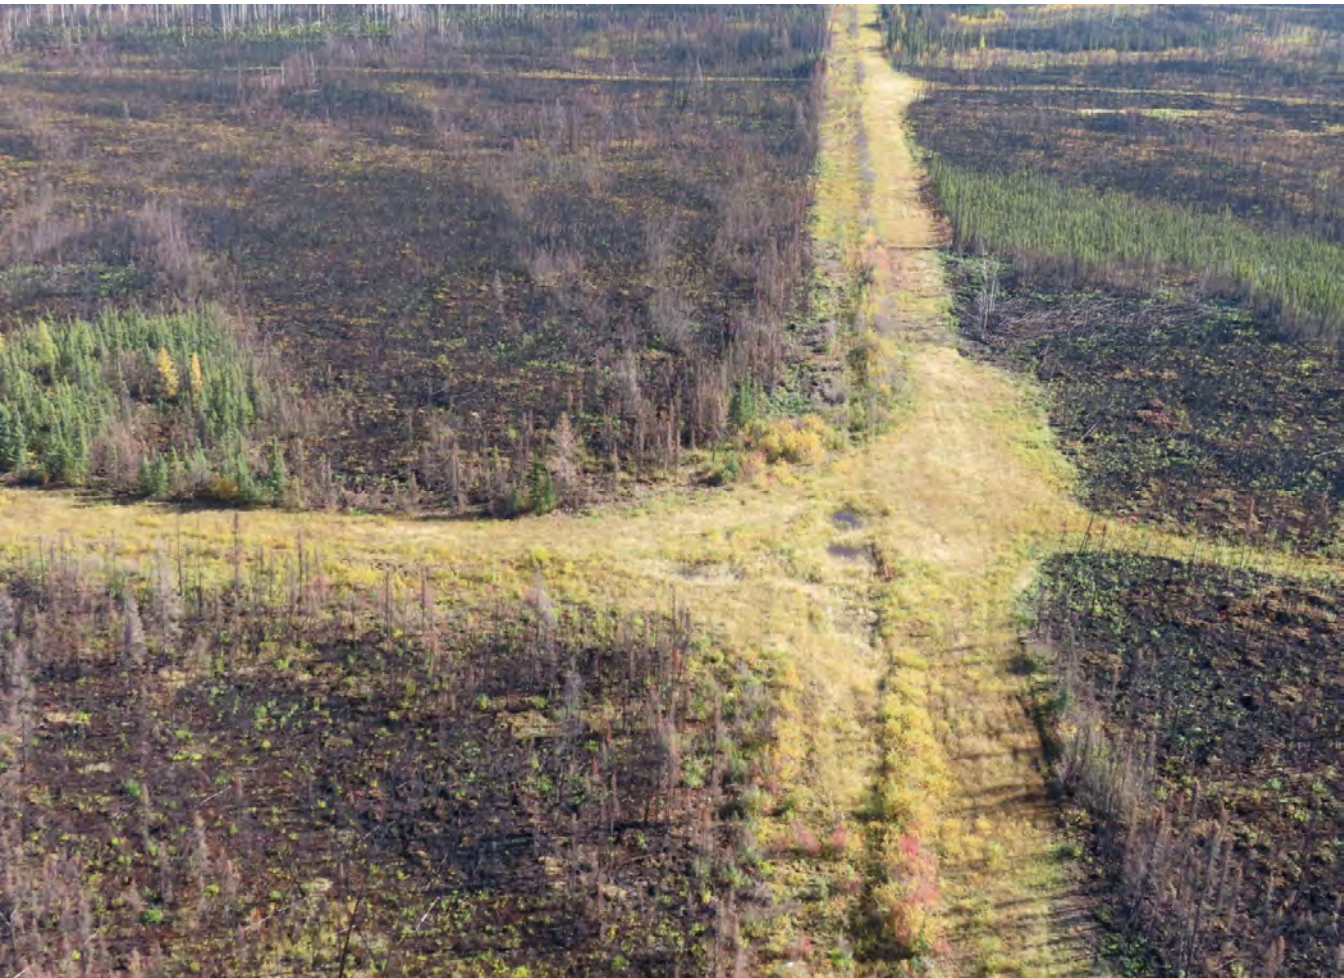
Figure 185

1. All access roads throughout the project area appeared satisfactory with no signs of erosion noted.

Access. Example of an access road in the Cameron Hills. Photo facing east near Wellsite N-06.

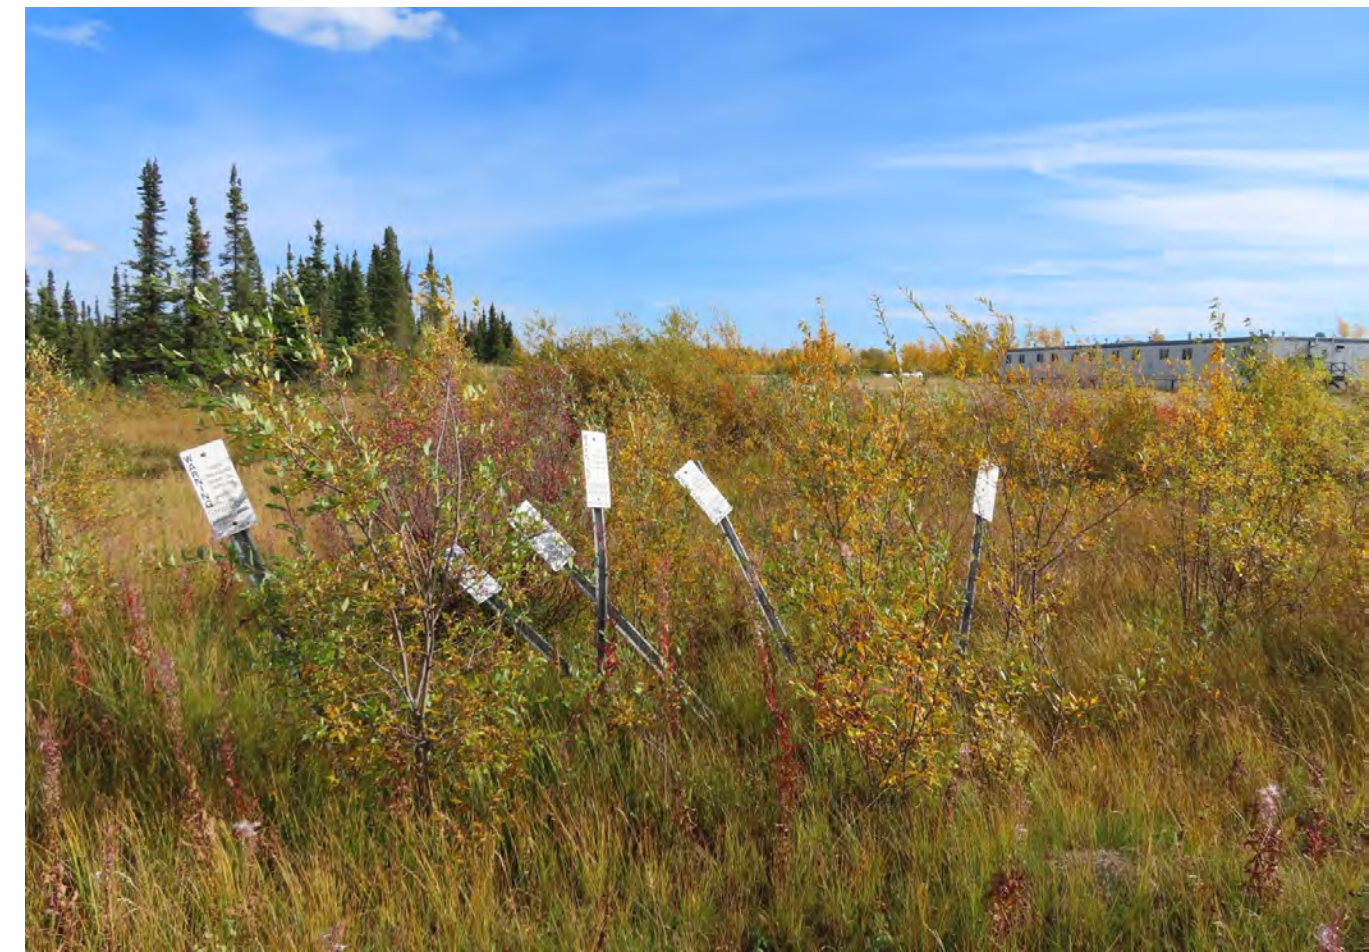
Figure 186

Access - Signage. Signs located near the H-03 Battery to be removed.

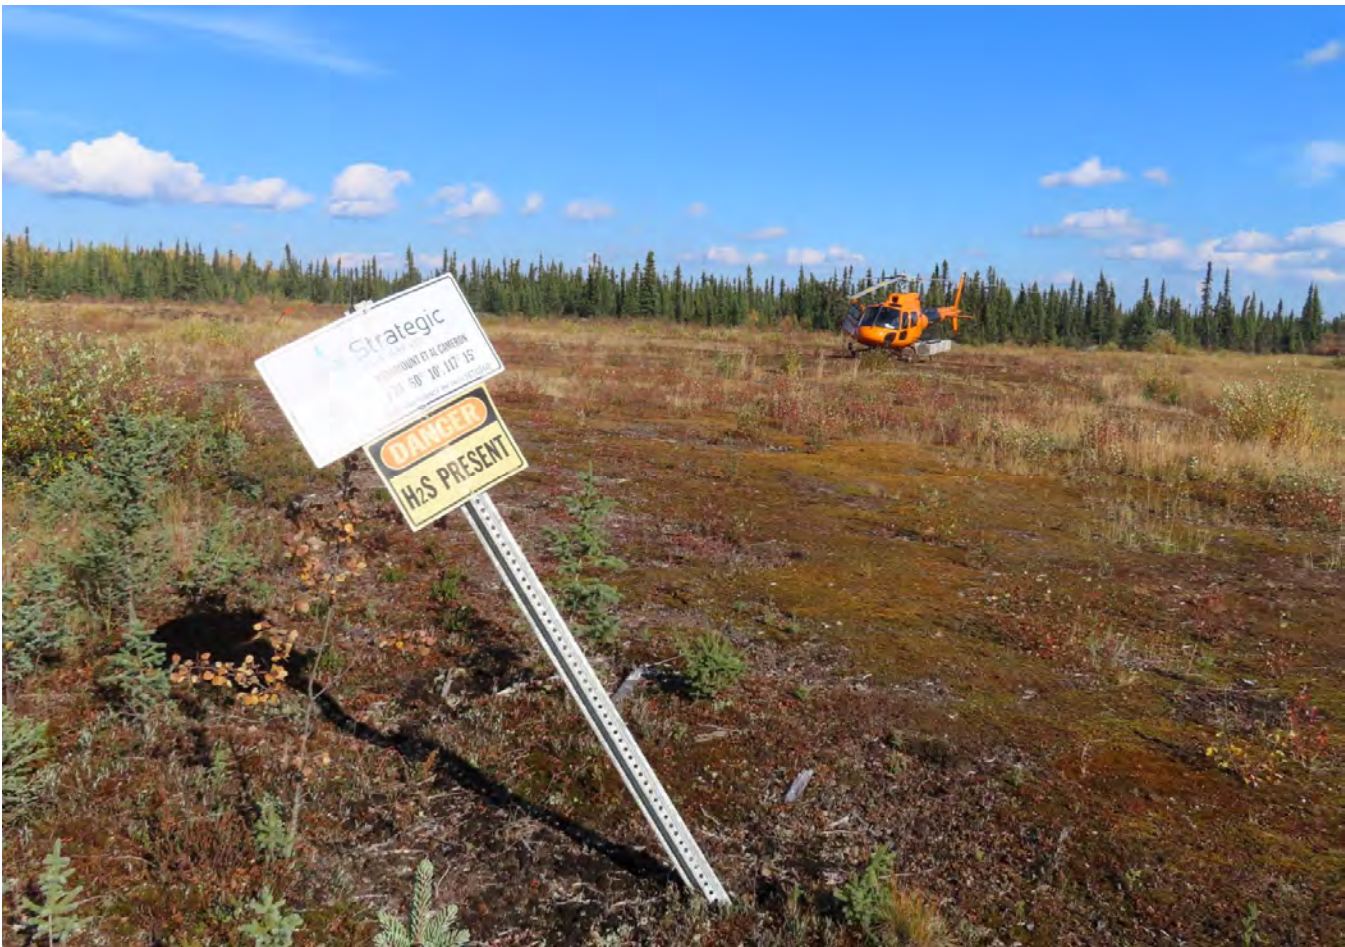
Figure 188

Access - Signage. Sign located at the entrance to a wellsite to be removed.

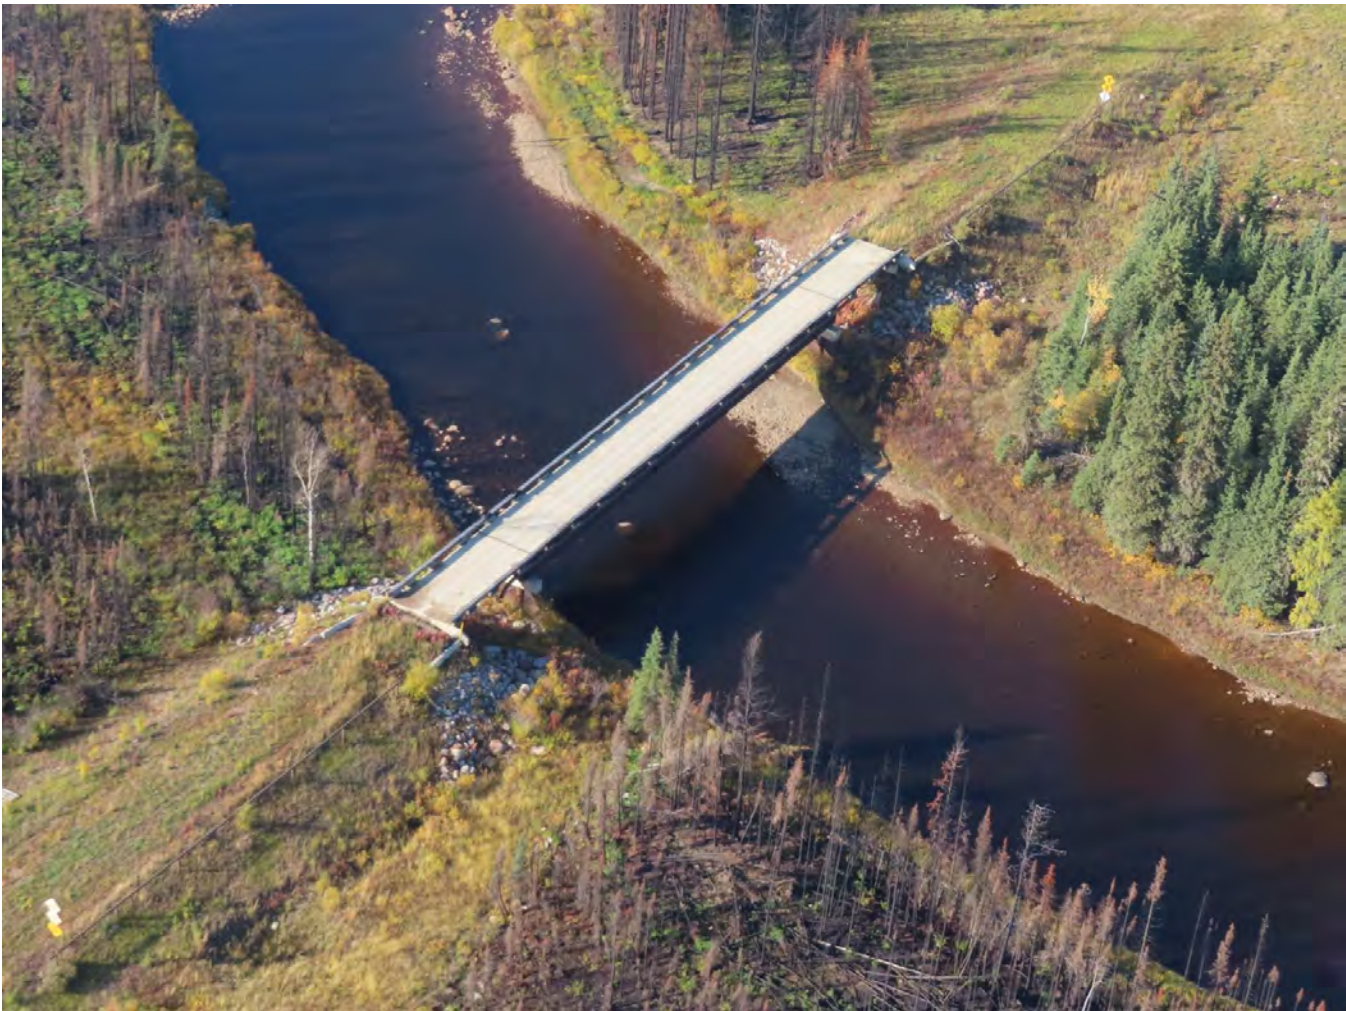
Figure 191

Access – Cameron River Bridge. Aerial view of the Cameron River Bridge facing north.

Access – Cameron River Bridge. Bridge with prefab concrete slabs. Bridge to be removed in accordance with Permit Condition #92 (FINAL CLEANUP AND RESTORATION).

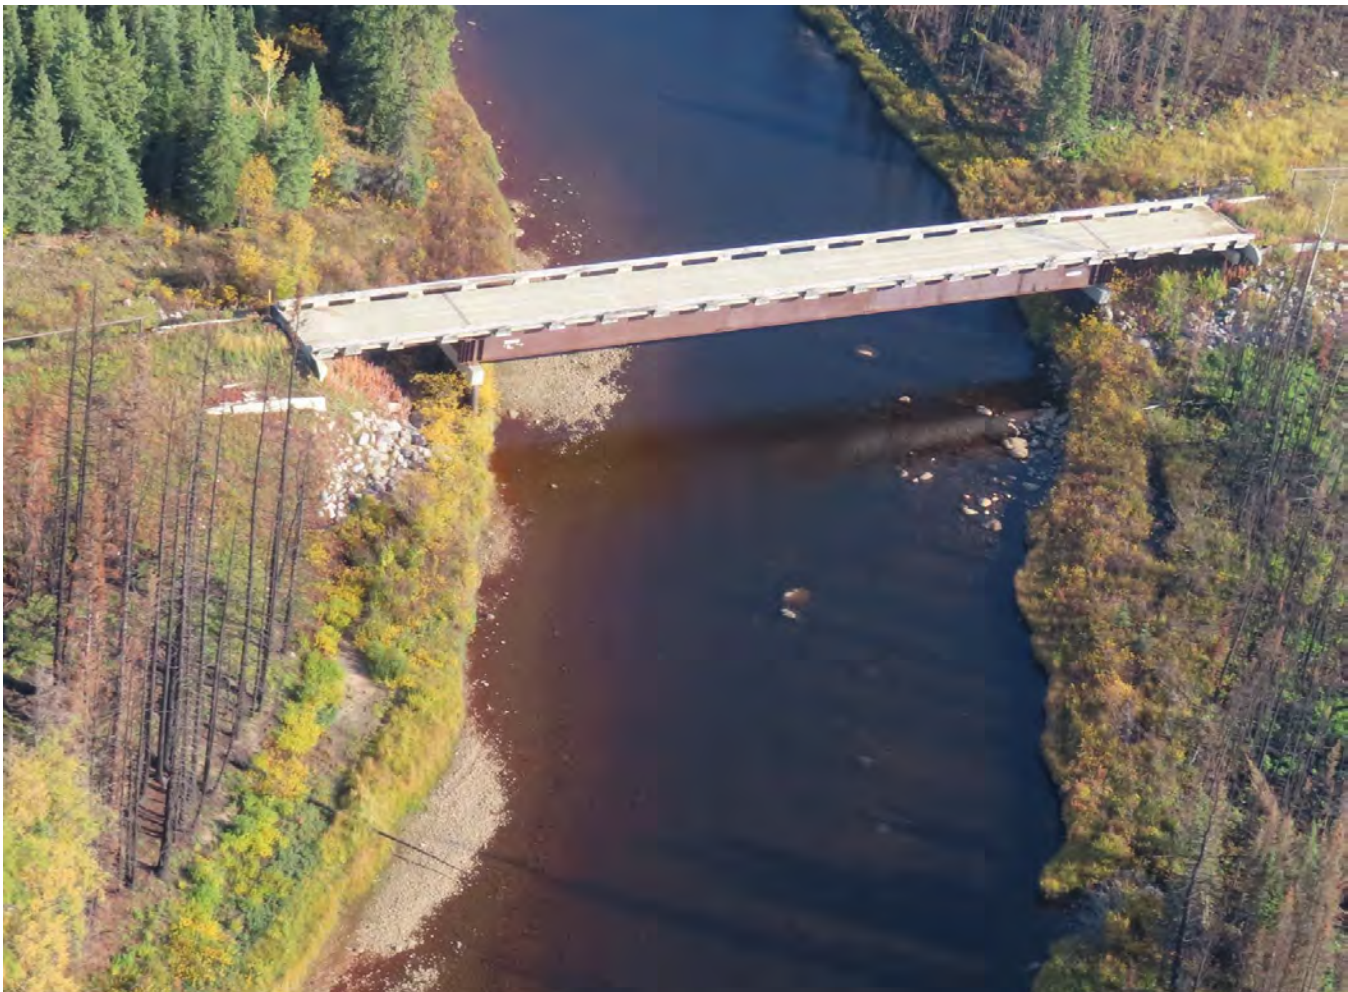
Figure 192

Access – Cameron River Bridge. Aerial view of the Cameron River Bridge facing west.

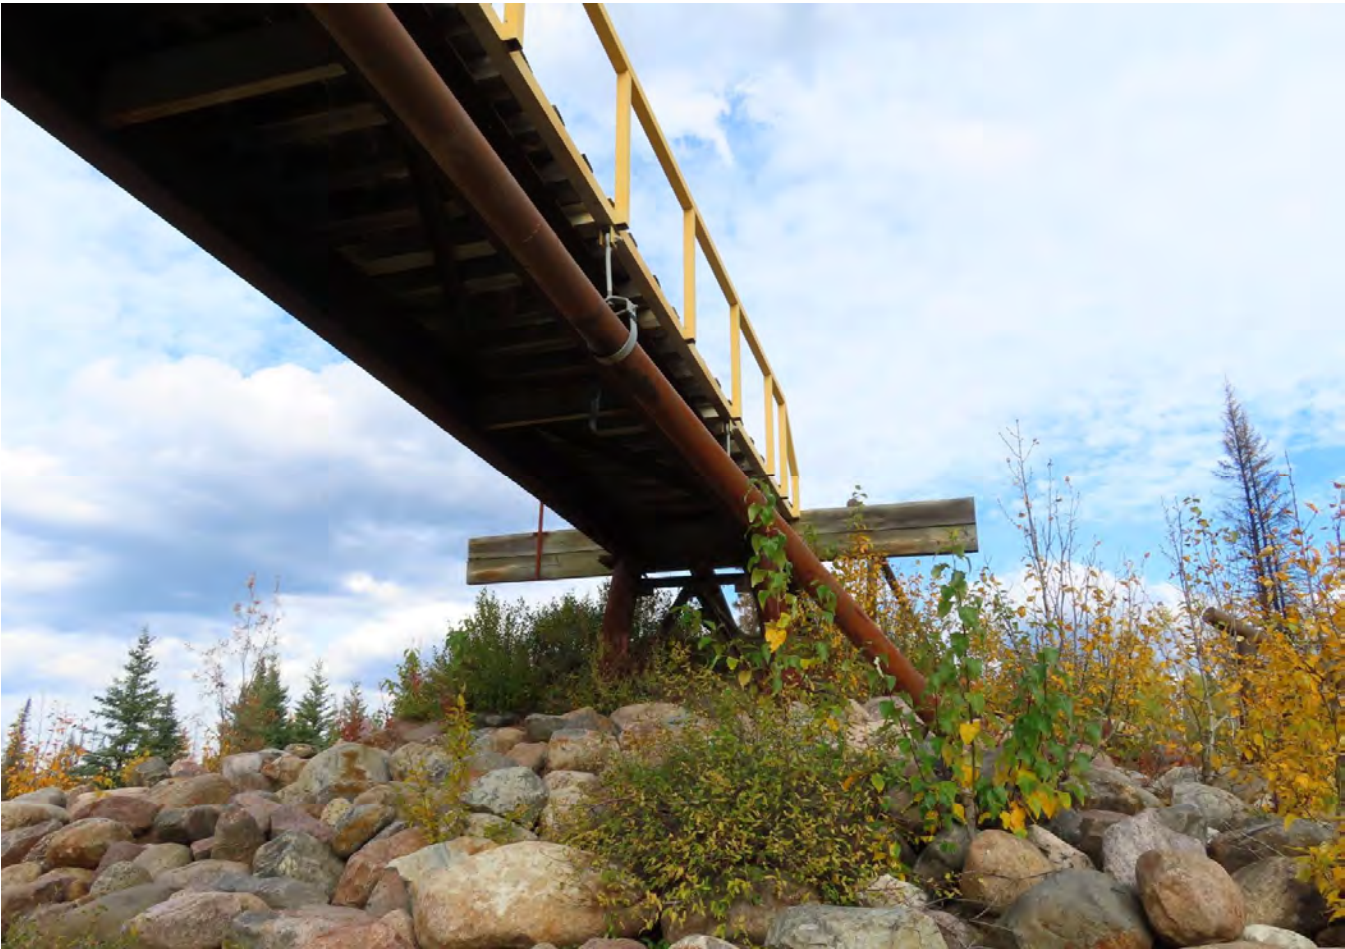
Figure 197

Access – C-50 Bridge. Photo showing rip-rap placed under the bridge to protect the river bank from erosion, attached pipeline and bridge supports.

Access – C-50 Bridge. Bridge with attached pipeline over the Cameron River facing west. Bridge to be removed in accordance with Permit Condition #92 (FINAL CLEANUP AND RESTORATION).

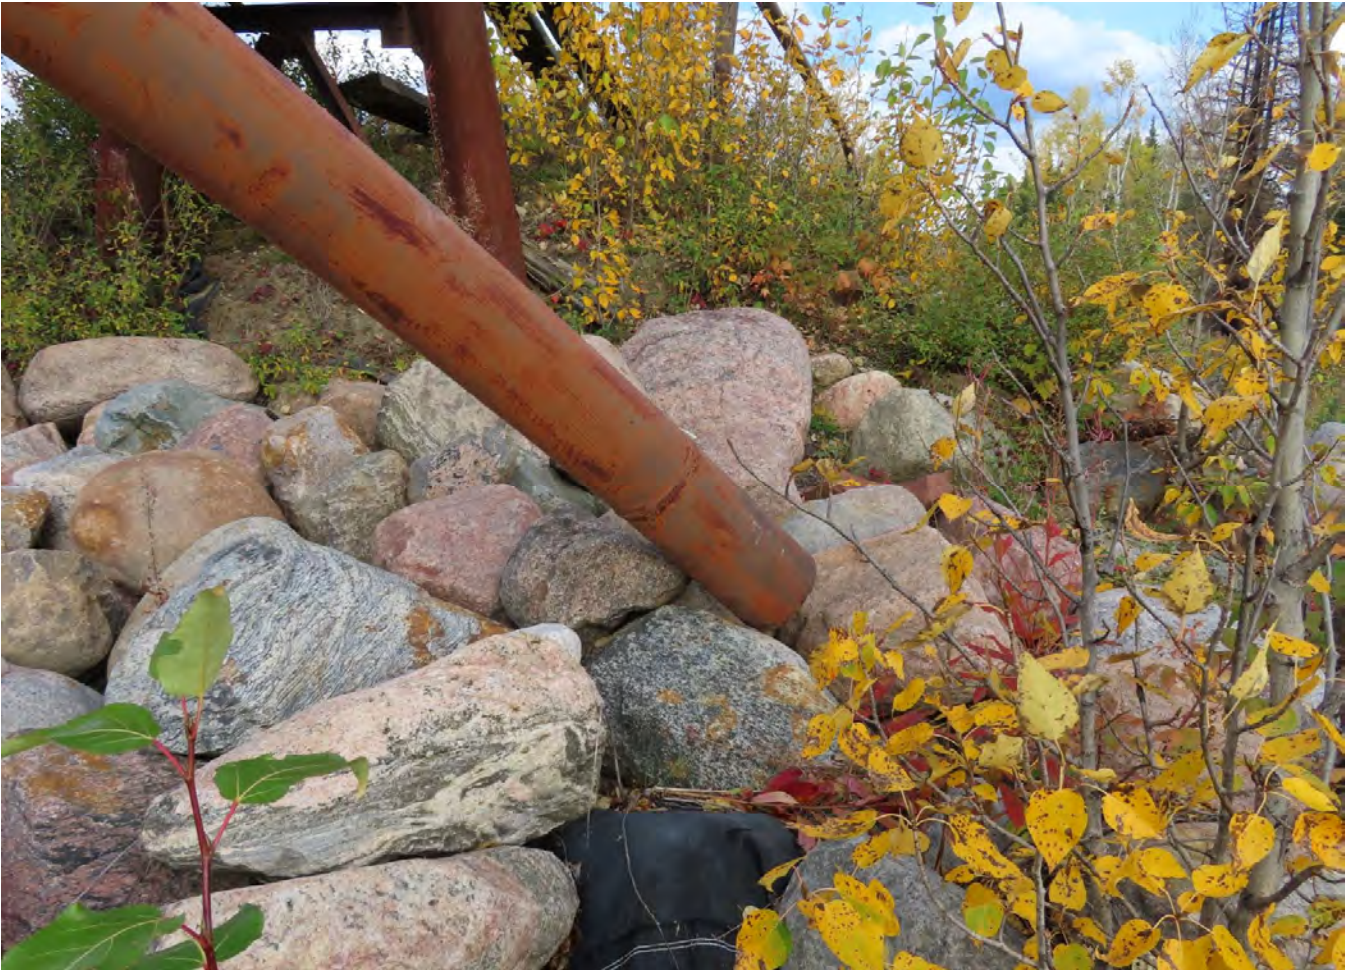
Figure 198

Access – C-50 Bridge. Pipeline attached to the bridge was decommissioned in February 2024 and cut at ground level.

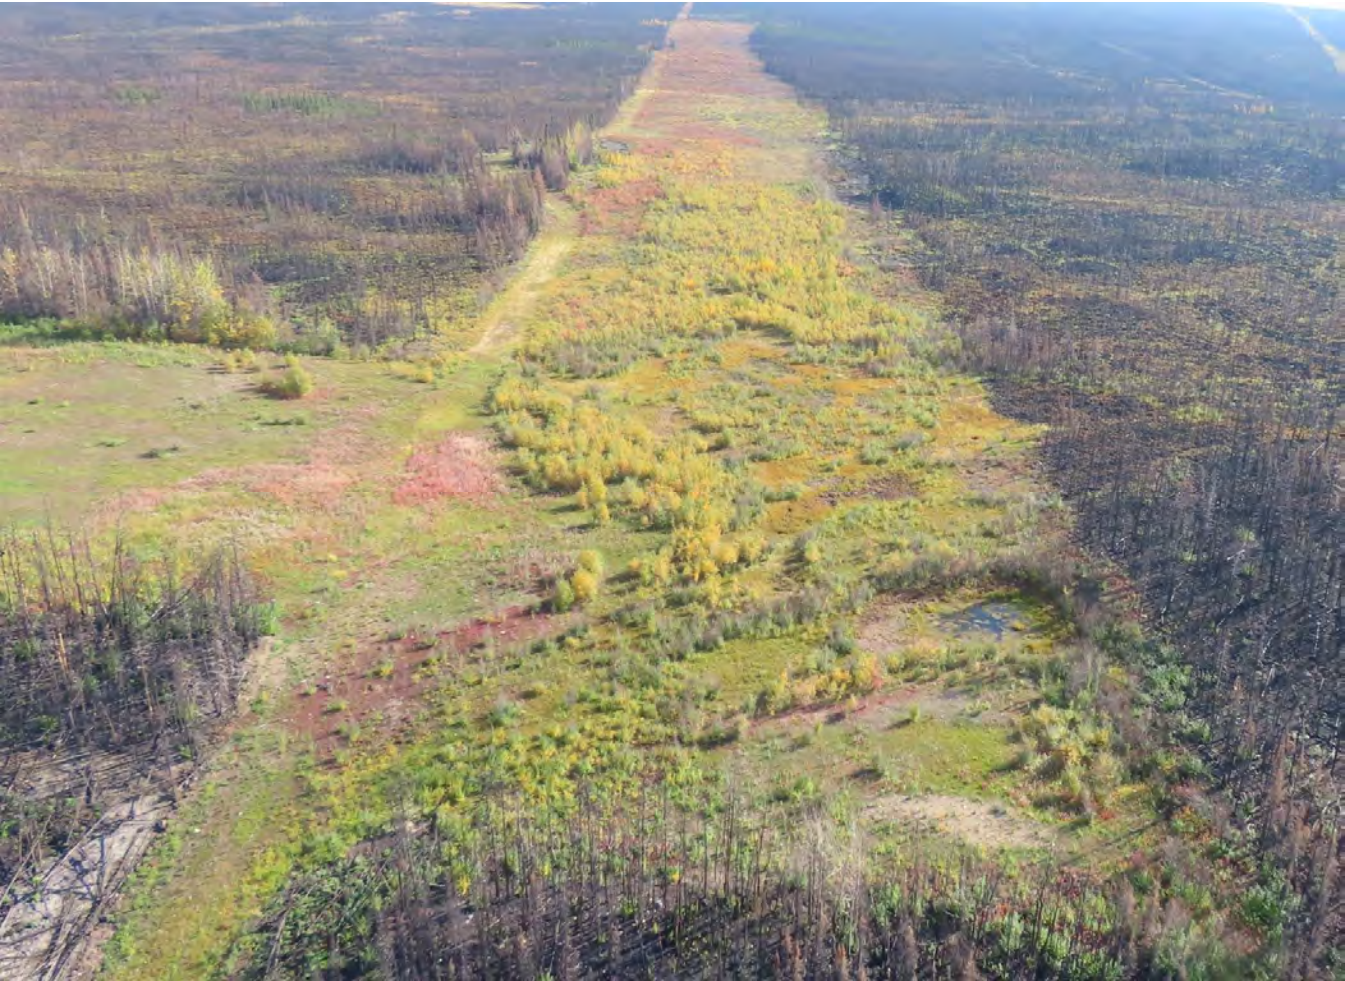
Figure 199

Access – Airstrip. Aerial view airstrip facing east.

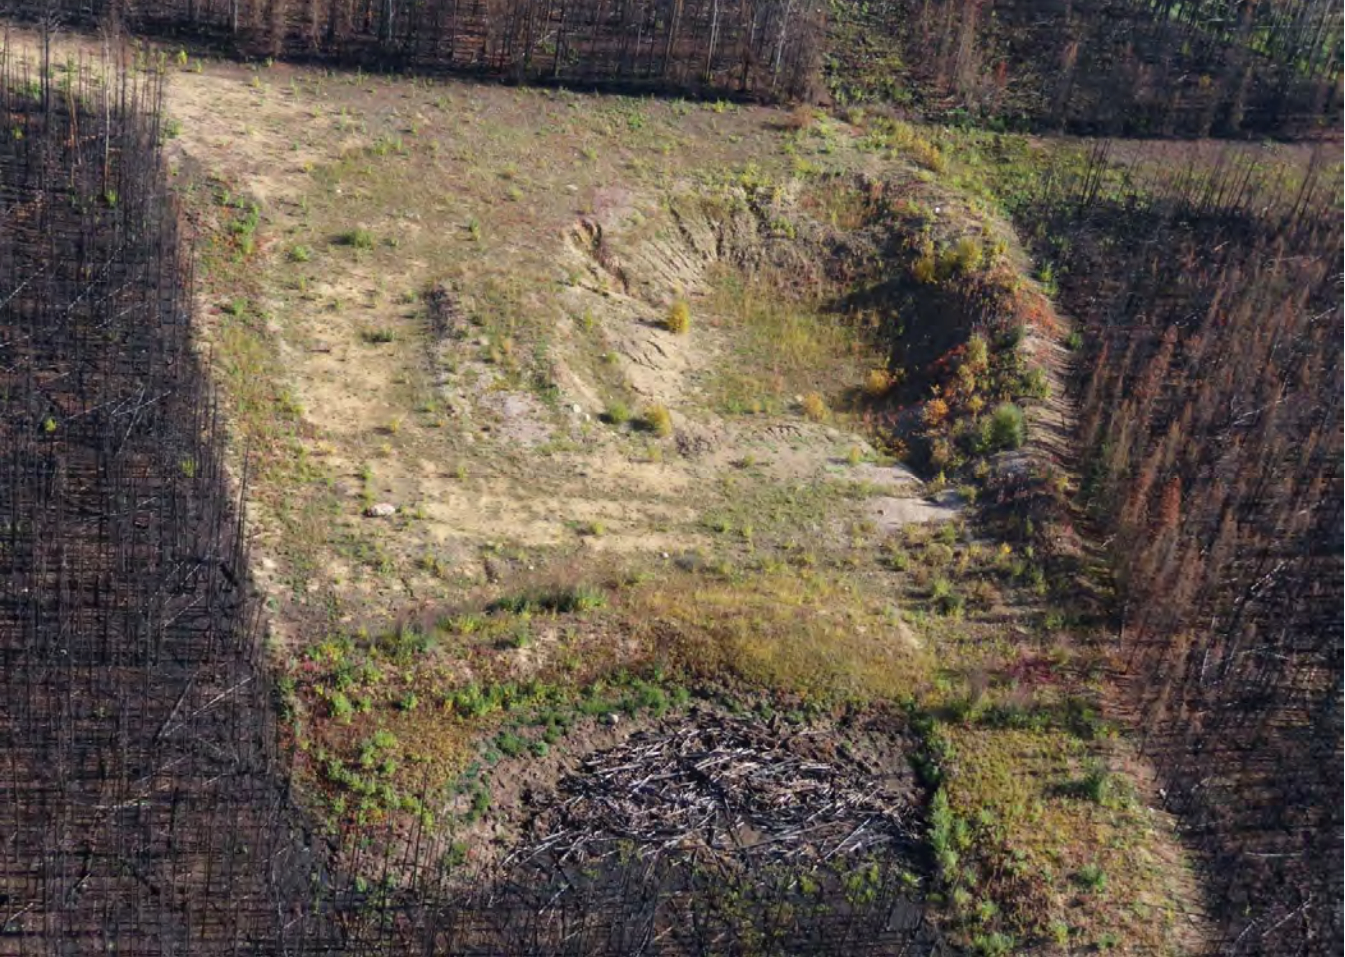
Figure 200

Access – E-07 Gravel Pit. Aerial view of the E-07 Gravel Pit facing east.

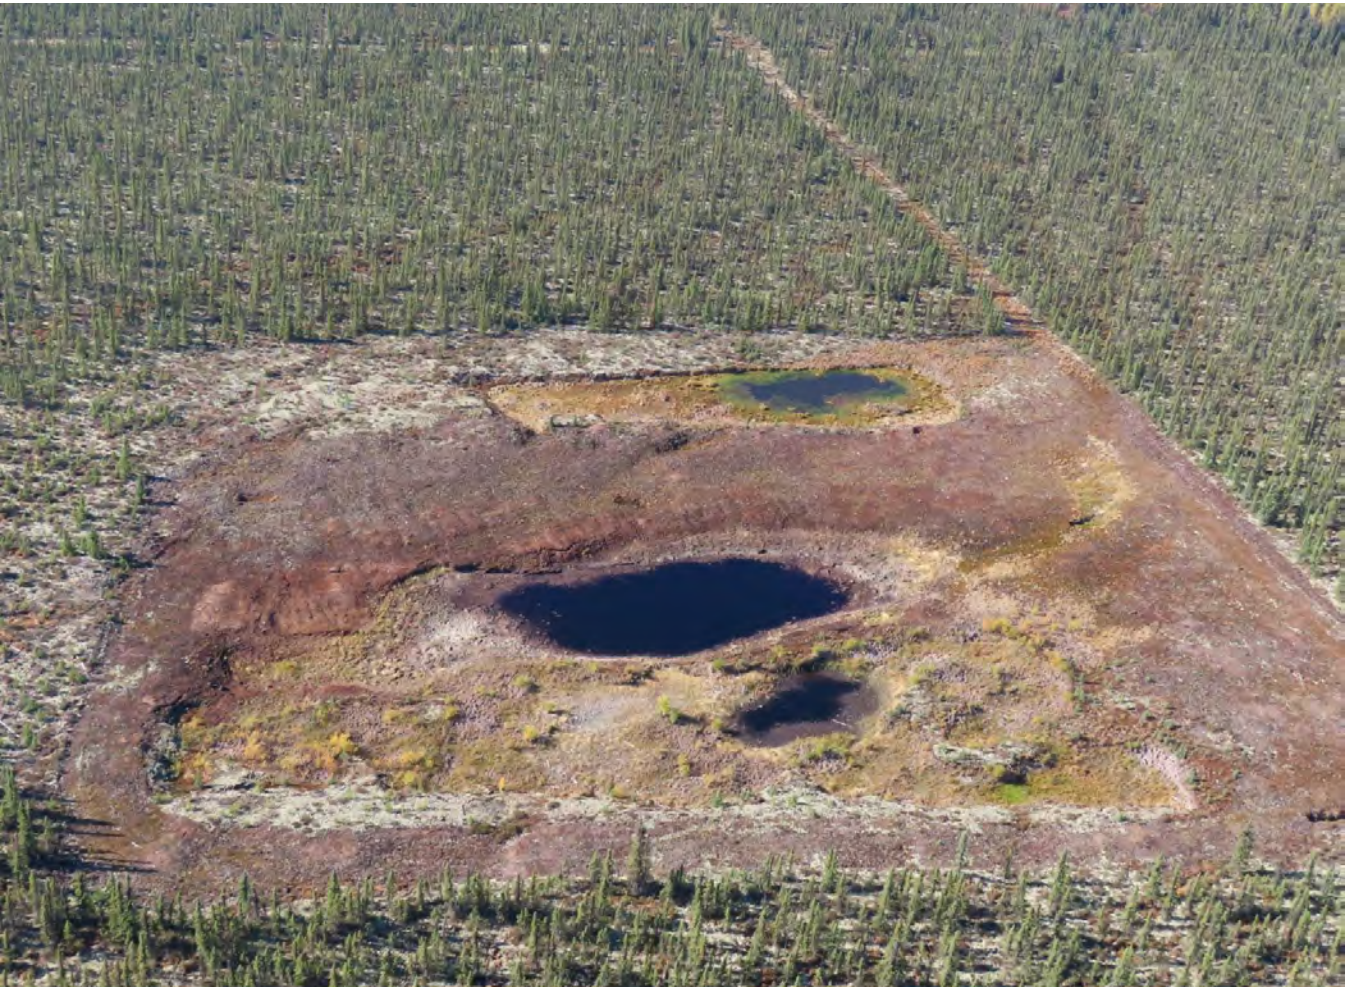
Figure 201

Access – A-04 Clay Pit. Aerial view of the A-04 Clay Pit facing west.

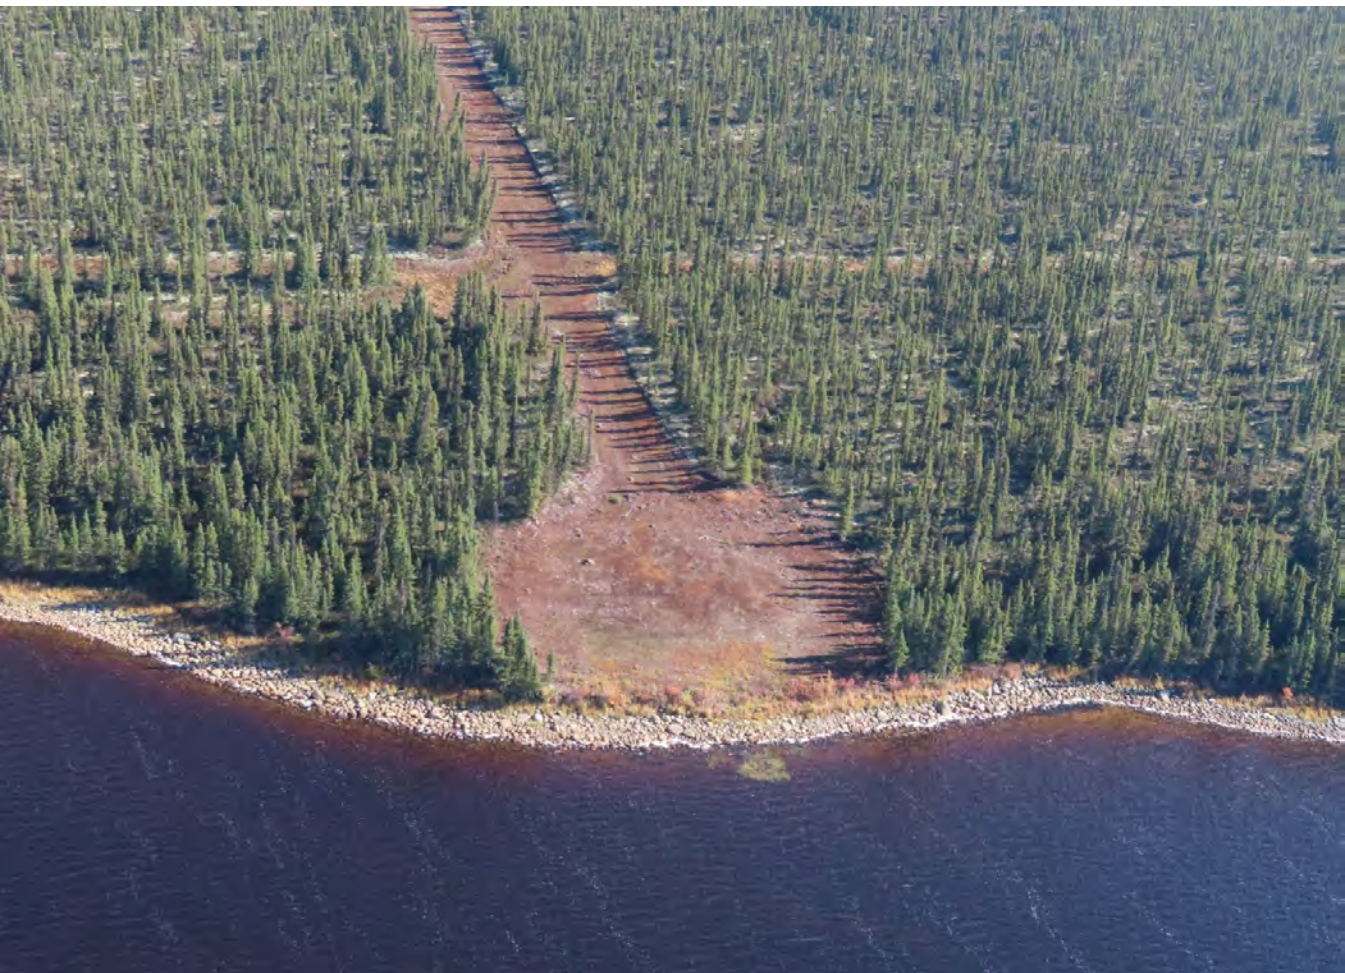
Figure 202

Access – Lake Source #3. Aerial view of Lake Source #3 and access road.

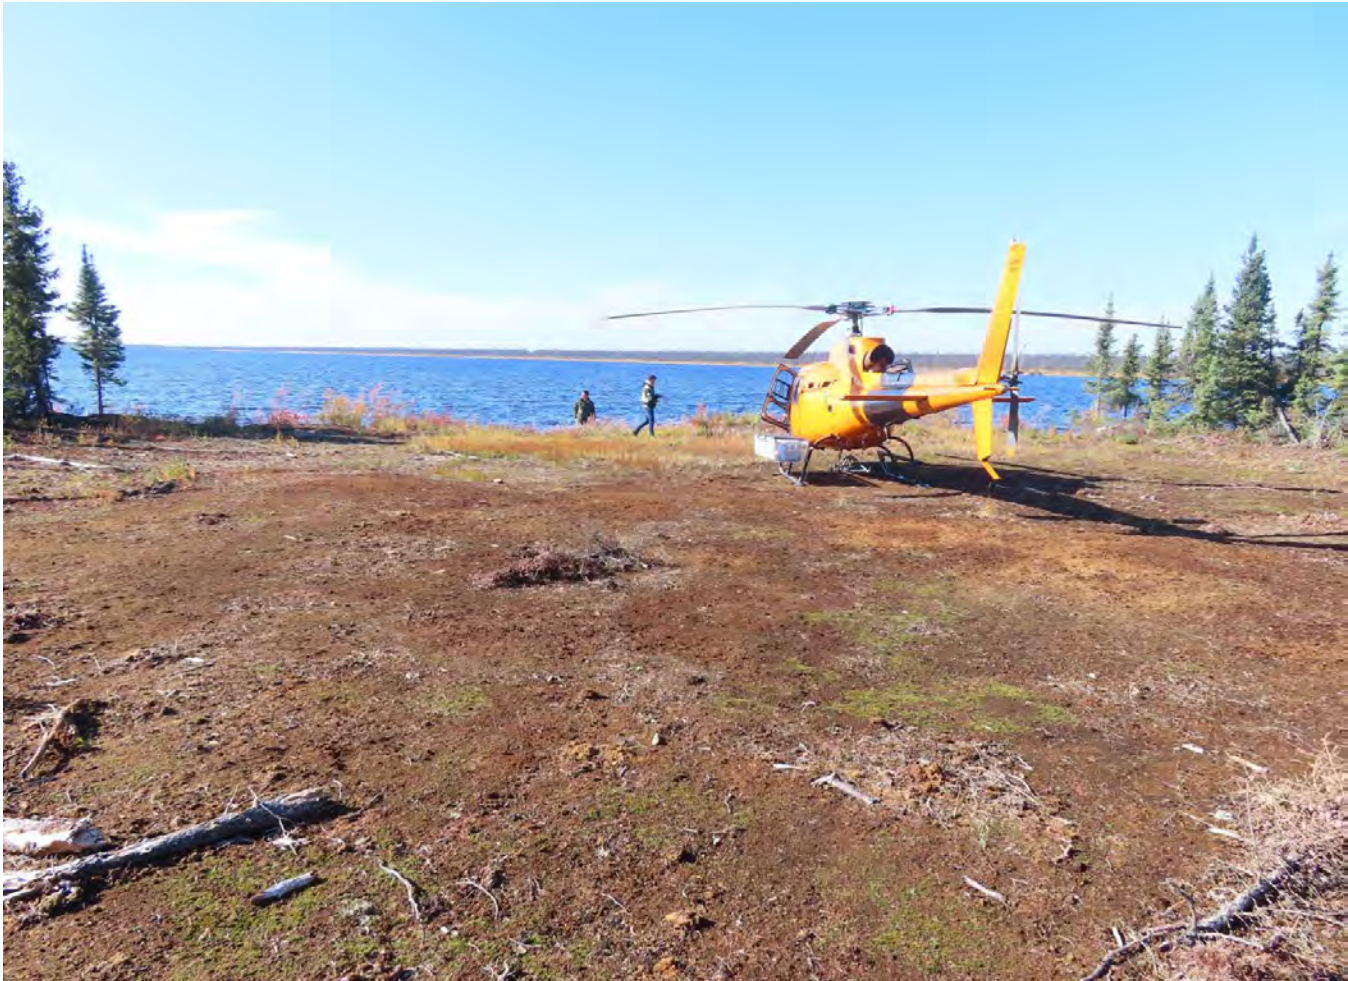
Figure 203

Access – Lake Source #3. The site including the shoreline was clean of debris and no environmental concerns were noted during the inspection.
