Cantung Mine Closure Geotechnical Stability Assessment

PRESENTED TO
North American Tungsten Corp. Ltd.
c/o Alvarez & Marsal LLC

JULY 2019
ISSUED FOR USE
FILE: 704-ENW.WENW03039-03.007

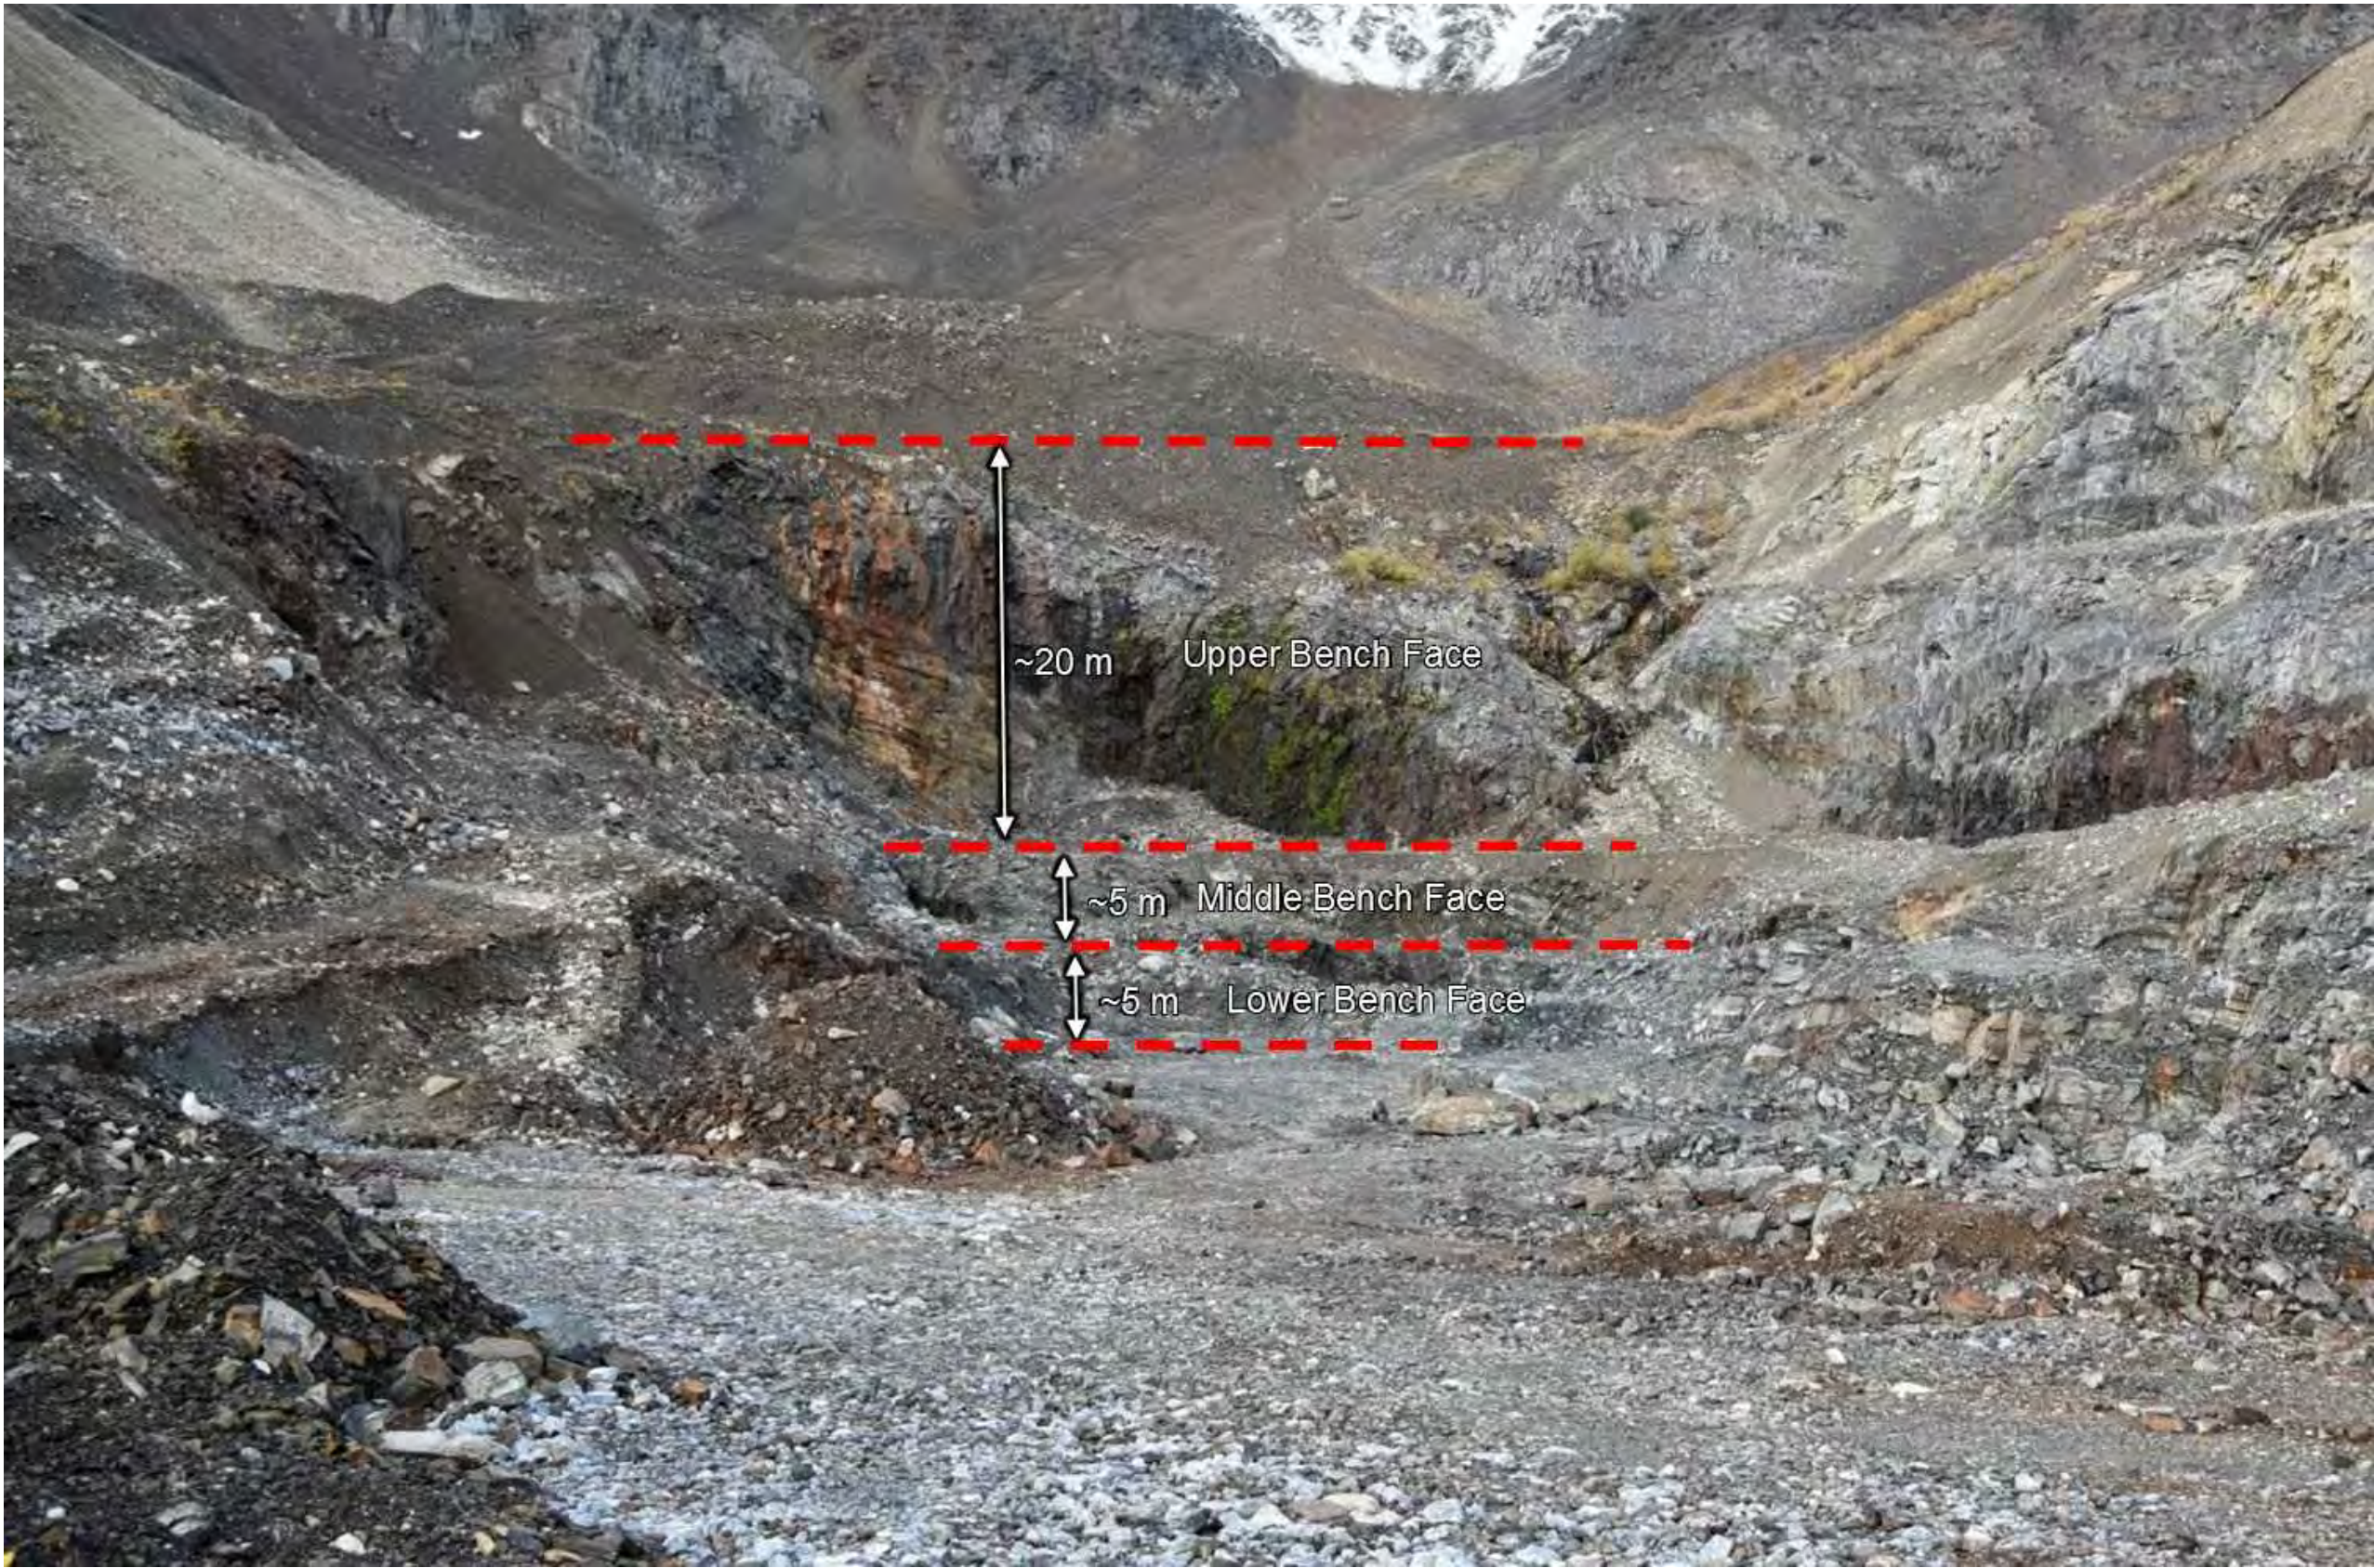
The Southwest Wall consists of one large, upper face and two smaller, lower faces. Above the upper face, waste rock was dumped in order to continue the ramp that leads to the bench between Faces 2 and 3 of the Northwest Wall. Figure 4 shows an image of the Southwest Wall with bench-faces and heights labelled. The structure in the Southwest Wall consists of a bedding-parallel joint set that dips approximately 20° to the northwest, as well as two sub-vertical joint sets. The two lower faces are both approximately 5 m high while the upper face is approximately 20 m high.

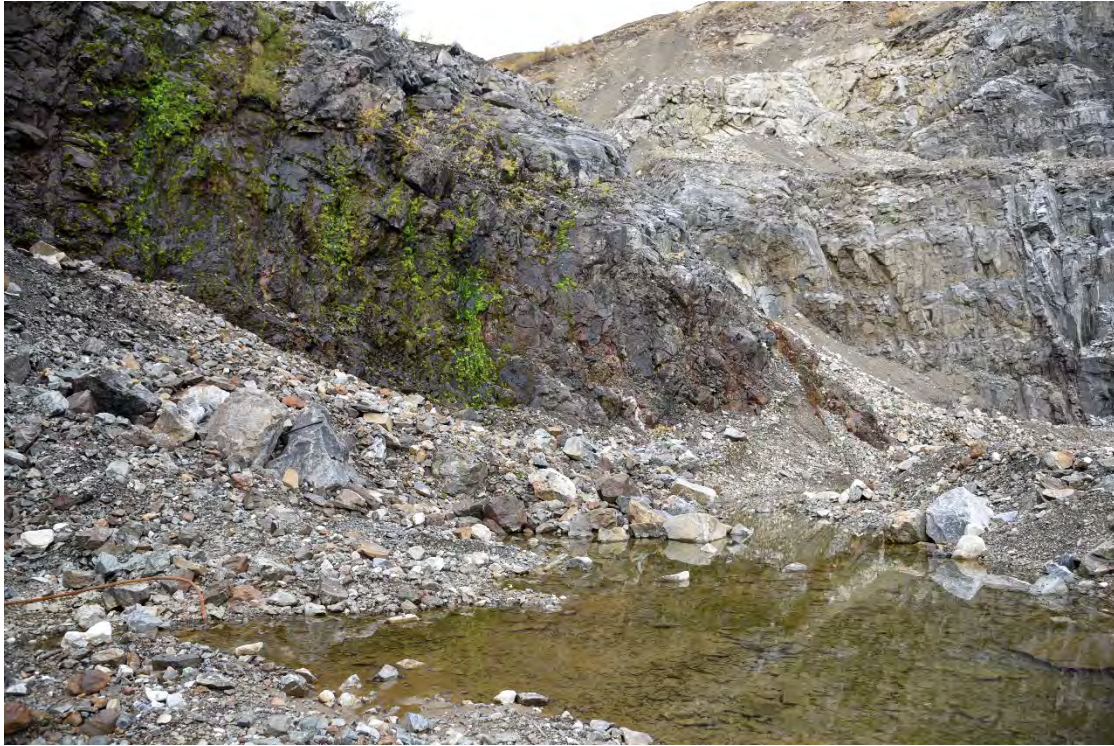
There is a small waterfall located in the west corner of the pit, and an approximately 25 m length of the southwest face is wet and moss-covered due to groundwater seepage. Ponding is occurring at the base of this waterfall and most of the wet rock is iron-stained. It appears that the rest of the Southwest Wall is typically exposed to some type of water flow due to significant iron staining, particularly near the south corner of the pit. These features are shown in Photos 5 and 6.

Photo 5: Southwest wall of the Open Pit showing seepage through the upper bench-face, ponding water on the upper-middle bench, and the rock fall berm to the right of the photo.

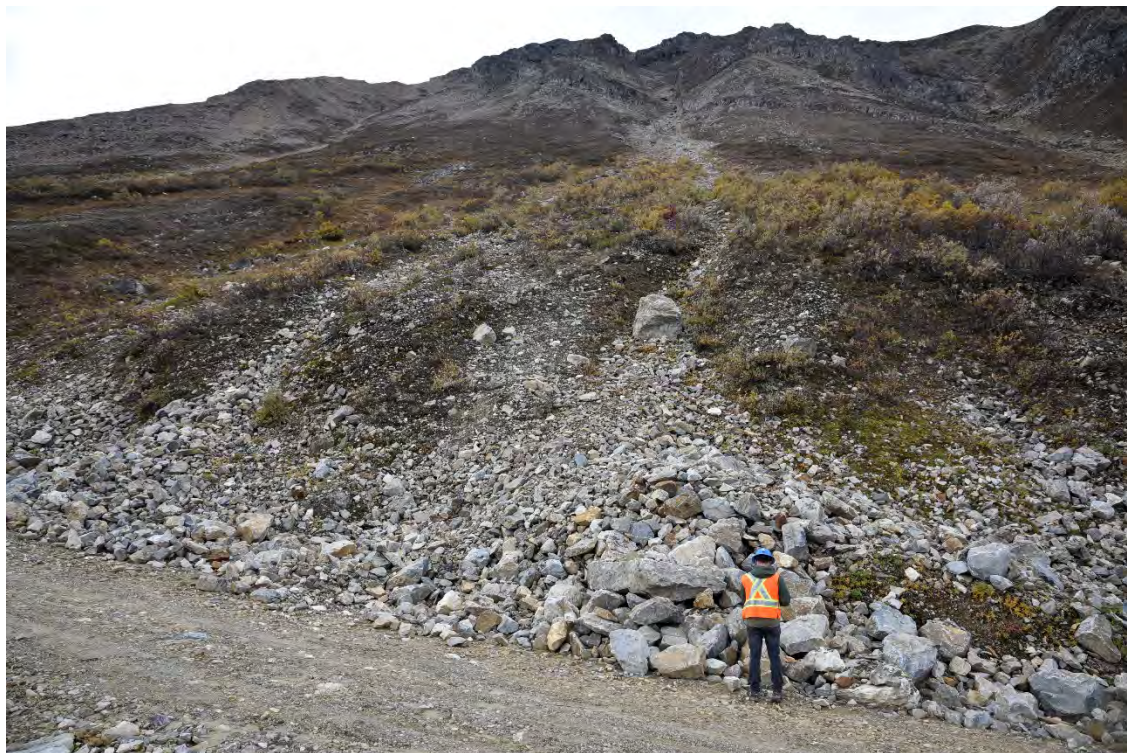
Photo 10: Drainage Channel 3 crossing the Open Pit Access Road.

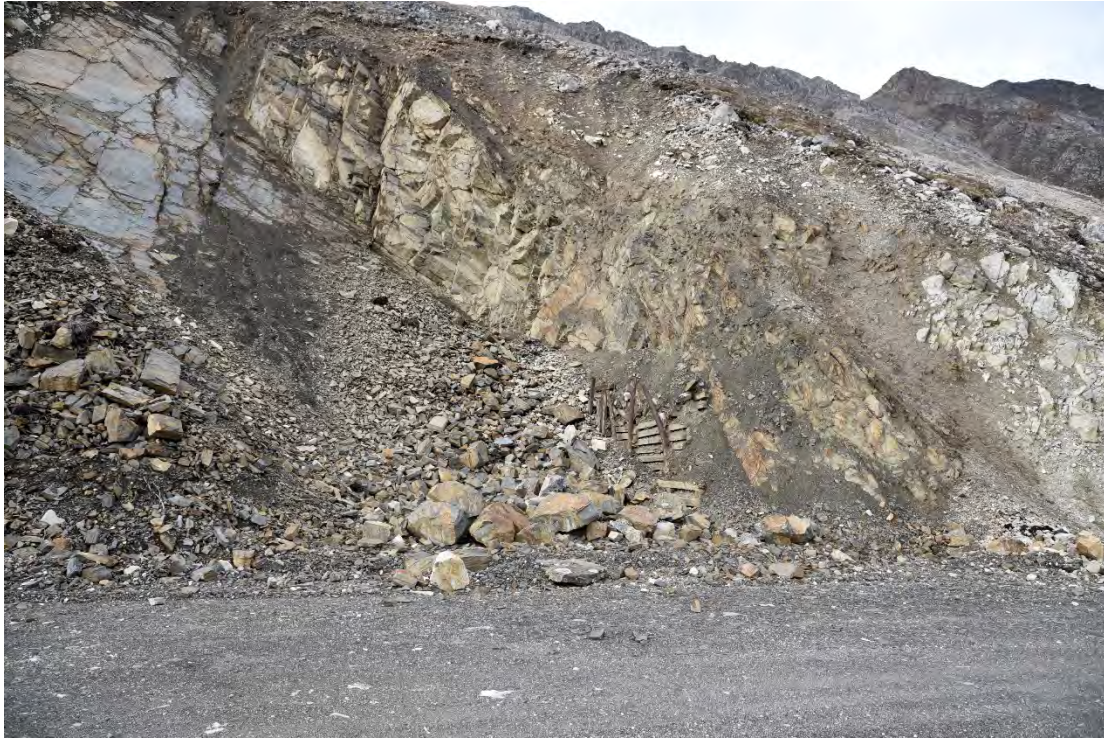
Photo 14: Remnants of the Alimak Adit visible along the Open Pit Access Road; this area should be backfilled with inert aggregate material.

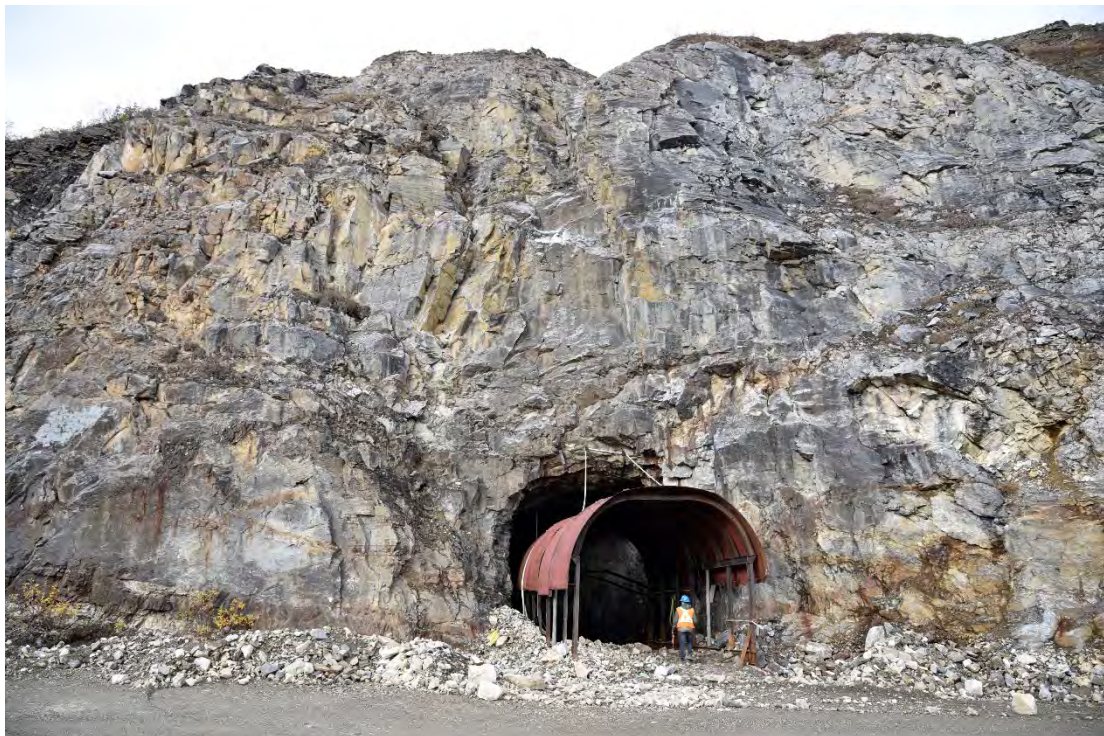
Photo 15: The PUG Portal and slope. The metal canopy structure should be removed, and slope stabilization should include an allowance for scaling and rock bolting.

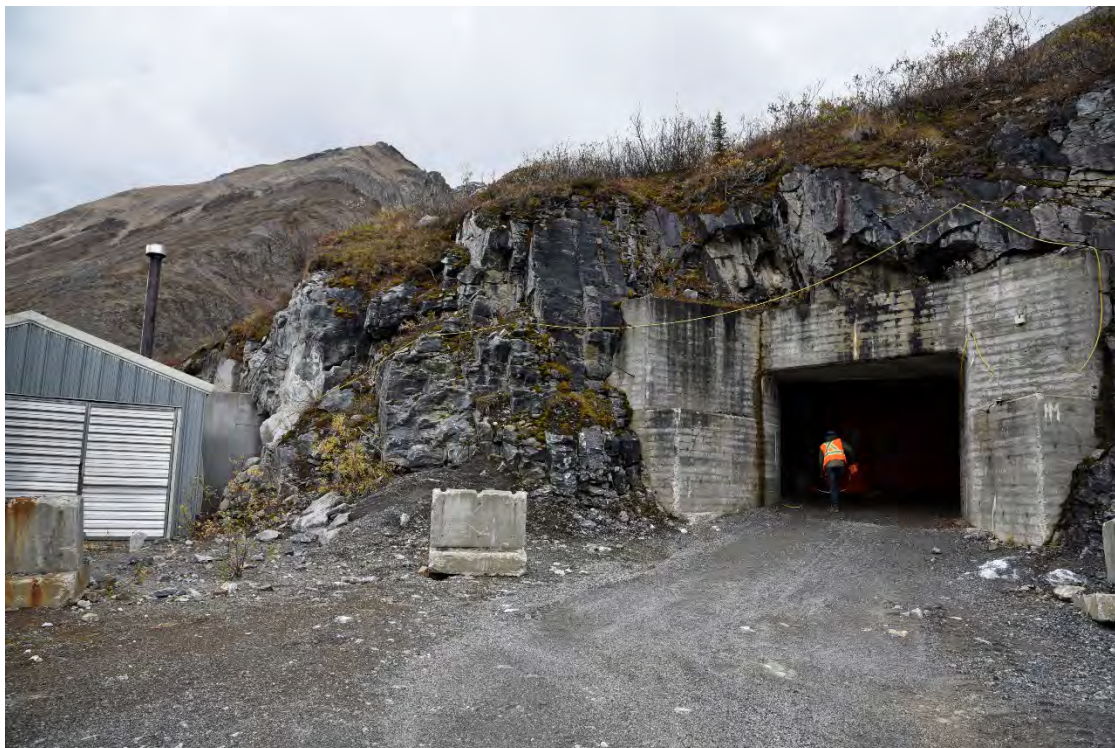
**Photo 17: The Vent Adit, showing the vent portal (left) and manway (right, where the person is pictured).
The vent buildings to the left should be removed.**

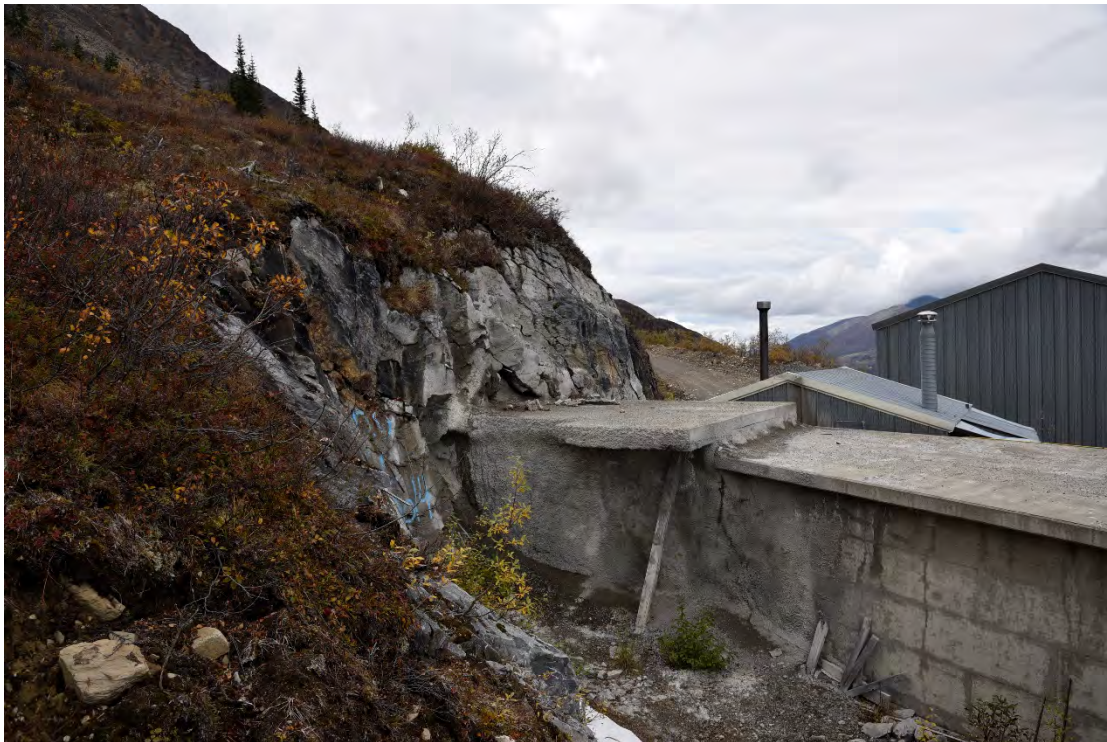
Photo 19: Vent Adit portal structure and Southeast Slope.

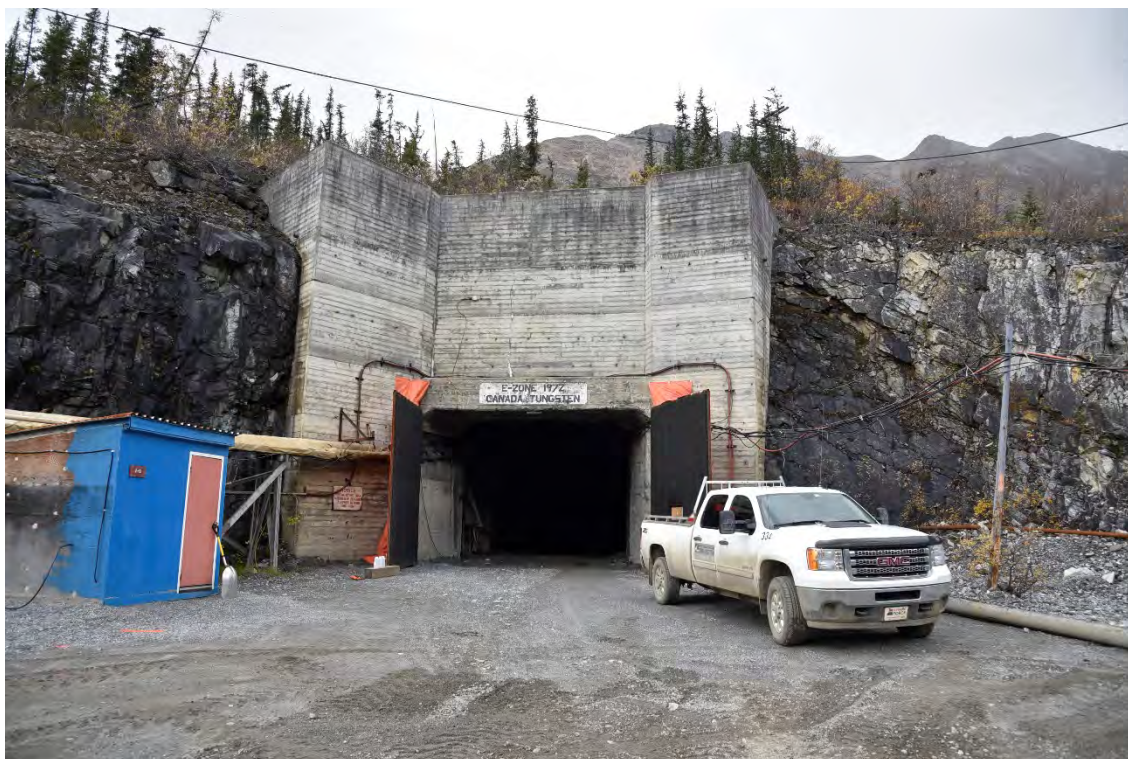
Photo 21: Main Haulage (3950 Level) Portal.

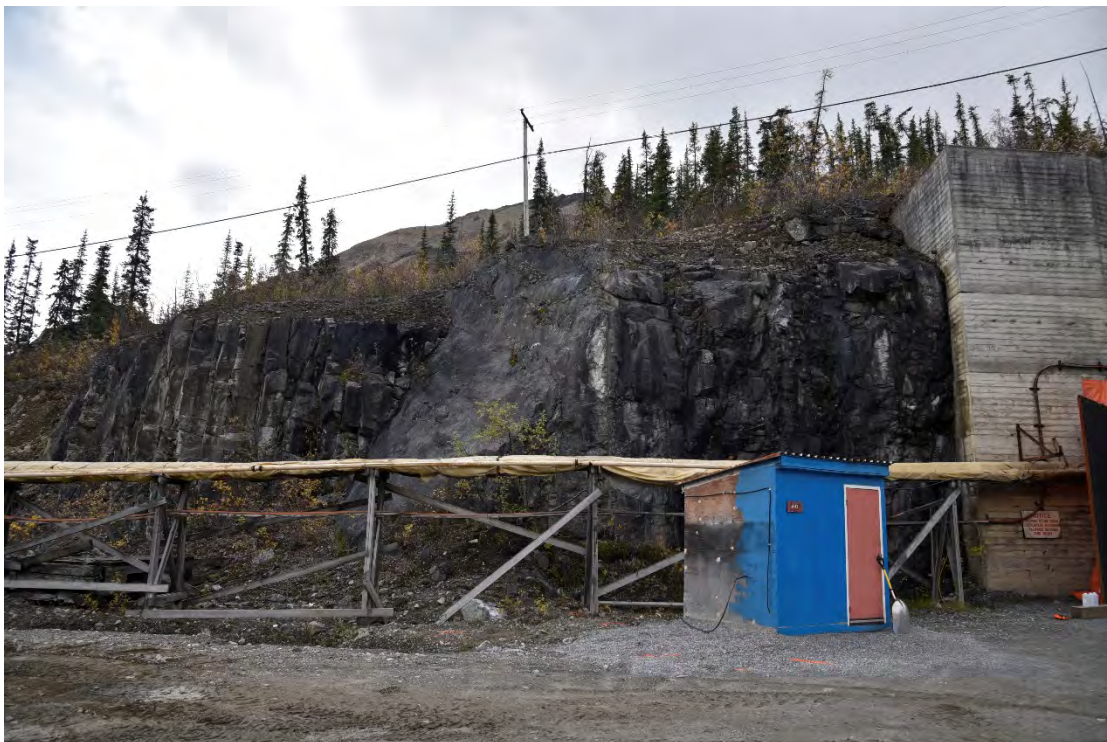
Photo 23: Southeast Slope of the Main Haulage Portal.

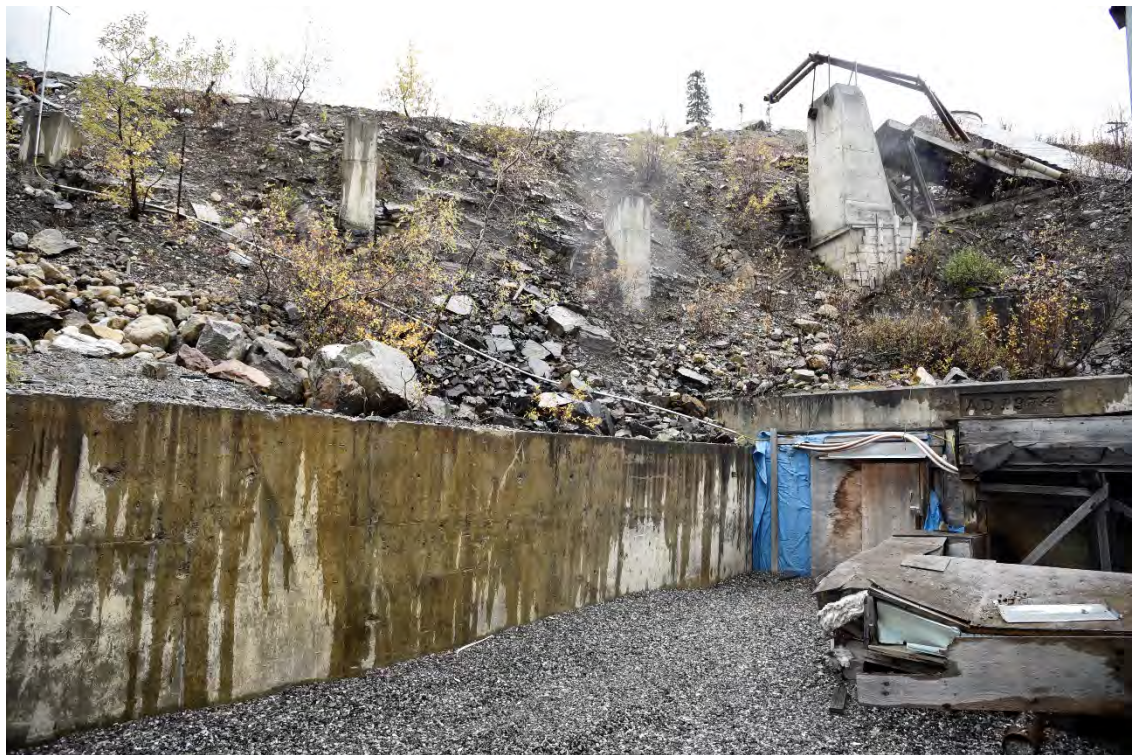
Photo 25: Conveyor Adit portal and slope.

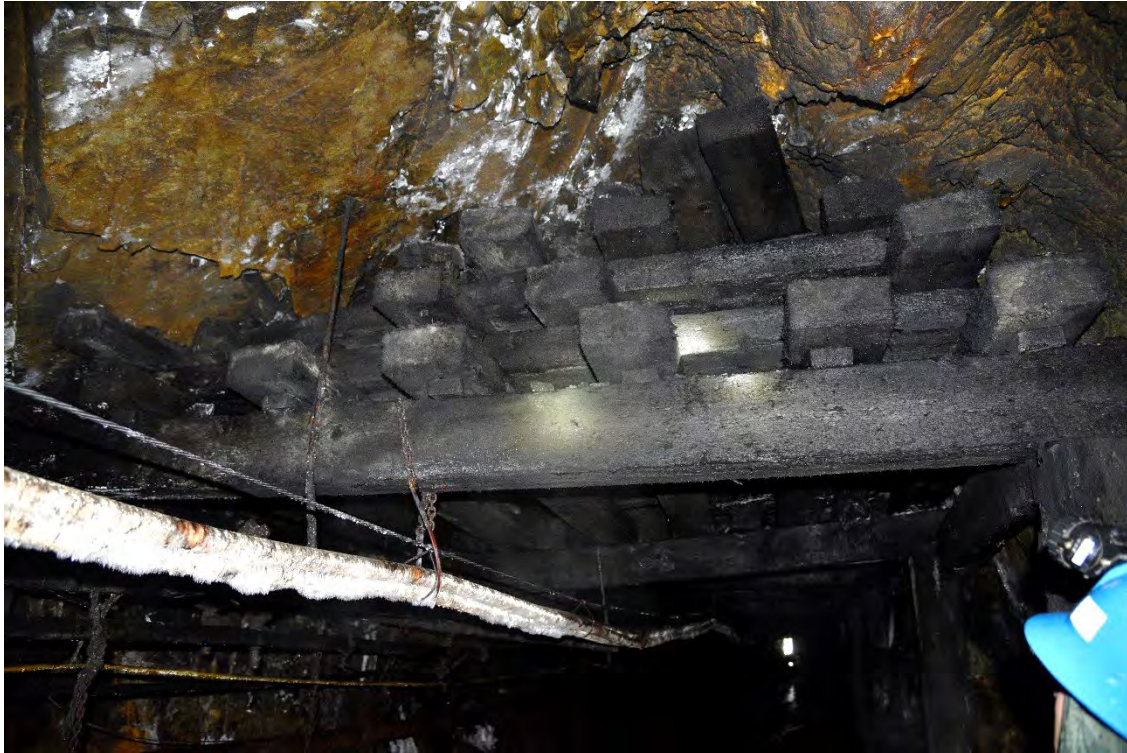
Photo 26: Conveyor Adit crown support.

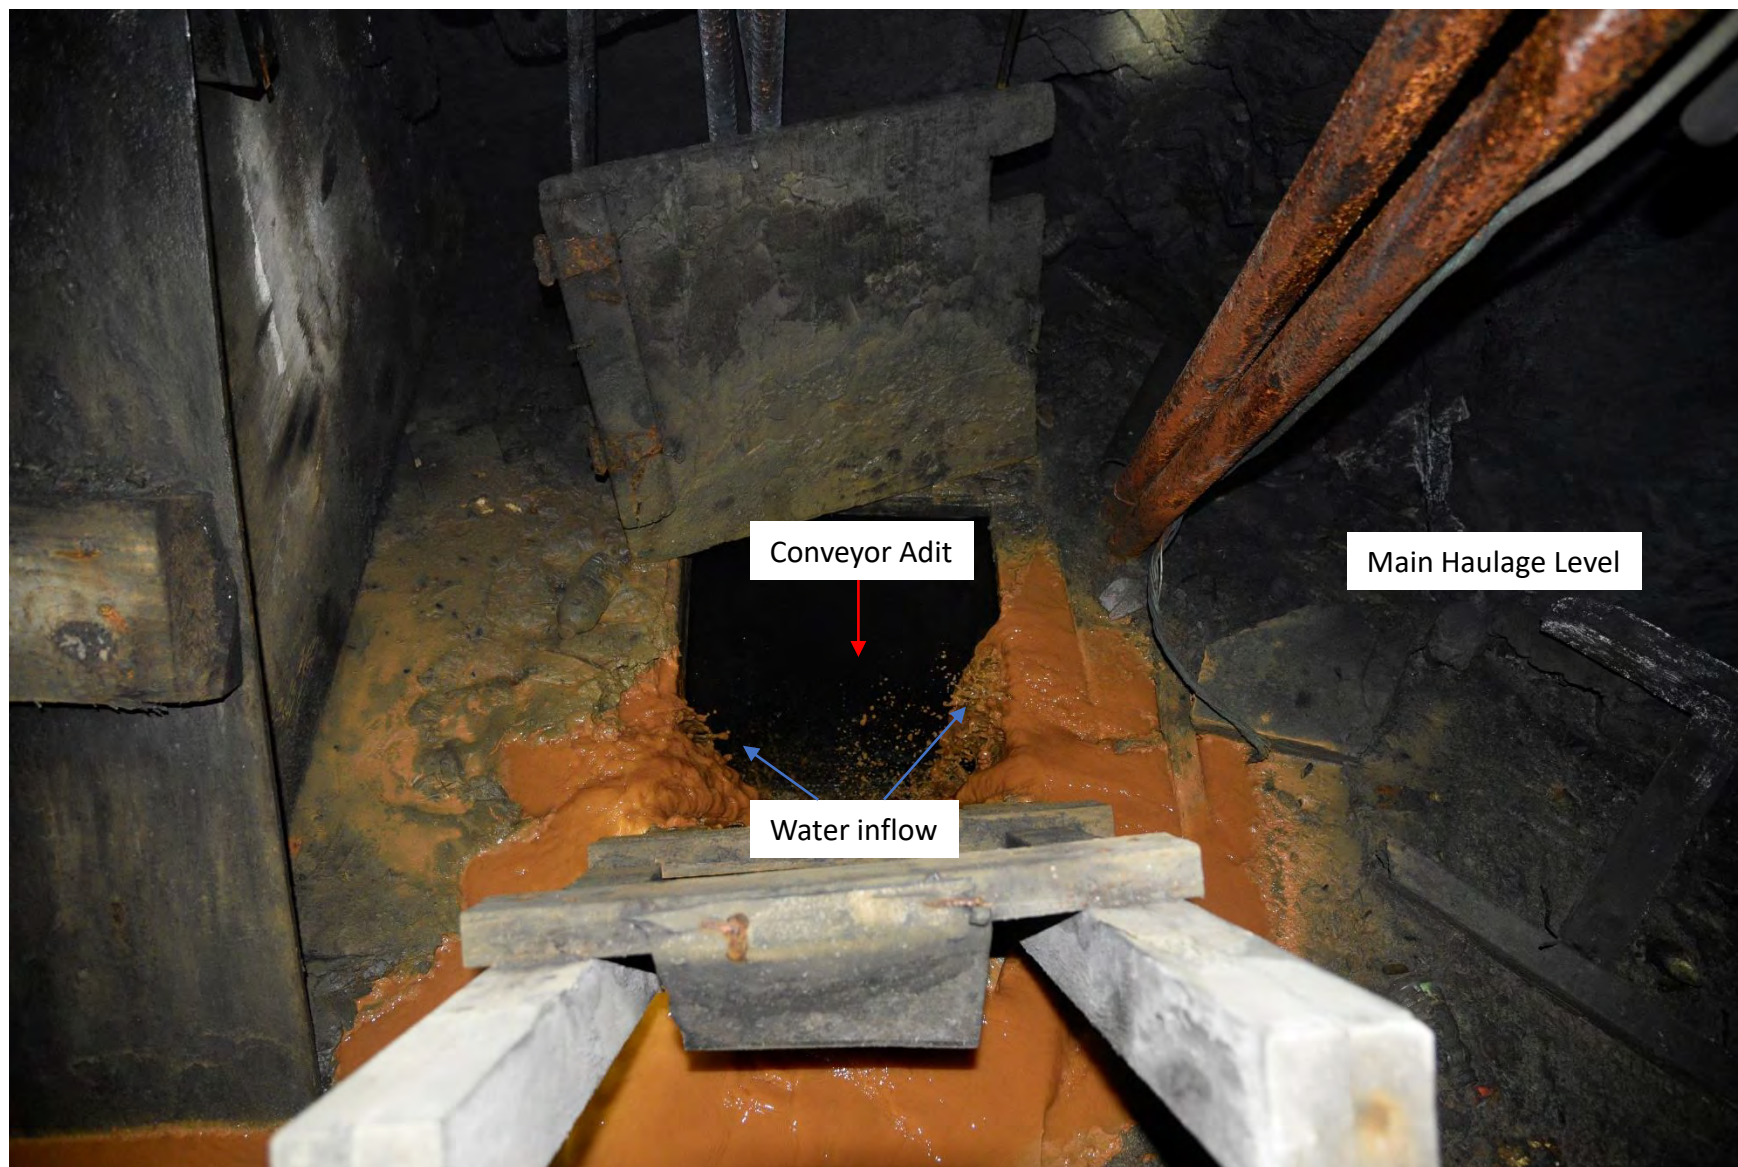
Photo 6: Looking down inclined raise from Main Haulage to Conveyor Adit

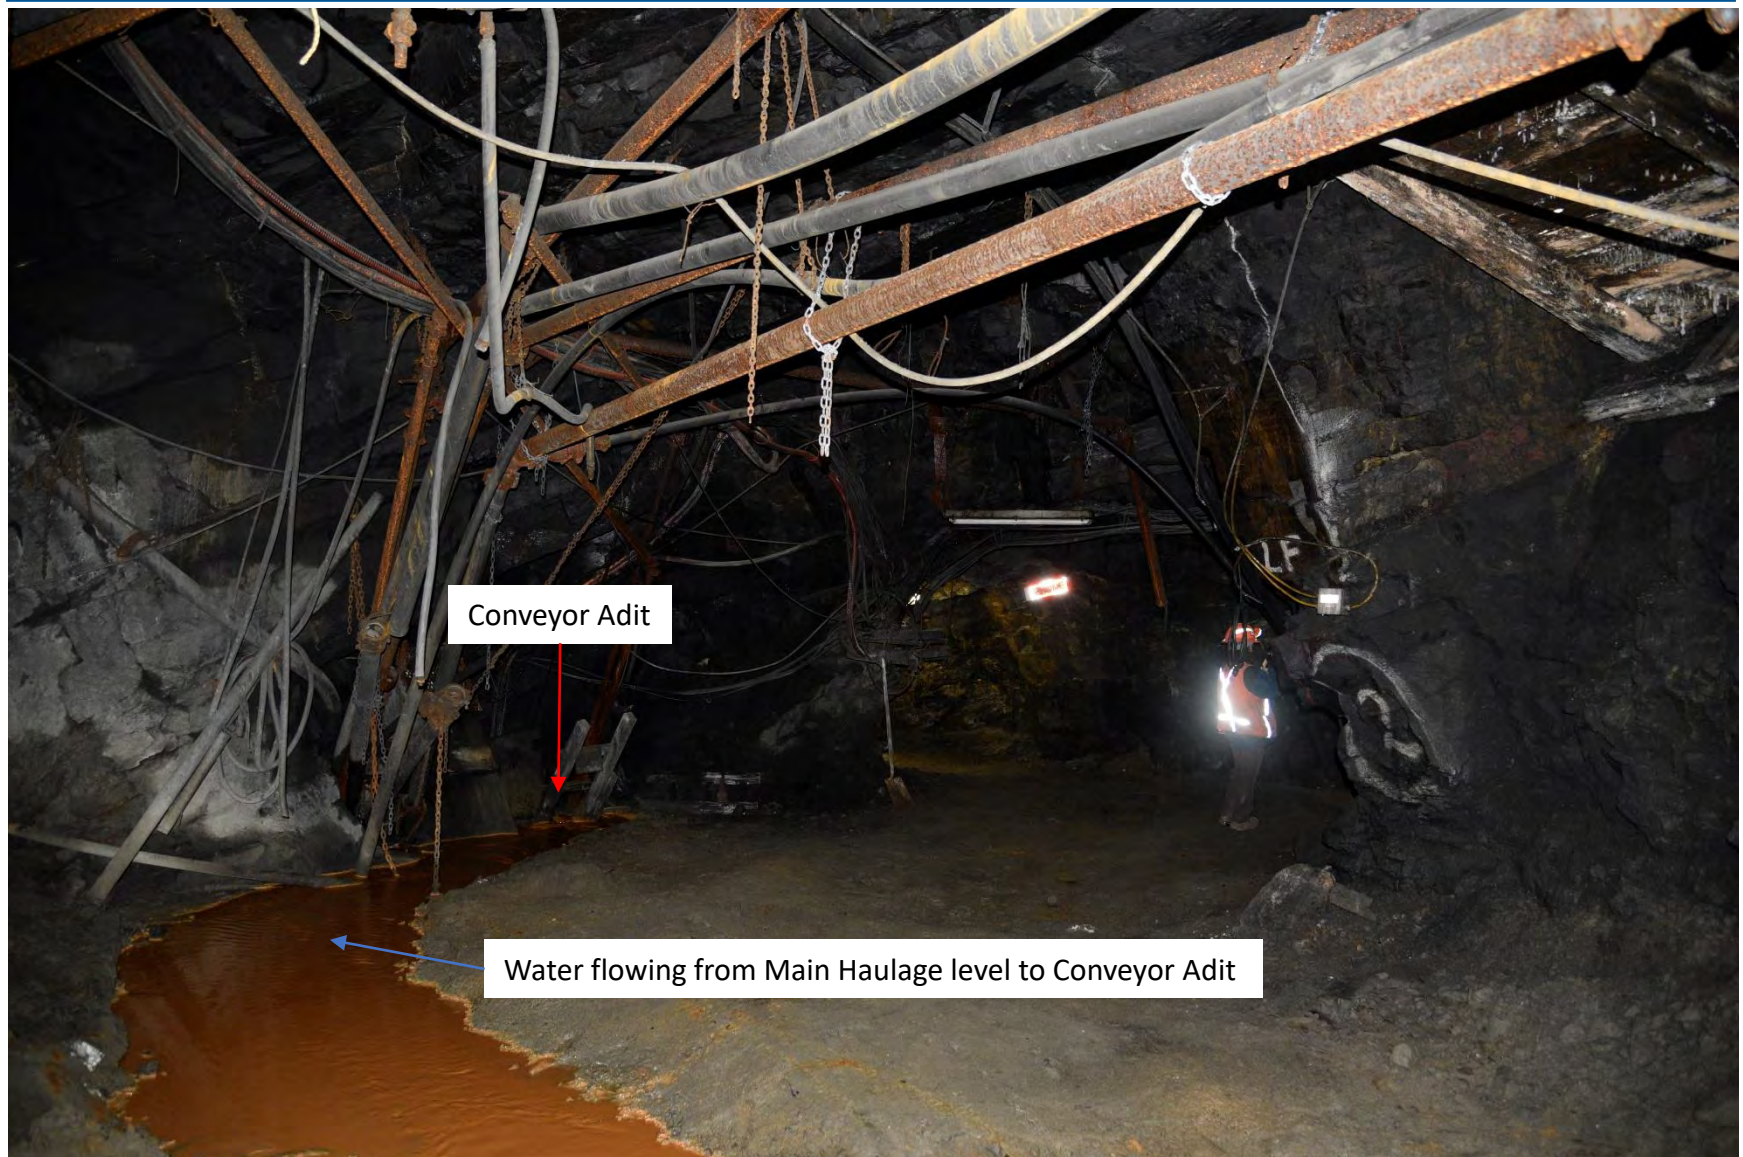
Photo 7: Overview of entrance to inclined raise down to Conveyor Adit

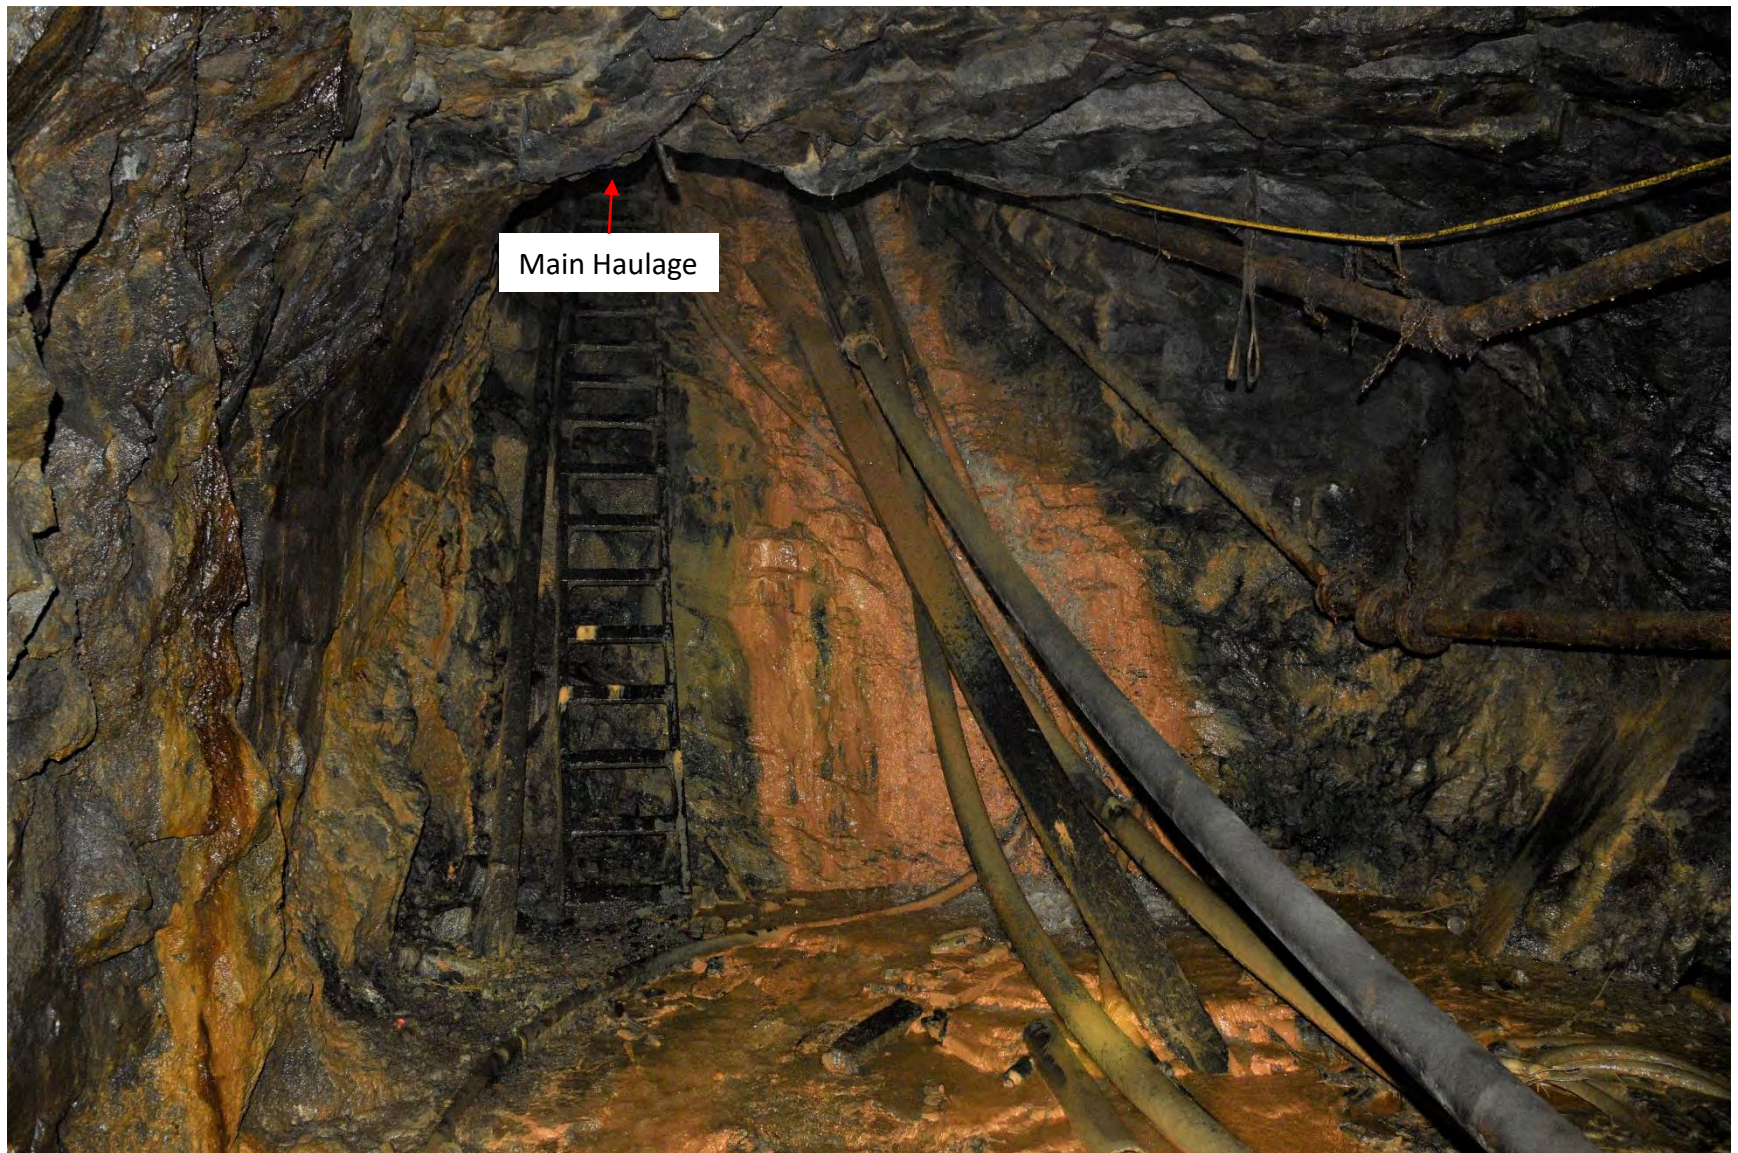
Photo 8: Inclined raise from Conveyor Adit to Main Haulage

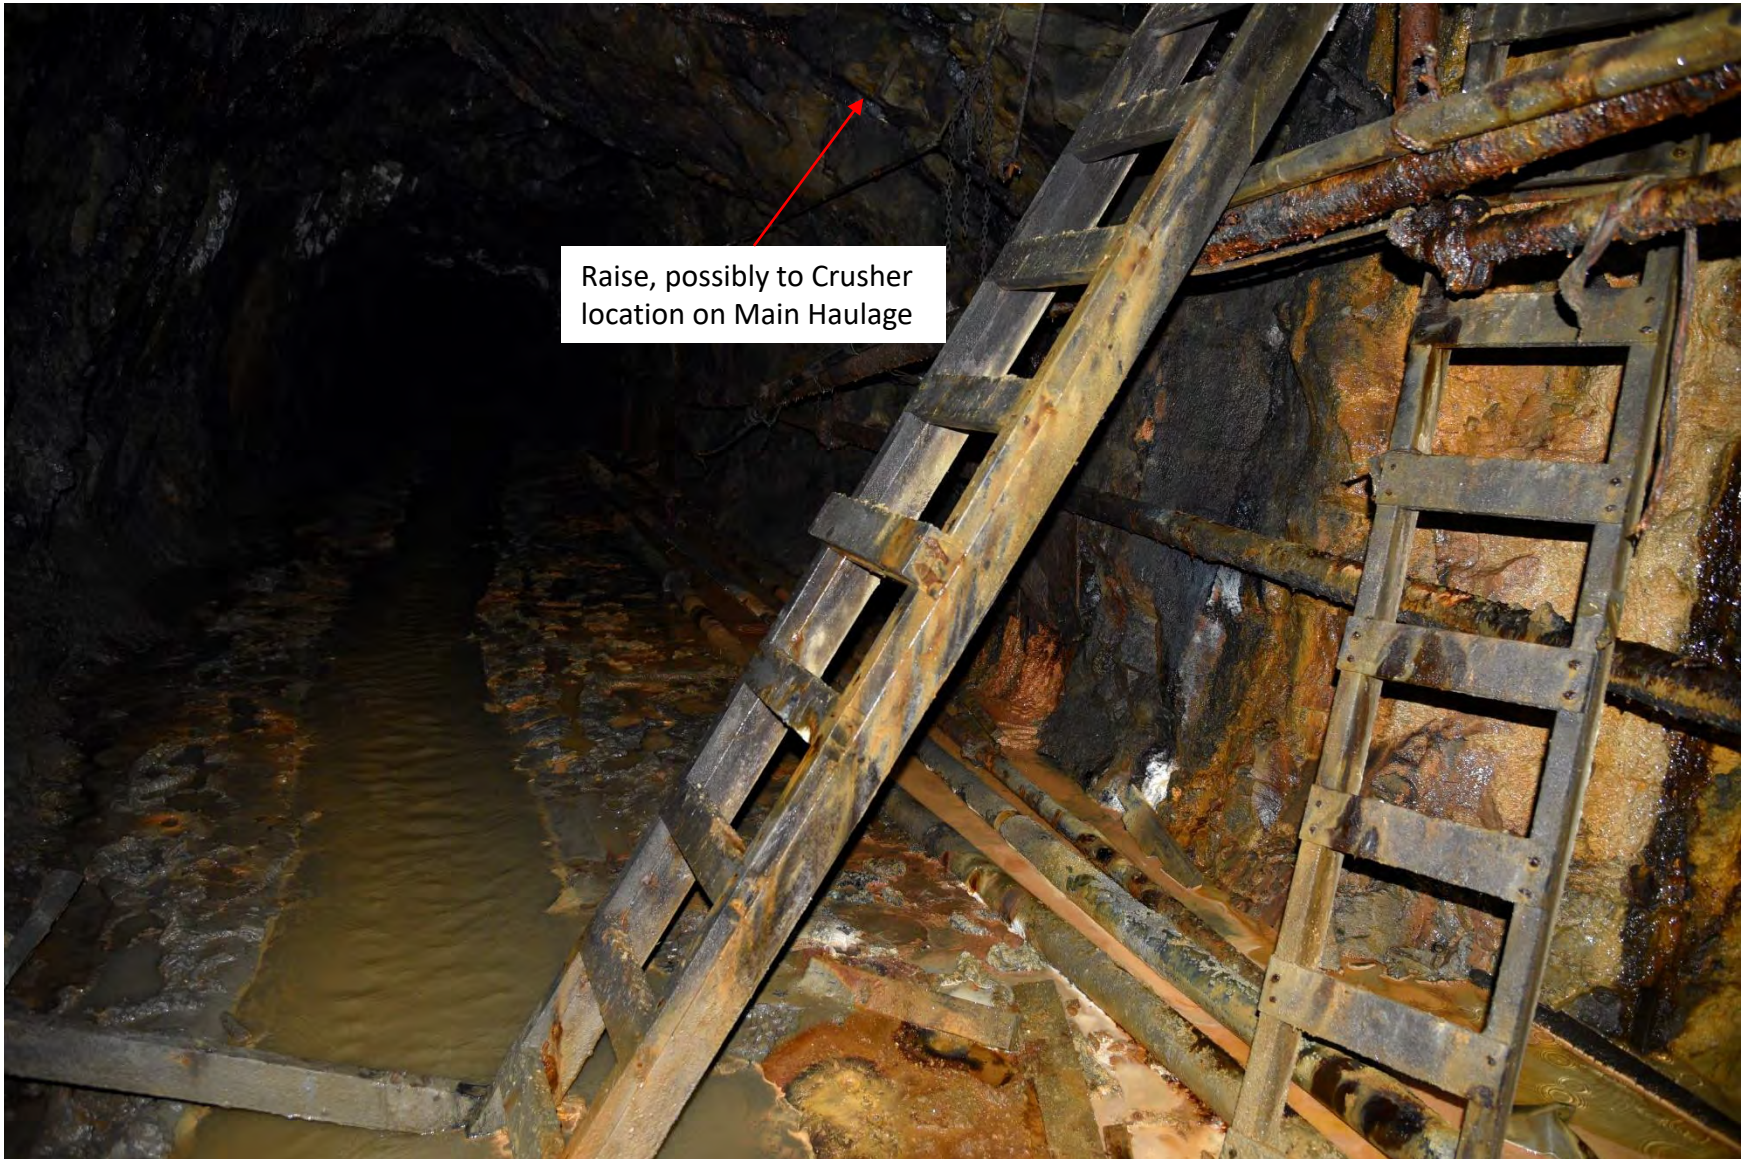
Raise, possibly to Crusher
location on Main Haulage

Photo 9: Ladder leading to crusher point raise

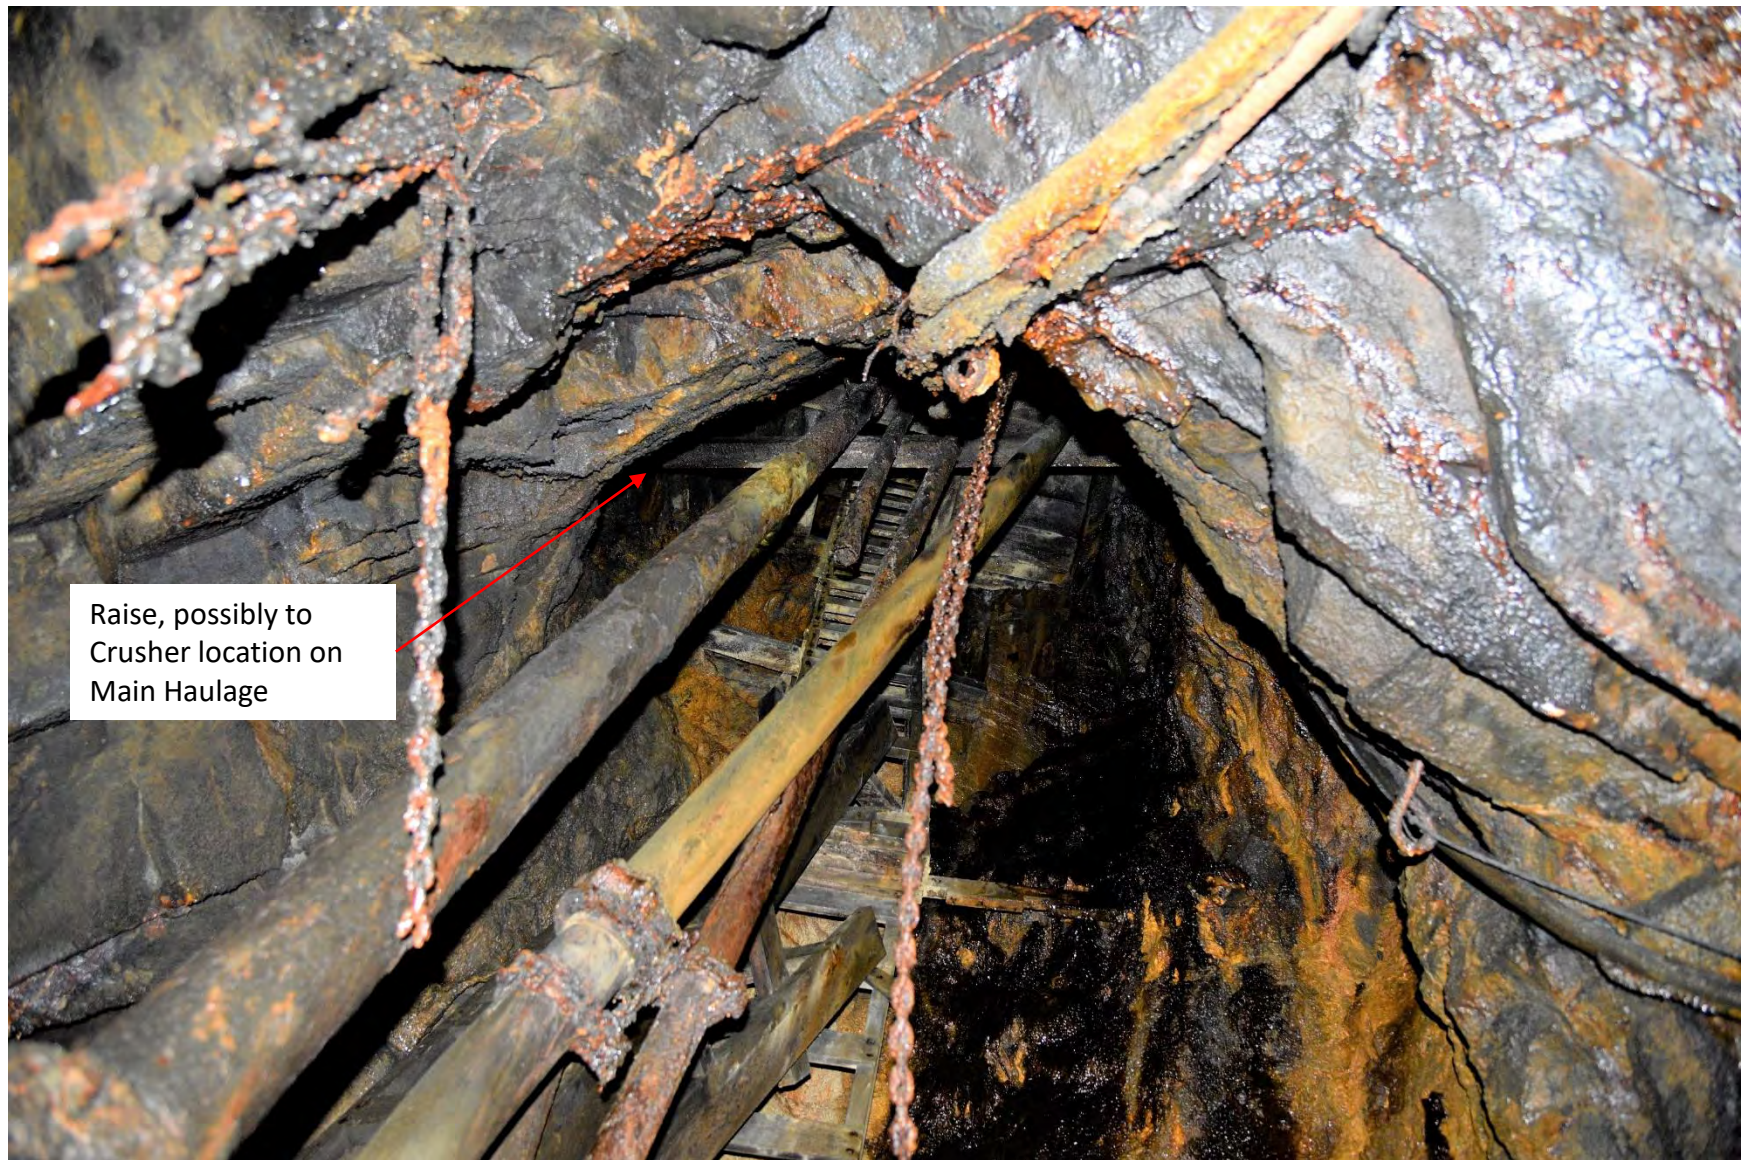
Raise, possibly to
Crusher location on
Main Haulage

Photo 10: Looking up crusher point raise
