Cantung Mine Closure Geotechnical Stability Assessment

PRESENTED TO
North American Tungsten Corp. Ltd.
c/o Alvarez & Marsal LLC

JULY 2019
ISSUED FOR USE
FILE: 704-ENW.WENW03039-03.007

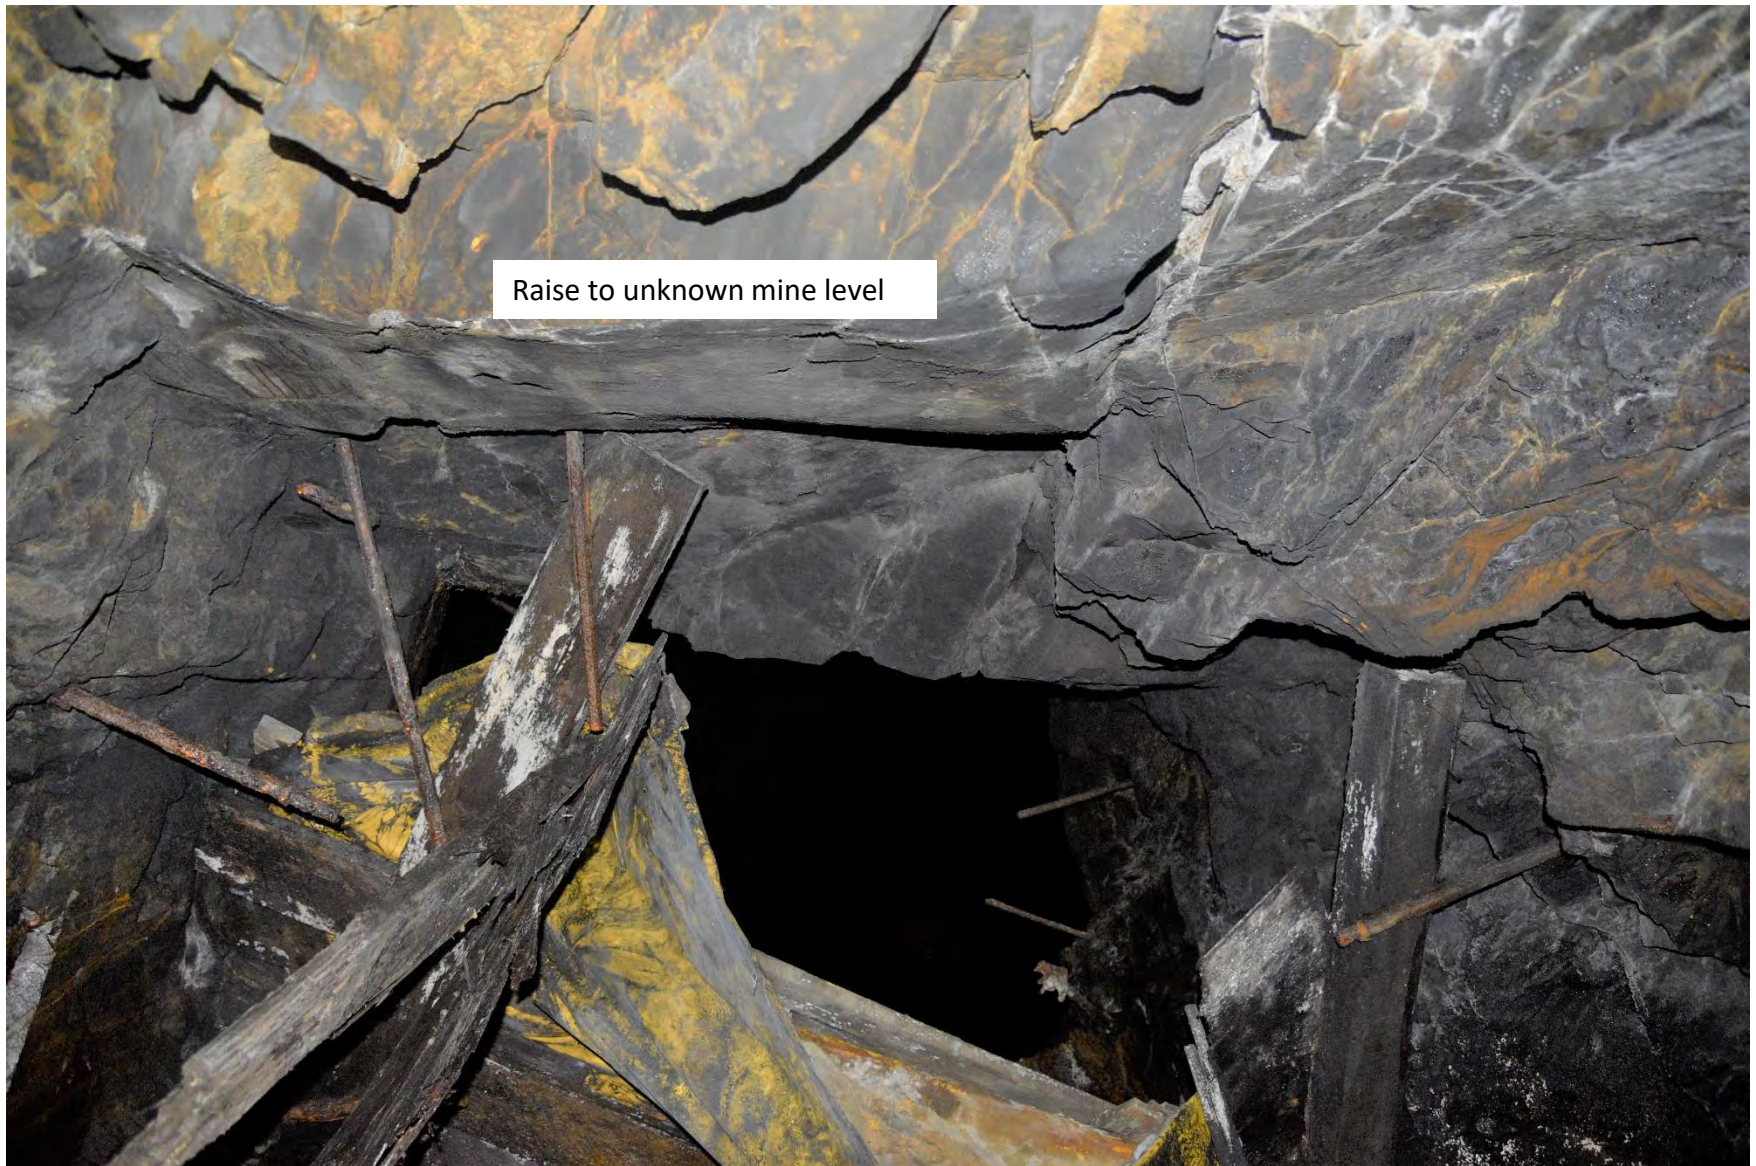
Photo 11: Raise to unknown mine level at 495 m

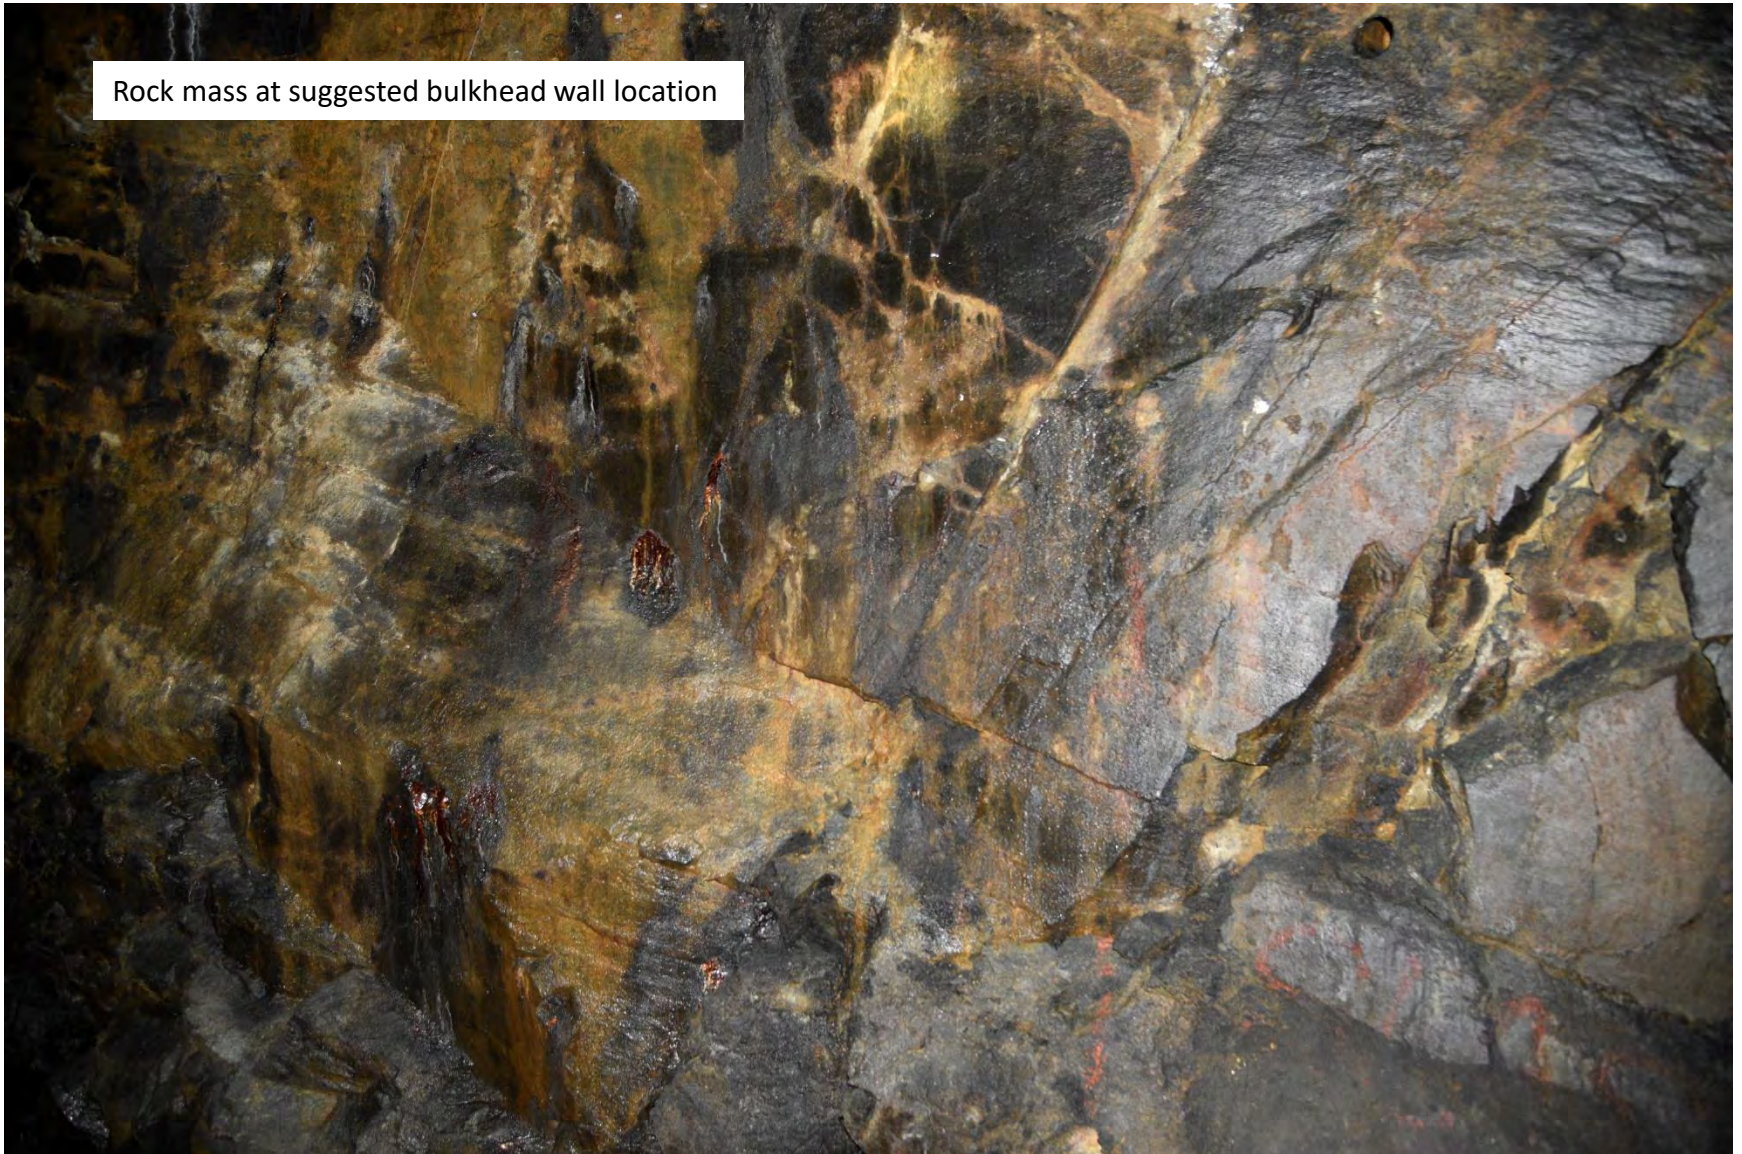
Rock mass at suggested bulkhead wall location

Photo 14: Rock mass at Recommended Bulkhead Location in Conveyor Adit (470 to 480 m)

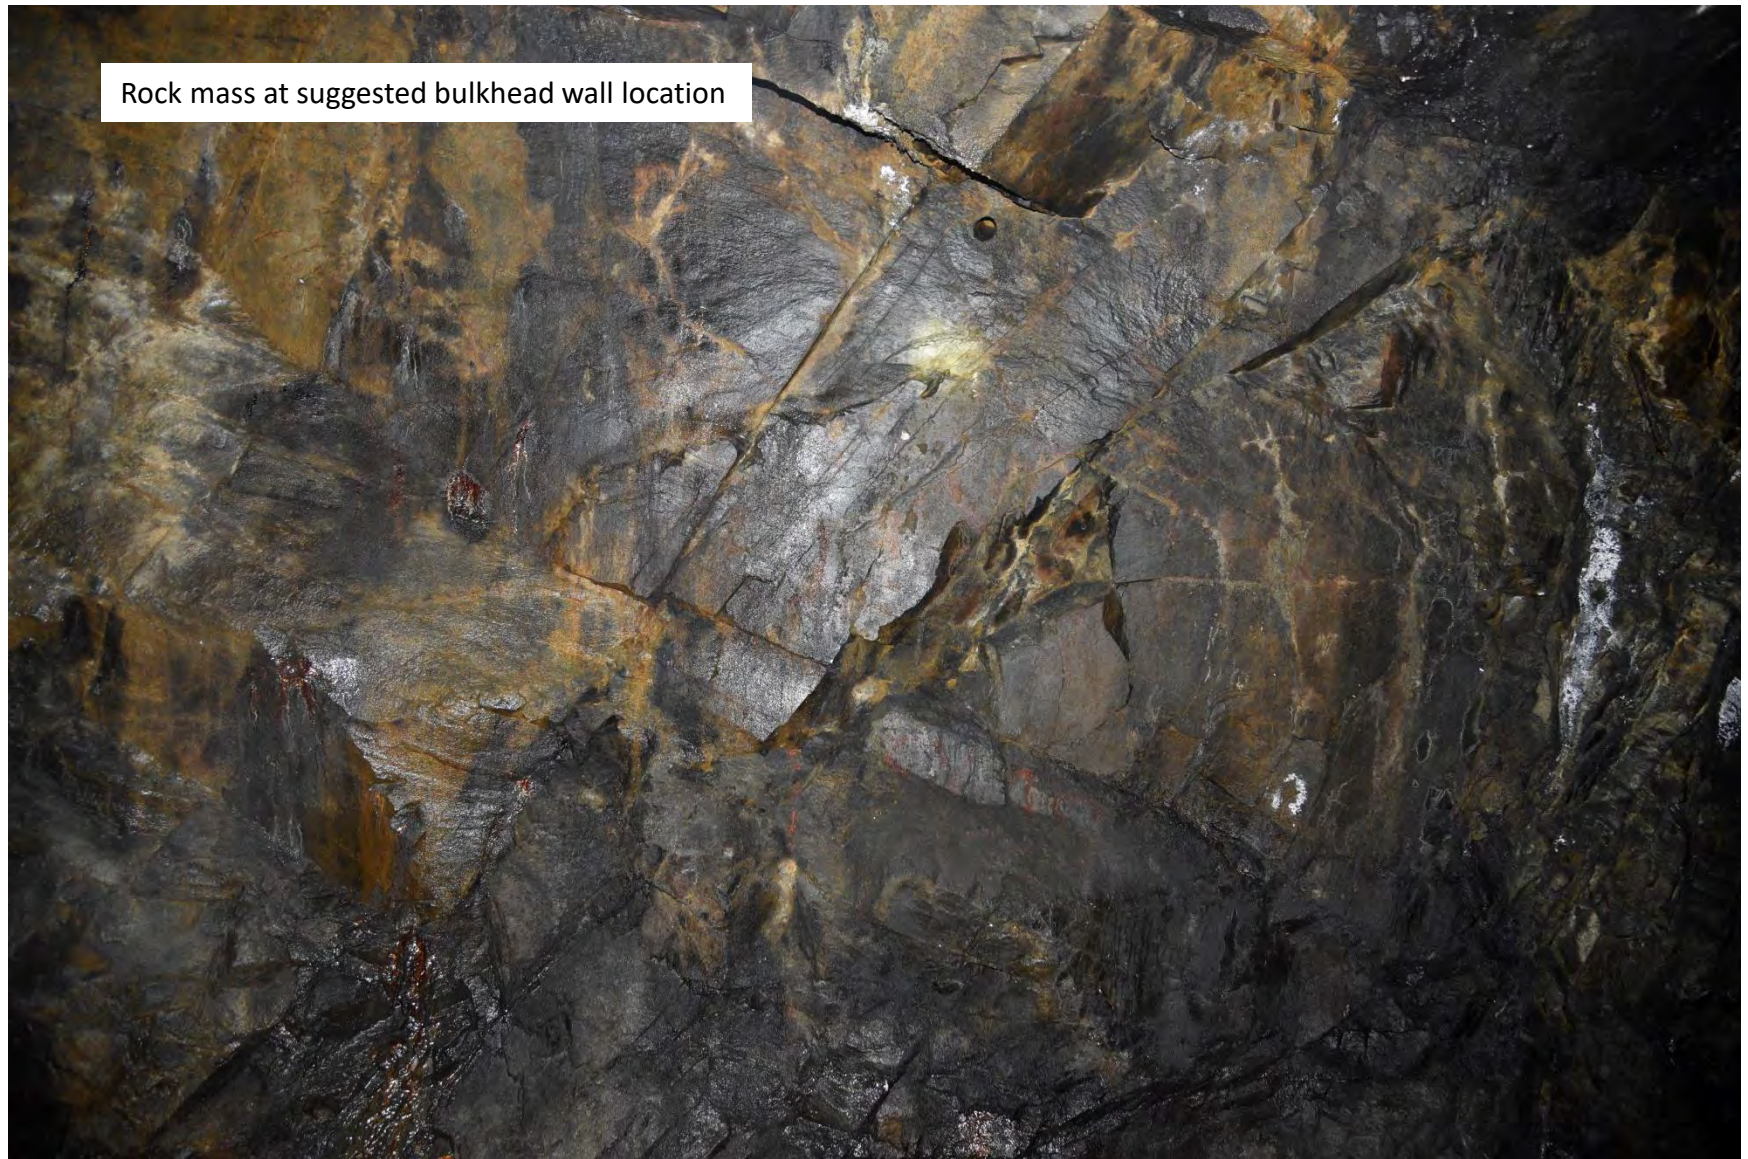
Rock mass at suggested bulkhead wall location

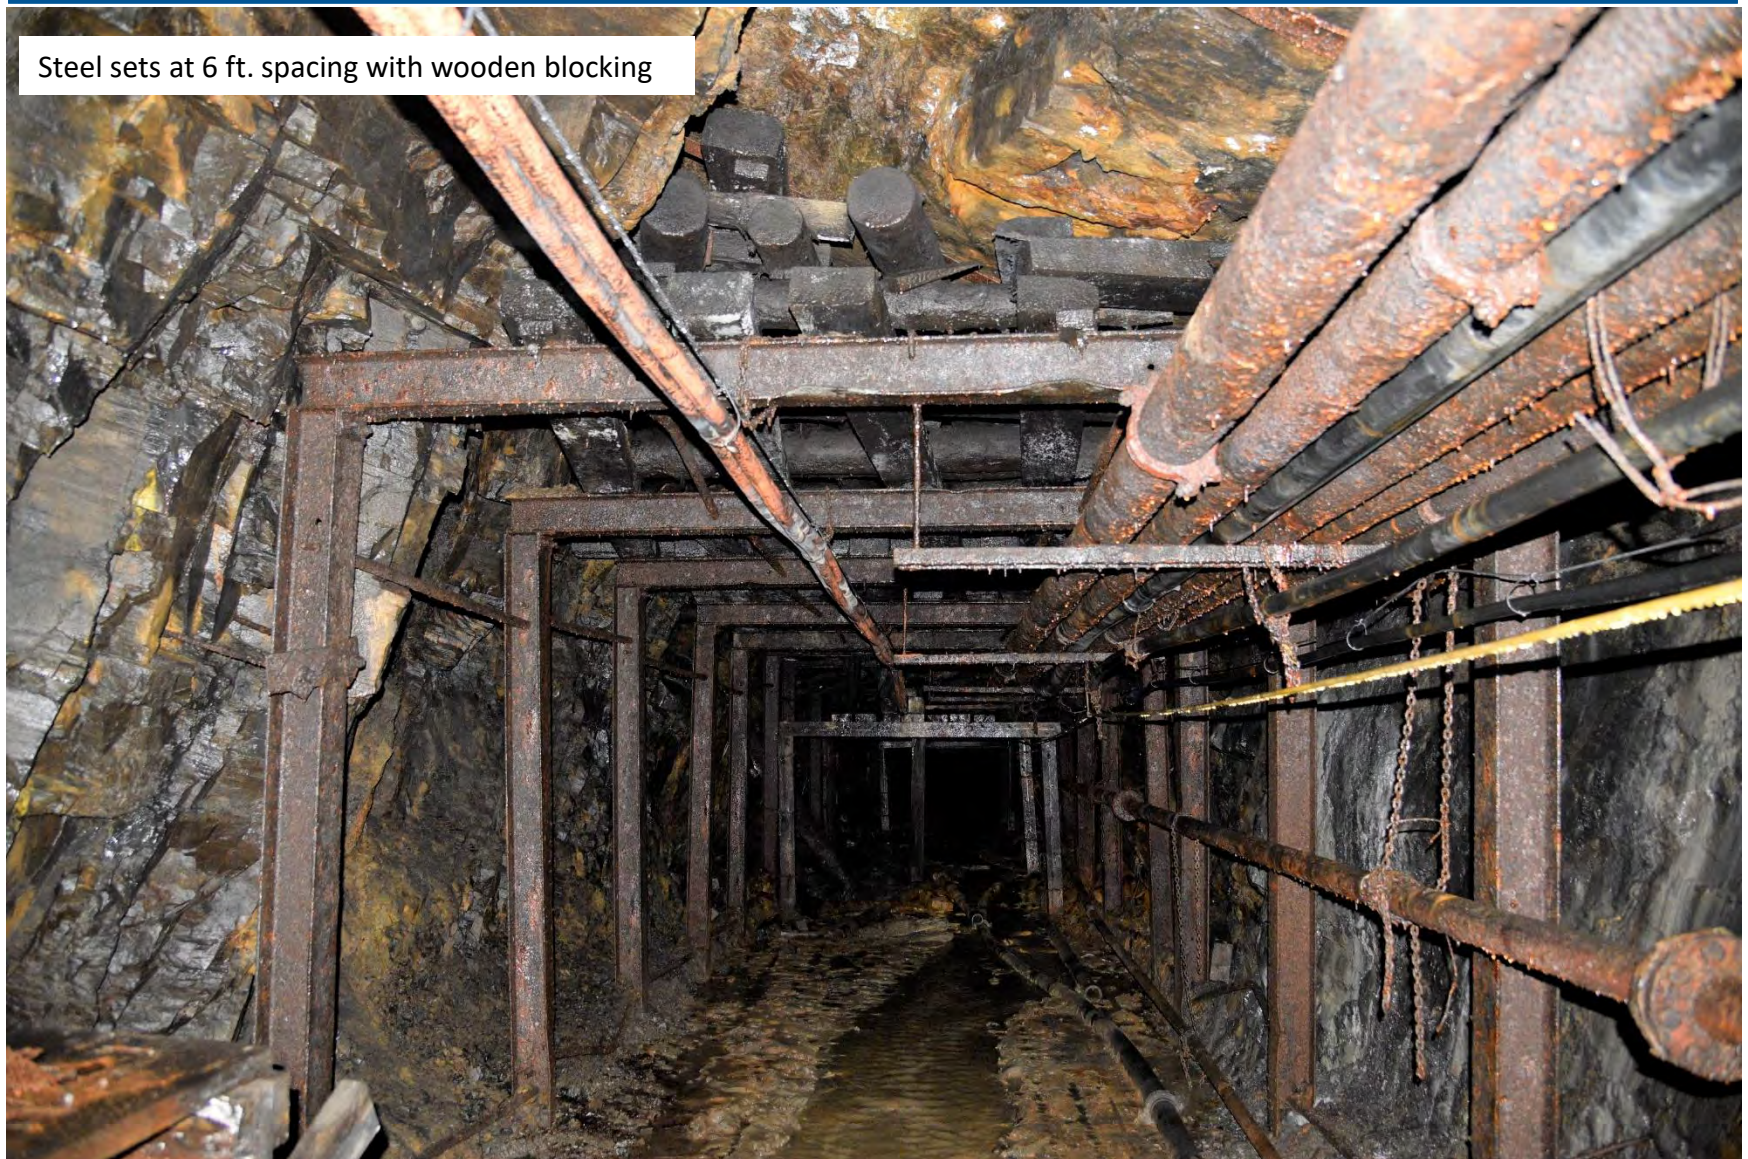
Steel sets at 6 ft. spacing with wooden blocking

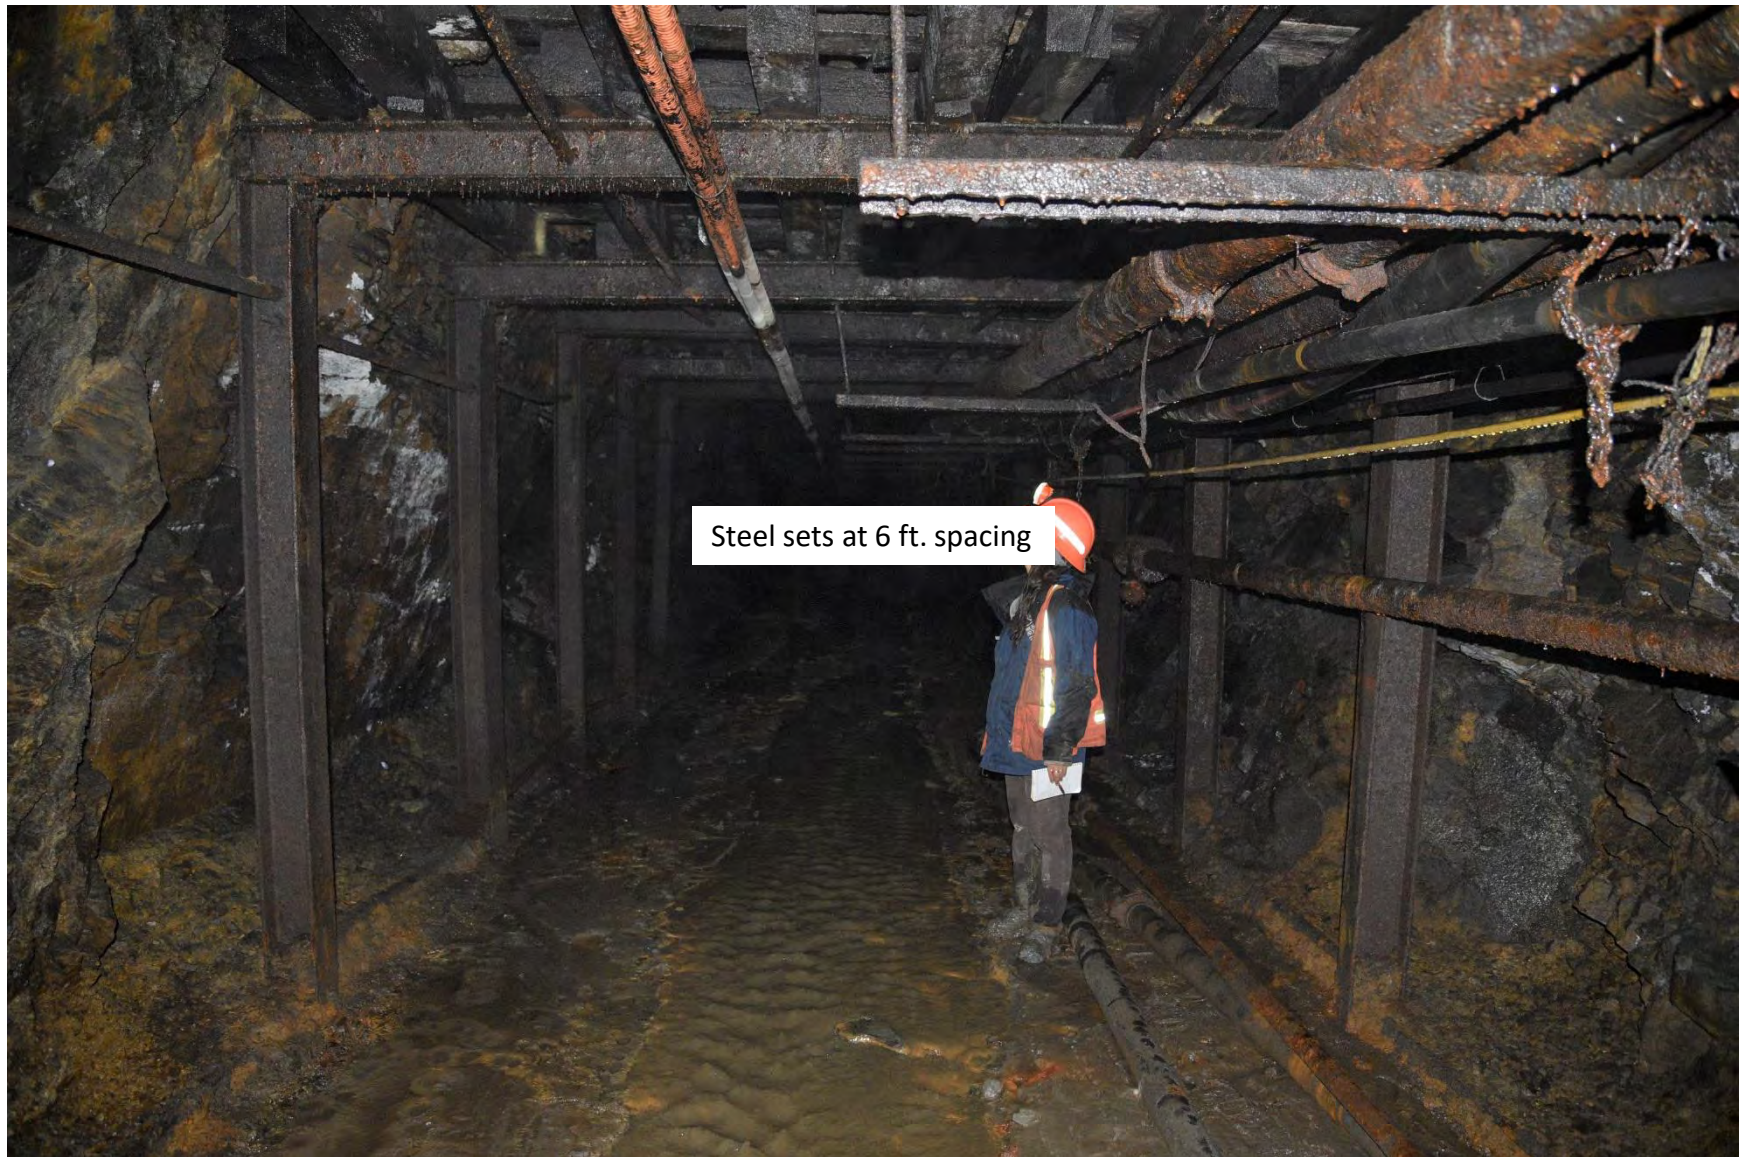
Photo 19: Steel sets from 223 to 235 m.

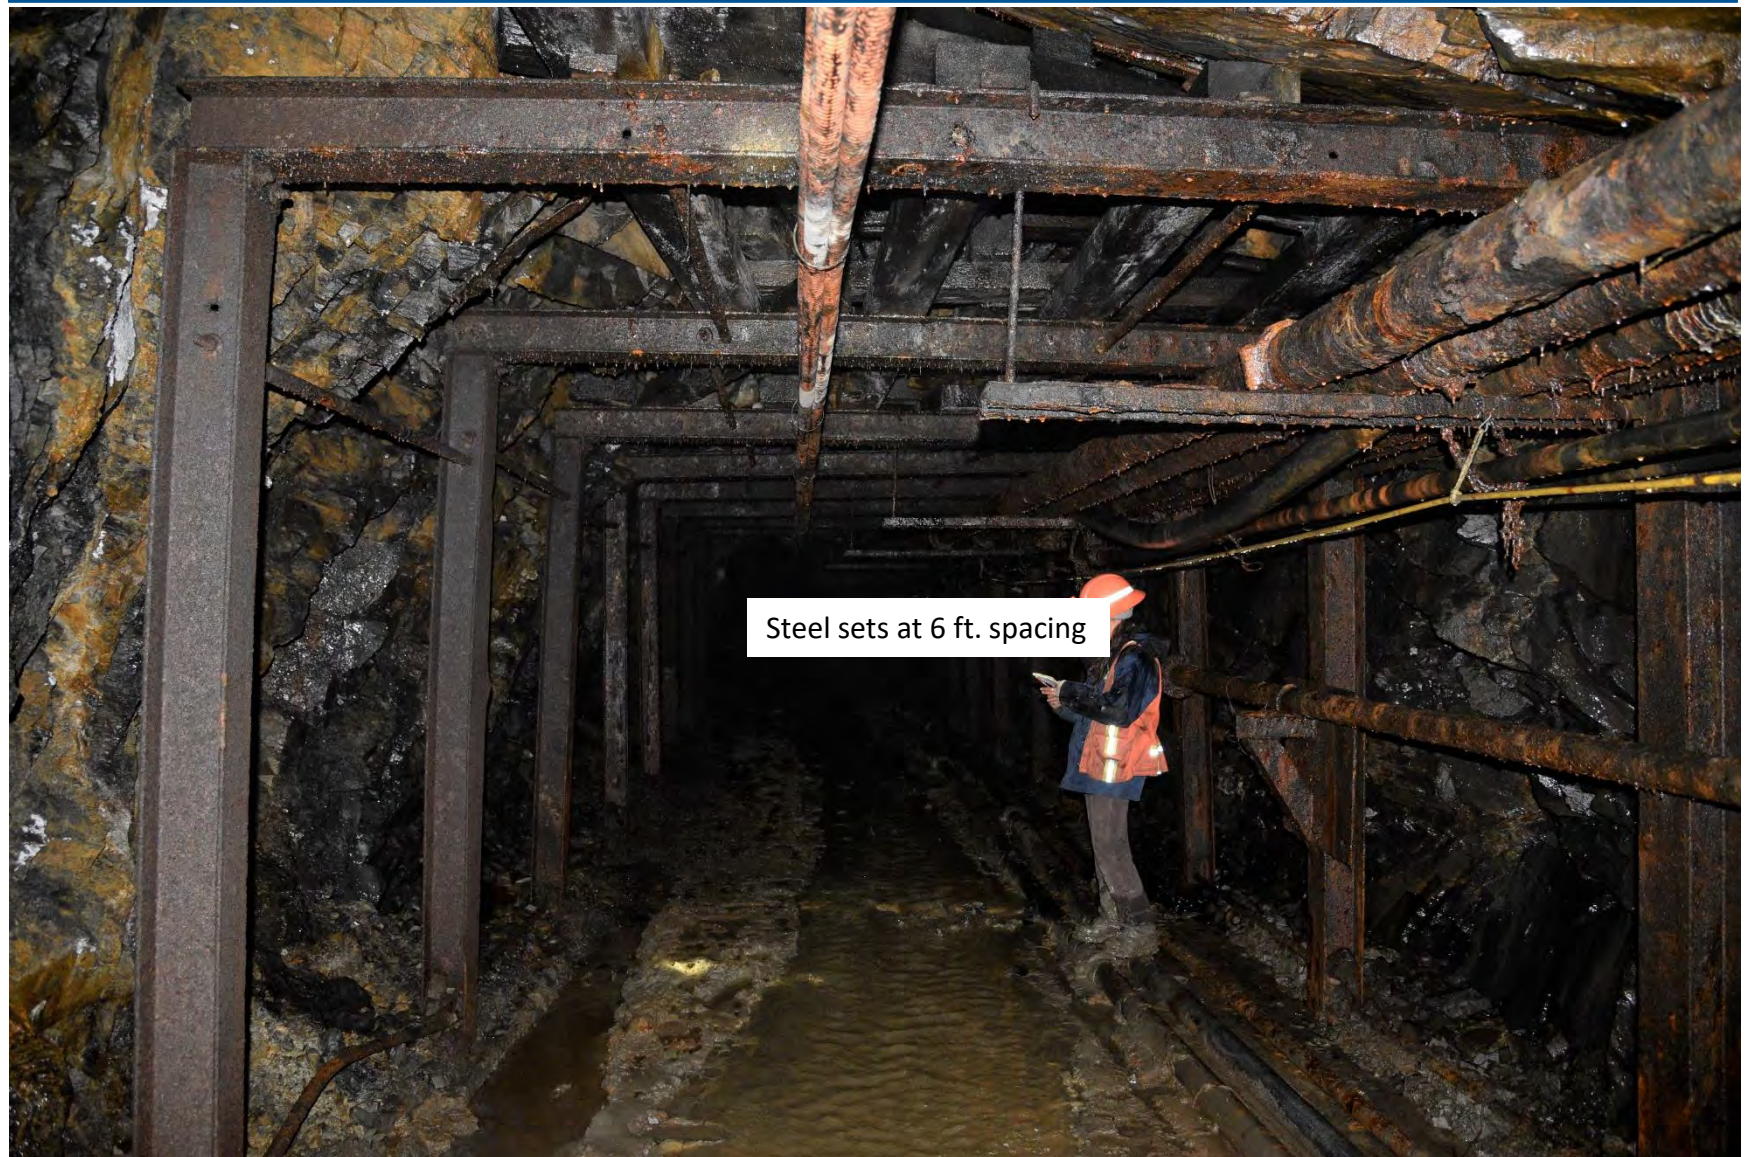
Photo 20: Steel sets from 196 to 207 m.

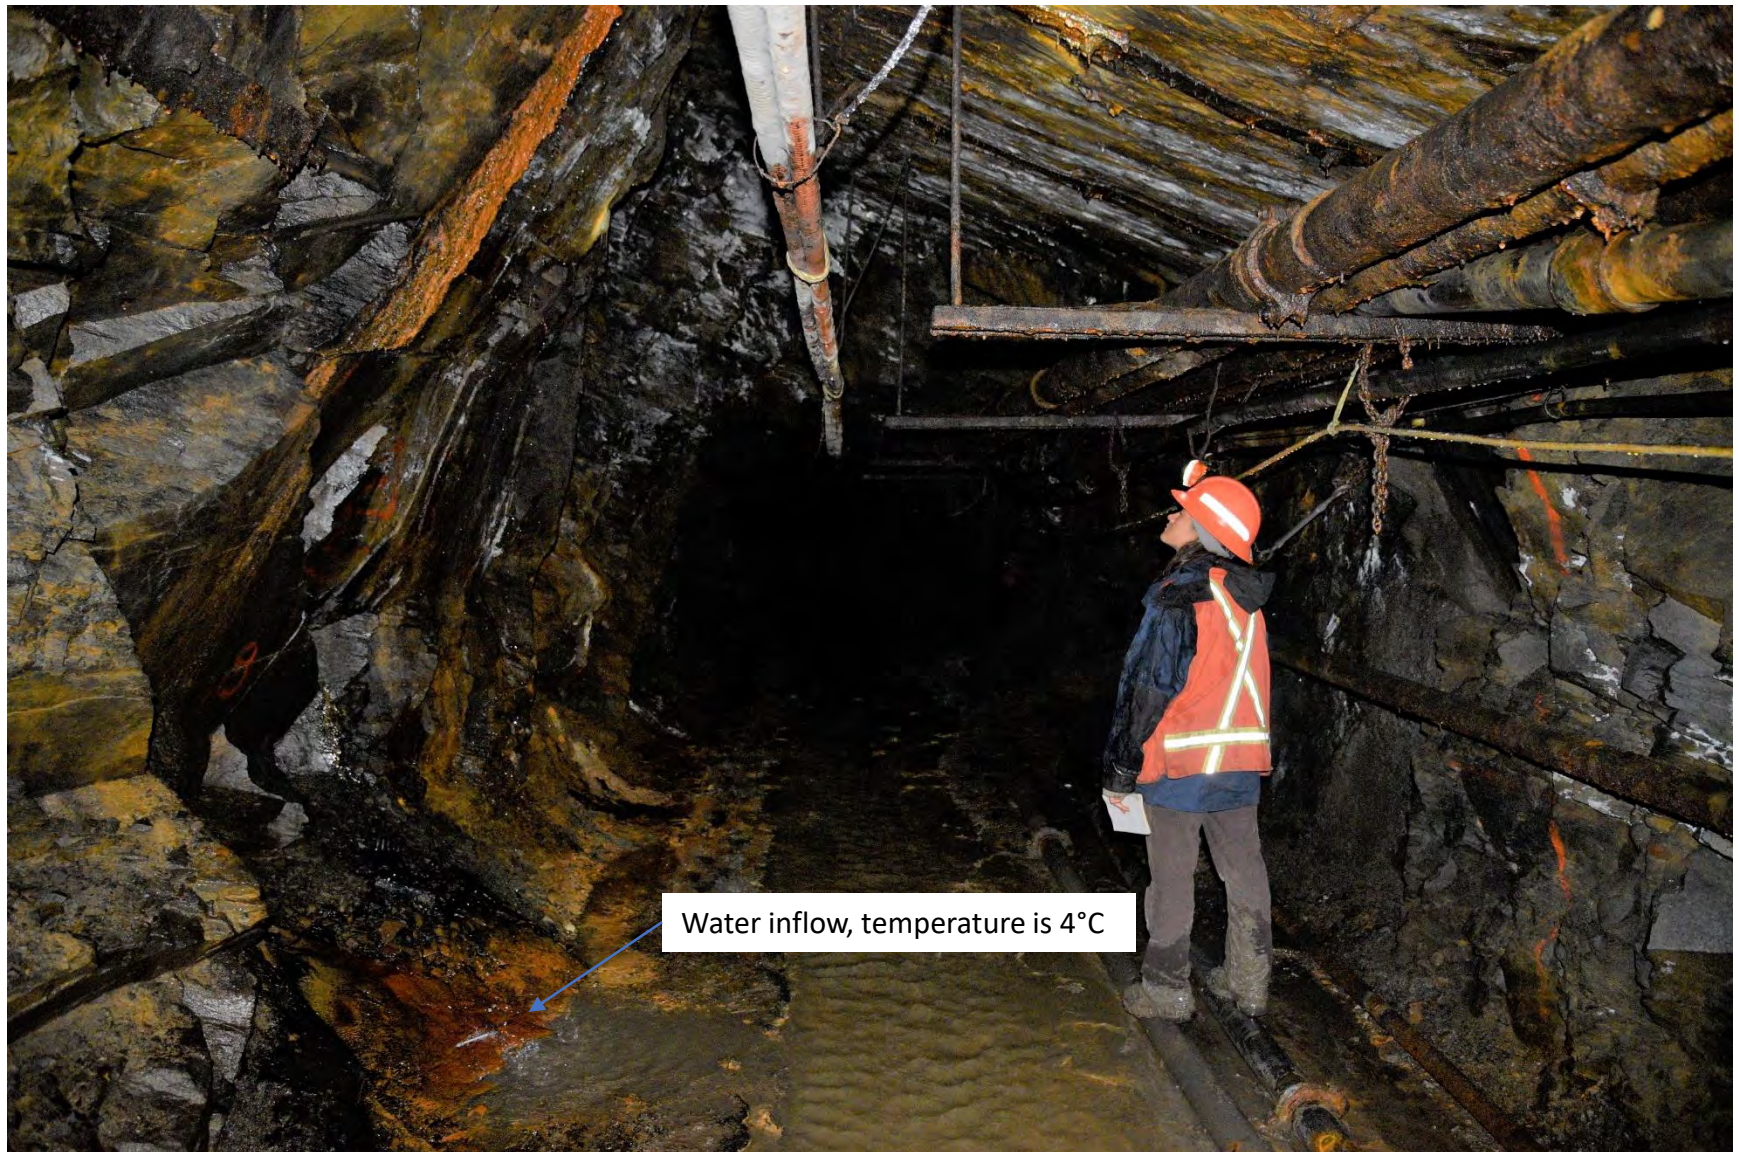
Photo 21: Water inflow temperature measurement at 157 m

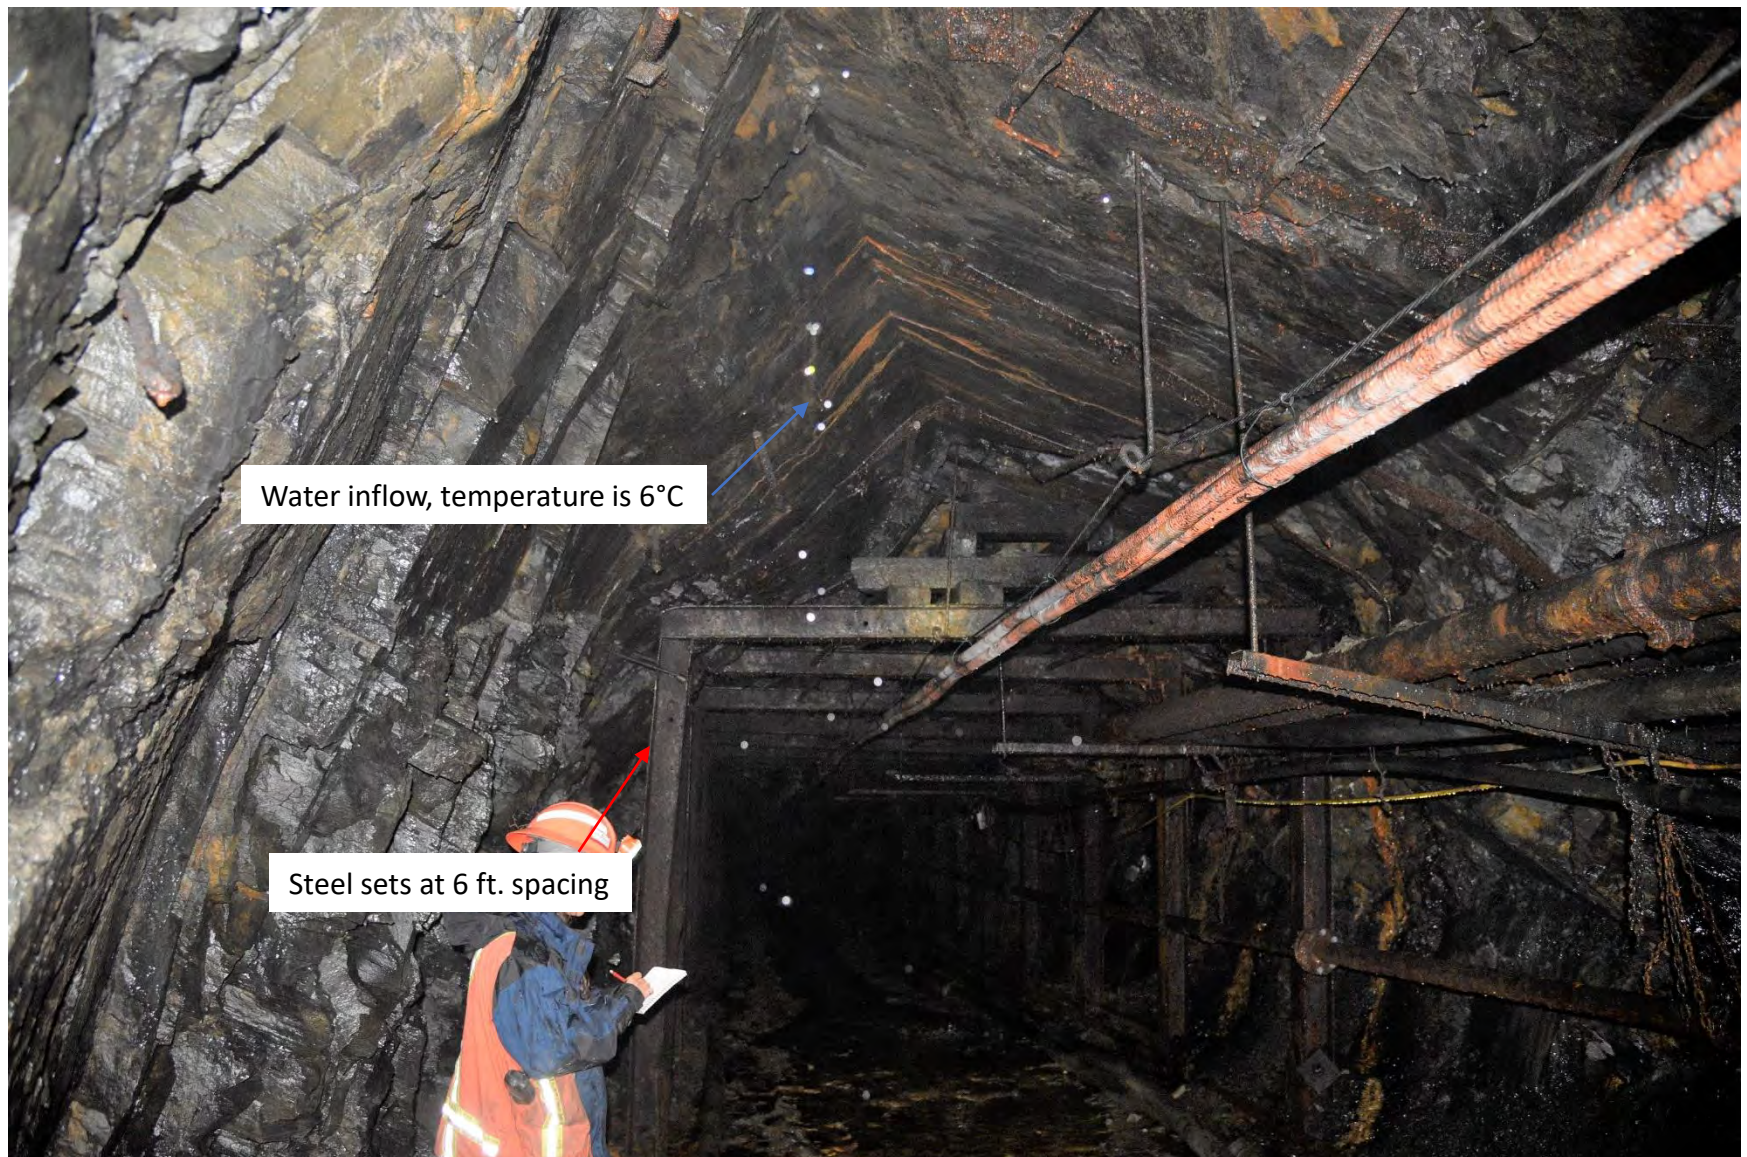
Photo 22: Water inflow temperature measurement at 154 m

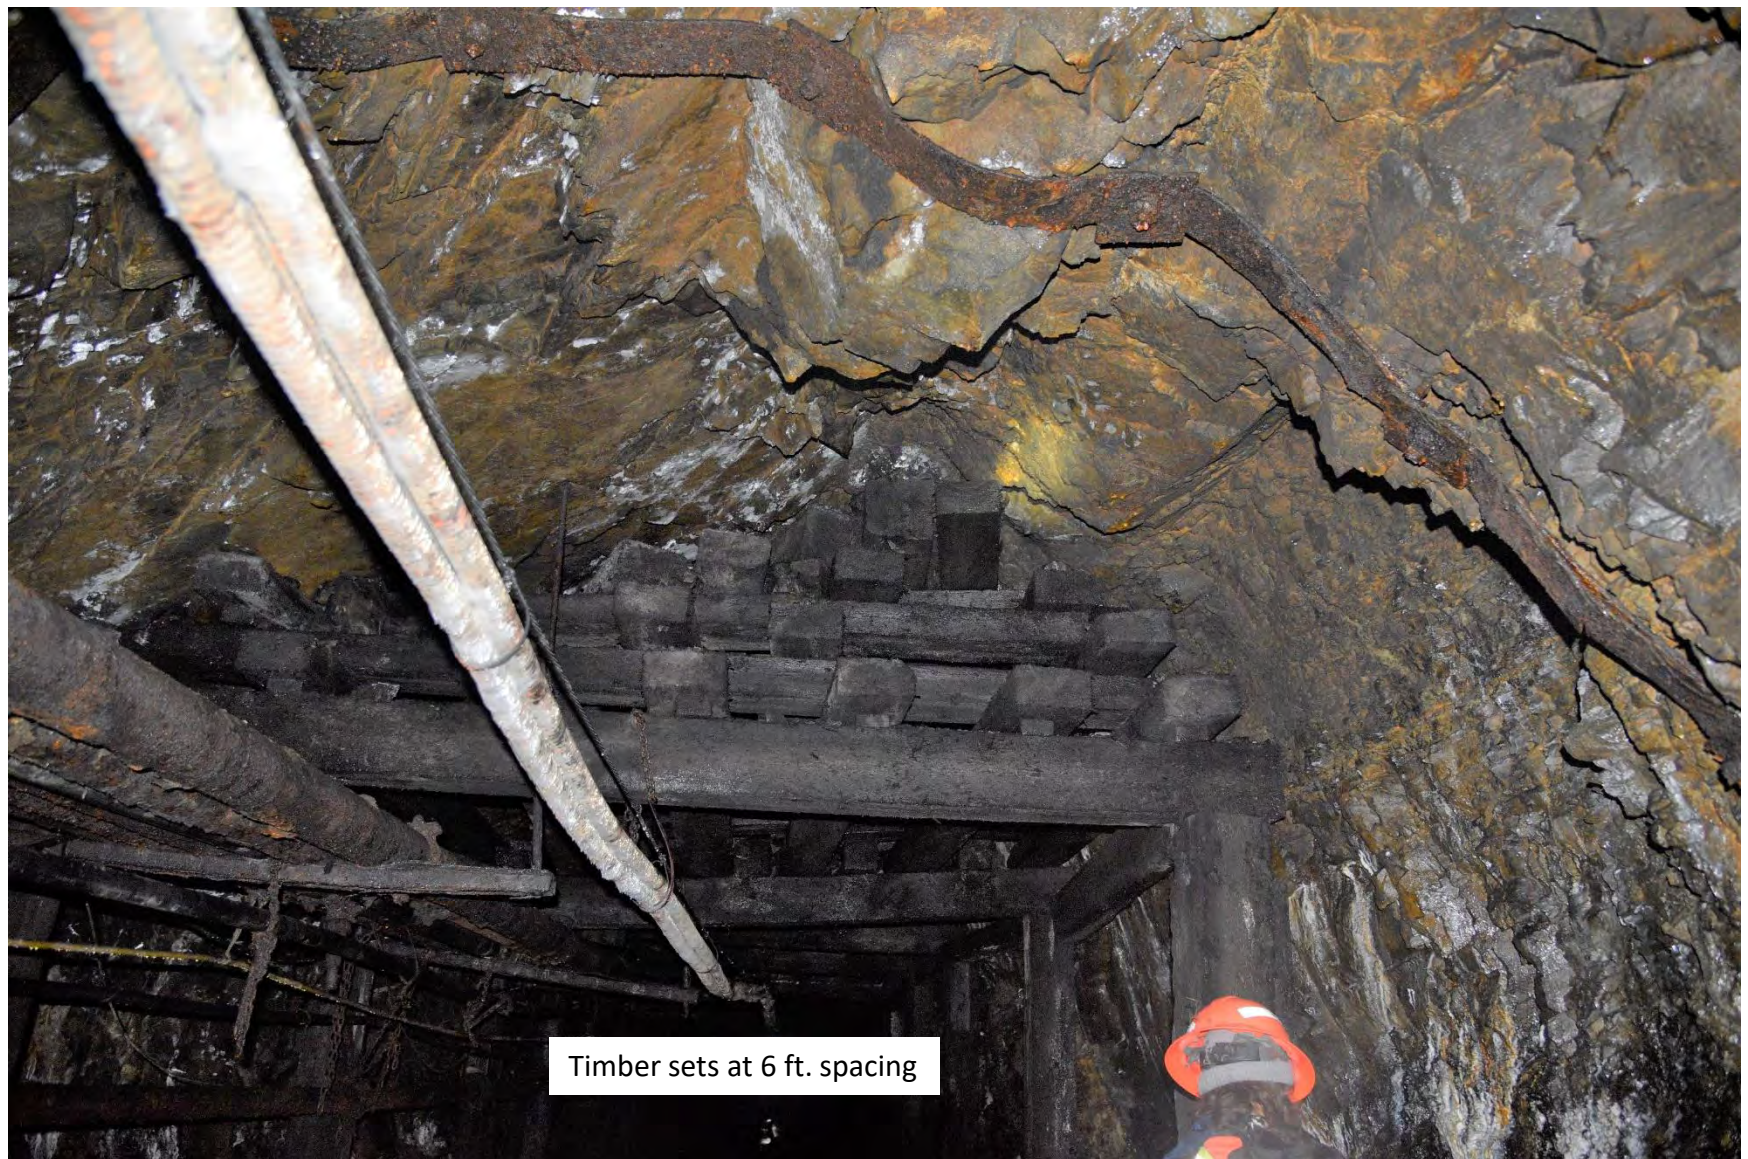
Timber sets at 6 ft. spacing

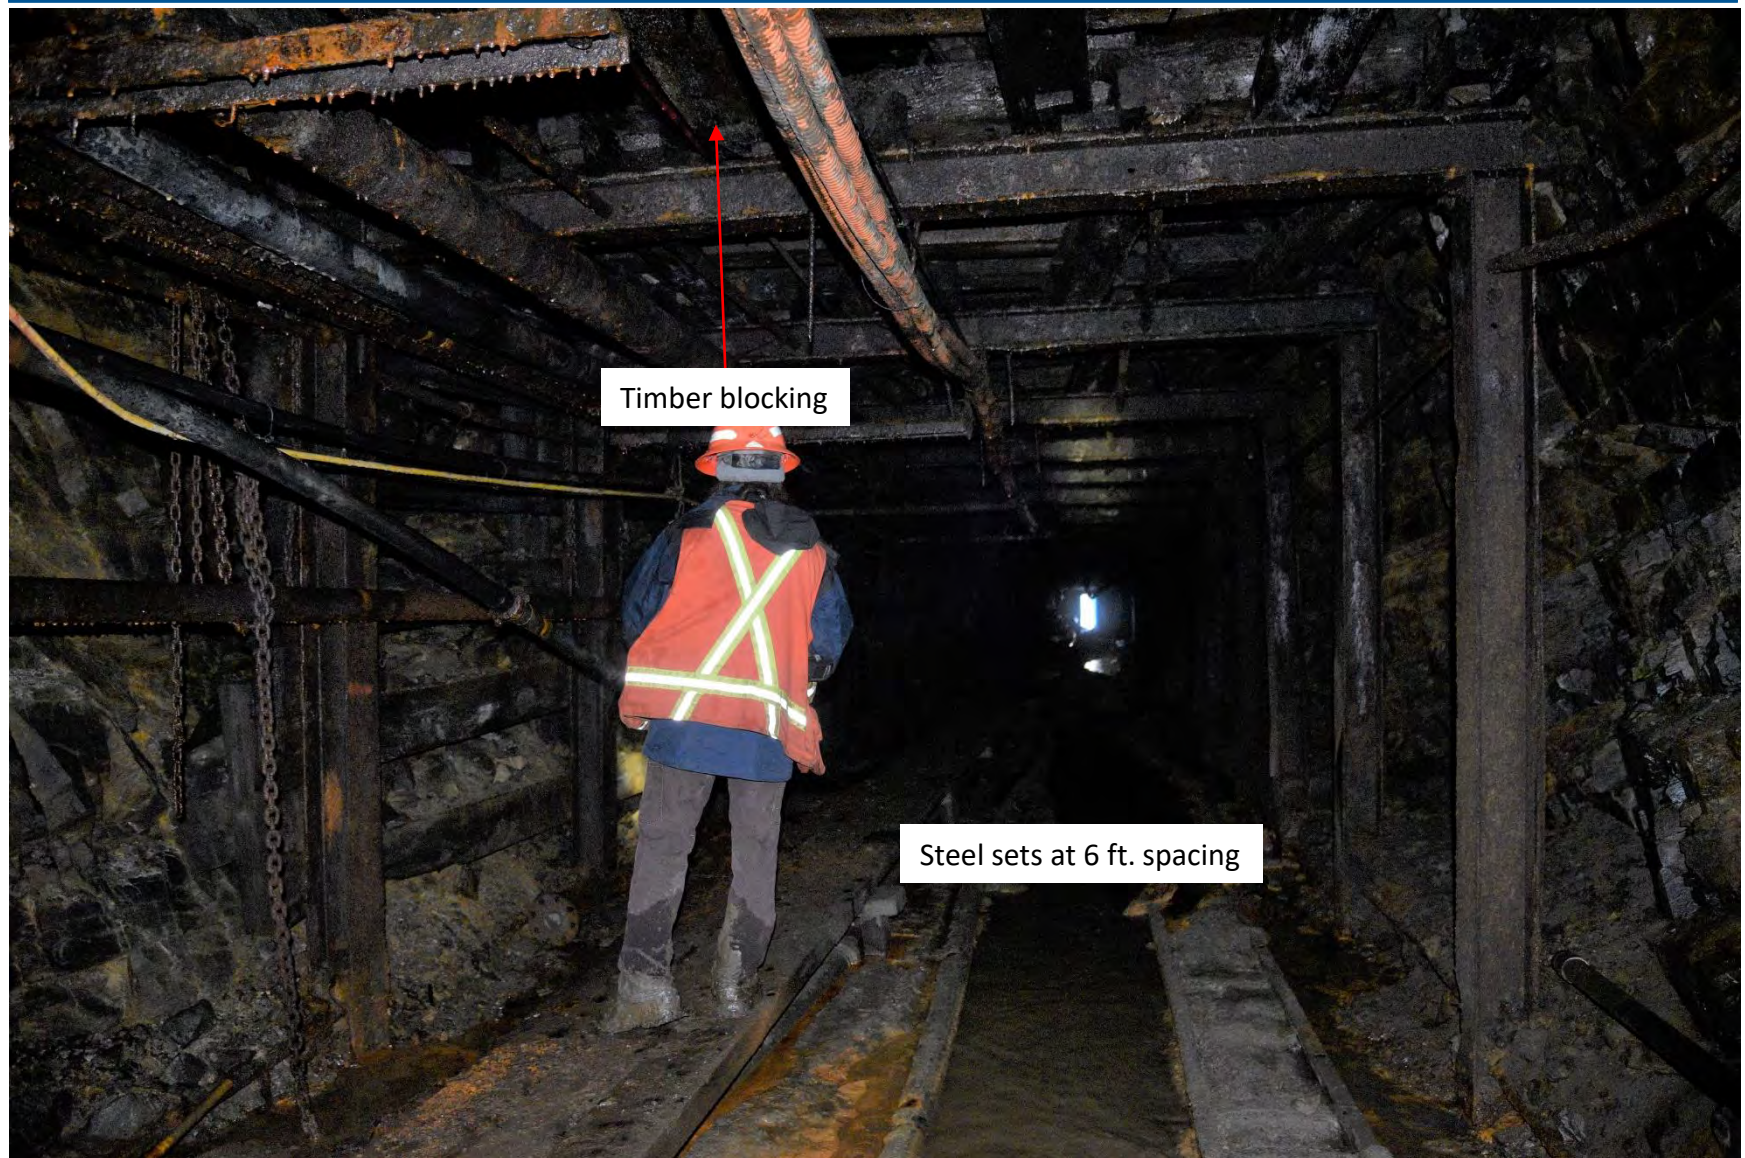
Timber blocking

Steel sets at 6 ft. spacing
