**FINAL REPORT: LONG-TERM
MONITORING (YEAR 2) –
GORDON LAKE GROUP OF
SITES**

Prepared for:
Public Services and Procurement
Canada on behalf of
Crown-Indigenous Relations and
Northern Affairs Canada

Prepared by:
Stantec Consulting Ltd.
40 Highfield Park Drive, Suite 102
Dartmouth, NS B3A 0A3

March 31, 2021

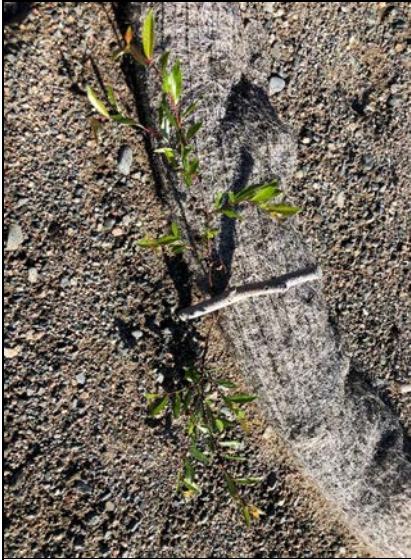
Photo 1

Willow growth at TSCA.

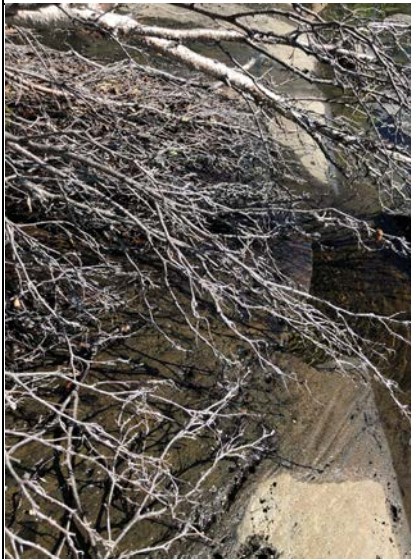
Photo 2

Potential seepage water east of TSCA.

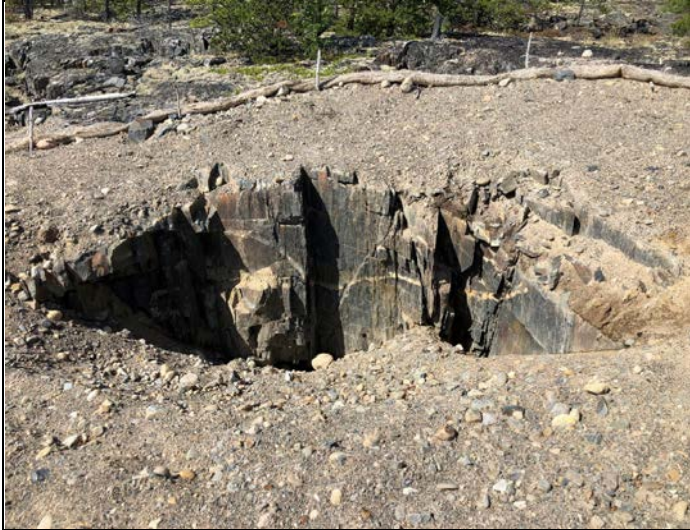
Photo 3

Subsidence at Kidney Portal. CIRNAC painted the line shown in 2019.

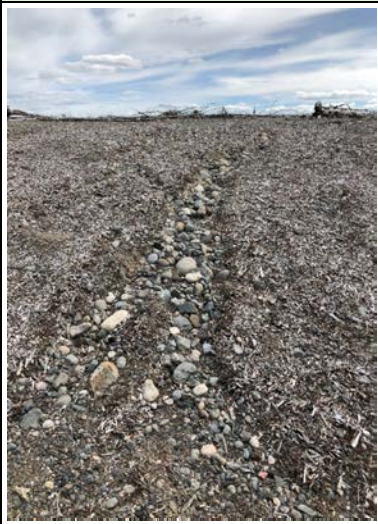
Photo 3
		TSCA minor erosion gully.

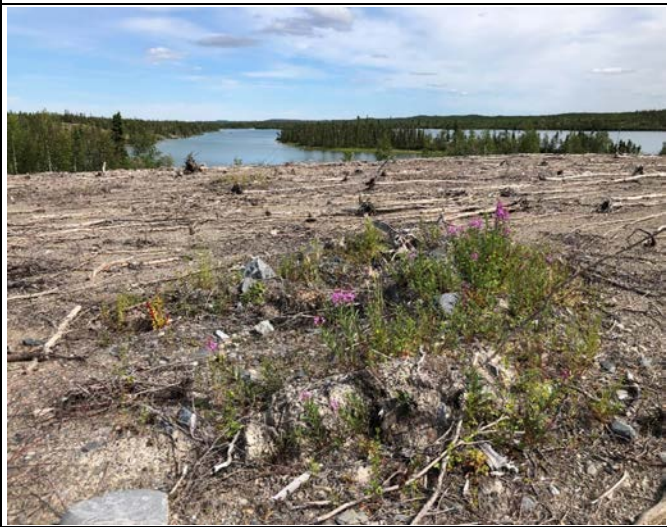
Photo 4
		TSCA vegetation.

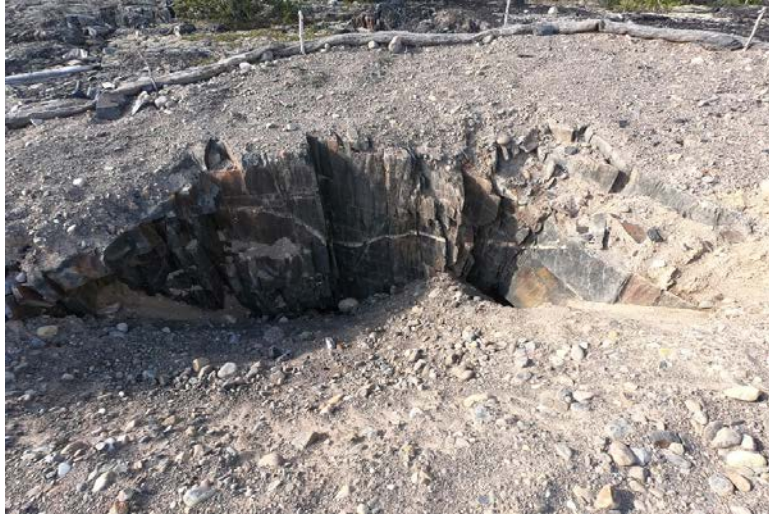
Photo 3

QA and Specialist Services:	
QA and/or Specialist:	None
Activity Completed:	None
Communications / Submissions:	
A predetermined check-in procedure was determined with the Stantec project team prior to the field visit and was completed at 12:00 via satellite phone.	
Summary of Findings (including notes on Wildlife)	
<u>General notes</u> - Stantec geotechnical engineer inspected the TSCA at Camlaren including hand dug test pits to determine cover thickness at areas of potential concern. The cover on the west embankment is not sufficient, in some areas it is less than 200 mm, in one spot the liner was exposed. This is a trigger for repairs. Remedial options to be discussed. - CIRNAC representatives were onsite at Camlaren to complete inspections and shadow geotechnical inspection. - The ditches of the TSCA were inspected and clear of debris. - Monitoring wells are all in excellent condition (reference Photo 5 and Photo 6). - A visual inspection of Kidney Pond Portal subsidence was completed by Stantec. Cover material has subsided exposing approximately 2.0m and the portal entry is visible (reference Photo 3). - Vegetation growth was observed at Kidney Pond (reference Photo 4).

Slumping at Kidney Portal. Facing northwest.

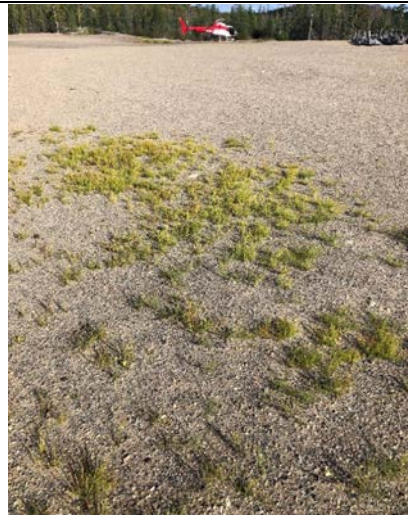
Photo 4

Vegetation growth at Kidney Portal sand cover.

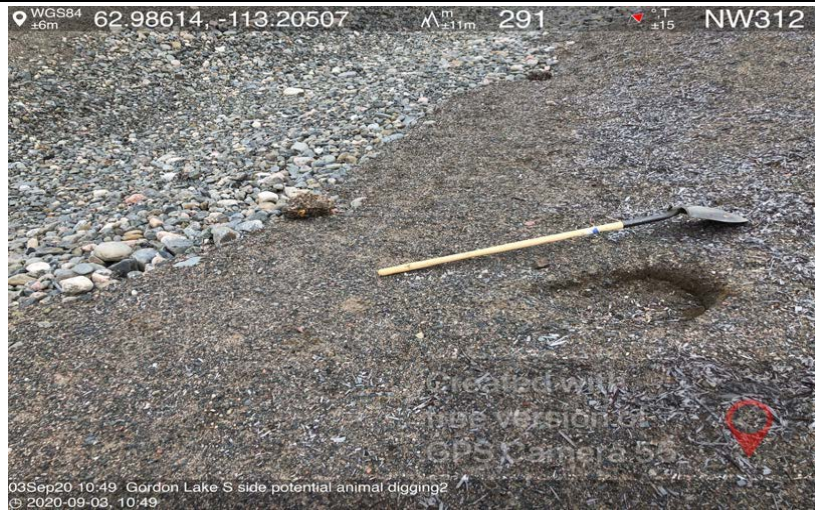
Photo 7

Potential animal digging along south side of TSCA.

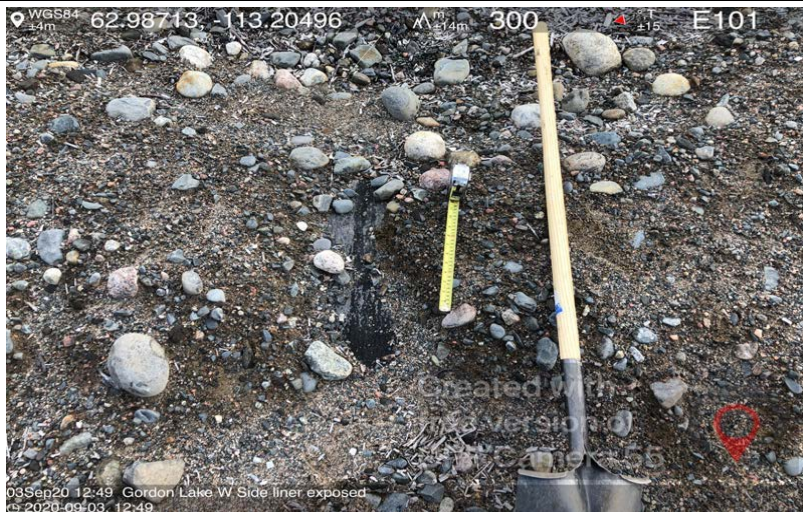
Photo 8

Exposed liner on the west side of the TSCA.

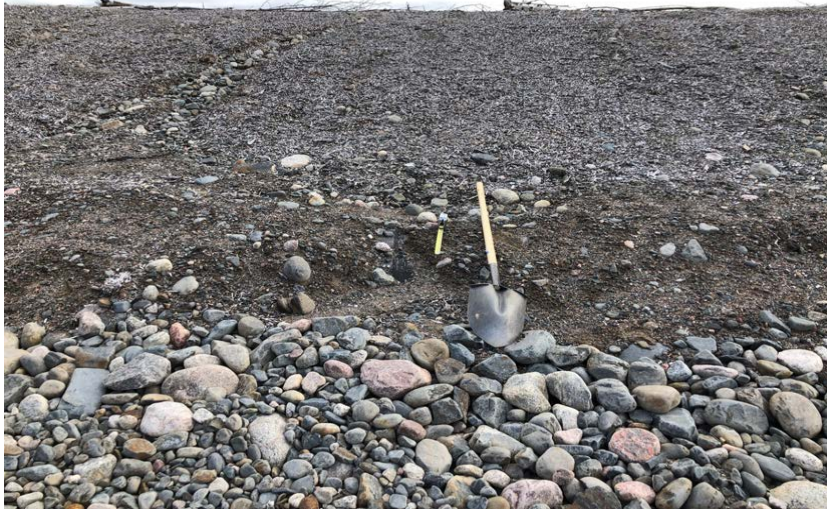
Photo 9

West side showing erosion and exposed liner on the west side of the TSCA.

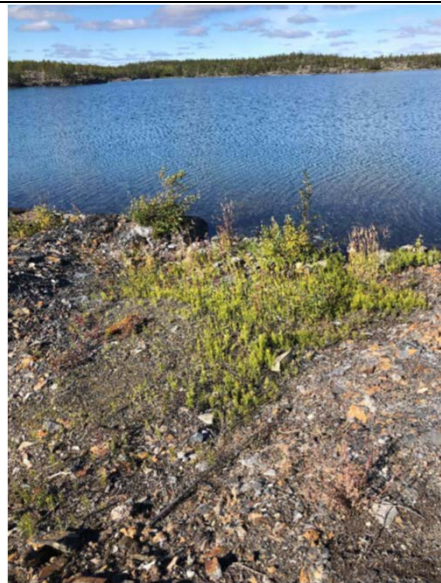
Photo 6

QA and Specialist Services:	
QA and/or Specialist:	None
Activity Completed:	None
Communications / Submissions:	
A predetermined check-in procedure was determined with the Stantec project team prior to the field visit and was completed at 12:00 via satellite phone.	
Summary of Findings (including notes on Wildlife)	
<p>General notes:</p> <ul style="list-style-type: none"> - VB#1, VB#2, VB#3, VT#1 and VT#2 data loggers at the TSCA were downloaded and their batteries replaced. - Vegetation growth was observed at the rough and loose revegetation area at Zenith Portal (reference Photo 3). - Vegetation growth was observed at the trench at Treacy (reference Photo 6). - Fish were observed while flying over Gordon Lake.

Vegetation growth at Treacy trench.
Facing west.

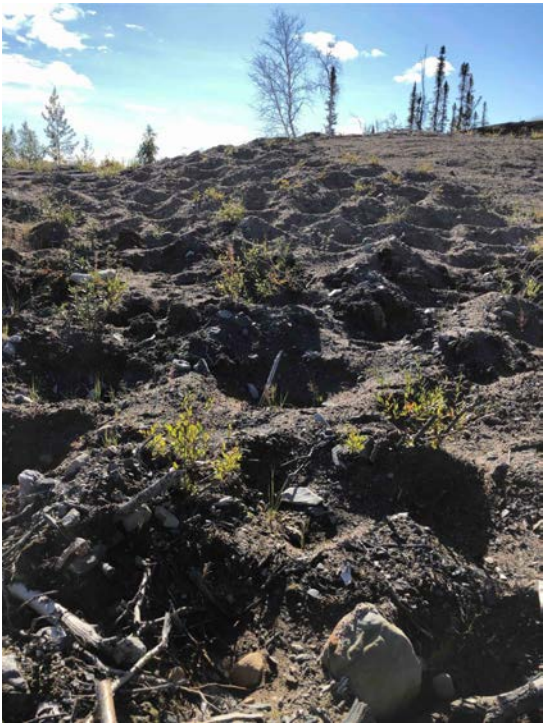
Photo Location: Revegetation efforts on Zenith Shaft			
Direction: Looking southeast			
Survey Date: 9/4/2020			
Comments: Viewpoint 3 (Figure A2.4, Appendix A)			
Photograph ID: 4

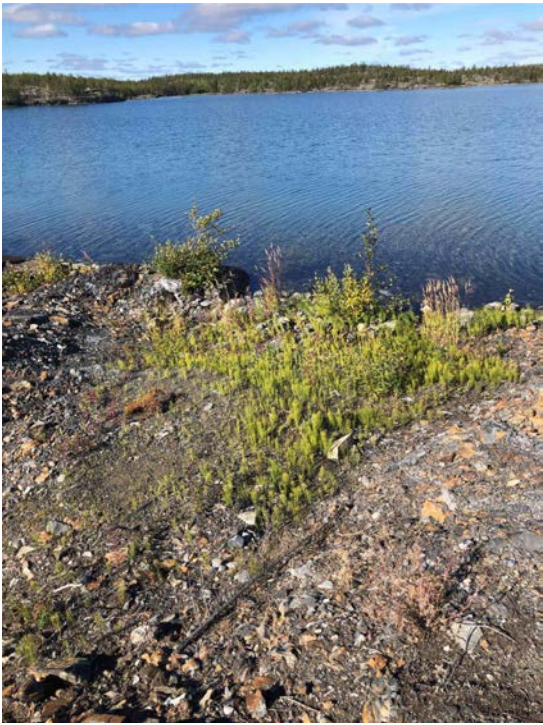
Photo Location: Vegetation growth at Treacy			
Direction: Looking northwest			
Survey Date: 9/4/2020			
Comments: Viewpoint 3 (Figure A7.2, Appendix A)
